**Region 6 - Enforcement & Compliance Assurance Division**  
**INSPECTION REPORT**

| Inspection Date(s): | 06/28/2023 | |
| Regulatory Program(s) | AWIA/SDWA | |
| Facility Name: | <b>Hot Springs Utilities</b> | |

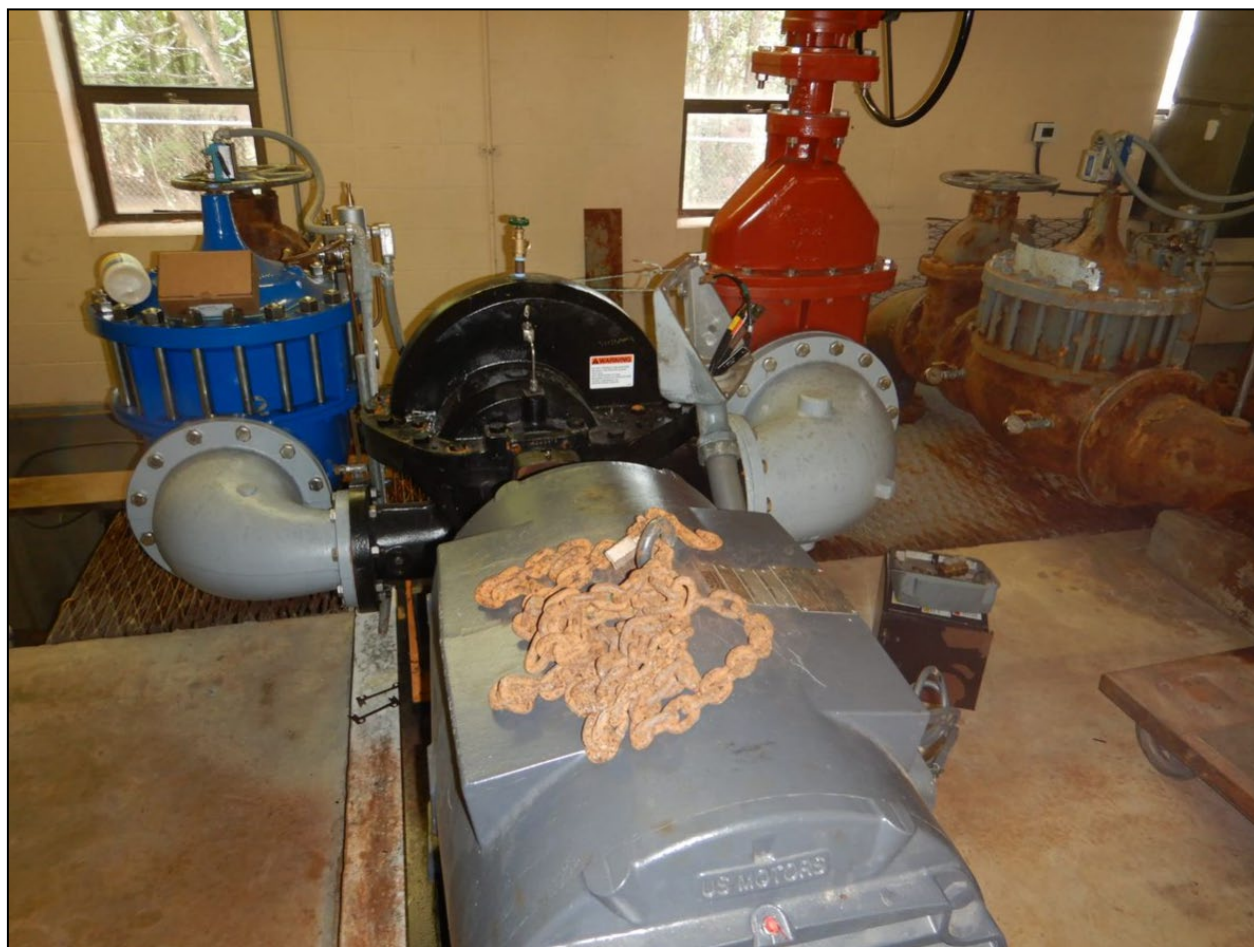
**Photograph 38. Music Mountain Pump Station** View of a newly replaced pump inside of the Music Mountain Pump Station.

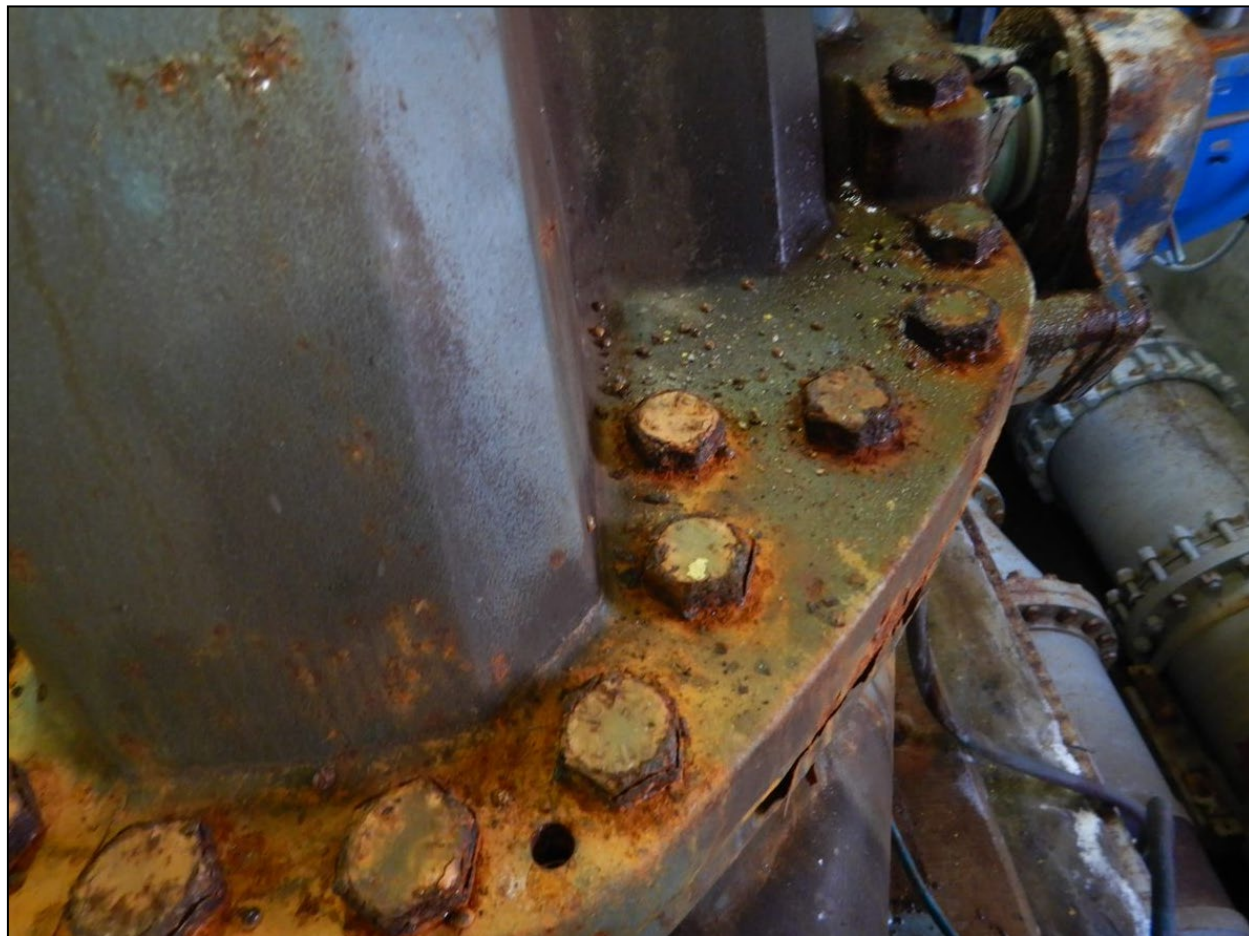
**Photograph 39. Pump No. 4, Music Mountain Pump Station** View of the metal loss/corrosion that was taking place on the bolts and flange of Pump No. 4. The metal also appeared to be wet.

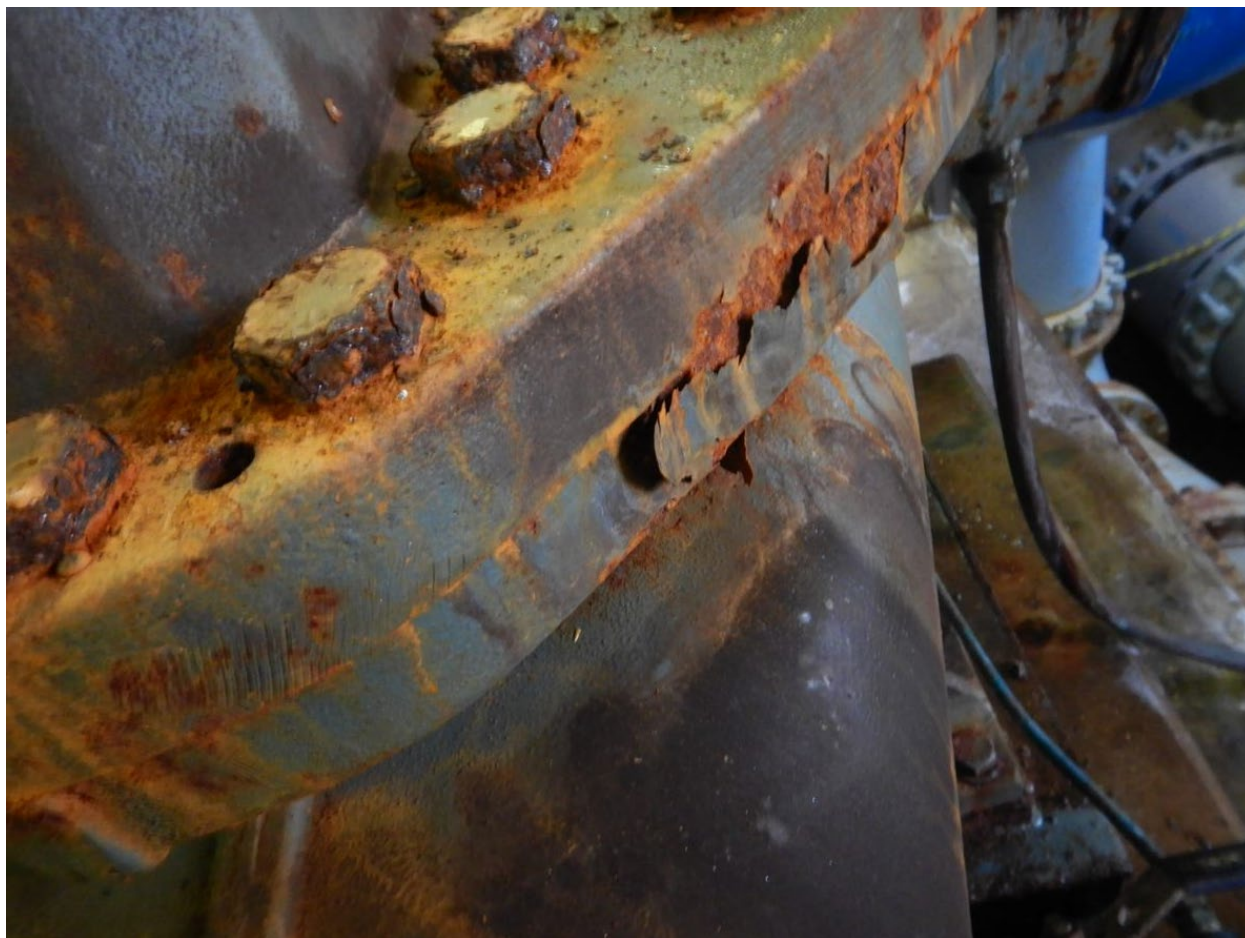
**Photograph 40. Pump No. 4, Music Mountain Pump Station** Close up view of the metal loss/corrosion that was taking place on the bolts and flange of Pump No. 4. The metal also appeared to be wet.

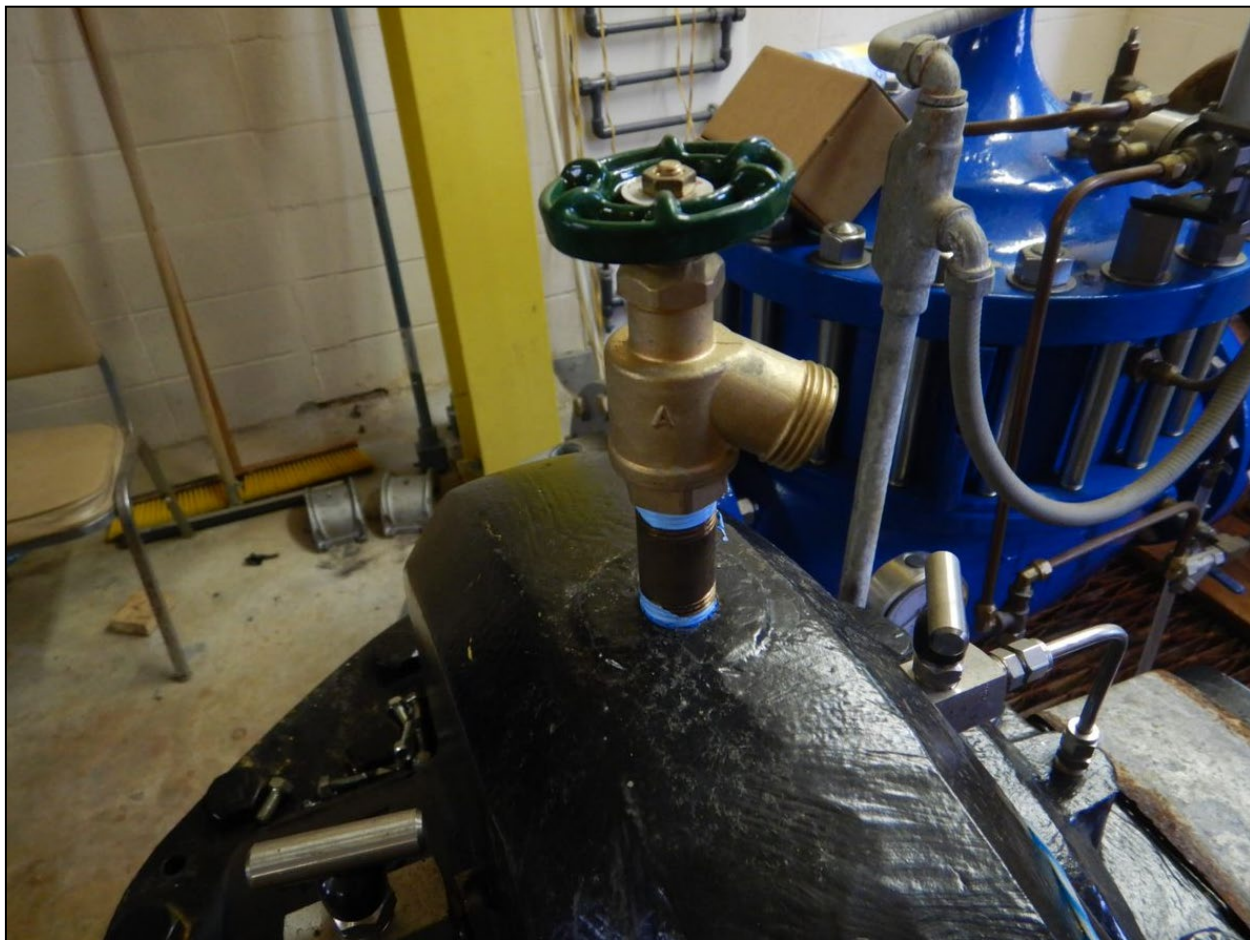
**Photograph 41. Threaded Hose Tap, Music Mountain Pump Station** View of a threaded hose tap without backflow prevention that was extending off of a pump in the Music Mountain Pump Station.

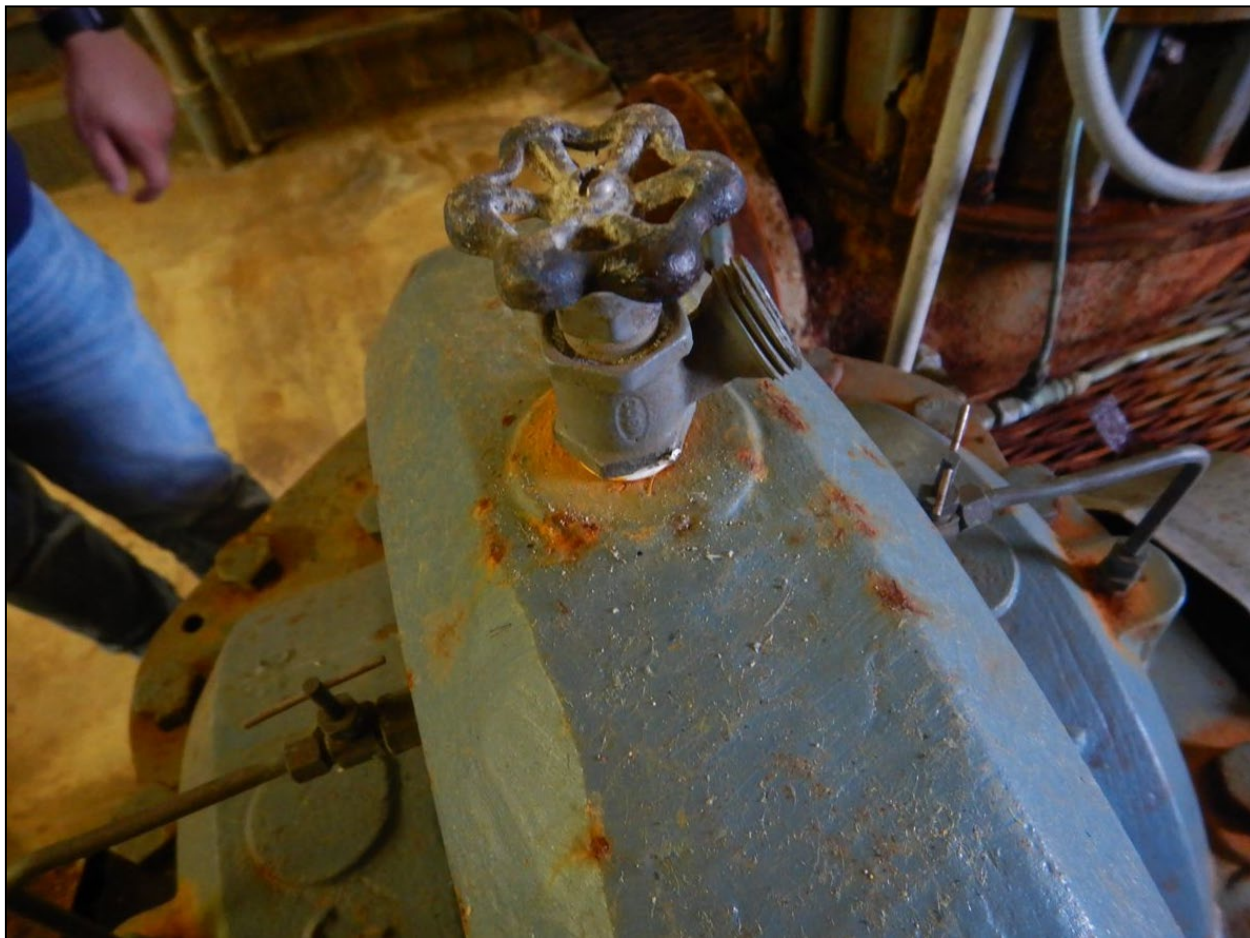
**Photograph 42. Threaded Hose Tap, Music Mountain Pump Station** Additional view of a threaded hose tap without backflow prevention that was extending off of a pump in the Music Mountain Pump Station.

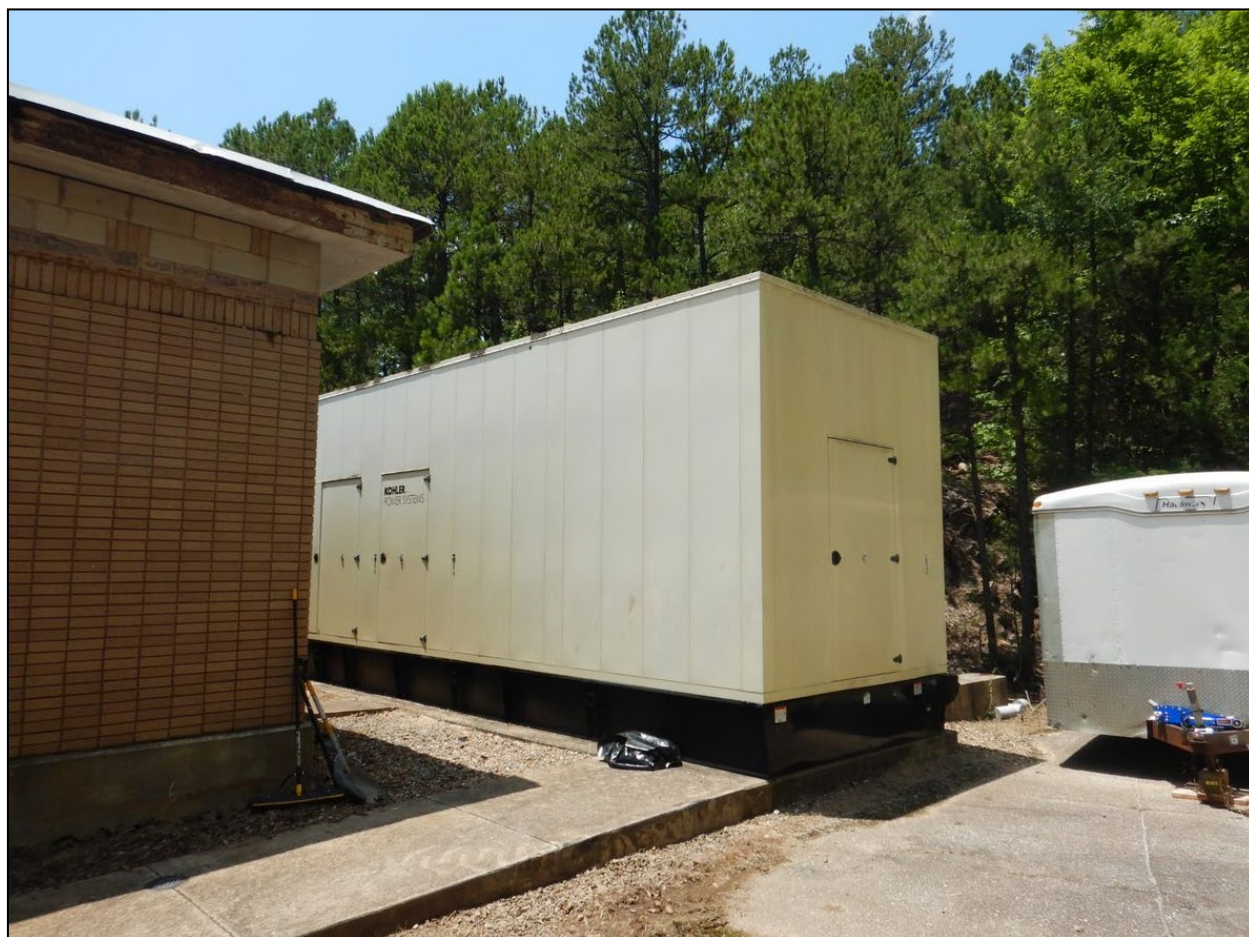
**Photograph 43. Backup Generator, Music Mountain Pump Station** View of an emergency backup generator that was present outside of the Music Mountain Pump Station. The Water Production Manager stated that it would turn on automatically in the event of a power outage.

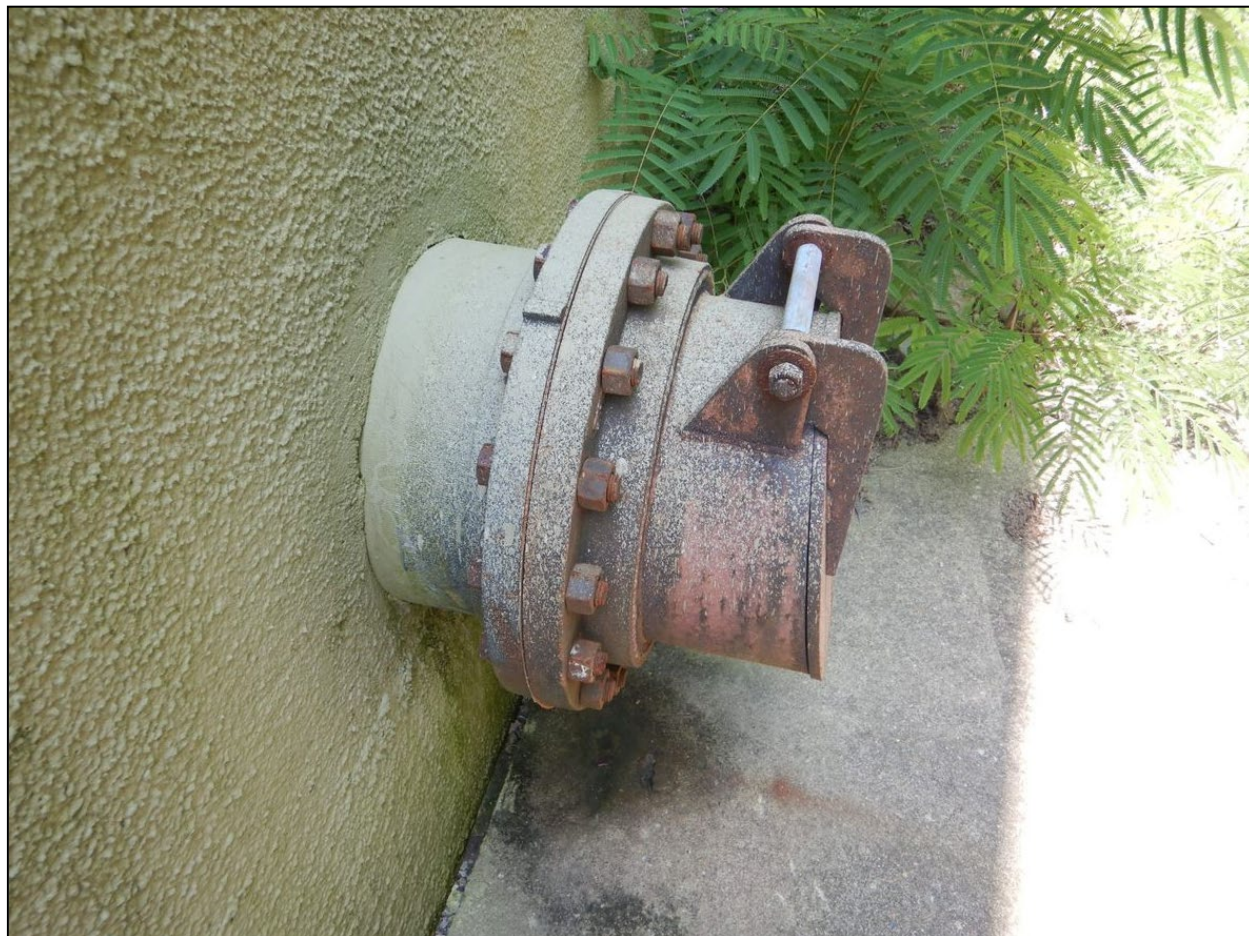
**Photograph 44. Overflow Pipe, Music Mountain Water Storage Tank** View of the overflow pipe that extended from the tank. The opening was covered by a flapper with a tight seal.

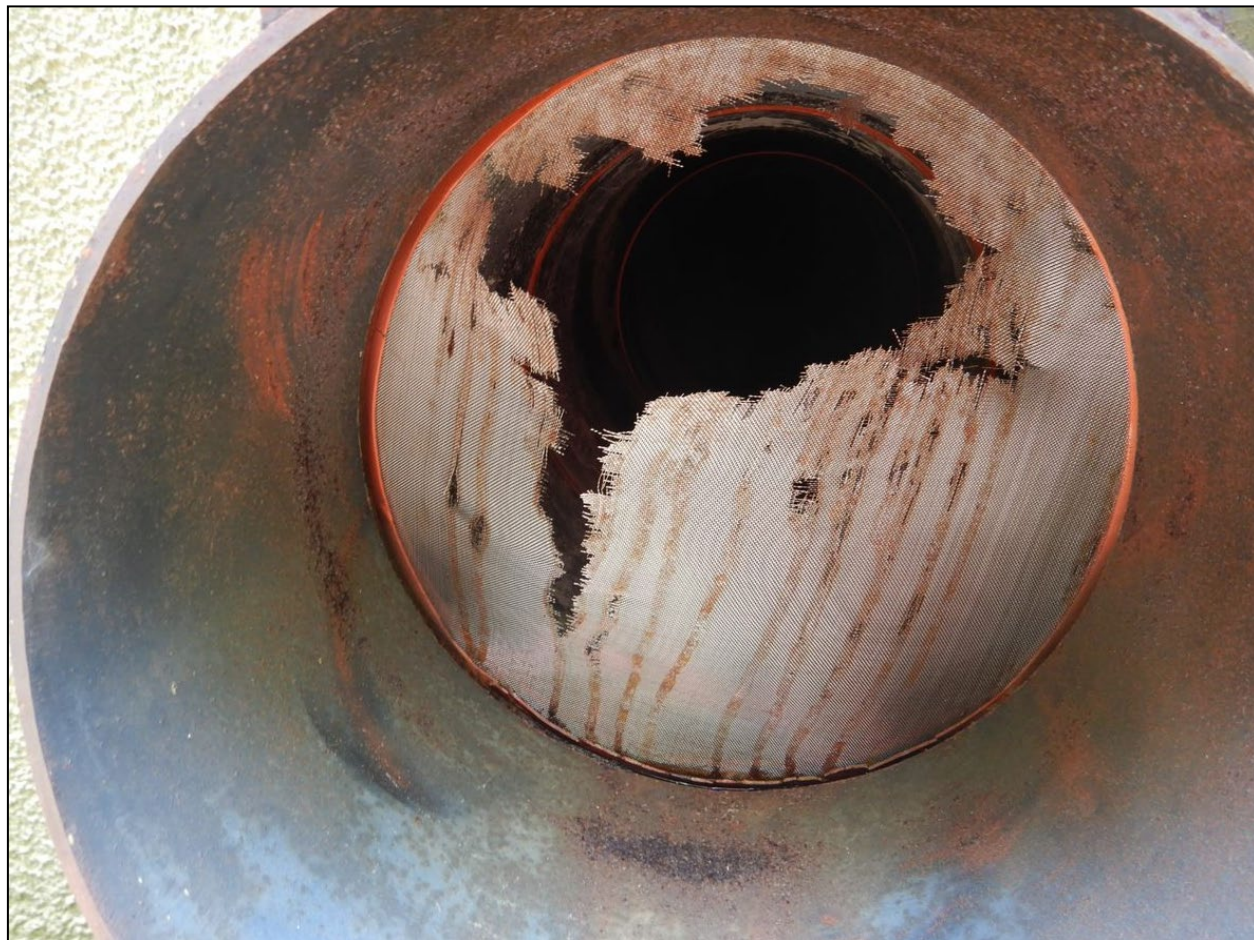
**Photograph 45. Overflow Pipe, Music Mountain Water Storage Tank** View of the inside of the overflow pipe that extended from the tank. The mesh screen under the flapper was ripped and had a large hole.

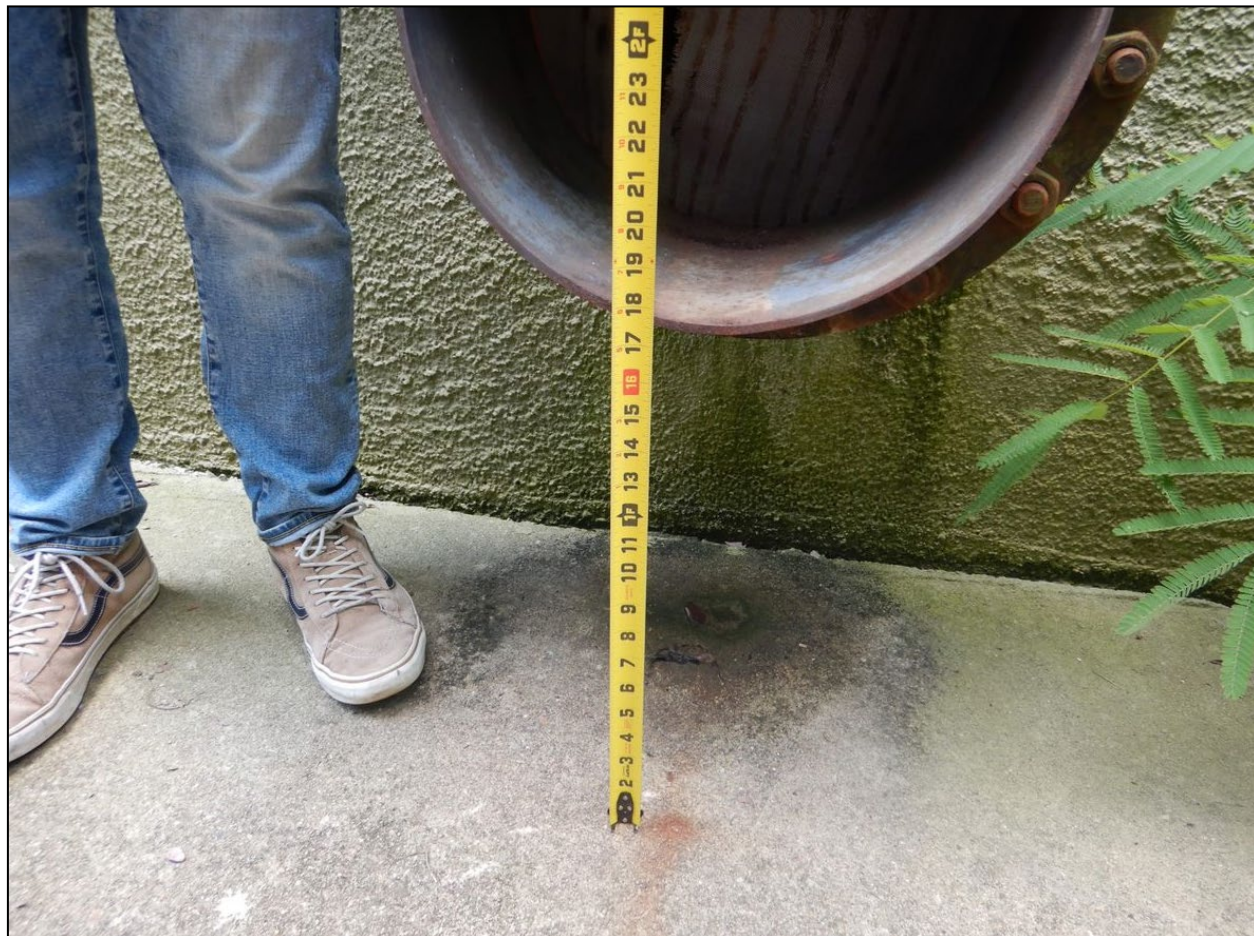
**Photograph 46. Overflow Pipe, Music Mountain Water Storage Tank** View of the end of the overflow pipe extending from the Music Mountain Water Storage Tank. The pipe terminated over a concrete splash pad, but it was not two pipe diameters above the pad.

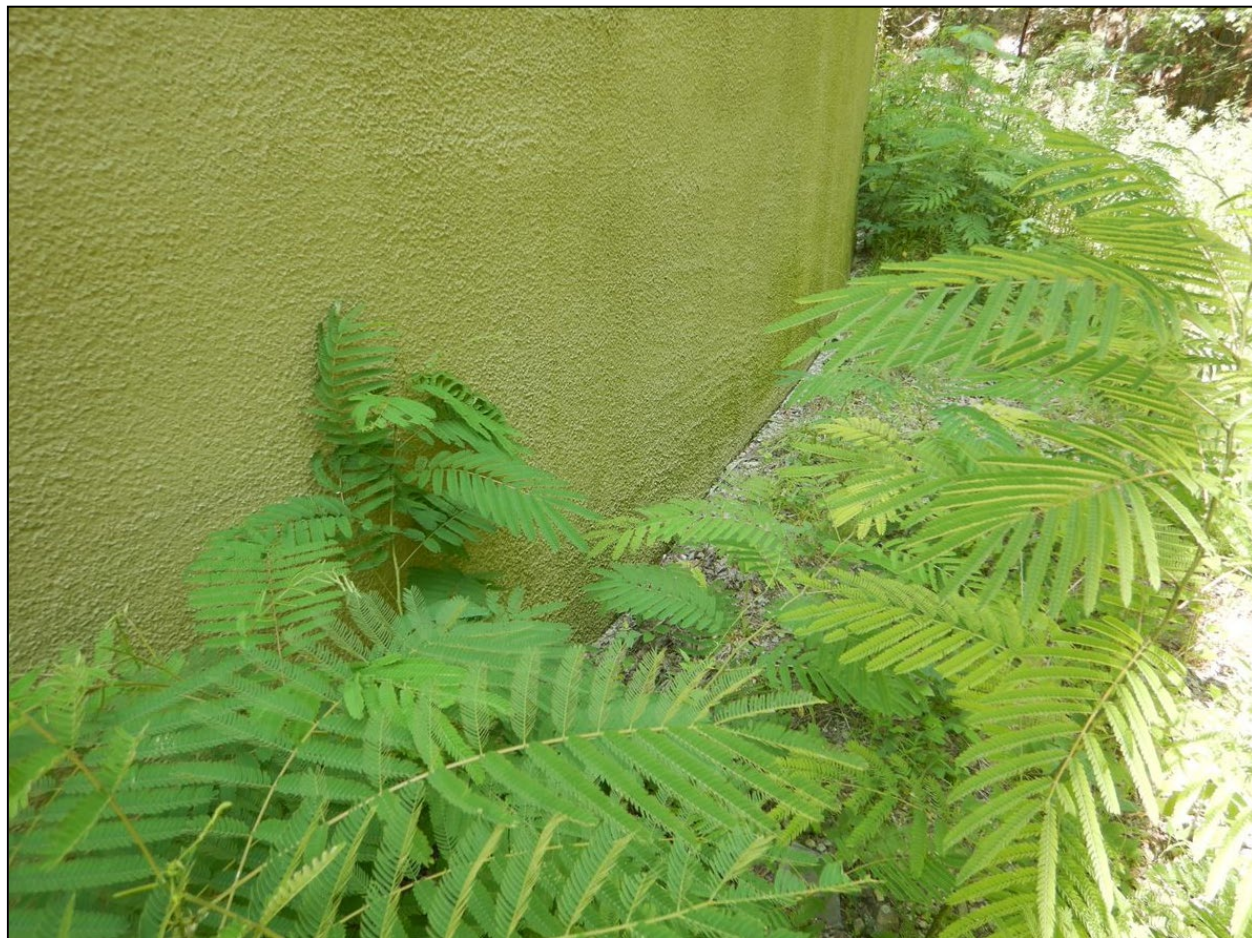
**Photograph 47. Music Mountain Water Storage Tank** View of the back of the Music Mountain Water Storage Tank. There were plants growing against the back wall of the tank and System representatives stated that the mowing crews had not been mowing behind the tank.
