## **RCRA Inspection Report**

NCI Group, Inc. DBA Metal Coaters of Georgia (Metal Coaters)  
1150 Marietta Industrial Drive NE  
Marietta, Georgia 30062

June 3, 2021

**COMPLIANCE EVALUATION Inspection**

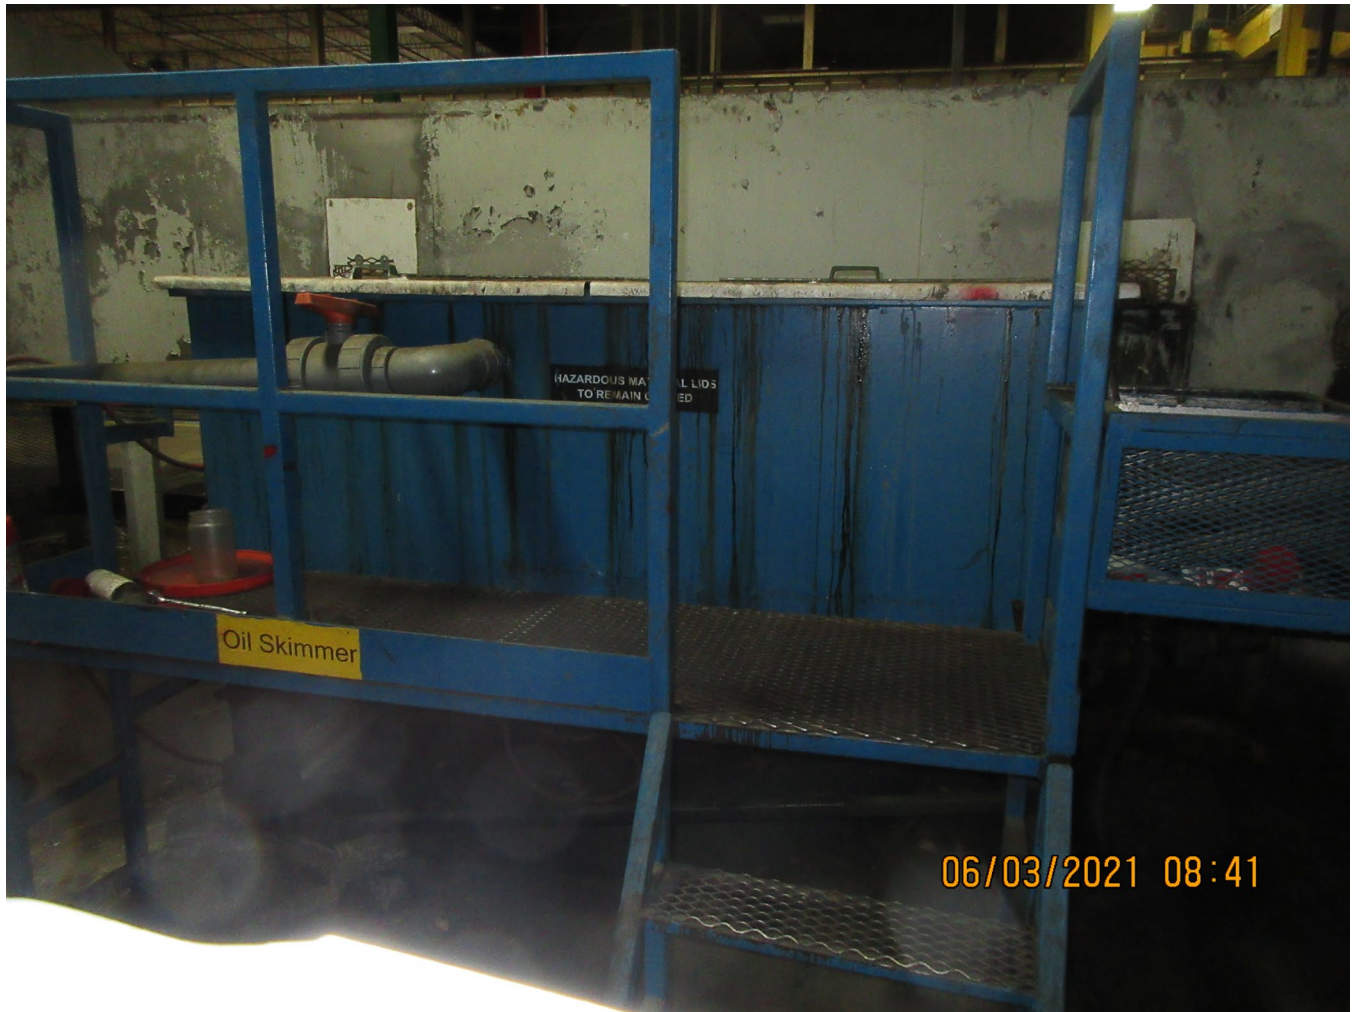
Oily water is separated from the baths at this location via gravity oil/water separation vessels (Photos 1 and 3). Concentrated oily water is then skimmed off the surface of separation vessels and piped into a 55-gallon drum (Photo 2) within a satellite accumulation area. The drum was labeled with the words “Hazardous Waste” and marked with a D007 characteristic hazardous waste code indicating that it was hazardous for chromium. Other waste waters from this location are piped to the facility’s wastewater treatment plant

Photo 1 – Oil Skimming tank in Chemical Treatment Tank Area

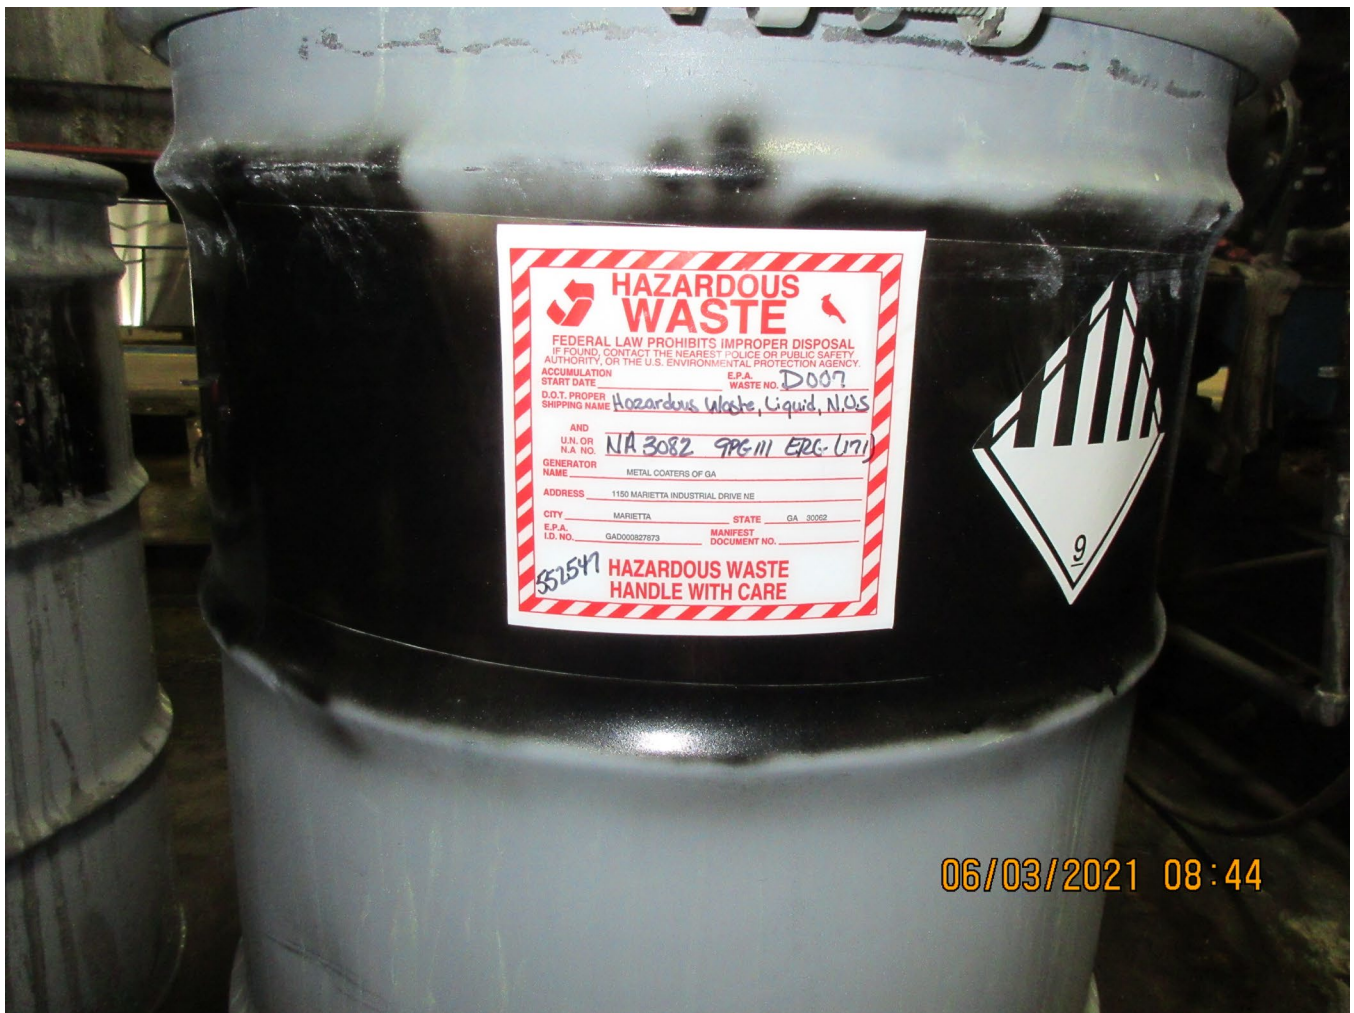
Photo 2 – Hazardous waste oil generated from oil skimming tank shown in Photo 1

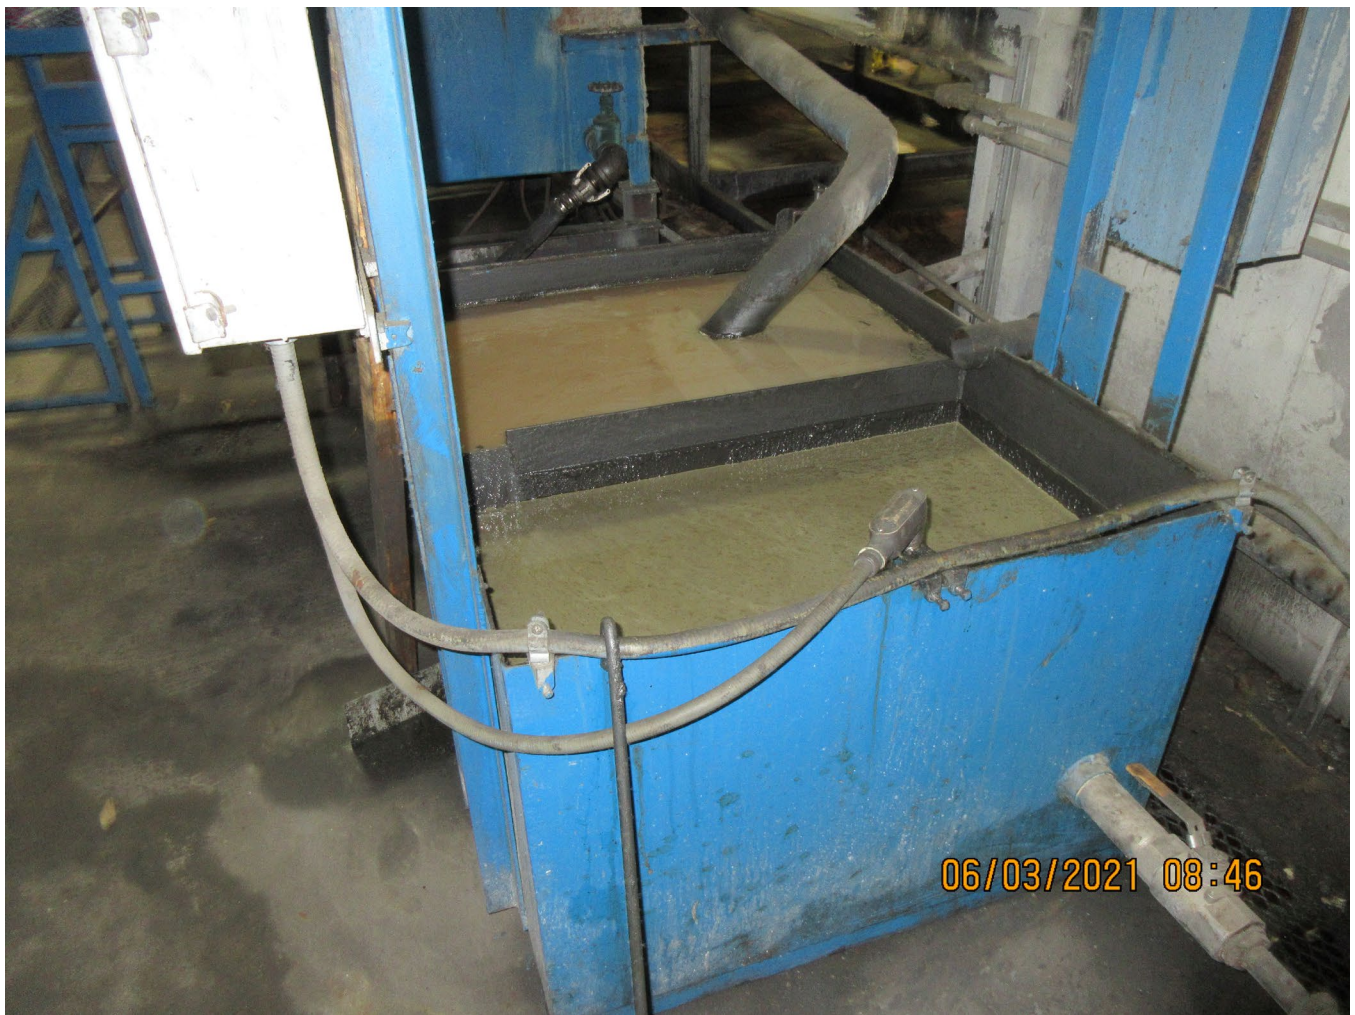
Photo 3 – Oil Separation tanks in Chemical Treatment Area
