**Region 6 - Enforcement & Compliance Assurance Division**  
**INSPECTION REPORT**

| Regulatory Program(s) | NPDES CAFO | |
| Company Name: | W.H.B. Cattle, LP | |
| Facility Name: | Braum's Dairy | |

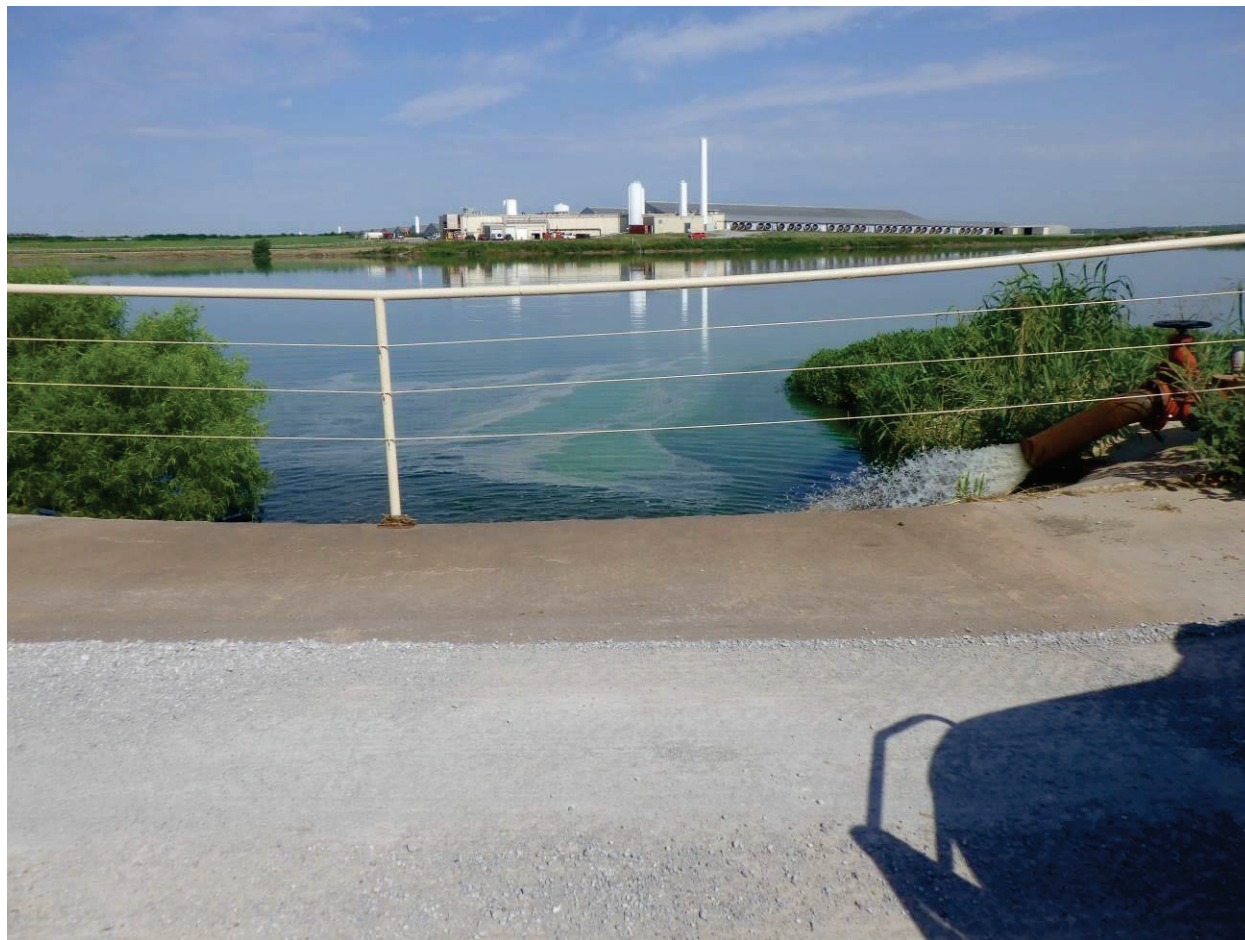
Description: This is a photo of the RO Pond. A rusty pipe on the right side of the photo is used to fill the RO Pond on the east side of the pond with water from Snake Creek Pond. View is toward the west-northwest.

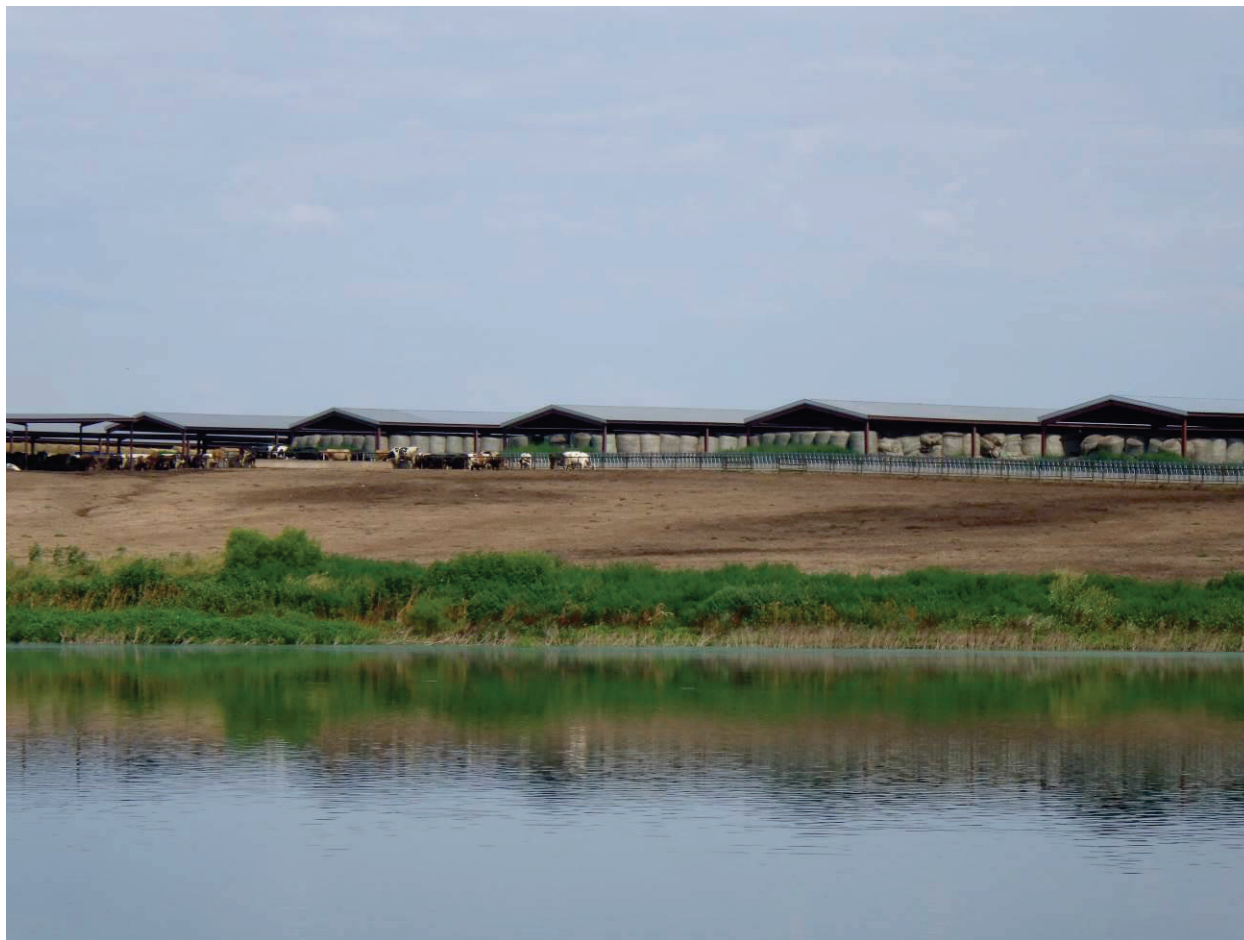
Description: Cattle pens located on the opposite shore as the discharge seen in Photos 38-41. These pens are located west of the Sample 3 location. The pens are sloped toward the RO Pond and will discharge storm water runoff into the RO Pond. Note the stained discharge channels coming off the cattle pens. View is toward the west-northwest.
