**Region 6 - Enforcement & Compliance Assurance Division**  
**INSPECTION REPORT**

| Company Name: | <b>Kirtland Air Force Base, 377<sup>th</sup> Air Base Wing</b> | |
| Facility Name: | <b>Bulk Fuels Facility</b> | |
| Identification/Permit Number: | NM0031216 | |

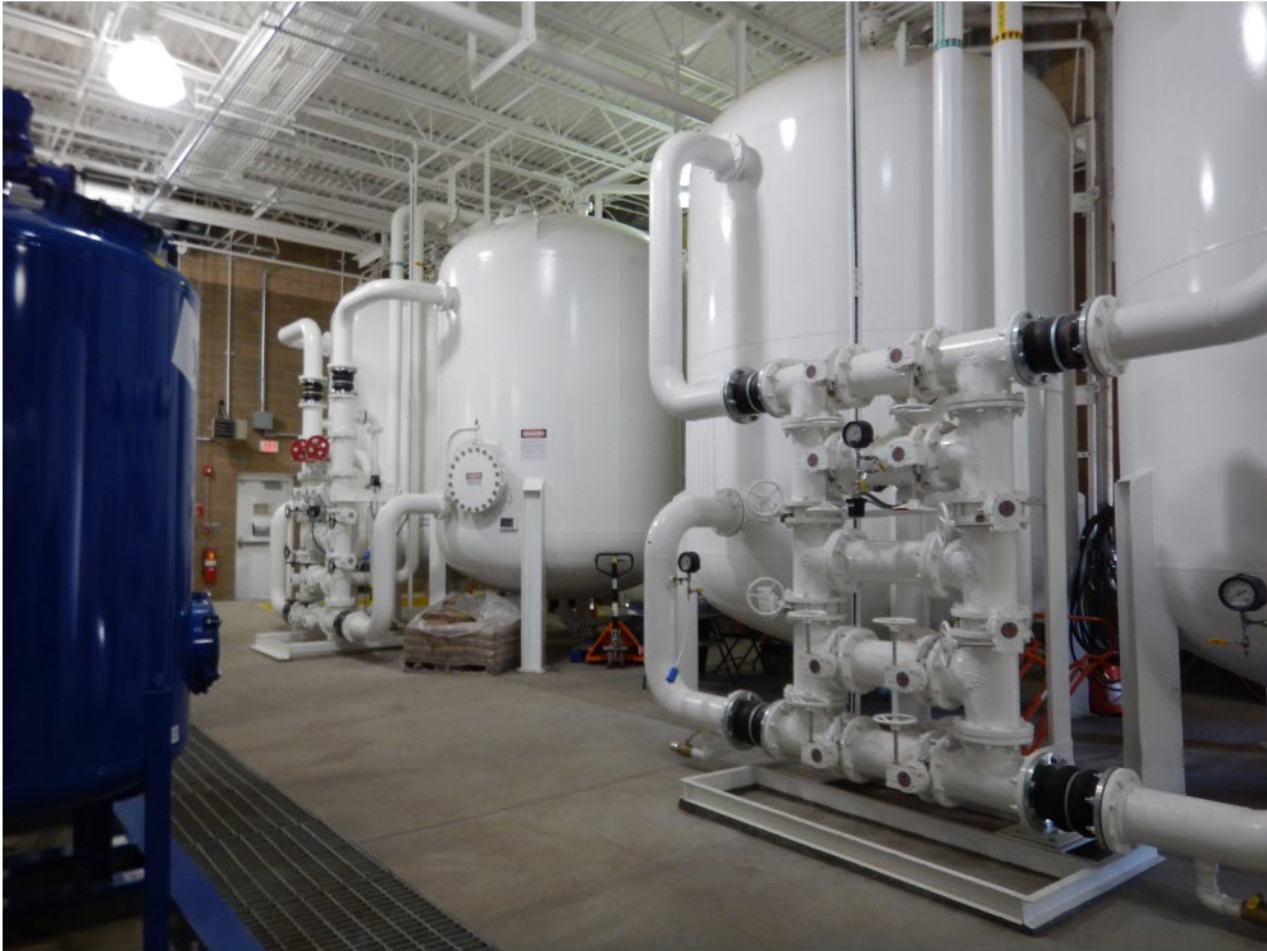
Photo No. 1

Description: View inside the GWTS building, showing the white Granular Activated Carbon (GAC) tanks.

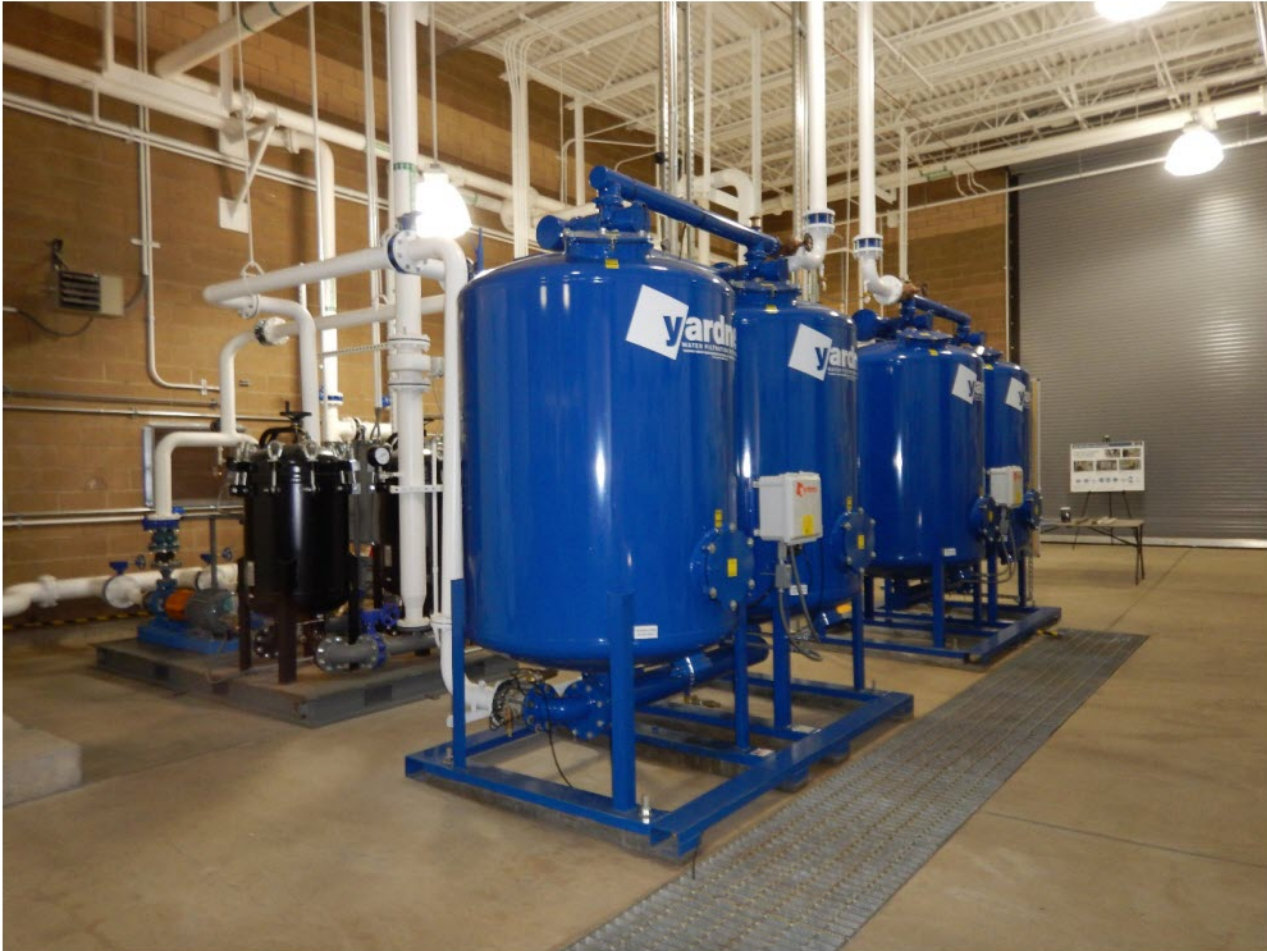
Photo No. 2

Description: View inside the GWTS building, showing the blue sand filter tanks.

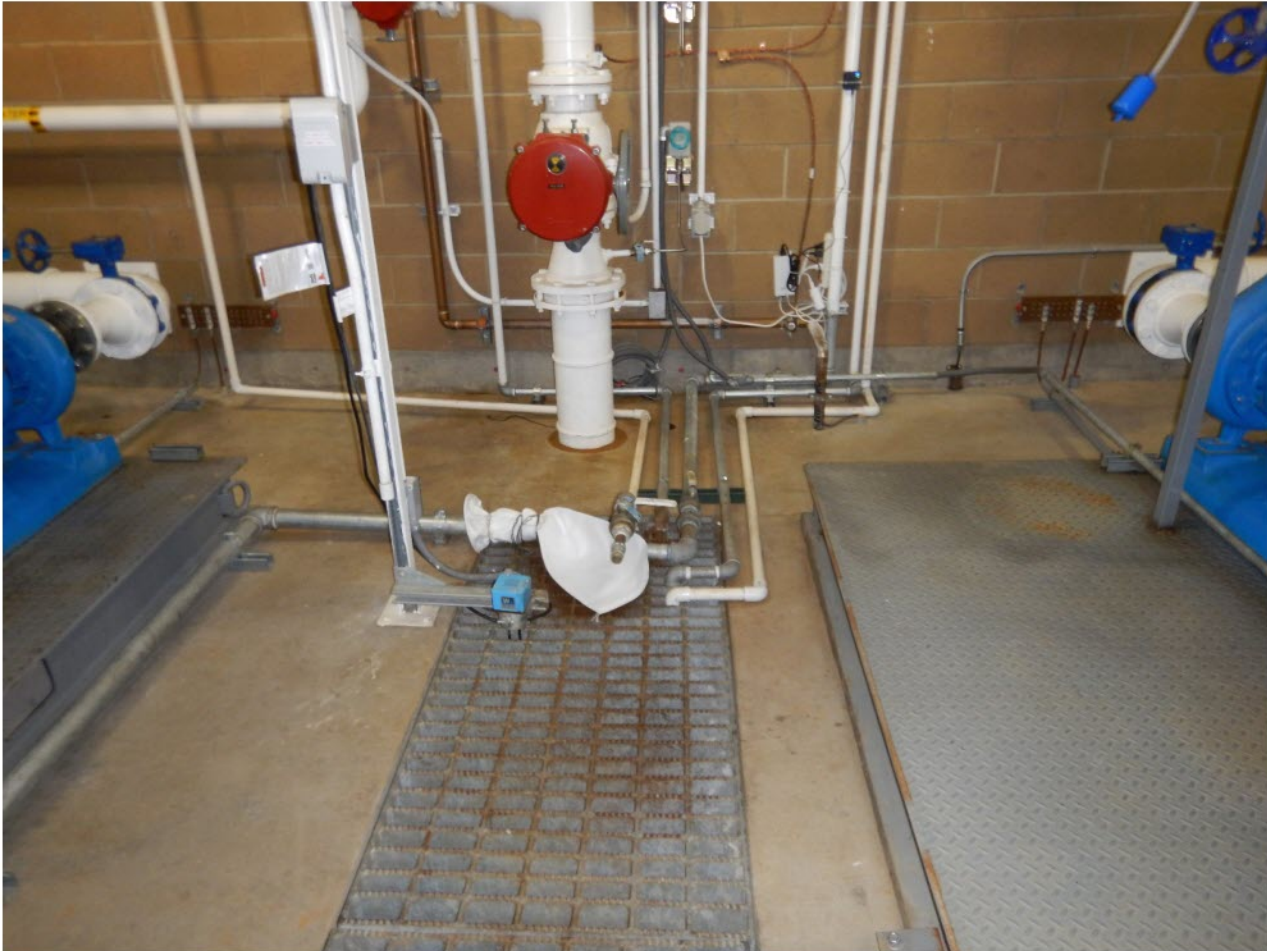
Photo No. 3

Description: View inside the GWTS building, showing the sample ports and floor drain that feeds back to the influent intake.

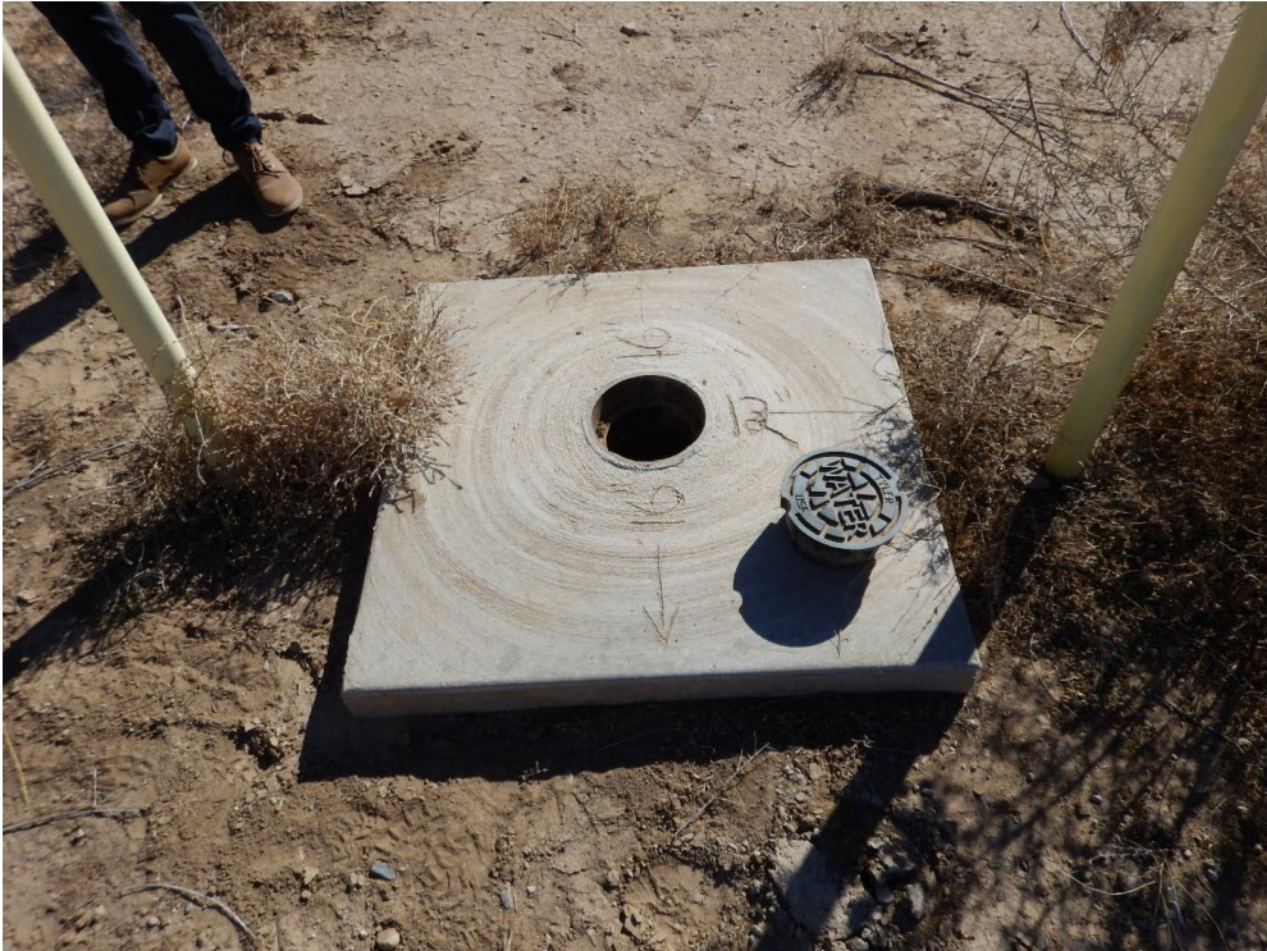
Photo No. 4

- ❖ Control valve to Outfall 001
  - This valve controls whether the water is discharged at the outfall or continues flowing to the golf course pond
  - There are bollards around the concrete valve pad, but no lock or fence around the valve. The valve requires a special key to turn. There is no signage indicating who to contact in case of an emergency.

On the day of the inspection, signage was not present at the control valve to the outfall, or at Outfall 001 to indicate who is responsible for the valve in the case of an accidental release, or to warn pedestrians of the non-potable nature of the potential discharge water. After the inspection, facility personnel confirmed that signage has been added at both locations.

Description: View of the concrete pad and bollards around the outfall control valve.

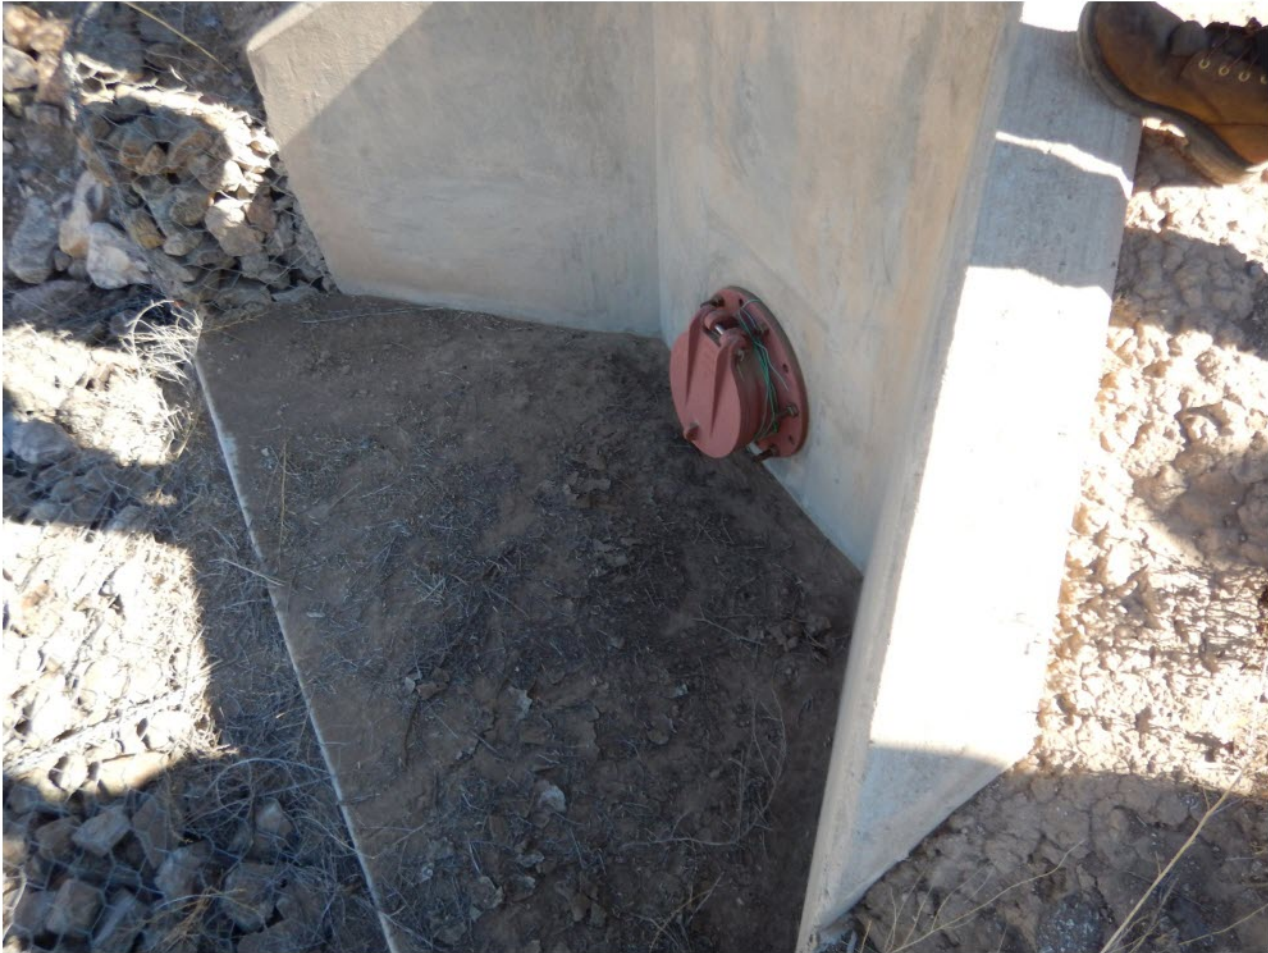
Photo No. 5

- ❖ NPDES Outfall 001
  - No discharge or evidence of prior discharge at outfall. No signage indicating that discharge would be non-potable.
- ❖ Golf course reuse storage pond and water traps

Description: View of Outfall 001.

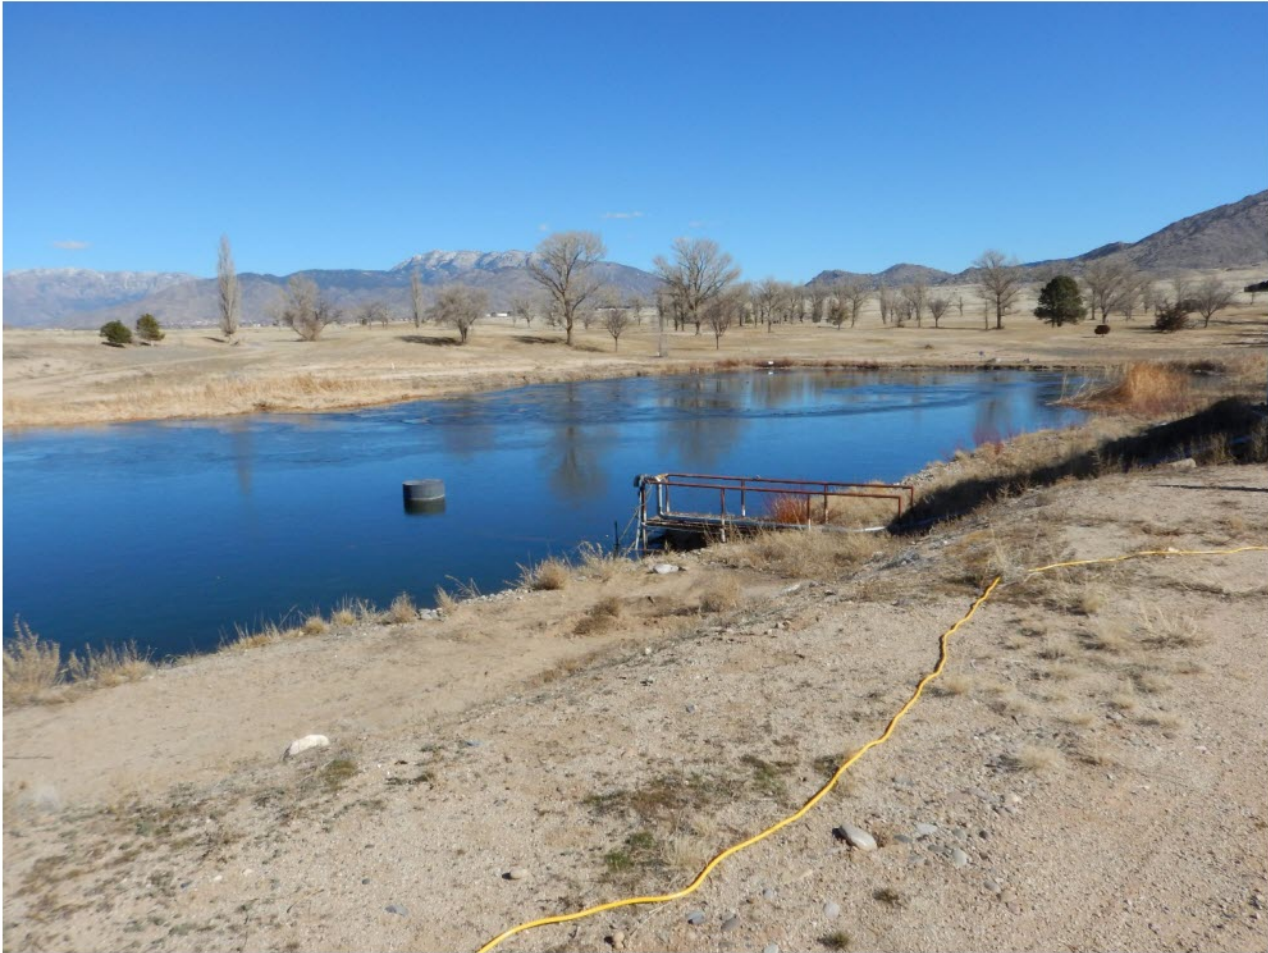
Photo No. 6

The KAFB golf course reuse storage pond capacity is 4 or 5 million gallons. A second injection well (IW-2) was installed in October 2020. On the date of this inspection, all effluent flow was going to IW-2 because the golf course pond was undergoing leak detection. Leak detection is done by not pumping to or from the pond, and calculating water drop versus evaporation and rainfall. Pond maximum level is 4.5 feet.

- The other ponds at the golf course are water traps for playing golf – water can be pumped to them but not from them. High level overflow at each water trap pond goes back to the reuse storage pond. There is no flow meter at the reuse pond, just at the plant and at the injection wells; it is not clear if there is a flow meter present that would measure individual flow to the golf course pond and to Outfall 001, if discharge at the outfall were to occur.

Description: View of the golf course reuse storage pond.
