KN 77-6

NEWARK PLANT

EVALUATION OF ENCLOSED DISCHARGE FILTER PRESS  
TO REDUCE AREA FOGGING

FINAL REPORT

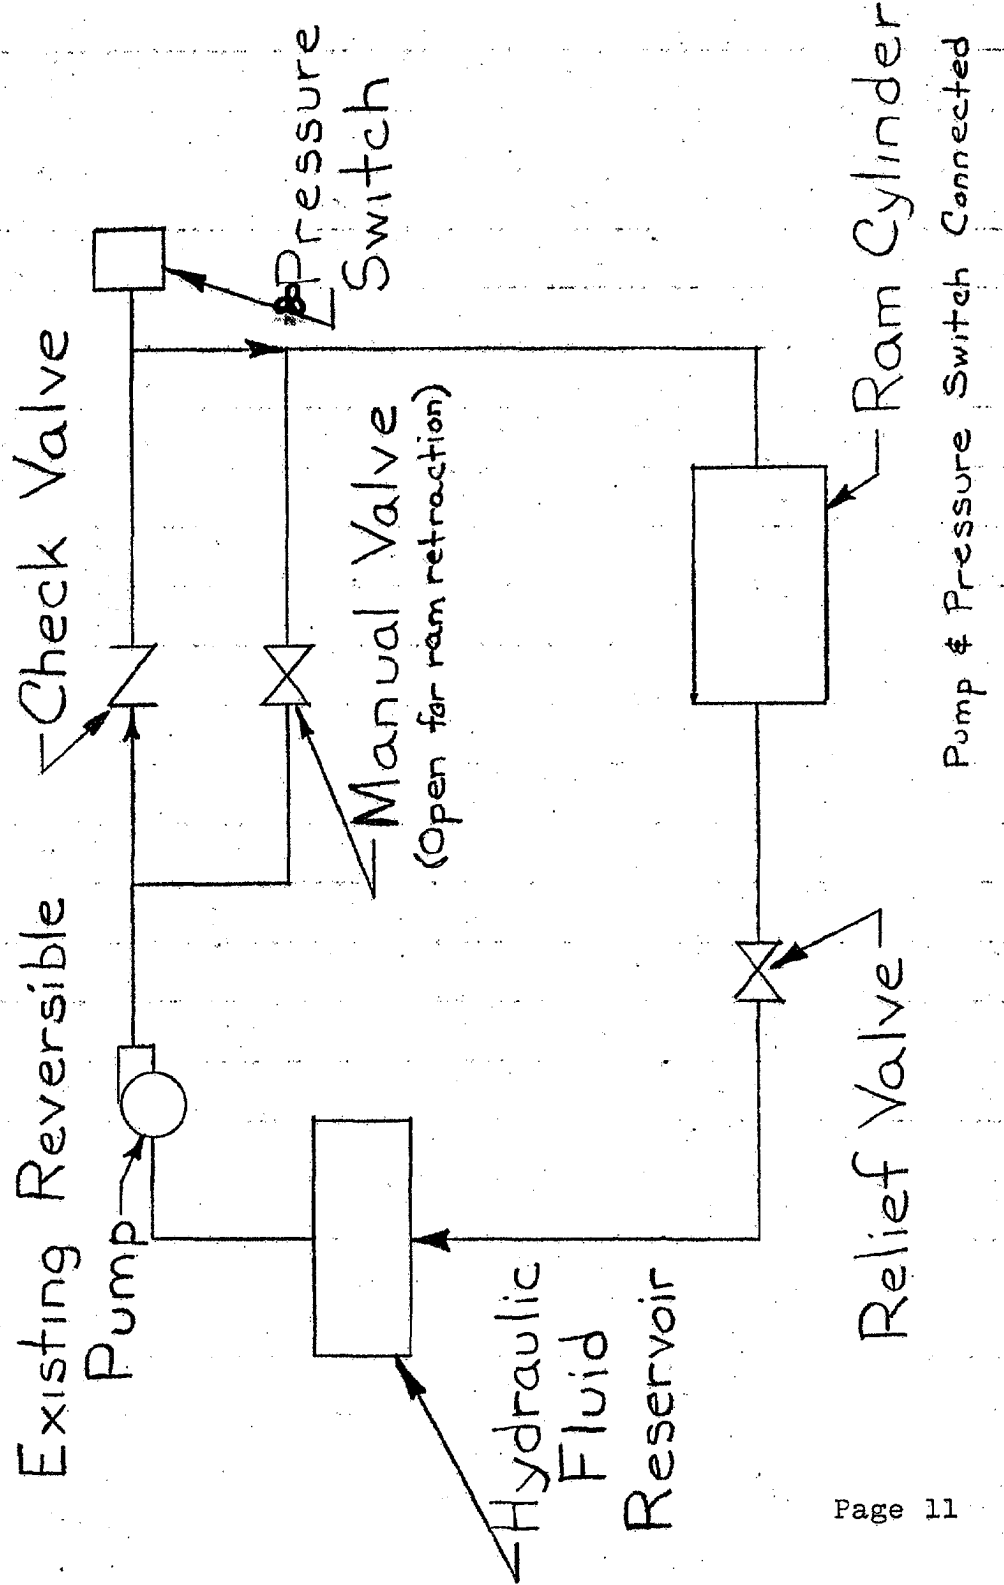
# Ram Hydraulic System For Polypropylene Filter Press

Use of polypropylene plates and frames required alteration of the press closure device. The press is closed and sealed by means of a hydraulic ram. When used with the previous iron elements, the press was sealed by the hydraulic ram to 1200 psig hydraulic pressure. At that point, a lock nut on the ram was secured and the hydraulic system was turned off. During operation, the ram was locked in a stationary position and the hydraulic system was not energized. Due to the relatively high thermal expansion of polypropylene, this system was not usable. When filling with hot slurry, the press length would expand and increase the stress on the press skeleton. This could result in permanent damage to the skeleton. Upon switching to cold water washing, the press length would contract and lower the clamping pressure. This could result in leakage throughout the press.

The ram hydraulic system designed for the polypropylene filter press is illustrated in Appendix 5. The lock nut was removed to prevent securing the ram in a fixed position. Valves and a pressure switch were installed in the hydraulic lines. During operation, the control switch is left on and the pressure switch controls the pump. The low (1050 psig) limit on the switch restarts the pump, thereby preventing underpressurizing the press. When hydraulic pressure reaches 1200 psig, the switch shuts off the pump. If pressure continues to increase due to thermal expansion, the relief valve limits the maximum pressure at 1300 psig. This prevents dangers due to over-pressurizing the press. The system worked well during the year of operation and is being used on all other polypropylene press conversions.

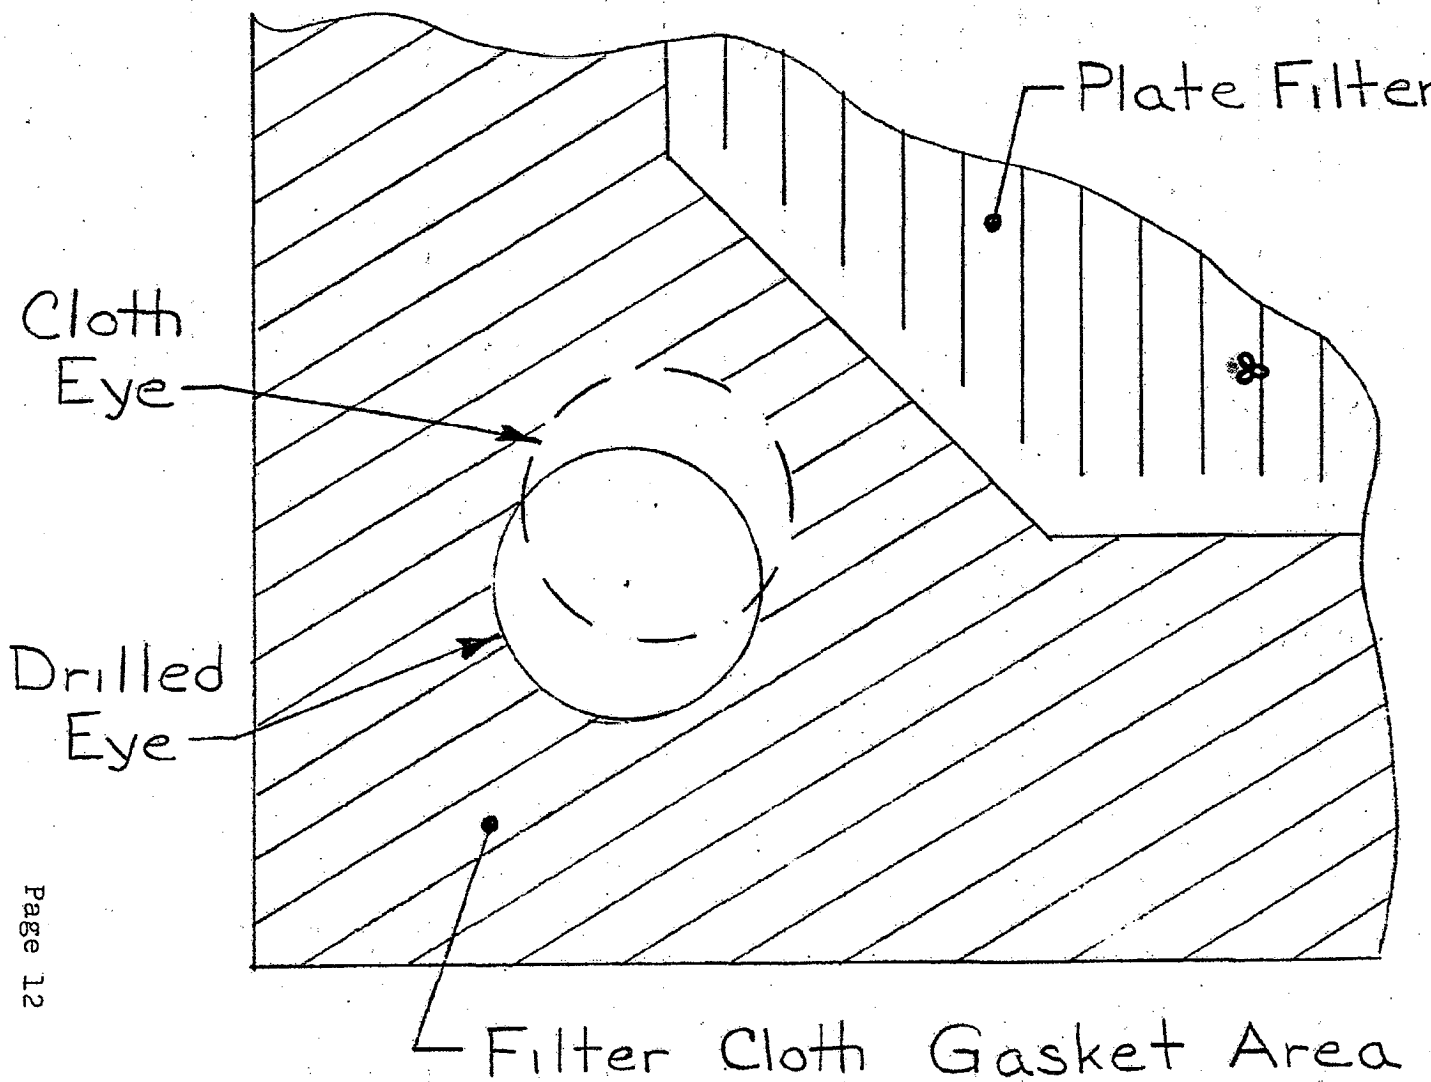
# Filter Cloth Misalignment Effluent Eye

Filter cloths were misaligned primarily because of inaccurately cut filter cloths and poor accessibility of the effluent eye. Filter cloths are cut from bulk material on the plant. Due to the limited facilities available for this work, location of cut eyes on the cloths is erratic. This type of error is marginally acceptable with the two eye presses now used. However, with a third eye in the lower corner of the press, alignment of the upper two eyes often results in the third eye being off center. The problem is compounded by the location of the third eye. These eyes are on a level with the platform upon which the operators are standing. Therefore, in aligning the upper two eyes, the misalignment of the lower eye can pass unnoticed.

The result of filter cloth misalignment is illustrated in Appendix 6. The error in the cloth eye position was always above and normally toward the center of the desired spot. This reduced the gasket area of the cloth which separates the frame chamber from the effluent eye. As the slurry pressure increased during the fill cycle, pigment could be forced past the reduced gasket area into the effluent line. This resulted in product loss and pluggage of effluent lines. Pigment could also be forced through to the plate filter area, resulting in bleeds throughout the press. An attempt was made to correct this problem by gluing the filter cloths to the press. A mastic produced by 3M was used to secure the two layers of filter cloth together and to the polypropylene plate. The mastic performed well and prevented misalignment. However, several difficulties exist. The gluing operation is time and labor intensive. Based on the time required by R & D during the test, 24 hours by two men would be required to secure an entire press. This would be required approximately once every two months. During regular operation, individual defective cloths are replaced during the unloading of the press between batches. This would be difficult using the gluing procedure. Further, the problem of miscut filter cloths would still exist.

A possible solution which was not evaluated is the use of precut cloths supplied by an outside vendor. Use of ties on the outside edges would prevent cloth misalignment. This was not pursued due to Manufacturing concern over increasing tramp material into the product.

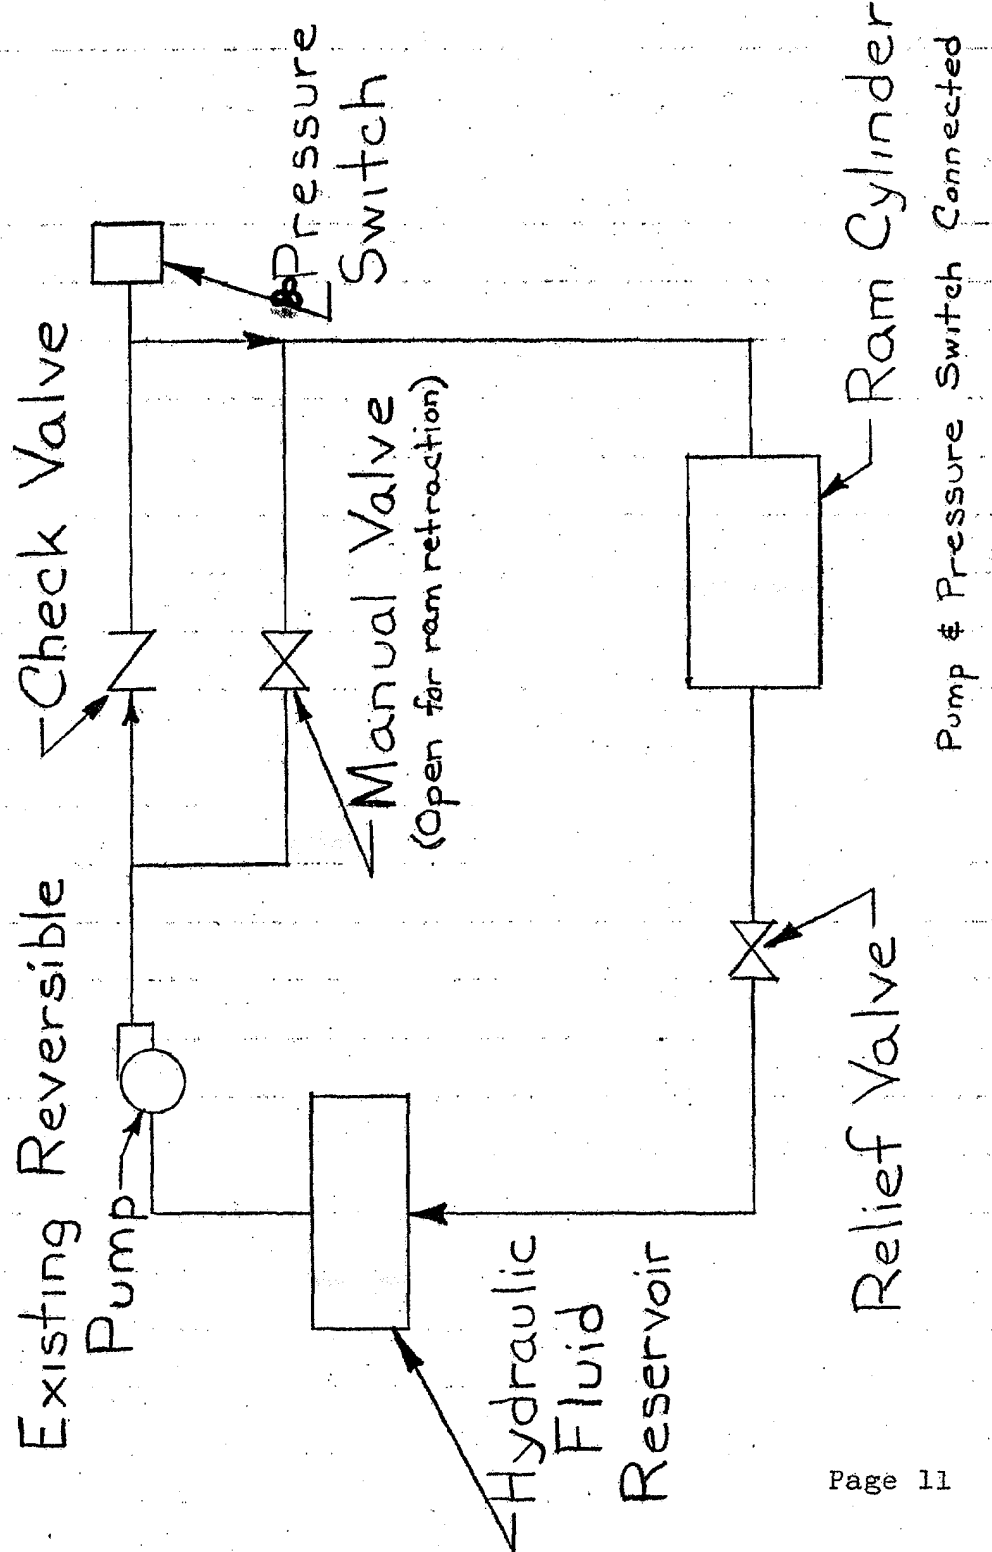
# Ram Hydraulic System For Polypropylene Filter Press

Use of polypropylene plates and frames required alteration of the press closure device. The press is closed and sealed by means of a hydraulic ram. When used with the previous iron elements, the press was sealed by the hydraulic ram to 1200 psig hydraulic pressure. At that point, a lock nut on the ram was secured and the hydraulic system was turned off. During operation, the ram was locked in a stationary position and the hydraulic system was not energized. Due to the relatively high thermal expansion of polypropylene, this system was not usable. When filling with hot slurry, the press length would expand and increase the stress on the press skeleton. This could result in permanent damage to the skeleton. Upon switching to cold water washing, the press length would contract and lower the clamping pressure. This could result in leakage throughout the press.

The ram hydraulic system designed for the polypropylene filter press is illustrated in Appendix 5. The lock nut was removed to prevent securing the ram in a fixed position. Valves and a pressure switch were installed in the hydraulic lines. During operation, the control switch is left on and the pressure switch controls the pump. The low (1050 psig) limit on the switch restarts the pump, thereby preventing underpressurizing the press. When hydraulic pressure reaches 1200 psig, the switch shuts off the pump. If pressure continues to increase due to thermal expansion, the relief valve limits the maximum pressure at 1300 psig. This prevents dangers due to over-pressurizing the press. The system worked well during the year of operation and is being used on all other polypropylene press conversions.

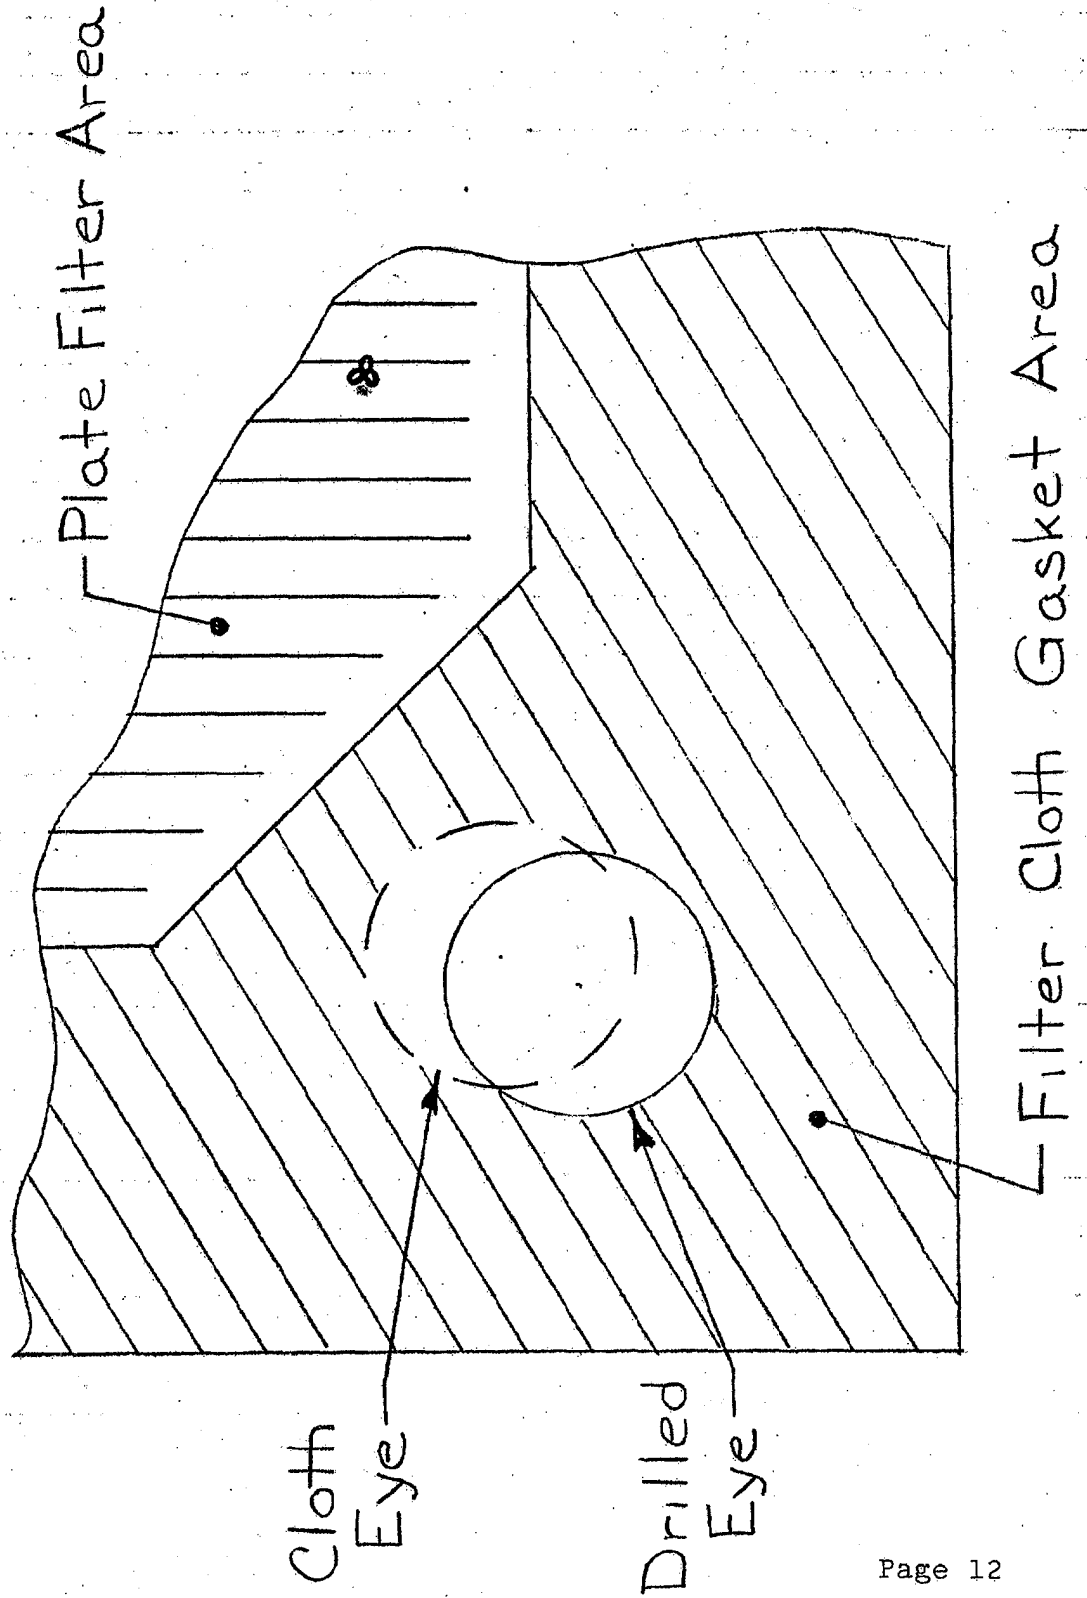
Filter Cloth Misalignment  
Effluent Eye

Filter cloths were misaligned primarily because of inaccurately cut filter cloths and poor accessibility of the effluent eye. Filter cloths are cut from bulk material on the plant. Due to the limited facilities available for this work, location of cut eyes on the cloths is erratic. This type of error is marginally acceptable with the two eye presses now used. However, with a third eye in the lower corner of the press, alignment of the upper two eyes often results in the third eye being off center. The problem is compounded by the location of the third eye. These eyes are on a level with the platform upon which the operators are standing. Therefore, in aligning the upper two eyes, the misalignment of the lower eye can pass unnoticed.

The result of filter cloth misalignment is illustrated in Appendix 6. The error in the cloth eye position was always above and normally toward the center of the desired spot. This reduced the gasket area of the cloth which separates the frame chamber from the effluent eye. As the slurry pressure increased during the fill cycle, pigment could be forced past the reduced gasket area into the effluent line. This resulted in product loss and pluggage of effluent lines. Pigment could also be forced through to the plate filter area, resulting in bleeds throughout the press. An attempt was made to correct this problem by gluing the filter cloths to the press. A mastic produced by 3M was used to secure the two layers of filter cloth together and to the polypropylene plate. The mastic performed well and prevented misalignment. However, several difficulties exist. The gluing operation is time and labor intensive. Based on the time required by R & D during the test, 24 hours by two men would be required to secure an entire press. This would be required approximately once every two months. During regular operation, individual defective cloths are replaced during the unloading of the press between batches. This would be difficult using the gluing procedure. Further, the problem of miscut filter cloths would still exist.

A possible solution which was not evaluated is the use of precut cloths supplied by an outside vendor. Use of ties on the outside edges would prevent cloth misalignment. This was not pursued due to Manufacturing concern over increasing tramp material into the product.
