## Region 6 - Enforcement & Compliance Assurance Division

### INSPECTION REPORT

| Company Name: | <b>Cherokee Nation</b> | | |
| Facility Name: | <b>Cherry Tree WW Collection and Treatment System</b> | | |

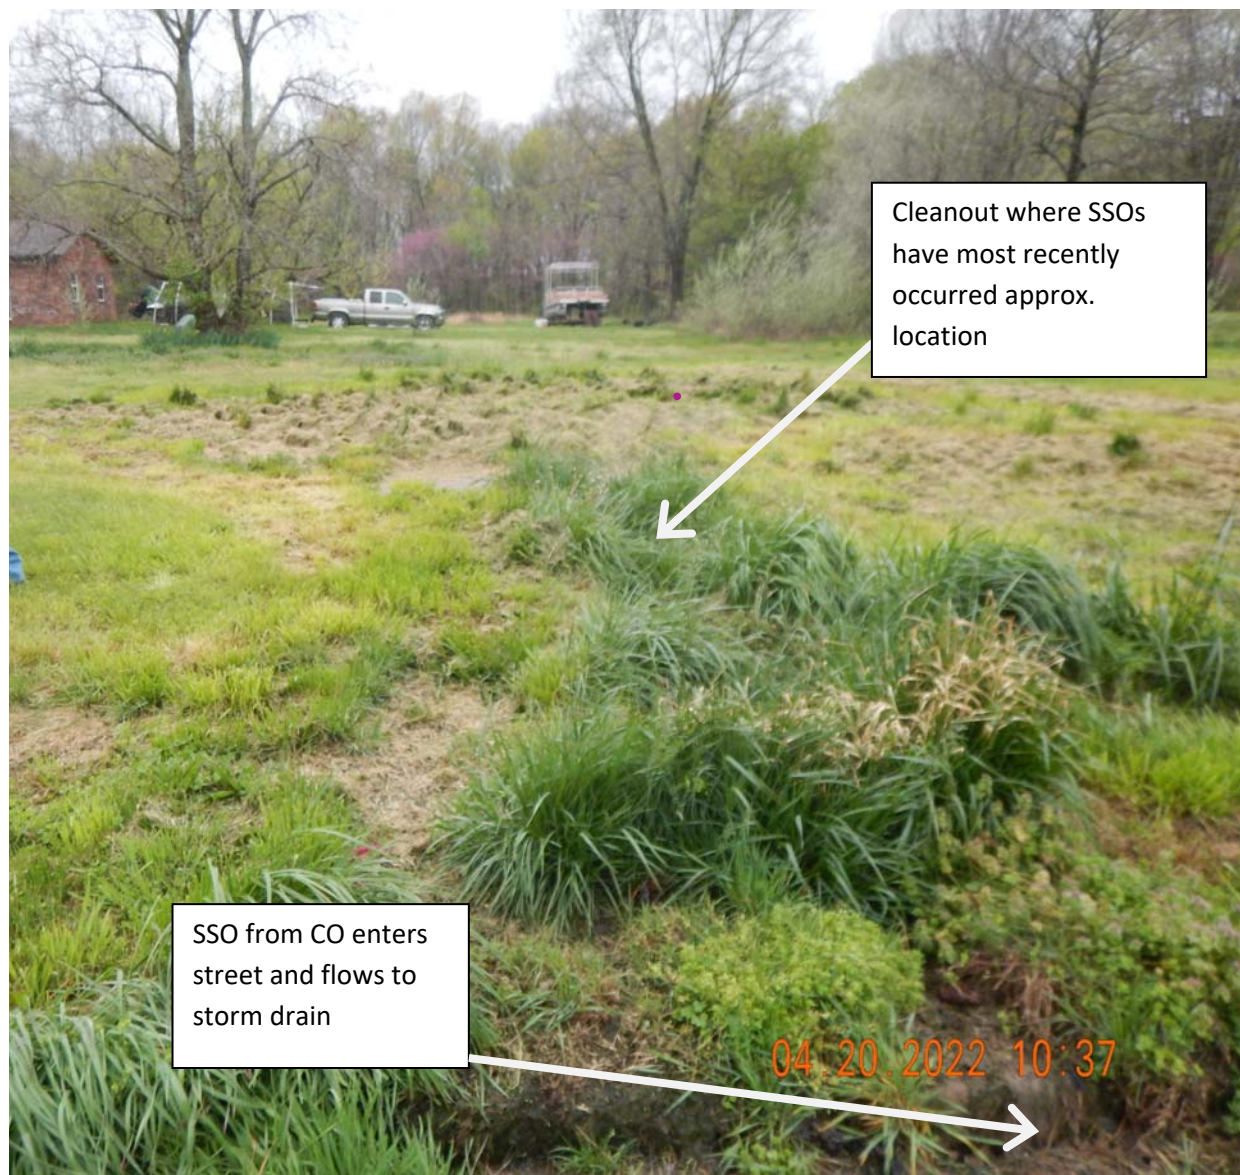
Photo No. 2

Reportedly, for the last several years, SSO problems have been caused by the LS pumps or related electrical systems not working. This has caused SSOs from a down gradient cleanout (CO), then onto private property, then into the street, to a CTC storm drain culvert system (reference Photos 2 and 3 in Appendix 1) and finally to Hanging Dog Creek and Sallisaw Creek. I analyzed CT-RWD work orders from 6/1/2020 to 3/4/2022. The results indicated three SSOs at the same CO that were caused by 1) LS electrical problems, 2) LS pump failure, and 3) LS pump system not operating automatically requiring manual operation or manual pump down. I additionally observed LS SSO issues illustrated in ODEQ investigative reports and several customer inquiries logged with EPA.

Description: Most Recent SSO due to LS failure location.

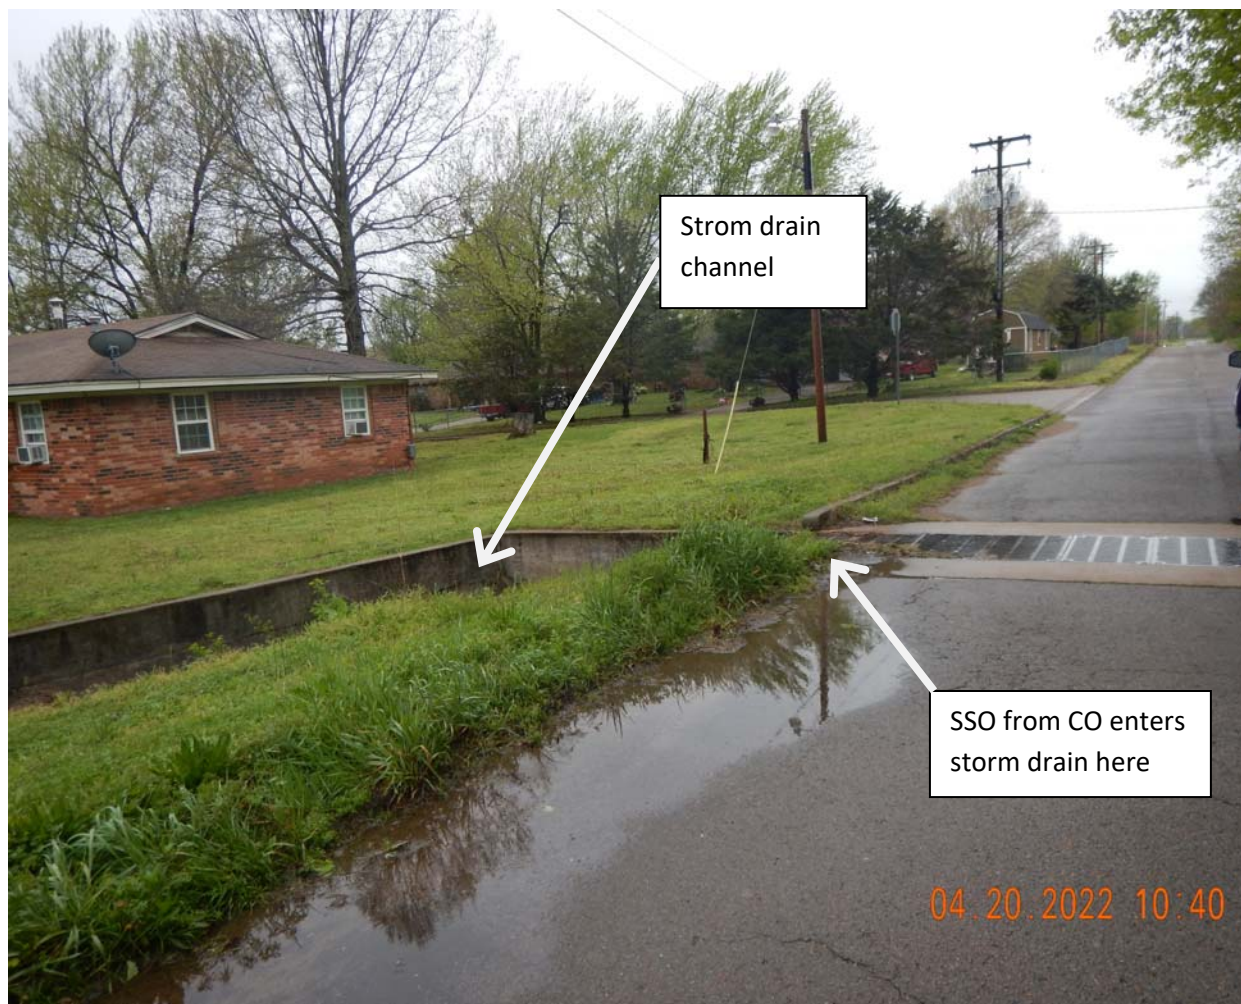
Photo No. 3

Description: Most recent SSO flow path.

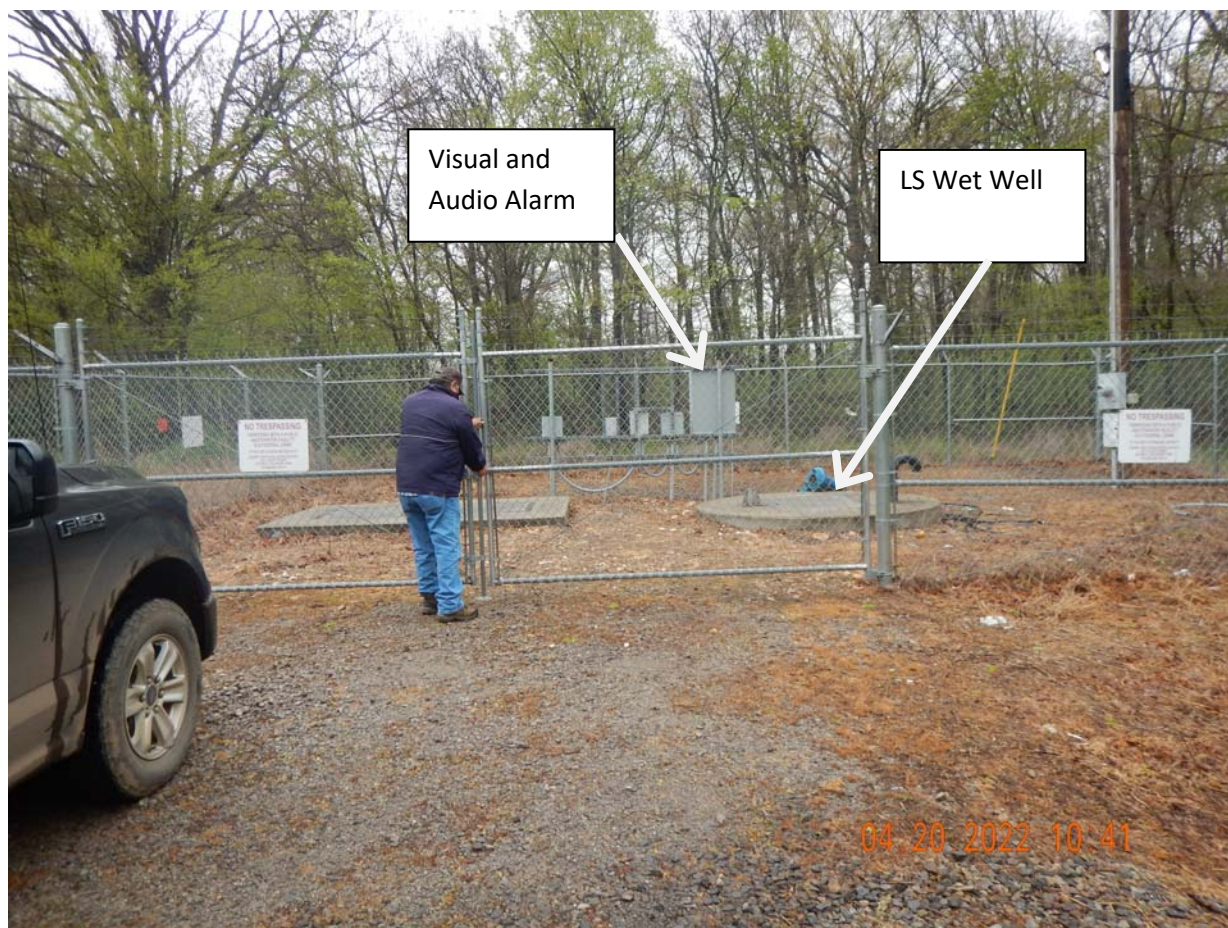
Photo No. 4

I observed that the LS was currently operating and appeared to be in good condition. The previously reported LS SSO issues were fixed via installation of a new pump and new LS electrical components. The LS is now operating automatically and visited by a CT-RWD operator daily. The CTC industrial facility does not use process water for its manufacturing, however WW services for employees are provided. The industrial facility reportedly makes airplane oil filters. The current CTRWD Class D licensure meets ODEQ minimum requirements. I observed that the LS high level or low-level alarm system consisted of both audio and visual (flashing red light) – (reference Photo 4 in Appendix 1). This adheres to ODEQ minimum requirements. The existing LS can operate 24 hours if a failure occurs at high level - meeting ODEQ standards as well.

Description: Cherokee Nation Lift Station.

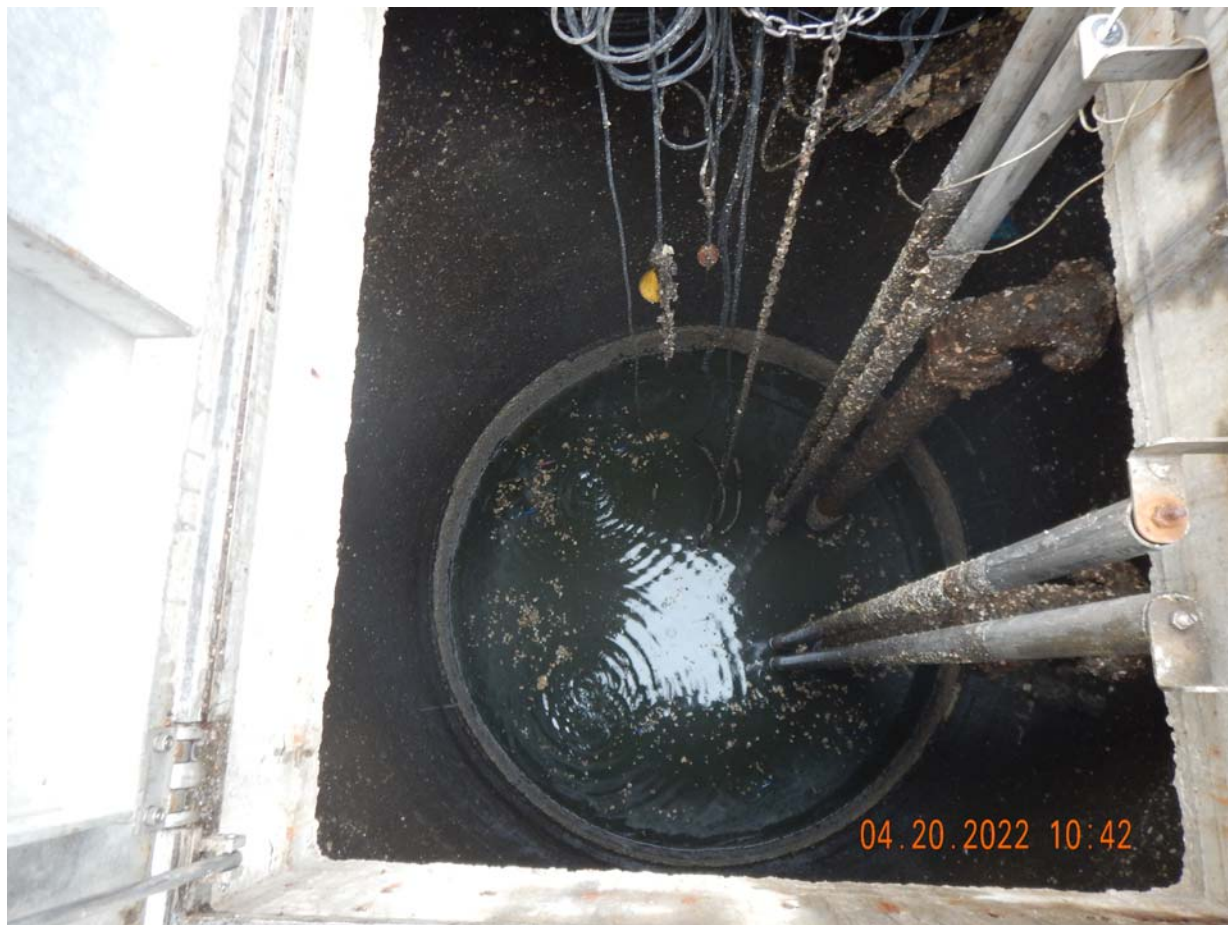
Photo No. 5

Description: Inside lift station wet well.
