**Region 6 - Enforcement & Compliance Assurance Division**  
**INSPECTION REPORT**

| Regulatory Program(s) | Clean Water Act – National Pollution Discharge Elimination System (Brine) | |
| Company Name: | PE-Osage, LLC | |
| Facility Name: | Flat Rock Unit | |

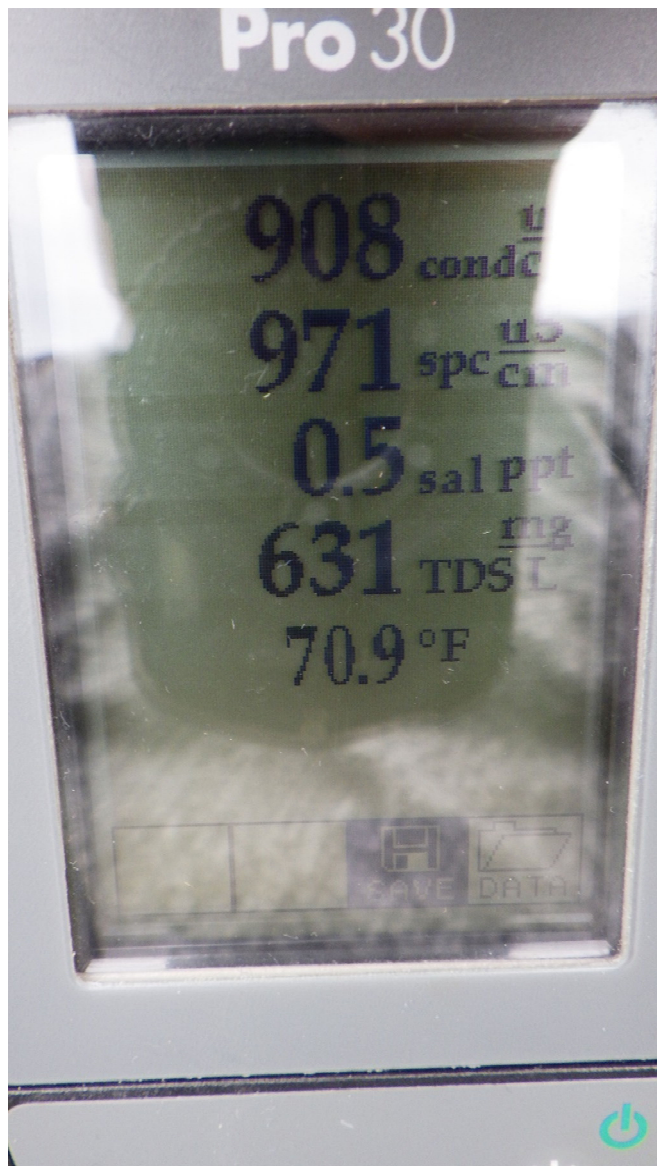
Photo No. 1

I observed a Total Dissolved Solids (TDS) field reading of 631 mg/L in the main channel of the impacted tributary (see Appendix 1/photo log, photo No. 1), immediately adjacent to the area of brine impacted soil and grass. The TDS field reading was taken with a properly calibrated YSI Pro 30 conductivity meter. I observed the bed and bank features of the impacted tributary, these observations are documented in photo No. 2. I observed the flow path of the spill overland, approximately 70 percent of the land impacts had fully recovered with vegetation. Evidence of the re-vegetation was documented in photos No. 3 and 4. All observation were made from the approximate GPS location of 36.230861, -96.027011.

**Description:** This was a TDS field reading of 631 mg/L taken in the main channel of the impacted tributary immediately adjacent to an area of impacted soil and vegetation.

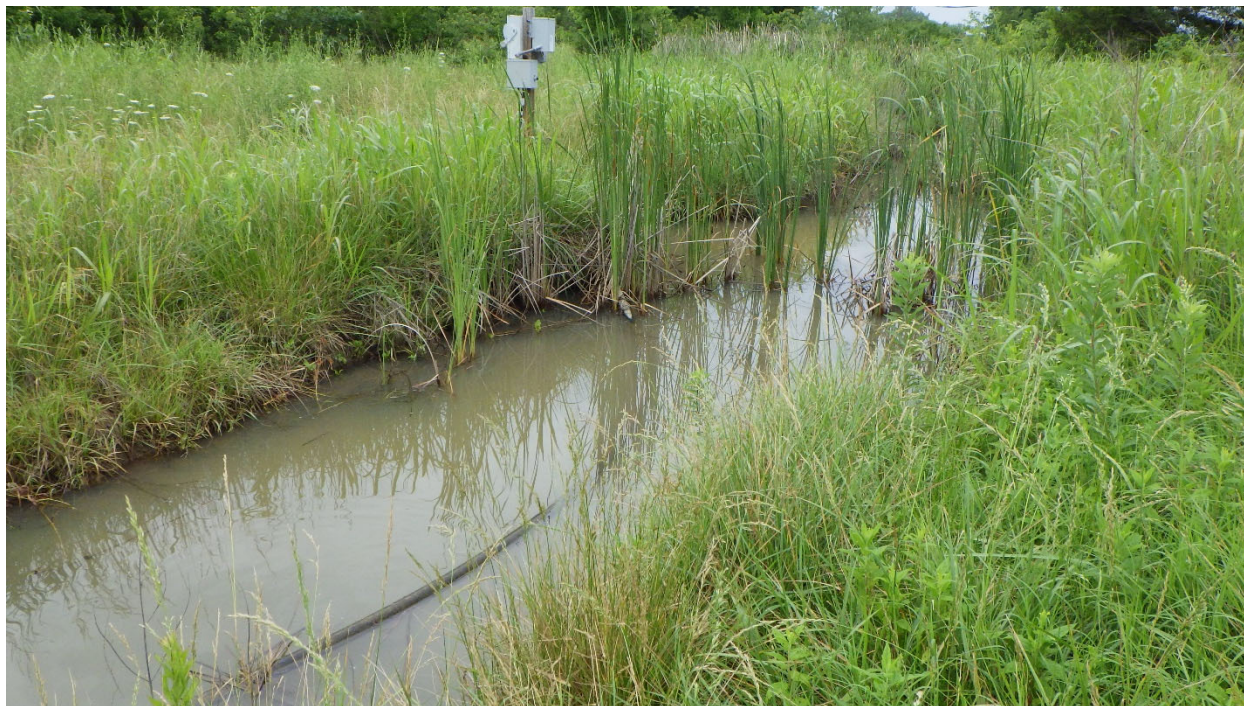
Photo No. 2

**Description:** This was a photo of the impacted tributary, with a view to the northeast, showing the bed and bank features of the tributary.

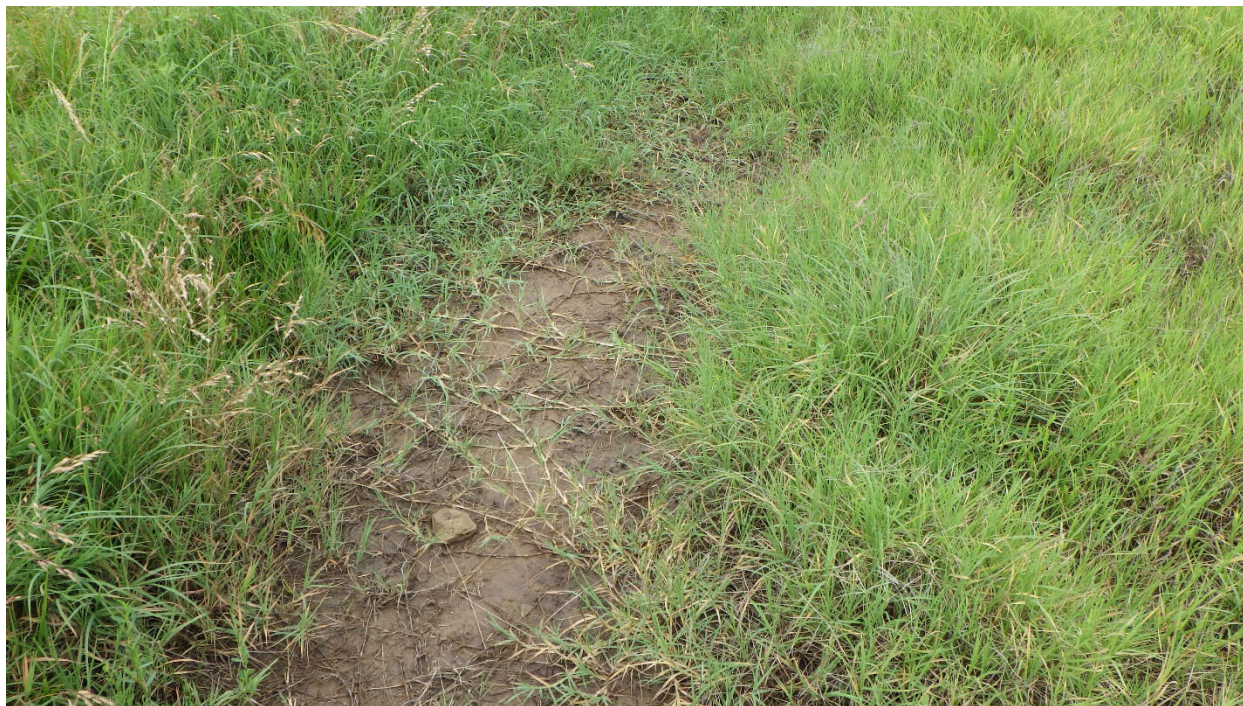
Photo No. 3

**Description:** This was a photo showing the grass had begun to re-establish across portions of the flowpath.

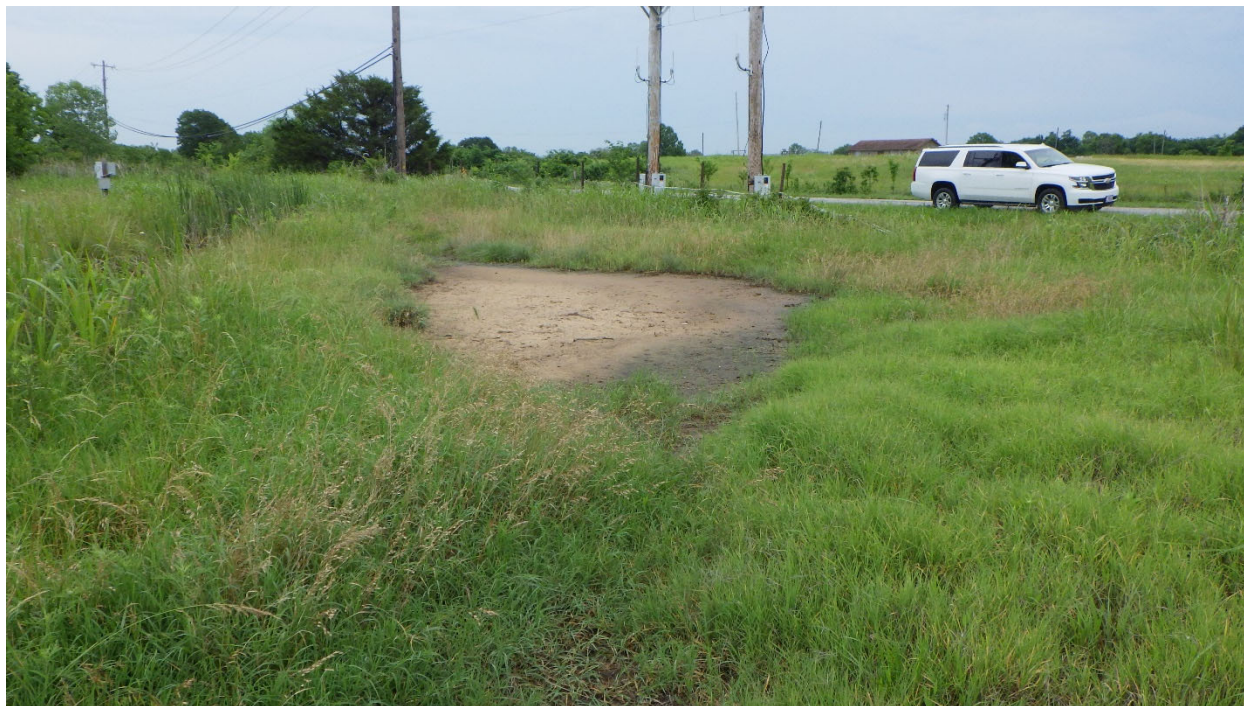
Photo No. 4

EPA Region 6 inspectors observed an area of brine impacted soil measuring approximately 15 feet in width by 30 feet in length. The impacted area should be monitored for continued improvement, if no improvement is documented, PE-Osage, LLC should clean the affected area to remove brine from the flowpath.

**Description:** This was a photo showing the portion of the flowpath/impacted soil and grass that had not been able to re-establish vegetation due to brine impacts. Approximately 70 percent of the land impacted area had been fully recovered with vegetation.
