# NPDES Compliance Inspection Report

## Entiat National Fish Hatchery

**NPDES Permit Tracking Number  
# WAG130002**

**Inspection Date: July 19, 2023**

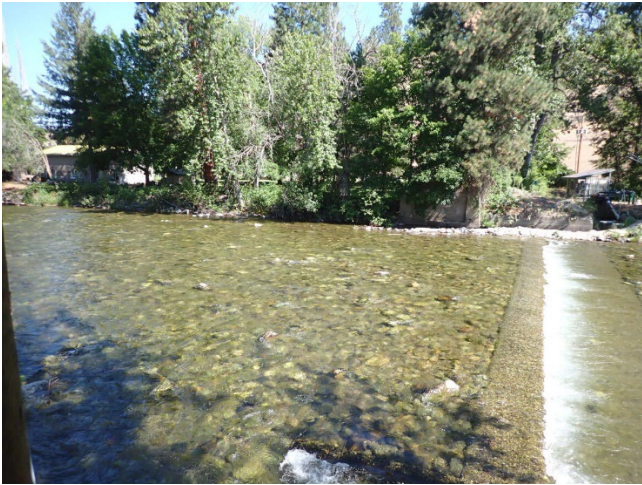
Photo #:01 (P7190160)

While inside the main river intake building, river water intake was taking place to supply water for adult ponds due to insufficient groundwater (**Photo 1 and Photo 2**). A rack in front of the intake area catches debris (**Photo 2**), and a valve draws water into vault and runs 1000 feet underground via a 36-inch concrete pipe to the screen chamber building. Sampling is conducted in front of black grate using a bucket. The sample is immediately measured with a multi-meter for pH and then refrigerated. The meter is calibrated monthly before each pH measurement.

Description: Facing north, photo of the Entiat River at the intake area.

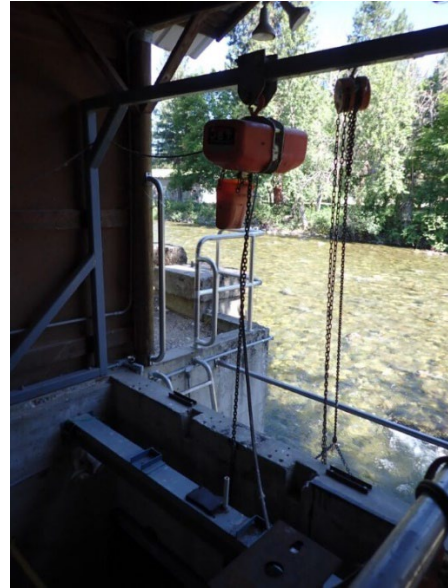
Photo #:02 (P7190164)

Description: Facing north, photo of river intake going through grates and screens.

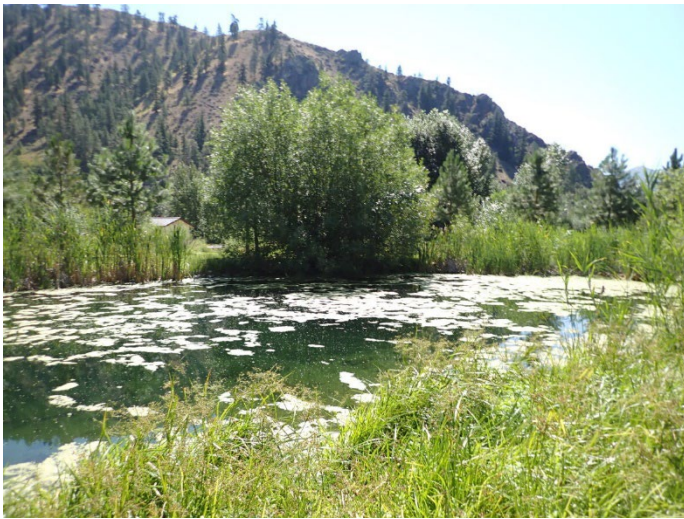
Photo #:03 (P7190167)

We walked to the trout pond that was previously used for a kids fishing program (**Photo 3**). The kids fishing program went away during COVID, and the trout pond is currently used for site irrigation and for landscaping. We then stopped at the screen chamber building where water enters through screens and then into sand settling basin (**Photo 4 and Photo 5**). The screens allow for safe bypass of incidental fish and are scrubbed twice per day. The groundwater infiltration gallery is also located next to the sand settling basin (**Photo 6**), which only goes 15-20 feet underground and does not produce sufficient water as an intake source for the Facility.

Description: Facing southeast, photo of the Facility's trout pond used for irrigation and landscaping.

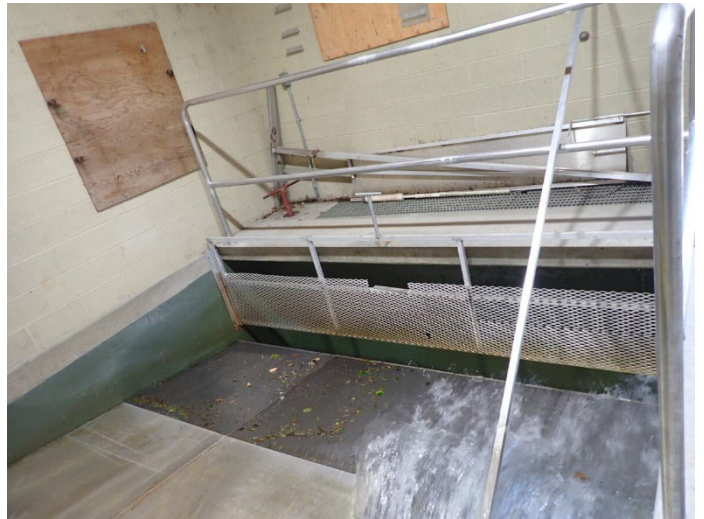
Photo #:04 (P7190171)

Description: Photo of intake water going through screens in the Facility's screen chamber building.

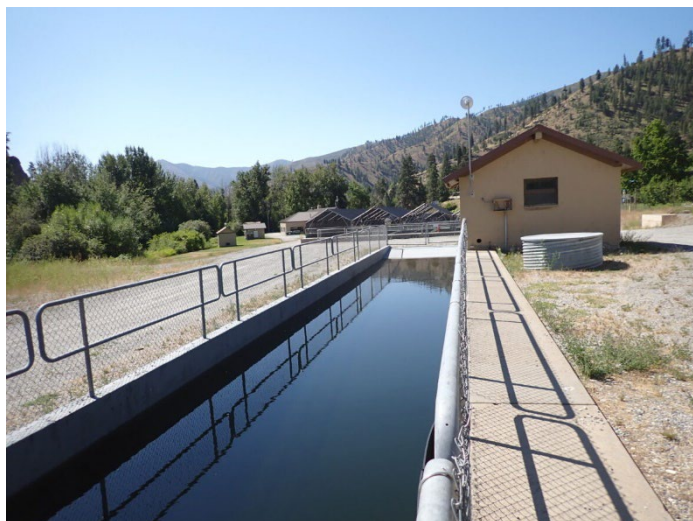
Photo #:05 (P7190174)

Description: Facing north, photo of the river intake sand settling basin after going through the screen chamber building.

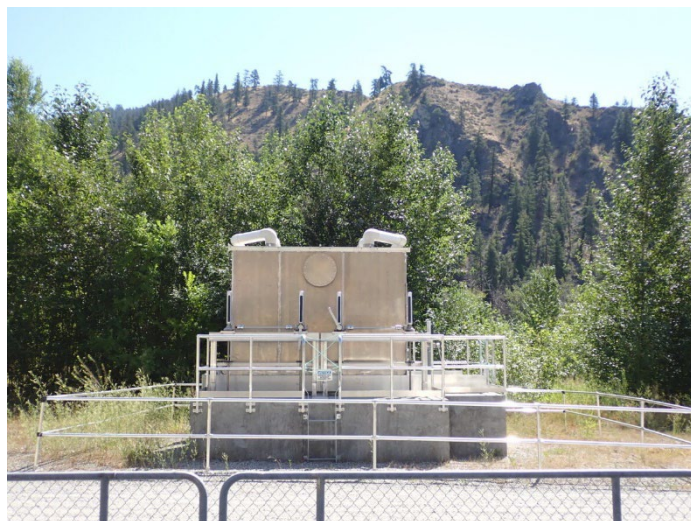
Photo #:06 (P7190175)

Description: Facing east, photo of the Facility's infiltration gallery.

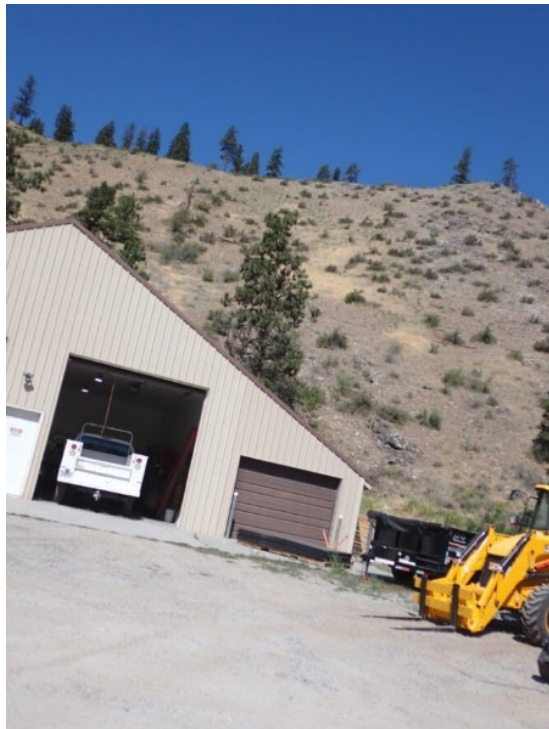
Photo #:07 (P7190177)

On our way to the aeration chamber, we passed a maintenance building where vehicle and other equipment maintenance is conducted (**Photo 7**). Some chemicals are stored in the building, and oil/grease is properly disposed of at an O'Reilly's auto parts store in Wenatchee, WA. I did not observe any improper storage of oil or chemicals in the maintenance building.

Description: Facing west, photo of the Facility's maintenance building where vehicle and equipment maintenance is conducted.

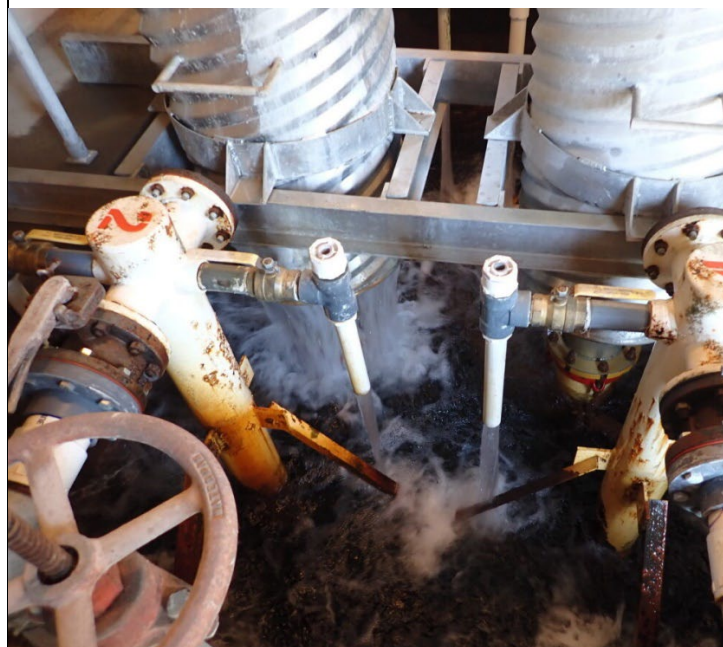
Photo #:08 (P7190179)

At the aeration chamber, all ground water collects in the chamber (**Photo 8**). Each cylinder receives water from different intake sources: 6 wells, spring, and infiltration gallery. Intake sampling is conducted in the aeration chamber using a bucket to take three samples at 0.5-hour intervals. I informed Mr. Chisam and Mr. Hansen of the required four or more discrete samples for influent composite samples for net TSS analysis. When the Facility is using both the aeration chamber and the river as intake sources, composite samples incorporating both intake categories are taken. Groundwater from the aeration chamber is pumped underground to the adult ponds in raceways.

The Facility takes three samples at 0.5-hour intervals for influent composite sampling in the aeration chamber instead of four samples. I informed Mr. Chisam and Mr. Hansen of the required four or more discrete samples for influent composite samples for net TSS analysis, and they indicated they will start collecting four samples for the next monthly monitoring event.

Description: Photo of inside the Facility's aeration chamber where different intake sources meet and where influent sampling occurs.

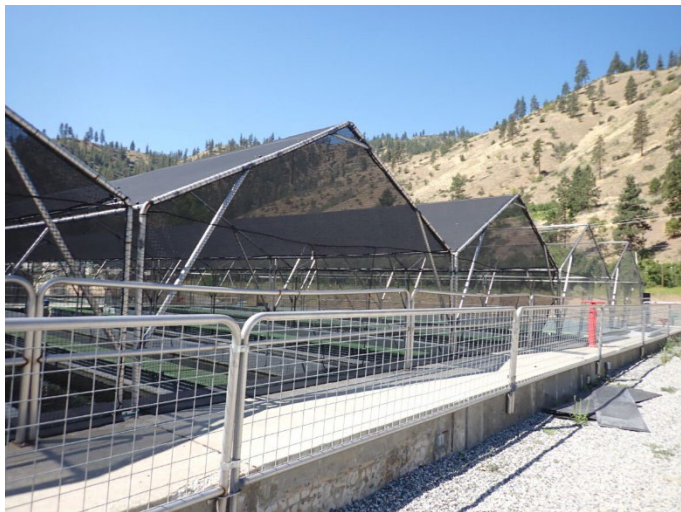
Photo #:09 (P7190183)

We walked by some of the raceways (**Photo 9**). Approximately 75,000 fish can fit in each raceway. There have been fish in the raceways since the first week of May. A staggered approach is used to move fish to different raceway pods as fish grow and require more space over time. Groundwater is reused to help spread fish into all 30 raceways. A vet visits the Facility once a month to conduct routine fish health checks. None of the raceways are drained until fish release occurs in mid-April. Raceway fish are pumped directly into the Entiat River using a hose. Raceways are cleaned using a vacuum brush (**Photo 10**), and any vacuumed flows are pumped to the pollution abatement pond, also called the offline settling basin. Algae build-up is pressure washed using only water and then gravity flows to the pollution abatement pond/offline settling basin.

Description: Facing west, photo of some of the adult pond raceways.

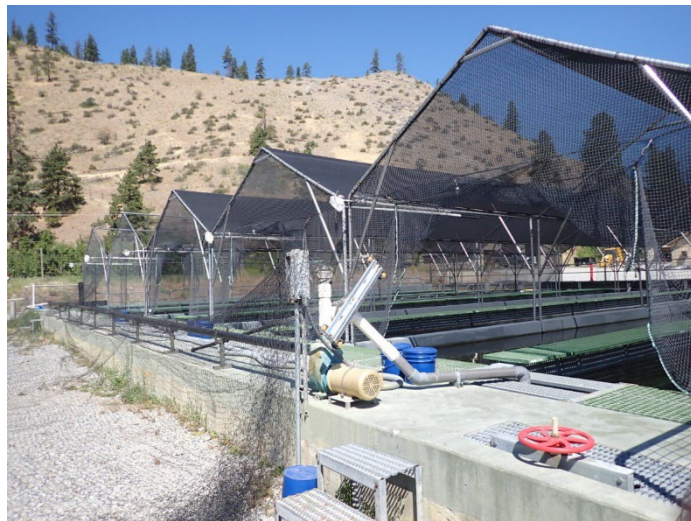
Photo #:10 (P7190184)

Description: Facing west, photo of the vacuum brush used to clean raceways. Vacuumed flow is then pumped to the offline settling basin.

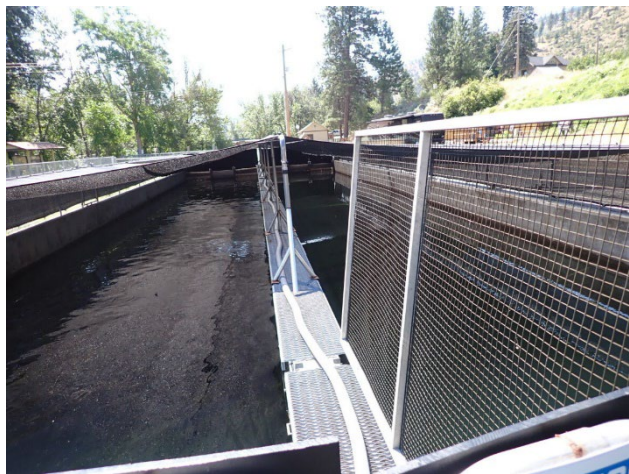
Photo #:11 (P7190195)

We then walked to the spawning building where I observed the adult pond with the brood stock that will remain until spawning in October (**Photo 11**). The right side of this pond was a trap side that uses river water to run the fish ladder. The left side was a brood stock with reused groundwater. Fish from the fish ladder go into the trap side to

Description: Facing southeast, photo of the adult and brood holding and trap ponds next to the spawning building. The right side is the river water trap side whereas the left side is the brood side and where fish are held.

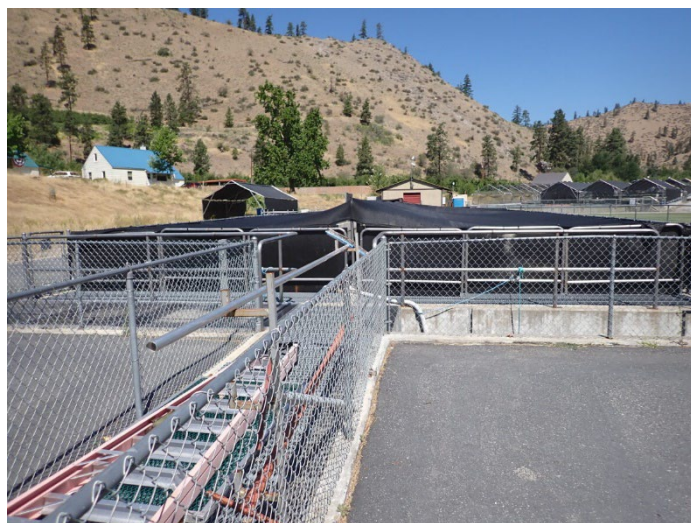
Photo #:12 (P7190199)

We followed the fish ladder to where it meets the Entiat River at Outfall 001, where discharge was occurring at the time of inspection from spillover of raceway water (**Photo 12, Photo 13, Photo 14, and Photo 15**). Evidence of fish released from the raceways via a hose into the river can be seen looking at **Photo 16** in which the Facility cut a hole in the fence to fit the hose through. Effluent sampling is conducted by standing on top of the screen area and dropping a bucket tied to a rope.

Description: Facing northwest, photo of the Facility's fish ladder that brings fish into the river trap side of the adult holding pond for spawning.

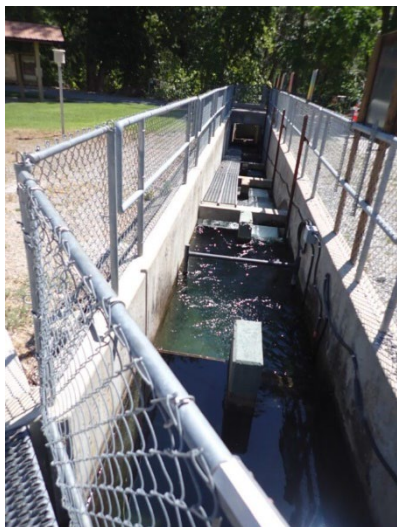
Photo #:13 (P7190204)

Description: Facing southeast, photo of the fish ladder between the Entiat River and spawning building.

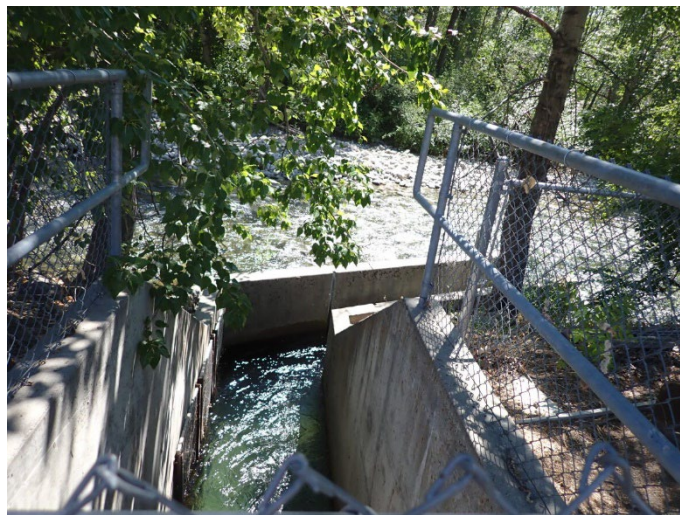
Photo #:14 (P7190207)

Description: Facing southeast, photo of outfall 001 connected to the Facility's fish ladder.

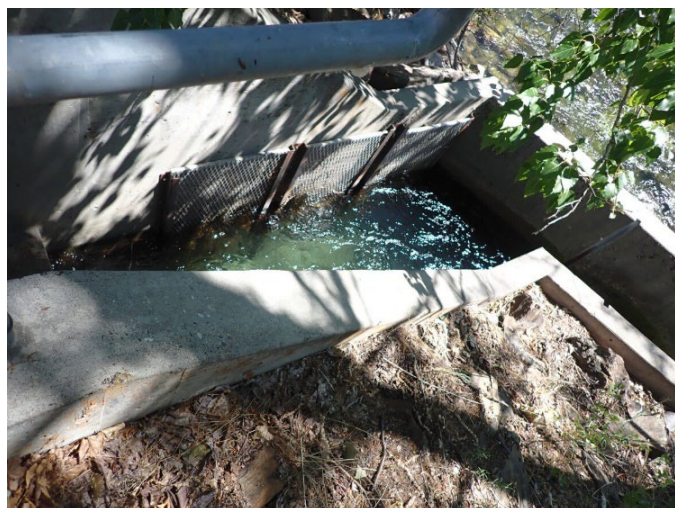
Photo #:15 (P7190208)

Description: Facing south, another photo of the Facility's outfall 001 with active discharge coming through screens.

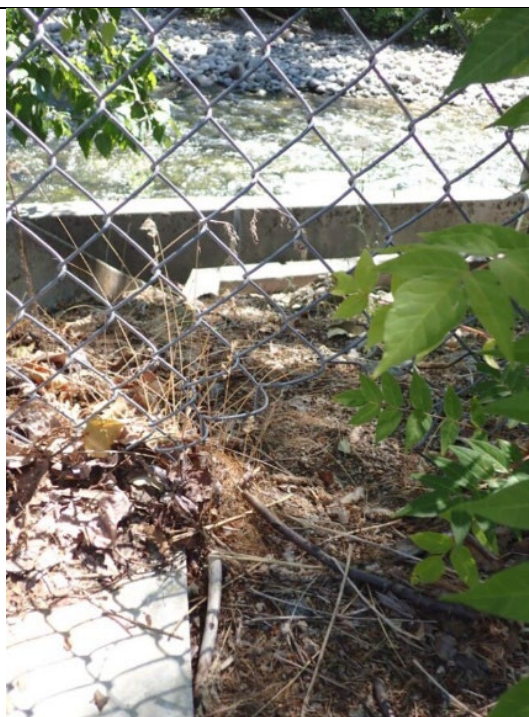
Photo #:16 (P7190209)

Description: Facing southeast, photo of the hole in the fence so that the Facility can fit a hose through for the release of fish into the Entiat River.

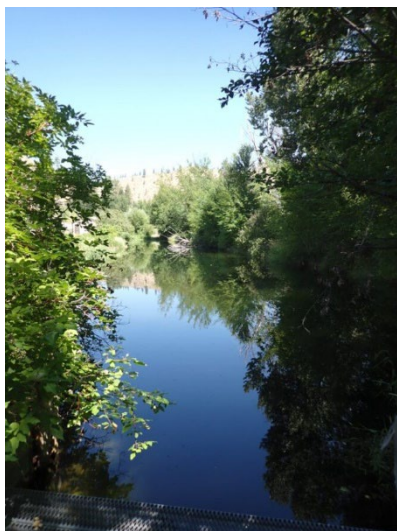
Photo #:17 (P7190211)

We walked to Outfall 002 at the abatement pond which was not running at the time of inspection (**Photo 17**). Effluent sampling is conducted using a bucket tied to a rope collecting effluent after the weir, and flow is measured by hand using a ruler to ascertain the height of water flow over the weir (**Photo 18**).

Description: Facing northwest, photo of the Facility's pollution abatement pond/offline settling basin at Outfall 002.

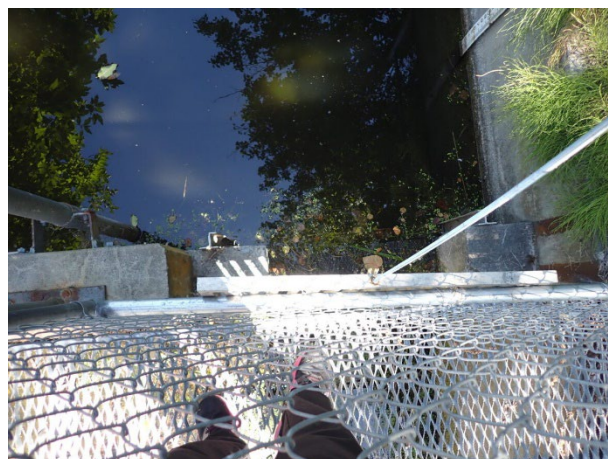
Photo #:18 (P7190214)

Description: Facing southeast, photo of where sampling and flow measurement occurs at outfall 002.

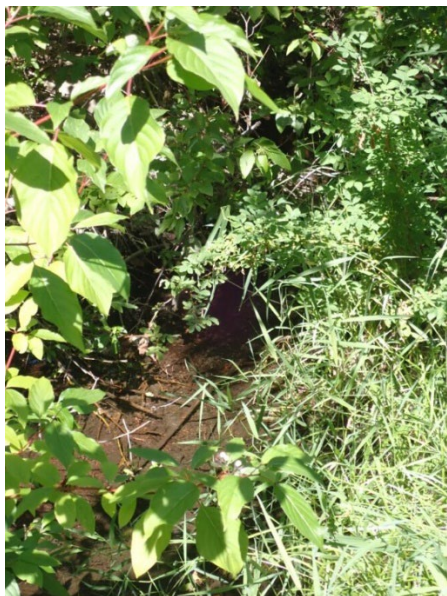
Photo #:19 (P7190216)

We then walked to observe Outfall 003 from a bridge. This outfall only visibly discharges when it is pumped but does trickle when not pumped and is still monitored. At the time of inspection, it was challenging to see an actual discharge through the vegetation, however I observed a small trickle over the board (**Photo 19**). I did not observe an obvious conveyance to the Entiat River, however Facility representatives explained to me that there was little flow from the outfall making it difficult to track the discharge to the river. Effluent sampling point using a bucket is conducted by the weir board, and the same flow measurement by hand as for Outfall 002 is done at Outfall 003.

Description: Facing northwest, photo of the Facility's outfall 003 that trickles until the Facility actually pumps to cause a visible discharge.

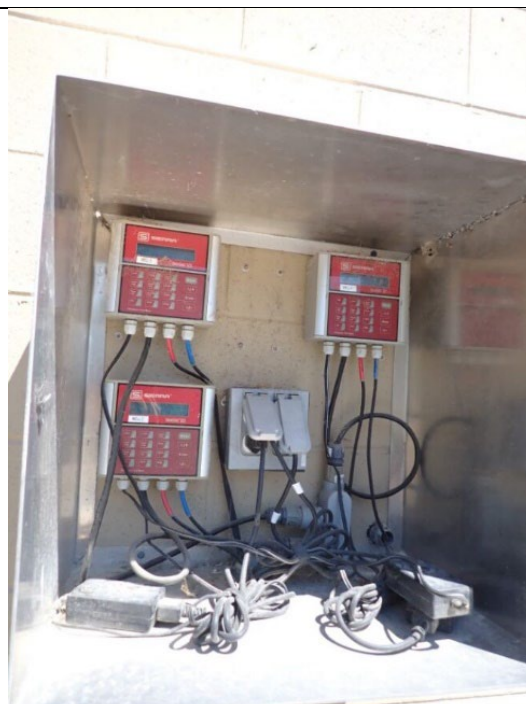
Photo #:20 (P7190219)

Mr. Chisam then showed me the flow meters scattered throughout facility. Examples of influent flow meters I observed for some of the underground wells were Sierra brand meters (**Photo 20 and Photo 21**) and are calibrated as required by the manufacturer. Flow meters are also replaced as needed when maintenance is performed on the wells.

Description: Photo of Sierra model flow meters for some of the Facility's groundwater wells.

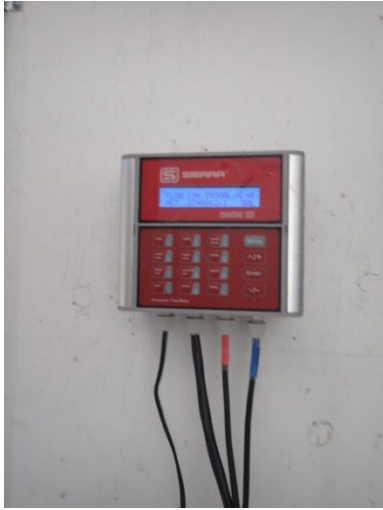
Photo #:21 (P7190223)

Description: Another photo of the one of the Facility's groundwater well flow meters.

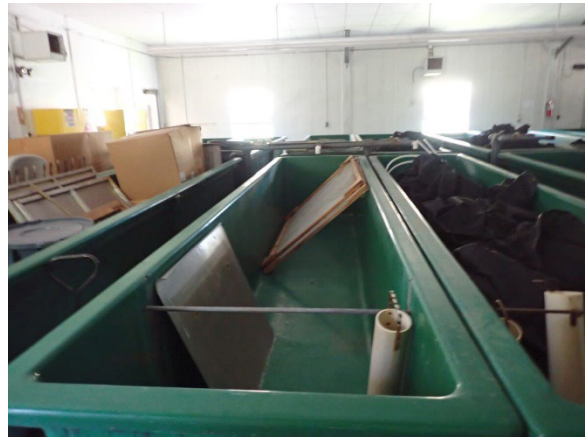
Photo #:22 (P7190228)

The site walkthrough ended at the incubation building where I observed empty green tanks and empty stacks (**Photo 22 and Photo 23**). Eggs from the spawning area are transported in Ziploc bags into incubation stacks. Iodine is applied during incubation to harden eggs.

Description: Photo of empty green tanks inside the Facility's incubation building.

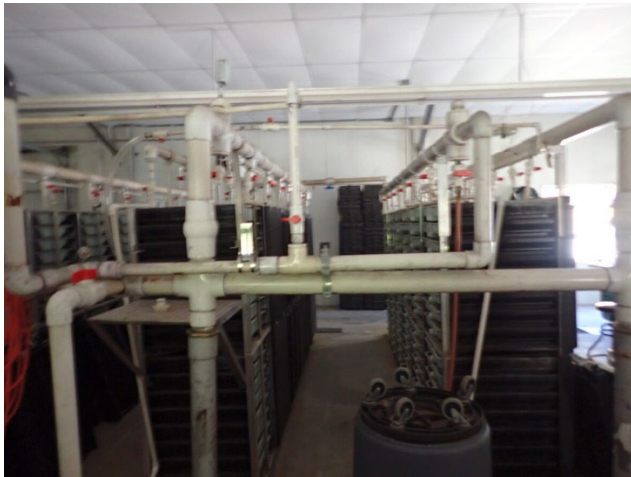
Photo #:23 (P7190229)

Description: Photo of the Facility's egg incubation trays inside the incubation building.

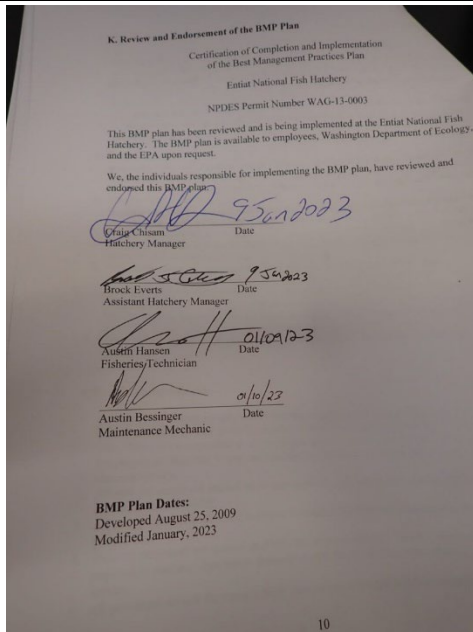
Photo #:25 (P7190232)

- Best Management Practices Plan (BMP Plan) – The Facility had a current BMP Plan onsite that was certified on January 9, 2023 (**Photo 25**). According to EPA’s ECHO and EPA’s Integrated Compliance Information System (ICIS), the Facility has submitted timely annual review certification statements. Upon deeper review of the BMP Plan, I observed the following deficiencies:

- Additional detail is needed to describe fish grading, harvesting, egg taking, and other activities within ponds or raceways and how the discharge of accumulated solids and blood wastes are minimized as described in Part IV.G.5.e.3 of the permit.

- Additional detail is needed to describe if any non-chlorinated disinfectants are used in rearing and holding unit water or in hauling trucks as described in Part IV.G.5.e.5.

- Additional detail is needed to describe fish grading, harvesting, egg taking, and other activities within ponds or raceways and how the discharge of accumulated solids and blood wastes are minimized as described in Part IV.G.5.e.3 of the permit.
- Additional detail is needed to describe if any non-chlorinated disinfectants are used in rearing and holding unit water or in hauling trucks as described in Part IV.G.5.e.5.

Description: Photo of the Facility's BMP Plan cover sheet certified in January of 2023.

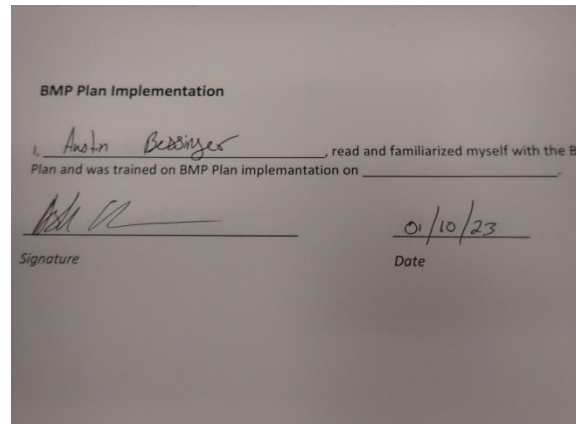
Photo #:26 (P7190238)

Description: Photo of one of the Facility's training documents certifying training in BMP Plan implementation.

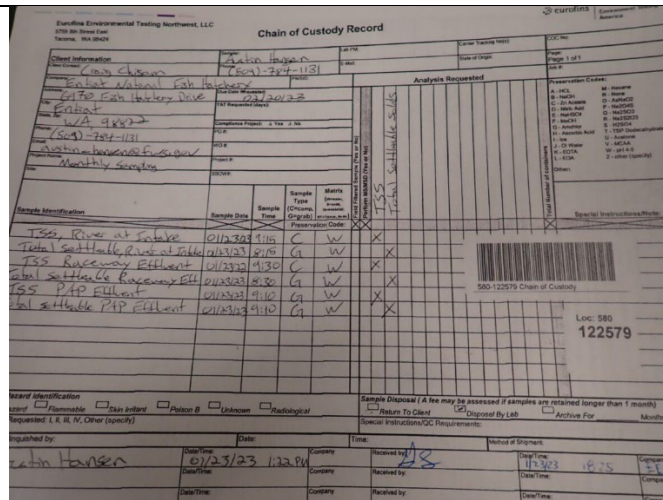
Photo #:27 (P7190242)

Description: Photo of one of the Facility's sampling chain of custody forms for January 2023 monthly monitoring.

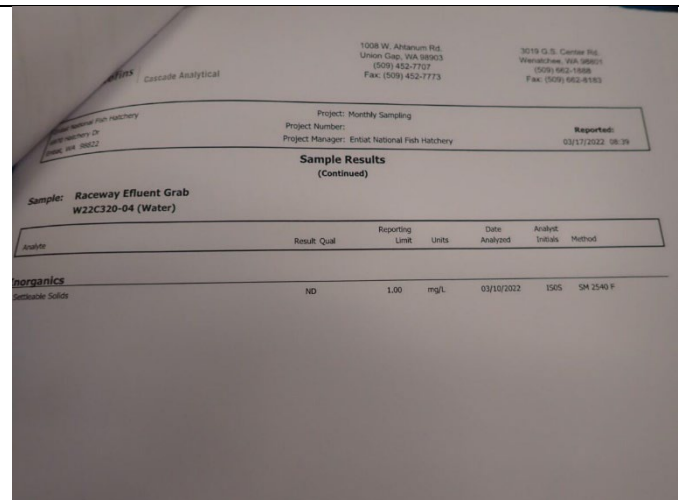
Photo #:28 (P7190246)

Description: Photo of an example of one of the Facility's laboratory analytical report results for settleable solids.
