REPORT OF COMPLIANCE EVALUATION INSPECTION  
(INDUSTRIAL STORMWATER)

**Advantage Metals Recycling LLC. – 12<sup>th</sup> Street Facility**

Authorization Number: **KSR000112**

ON  
June 22, 2023

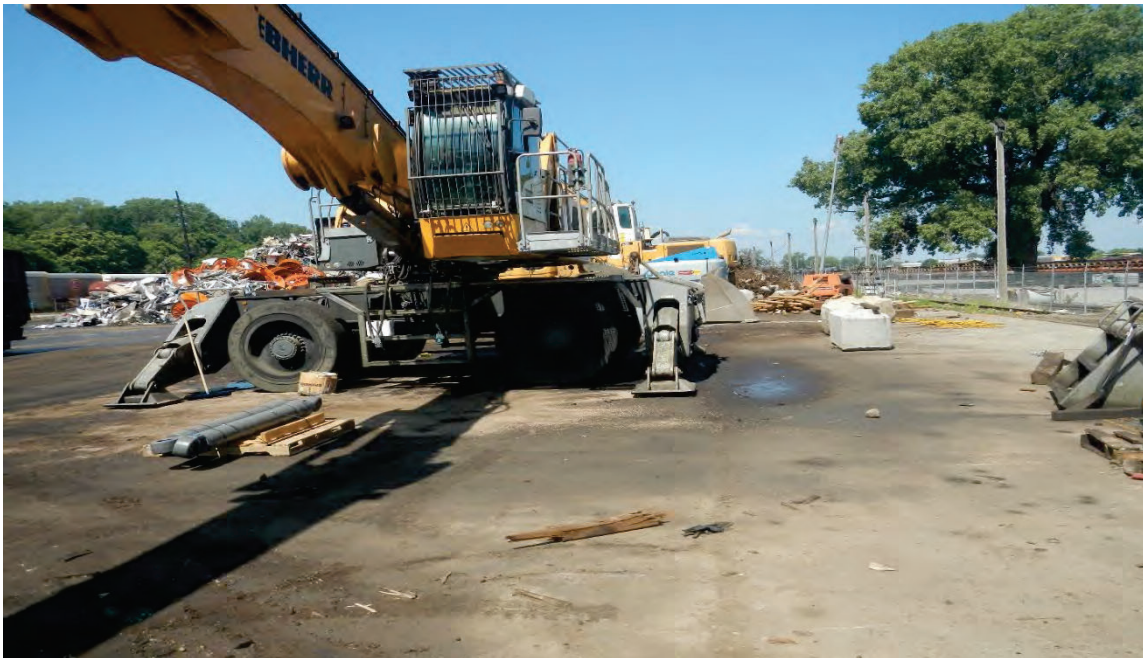
**Photo 15, significant ground discoloration**

3. During my visual inspection of the site, I observed a significant amount of ground discoloration caused by leaking equipment and improper maintenance practices within the equipment storage area (photos 15 and 16) as shown in photo 15 below. I pointed out to Facility personnel that my observation is an indication of poor housekeeping practices and it appeared that it's been going on for an extended period of time. Therefore, I issued NOPF #1 for the significant ground discoloration.

A few feet from my observation of the significant ground discoloration, was one of the stormwater inlets that conveys stormwater to Outfall 001 (photo 14). The inlet was protected by booms but had significant oil residue surrounding it.

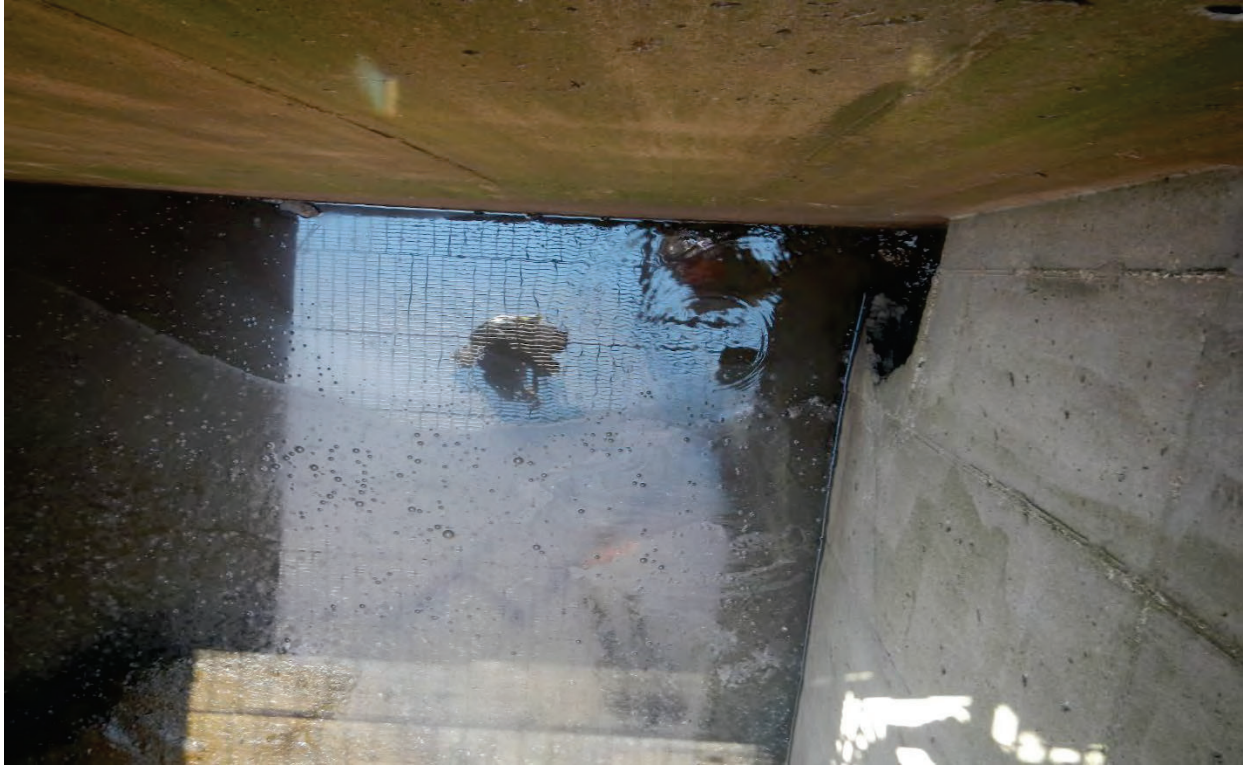
**Photo 20, oil sheen in the discharge of Outfall 001.**

4. At the time of the inspection onsite structural controls consisting of oil absorbent booms, appeared to be well maintained. However, I observed that the discharge from Outfall 001 was full of significant oil sheen (photo 20), therefore, I issued NOPF #2.

Overall, structural controls such as oil booms appeared to be installed correctly and records indicated that non-structural controls appeared adequate. However, evidence of oil spills on site and significant oil sheen in Outfall 001 indicates failure of good housekeeping practices and inadequacy of the current controls.
