INSPECTION REPORT

| Type of Inspection | Focused Compliance Inspection (FCI) | | | |
| Facility or Site Name | Gainco, Inc. | | | |
| Facility/Site Physical Address | 900 Floerke Road | | | |

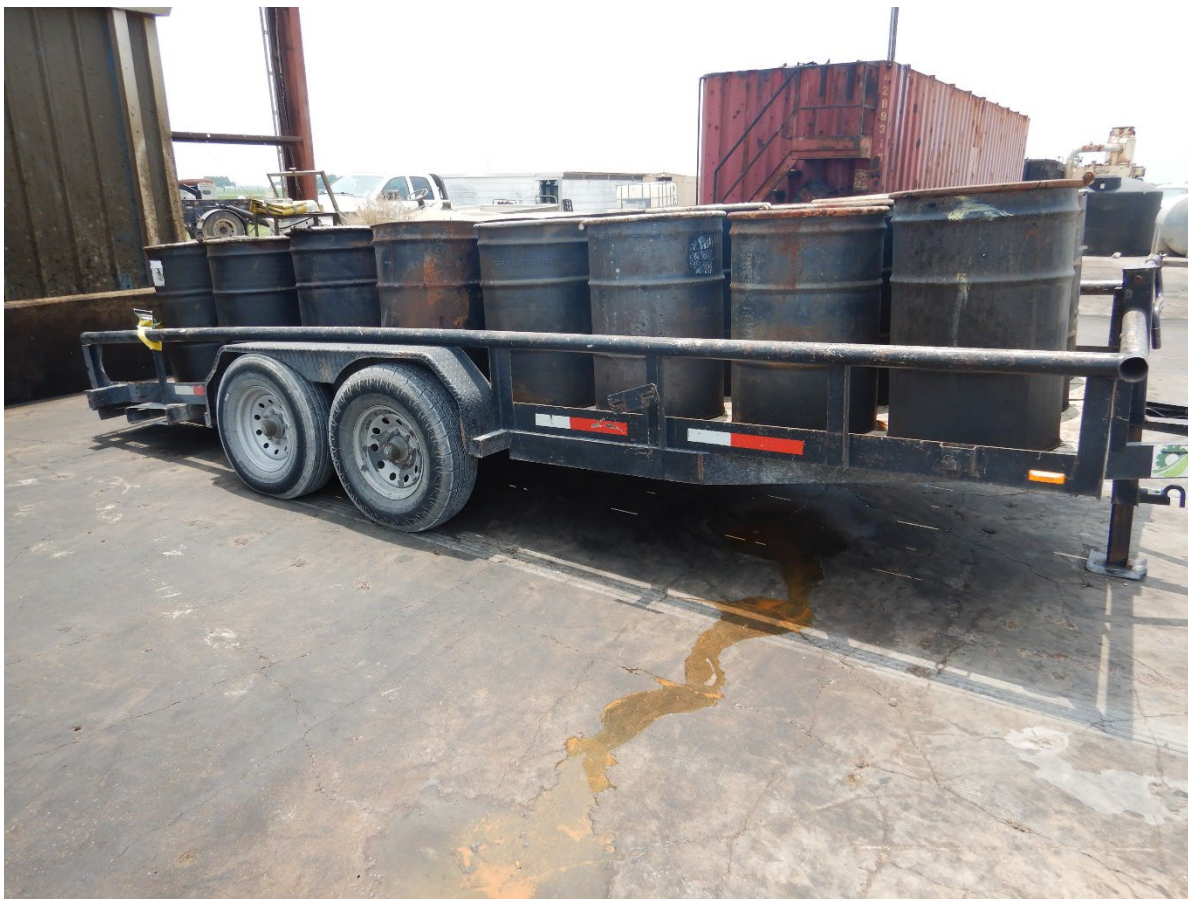
Photo No. 1

Description: Overview of trailer with 24 unlabeled 55-gallon steel drums of spent carbon/unknown waste in Gainco's general yard area.

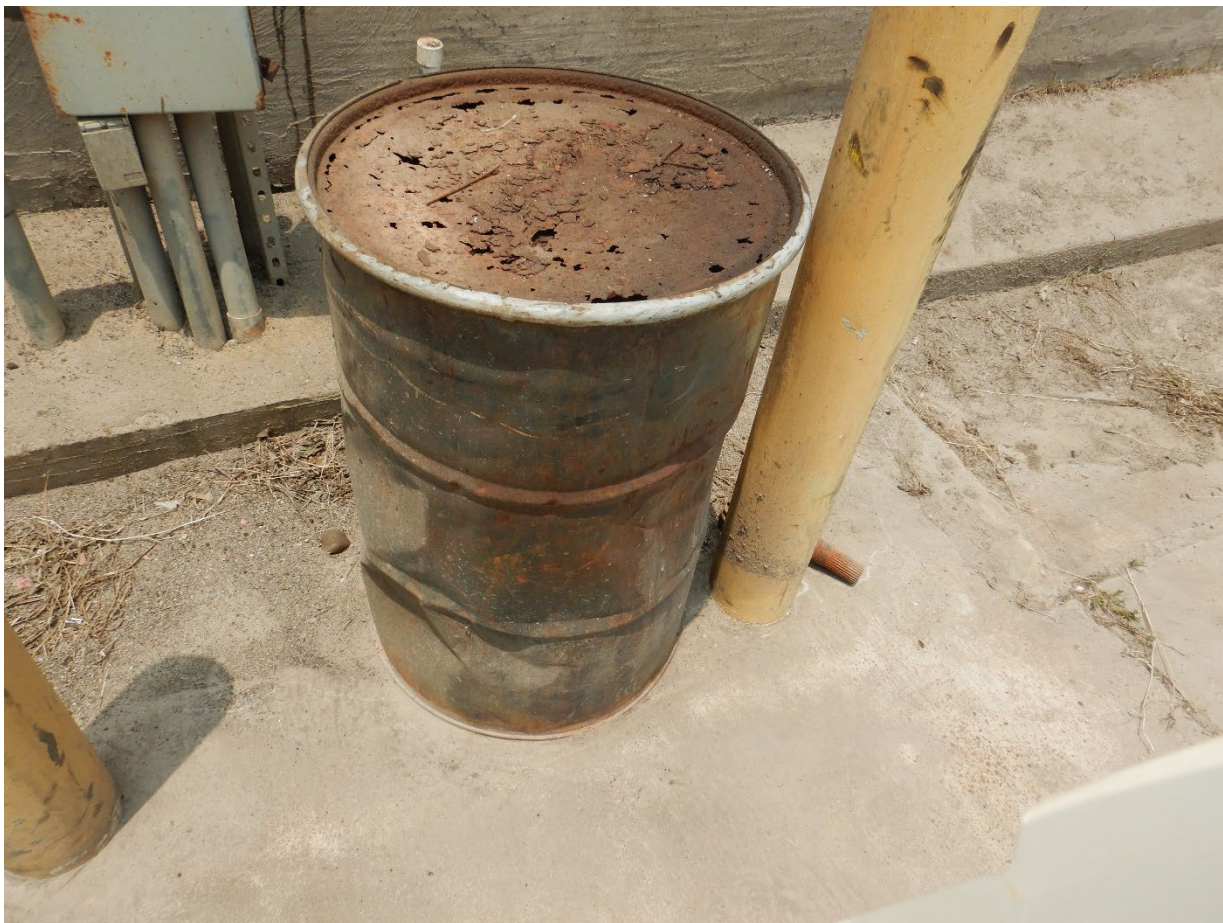
Photo No. 2

Description: View of unlabeled 55-gallon drum adjacent to Gainco's scale area with integrity issues in the drum lid.

replaced (see Appendix 5).

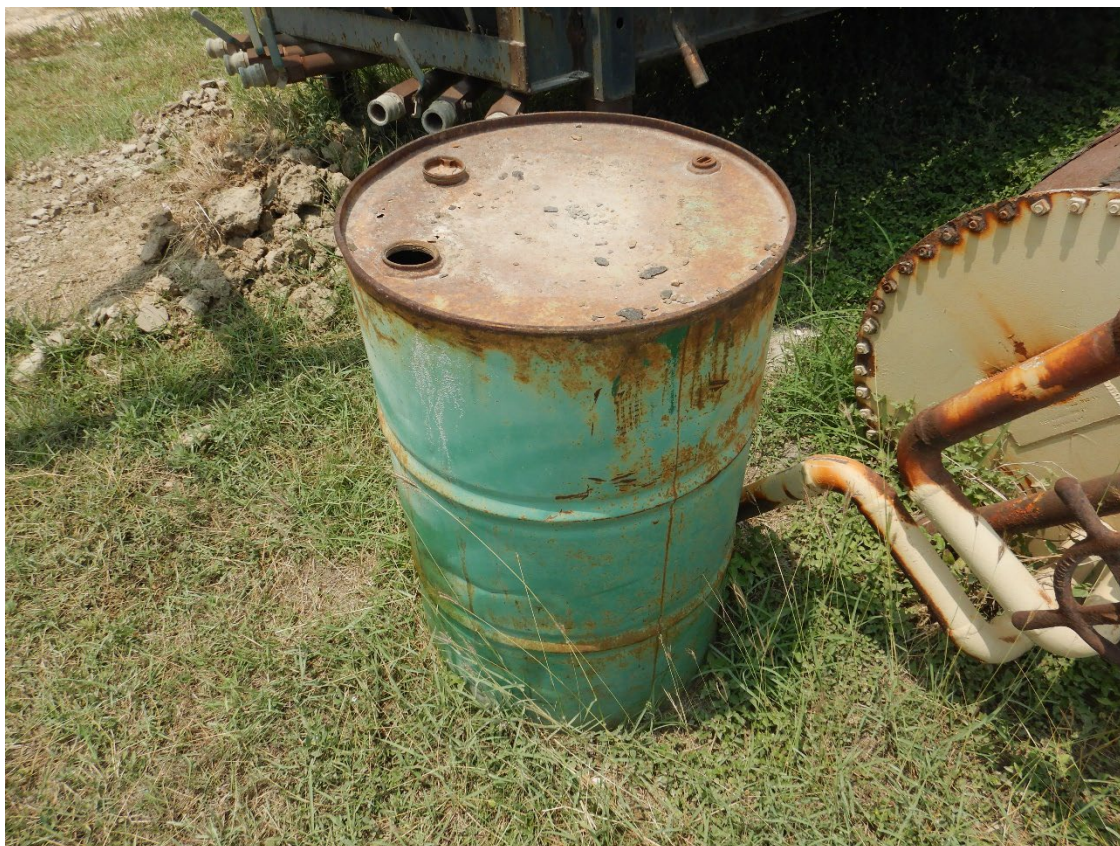
Photo No. 3

Description: View of unlabeled 55-gallon green drum with unknown waste in the northern portion of the facility.

- One unlabeled 55-gallon green drum with unknown waste on the northern portion of the facility (see Appendix 1 – Photo 3). In Ms. Garcia’s follow-up email from 06/03/2024 (see Appendix 2), an attachment was included showing that this drum was labeled as non-hazardous waste (see Appendix 6).
- One unlabeled 55-gallon drum with unknown waste adjacent to tire storage (see Appendix 1 – Photo 4). In Ms. Garcia’s follow-up email from 06/03/2024 (see Appendix 2), an attachment was included showing that this drum was labeled as non-hazardous waste (see Appendix 7).

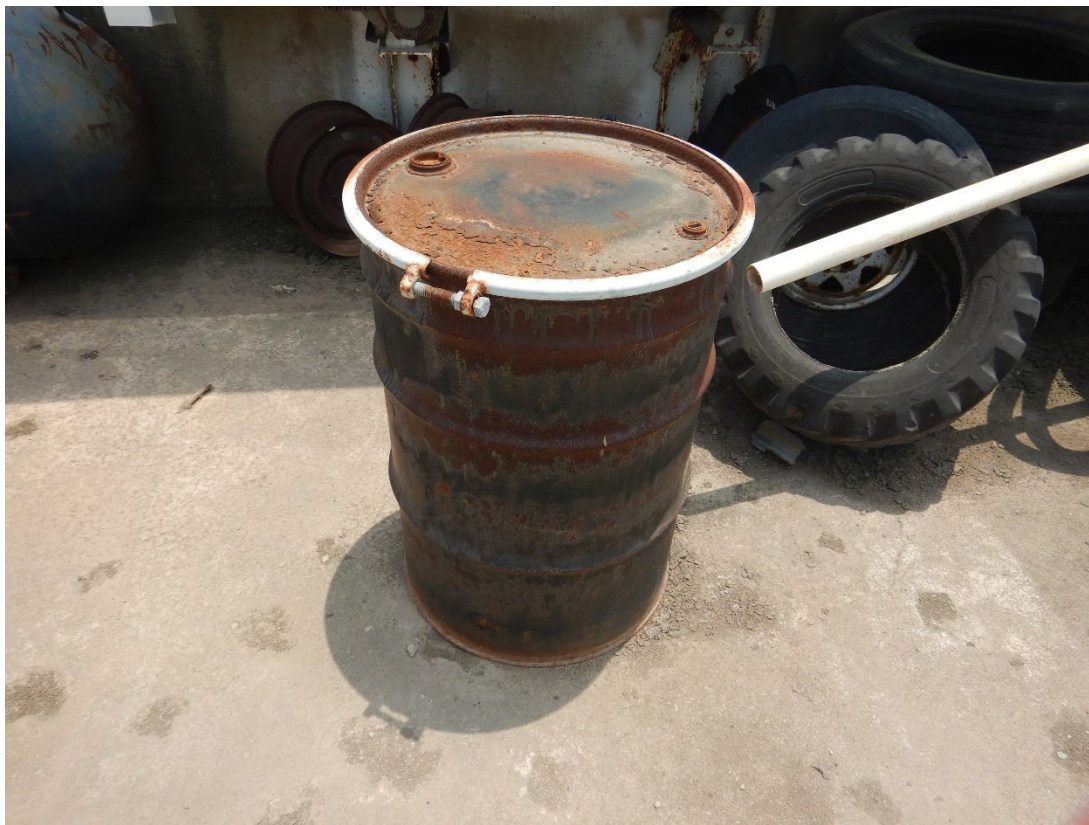
Photo No. 4

Description: View of unlabeled 55-gallon drum adjacent to Gainco's tire storage area.

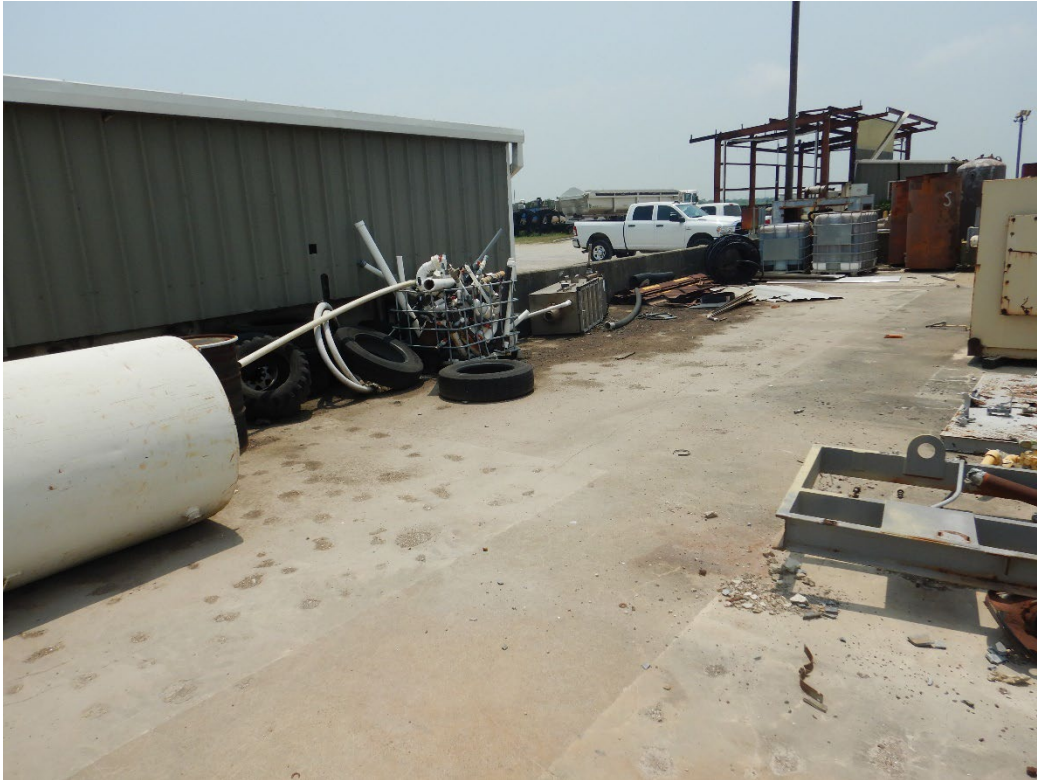
Photo No. 5

The inspection team also noted evidence of debris on the ground, which could potentially be waste from cleaning trucks or containers (see Appendix 1 – Photo 5). In Ms. Garcia’s follow-up email from 06/03/2024 (see Appendix 2), an attachment was included showing that this debris was removed, although no information was provided about whether the removed debris was determined to be a hazardous waste or how it was ultimately managed (see Appendix 8). The inspection team observed that liquid from a red frac tank was leaking into the secondary containment (see Appendix 1 – Photos 6 and 7). After the walkthrough, Gainco personnel indicated that this frac tank held non-hazardous oily water. The inspection team does not have sufficient information on the origin of the oily water to be able determine whether it is used oil or a non-hazardous waste stream.

Description: View of the area with evidence of debris on the ground, towards the top of the photograph, in Gainco's general yard area (observed).

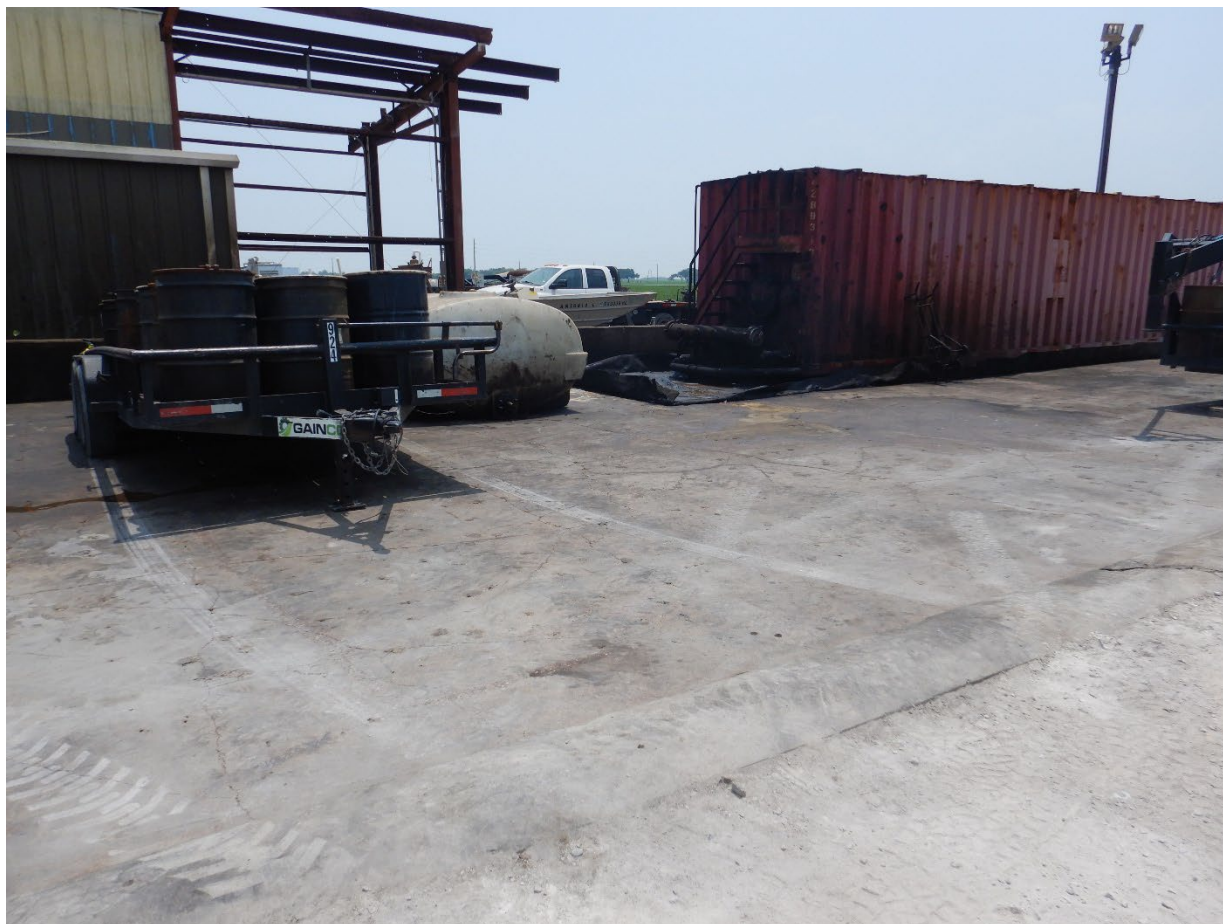
Photo No. 6

Description: Overview of area with trailer containing 24 unlabeled 55-gallon drums and leaking red frac tank in Gainco's general yard area.

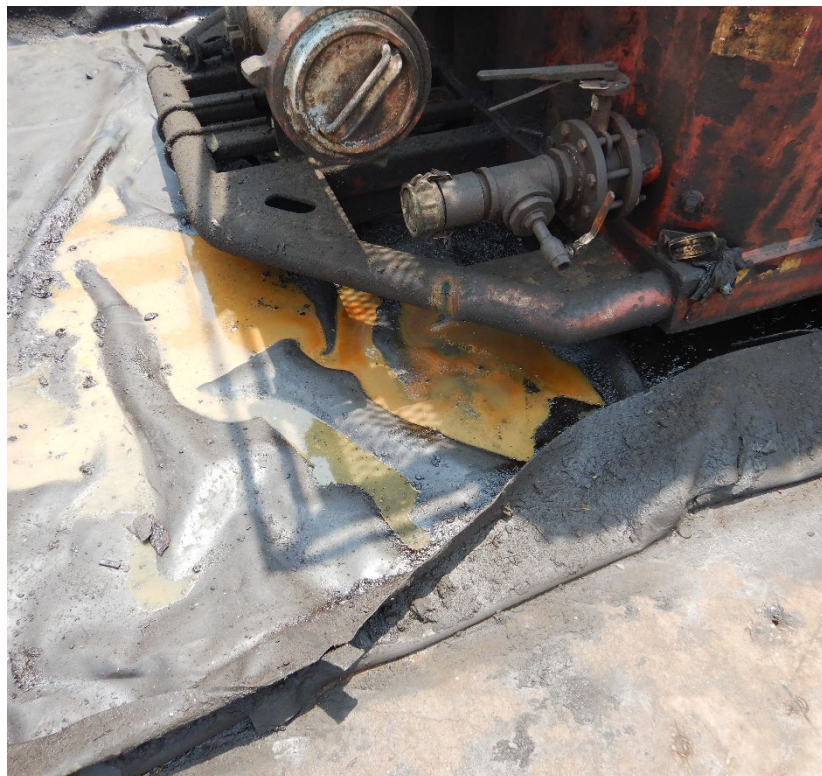
Photo No. 7

Description: Close-up of leaking liquid from the red frac tank shown in Photo No. 6 in Gainco's general yard area.

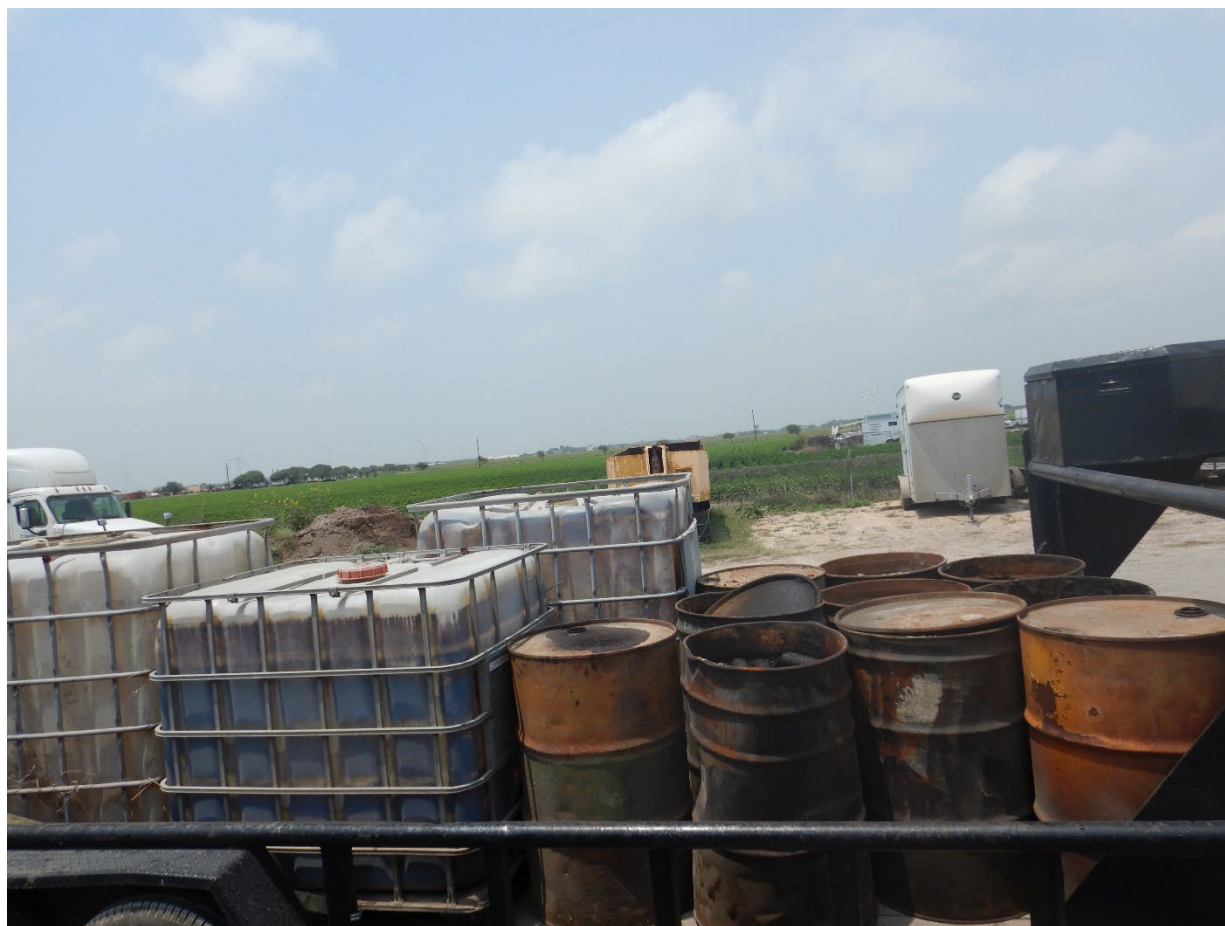
Photo No. 8

Description: Overview of trailer with 10 unlabeled 55-gallon drums of spent carbon/unknown material in Gainco's general waste area.
