## Region 6 - Enforcement & Compliance Assurance Division

### INSPECTION REPORT

| Facility Name: | <b>Denton Estates Mobile Home Park</b> | |
| Identification/Permit Number: | TX0610016 | |

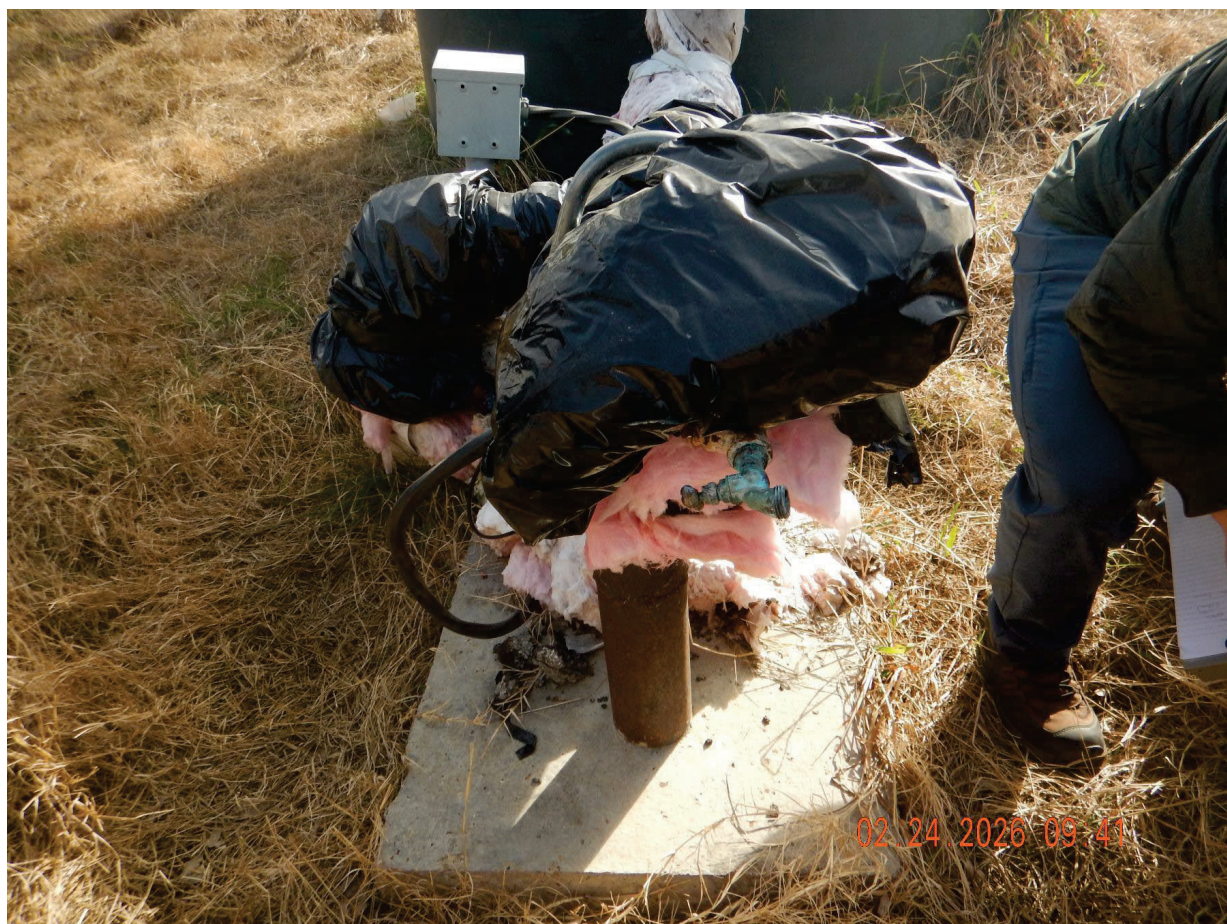
Photo No. 1

- Well No.1 was located outdoors on a concrete well pad (Appendix 2, Photo 1).
- The Well was equipped with 200 GPM pump and the pipe from the well was covered with insulation materials at the time of inspection (Appendix 2, Photo 2).

| Description: | View of concrete well pad. |

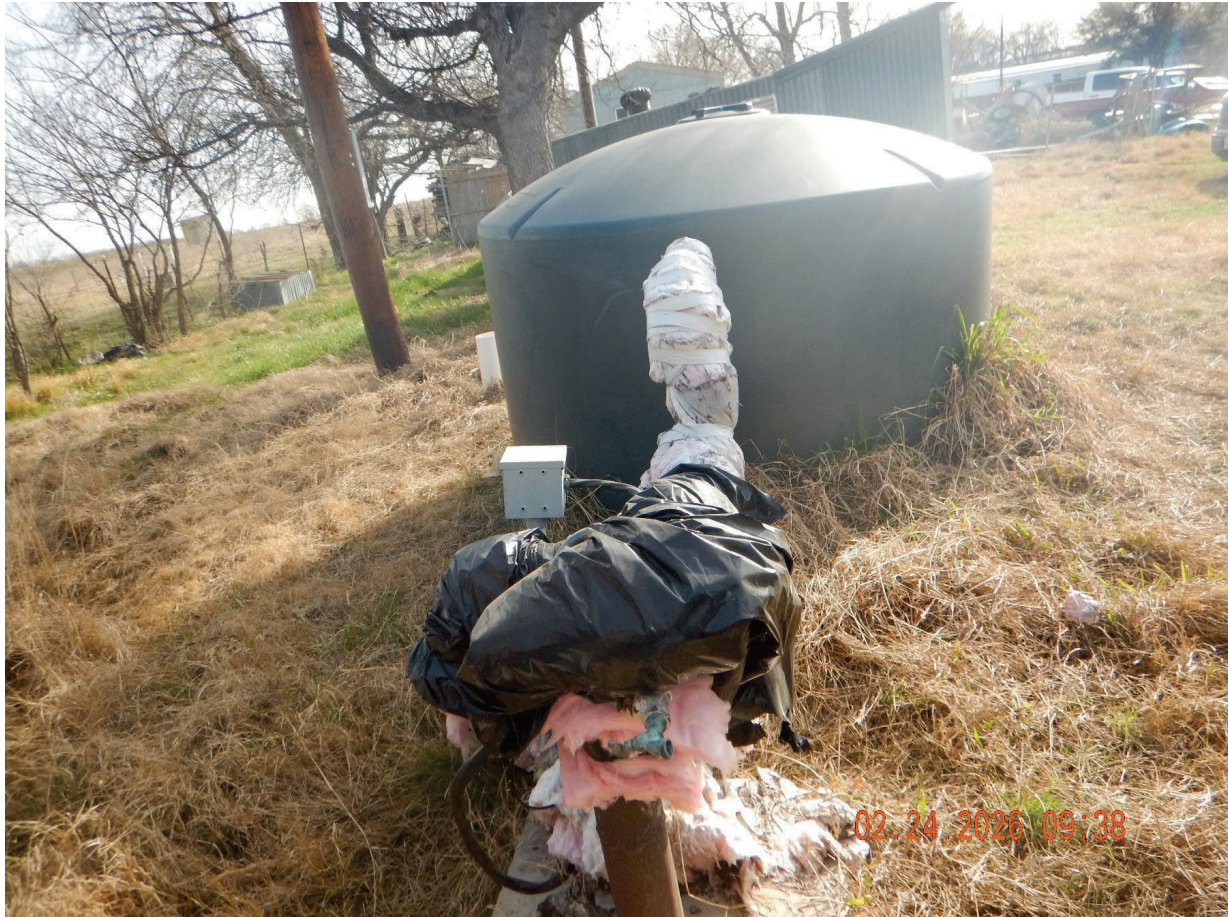
Photo No. 2

| Description: | View of Insulation materials. |

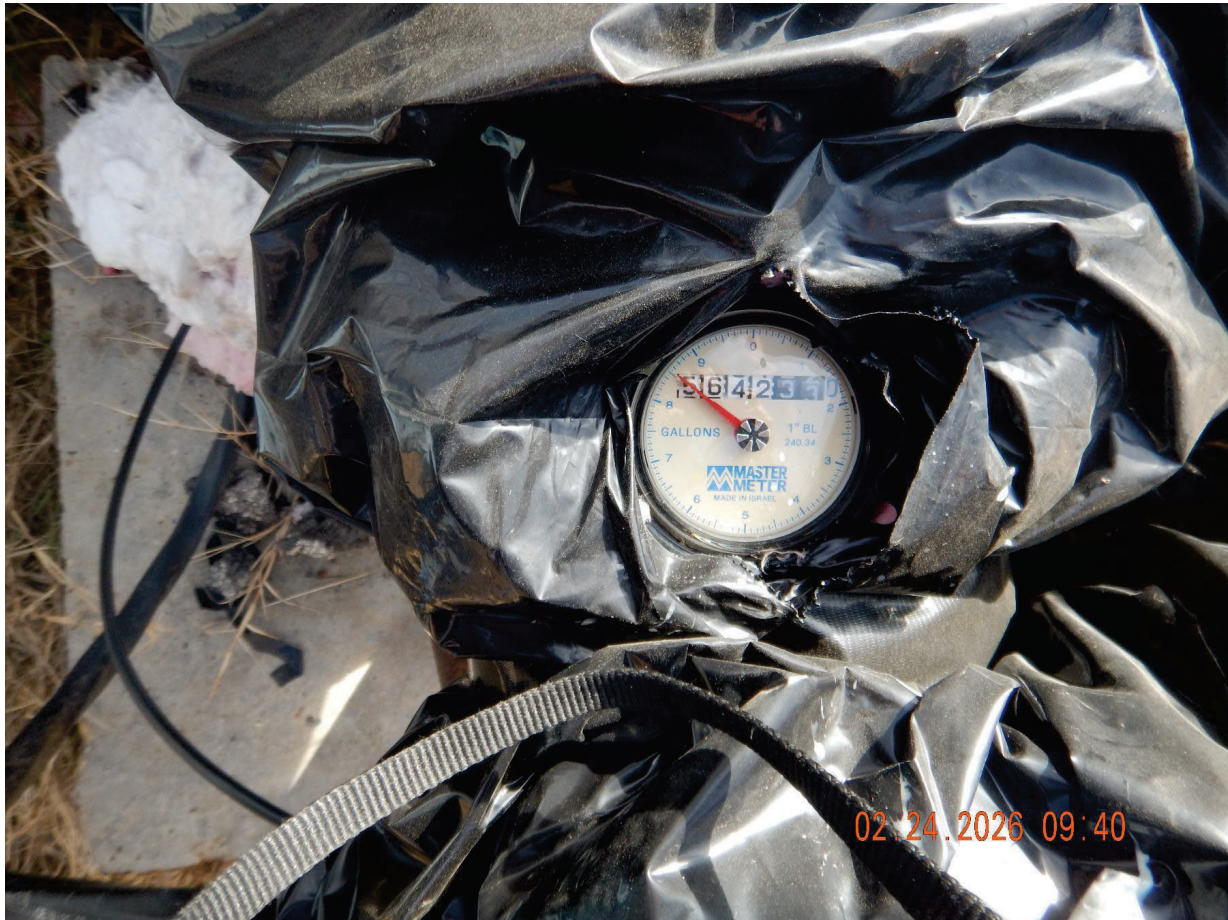
- The master meter is functional and in good repair (Appendix 2, Photo 3).
- The raw water sample tap displayed signs of corrosion (Appendix 2, Photo 4).

| Description: | View of master meter. |

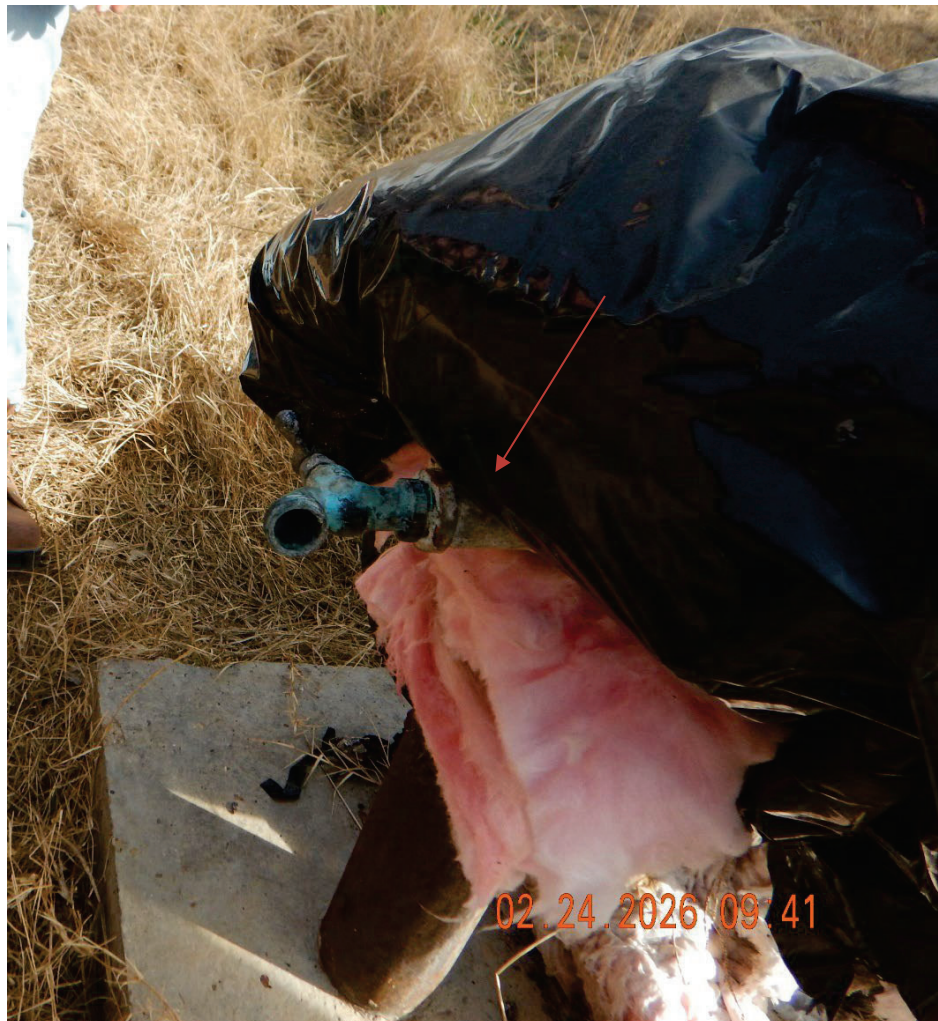
- The raw water sample tap was positioned horizontally instead of pointing down and the faucet appeared to be threaded (Appendix 2, Photo 4).
- The air relief valve appeared to be properly screened and in good repair (Appendix 2, Photo 5).

| Description: | View of Raw Water sample tap. Arrowing is pointing to corrosion on the sample tap. |

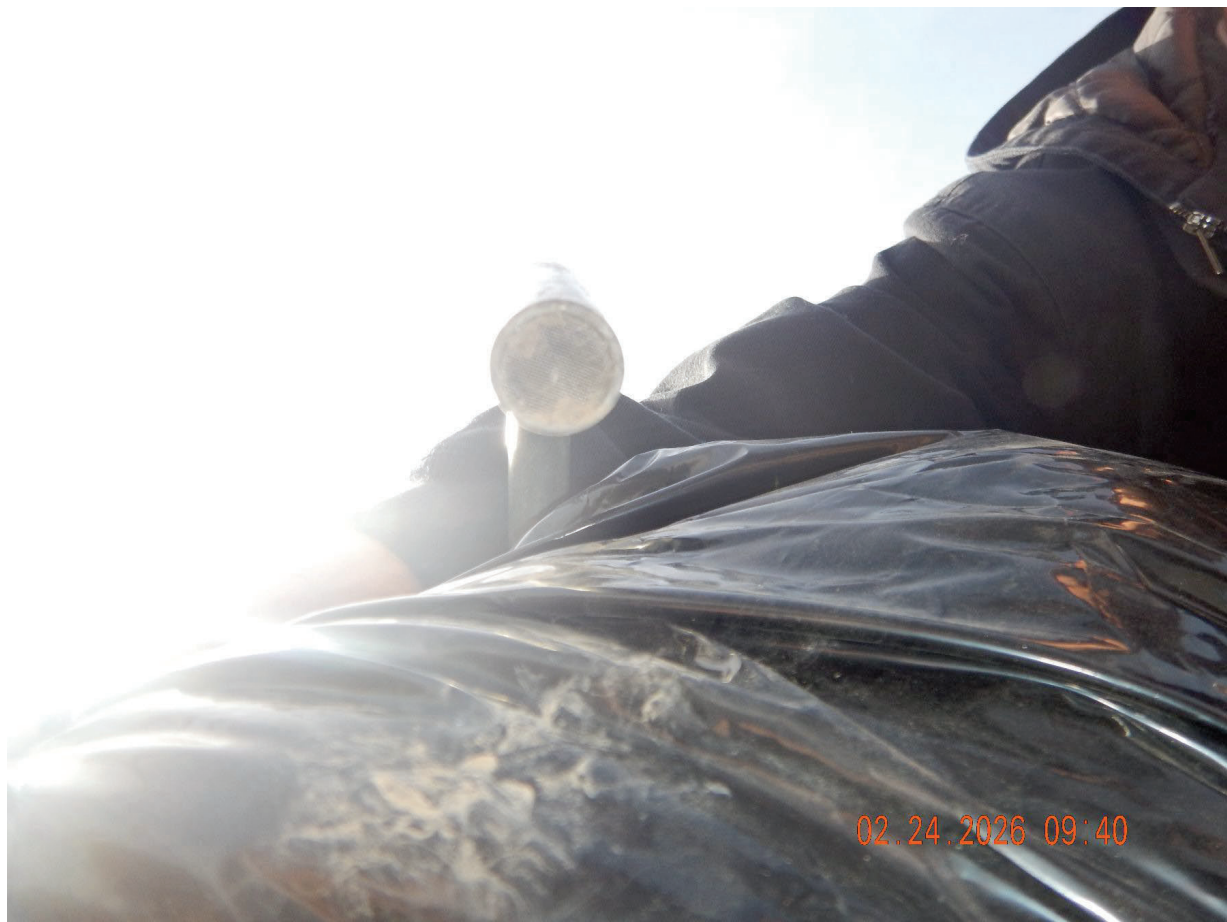
| Description: | View of screened air relief valve. |

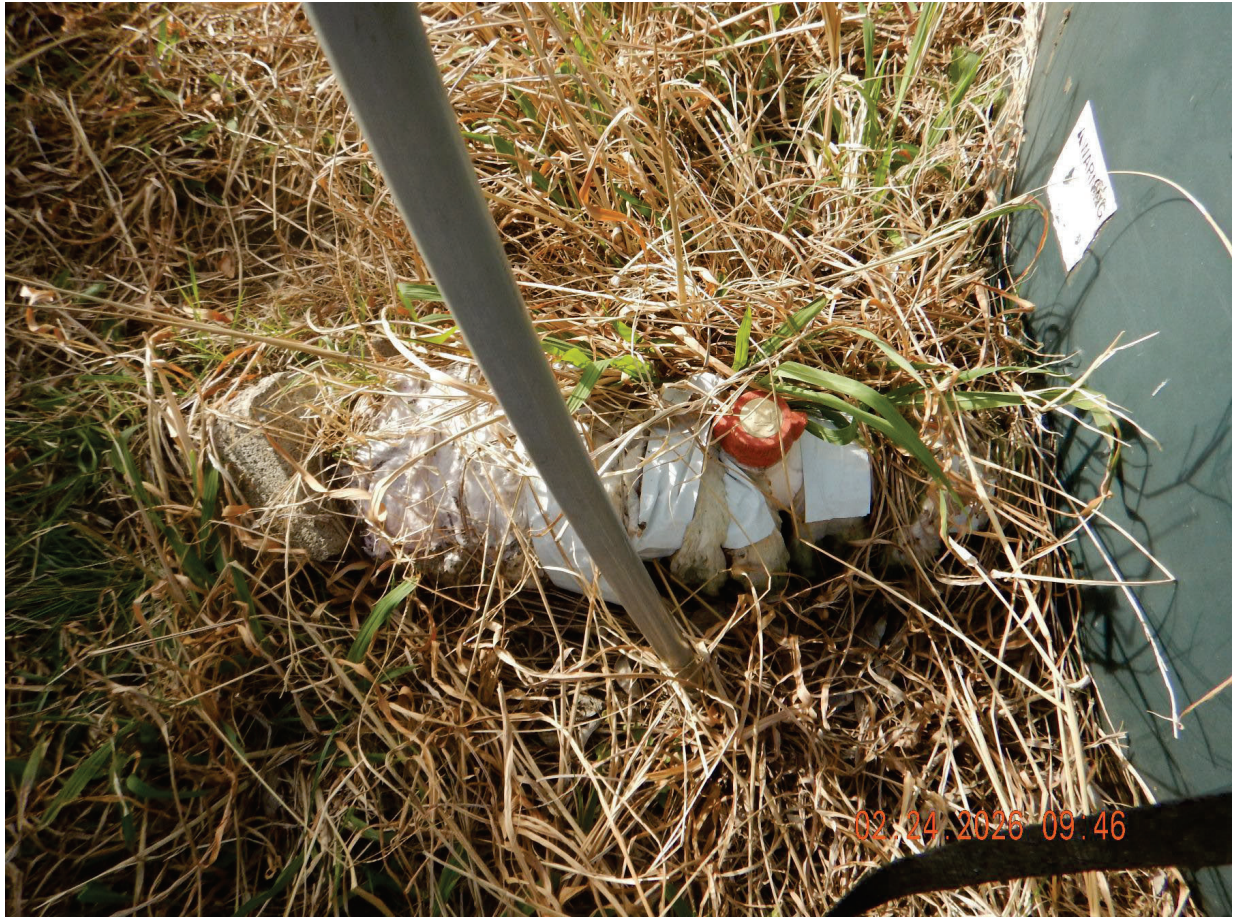
- The injection valve was covered in insulation (Appendix 2, Photo 9).
- The landscaping around the injection valve was overgrown and mostly covered the valve, making it not easily visible (Appendix 2, Photo 9).
- The system representatives stated that there are no flow alarms to indicate changes in chemical treatment.

| Description: | View of Chlorine Injection. Landscaping appears overgrown. |

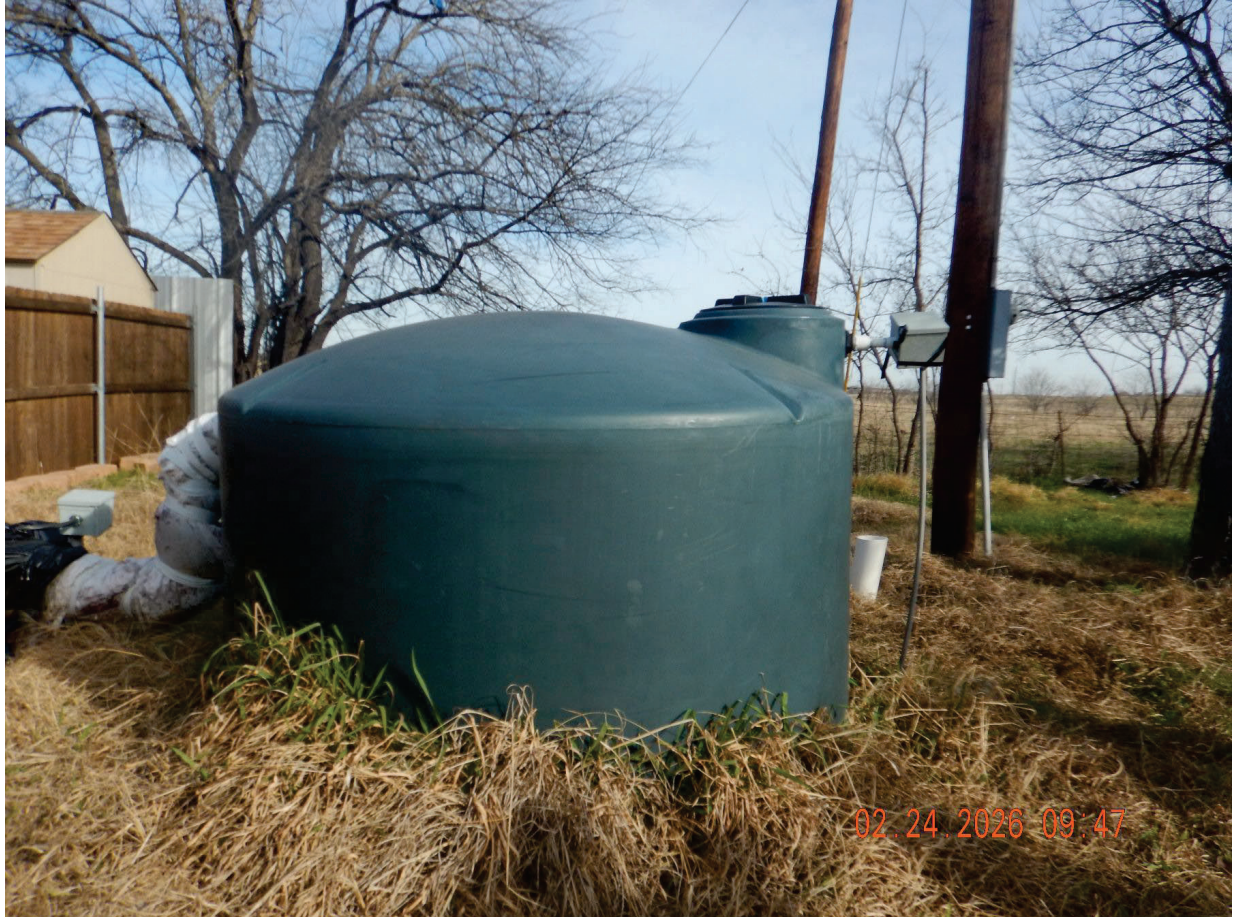
- 1500-gallon tank capacity
- The system uses a Polyvinyl chloride (PVC) tank.
- The landscaping around the tank did not appear to be properly maintained (Appendix 2, Photo 12). However, the system representatives stated that landscaping duties are normally performed on a monthly schedule.
- The tank did not have an overflow drainage pipe.
- The system representatives stated that inside the GST they have a float switch. The float switch was replaced last year.
- System representatives were unsure of when the tank had last been inspected.
- The GST appeared to be experiencing foundation settlement. The bottom of the tank was not visible due to the overgrown grass and the tank settling into the ground maintained. The tank also appeared uneven (Appendix 2, Photo 13).

**Area of Concern 8.** The ground storage tank lacked a foundation pad.

| Description: | View of grass growing alongside GST. |

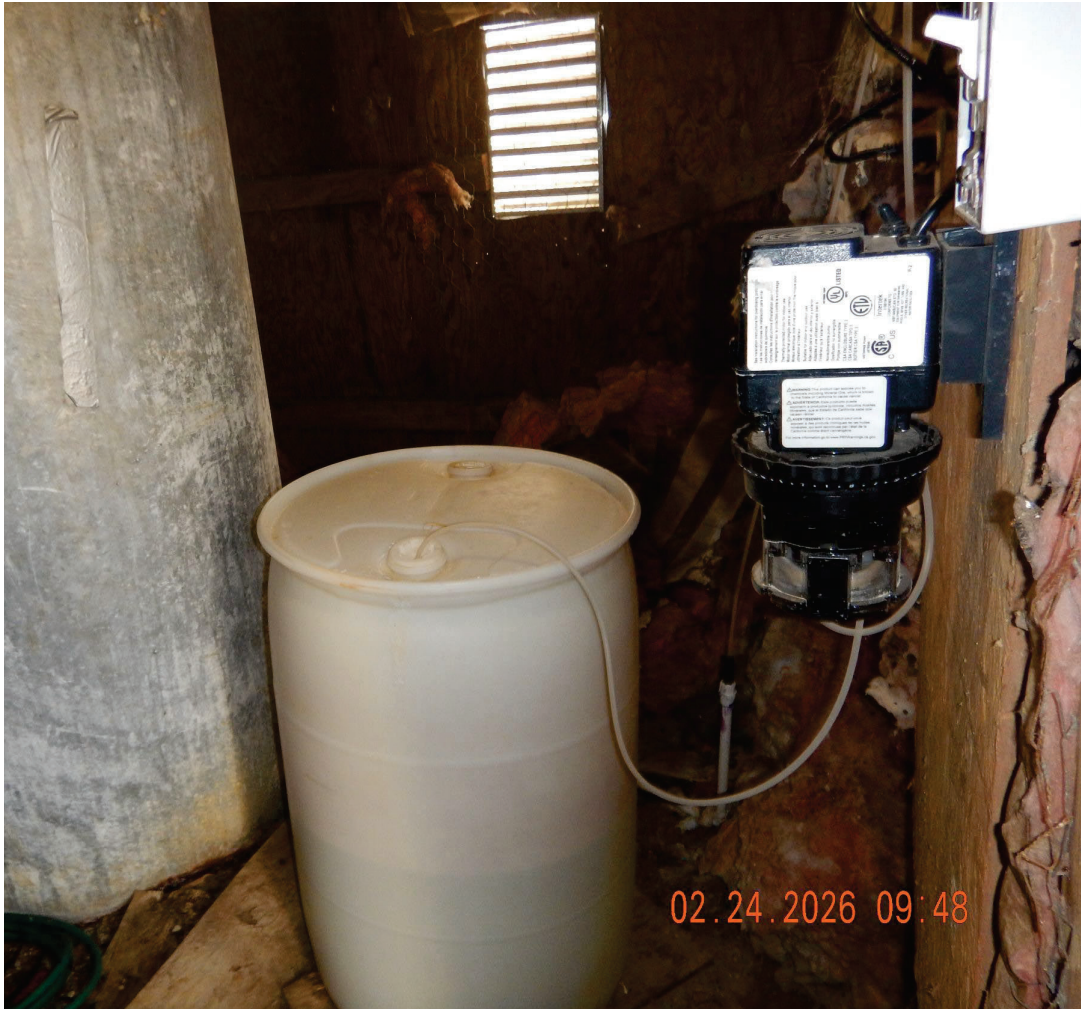
- The water is disinfected with liquid chlorine.
- The system representatives stated that they purchase a chlorine solution from DPC industries.
- The chlorine solution is stored inside the pump house.
- The chlorine solution is kept in a white 50-gallon tank (Appendix 2, Photo 14).
- The system representatives stated chlorine levels are monitored weekly during the operator's visits.
- The system representatives stated that their target chlorine residual is 1.0 mg/L.
- System representatives stated that the average chlorine residual is 0.77 mg/L. MORs submitted to TCEQ confirmed that.

| Description: | View of 50-gallon tank of chlorine solution in the pump house for well No.1 |

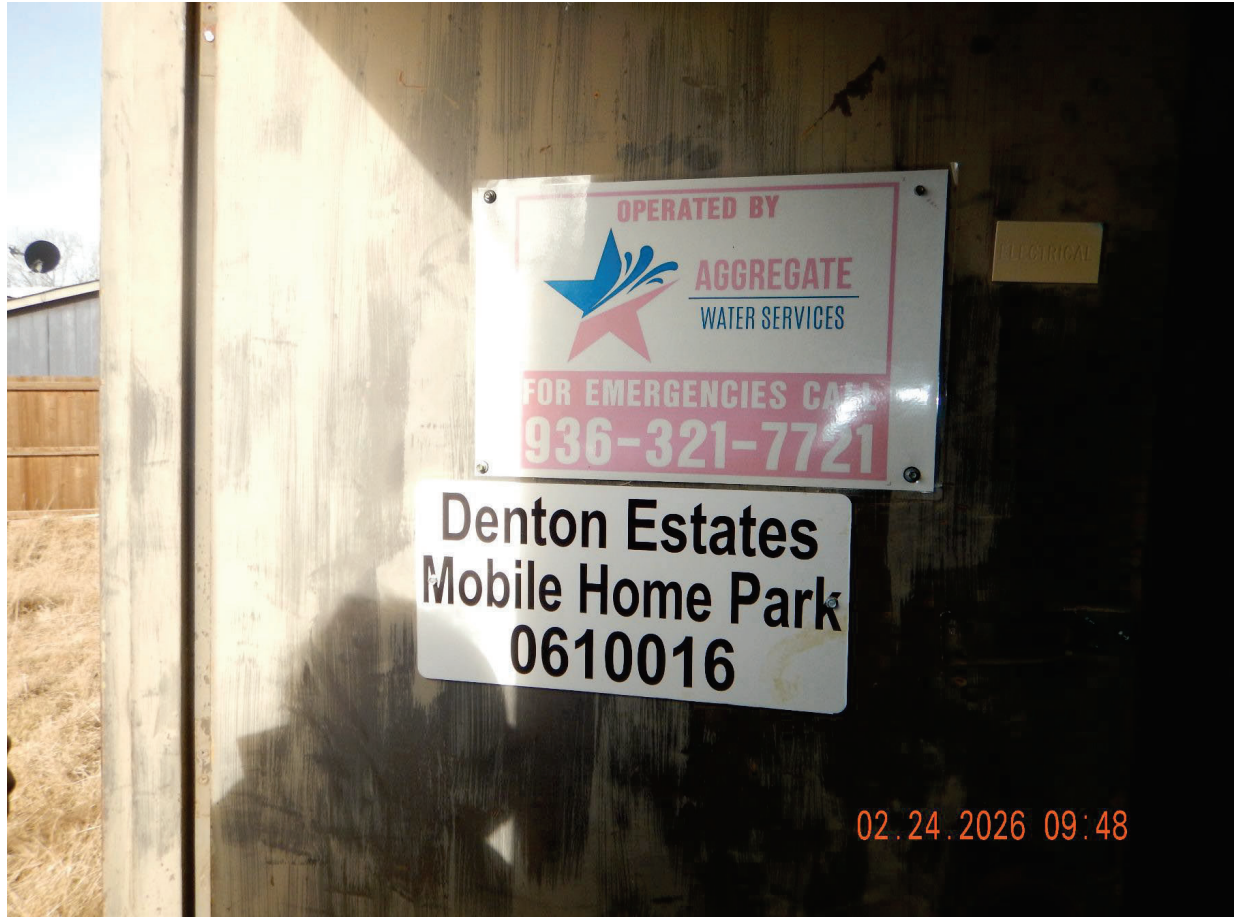
| Description: | View of signage posted on the door to the pump house. |

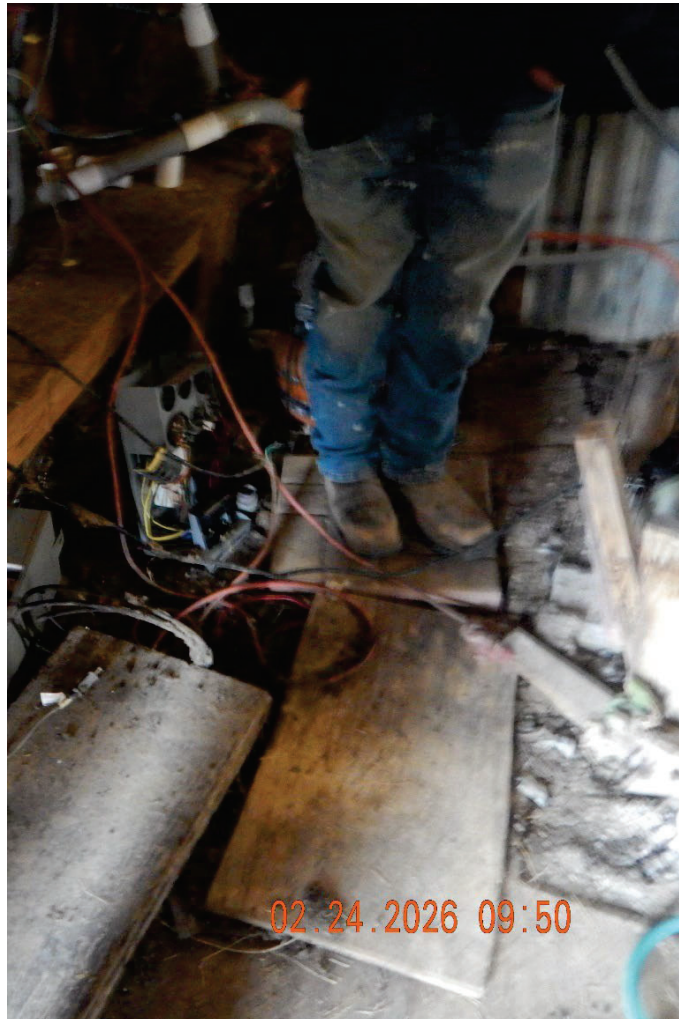
- An ownership sign with emergency contact information was posted on the door to the pump house (Appendix 2, Photo 10).
- [REDACTED]
- The floor of the pump house was constructed of loose wooden panels (Appendix 2, Photo 12)
- Various areas were covered in exposed insulation materials (Appendix 2, Photo 13).
- Various loose wires were observed close to the ground on inside of the Pump House. (Appendix 2, Photo 13).
- The inspection team identified small gaps in the back wall of the pump house.

| Description: | View of loose floorboards in the pump house. |

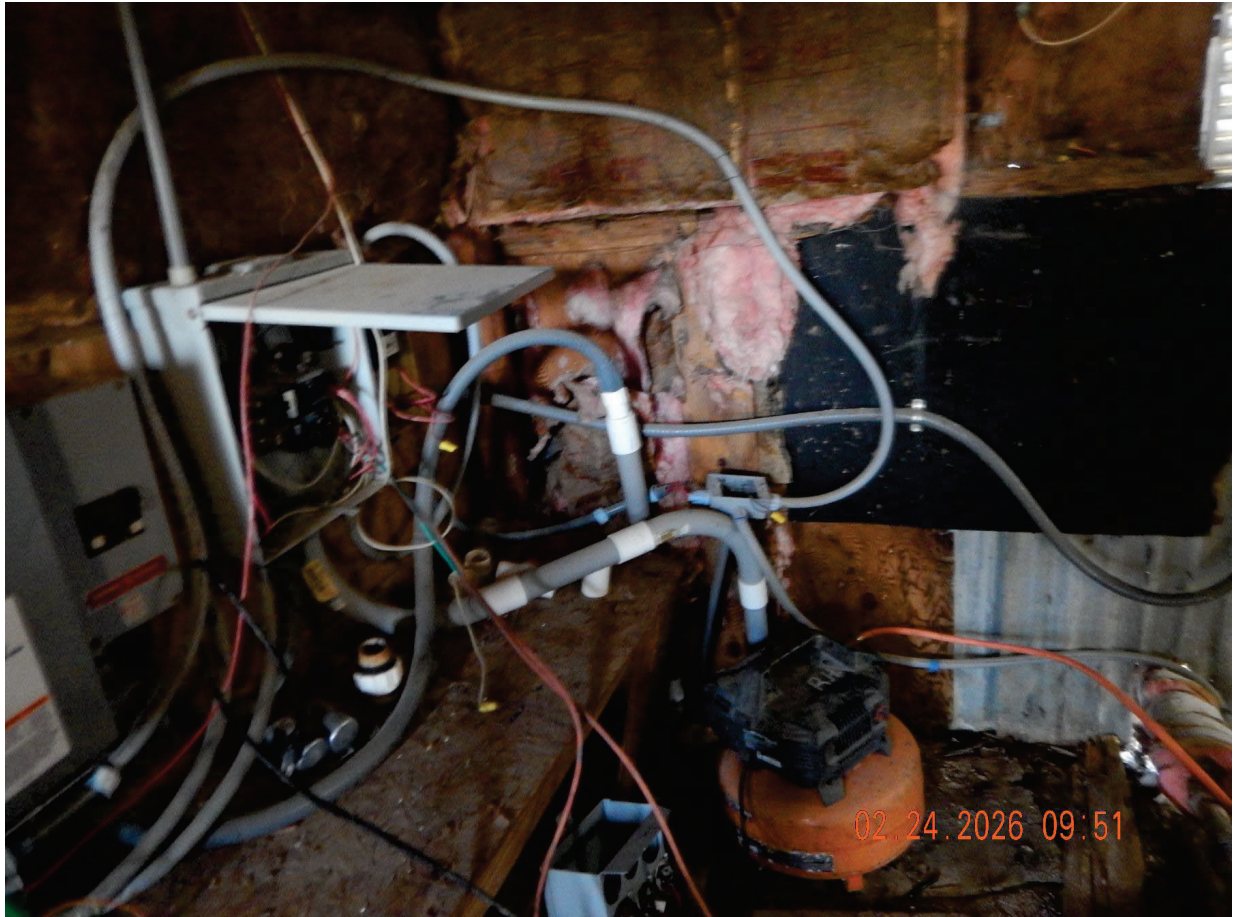
**Area of Concern 10.** The wires in the pump house of Well No.1 were exposed and not properly secured.

**30 TAC §290.46(v)** Electrical wiring. All water system electrical wiring must be securely installed in compliance with a local or national electrical code.

| Description: | View of loose wires in the pump house. |

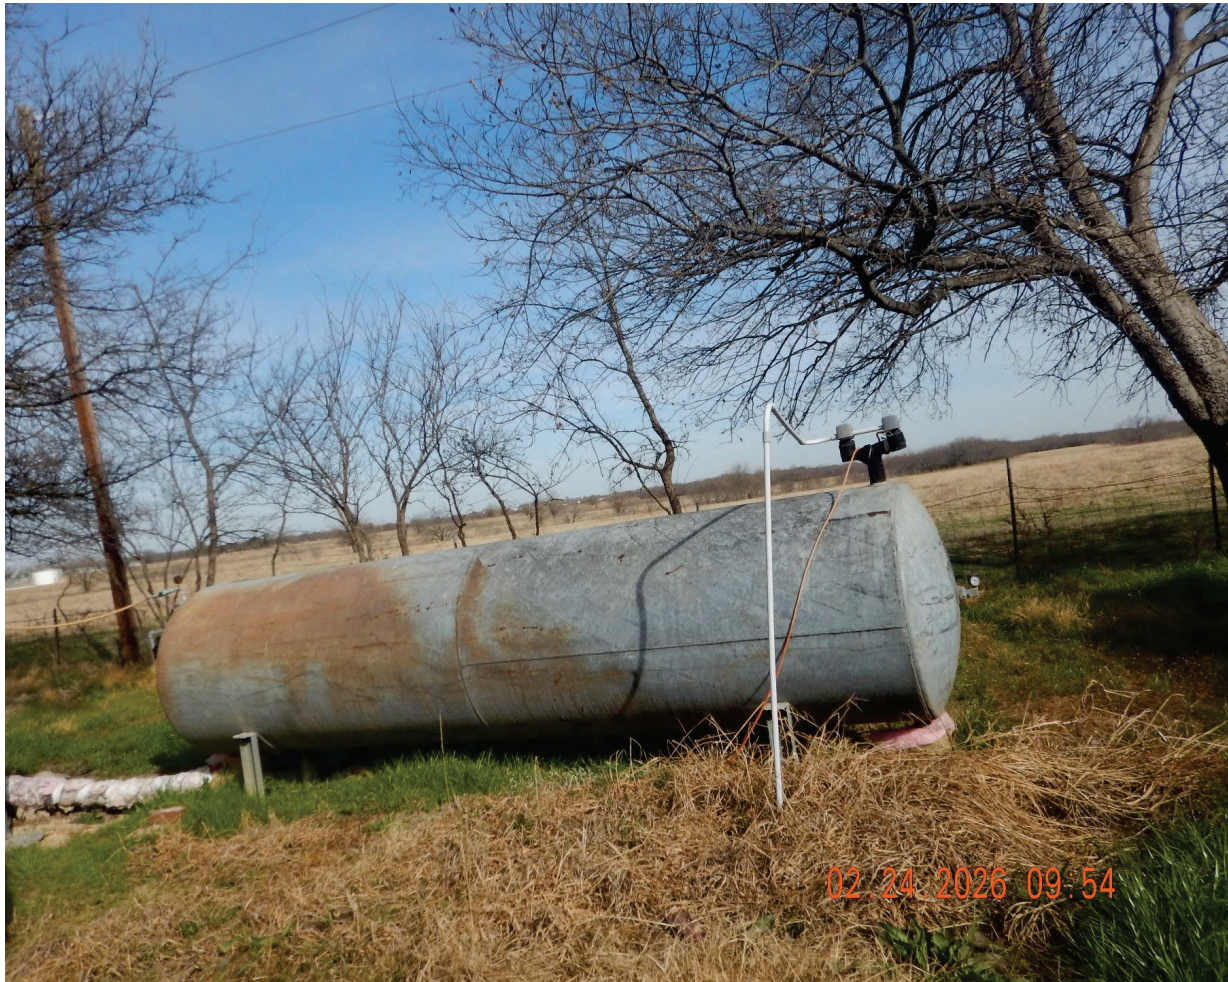
- The hydro-pneumatic tank has a capacity of 990-gallons.
- The pressure tank displayed signs of rust on the exterior (Appendix 2, Photo 14)
- Two pressure gauges we observed in working conditions.
- During the time of the inspection the pressure gauge monitoring the GST measured at 30 psi (Appendix 2, Photo 15).
- During the time of the inspection the pressure gauge monitoring the water pressure being sent to distribution measured at approximately 42 psi.

**Area of Concern 11.** The hydro-pneumatic tank at Well No.1 displayed signs of rust on the exterior.

**30 TAC §290.46(m)(1)(B)** Pressure tank inspections must determine that the pressure release device and pressure gauge are working properly, the air-water ratio is being maintained at the proper level, the exterior coating systems are continuing to provide adequate protection to all metal surfaces, and the tank remains in watertight condition. Pressure tanks provided with an inspection port must have the interior surface inspected every five years.

| Description: | View of rust on the Hydro-pneumatic Tank. |

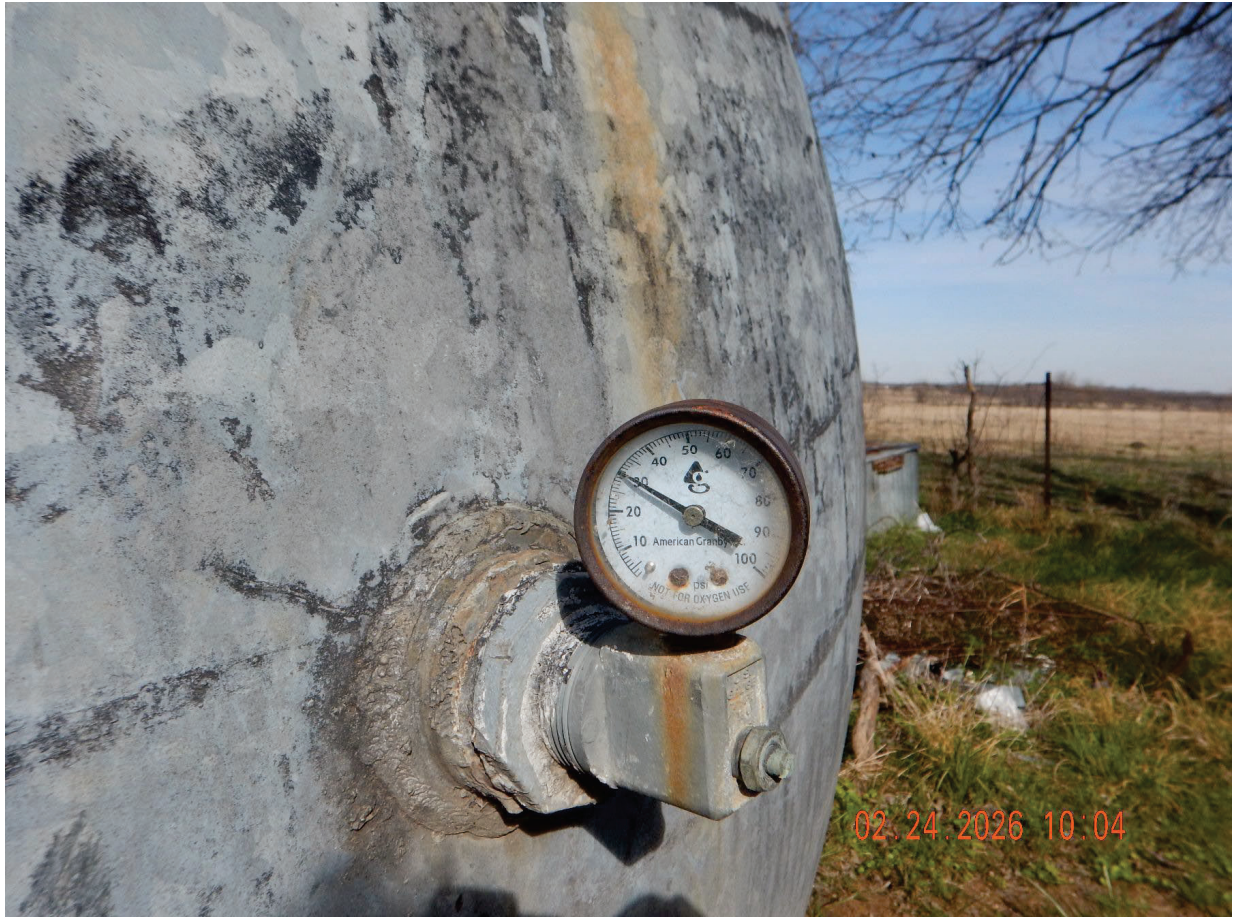
| Description: | View of pressure gauge on the Hydro-pneumatic Tank. |

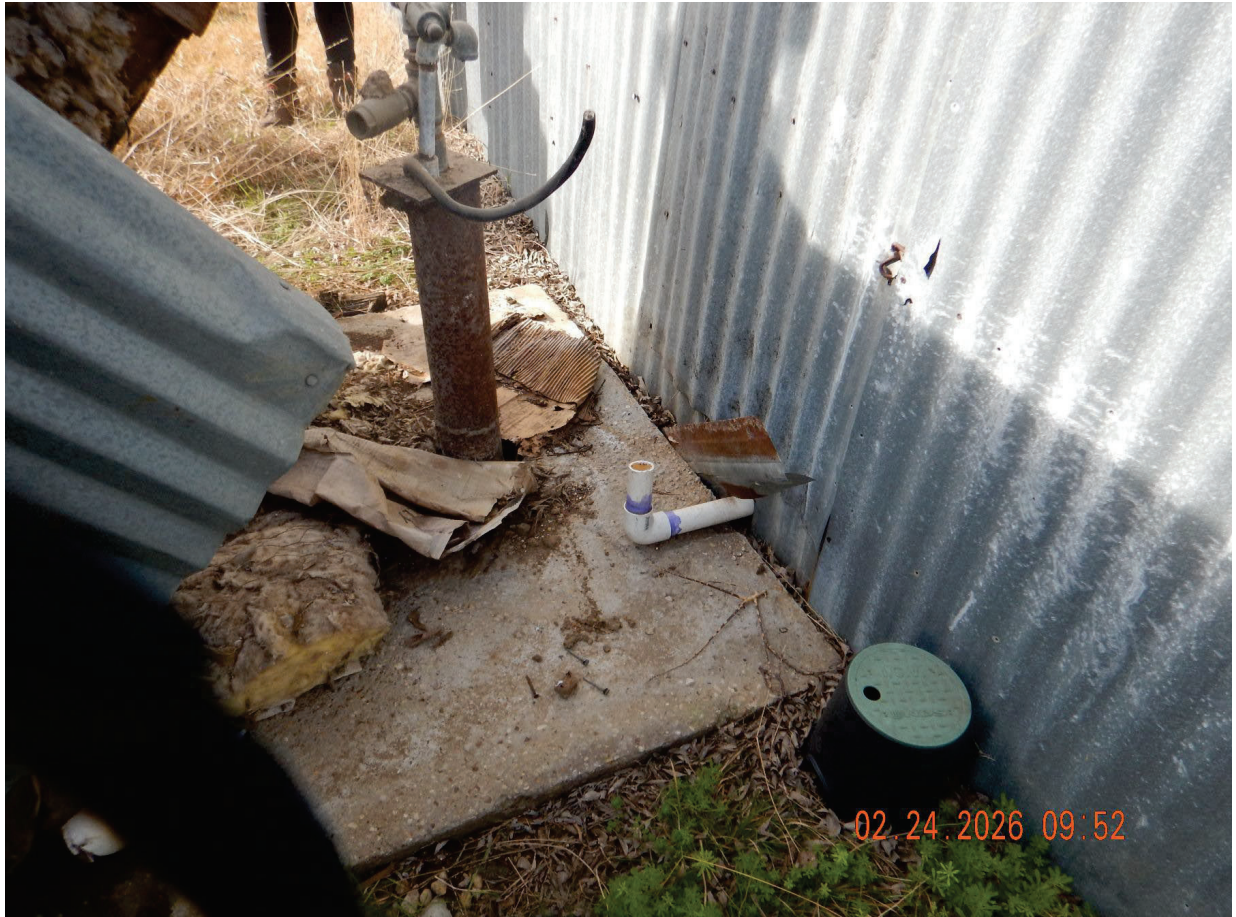
**Area of Concern 12.** Well No.2 had not been properly plugged.

**30 TAC §290.46(u)** Abandoned public water supply wells owned by the system must be plugged with cement according to 16 TAC Chapter 76 (relating to Water Well Drillers and Water Well Pump Installers). Wells that are not in use and are non-deteriorated as defined in those rules must be tested every five years or as required by the executive director to prove that they are in a non-deteriorated condition. The test results shall be sent to the executive director for review and approval. Deteriorated wells must be either plugged with cement or repaired to a non-deteriorated condition.

| Description: | View of concrete well pad of well No.2 |

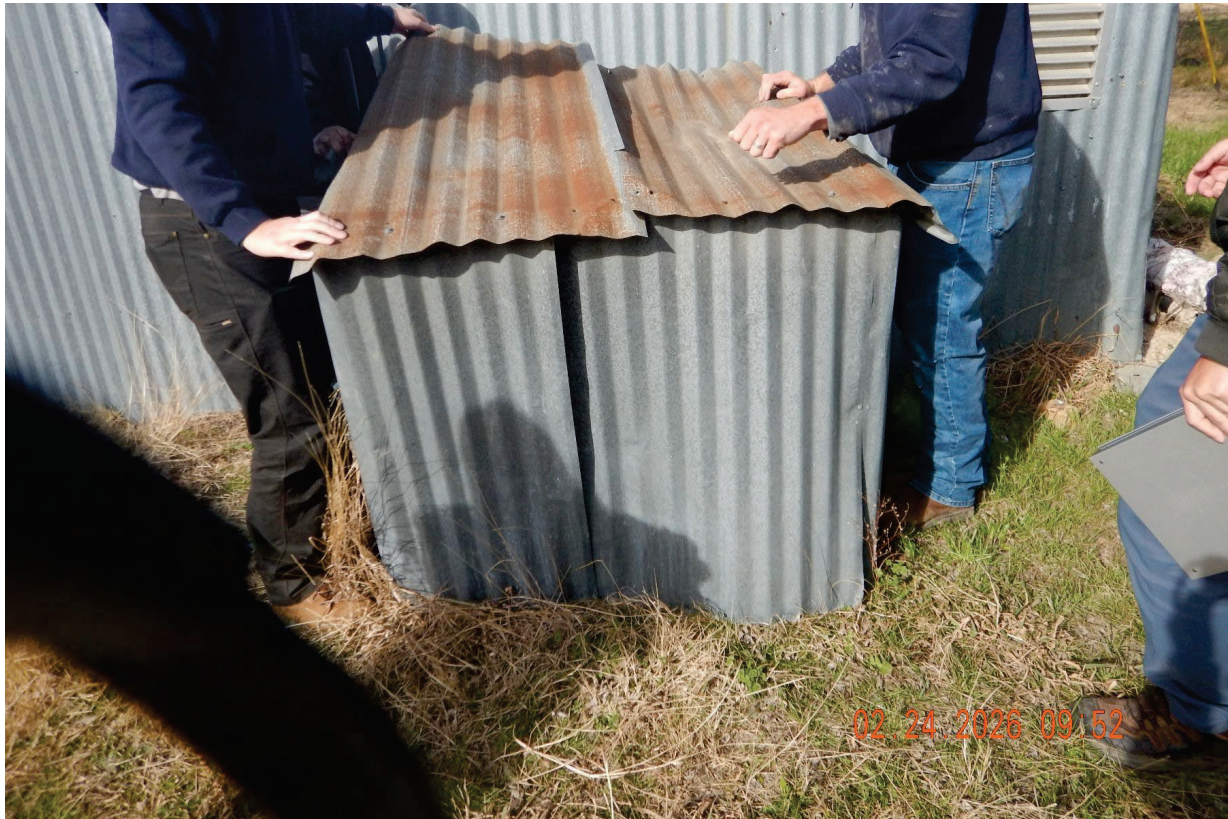
**Area of Concern 9.** In the pump house various holes were observed along the back wall.

**Area of Concern 15.** The well house had a crack along the wall and a gap in the seam.

| Description: | View of well house. |
