**Clean Water Act (CWA) Inspection Report**

| <b>Program:</b> Industrial Stormwater | <b>Inspection Type:</b> Compliance Evaluation Inspection (CEI) | |
| <b>Facility Inspected:</b> Drew's Auto Parts, A Division of Camaro Heaven, 112 Clark Road, Tilton NH 03276 | <b>Lat, Long:</b> 43.448773°, -71.614740°<br><b>NAICS / SIC Code:</b> Not known by the On-site Facility Representative | |

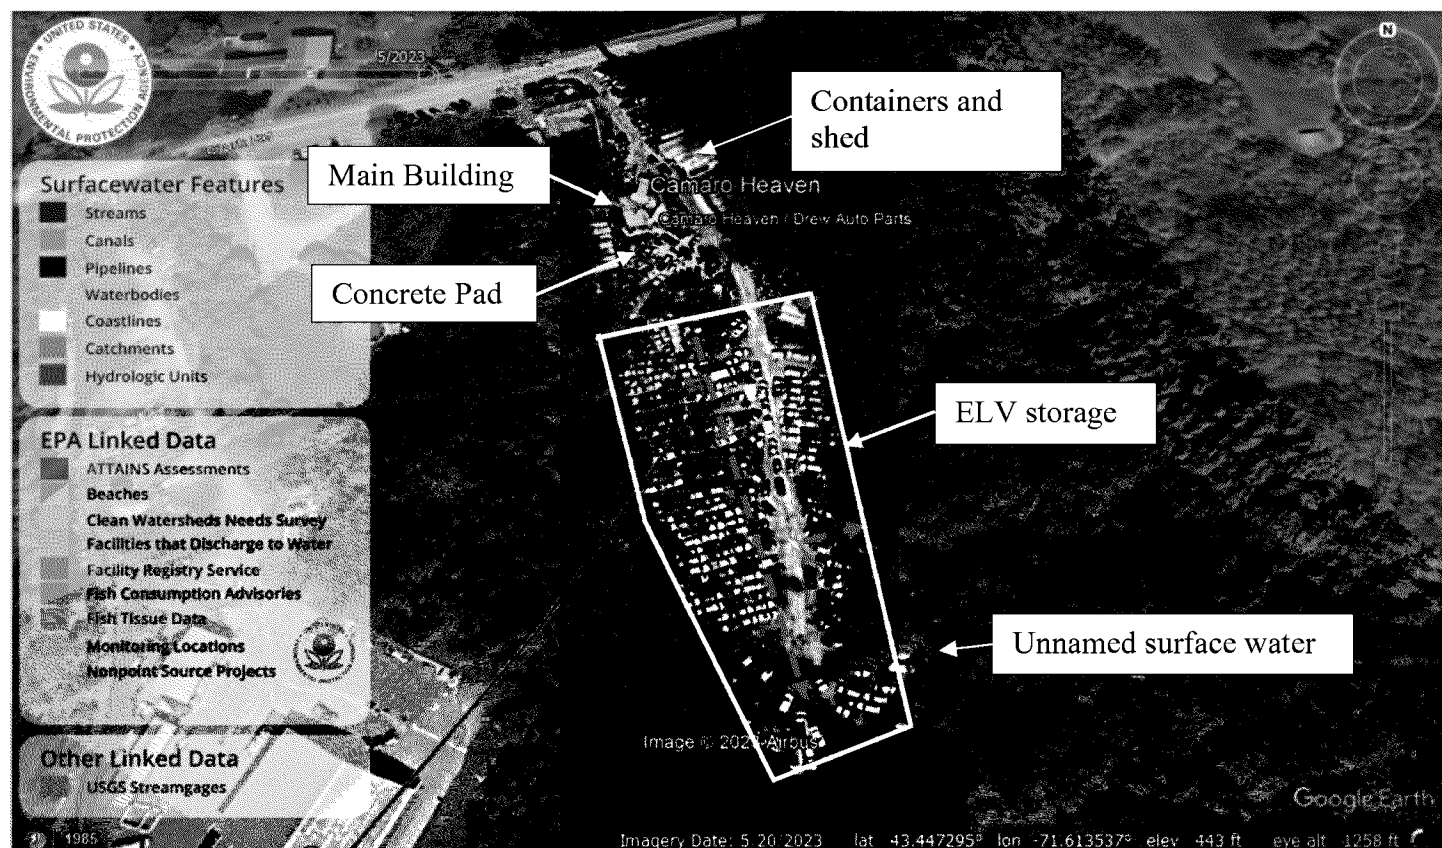
Figure 1. Google Earth with EPA WATERS feature layer aerial view of the Facility. The blue arrows depict observed flow patterns, the red line shows the unnamed surface water mapped by the EPA WATERS extension.

The EPA Inspector observed stormwater would flow south from the front of the Facility to the back of the Facility then discharge to the unnamed surface water. The unnamed surface water was approximately 10 feet south of the Facility's southern perimeter (refer to [Appendix A, Photographs 2, 4, 5, 6, 7, and 8](#)). The EPA Inspector observed locations along the eastern perimeter where the unnamed surface water was less than five feet away from the ELV storage area, stormwater runoff from ELVs on the eastern edge of the Facility could enter the unnamed surface water at these locations (refer to [Appendix A, Photographs 9 and 10](#)). The EPA Inspector observed that the Facility was not equipped with a berm or other structural best management practice (BMP) to prevent or inhibit the flow of stormwater offsite and into the unnamed surface water.

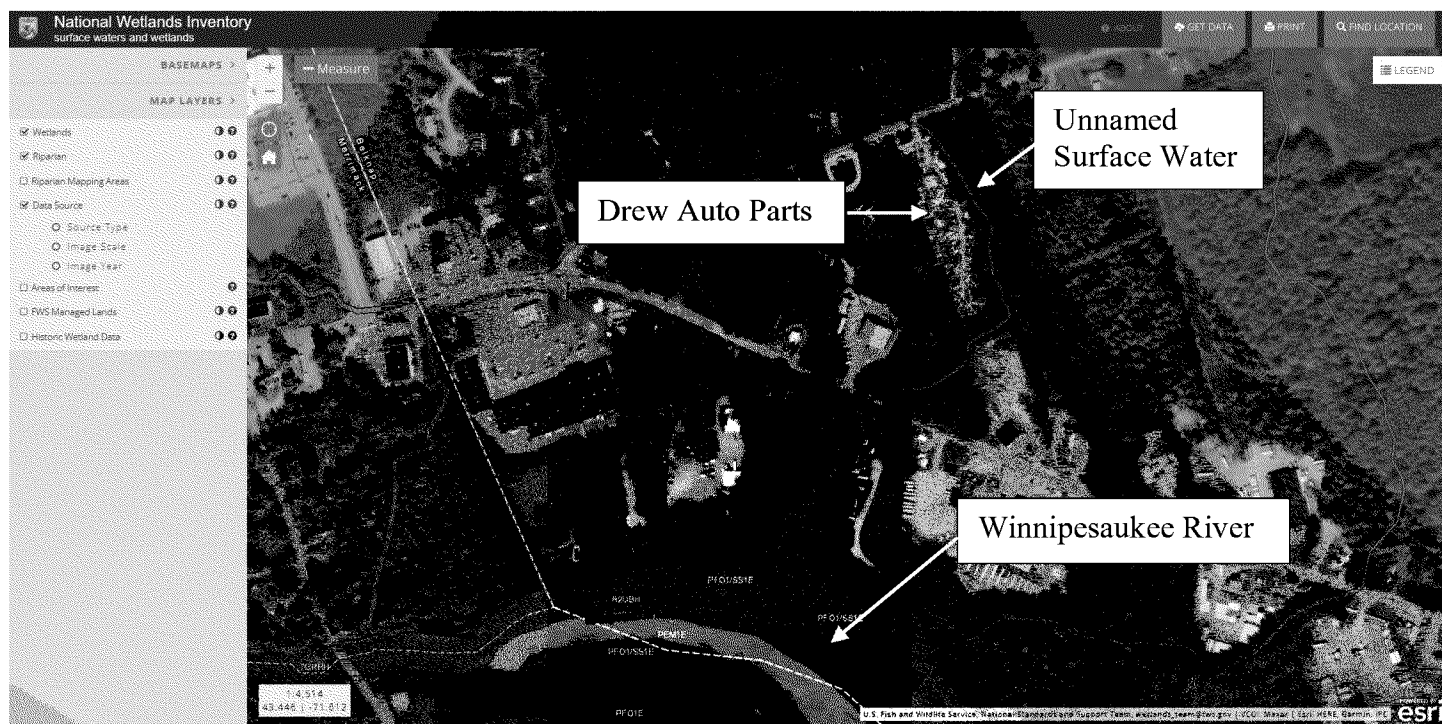
The yard throughout the Facility is compacted earth. An unnamed receiving water flows along the Facility's eastern and southern perimeter (refer to [Appendix A, Photographs 5, 6, 9, and 10](#) and Figure 1). The unnamed receiving water is a tributary to the Winnepesaukee River located approximately 1,200 feet to the south of the Facility (Figure 2).

Figure 2. NWI Map of the area surrounding Drew Auto Parts
