NPDES Inspection
Animal Feeding Operation

FINCA BETANIA DAIRY FARM

NPDES Tracking Number PRU201809

Inspection Date: January 8, 2025

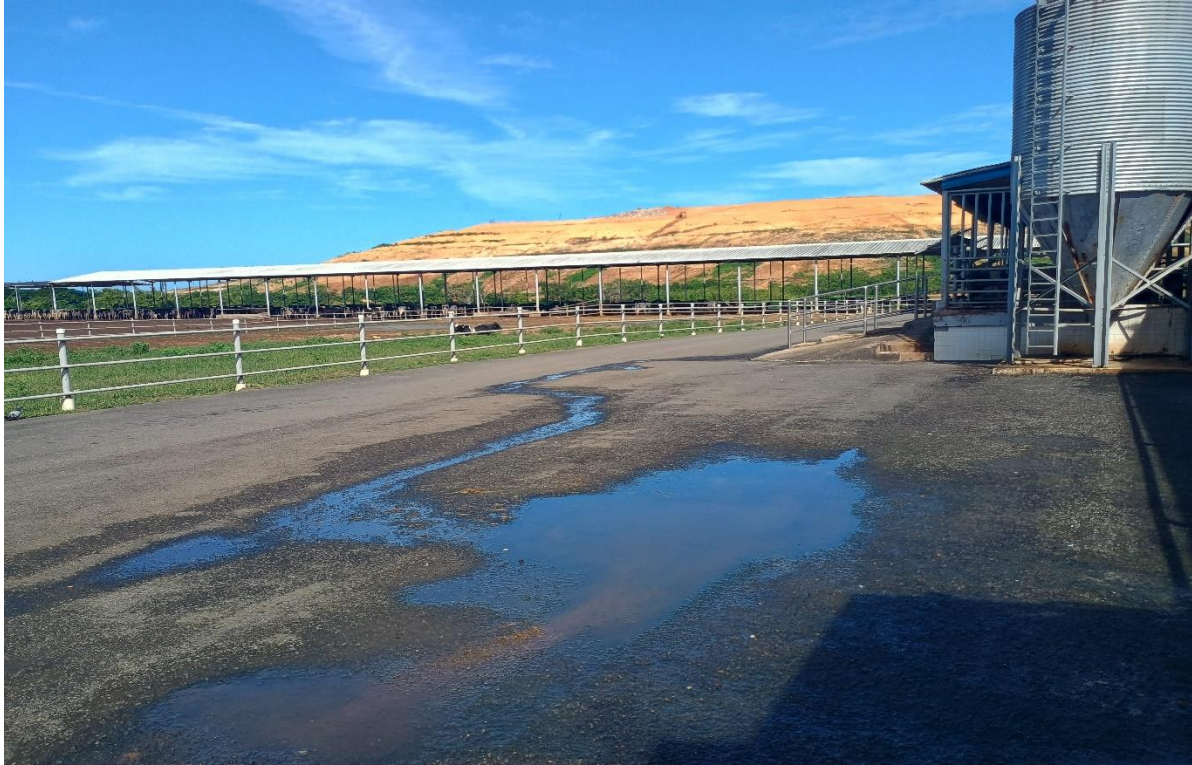
Picture # 1

Depicts a view of the dairy farm facility entrance. Stormwater runoff from adjacent field pasture was observed in the pavement.

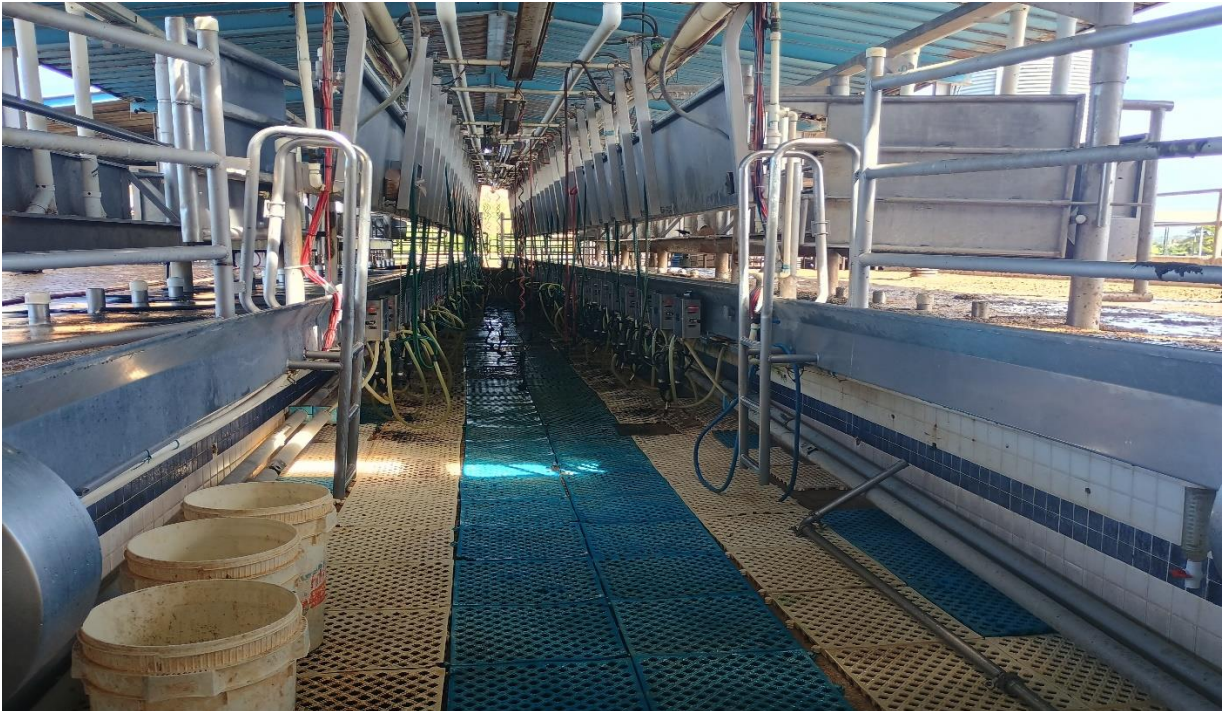
Picture # 2

Depicts a view of the dairy farm milking parlor.

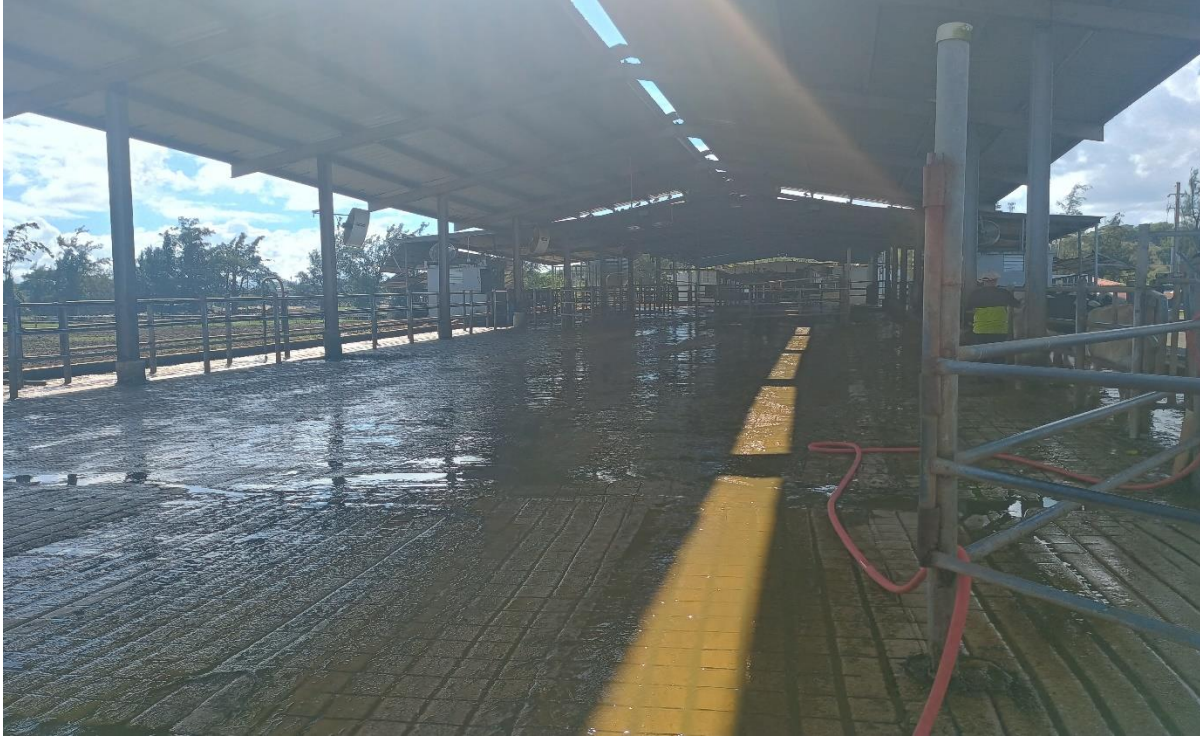
Picture # 3

Depicts a view of the dairy farm milking cows waiting area.

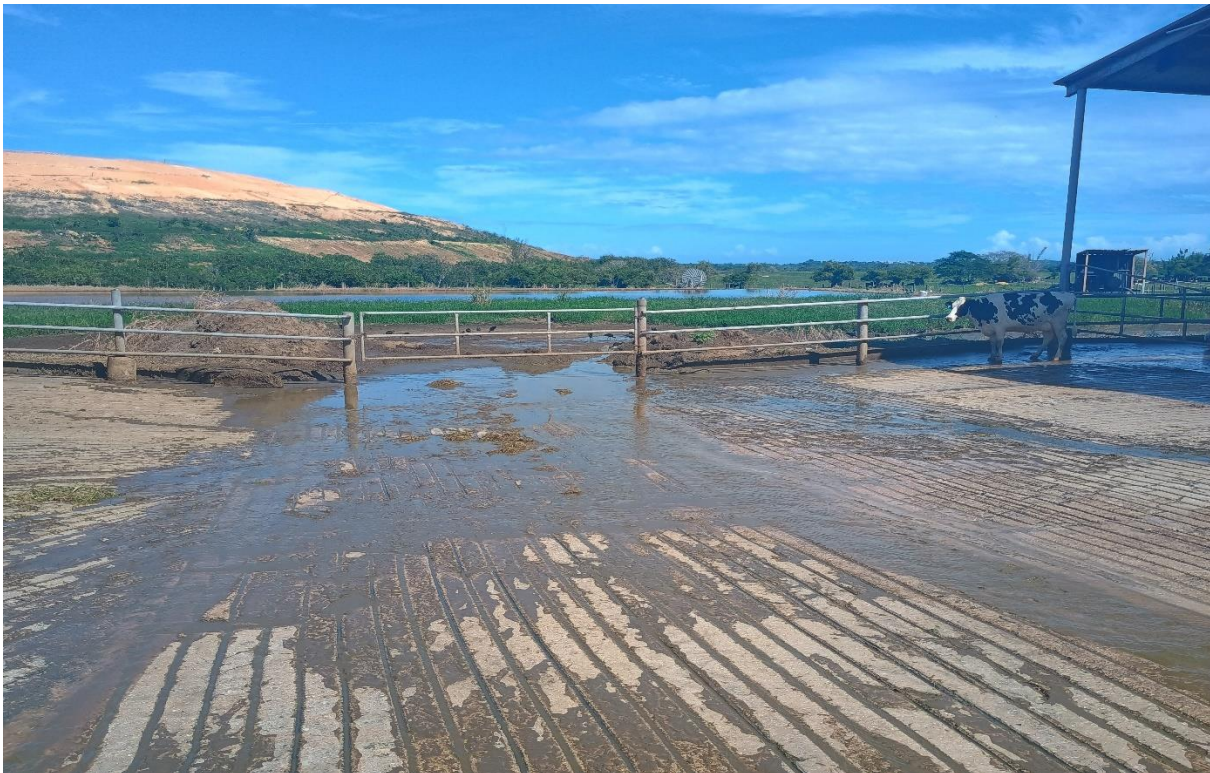
Picture # 4

Depicts a view of the manure that comes from the feeding barns drainage area that flows via gravity into the manure storage lagoons.

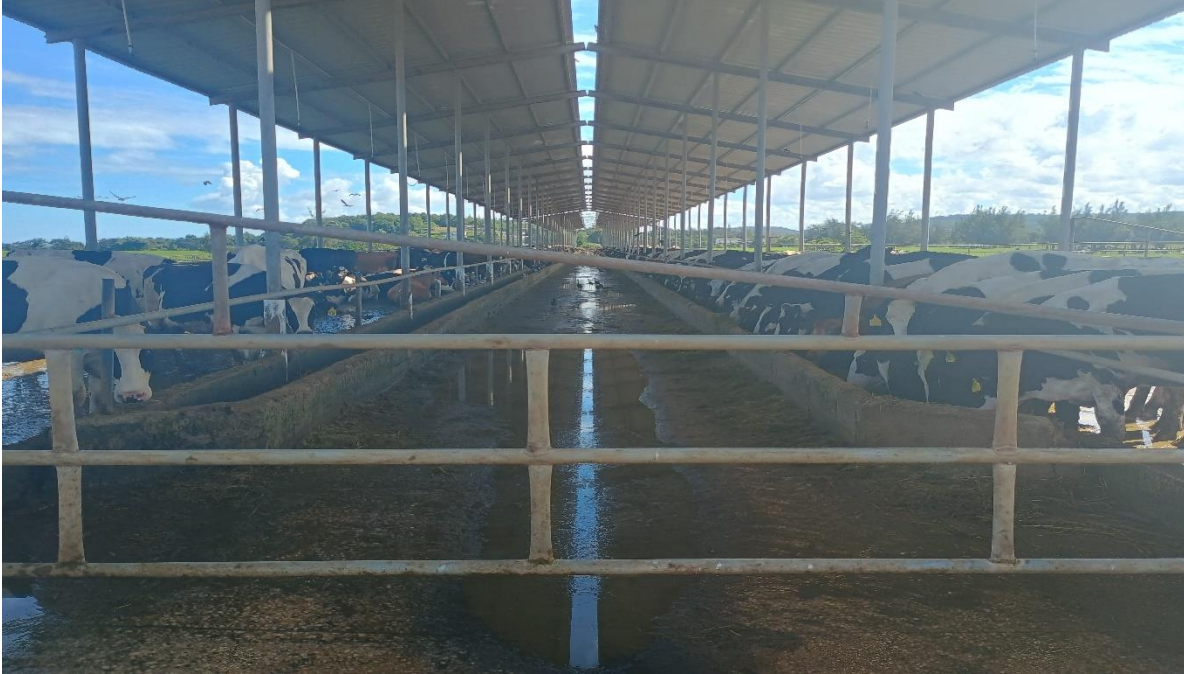
Picture # 5

Depicts a view of one of two dairy cattle feeding barns. Manure from the barn is collected in this area and via gravity conveyed through the concrete floor to the manure storage lagoons.

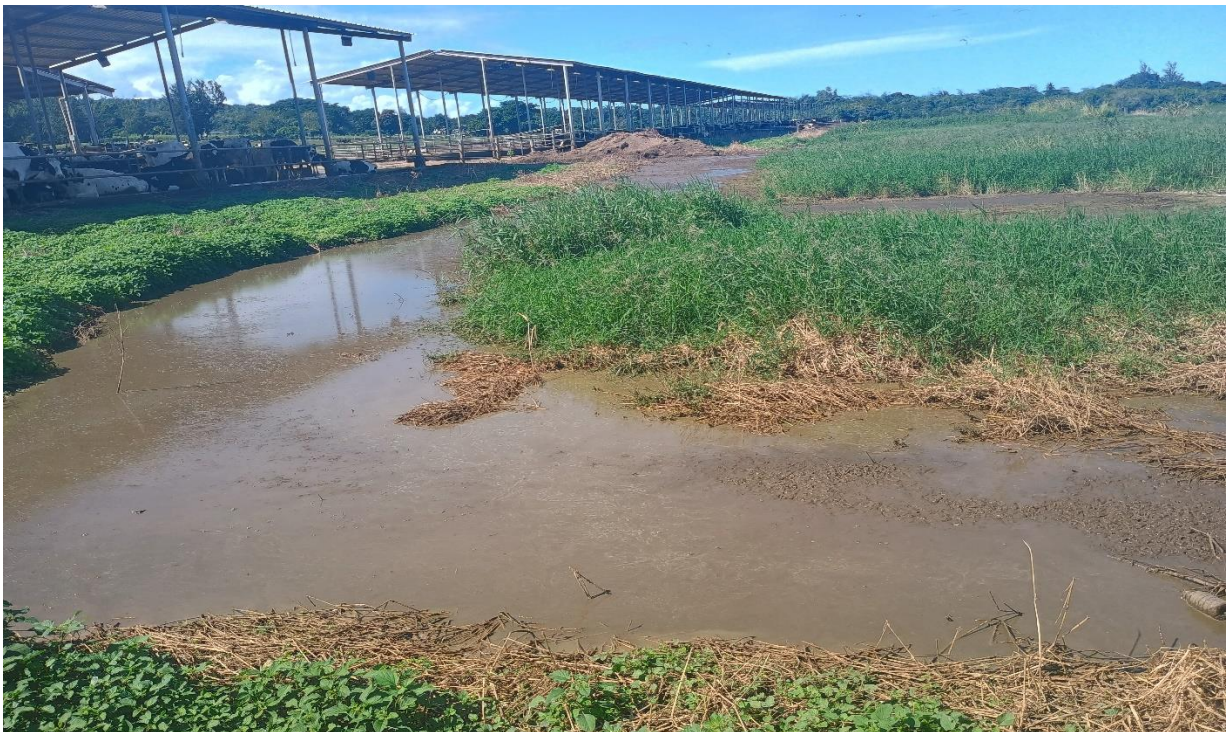
Picture # 6

Depicts a view of the receiving manure storage lagoon fill with solids and vegetation. The lagoon was observed almost with no freeboard.

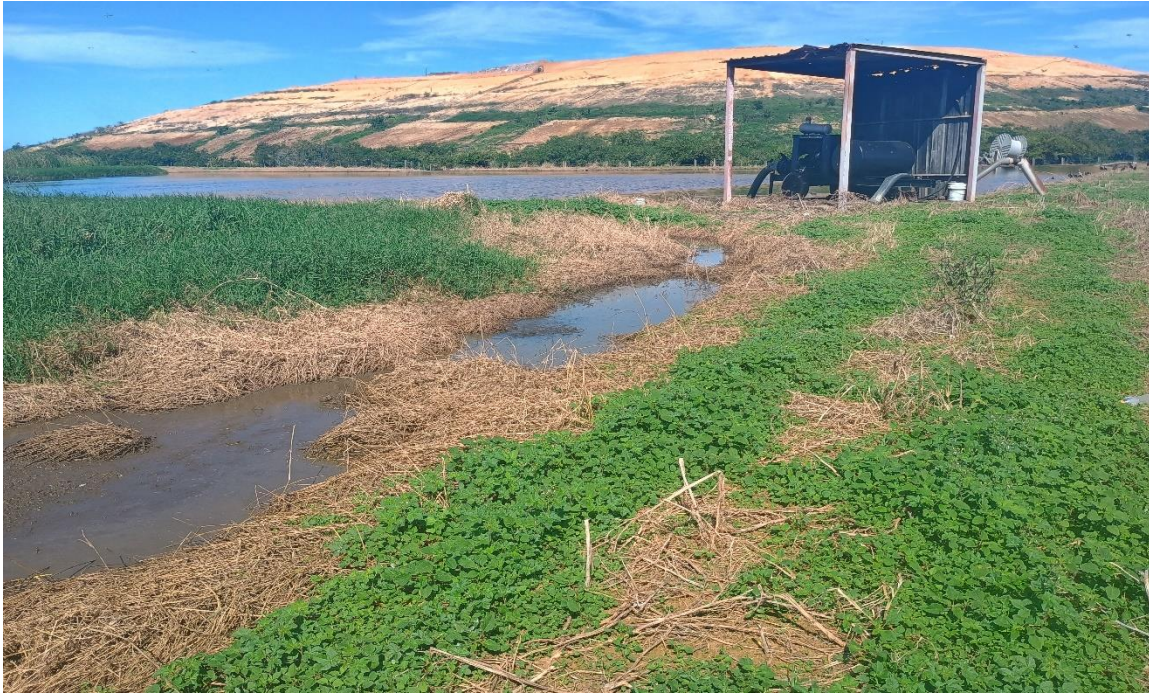
Picture # 7

Depicts another view of the receiving manure storage lagoon filled with solids and vegetation growth, and the manure pump house in the background.

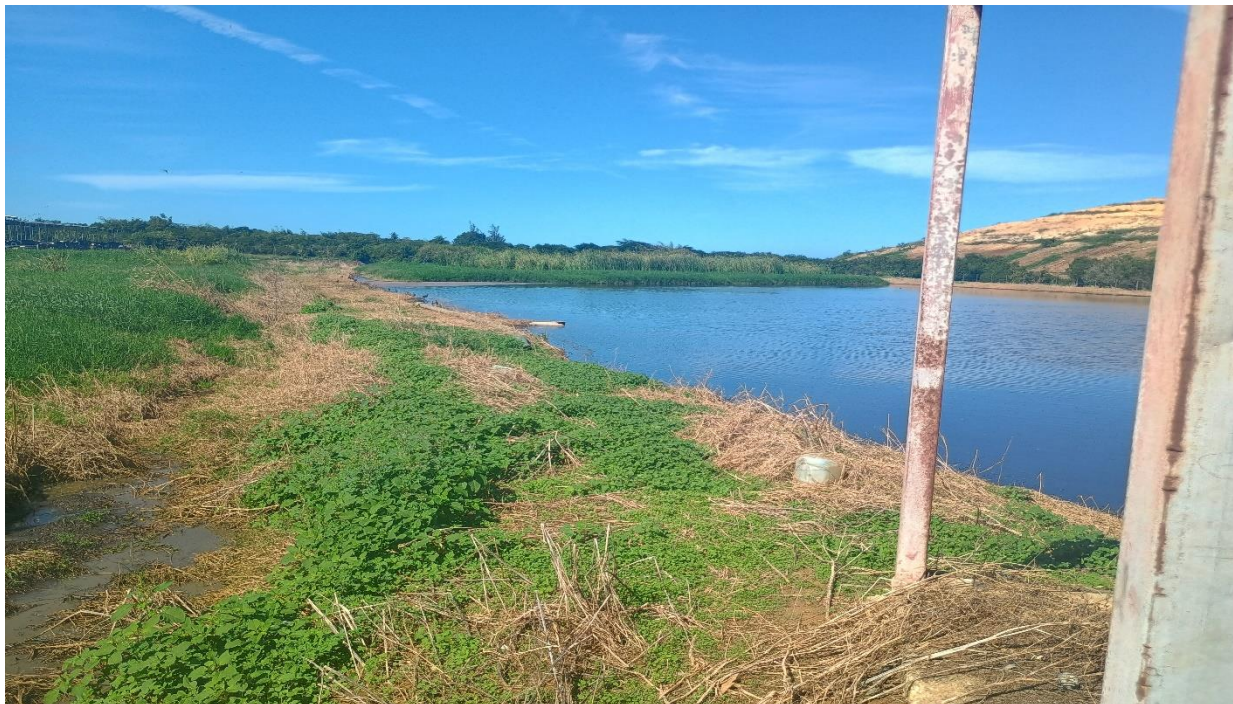
Picture # 8

Depicts a panoramic view of the liquid manure storage lagoon (second lagoon), which receives the overflow discharge from the receiving manure storage lagoon. The Arcibo Solid Waste Municipal Landfill is depicted in the background.

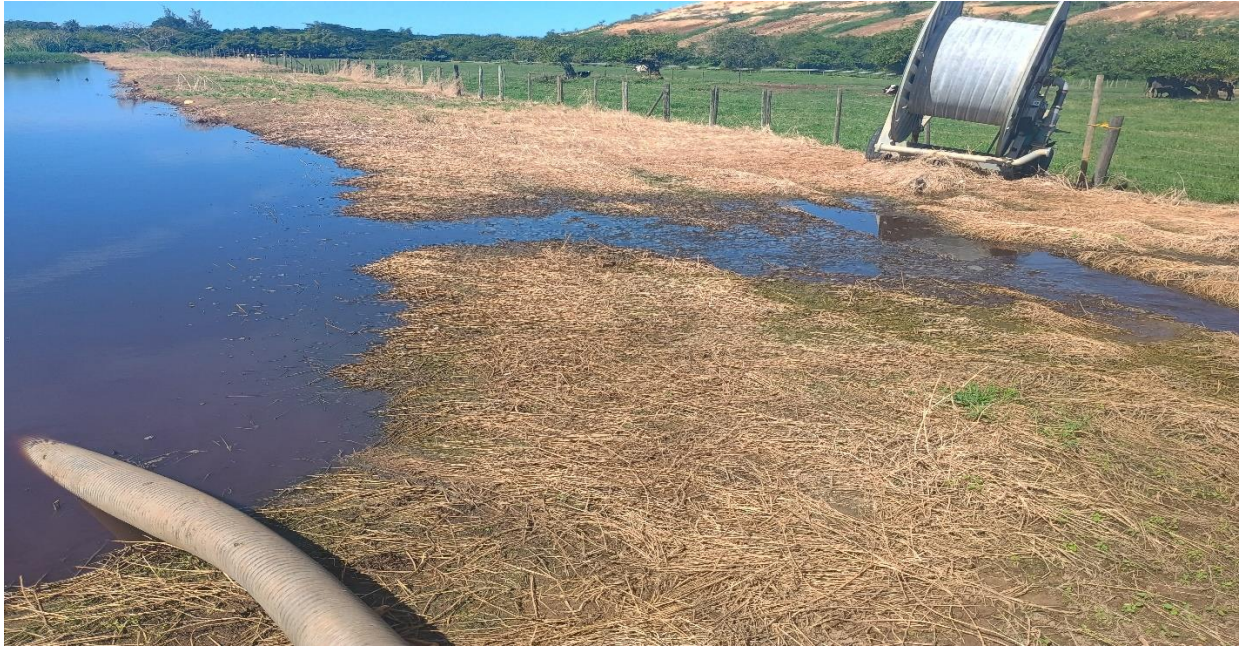
Picture # 9

- d. The EPA Inspector observed that the liquid manure storage lagoon did not have a free board, and it was overflowing at the time of the Inspection. The wastewater discharge flows pathway through the pastures were also observed and reached an unnamed stream tributary of Caño Tiburones.

Depicts a view of the liquid manure storage lagoon with no freeboard and overflowing towards the pasture. The overflow was located at the northeast side corner of the lagoon.

After the completion of the walkthrough, the EPA Inspector had an exit meeting with Mr. Vélez between 12:20 p.m. and 12:30 p.m. The EPA Inspector provided a summary of his observations made during the walkthrough, noting that the overflow discharge from the liquid manure storage lagoon must stop, and emphasized the need to lower the lagoon level to a point that prevents future discharges into waters of the United States.

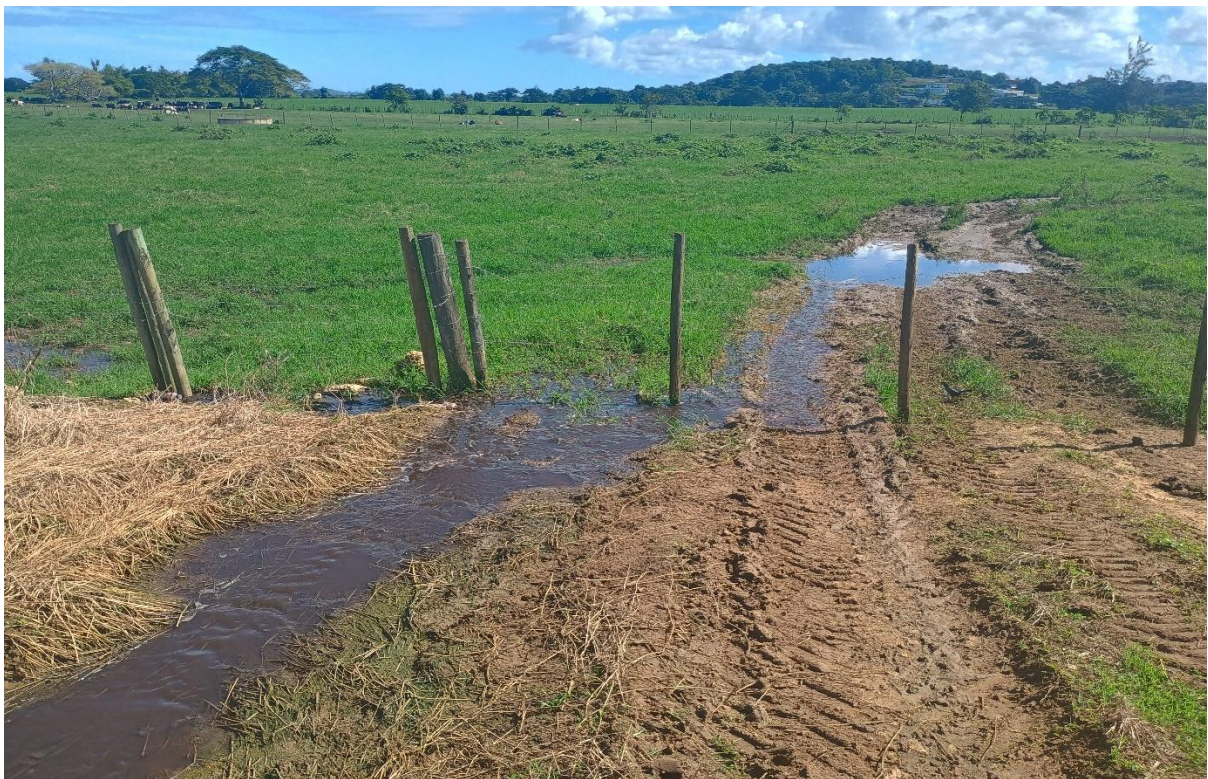
Picture # 10

- e. The EPA Inspector observed evidence of actual liquids manure flows running through the adjoining field, which is used as pasture, where there was a channel which meandered through the pasture and a cattle loafing area that eventually led to unnamed stream or drainage channel tributary of the Caño Tiburones.

Depicts a view of the liquid manure overflow pathway towards the field pasture.

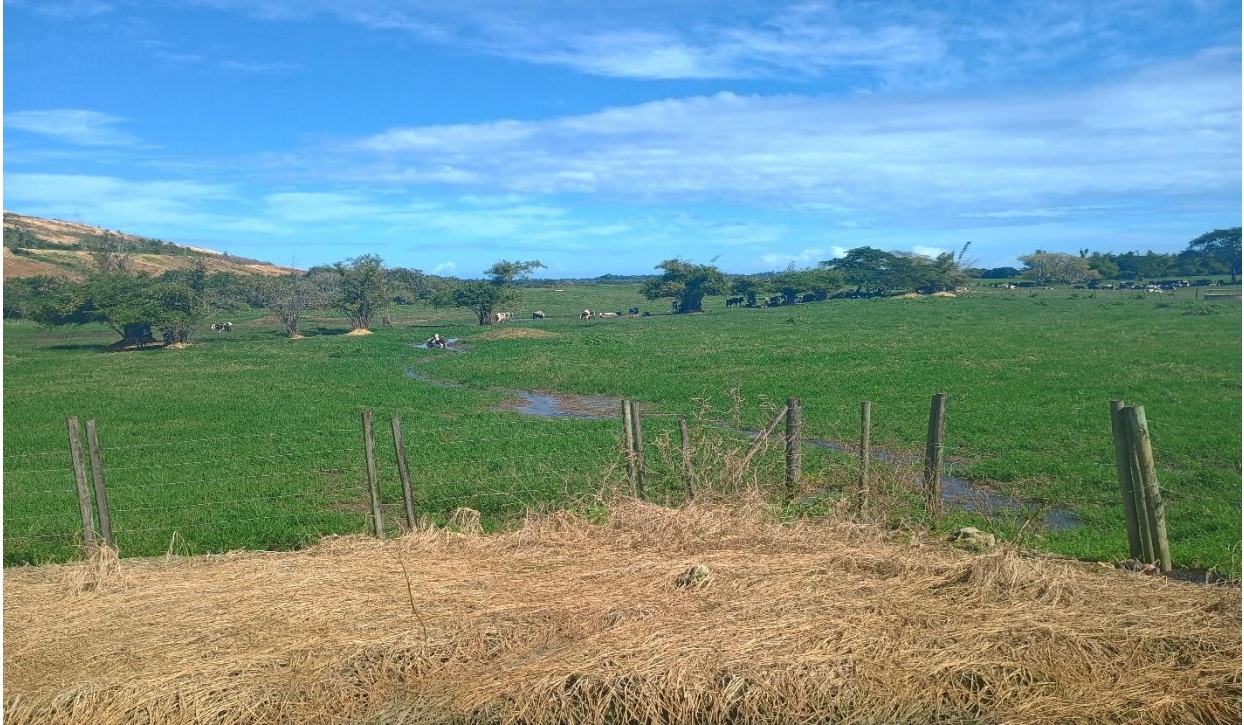
Picture # 11

Depicts a panoramic view of the overflow drainage pathway in the pasture field.

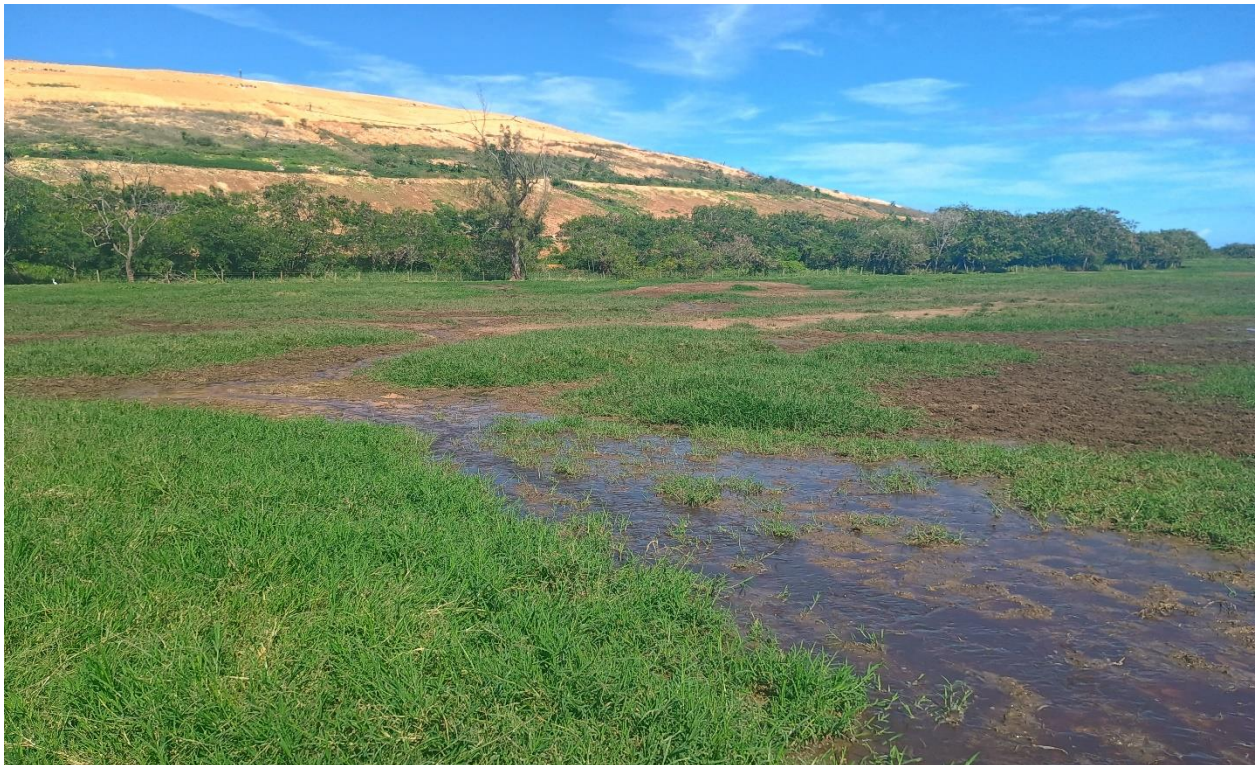
Picture # 12

Depicts another panoramic view following the liquid manure overflow pathway meandering over the field pasture. Solids from manure were observed accumulated along the way.

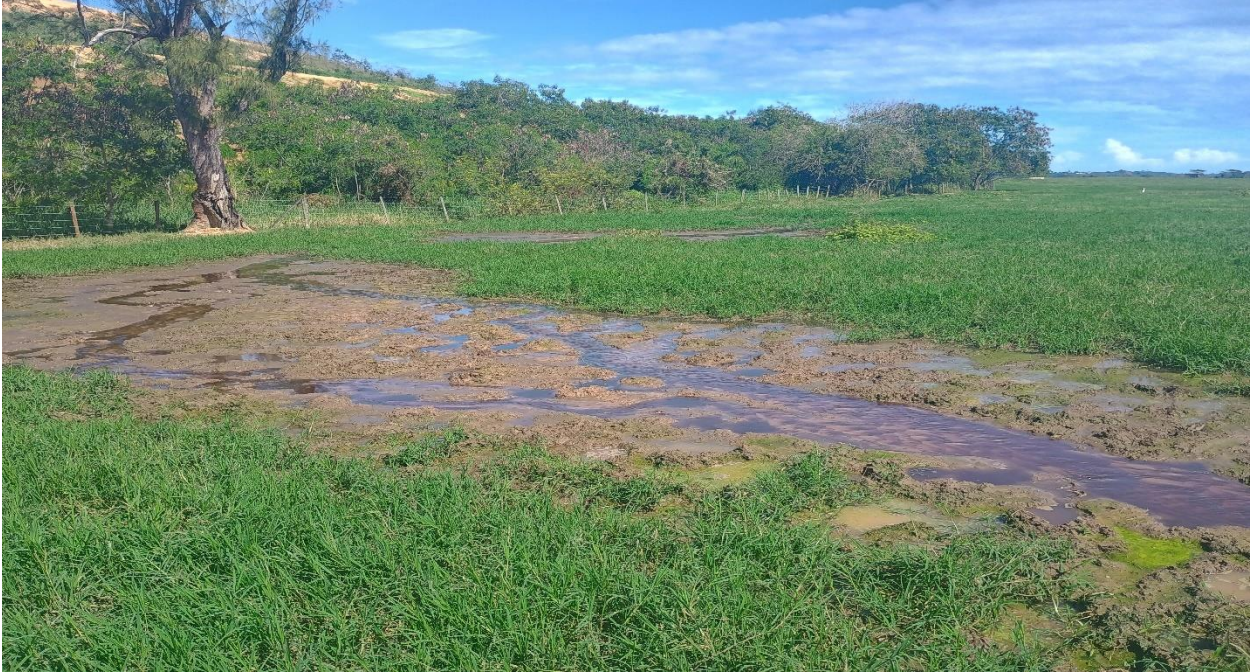
Picture # 13

Depicts a closer view of the downstream liquid manure overflow pathway over the pasture field. Solids from manure were observed accumulated in this area. The flow reaching the Site fence line between the pasture field and the unnamed stream adjacent to the Arecibo Landfill was observed.

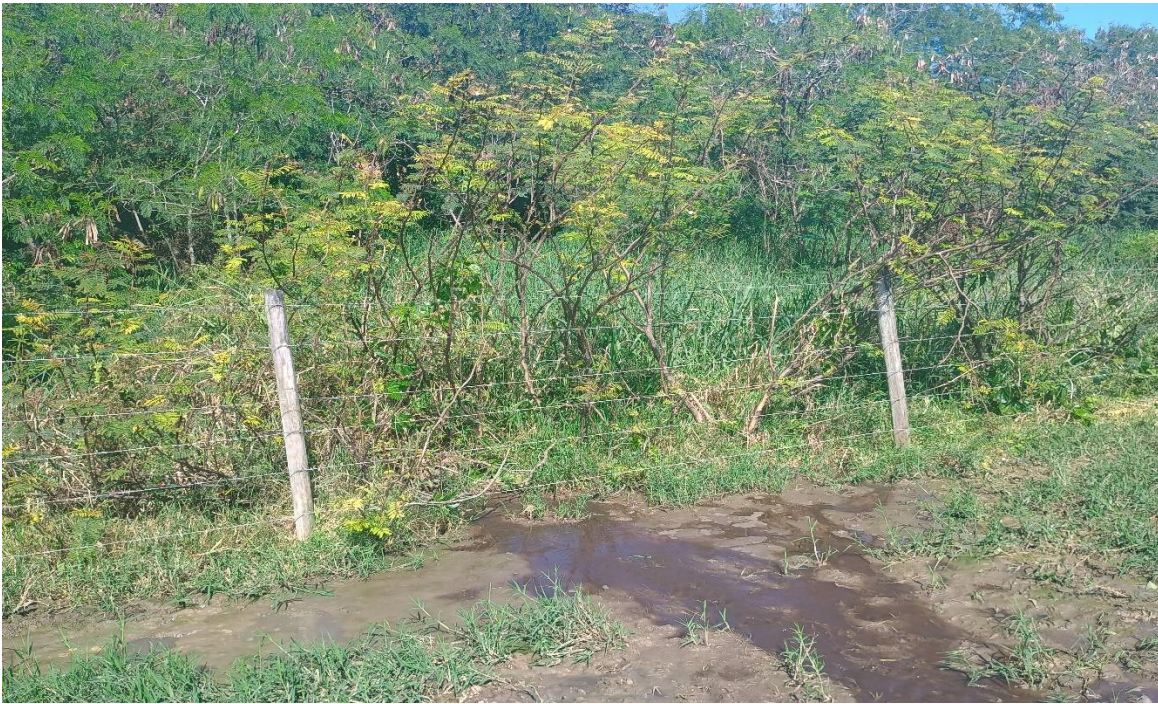
Picture # 14

Depicts a view of the liquid manure overflow pathway reaching the fence line flowing towards the unnamed stream.

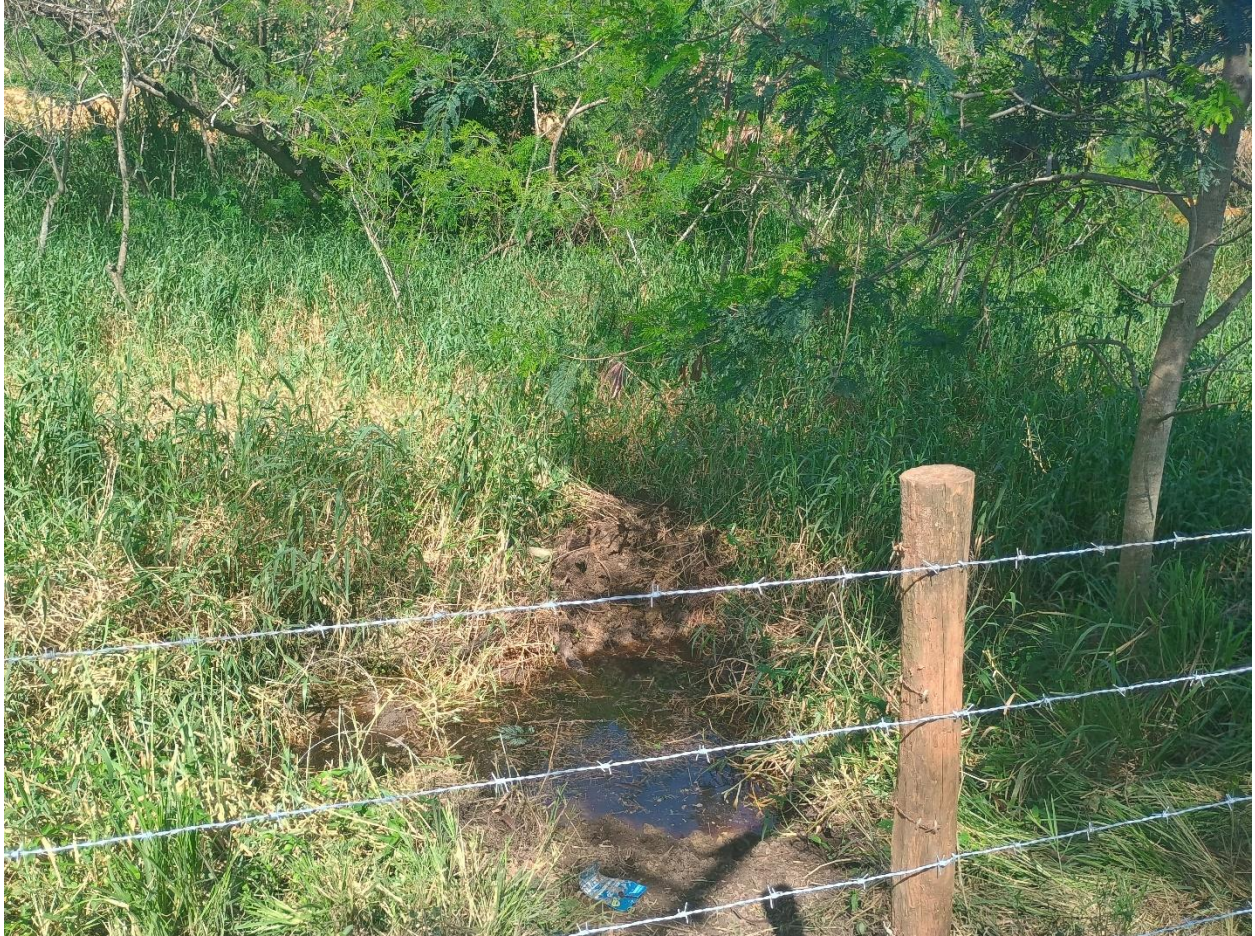
Picture # 15

Depicts a view of the liquid manure overflow pathway reaching a Site fence line flowing under it into the unnamed stream.
