INSPECTION REPORT

| Type of Inspection | Compliance Evaluation Inspection (CEI) | | |
| Facility or Site Name | Menominee Tribal Enterprises Sawmill | | |
| Permit Number(s) (If Applicable) | WI0046868 | | |

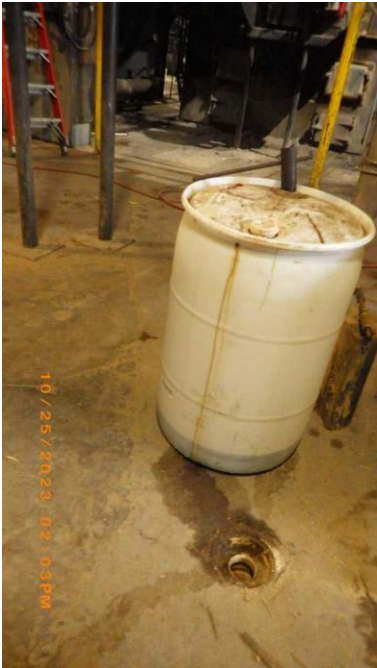
| Floor Drain in Boiler Blowdown Room. | | | MTES0338.JPG |

| Observed fresh spill staining from drum with unknown dark contents. Spill staining led to a nearby floor drain in the boiler blowdown room (see photo MTES0338 in Appendix 2 - Photo Log). The Facility's NPDES permit only authorizes the discharge of boiler blowdown from Outfall 001. | |

| Observed fresh spill staining from drum with unknown contents. | | | |

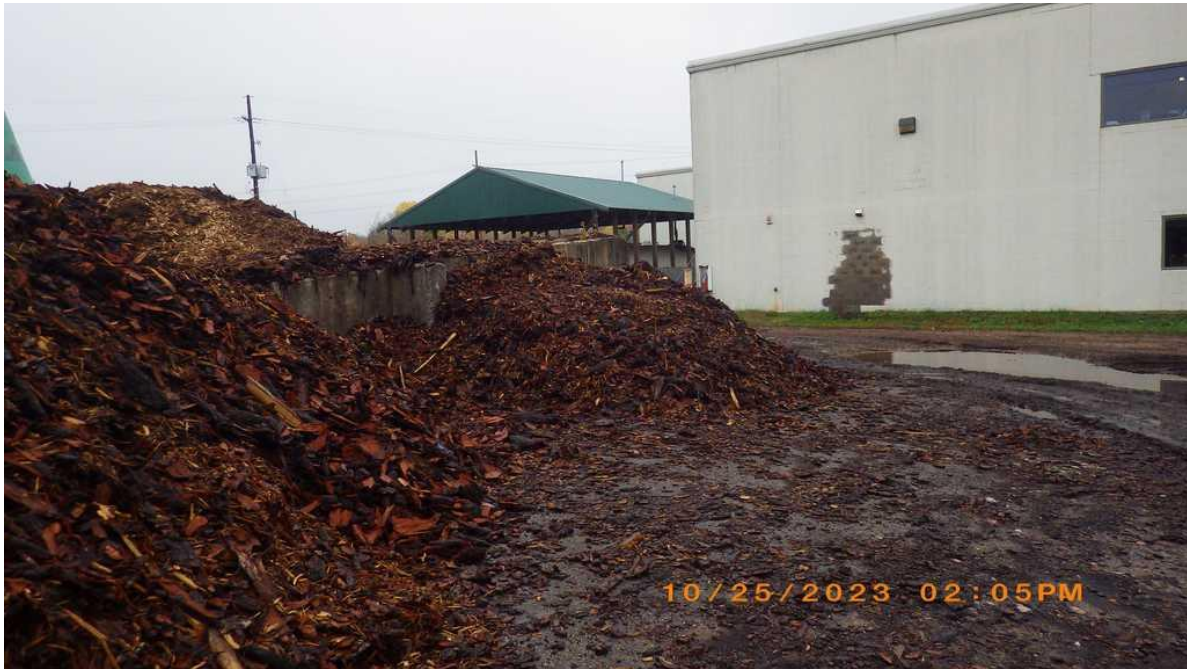
| Bark staging area. | | | MTES0339.JPG |

| Trucks pull up to this area to load bark. | | | |

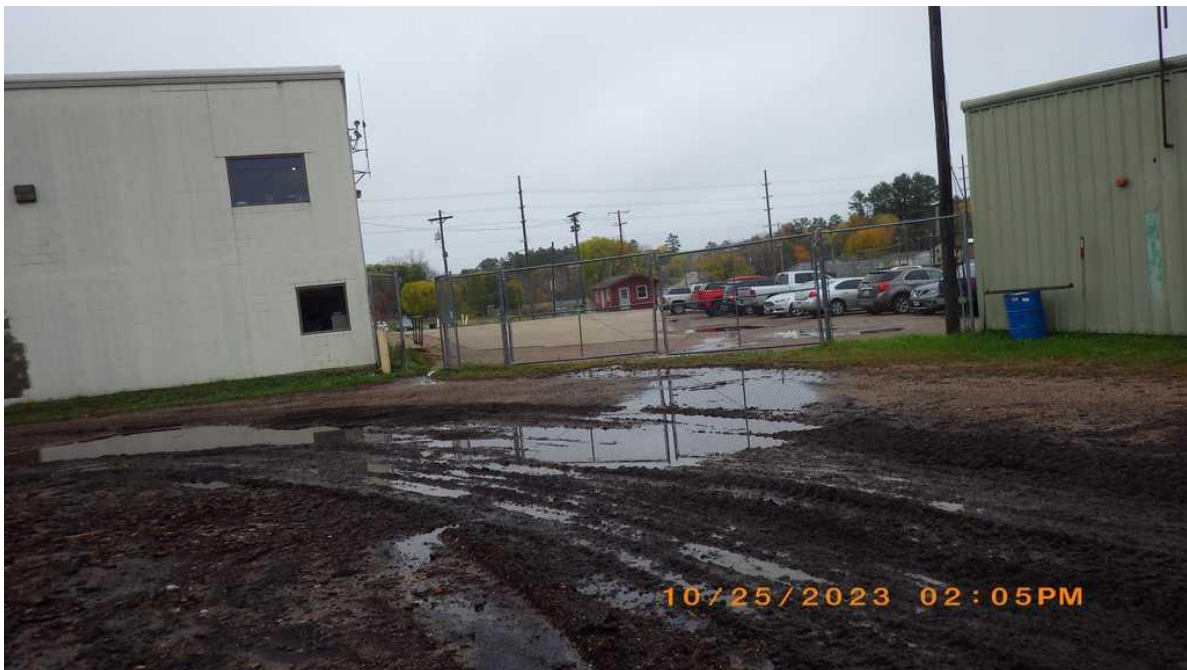
| Runoff from Bark Pile area. | | | MTES0340.JPG |

| Observed runoff from Bark Pile area flowing toward parking lot. | | | |

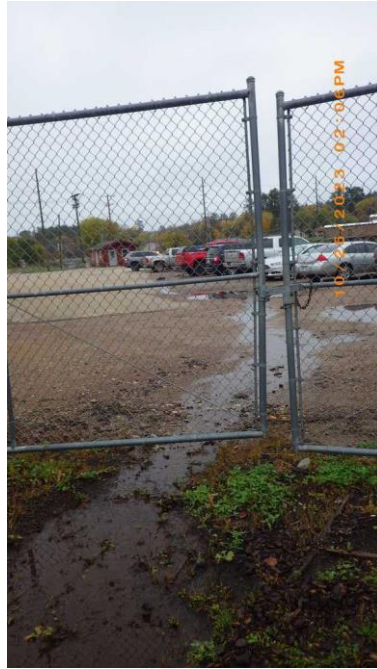
| Continuation of runoff from Bark Pile area. | | | MTES0341.JPG |

| Runoff from Bark Pile area flowing toward parking lot. | | | |

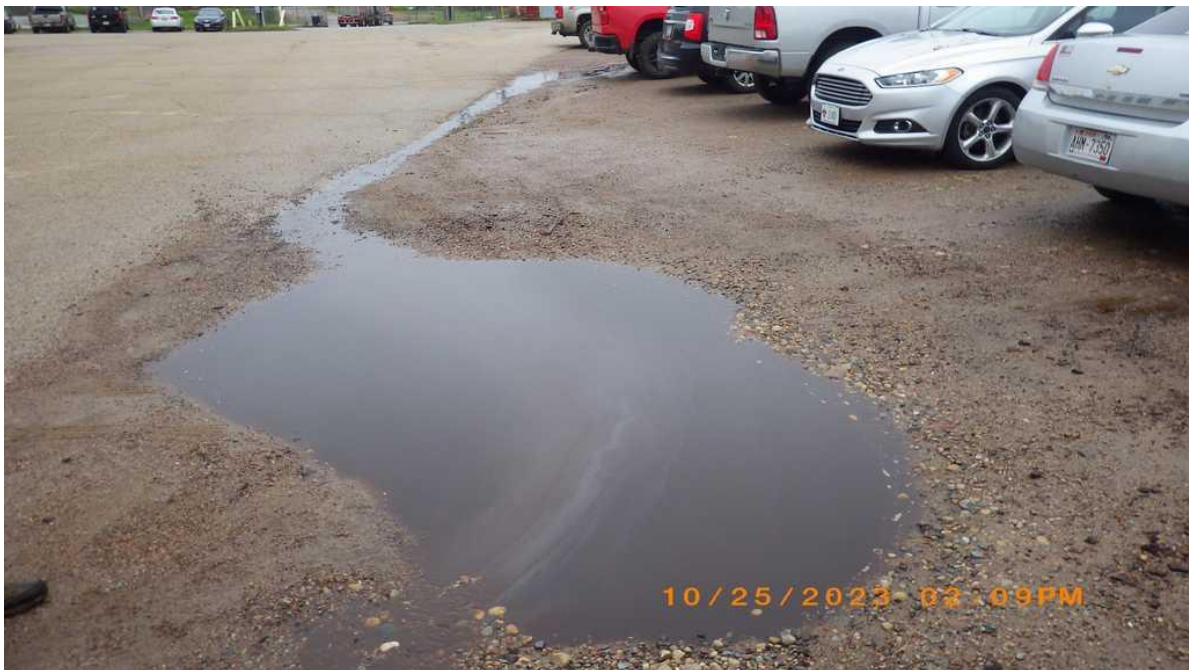
| Continuation of runoff from Bark Pile area into parking lot. | | | MTES0342.JPG |

| Observed runoff from Bark Pile area flowing across parking lot. Observed turbid flow with sheen. I asked Mr. Fish if he could measure pH in the flow. He measured a pH of 8.2 SU. | | | |

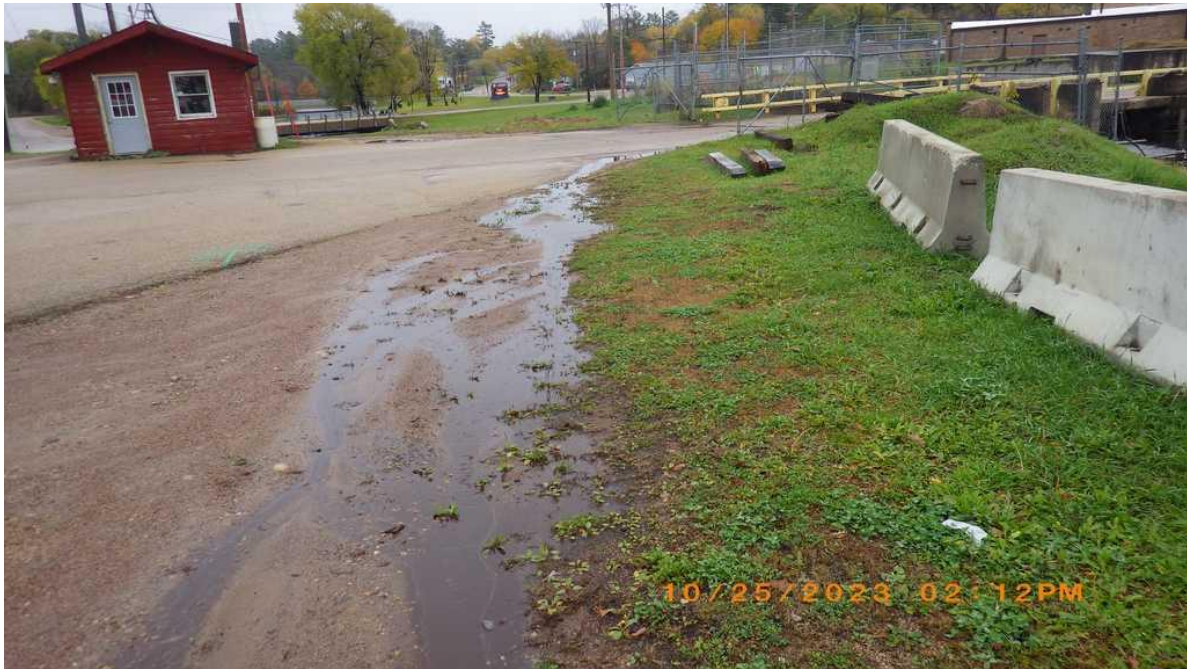
| Continuation of runoff from Bark Pile area from parking lot toward the West Branch of the Wolf River. | | | MTES0343.JPG |

| Observed runoff from Bark Pile area flowing toward bridge over the West Branch of the Wolf River. | | | |

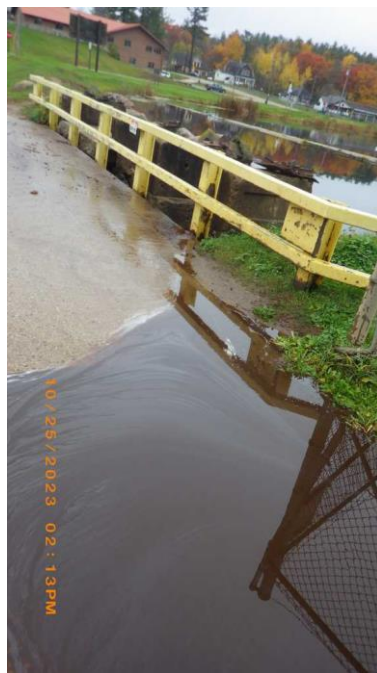
| Runoff from Bark Pile area flowing onto a bridge and into the West Branch of the Wolf River. | | | MTES0344.JPG |

| Runoff from Bark Pile area flowing across the bridge and into the West Branch of the Wolf River. Note turbidity and sheen in the runoff. | | | |

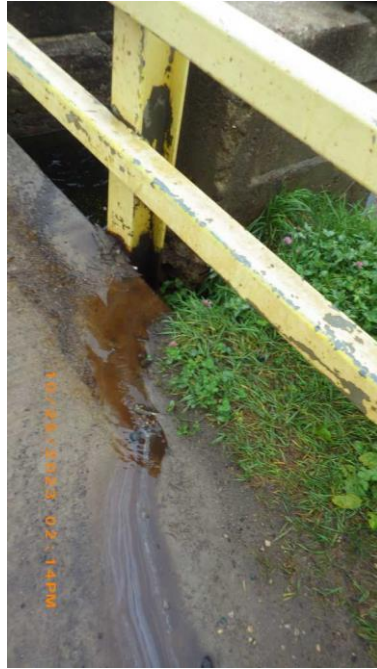
| Runoff from Bark Pile area flowing over the side of the bridge and into the West Branch of the Wolf River. | | | MTES0345.JPG |

| Runoff from Bark Pile area flowing over the bridge and into the West Branch of the Wolf River. Note turbidity and sheen in the runoff. | | | |

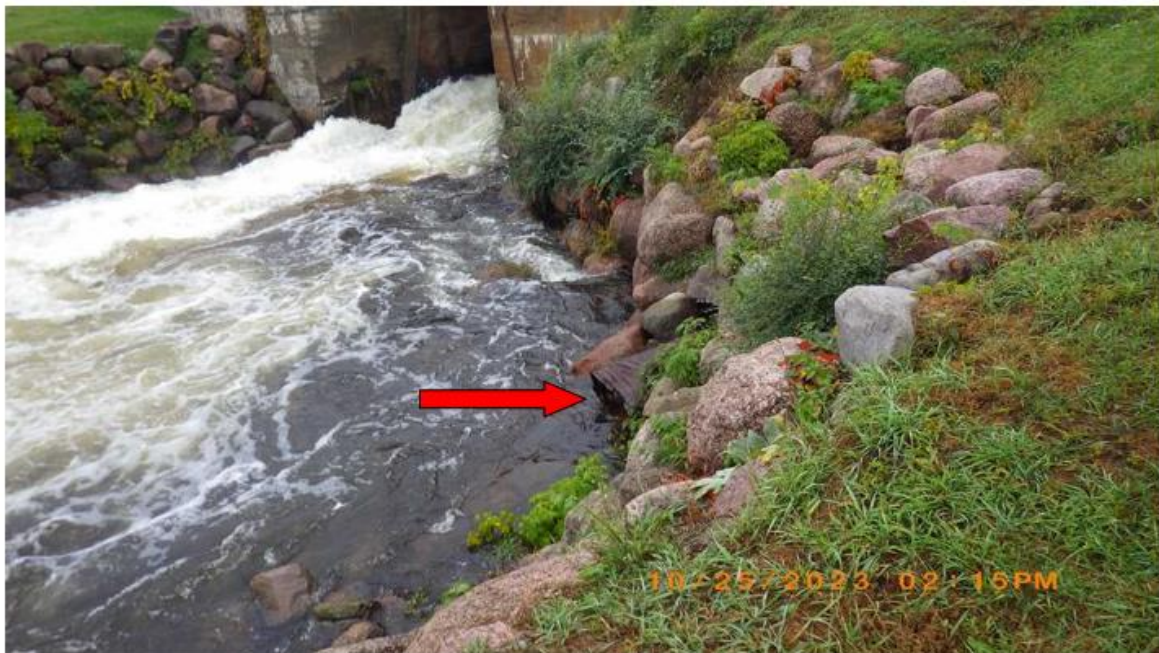
| Outfall 001 to the West Branch of the Wolf River. | | | MTES0346.JPG |

| Outfall 001 (red arrow) discharges boiler blowdown water immediately east of the bridge referenced in the photos above. River flows from right to left through the bridge culvert. | | | |

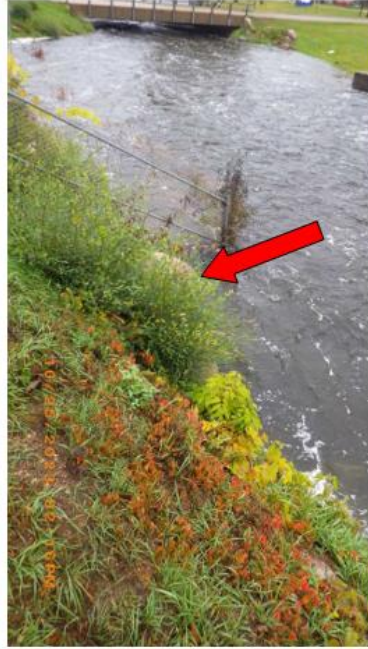
| Outfall 002 to the West Branch of the Wolf River. | | | MTES0347.JPG |

| Outfall 002 (red arrow) discharges stormwater into the West Branch of the Wolf River. River flows toward another bridge (top of image) east of the bridge referenced in the photos above. | | | |

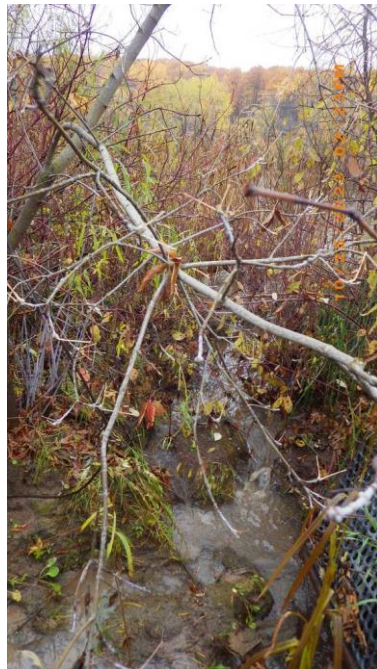
| View of Log yard stormwater pond and caged inlet. | | | MTES0348.JPG |

| View of Log yard stormwater pond (through brush at top of photo) and caged stormwater inlet (bottom right of photo). | | | |

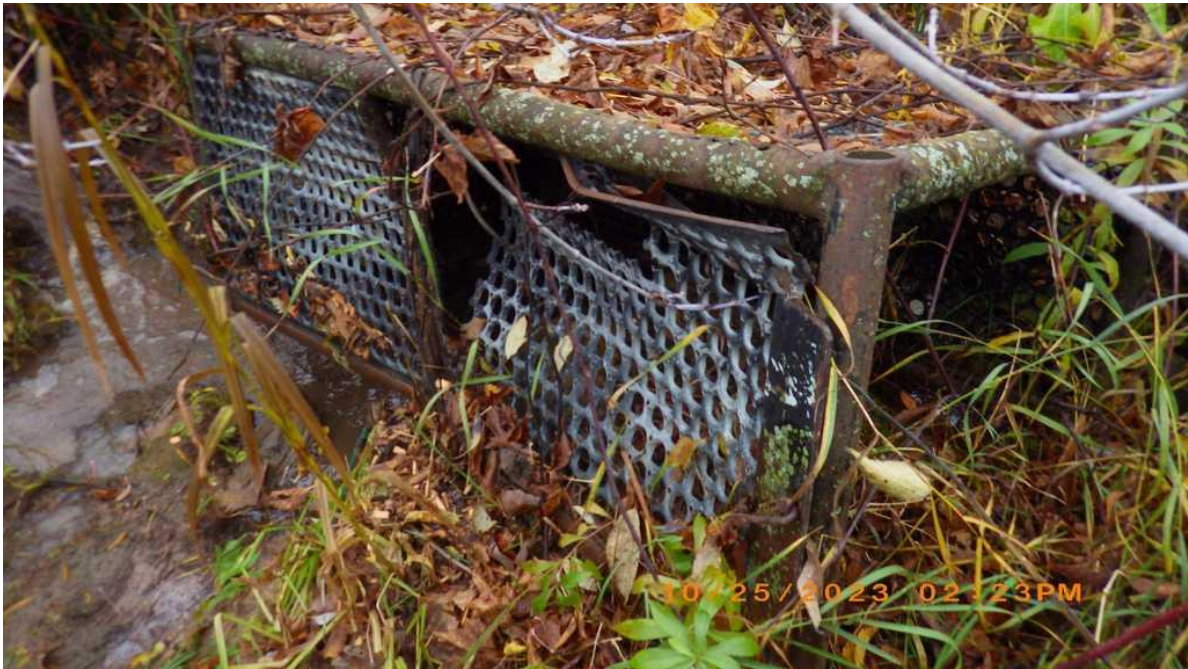
| Caged stormwater inlet. | | | MTES0349.JPG |

| <ul style="list-style-type: none"> <li>• Stormwater control measures were not maintained to minimize pollutant discharges, including: <ul style="list-style-type: none"> <li>▪ Damage to stormwater catch basin inlet cage in Location 11 (see photo MTES0349 in Appendix 2 – Photo Log);</li> <li>▪ Stormwater inlet grates partially filled and blocked by debris in Location 12 (see photo MTES0350 in Appendix 2 – Photo Log);</li> <li>▪ Hay bales separated or offset, allowing stormwater discharges to pass without treatment in Locations 14 and 15 (see photos MTES0355 and MTES0356 in Appendix 2 – Photo Log).</li> </ul> </li> </ul> | |

| Note damage to catch basin inlet cage. | | | |

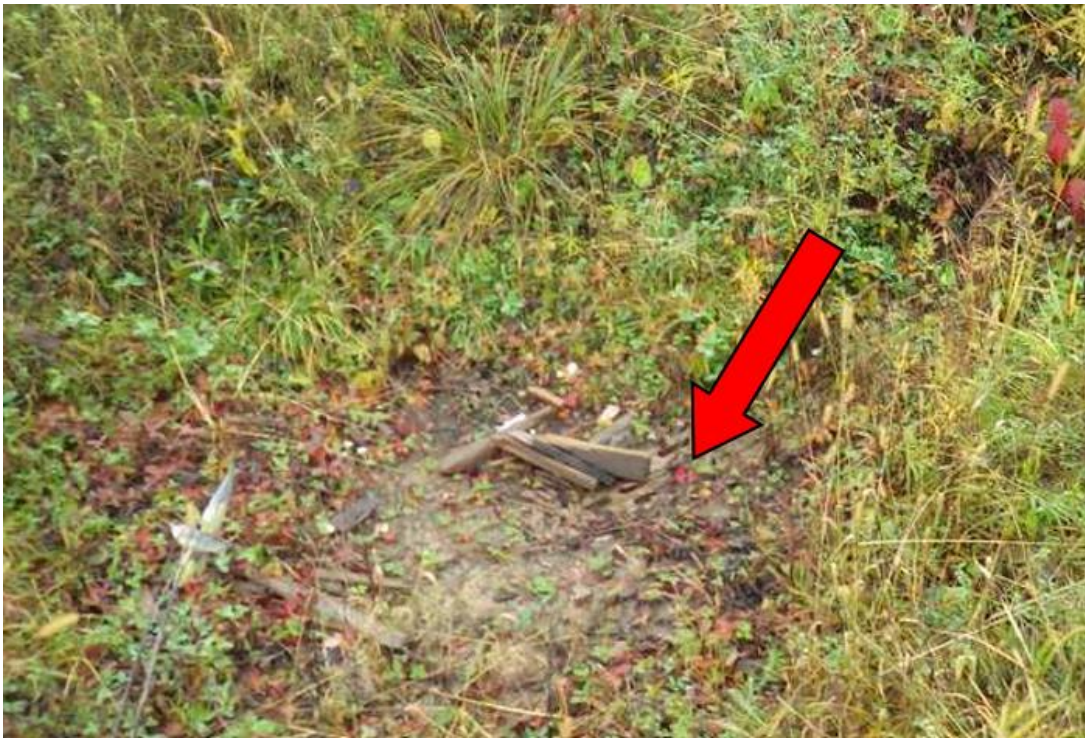
| Stormwater inlet. | | | MTES0350.JPG |

| Note stormwater inlet grates (red arrow) partially filled and blocked by debris. | | | |

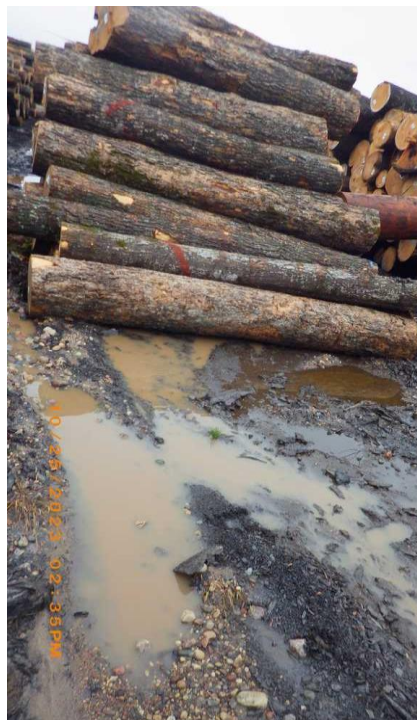
| Runoff from log decking area. | | | MTES0352.JPG |

| Observed runoff from log decking/staging area. Note, turbid discharge. | | | |

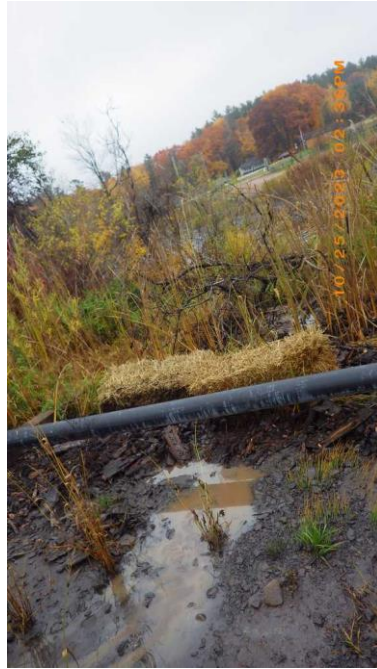
| Runoff from log decking/staging. | | | MTES0353.JPG |

| Observed runoff from log decking/staging area flowing through hay bales and into the West Branch of the Wolf River. | | | |

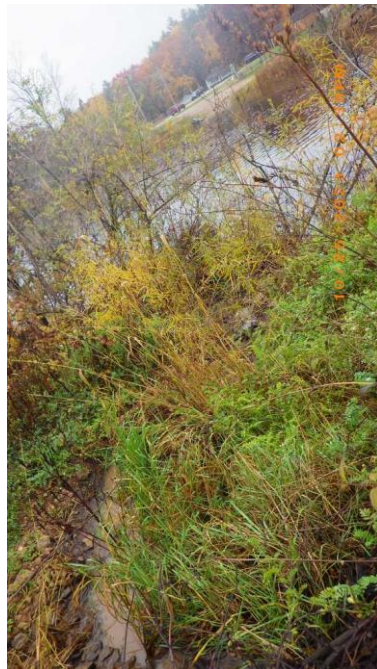
| The West Branch of the Wolf River is at the top of the photo and the runoff from log decking/staging can be seen at the bottom left of the photo until obscured by vegetation. Raymond Fish said this was a new stormwater discharge to the river and not Outfall 003. Mr. Fish measured the pH of the discharge (8.2 SU). | | | |

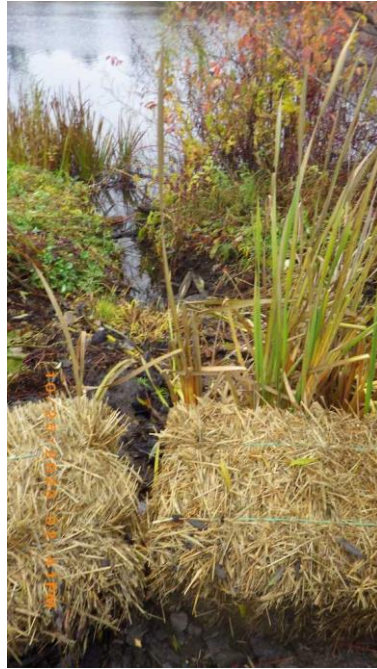
| Outfall 003 discharge from wet decking area. | | | MTES0355.JPG |

| Note, hay bales seperated, allowing discharge to pass without treatment. The West Branch of the Wolf River is visible in the upper part of the photo. | | | |

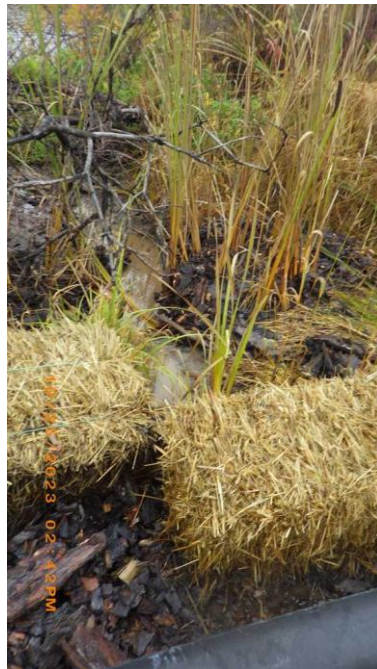
| I returned to the Location 14 (runoff from log decking/staging) to document the condition of the hay bales. Note, the hay bales are offset allowing water to flow past without treatment. Once past the bales, the discharge flows a short distance to the West Branch of the Wolf River (top of photo). | | | |

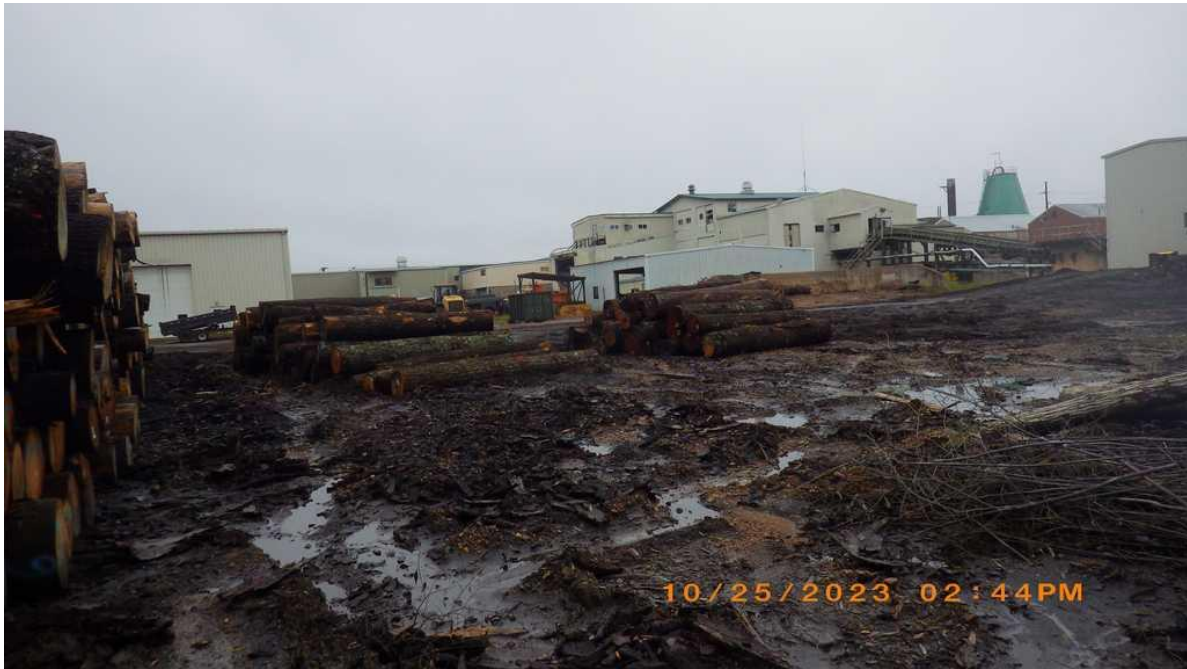
| Runoff from wet decking area. | | | MTES0357.JPG |

| Observed runoff from wet decking area, flowing toward bottom of the photo and to Outfall 003 and the West Branch of the Wolf River (photo MTES0355.jpg, above). | | | |

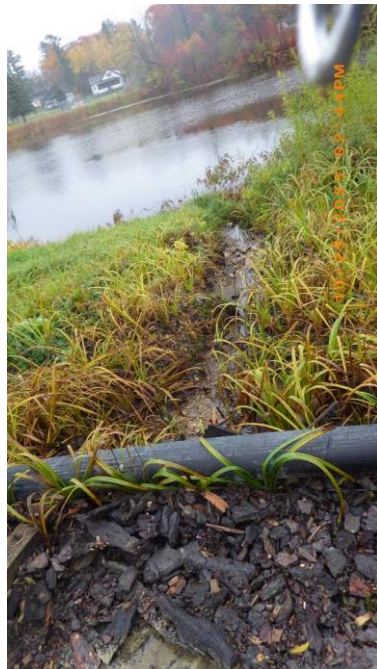
| Another stormwater discharge to the West Branch of the Wolf River. | | | MTES0358.JPG |

| Observed stormwater flowing from the yard in Location 16 and discharging to the West Branch of the Wolf River. The discharge is not identified as an outfall in the current permit. | | | |

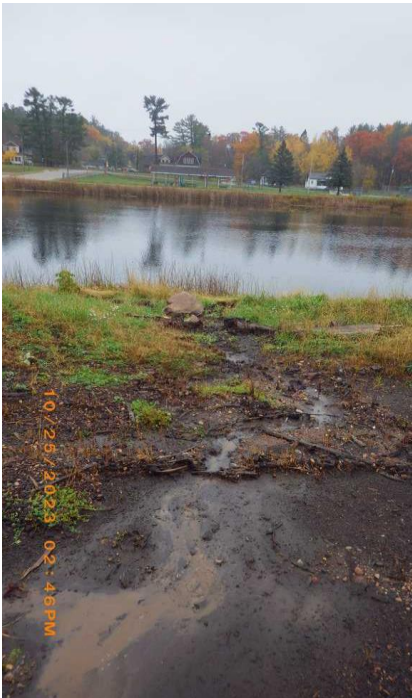
| Another stormwater discharge to the West Branch of the Wolf River. | | | MTES0359.JPG |

| Observed a stormwater flowing from the yard in Location 17 and discharging to the West Branch of the Wolf River. The discharge is not identified as an outfall in the current permit. | | | |
