## RCRA Compliance Evaluation Inspection Report

#### **Daikin America Inc.**

#### **MDA Manufacturing Inc.**

June 29, 2021, 9:15 a.m.

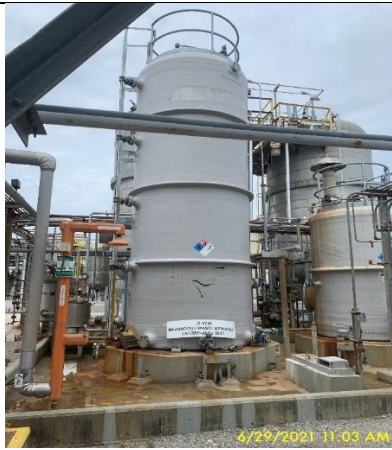
After the visit to the control room, the inspectors proceeded to inspecting the Waste J2 Methanol Tank. Mr. Hollis stated that the tank was upgraded to manage the waste stream better from an approximately 3,000-gallon tank to a 6,500-gallon double walled fiberglass tank in May 2019. The tank was observed to be labeled with the words 'Hazardous Waste'. The waste codes on the

Picture-1 Waste J2 Methanol tank

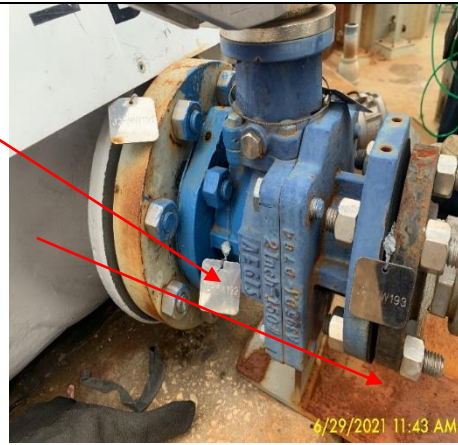
The inspectors observed discoloration on the ancillary equipment and piping associated with the Waste J2 Methanol Tank (Pictures-2,3,4,5). Daikin responded to the concern raised by the inspectors during the inspection in a letter dated July 28, 2021 to the EPA. Daikin mentioned that as part of Daikin's Process Safety Management (PSM) program, applicable equipment including piping are evaluated in pursuant to Daikin's maintenance quality control procedures which includes In-Service Inspections of Pressure Vessels (mnt-qc-001); In-Service Inspection of Storage Tanks (mnt-qc-002); in-service examination of piping (mnt-qc-003); and examination of relief and vent systems (mnt-qc-004).

Picture-4 Subpart BB tags, Discoloration of Ancillary Equipment

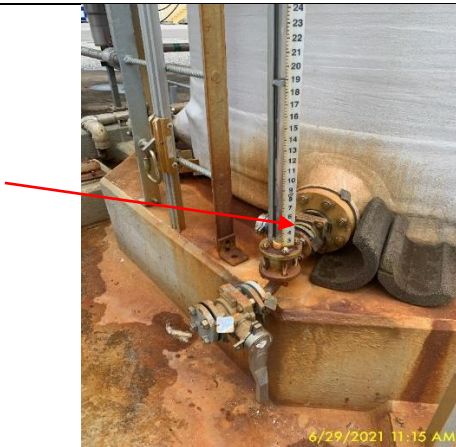
tank was D001, D035 and F005. The secondary containment for the tank was observed to be intact and free of any cracks or gaps (Picture-2). The volume of the material in the tank is monitored by the DCS in the control room. The alarm testing for the tank is conducted on an annual basis per the facility's preventive maintenance schedule.

Picture-2 Secondary Containment; Discoloration on Piping and Ancillary Equipment

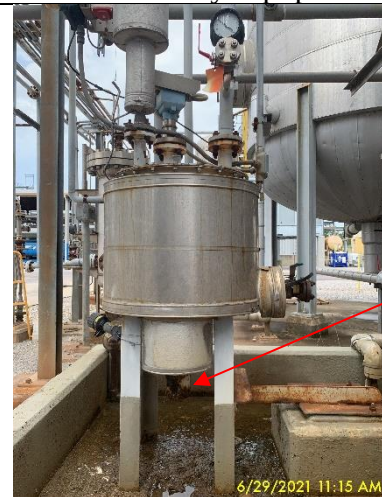
Picture-5 Potential Rust on the Ancillary Equipment associated with the Waste J2 Methanol Tank

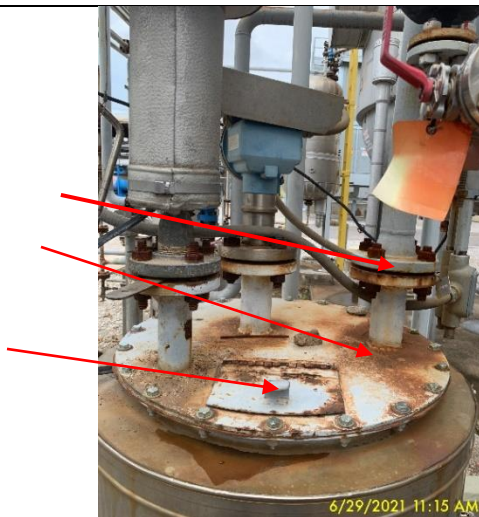
Picture-3 Discoloration on Piping and Ancillary Equipment associated with the Waste J2 Tank

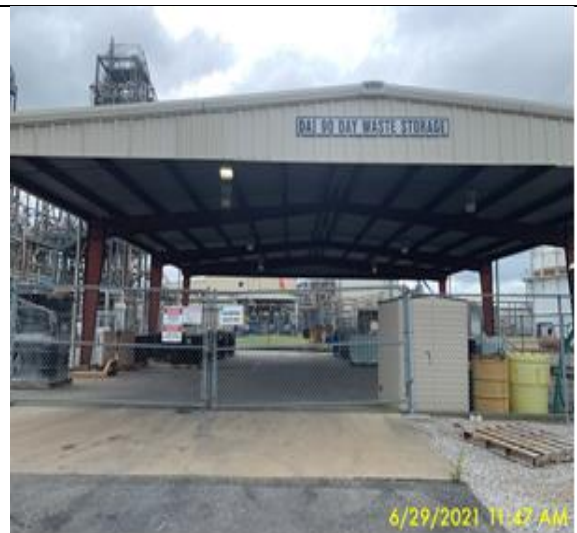
This storage area is located at the end of MDA production area on the north side of the property. The hazardous waste storage area is comprised of a corrugated metal roof structure surrounded by a chain-link fence (Picture-6). The gate was closed, and the warning signs were posted at the entrance. The building was sloped with concrete berms around the perimeter of the storage area. The concrete floor was free of any cracks or gaps.

Picture-6 DAI 90-day Waste Storage Area

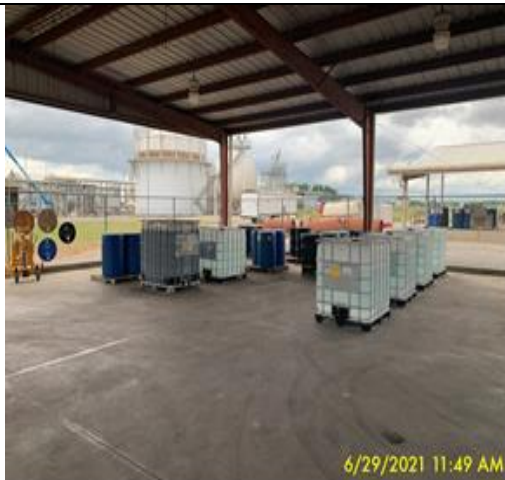
The storage area is divided into two sides, Hazardous and Non-Hazardous. There were four 250-gallon totes of waste methanol in storage at the time of inspection (Picture-7). The oldest accumulation date on the totes was observed to be 04/14/21. There were 26 55-gallon waste drums, 21 55-gallon used oil drums and three 250-gallon used oil totes on the nonhazardous waste side. All the containers and totes were observed to be closed, labeled, and dated. There was adequate aisle space in the storage. There were no leaks or spills observed in the storage area. The storage area was observed to be equipped with fire extinguisher and spill kits.

The inspectors observed some of the labels on the containers in storage were peeling. Daikin responded to the inspector's concern observed during the inspection in a letter dated July 28, 2021. According to Daikin, all the labels on the containers that were observed to be peeling at the time of inspection were replaced with new labels. All appropriate labels affixed are checked as part of the weekly inspection. In addition, appropriate shipping labels provided by the designated Treatment, Storage and Disposal (TSD) facility are placed on the containers prior to the shipping.

Picture-7 Hazardous Waste in the DAI Waste Storage

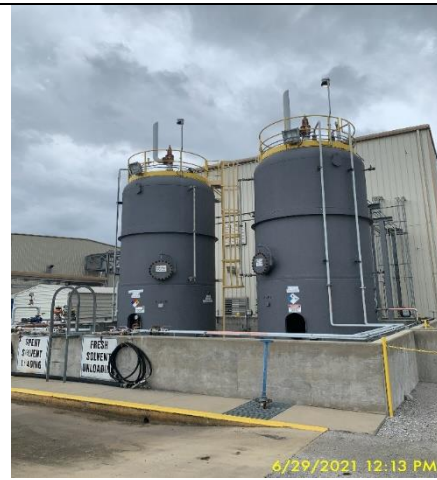
The tank farm consists of two 15,000-gallon aboveground storage tanks located in the Daikin production area (Picture-10). One 15,000-gallon tank contained spent Methyl Ethyl Ketone (MEK); the other 15,000 tank contained clean product solvent (MEK). Both the tanks were observed to be labeled and placarded. Both the tanks are monitored by DCS. The spent MEK is sent offsite for reclamation twice a week and returned to the facility for reuse in the production process. The secondary containment for the tanks was observed to be intact and free of any cracks or gaps (Picture-11). There were no leaks or spills observed in the secondary containment.

Picture-10 DAI Spent MEK Tank & Product Tank

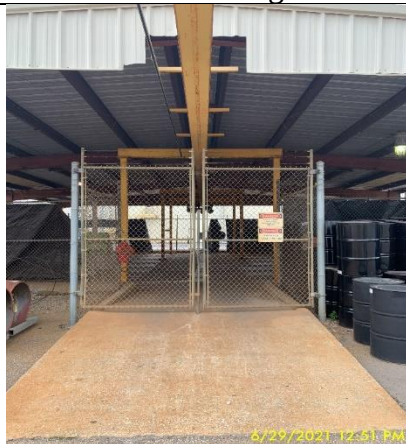
The hazardous waste storage area comprised of a corrugated metal roof structure surrounded by a chain-link fence (Picture-8). The gate was closed, and warning signs were posted at the entrance. The building was sloped with concrete berms around the perimeter of the storage area. The concrete floor was free of any cracks or gaps. The inspectors observed a fire extinguisher and a portable eye wash station. The storage area is divided into two sides, Hazardous and Non-Hazardous. There was adequate aisle space in the storage area. There were six 250-gallon totes of waste methanol (Picture-9) and one 55-gallon drum of waste methanol (Solids) in storage at

the time of inspection. All the totes and the drum were observed to be closed, labeled, and dated. The waste codes on the totes and the drum were observed to be D001, D002 and D007. The oldest accumulation date was observed to be 05/30/2021. The inspectors stated that the housekeeping could be improved at the MDA Storage.

Picture-8 MDA 90-day Waste Storage Area

Daikin responded to the inspector's concern observed during the inspection in a letter dated July 28, 2021 to the EPA and the State. Daikin indicated that they have prepared a plan to upgrade the MDA 90-day storage which includes installing a bird netting, recoat the floor and paint the plywood wall, remove stained/torn tarps from the side wall, restripe the area for the designated container location, install a new signage and replace the portable eye wash unit with an installation of a permanent shower / eyewash station.

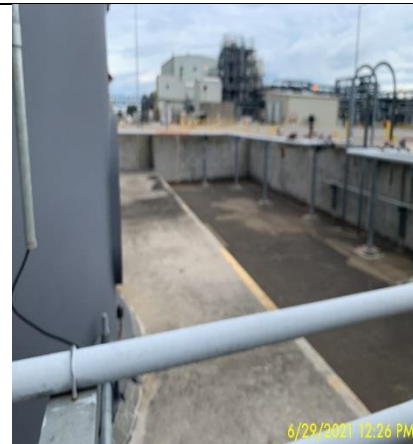
Picture-11 Secondary Containment DAI Spent MEK Tank Area

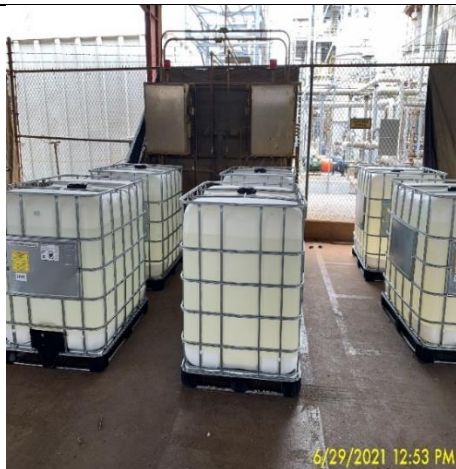
Picture-9 Waste Methanol in MDA 90-day Storage

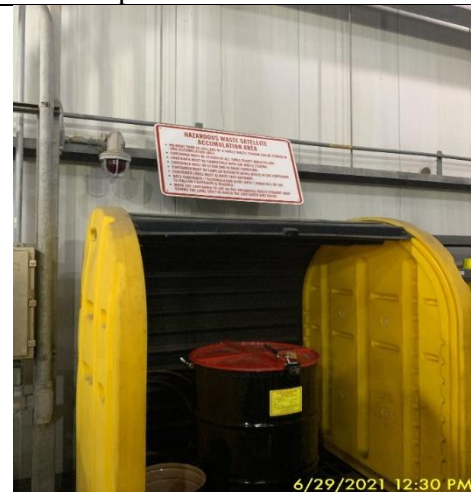
Three satellite accumulation areas (SAAs) in the B9 (Picture-12) and B10 units were inspected in the DAI area of the facility. There was one SAA drum in the B9 unit (Picture-12). Two 55-gallon SAA drums in the B10 unit. The SAA drums in both the units were observed to be closed and labelled with the words "Hazardous Waste". Both the drums had waste codes. None of the SAA drums in both the SAA units had markings and/or labels indicating the hazard.

The inspectors told Mr. Hollis although the drums had hazardous waste labels and waste codes, however, pursuant to ADEM Admin. Code r. 335-14-3 [40 C.F.R. § 262.15(a)(5)] which is a condition of the SAA Permit Exemption, a generator is required to mark or label its container with (i) with the words "Hazardous Waste" and (ii) with an indication of the hazards of the content. Mr. Hollis later showed pictures of the SAA containers having pictograms before the end of the inspection. The inspectors stated to Mr. Hollis that all the SAA containers in the production area should have labels and/or marking indicating the hazard. Mr. Hollis stated to the inspectors that he would ensure that all SAA containers in the production area would have pictograms and would also ensure that the procedures for SAA containers are updated to include the placement of DOT labels on the SAA containers.

Picture-12 B9 SAA Drum

Daikin further responded to the inspector's concern observed during the inspection in a separate letter dated July 28, 2021 to the EPA. Daikin stated that as part of their continual improvement action, Daikin had placed applicable DOT labels on their SAA containers at other locations and revised their procedure to include the placement of DOT labels on their SAA containers.
