COMPLIANCE EVALUATION INSPECTION REPORT  
U.S. ENVIRONMENTAL PROTECTION AGENCY, REGION 5

**Purpose:** NPDES Compliance Evaluation Inspection

**Facility:** OSI Environmental  
912 Tesch Court  
Waukesha, Wisconsin 53186

**Date of Inspection:** November 30, 2022

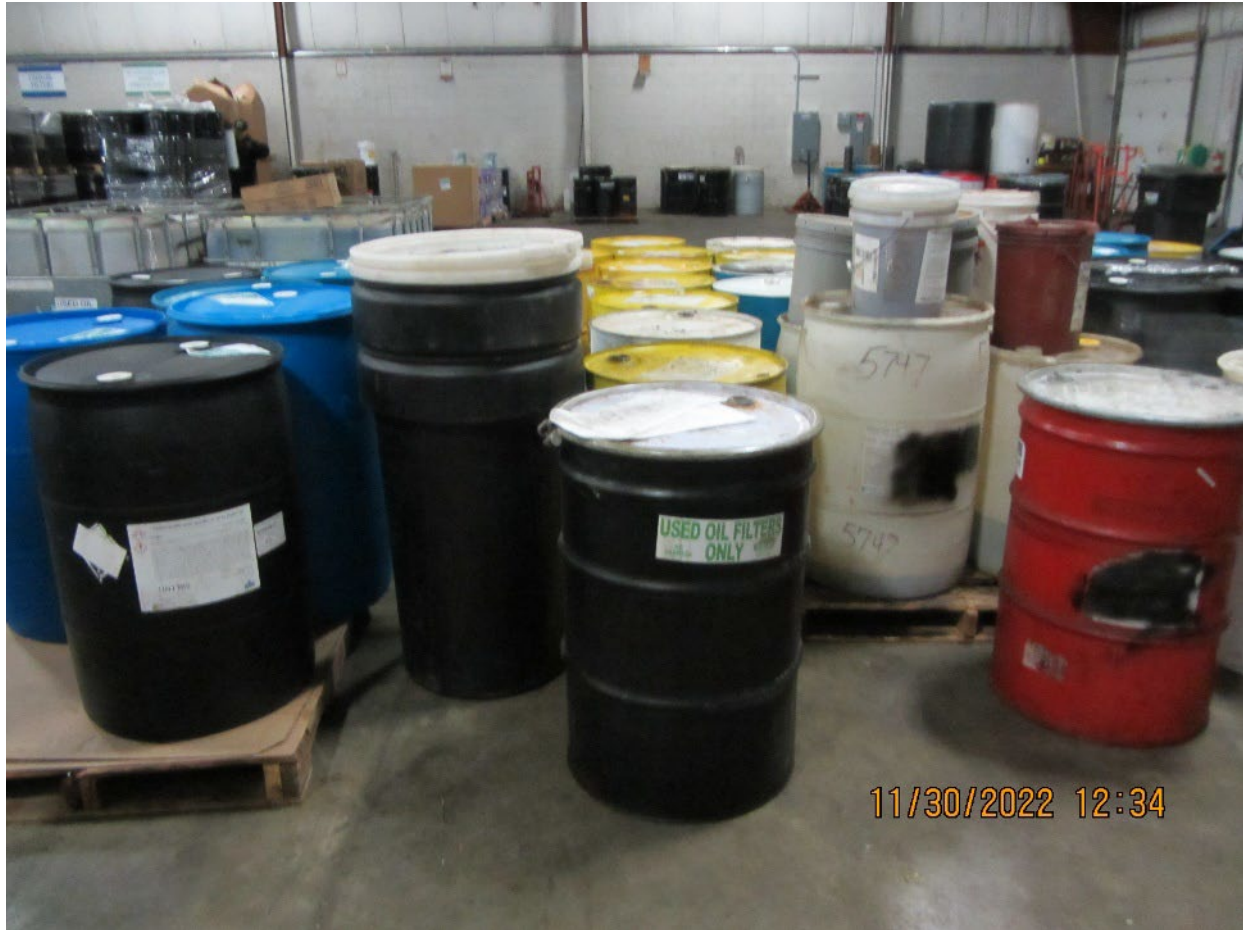
1: IMG\_0270

Near the loading area, I saw full drums of oily water waiting to be taken to the waste facility (Photo 1) and drums of gasoline ready to be transported to the underground tanks (Photo 2). Drums are offloaded into groups and stored near the loading area prior to processing (Photos 6-7).

Description: Drums of oily water located near the loading dock, waiting for transfer offsite to the contracted wastewater facility. One drum has a visible "USED OIL FILTERS ONLY" label.

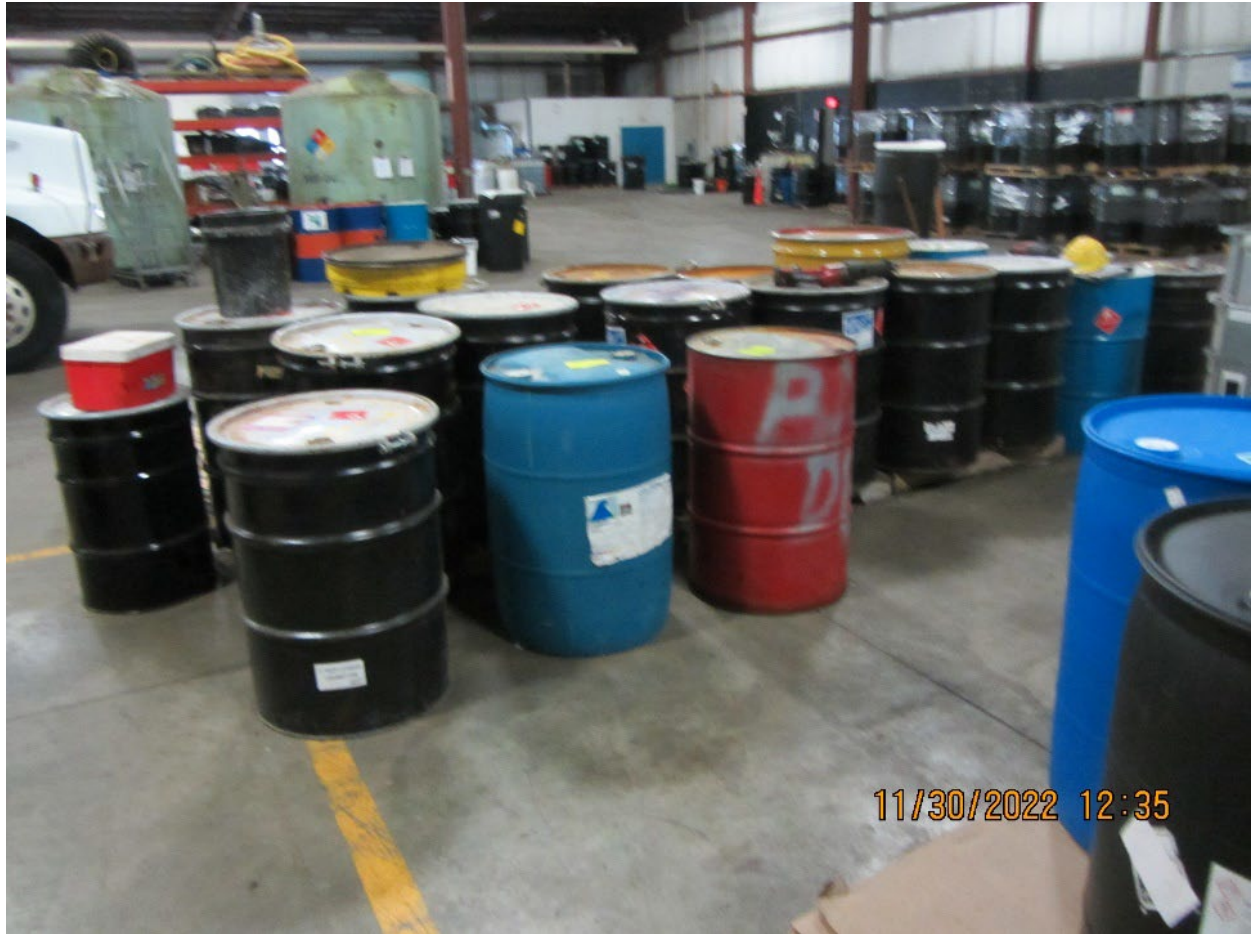
2: IMG\_0271

Description: Full drums of bad gasoline, situated near the loading dock, waiting to be transported to the underground tank.

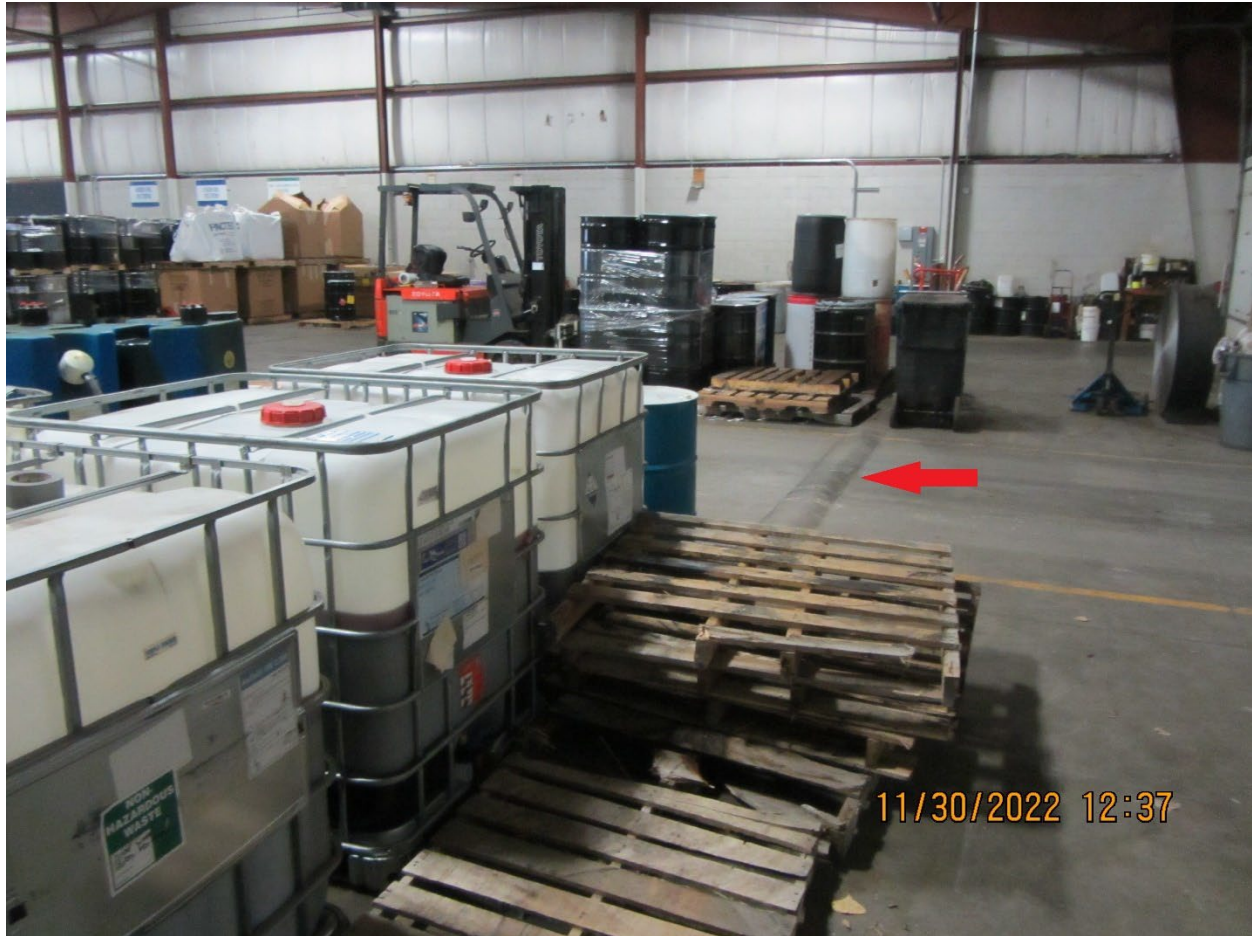
3: IMG\_0272

The warehouse area is an enclosed building with a concrete floor, no floor drains, and two loading docks. There is a berm surrounding the loading dock area (Photos 3 and 5), thus the floor of the warehouse is considered secondary containment for the petroleum stored onsite. The total petroleum storage onsite (including the tank farm and underground storage tank) is approximately 550,000 gallons, according to the Spill Prevention Control and Countermeasure plan prepared November 7, 2022 (SPCC).

Description: Two loading docks to the right of image. Red arrow (added by EPA to identify location) points to the berm that surrounds the loading dock.

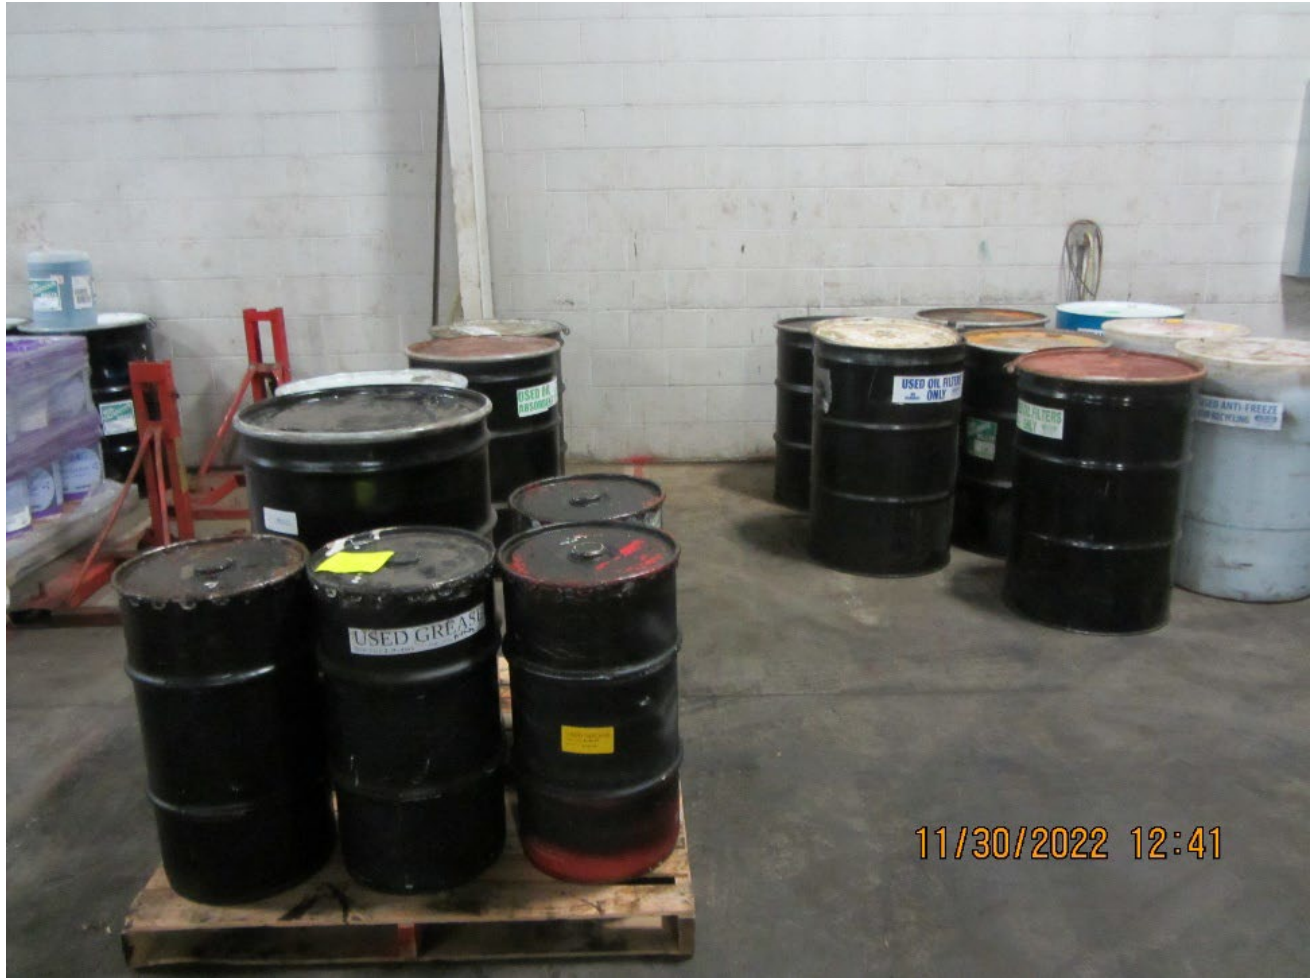
6: IMG\_0275

Description: Off loading area near the loading dock. Drums of similar wastes will be placed together prior to relocating and processing. Drums labeled "USED GREASE" on left and "USED ANTI-FREEZE" and "USED OIL FILTERS" on right.

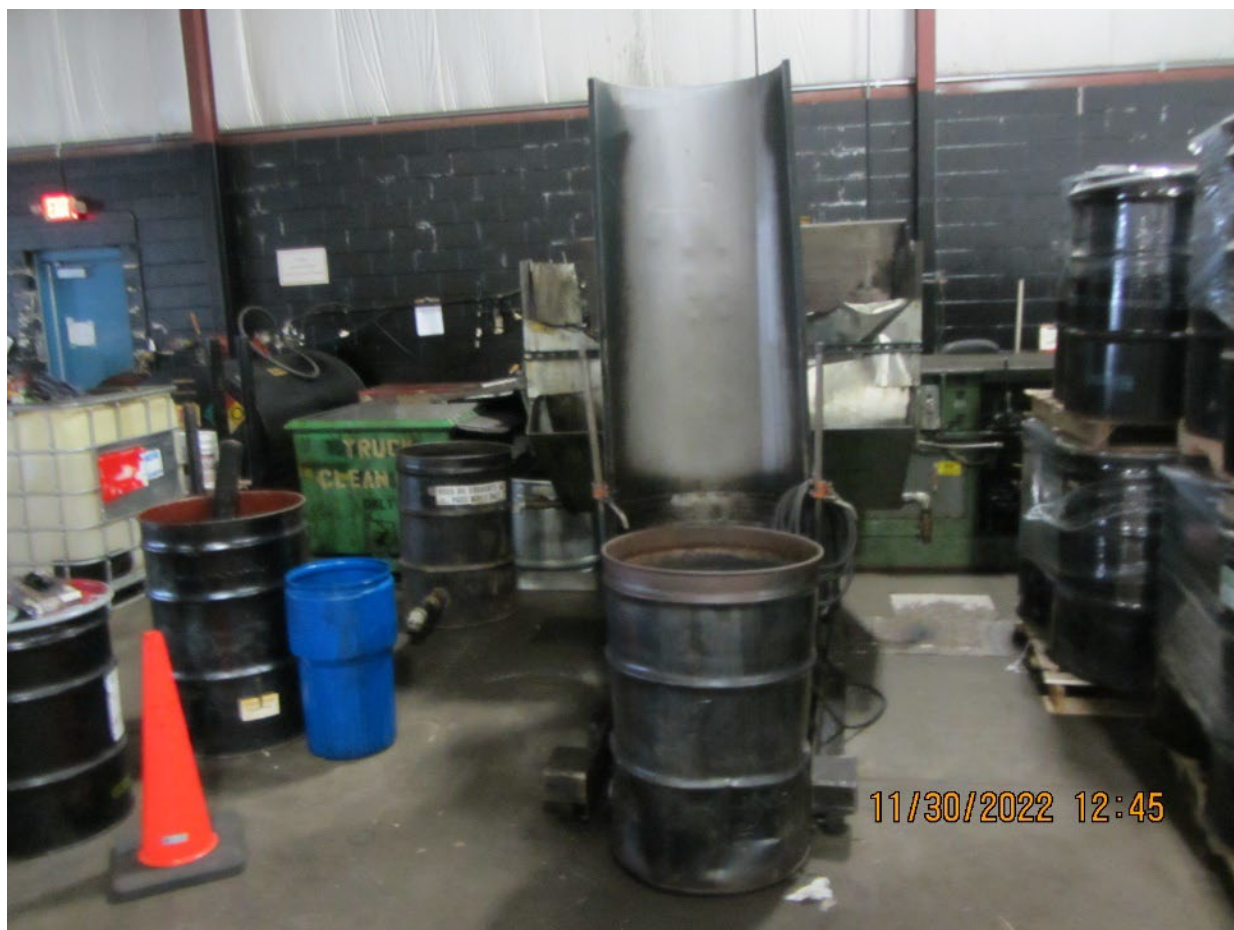
8: IMG\_0277

Description: Oil filter compactor which is not currently used, according to Mr. Rosier.

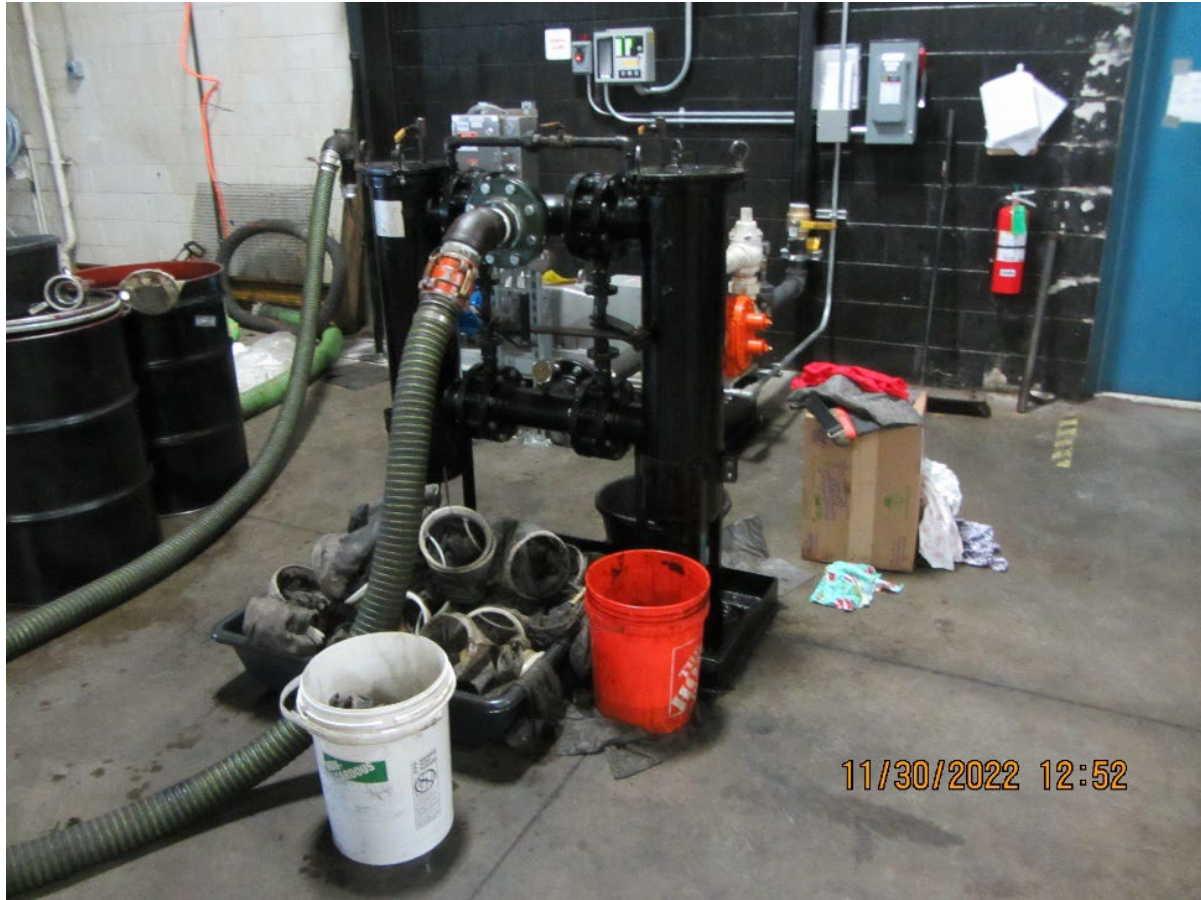
10: IMG\_0279

Description: Used oil offloading and filtration prior to sending oil to the tank farm. Used filters (white circles next to orange bucket) are stored under the filter prior to cleaning in parts washer and reuse.

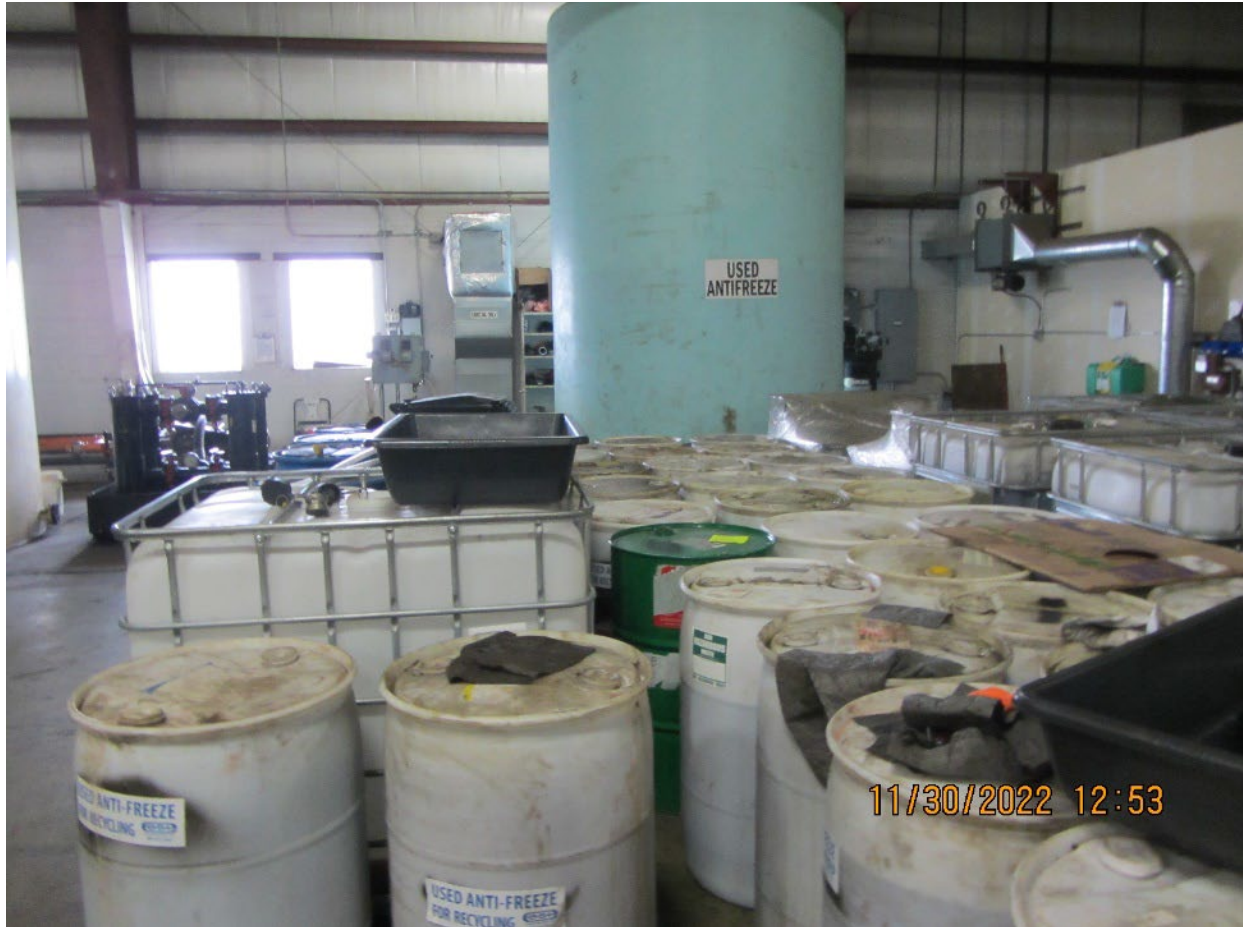
11: IMG\_0280

Description: Drums and totes labeled “ USED ANTI-FREEZE” in foreground. Used antifreeze tank in background. A coarse filter is in left background below the window.

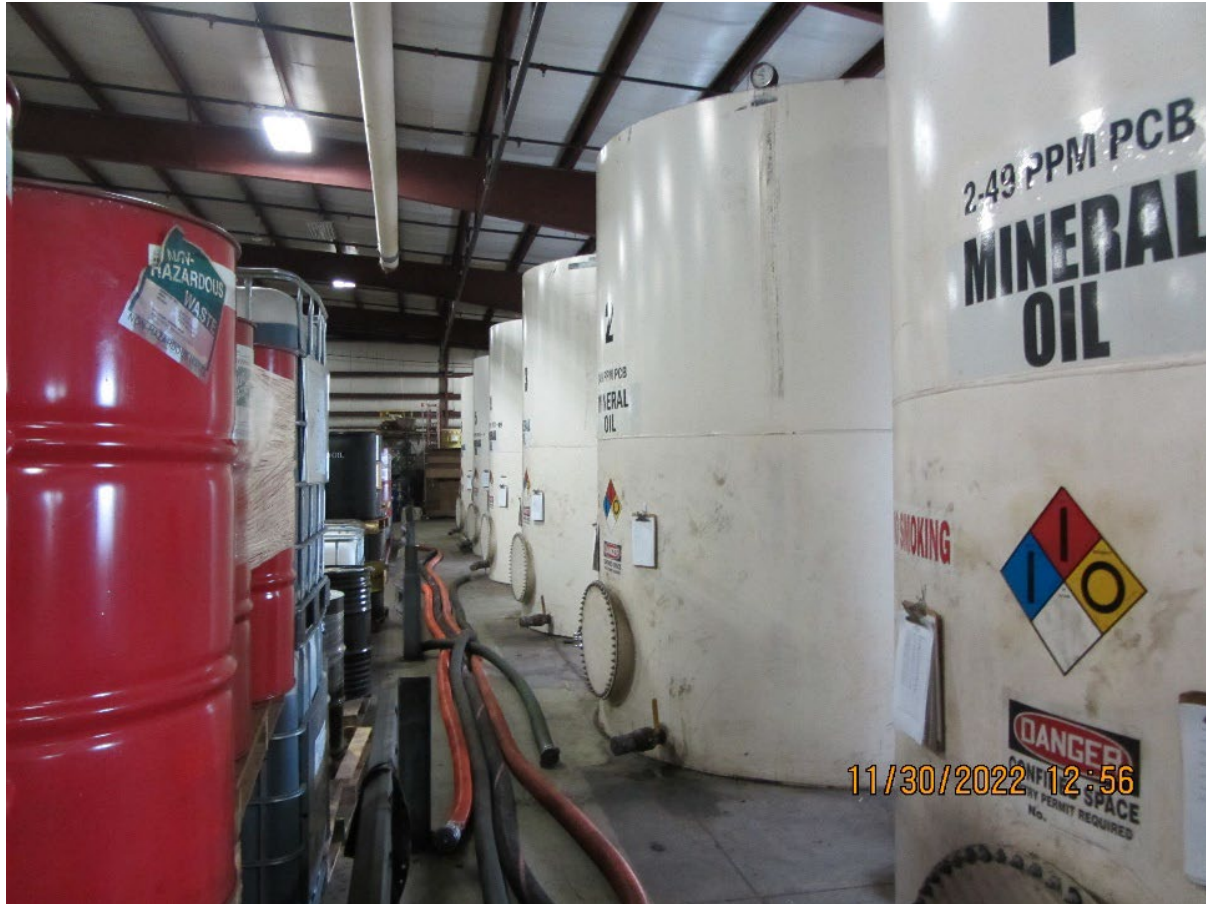
14: IMG\_0283

Description: Six 2-49 PPM PCB mineral oil tanks. Each tank has a separate clipboard that lists the products which have been pumped to the tank and their laboratory reports.

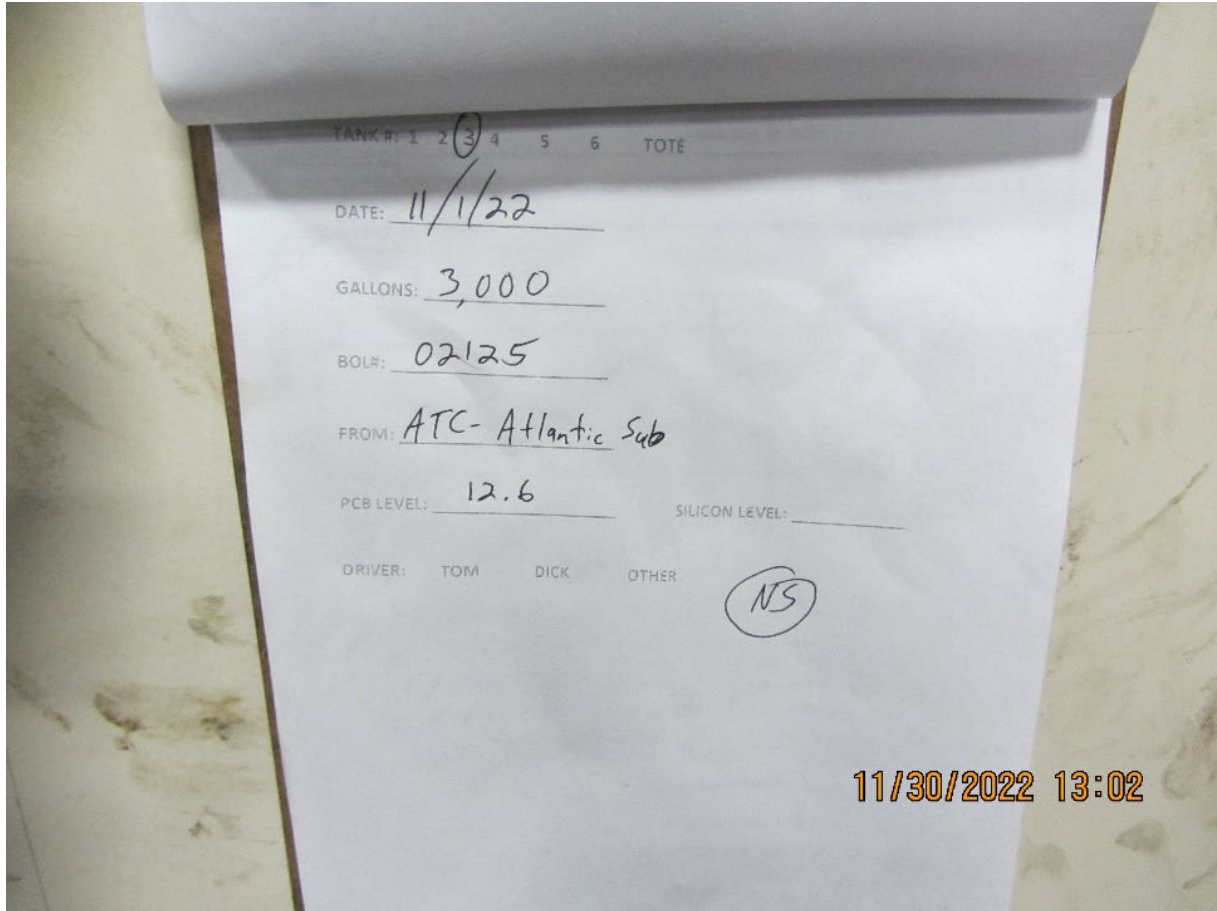
16: IMG\_0285

Description: Page of Mineral Oil Tank 3 clipboard that lists where the mineral oil was received, date, volume and PCB level for product that was pumped to the tank.

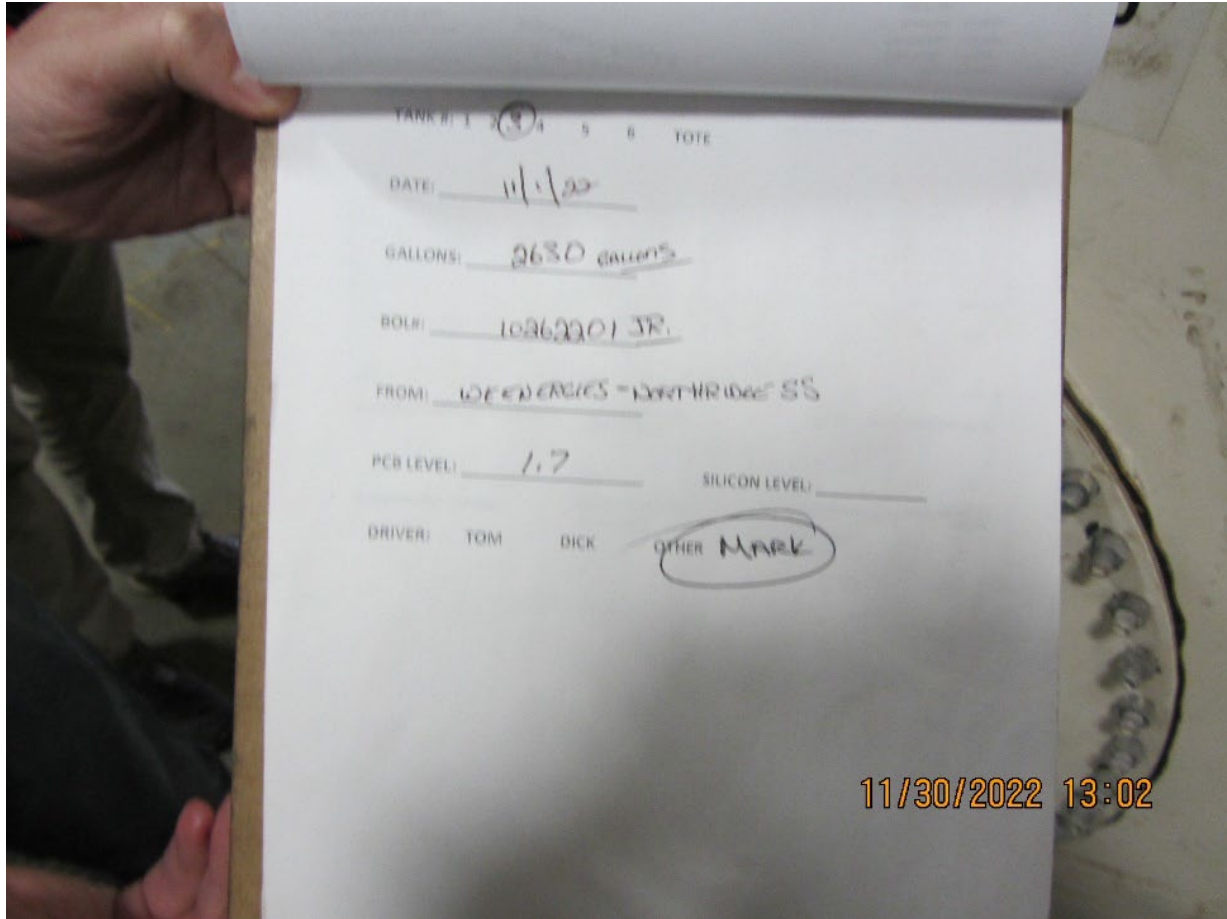
17: IMG\_0286

Description: Page of Mineral Oil Tank 3 clipboard that lists where the mineral oil was received, date, volume and PCB level for product that was pumped to the tank.

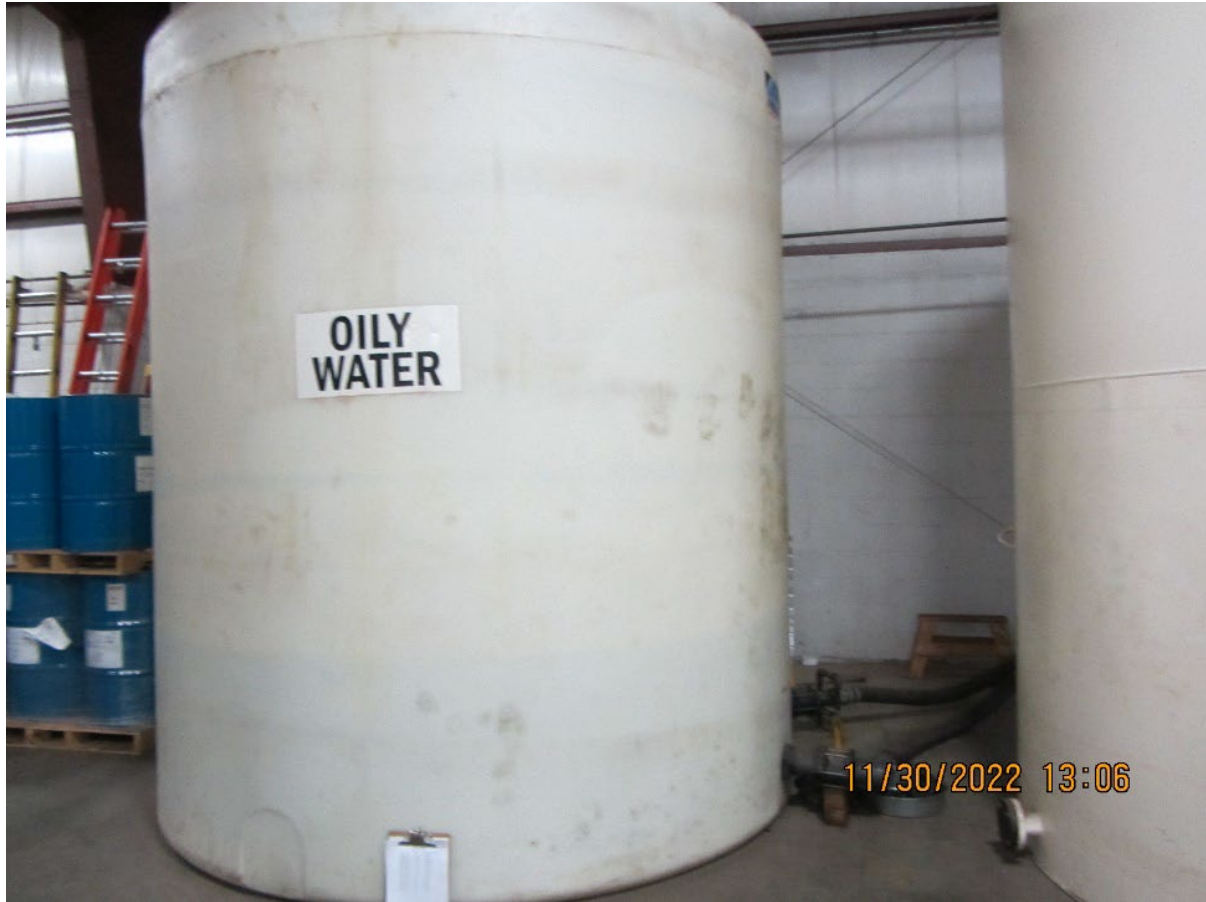
19: IMG\_0288

Description: Oily water tank that is located south of the mineral tanks.

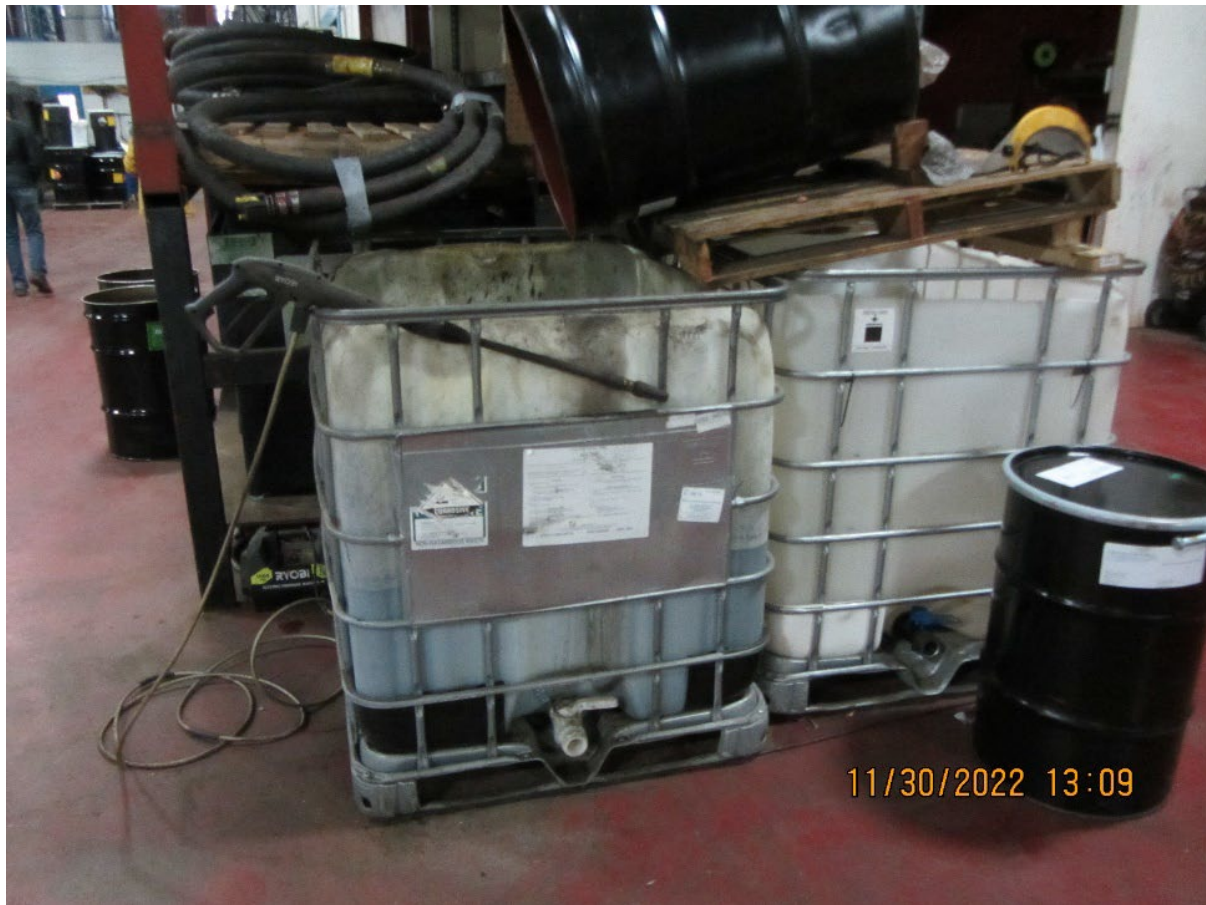
21: IMG\_0290

There is a maintenance area which has a parts washer, but this does not produce wastewater, according to Mr. Rosier. Drum cleaning is also done in this area. I saw an elevated drum that was draining into an open tote containing oily waste (Photos 21 – 22). Mr Rosier stated that the

Description: Inverted drum dripping into an open tote that is used as parts washer waste collection.

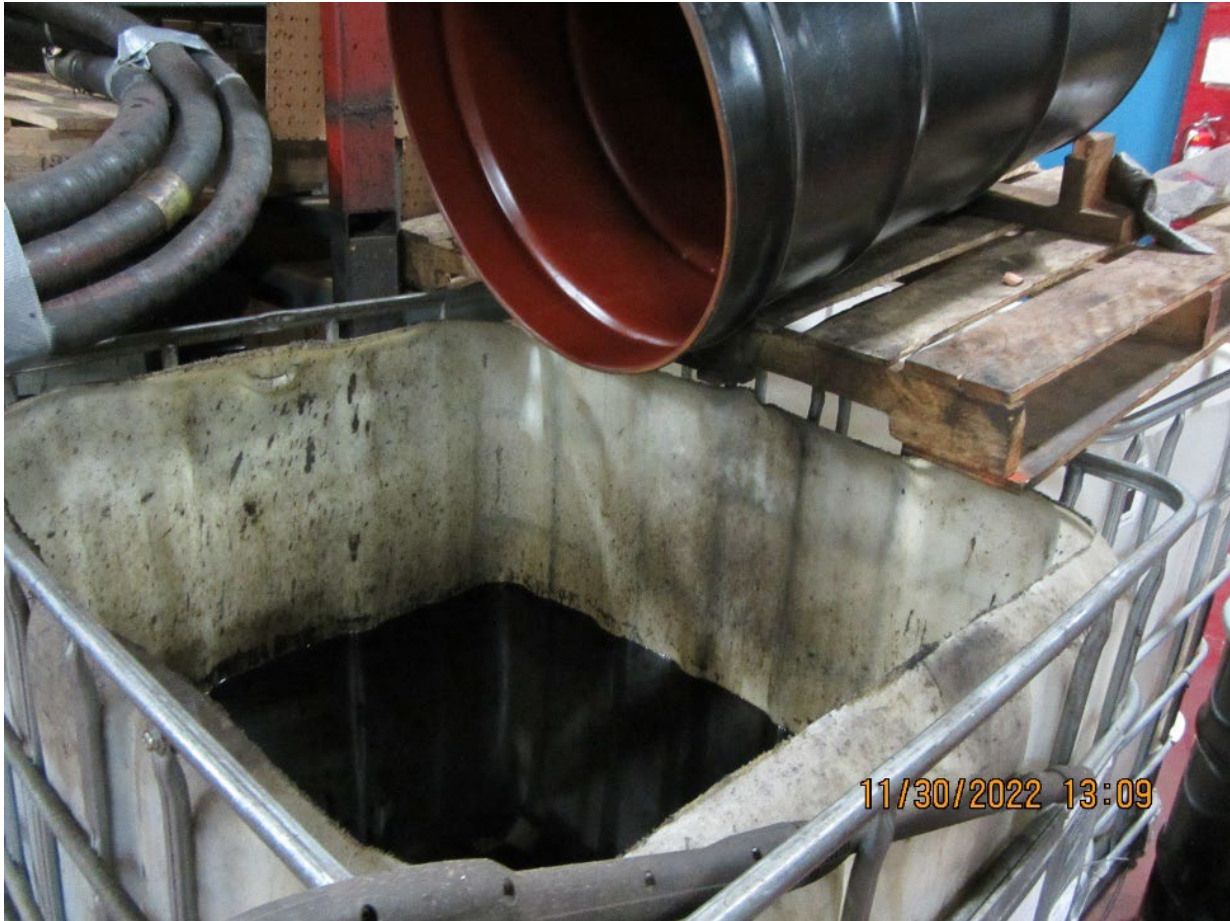
22: IMG\_0291

Description: Closer view of the open parts washer waste collection tote and inverted drum from Photo 21.

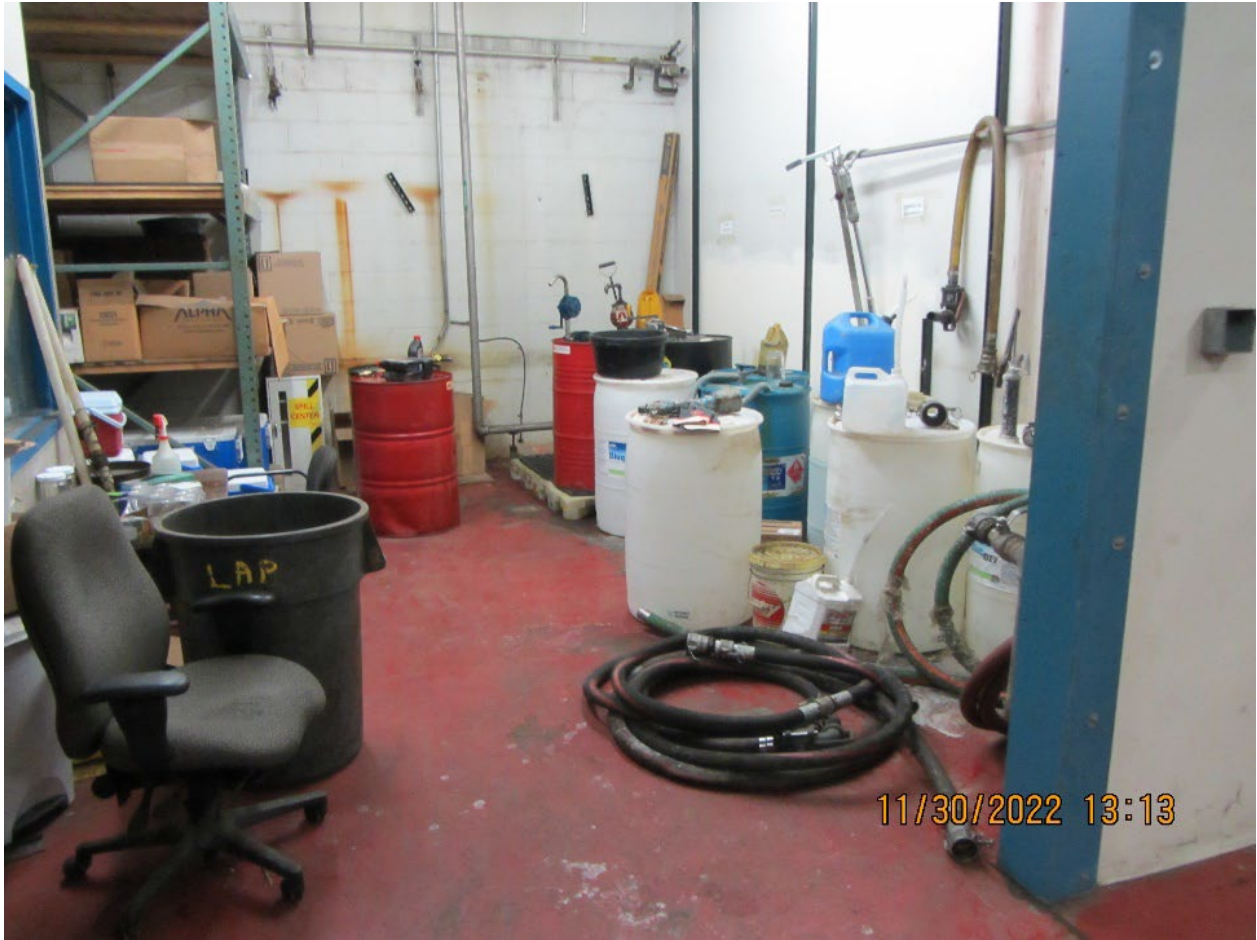
23: IMG\_0292

Description: Storage room for oil, antifreeze and washer fluid for trucks.

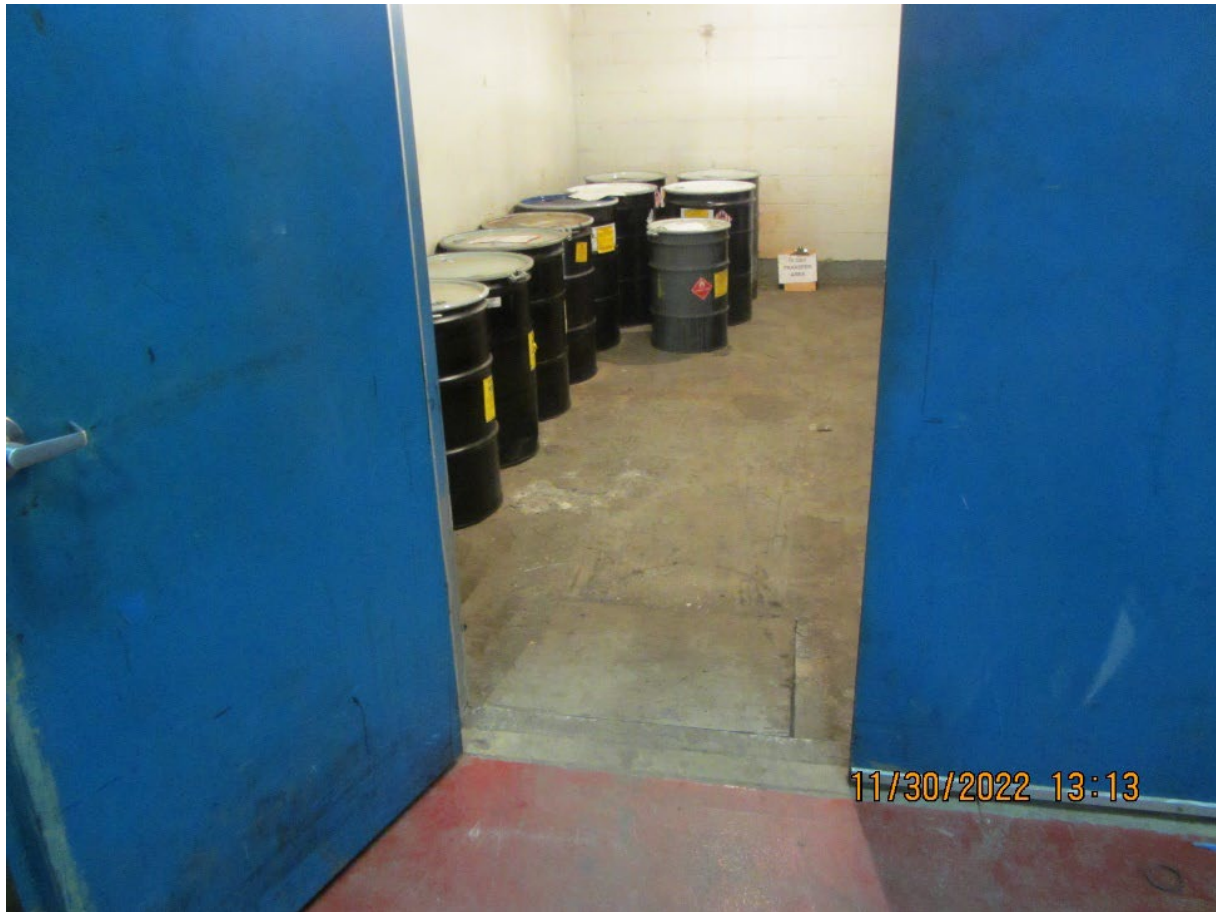
24: IMG\_0293

There is a hazardous waste room that has intrinsically safe lighting (Photo 24). Hazardous waste may be stored for up to 10 days. I noted some drums labeled as hazardous waste sitting outside the room waiting to be picked up for transfer.

Description: Hazardous waste drums stored in intrinsically safe hazardous waste room. Room is at a lower grade than the warehouse floor and a ramp leads into the room. Both blue doors are normally closed, but one was opened to take the photo.

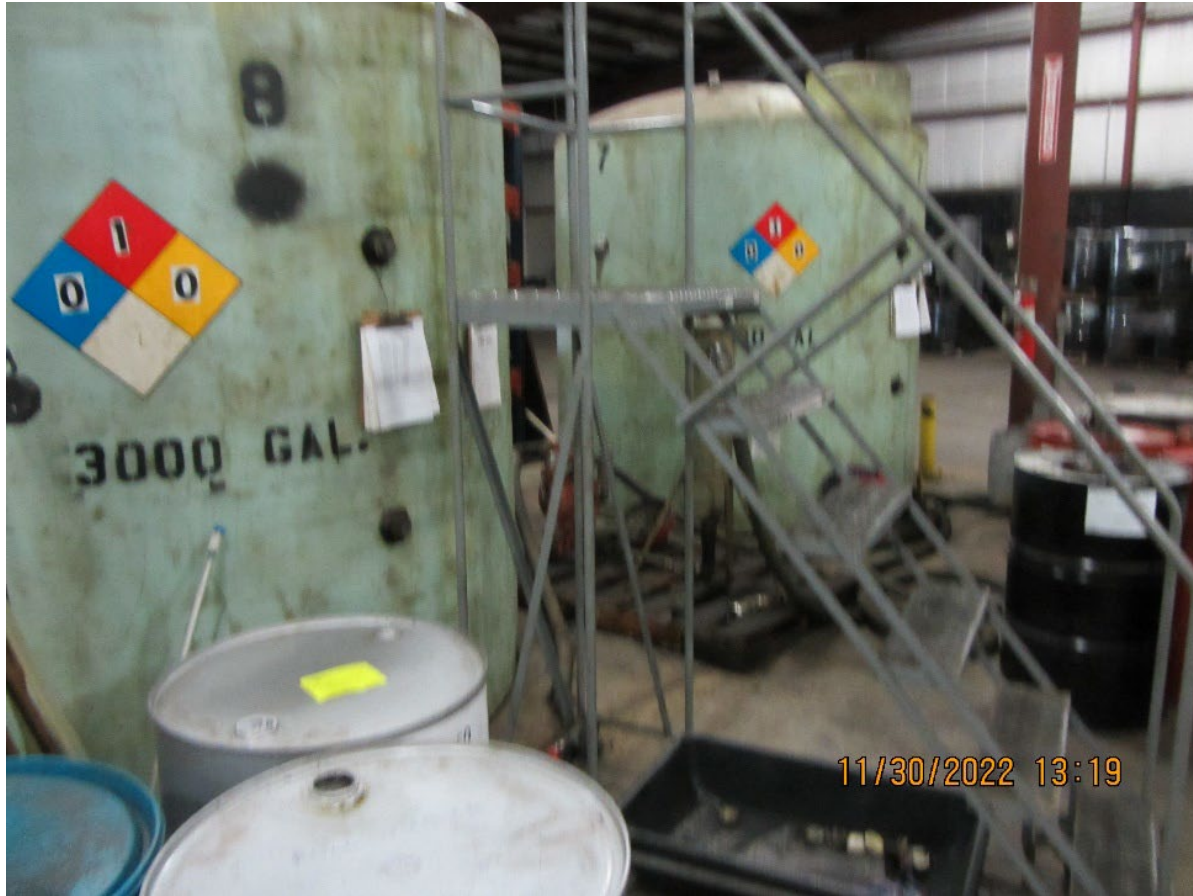
25: IMG\_0294

Description: Two 3000 gallon tanks that were not used at the time of the inspection, but are kept as backups.

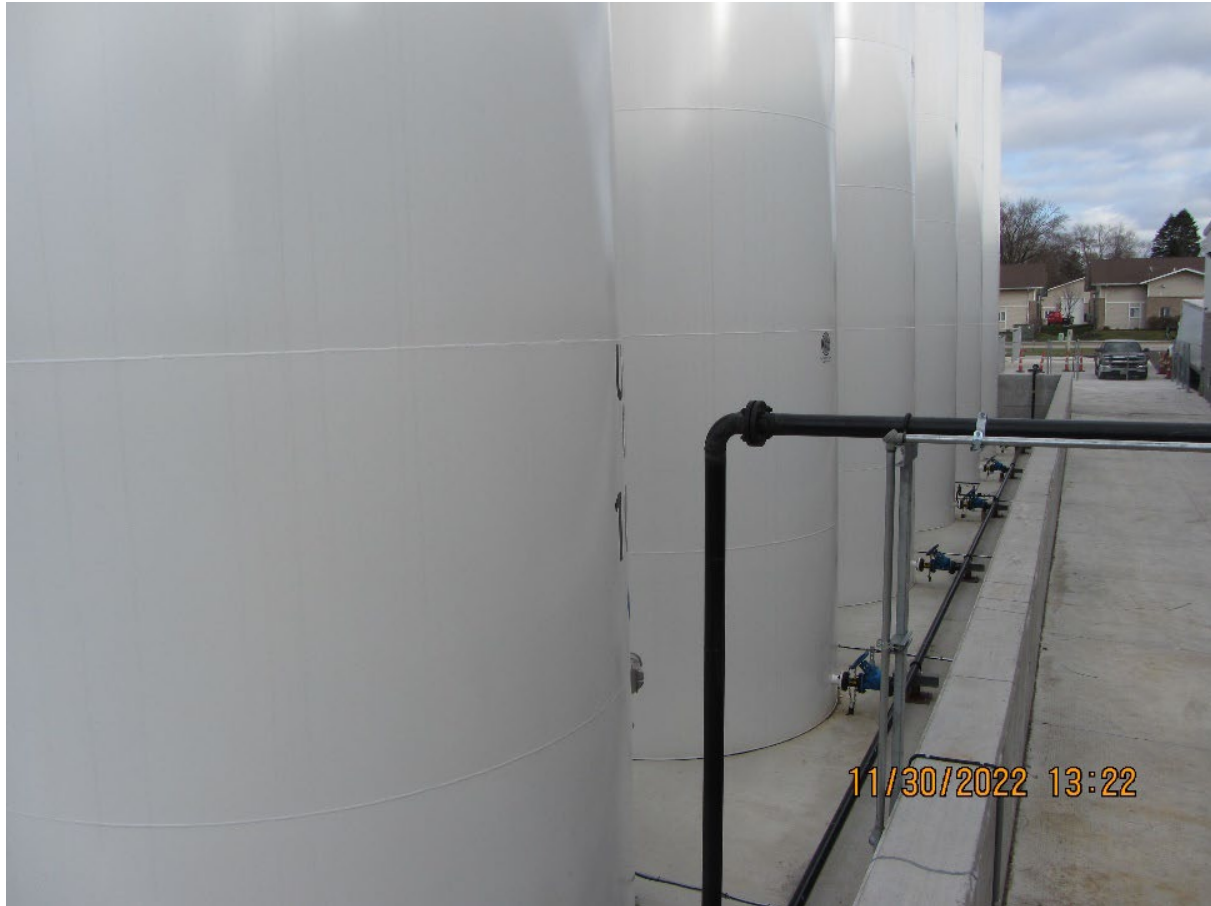
26: IMG\_0295

Description: Used oil tanks in recently constructed tank farm within a cement containment area.

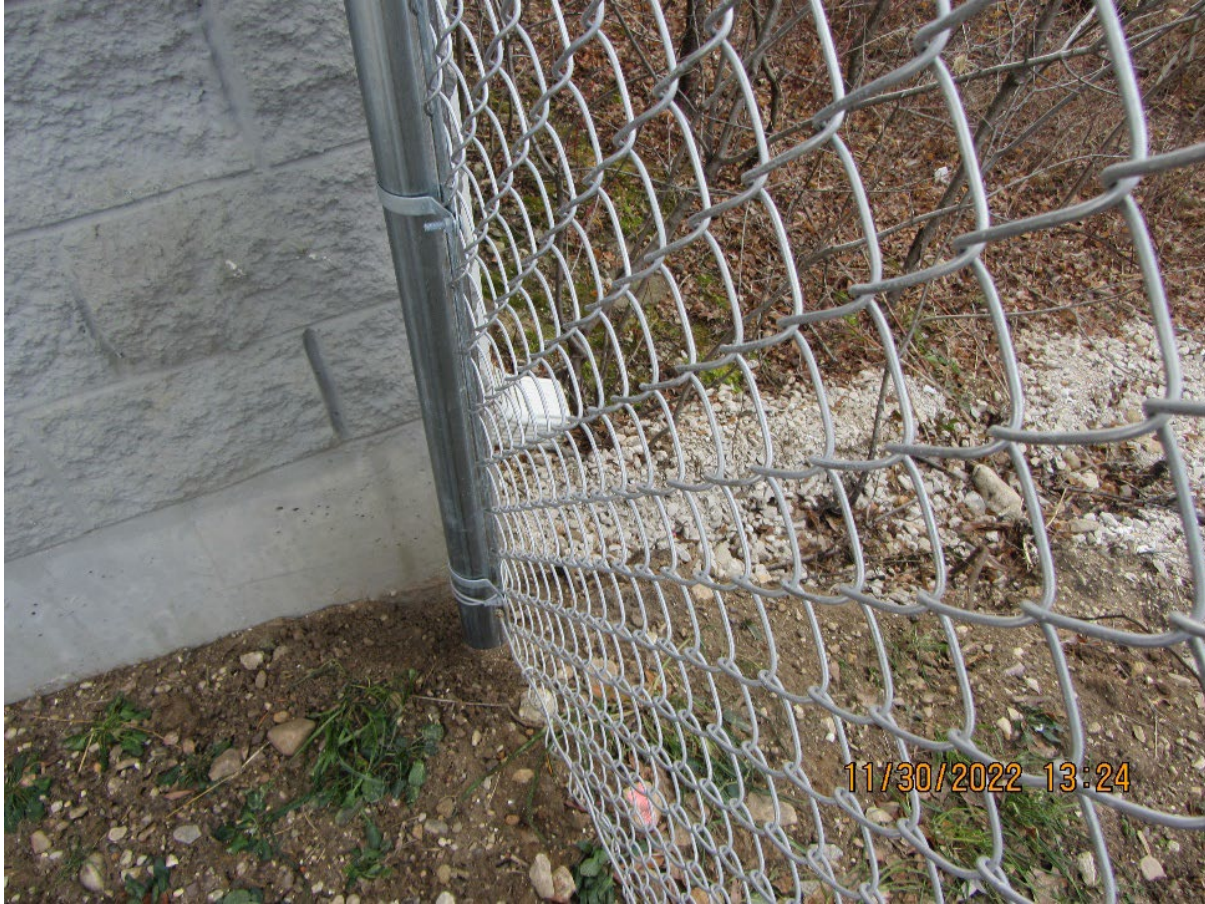
28: IMG\_0297

1. Flow from a roof drain flows behind the warehouse and towards a ditch area and not towards the stormwater pond. The drainage map (Appendix C) in the SWPPP dated

December 21, 2022 does not have the roof drains on the western side of the warehouse listed.

Description: Drain spout from roof of warehouse flows down west of warehouse.

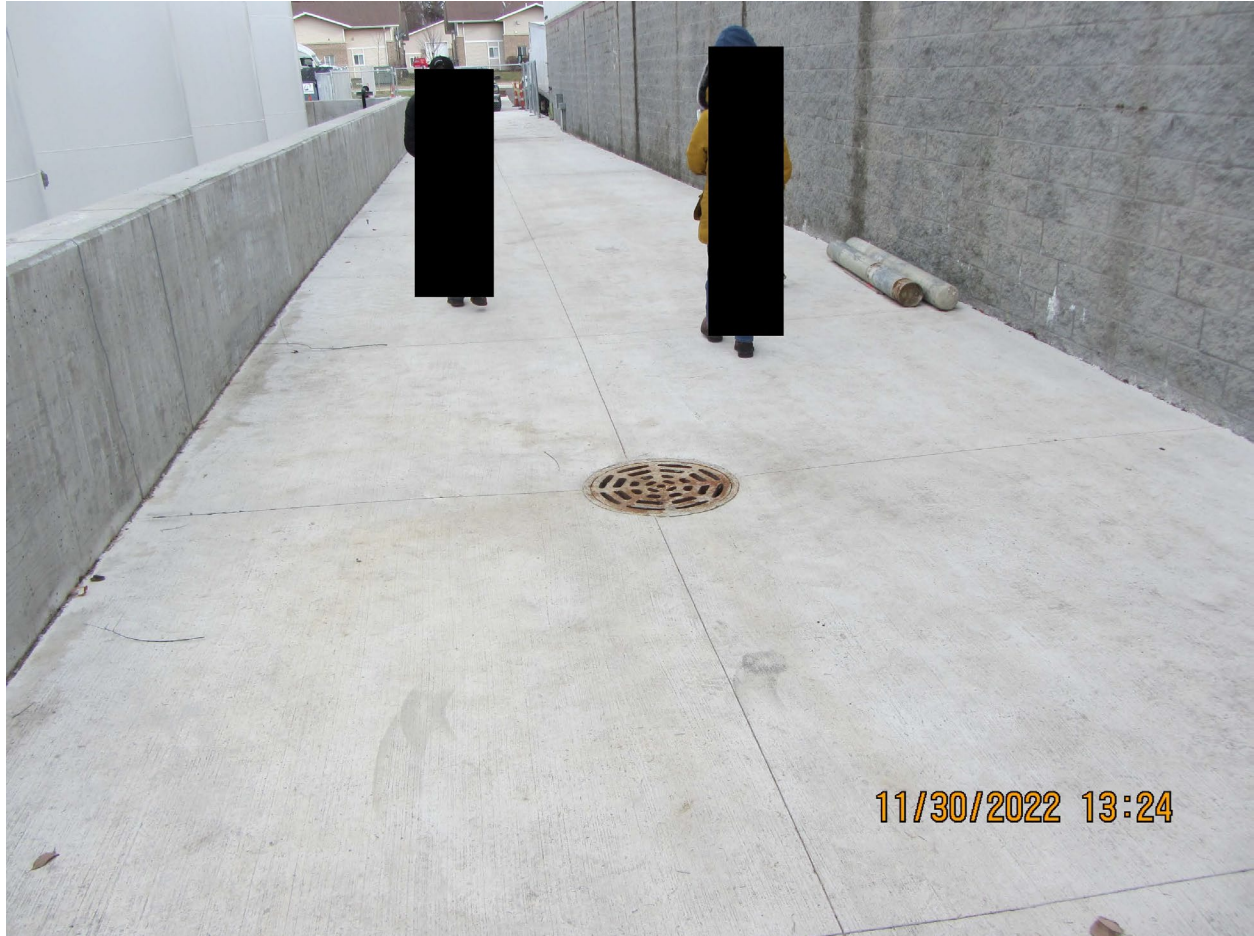
29: IMG\_0298\_redacted

Description: Stormwater drain built into the area between the warehouse and tank farm. Stormwater piping flows to the pond according to the SWPPP.
