COMPLIANCE EVALUATION INSPECTION REPORT  
U.S. ENVIRONMENTAL PROTECTION AGENCY, REGION 5

**Purpose:** NPDES Compliance Evaluation Inspection

**Facility:** OSI Environmental  
912 Tesch Court  
Waukesha, Wisconsin 53186

**Date of Inspection:** November 30, 2022

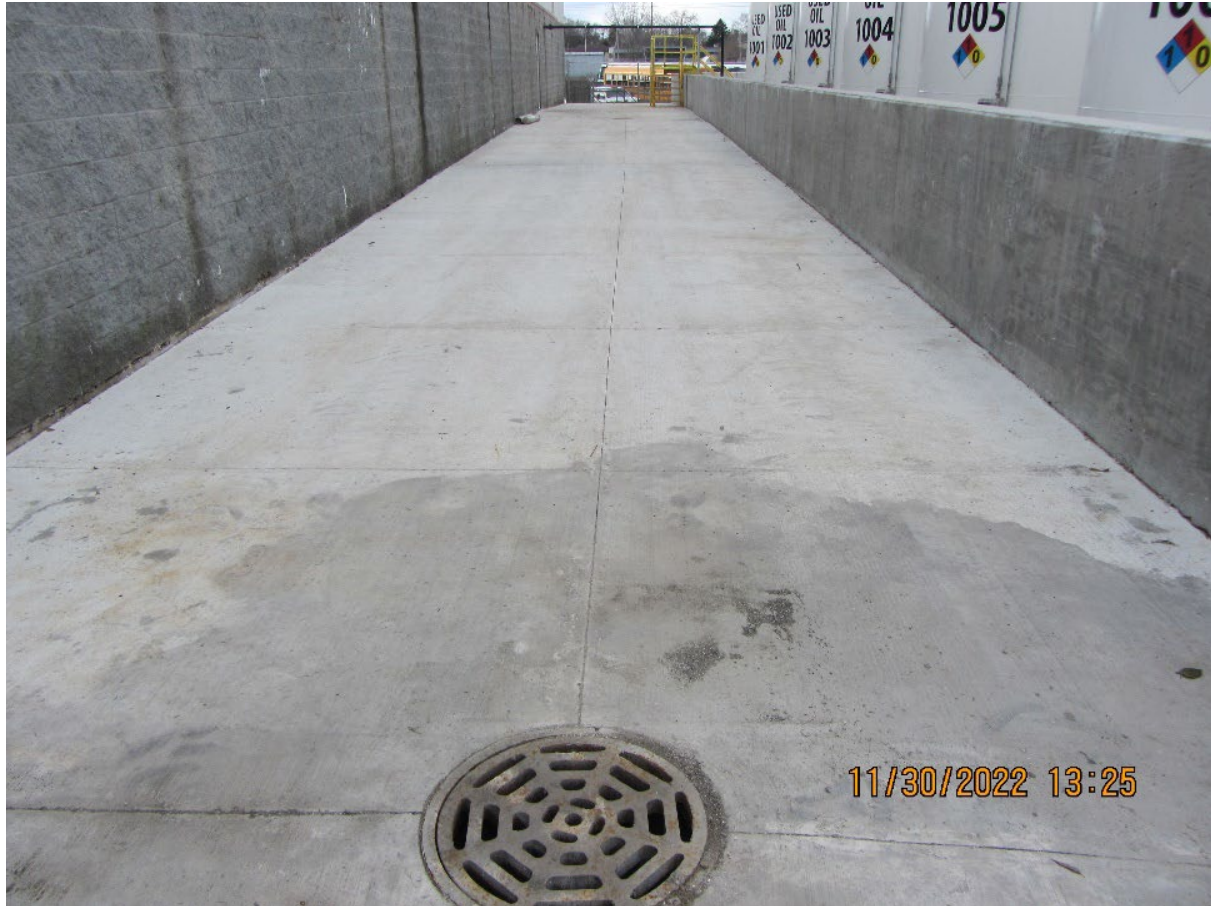
30: IMG\_0299

Description: Stormwater drain built into the area between the warehouse and tank farm. Stormwater piping flows to the pond. Same view as Photo 29 but looking in opposite direction.

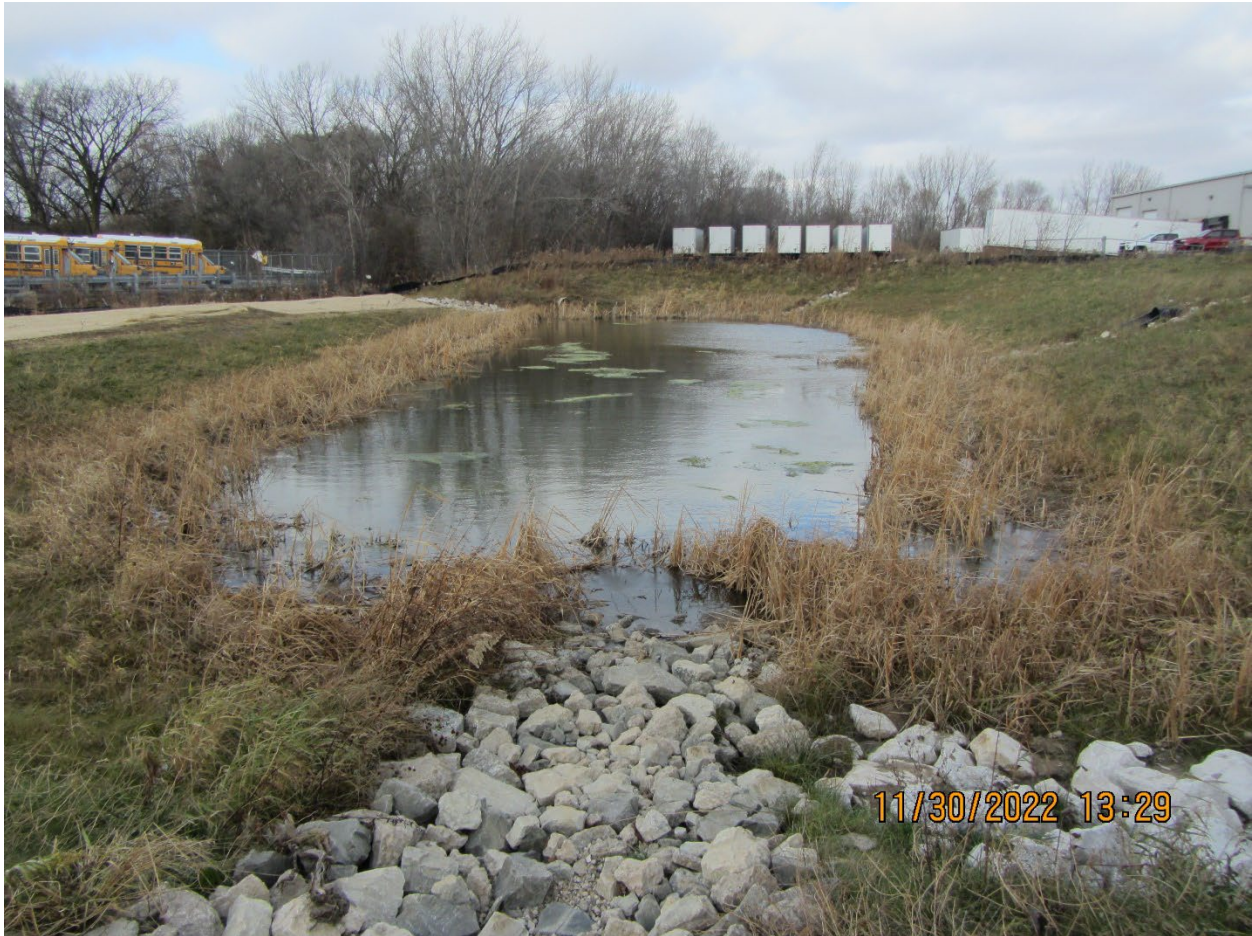
33: IMG\_0302

Description: View from the stormwater outfall looking towards the pond. The pond outfall to Fox Creek, visible at the far end of the pond, is located above the surface of the pond.

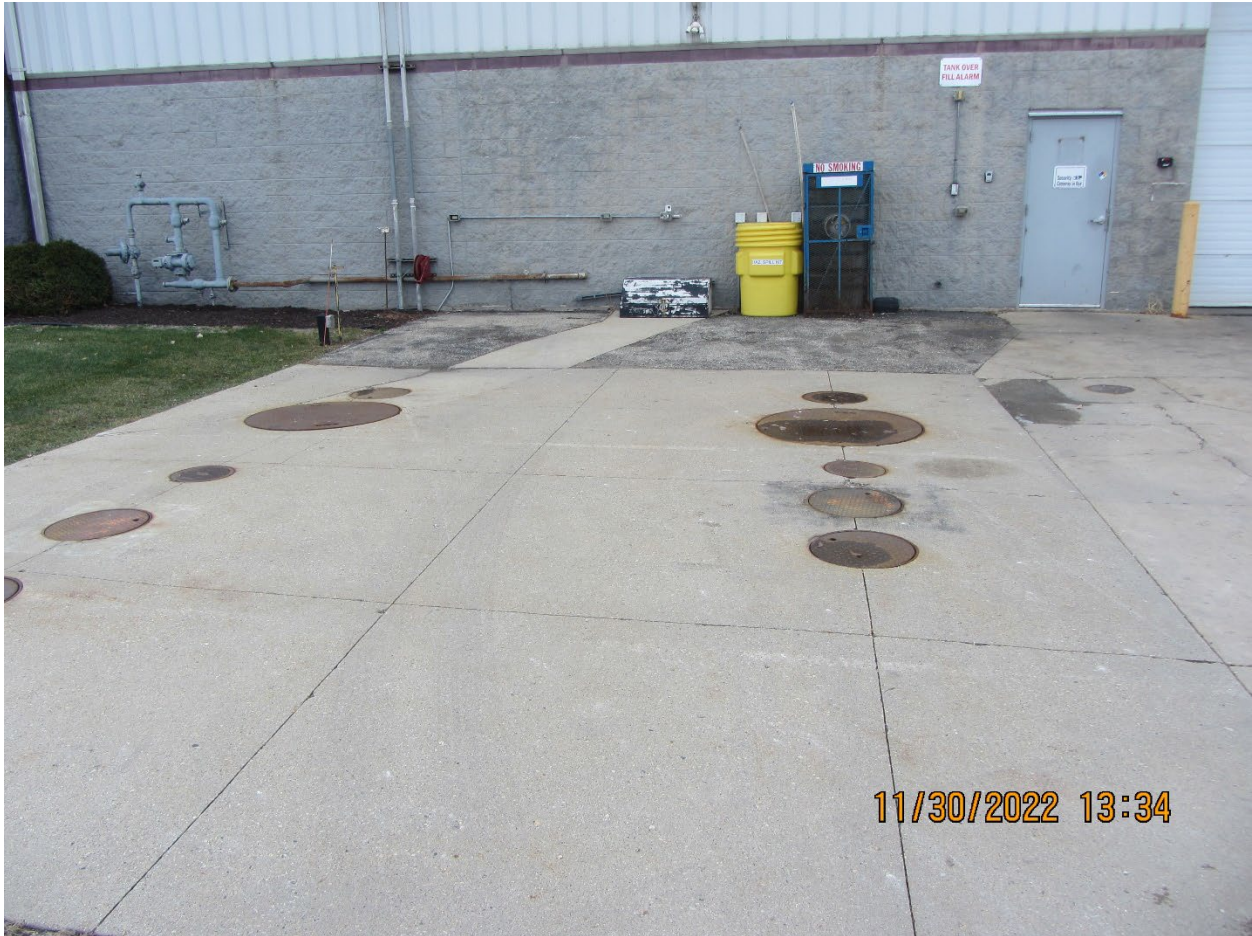
35: IMG\_0304

Description: Manhole plates are visible where two underground gasoline tanks are located. A yellow hazardous spill kit is located nearby against the building.

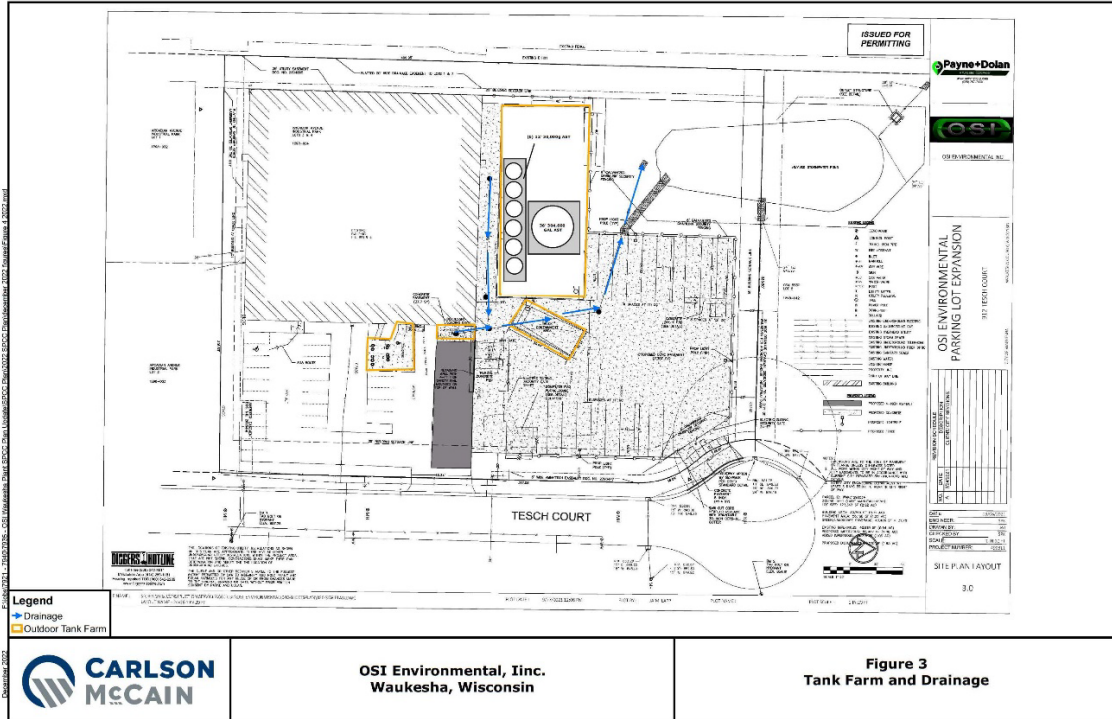
### Appendix C: Drainage Map from page 22 of Stormwater Pollution Prevention Plan dated December 21, 2022

1. Flow from a roof drain flows behind the warehouse and towards a ditch area and not towards the stormwater pond. The drainage map (Appendix C) in the SWPPP dated

December 21, 2022 does not have the roof drains on the western side of the warehouse listed.

Facility map shows flow from stormwater drains that enters the stormwater pond. This map omits northwestern roof drain which, according to Mr. Rosier, flows to a trench on the western side of warehouse and not to the stormwater pond.
