**U.S. ENVIRONMENTAL PROTECTION AGENCY  
REGION 3 WATER BRANCH, ENFORCEMENT  
AND COMPLIANCE ASSURANCE DIVISION  
CLEAN WATER ACT  
COMPLIANCE INSPECTION REPORT**

**Name of Facility:** Metal Center Recycling  
**Facility Address:** 4023 Ohio River Road, Huntington, WV 25702  
**Mailing Address:** 4023 Ohio River Road, Huntington, WV 25702

| <b>Type of Inspection:</b> | Industrial Stormwater |

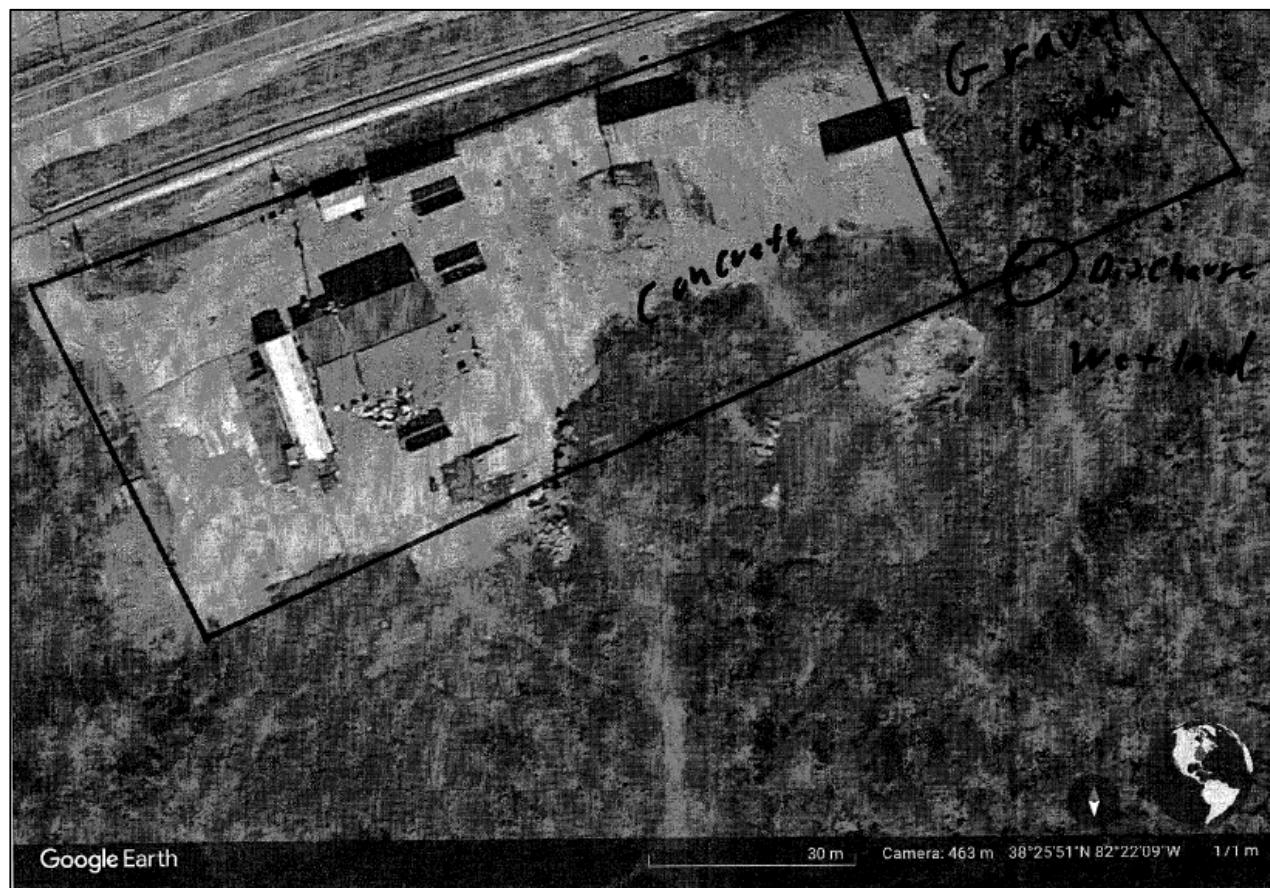
**Figure 1.** SWPPP Site Map

**Observation 4.** The site map contained in the Facility SWPPP was not detailed and did not contain information regarding stormwater drainage. Specifically, the map did not include depiction of BMPs, sheet flow direction, and drainage structures. The site map was simply an aerial image showing the Facility and where the outfall was but did not provide any other information (refer to Figure 1, SWPPP Site Map).
