**Region 6 - Enforcement & Compliance Assurance Division**  
**INSPECTION REPORT**

| Inspection Date(s): | 03/06/2026 | |
| Media Program: | RCRA | |
| Company Name: | Kiwo Inc. | |

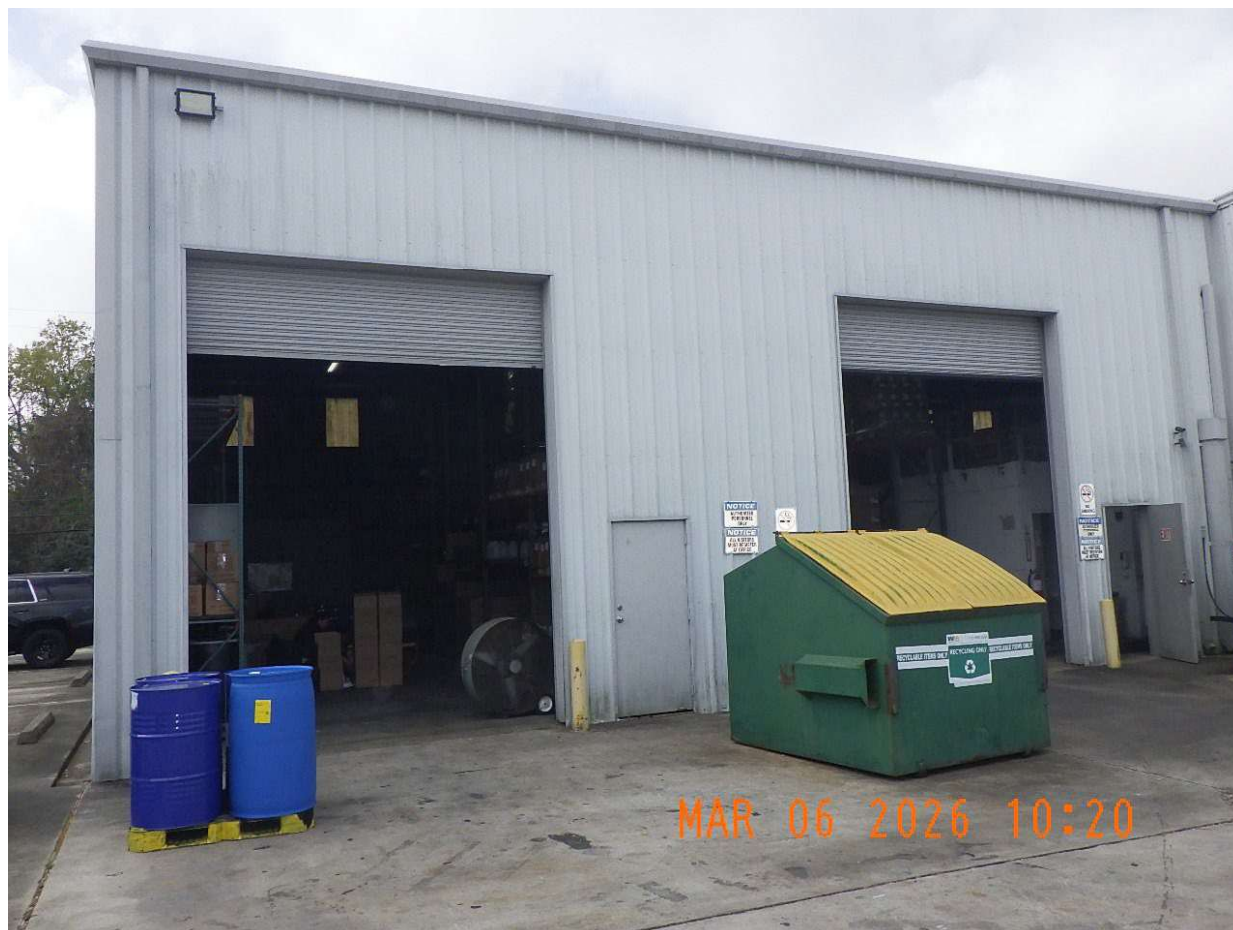
Photo No. 1

| Description: | Production and storage warehouse. Facility refers to the building as 1929. | | |

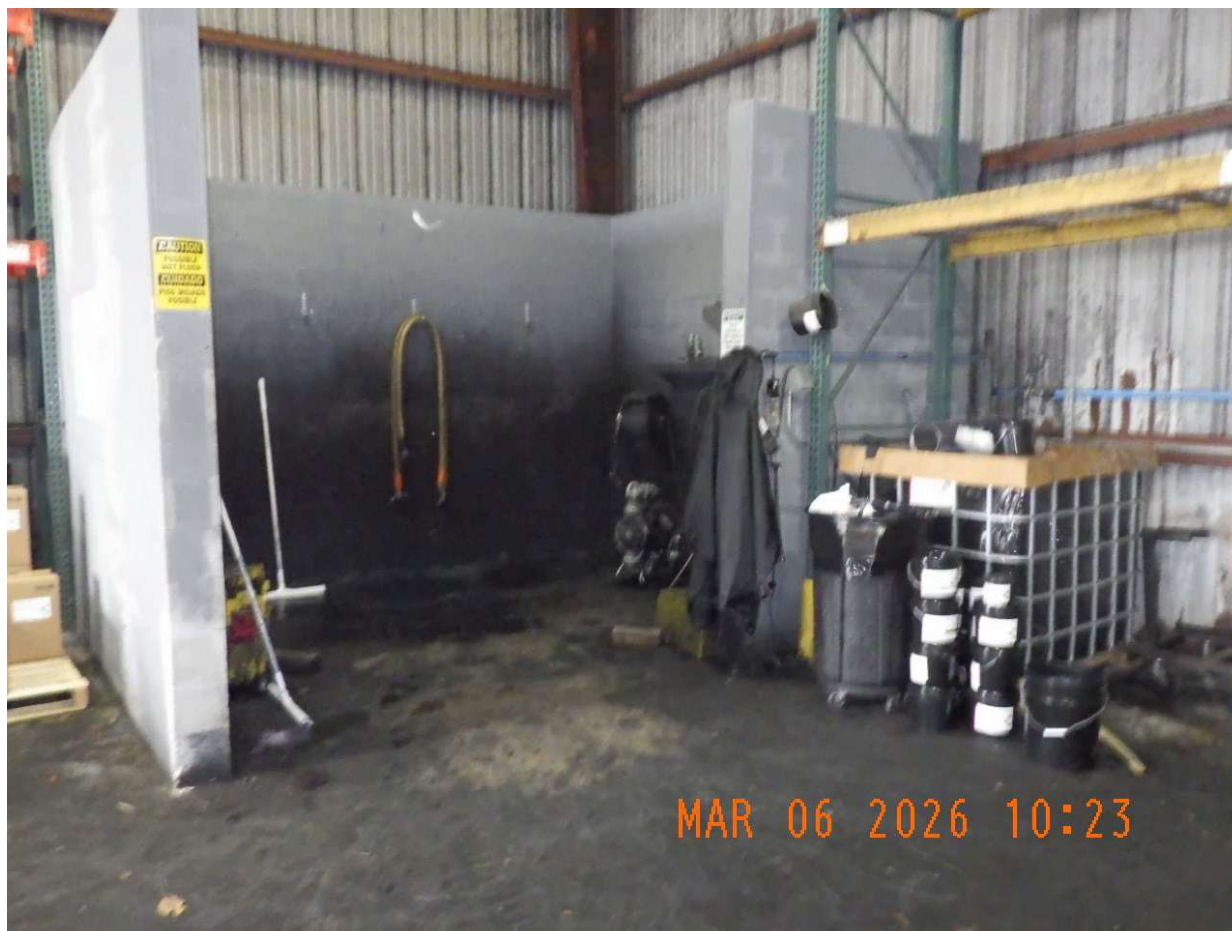
Photo No. 2

Walking in the production and storage warehouse (Appendix 1, Photos 3 and 4) I observed a wash area that is used to wash photo emulsion residue out of equipment from the production line (Appendix 1, Photo 2). Per the plant manager the waste generated is non-hazardous and the sump is emptied and hauled off by Specialized Waste Services (now TAZ). I then observed a second wash area that is used for washing mixing equipment and per the plant manager the drain goes directly to the sewer (Appendix 1, Photos 5).

| Description: | Process vat wash area. | | |

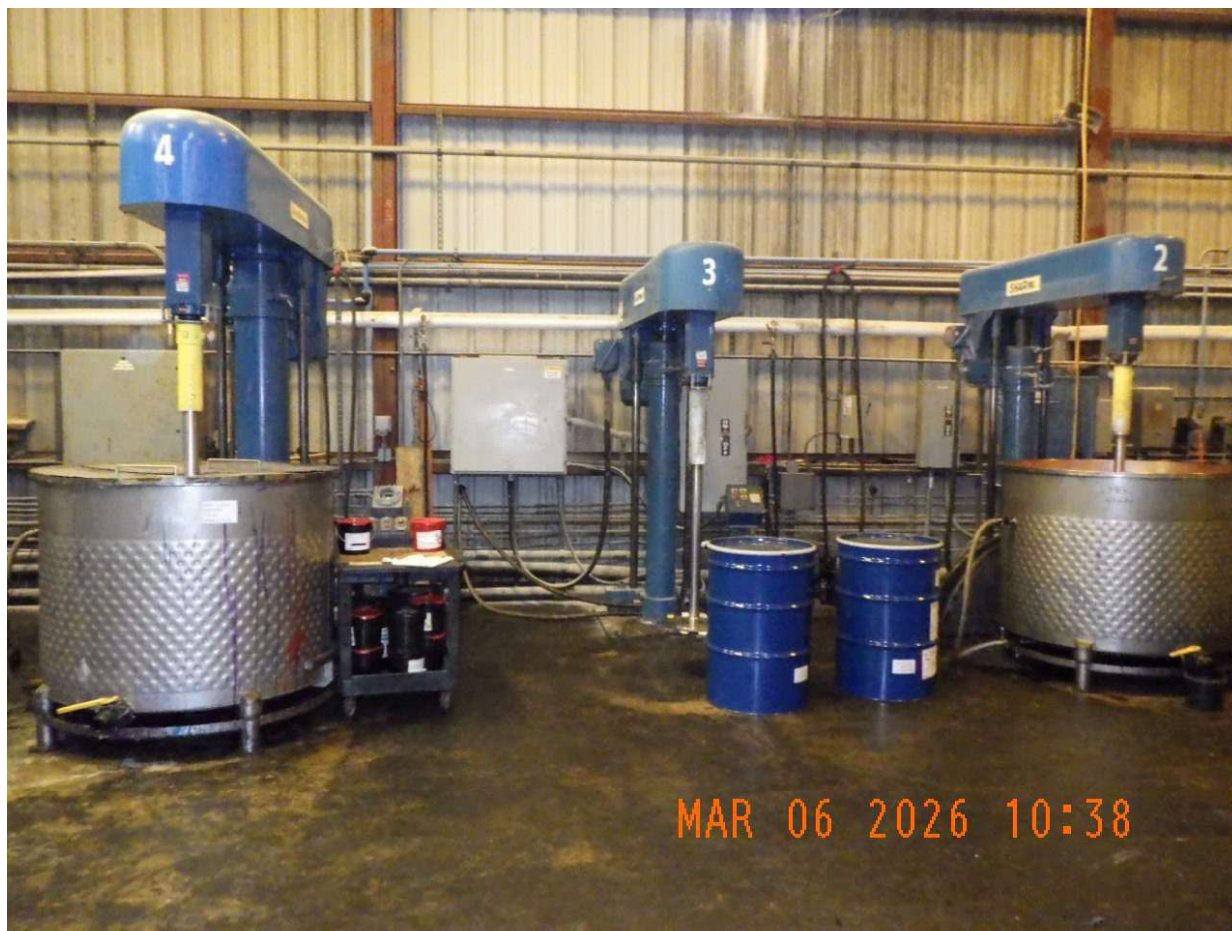
Photo No. 3

| Description: | Production floor. | | |

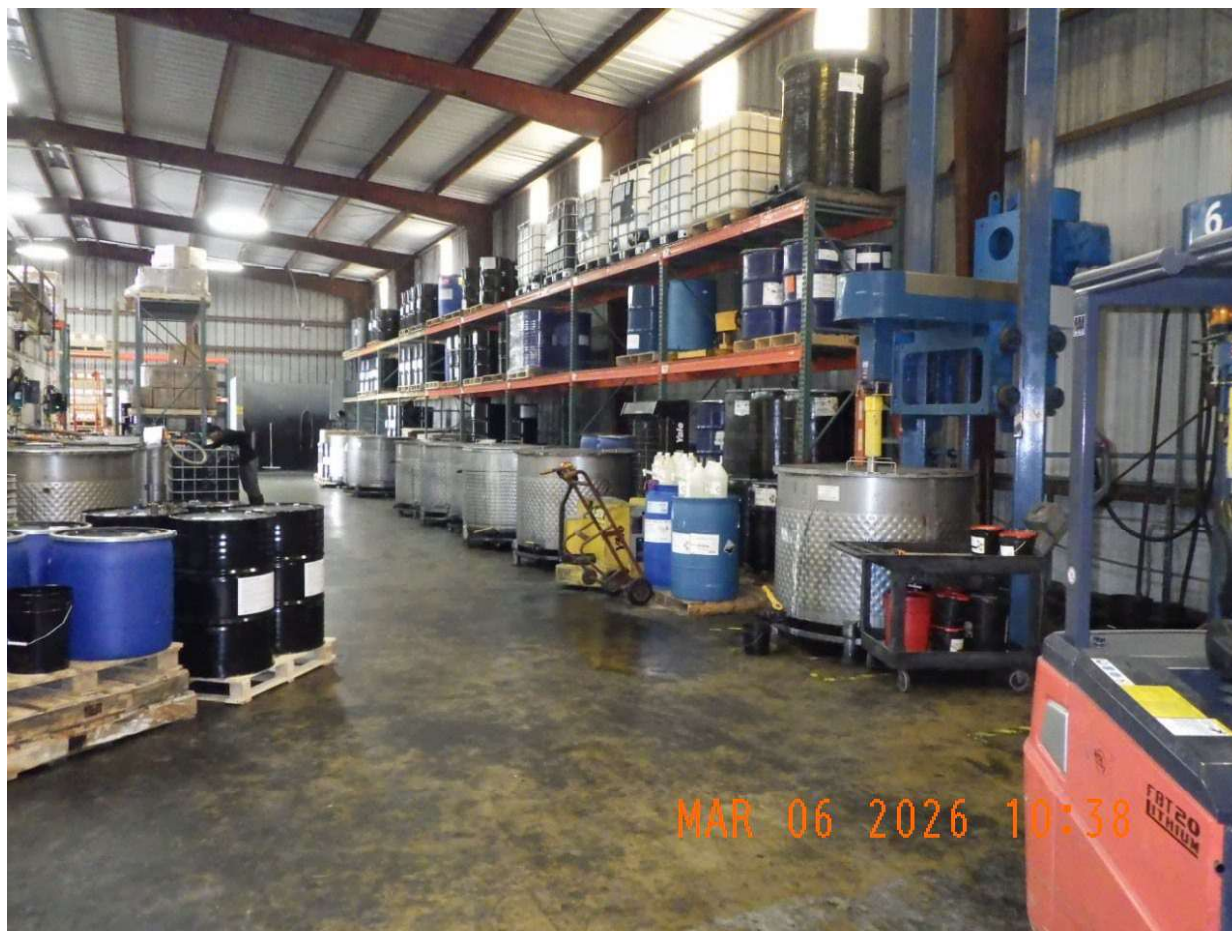
Photo No. 4

| Description: | Raw material and finished goods. | | |

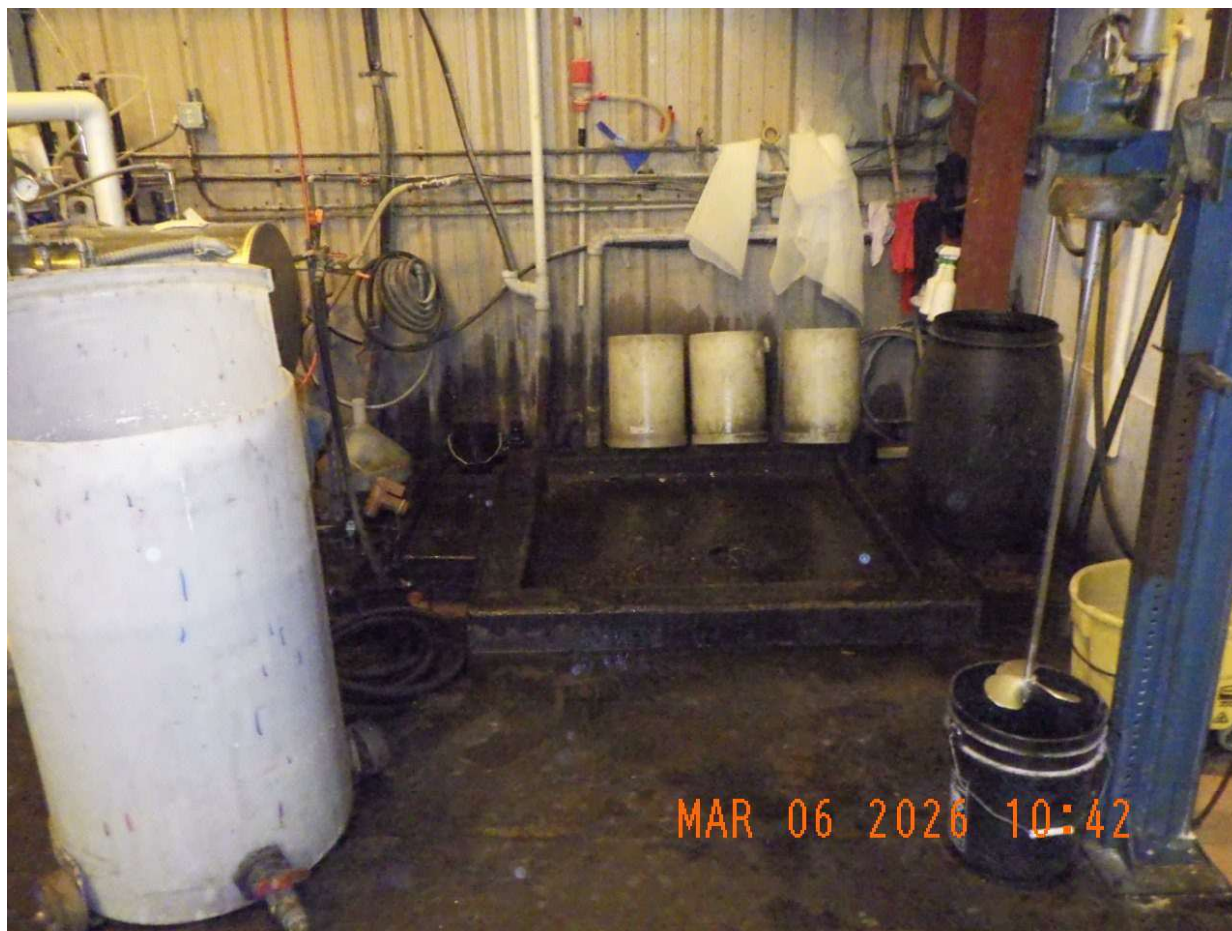
Photo No. 5

| Description: | Wash area goes to sewer. | | |

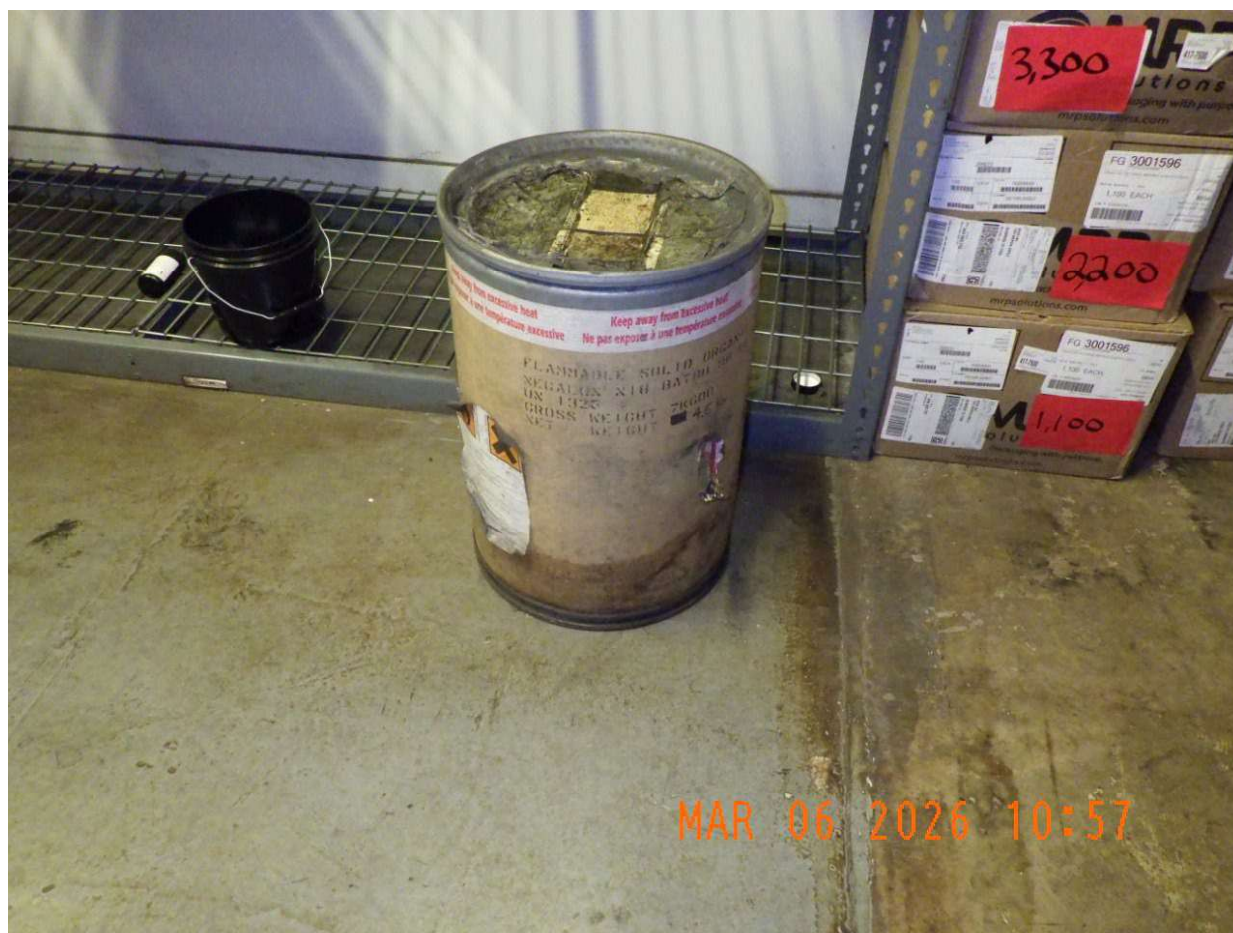
Photo No. 6

Inside the warehouse is small room called the Diazoe Room. I observed a drum of expired product (Hardwater Diazoe) (Appendix 1, Photo 6). The plant manager said they cannot use it if it's expired and they would need to get it disposed of.

- AOC 3 - Drum of expired hardwater Diazoe in the Diazoe room. Pursuant to 40 C.F.R. § 262.11, A person who generates a solid waste, as defined in [40 CFR 261.2](#), must make an accurate determination as to whether that waste is a hazardous waste in order to ensure wastes are properly managed according to applicable RCRA regulations.

| Description: | Drum of expired Diazoe. | | |

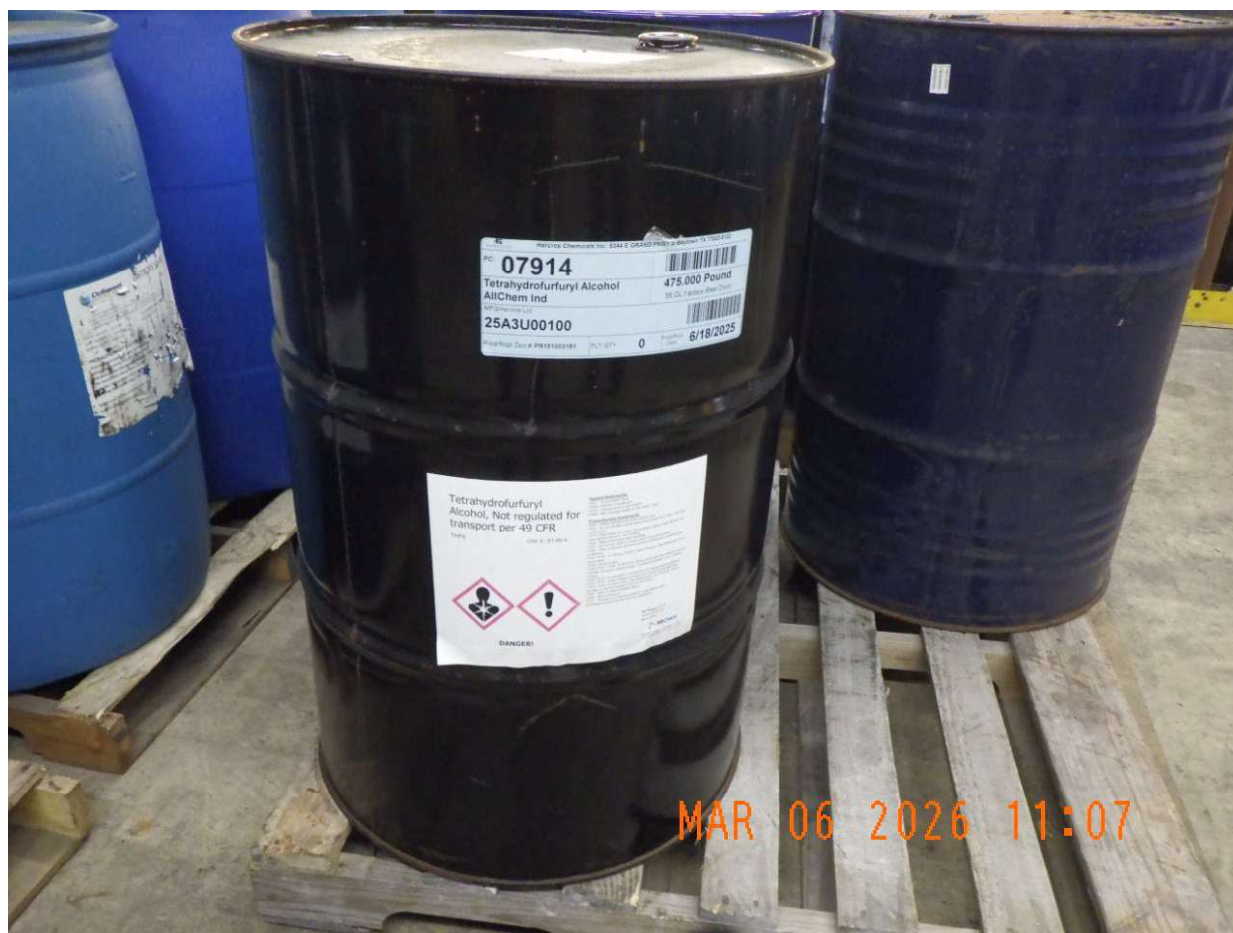
Photo No. 7

| Description: | Raw material container. | | |

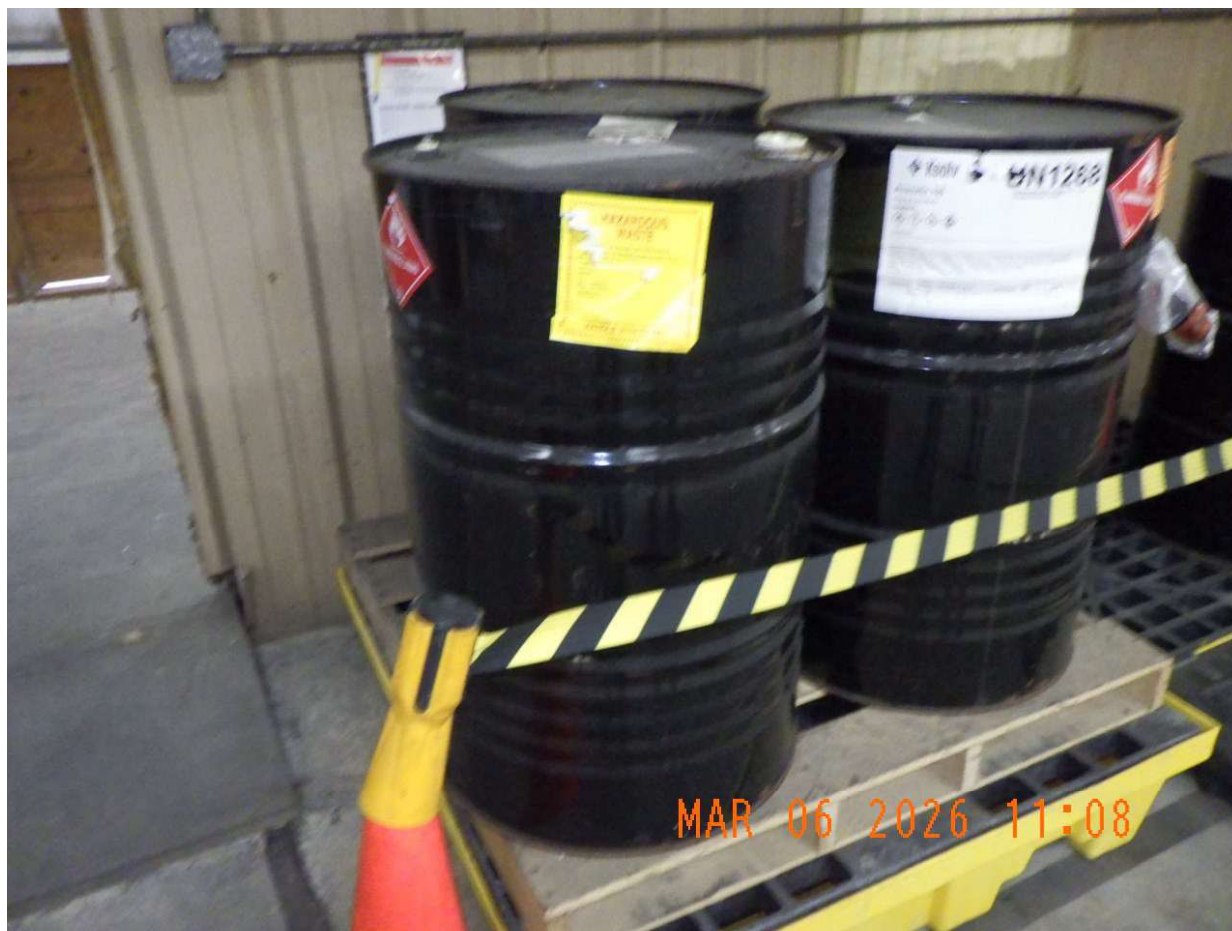
Photo No. 8

- AOC 1 - Drums labeled hazardous waste on “The Deck”. No regulatory requirement, however a drum that is determined to be off-spec product and still able to be used in the production process, labeled as hazardous waste, is confusing when assessing compliance with hazardous waste management regulations.

| Description: | Drum of material that could still be used labeled as hazardous waste. | | |

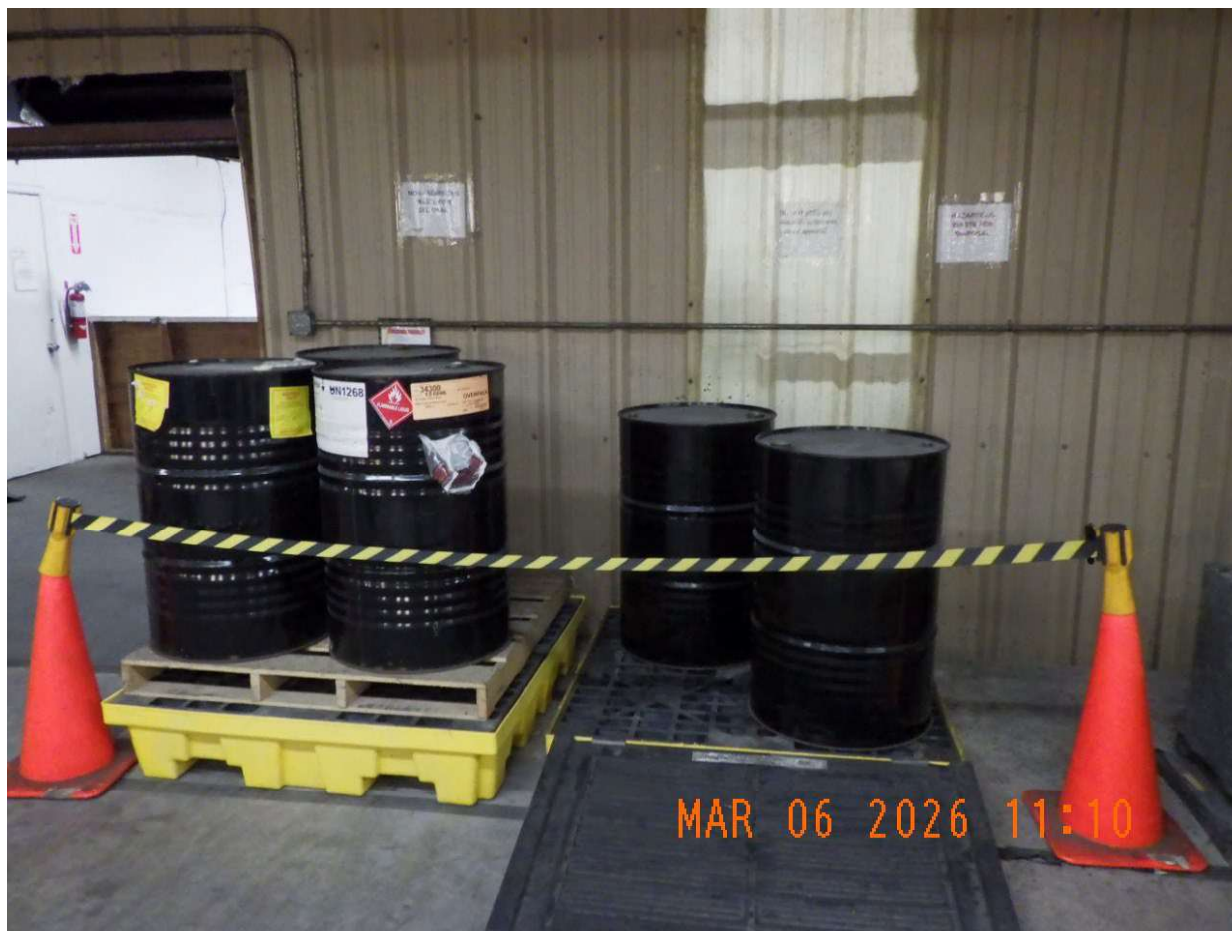
Photo No. 9

This was an upstairs area in the warehouse. The Deck is used for storing products used in the production process and includes a small area on one side to store waste, and a separate room with new and spent lamp bulbs. The waste storage area is divided into two sections, the section on the left in Photo 9 of Appendix 1 is labeled as non-hazardous waste storage and the section on the right in Photo 9 of Appendix 1 is labeled as hazardous waste storage. I observed 3 drums labeled hazardous waste in the waste storage area and per the plant manager, the drums held off-spec product that may still be used in their process, and the labels were placed on the drums to keep employees from using them by mistake (Appendix 1, Photos 8, 9, and 11). Please note that Photo 11 of Appendix 1 is a side photo of the 2 drums on the right in Photo 9 of Appendix 1 and was taken to show the hazardous waste labels that could not be seen from the front. In the separate room on the Deck, I observed lamp bulbs and per the plant manager the bulbs on the shelf are new and the bulbs in the white box are spent. The white box of universal waste lamp bulbs was not labeled (Appendix 1, Photo 10).

| Description: | Waste storage area. | | |

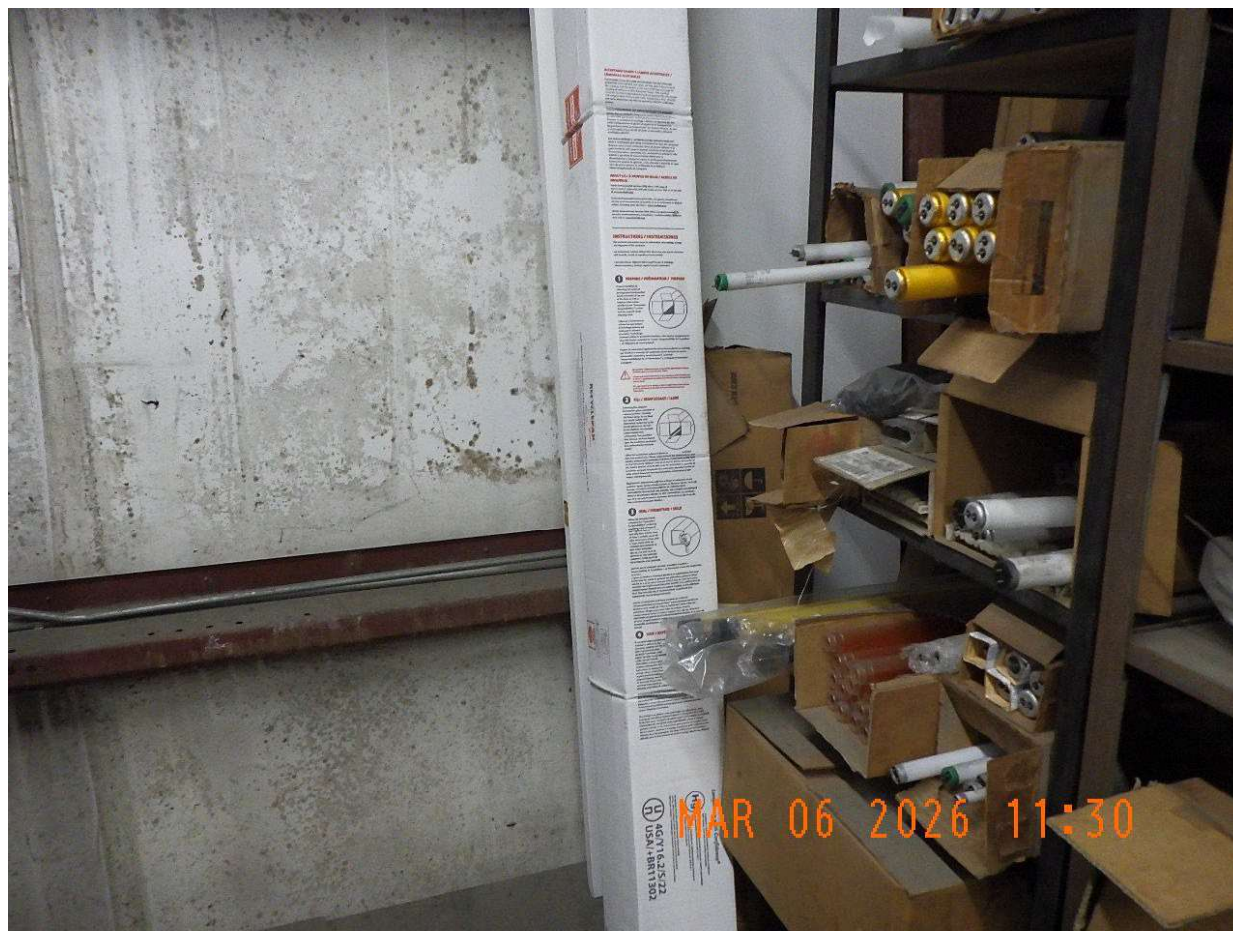
Photo No. 10

- AOC 2 - Box of universal waste lamp bulbs without label. Pursuant to 40 C.F.R. § 273.14(e), Each lamp or a container or package in which such lamps are contained must be labeled or marked clearly with one of the following phrases: “Universal Waste—Lamp(s),” or “Waste Lamp(s),” or “Used Lamp(s)”.

| Description: | Universal waste not labeled. | | |

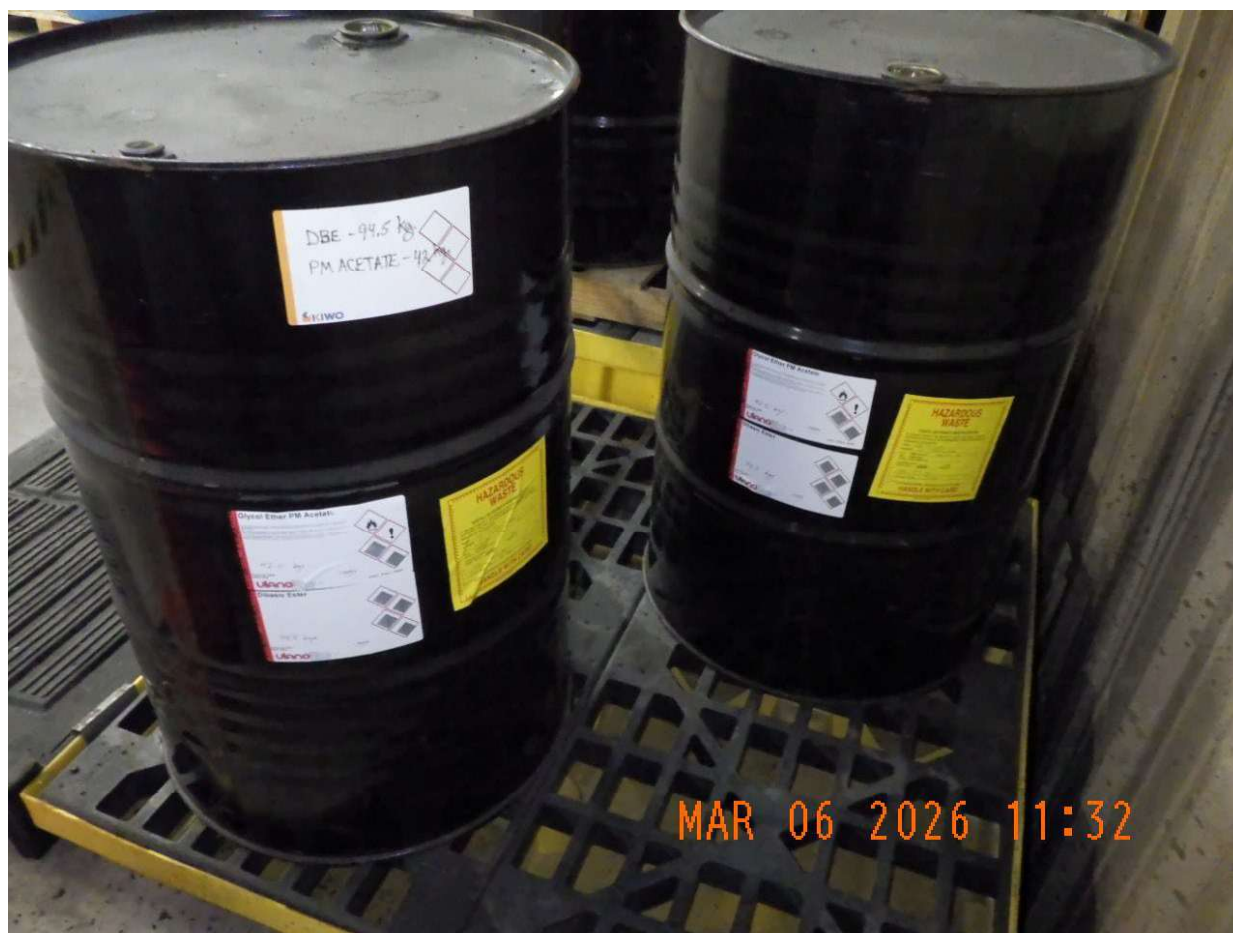
Photo No. 11

| Description: | Drums of off spec material that could still be used, labeled as hazardous waste. | | |
