**Well Inspection**  
**Osage DNR / Environmental Protection Agency**  
**1201 Elm Street, Suite 500**  
**Dallas, Texas 75270**

| <b>Operator Info</b> | CapturePoint, LLC (formerly Perdure Petroleum, LLC)<br>1101 Central Expwy S., Suite 150<br>Allen, TX 75013<br>Phone: 832-300-8221 | <b>Inventory ID</b> | OS0434000 | | |
| | | <b>Well ID</b> | 66-W2 | | |

### Photograph Log 1 Photo

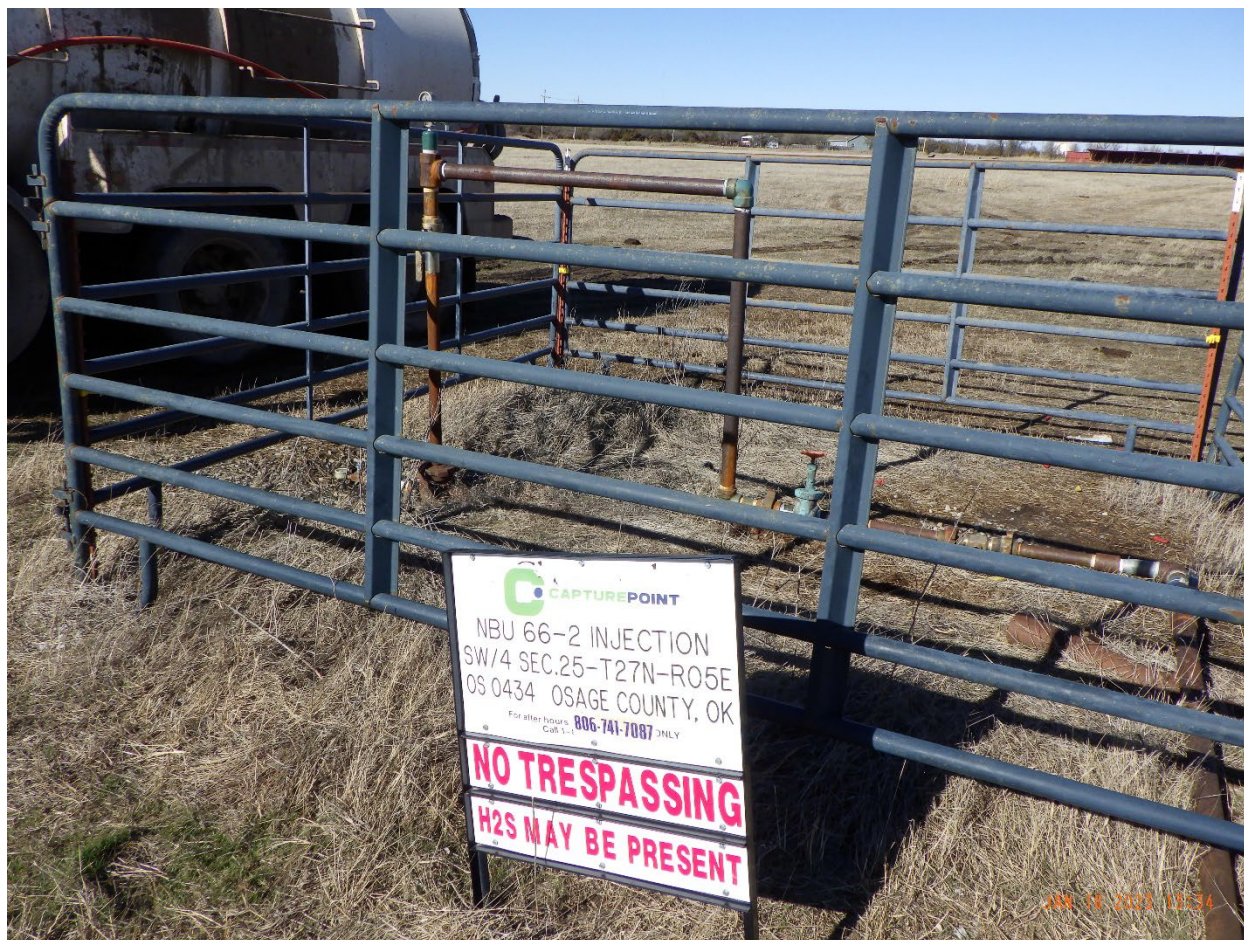
Photo No. 1

**Description:** This was well OS0434000 at the time of inspection.
