**Region 6 - Enforcement & Compliance Assurance Division**  
**INSPECTION REPORT**

| Inspection Date(s): | 05/22/2024 | |
| Company Name: | <b>MidAmerica Environmental Holdings, LLC</b> | |
| Facility Name: | <b>USA Disposal – El Dorado</b> | |

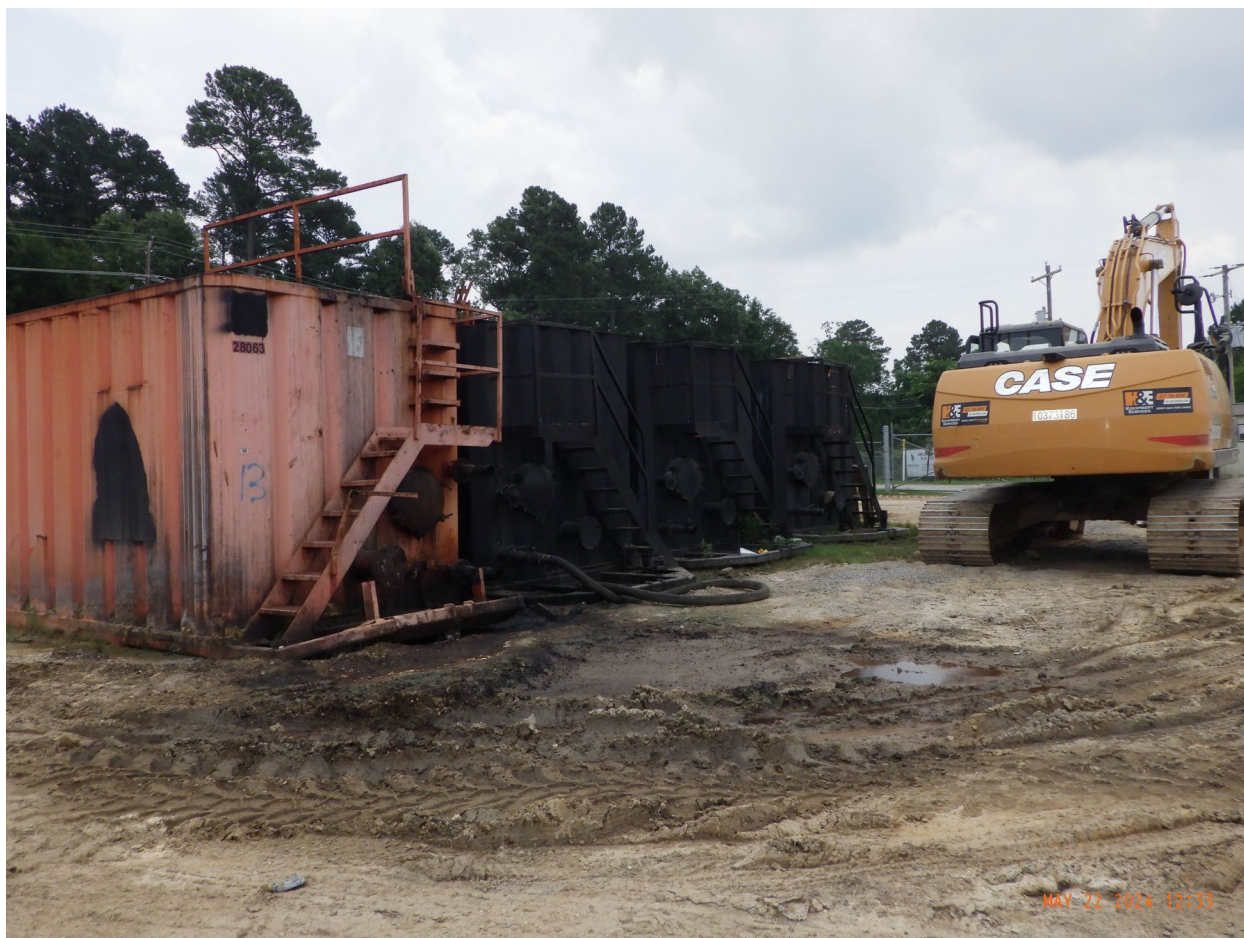
**Photo File Name:** R0010155

I observed eight (8) frac tanks with no secondary containment and heavy equipment, such as a bulldozer and an excavator, used for material handling. There was no labeling on the frac tanks, and black liquid and staining were observed on the ground. See Photo No. 3 through No. 5.

**Description:** Looking SE, this photo showed the opposite view from Photo No. 3. A spill was observed in front of the red frac tank.

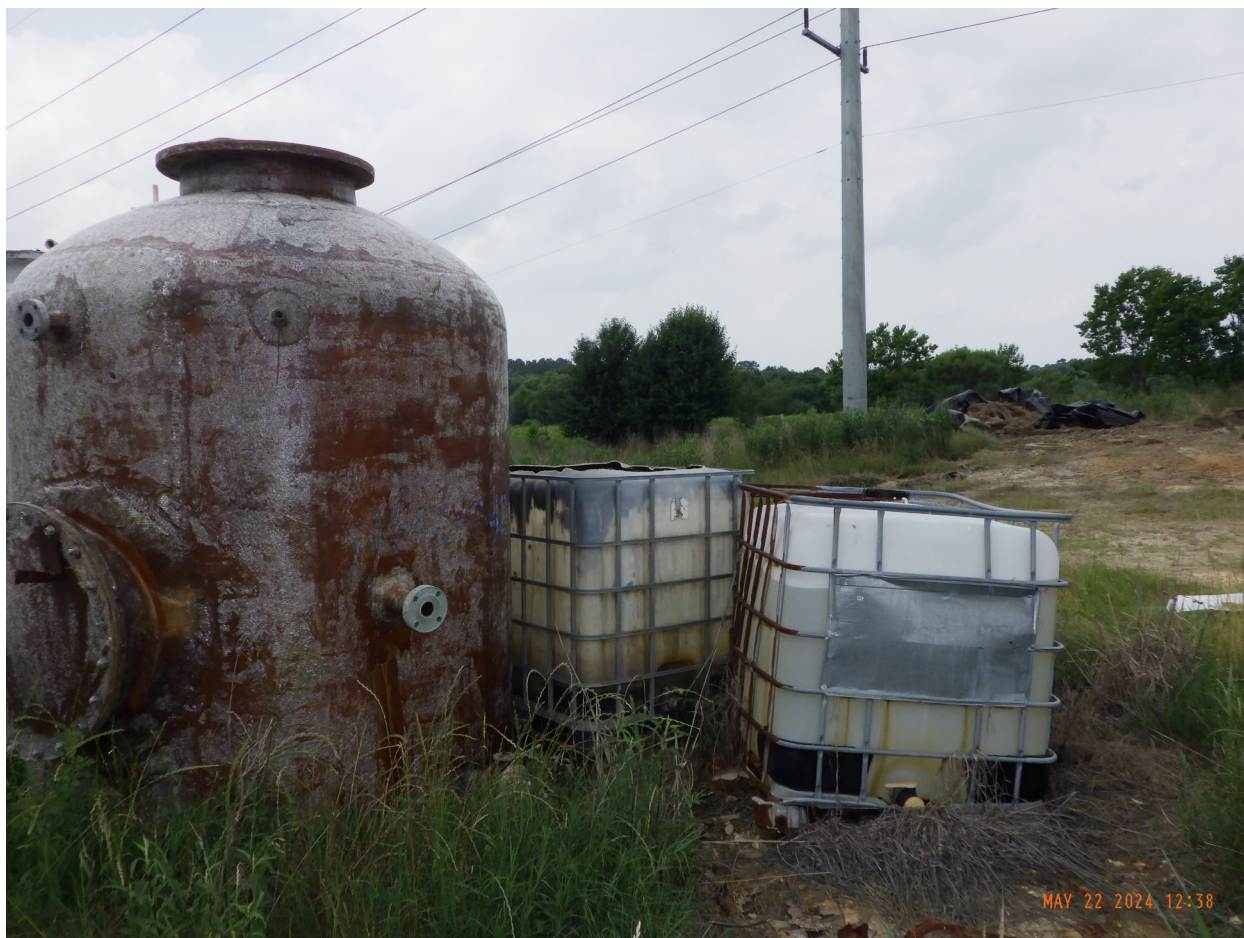
**Photo File Name:** R0010160

**Description:** Looking NW, this photo showed storage tanks at the facility. Dead vegetation was noted around the totes (contents unknown).

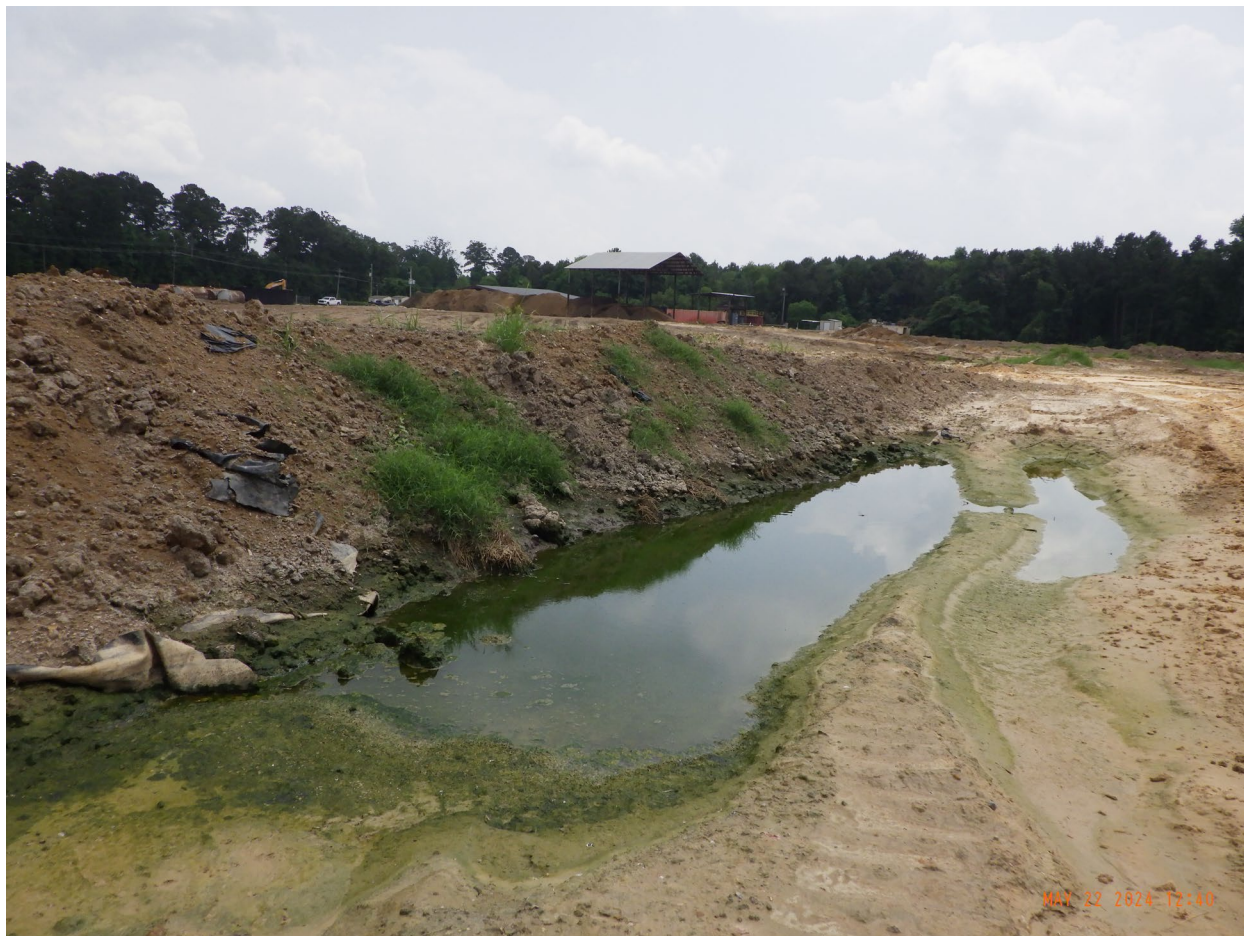
**Photo File Name:** R0010163

**Description:** Looking S-SE, this photo showed bulked waste material (liquid waste blended with sawdust) with runoff adjacent to the stockpile. Synthetic liner pieces were observed in the bulked material, and algal growth was noted in the adjacent pooled runoff.

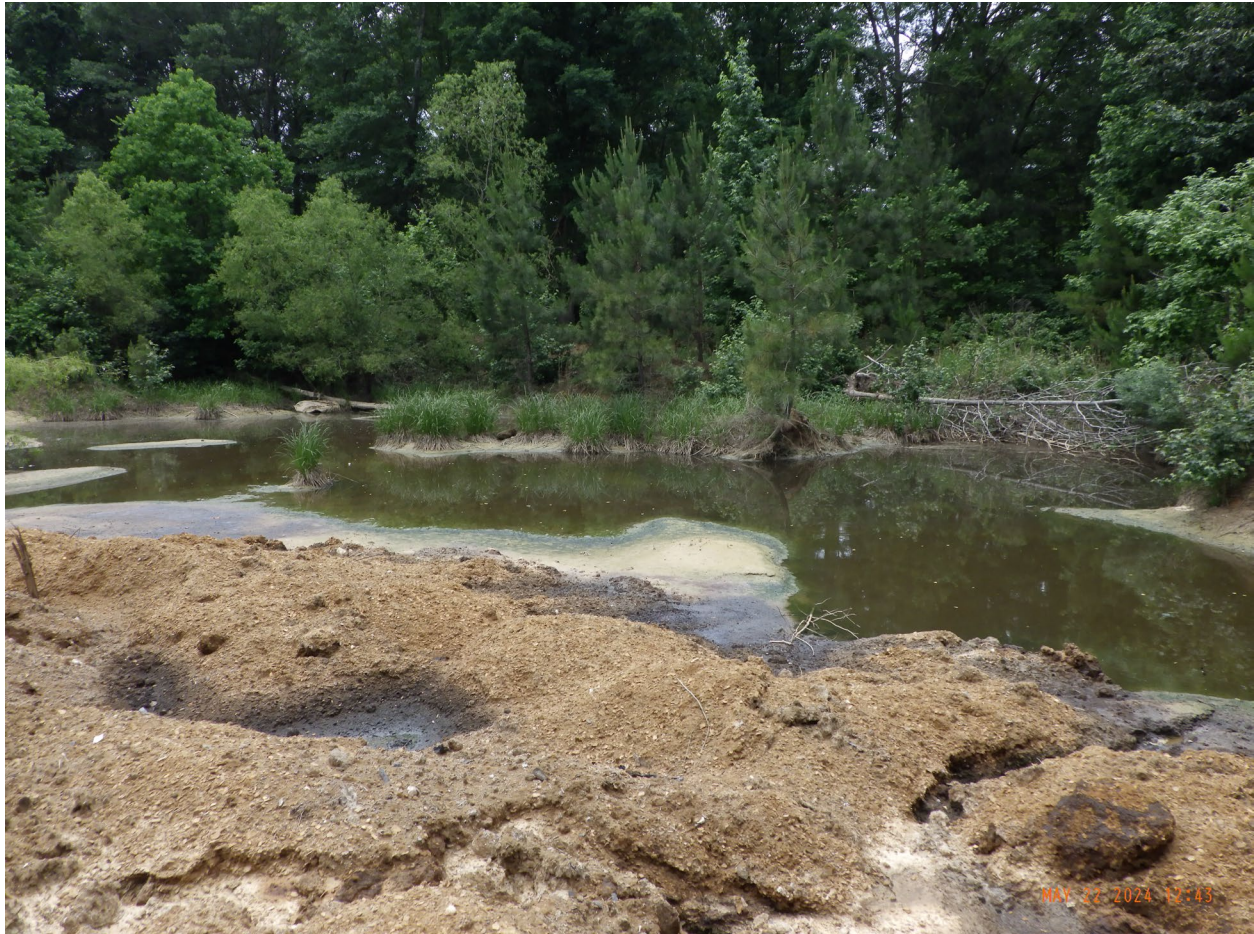
**Photo File Name:** R0010169

**Description:** Looking SW, this photo showed bulked material and leachate discharged into the wetland at the facility. Algal growth was noted in the surface water.

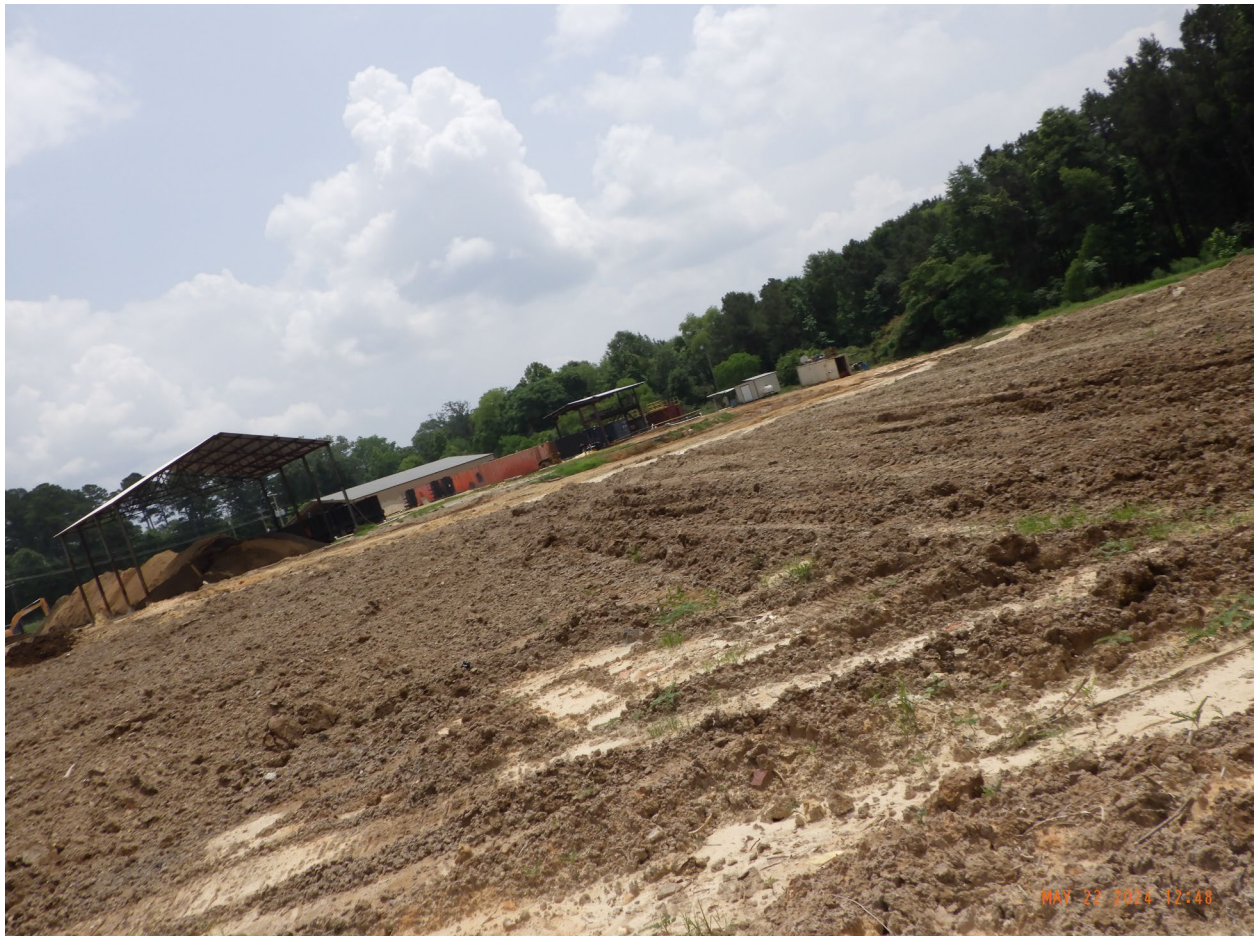
**Photo File Name:** R0010174

I observed bulked material land applied directly onto the ground at the property. See Photo No. 23.

**Description:** Looking SE, this photo showed bulked material land applied on top of the bare soil at the facility. The process area was observed in the background.

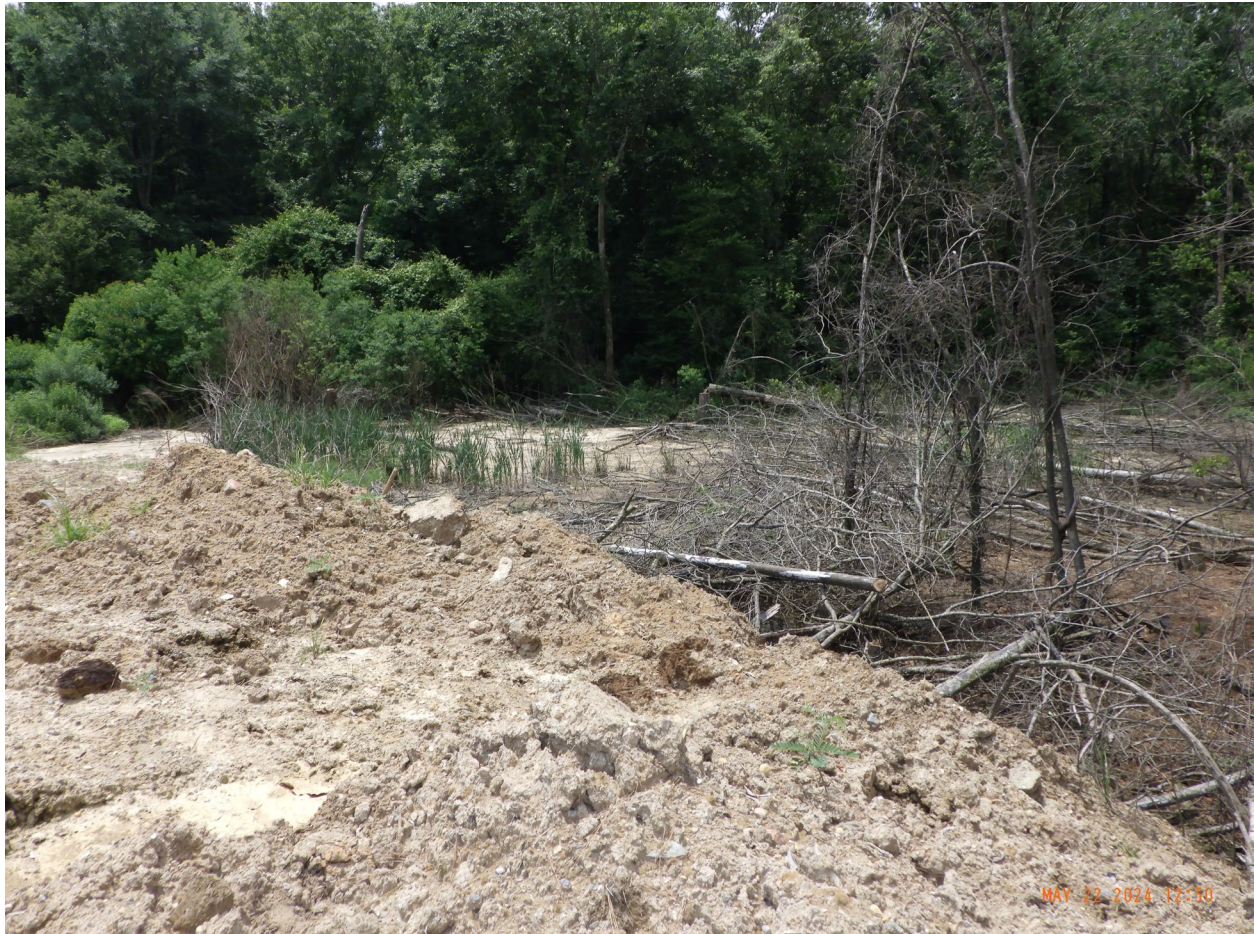
**Photo File Name:** R0010175

**Description:** Looking SW, this photo showed bulked material adjacent to another wetland located on the facility. Dead vegetation was noted within the wetland.

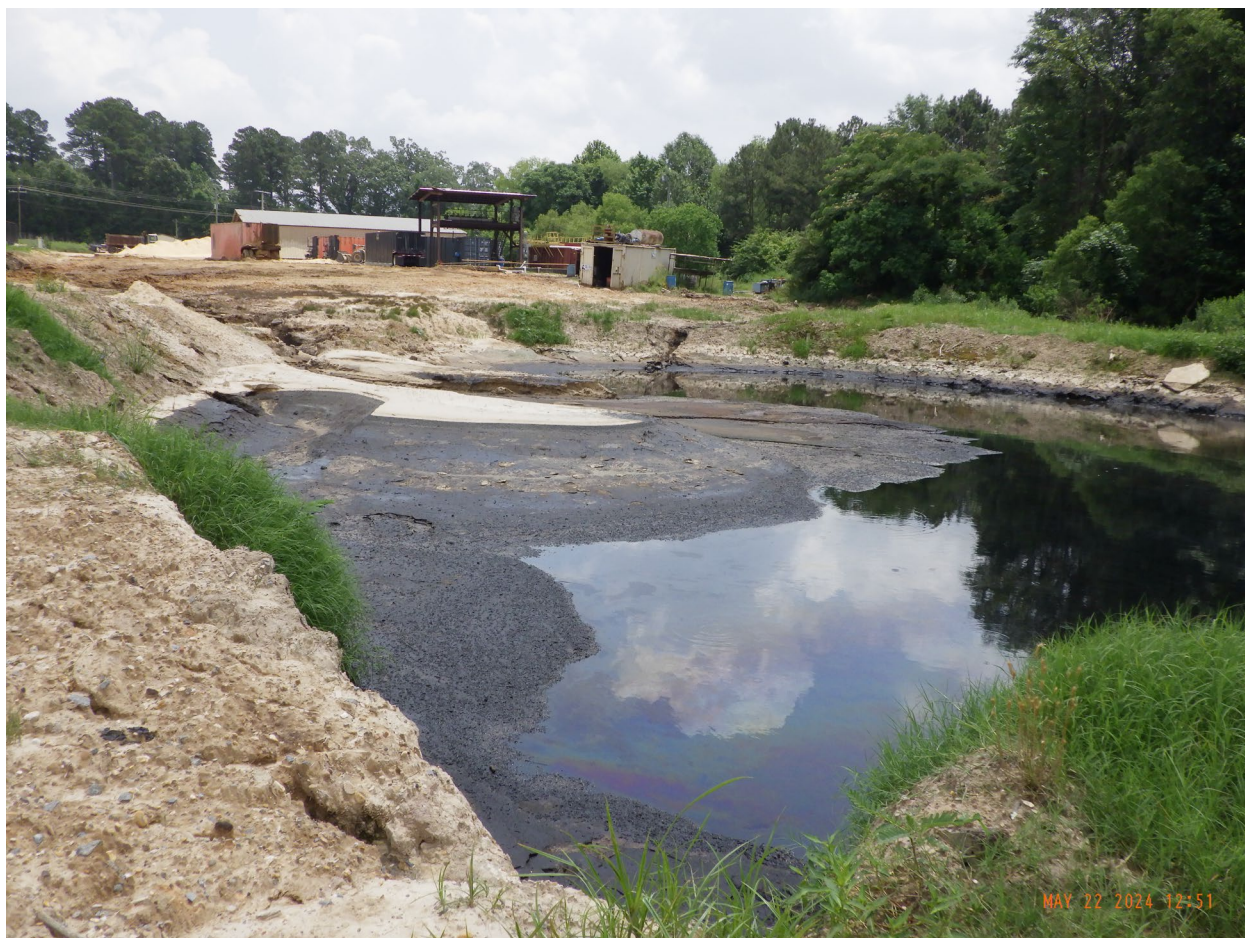
**Photo File Name:** R0010177

I observed the stormwater pond, which contained unknown liquid wastes and sediment. Black staining, a hydrocarbon sheen, gas bubbles, and an odor were noted from the stormwater pond. Erosion gullies leading to the receiving stream, an unnamed tributary (UT) of Boggy Creek, were noted in the stormwater pond levee. See Photo No. 26 through No. 30, and No. 35.

**Description:** Looking SW, this photo showed the stormwater pond utilized by the facility, which is permitted under NPDES permit ARR001445. Black color, hydrocarbon sheen, and odor were noted at the stormwater pond.

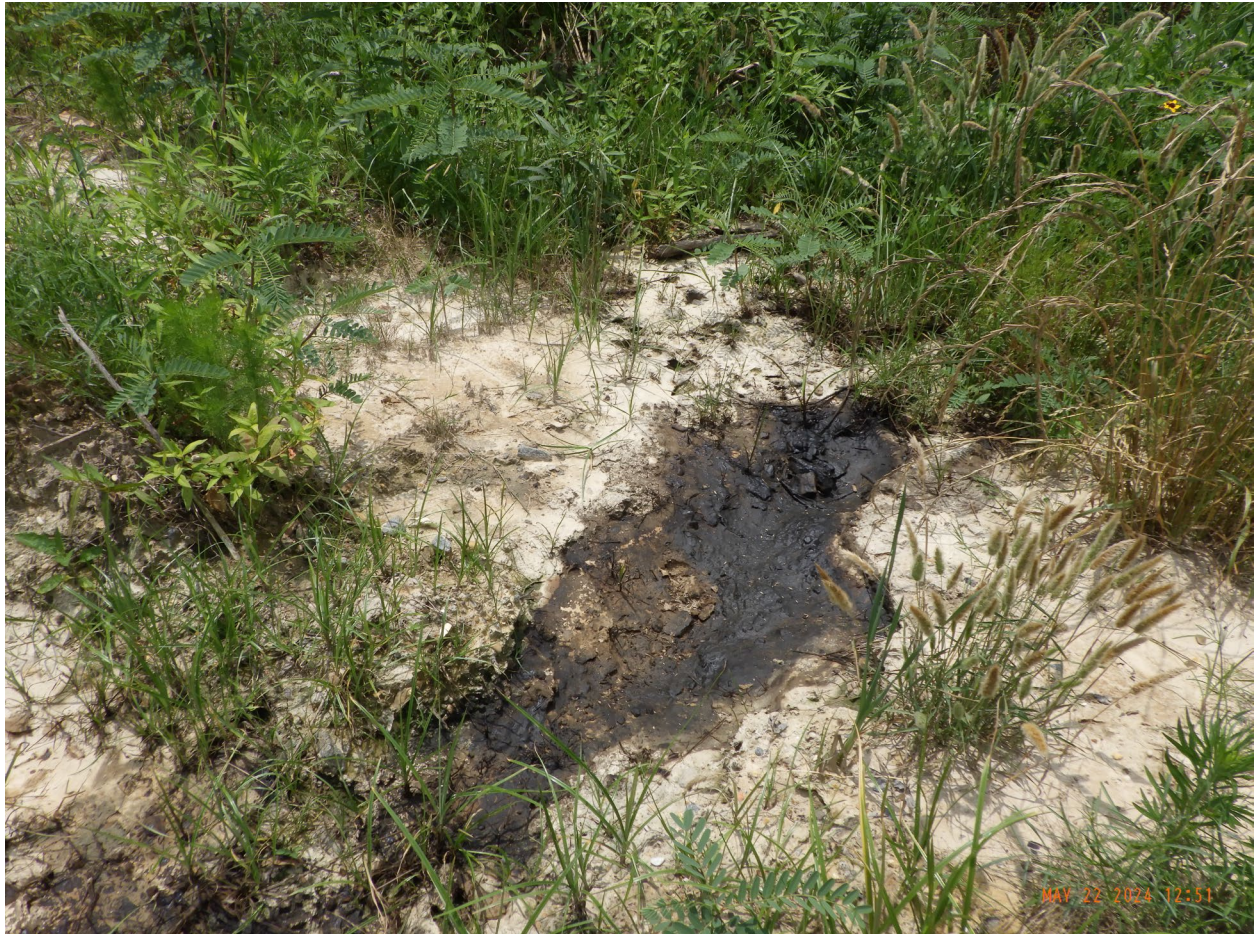
**Photo File Name:** R0010178

**Description:** Looking SW, this photo showed an erosion gully formed in the stormwater pond levee directed to the receiving stream, unnamed tributary (UT) of Boggy Creek. Black staining was noted within the gully.

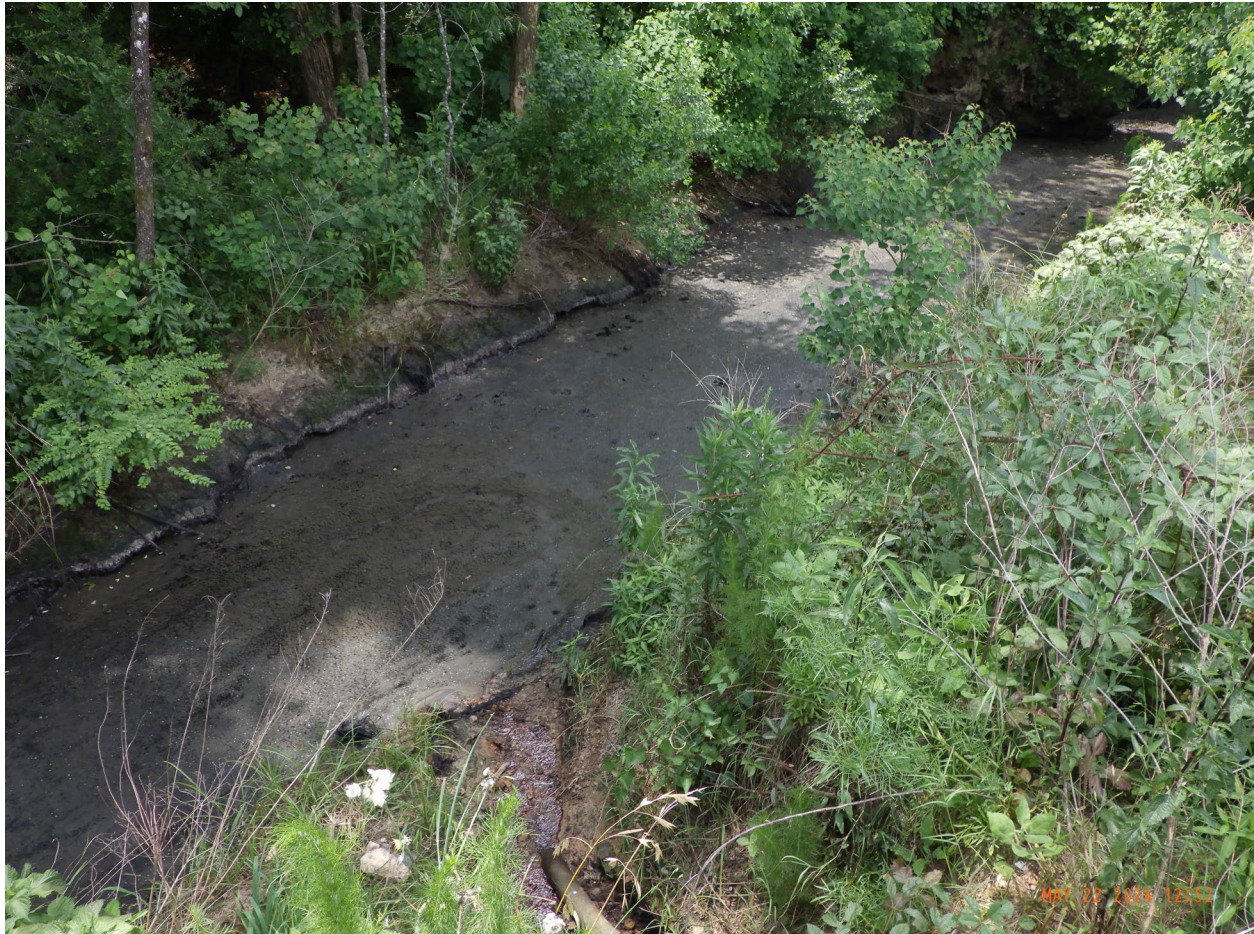
**Photo File Name:** R0010182

**Description:** Looking W-SW, this photo showed the receiving stream (UT of Boggy Creek) immediately downstream of the erosion gullies in the stormwater pond levee. Unknown material, black staining, and odor were noted at the receiving stream.

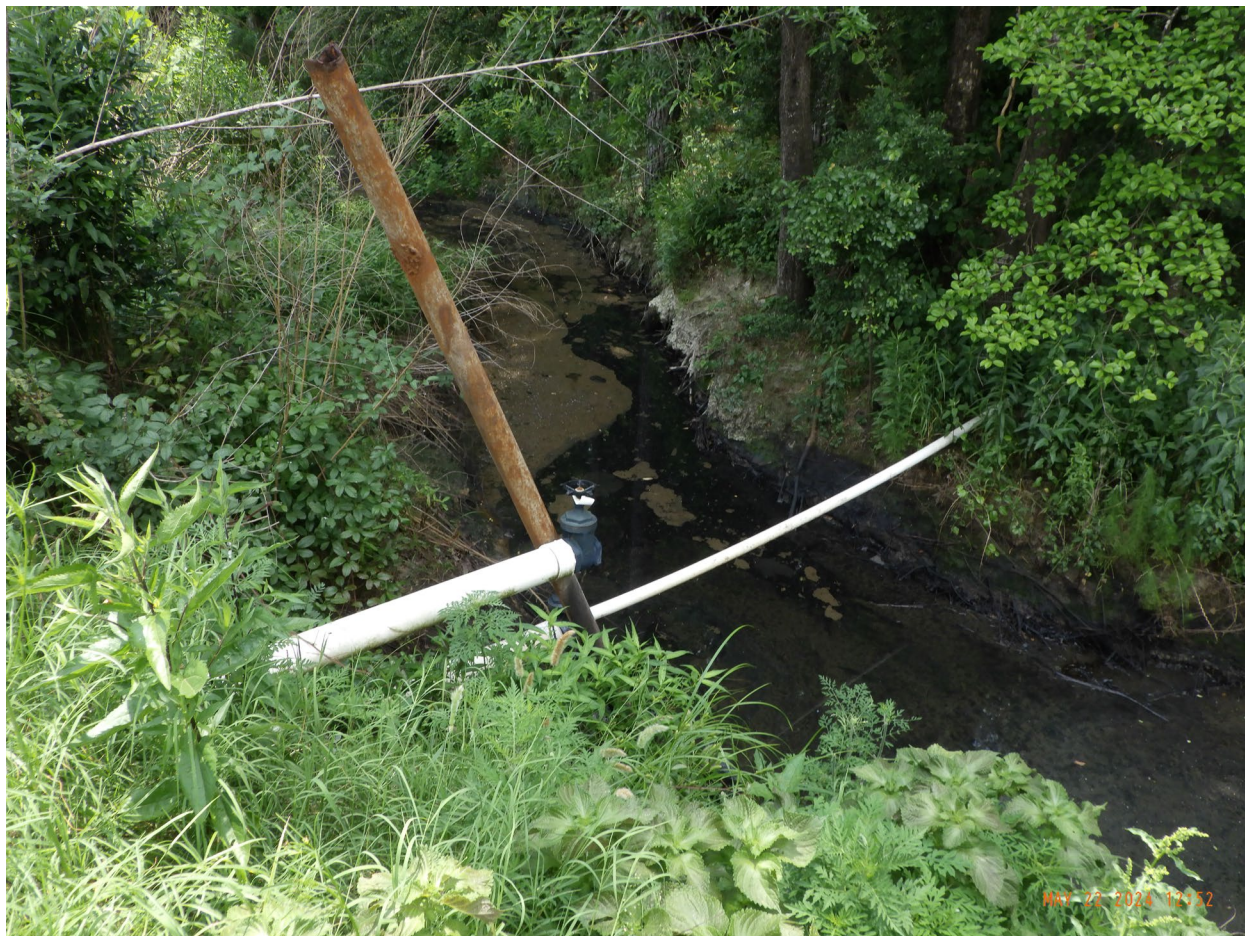
**Photo File Name:** R0010183

I observed the drainpipes, shutoff valves, and screw caps for the stormwater pond. The cap was missing from the uppermost drainpipe, and an active discharge to the receiving stream was observed. See Photo No. 31 through No. 33.

**Description:** Looking S, this photo showed two drainpipes for the stormwater pond. Both with shutoff valves and screw caps present, but the uppermost pipe was missing the screw cap and had an active leak. The two additional pipes, one in the vertical position and one crossing the receiving stream, are not connected or being used.

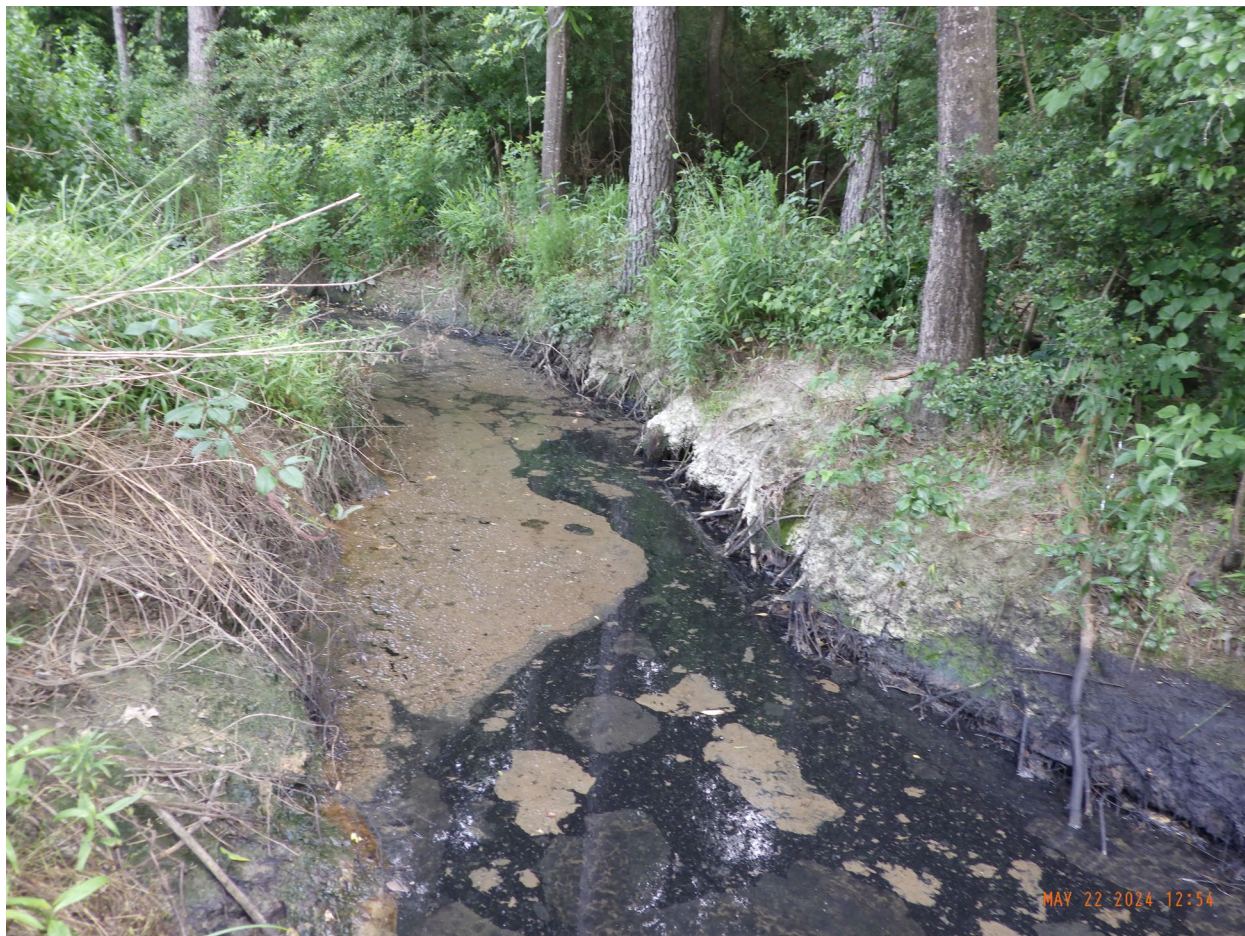
**Photo File Name:** R0010188

I observed the condition of the receiving stream directly upstream of the drainpipes and erosion gullies. Unknown material, black staining, and odor were noted from the receiving stream. See Photo No. 34.

**Description:** Looking S, this photo showed the condition of the receiving stream immediately upstream of the drainpipes for the stormwater pond. Unknown material, black staining, and odor were noted at the receiving stream.

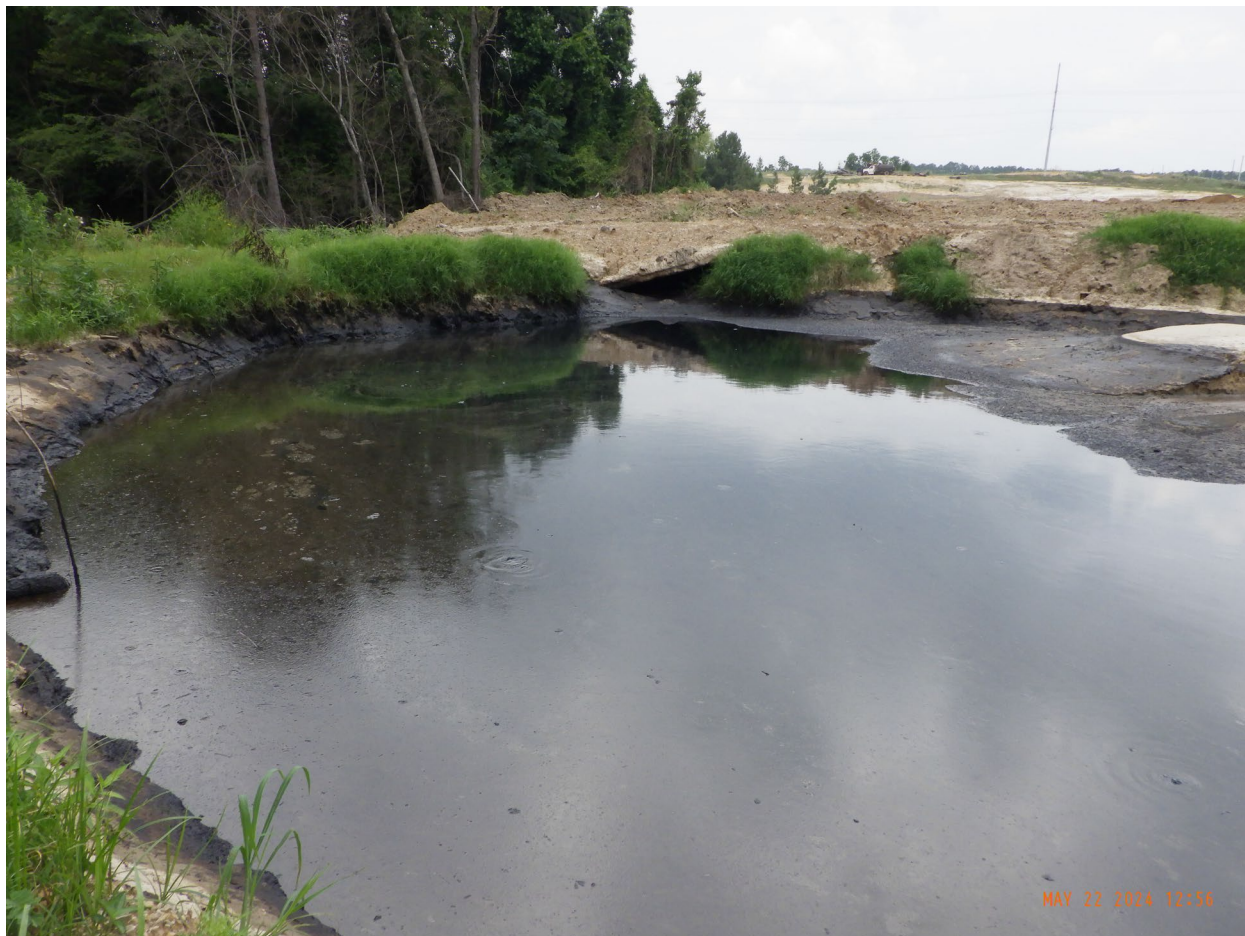
**Photo File Name:** R0010191

**Description:** Looking N-NW, this photo showed an additional view of the stormwater pond utilized by the facility. Gas bubbles generated from the material in the stormwater pond were noted.

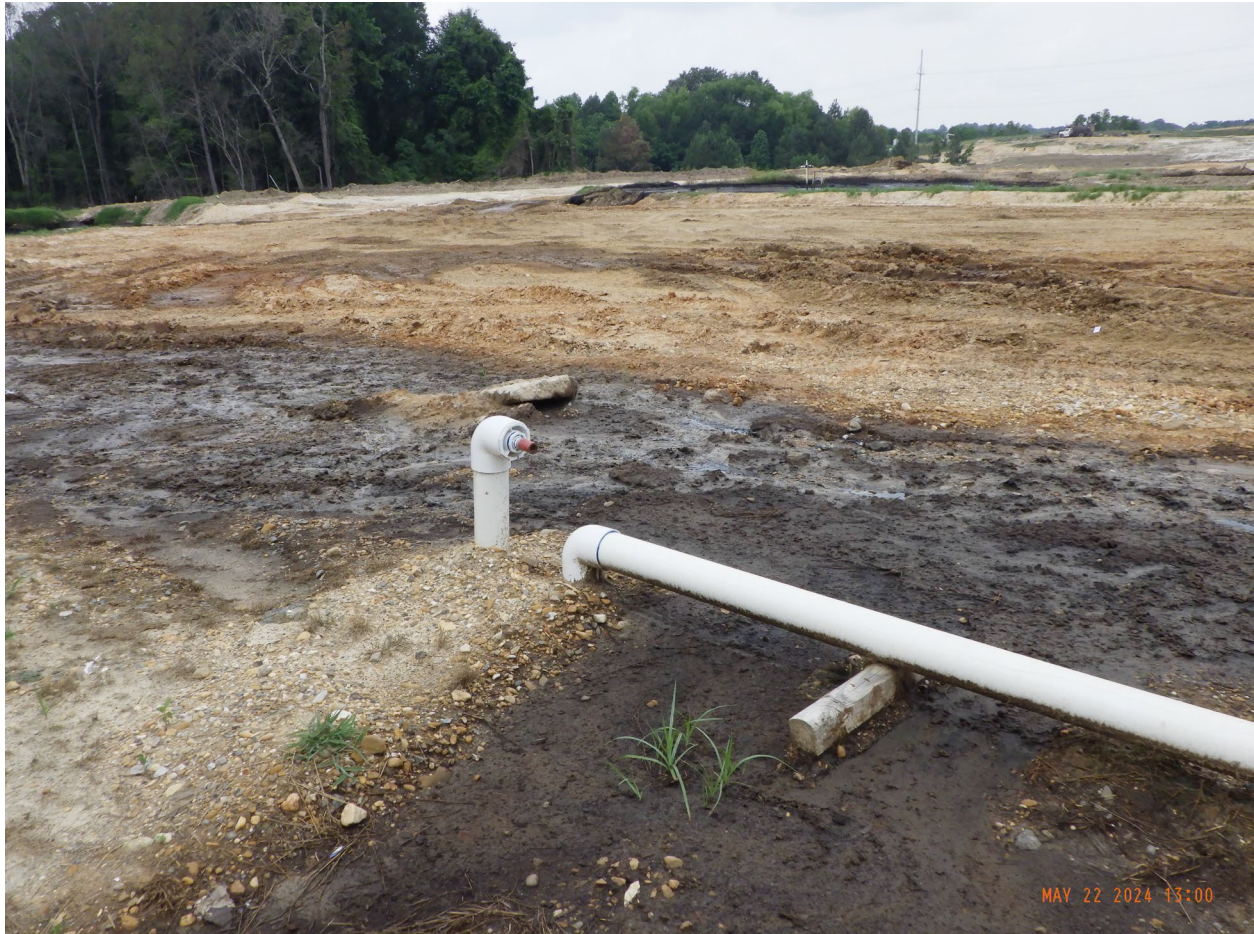
**Photo File Name:** R0010199

**Description:** Looking NW, this photo showed the piping at the holding pit viewed in Photo No. 38. Black staining, petroleum sheen, and flow indicators were noted in the process area.

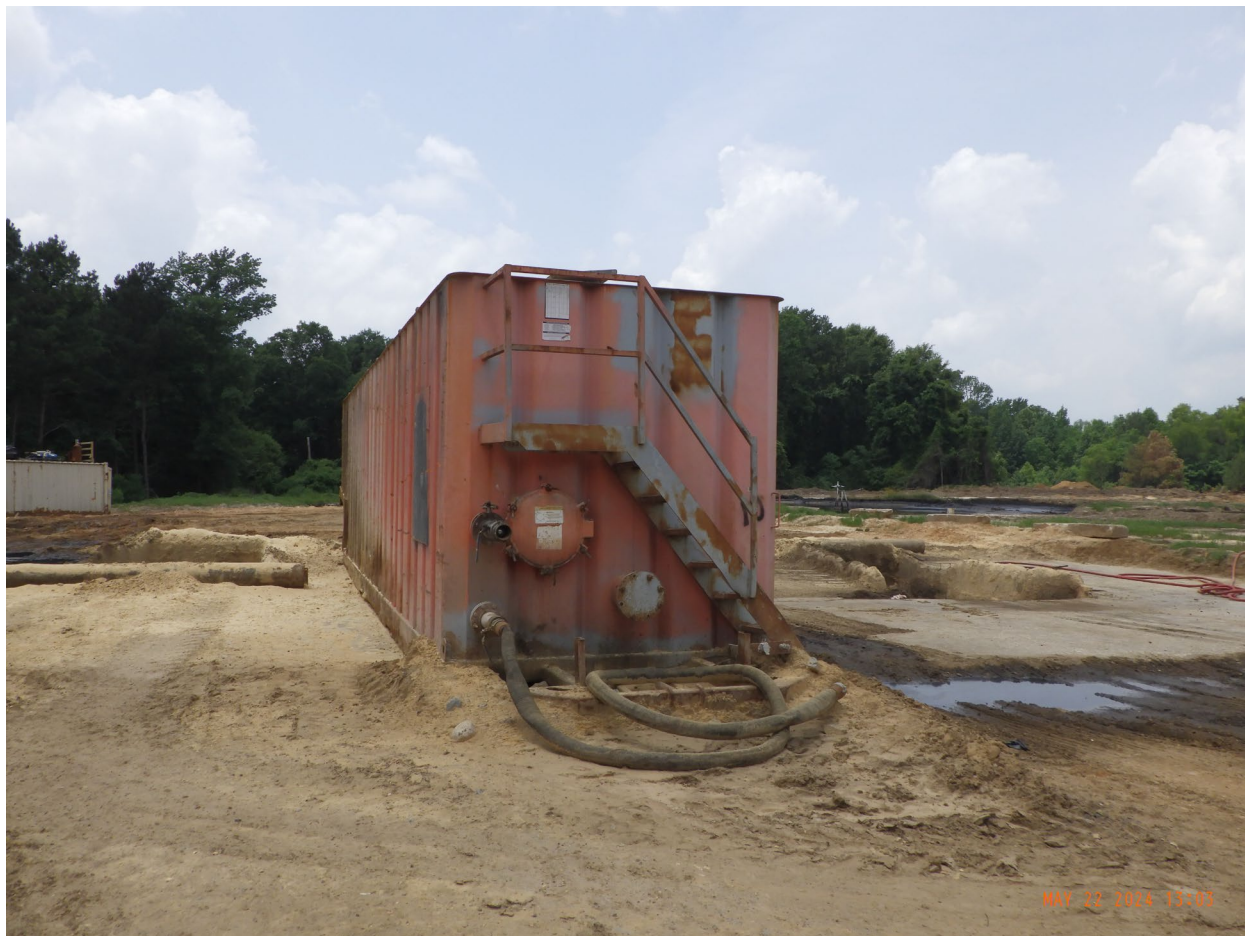
**Photo File Name:** R0010203

**Description:** Looking W-NW, this photo showed a frac tank stored between two (2) subsurface, concrete pits. Sawdust (bulking material) and black liquid noted around the area.

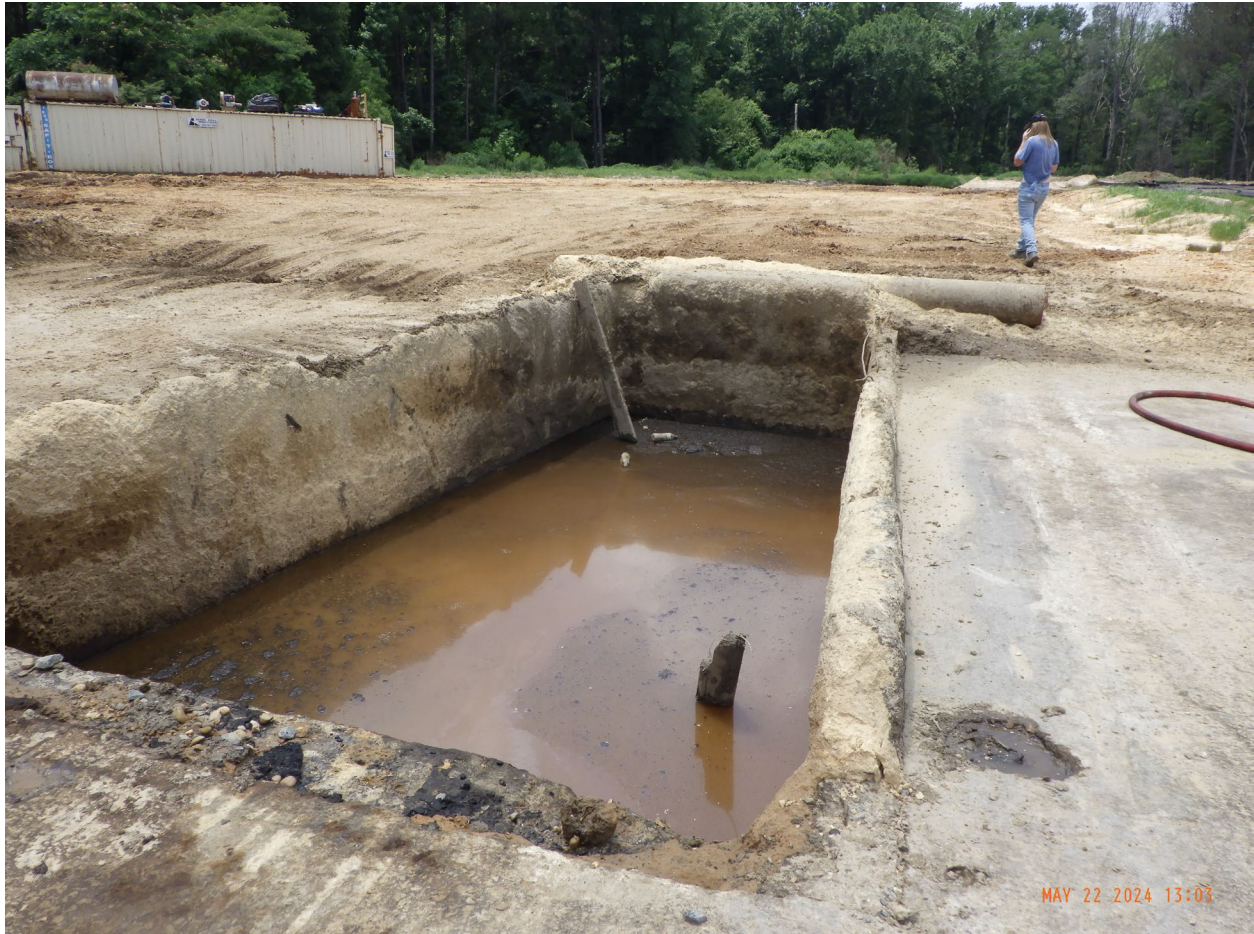
**Photo File Name:** R0010205

**Description:** Looking W-SW, this photo showed the subsurface, concrete pit to the right of the frac tank in Photo No. 42. Unknown liquid waste was observed in the pit.

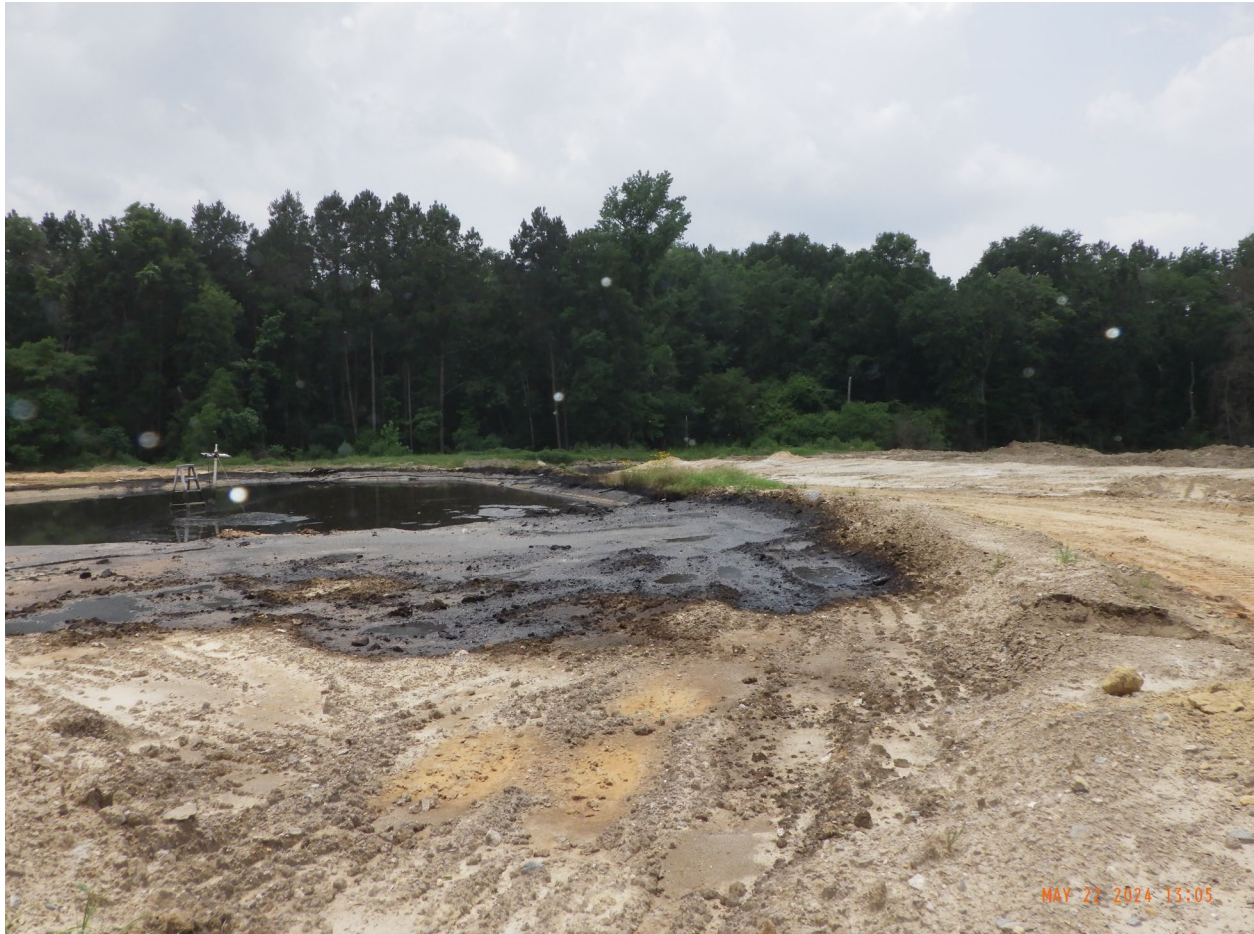
**Photo File Name:** R0010212

**Description:** Looking SW, this photo showed an additional view of the large, concrete pit in Photo No. 45. Black staining was noted outside the concrete pit.
