## **COUPLING FAILURE**

## **KEY FAILURES**

## **GT120 SCENARIO FOR COMPRESSOR WRECK**

## **GT71 PT BLADE FAILURE JUNE 1990**

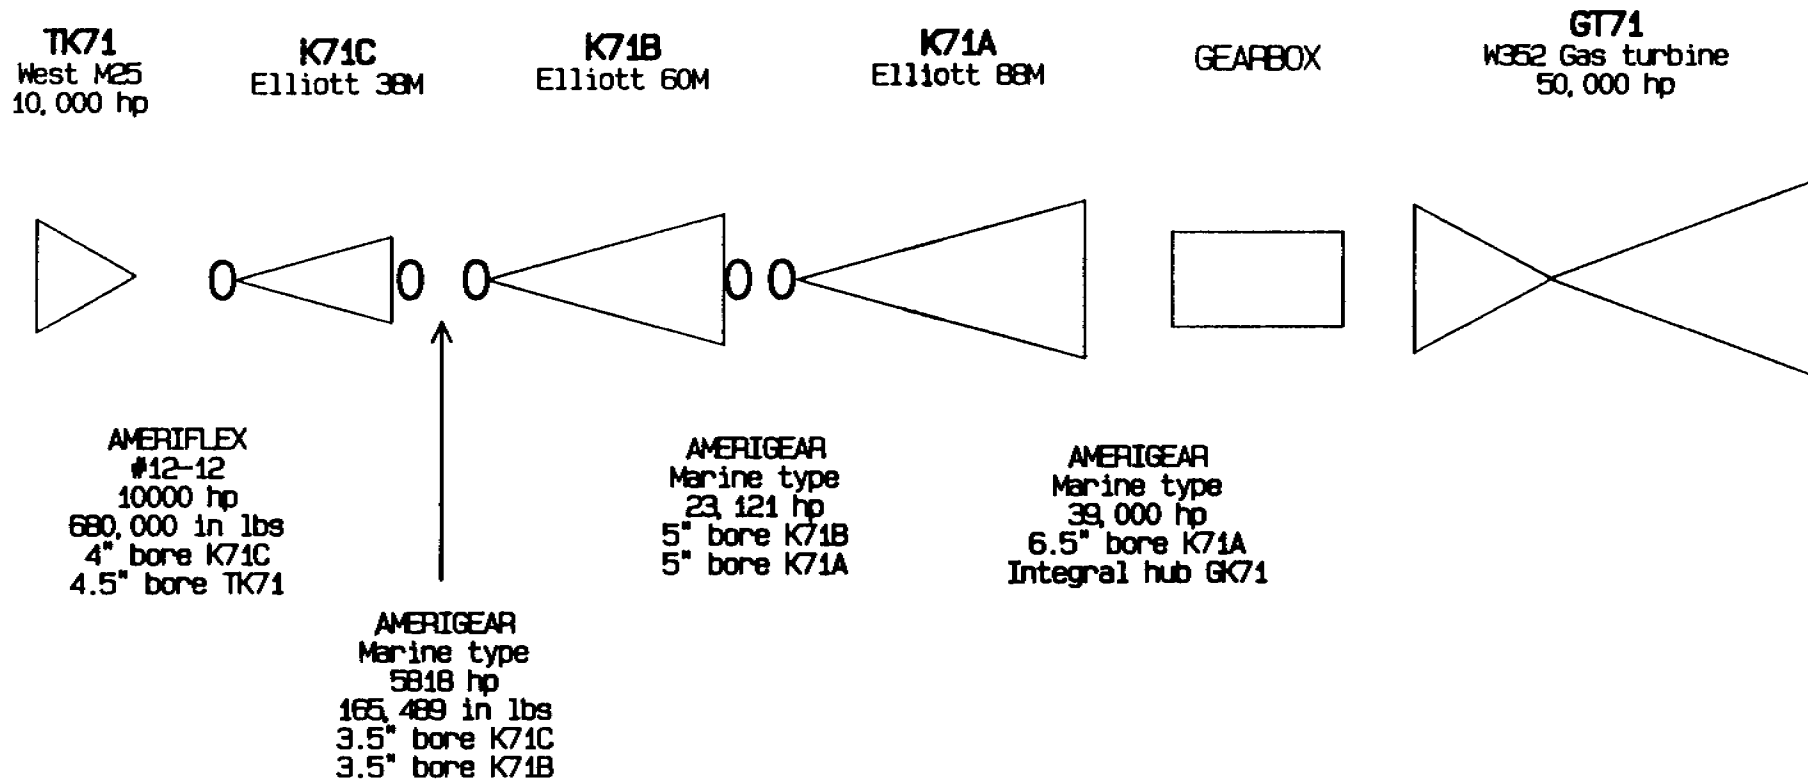
RED DENOTES HUBS THAT SPUN

ZURN MARINE TYPE CLASS I GEAR COUPLING

SPACER DROPPED STRAIGHT DOWN

ALL COUPLING BOLTS FAILED IN SHEAR (24 TOTAL, 3/8" DIAMETER, PLATED)

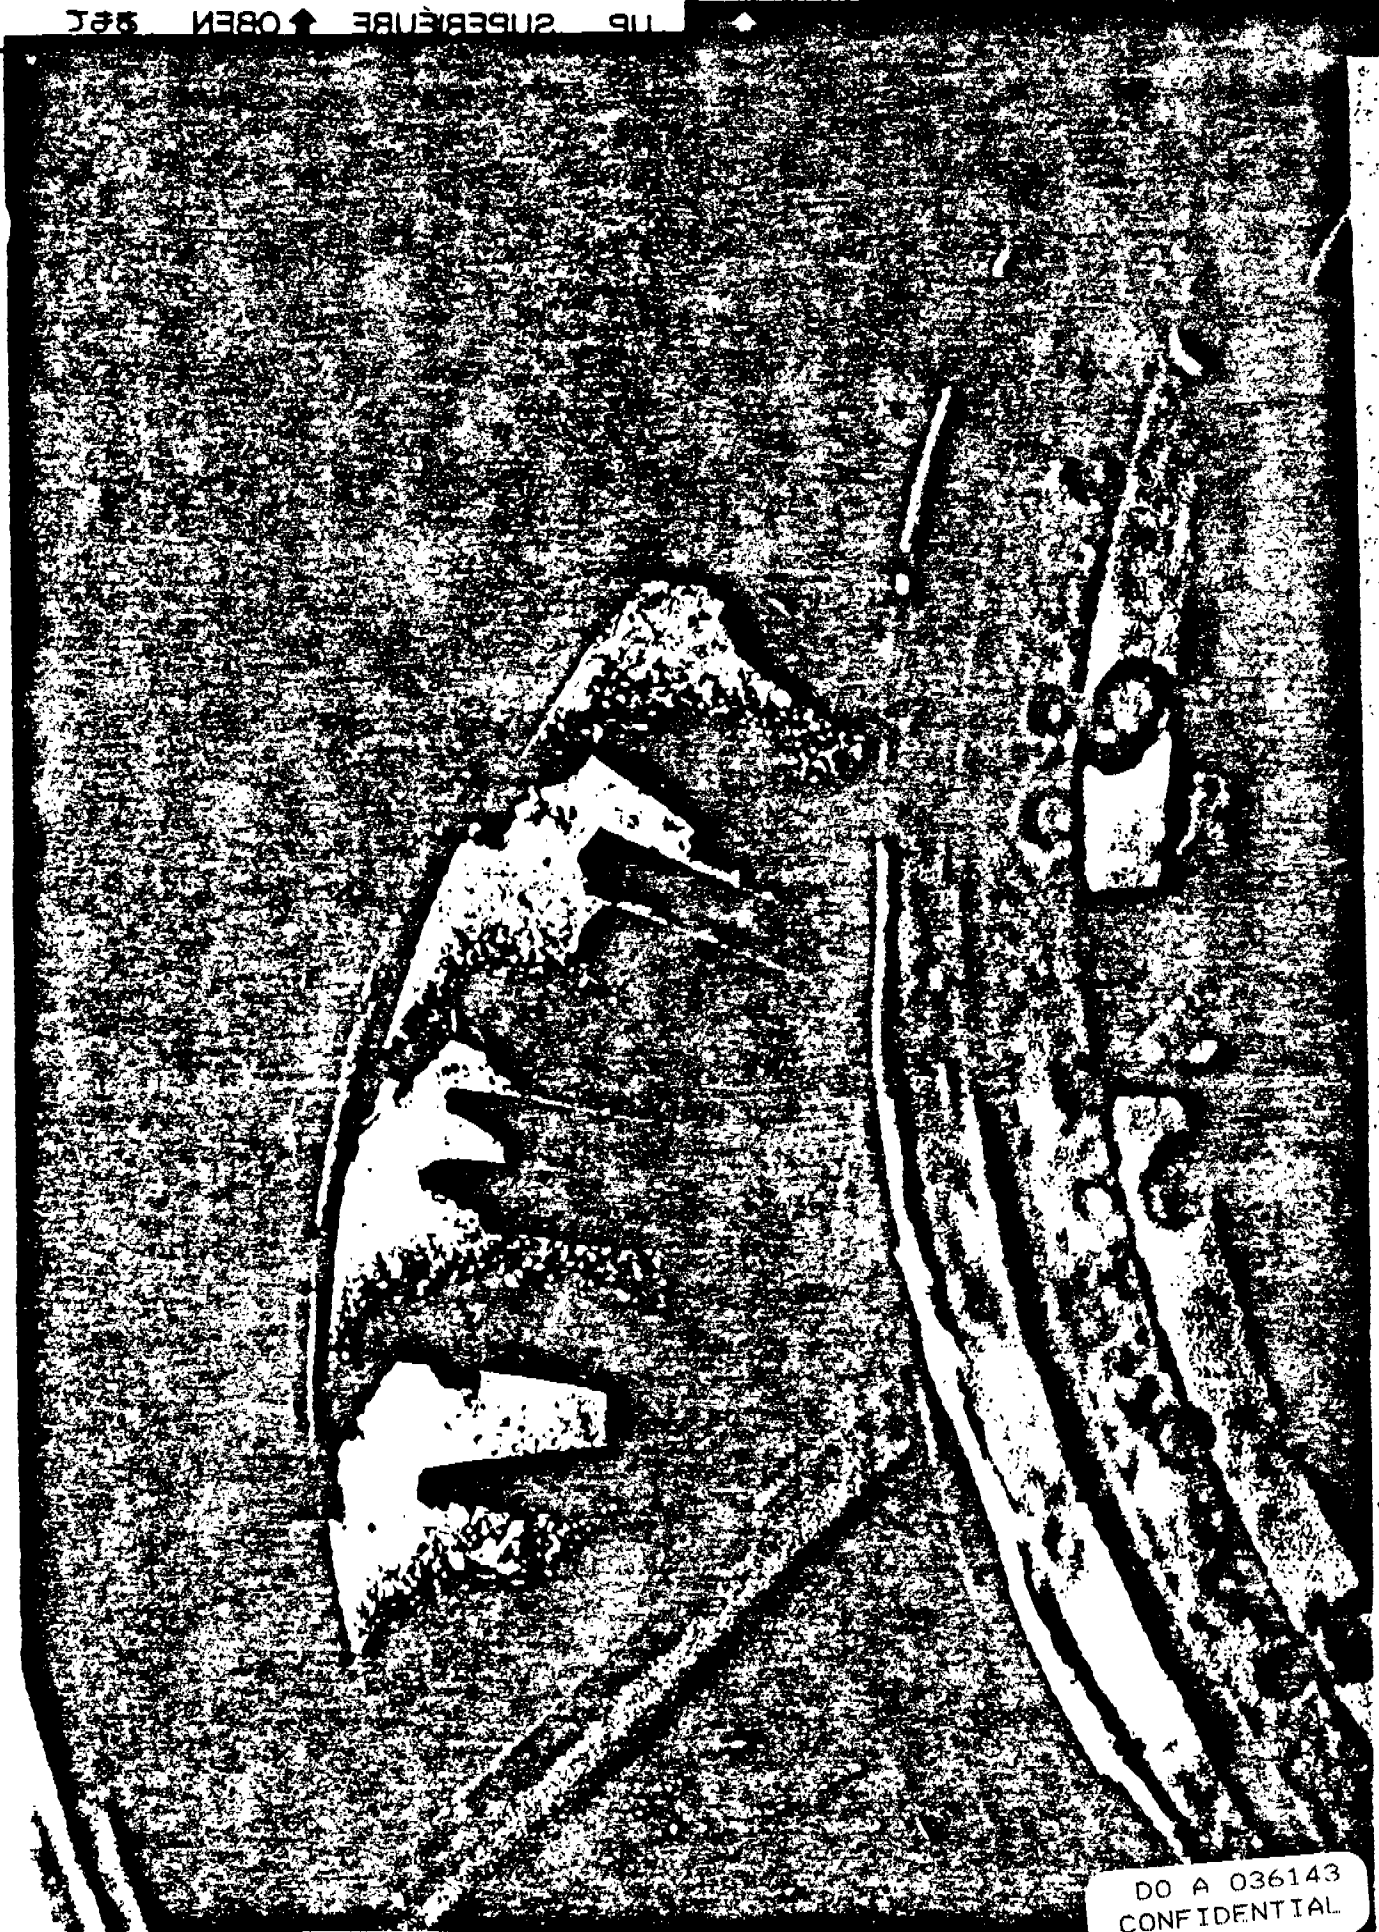
**NO WARNING PRIOR TO FAILURE**

**NOT ENOUGH EVIDENCE TO DETERMINE INITIAL FAILED BLADE**

**STRESS RUPTURE DATA ON WRECKED BLADES WAS WITHIN SPECIFICATION**

**#3 BEARING WAS DESTROYED. POSSIBLY IT FAILED FIRST (NOT LIKELY).**
