**Region 6 - Enforcement & Compliance Assurance Division**  
**INSPECTION REPORT**

| Media Program: | Water | |
| Regulatory Program(s) | NPDES | |
| Company Name: | [REDACTED] Livestock Auction | |

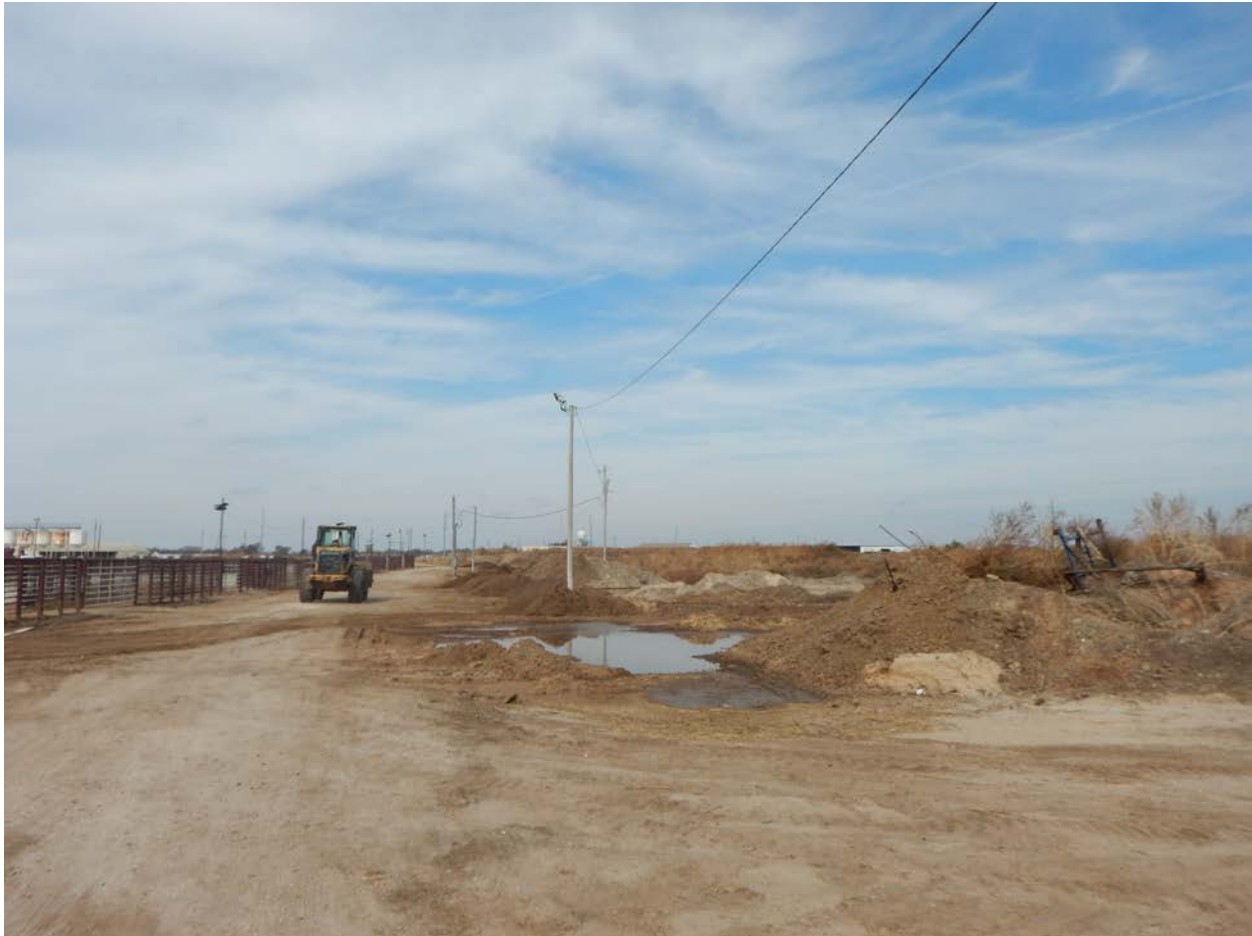
Photo No. 1

At the time of the inspection, I observed the lots to be well-kept and generally clean. I observed the uncovered three-acre area where the manure/lot scrapings were being stockpiled (Photos #1-3). This three-acre area was contained within a larger thirteen-acre area that was designed to receive runoff from the production area. This area was bermed on three sides to prevent wastewater from leaving the containment area [AOC 1]. This containment area has no liner and has not been certified by a professional engineer for lack of hydrologic connection; neither have the capacity or integrity of this bermed area been certified by a professional engineer. [REDACTED] informed us that, until recently, the facility had an agreement with an individual who would come collect the lot scrapings and haul them offsite; however, as of the date of this inspection, this arrangement was no longer in place.

Description: This photo was taken facing northwest across area where the manure/lot scraping storage area abuts the northern edge of the pens.

1. An operator of an unpermitted CAFO is never authorized to discharge from the CAFO under Clean Water Act § 301(a). All wastewater runoff must be prevented from entering a water of the U.S. As a best management practice, limit the amount of time manure is stored onsite; additionally, conduct regular visual inspections of the berm to ensure that wastewater cannot exit the storage area.

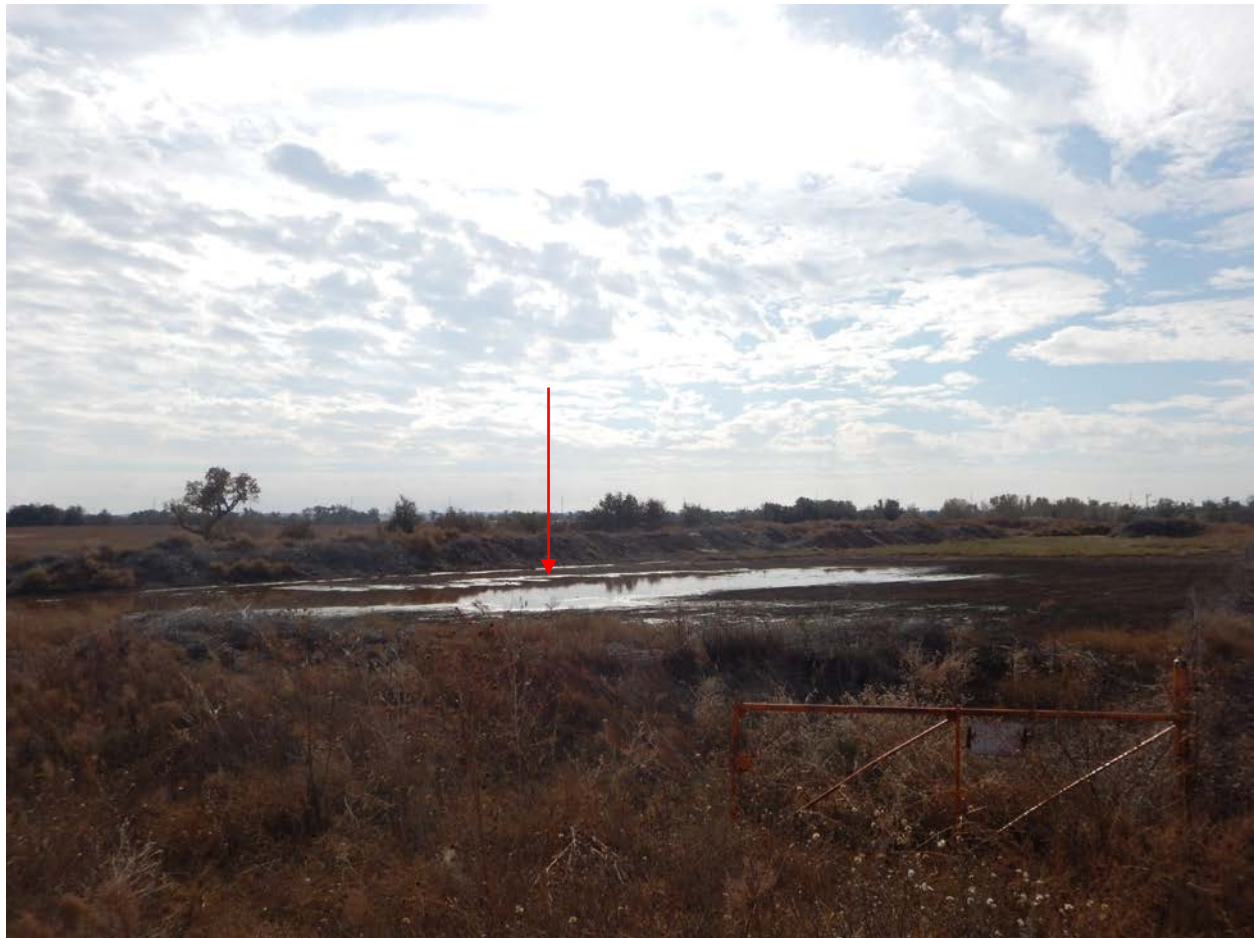
Photo No. 2

Description: This photo was taken facing east across the manure/lot scraping storage area. Note the standing wastewater.

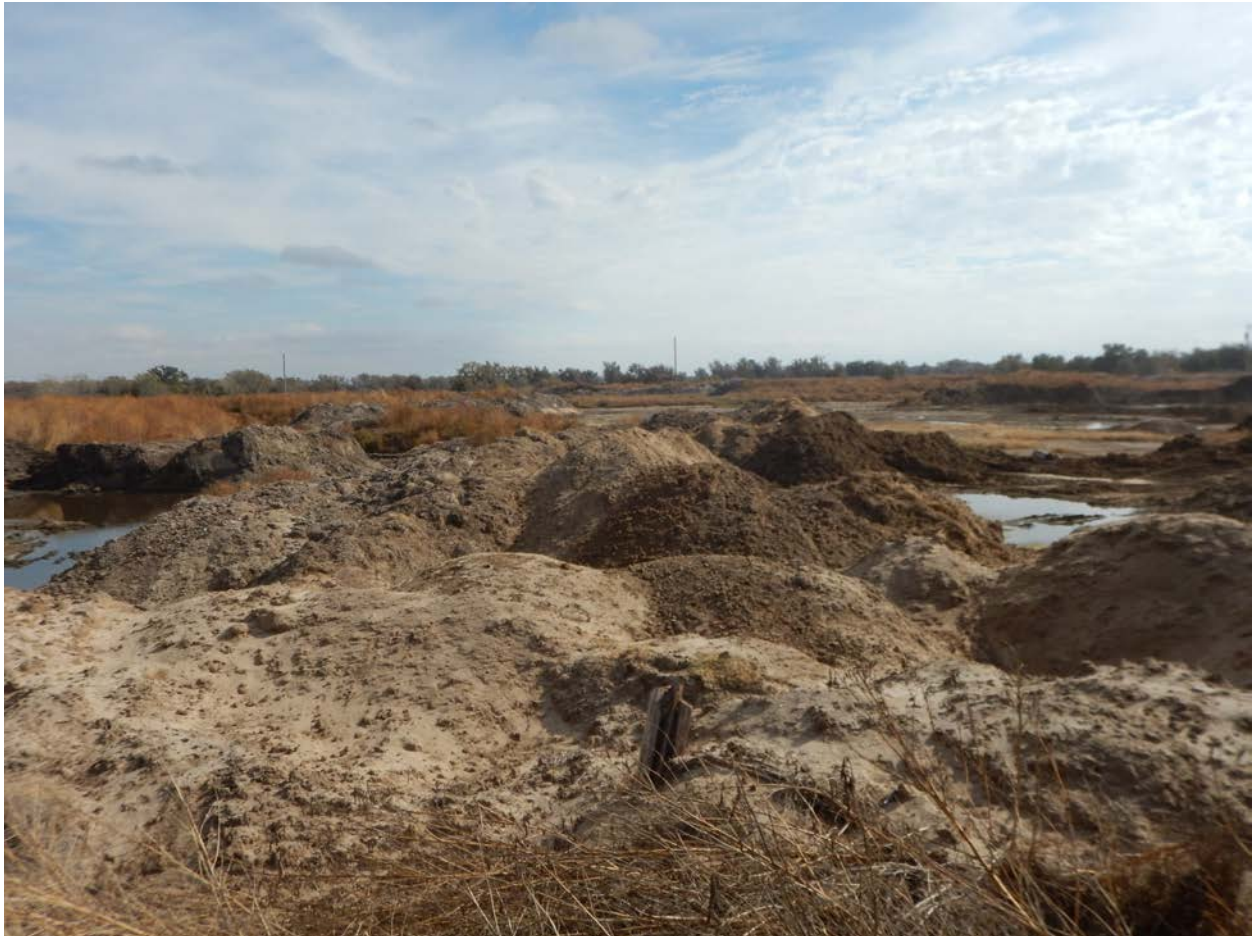
Photo No. 3

Description: This photo was taken facing northeast across the manure/lot scraping storage area.

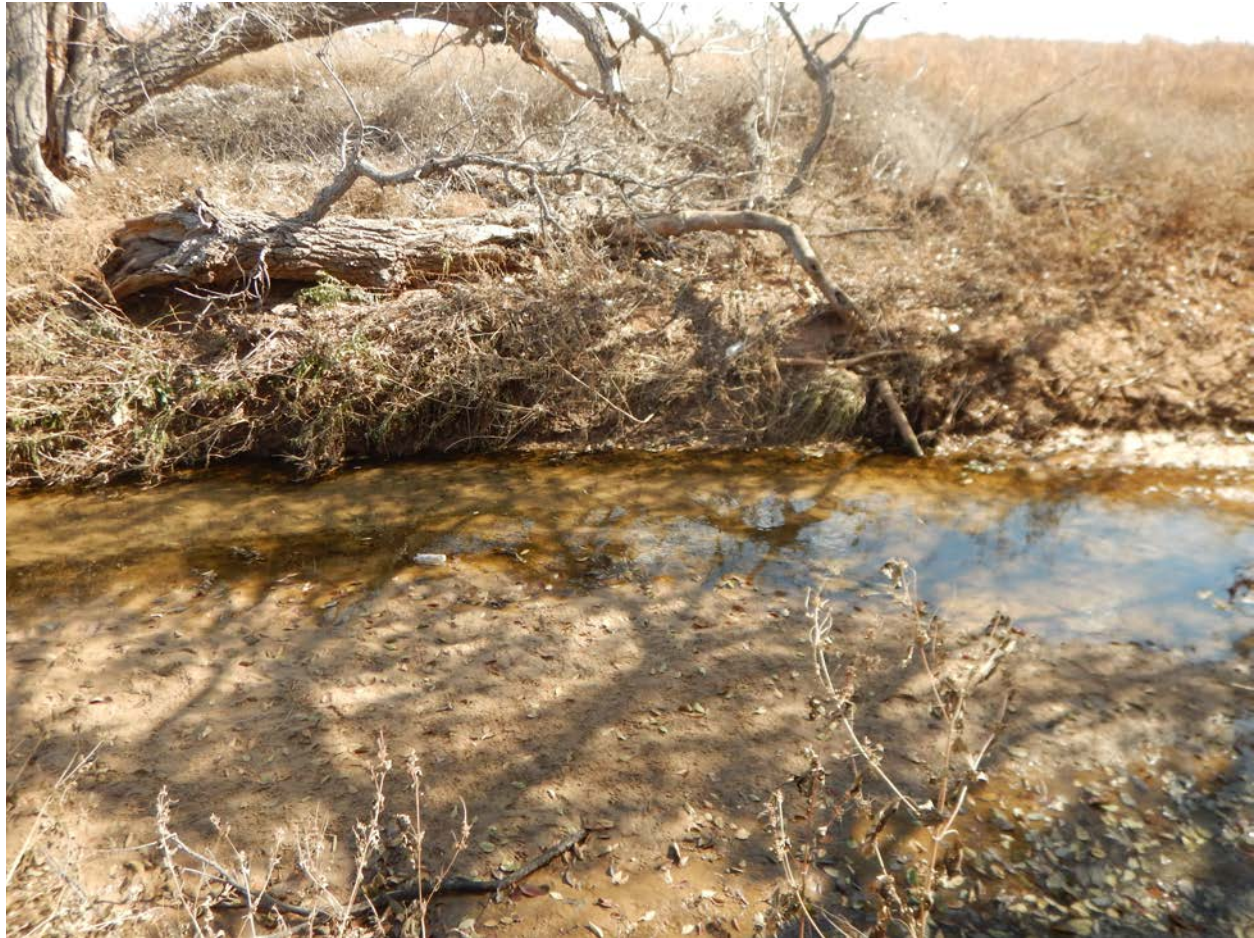
Photo No. 4

I did not observe any visual markers in [REDACTED] Creek which might signify wastewater from the facility had entered the creek (Photo #4).

Description: This photo was taken facing east across [REDACTED] Creek.
