**Region 6 - Enforcement & Compliance Assurance Division**  
**INSPECTION REPORT**

| Inspection Date(s): | 05/09/2024 | |
| Company Name: | <b>LANXESS Corporation – South Plant</b> | |
| Facility Name: | <b>SWD Trimble 9S (Class II injection well at 33.105418, -92.710991)</b> | |

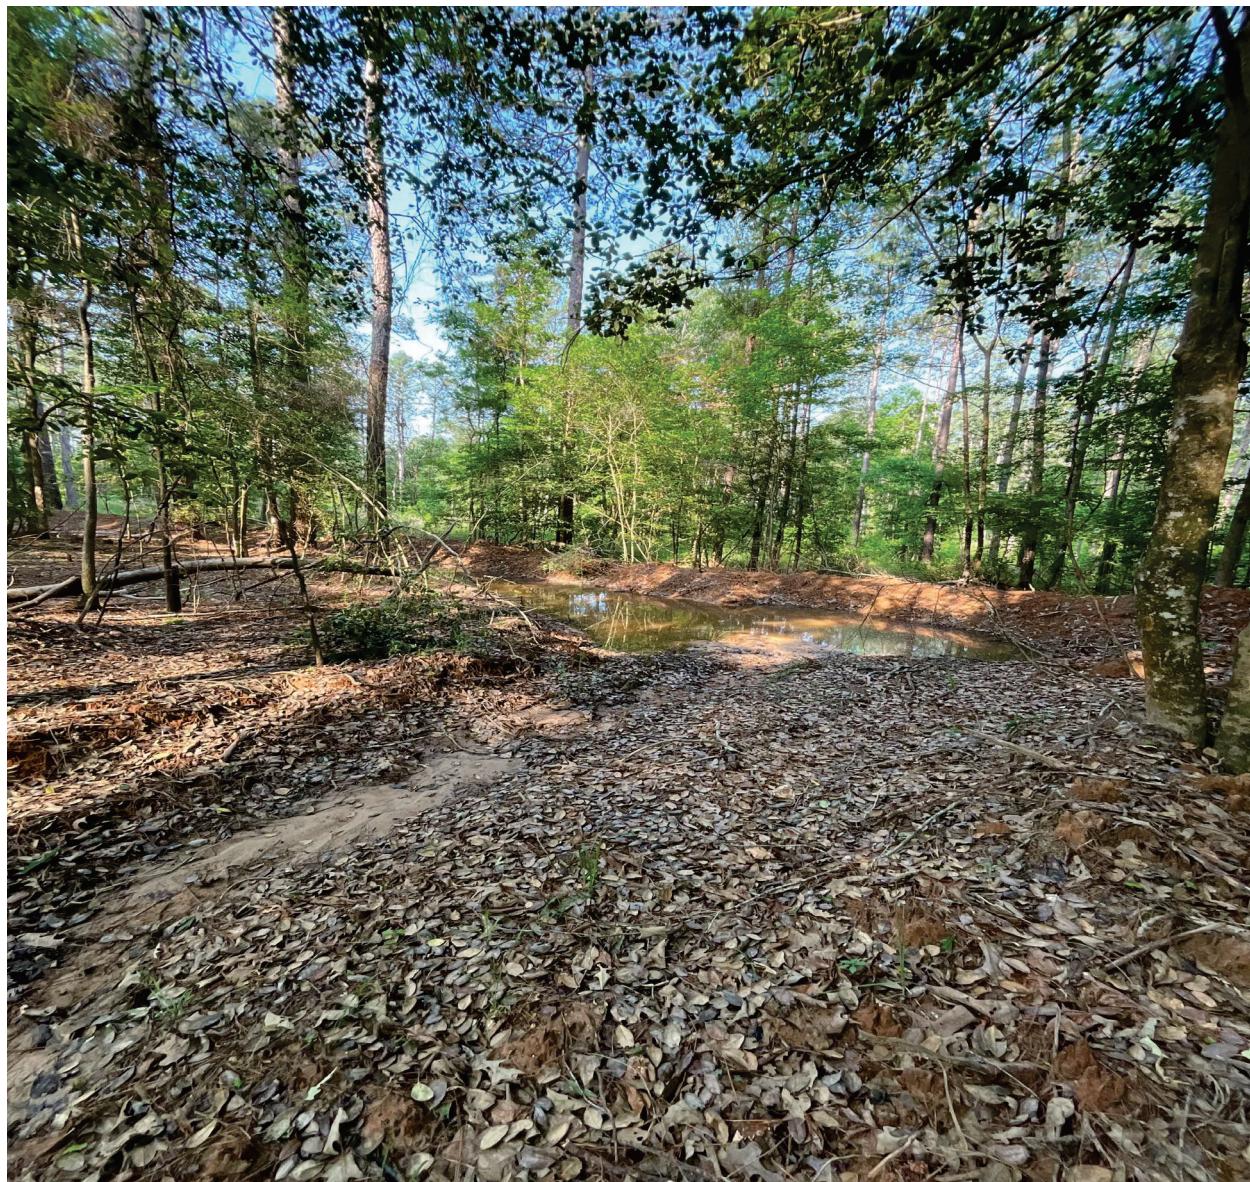
Photo No. 1

I observed the area of the August 2023 tail brine release, see Appendix 1 (Photograph Log), see Photo No. 1. For additional GPS location and photo metadata, see Appendix 1.

**Description:** Looking SW, this photo showed the earthen berm built to contain the release of tail brine.

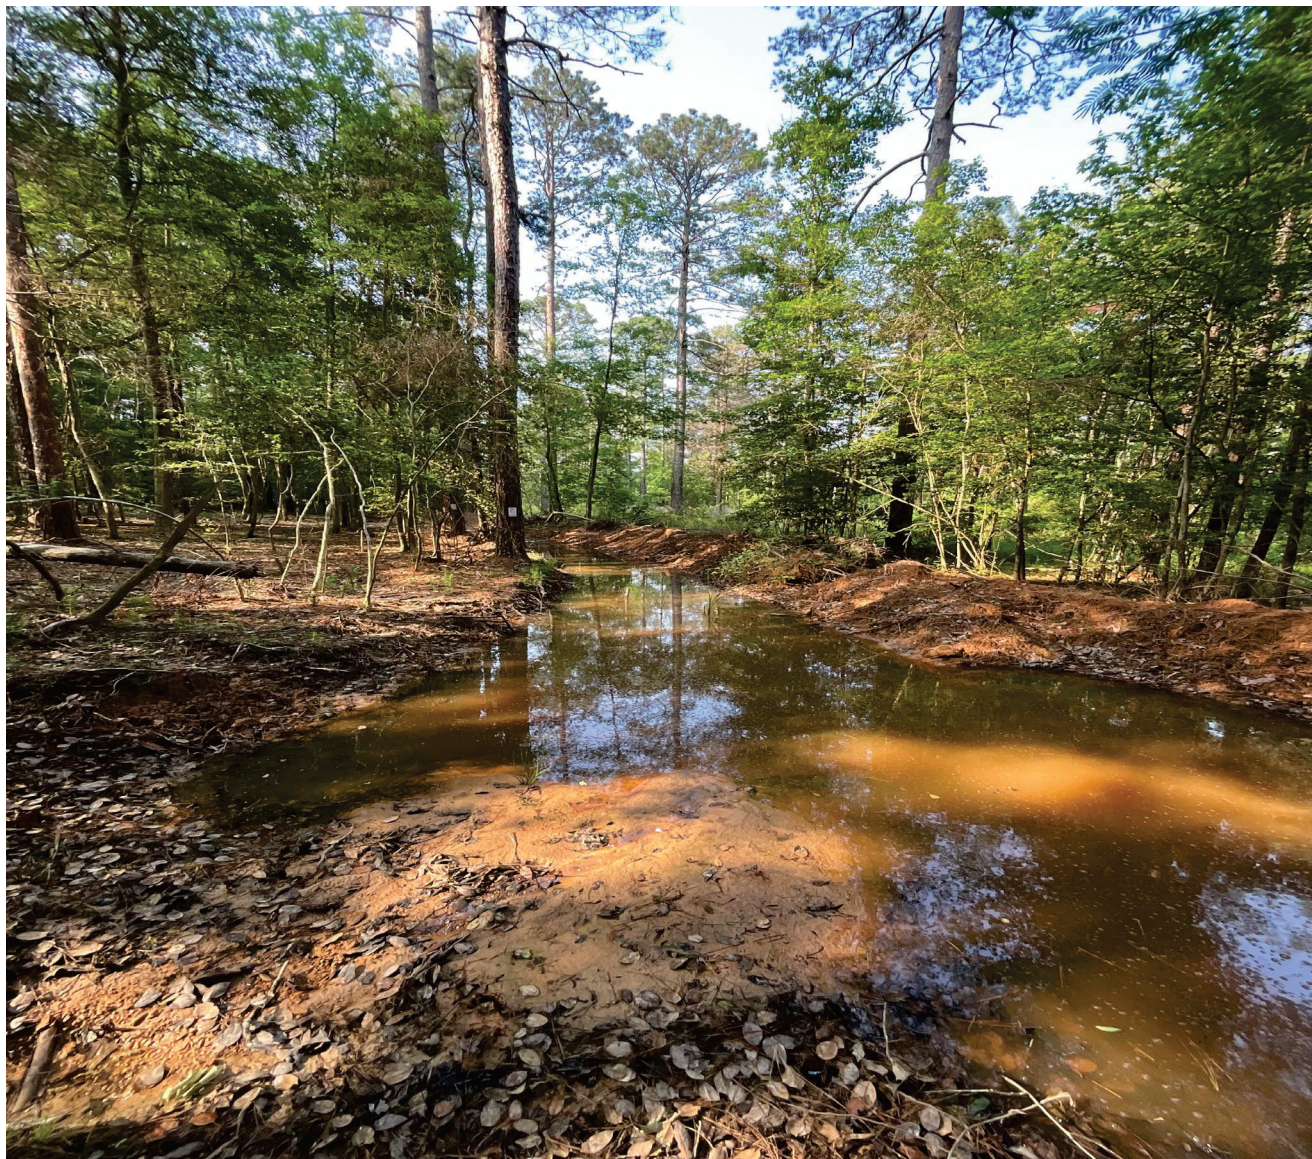
Photo No. 2

I observed an earthen berm that had been constructed to contain the tail brine release, see Photo No. 2.

**Description:** Looking S, this photo showed another view of the earthen berm used to collect the tail brine released.

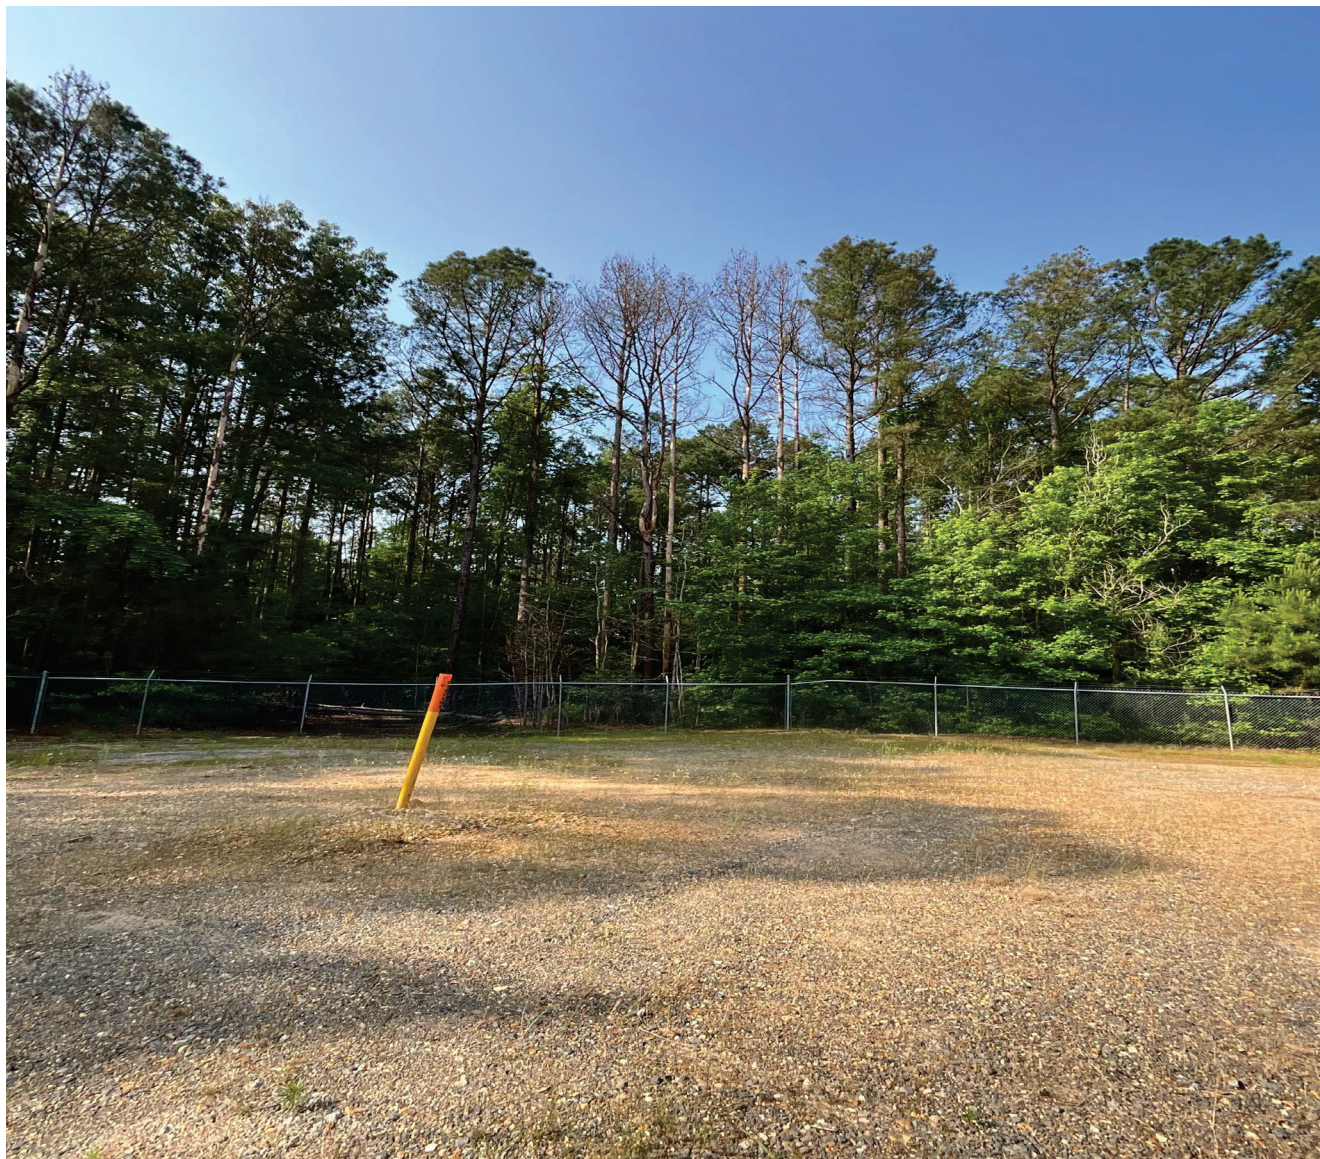
Photo No. 3

I observed an area on private property with standing dead trees, see Photo No. 3.

**Description:** Looking S, this photo showed the SWD pad with dead vegetation from the brine release in the background on private property.

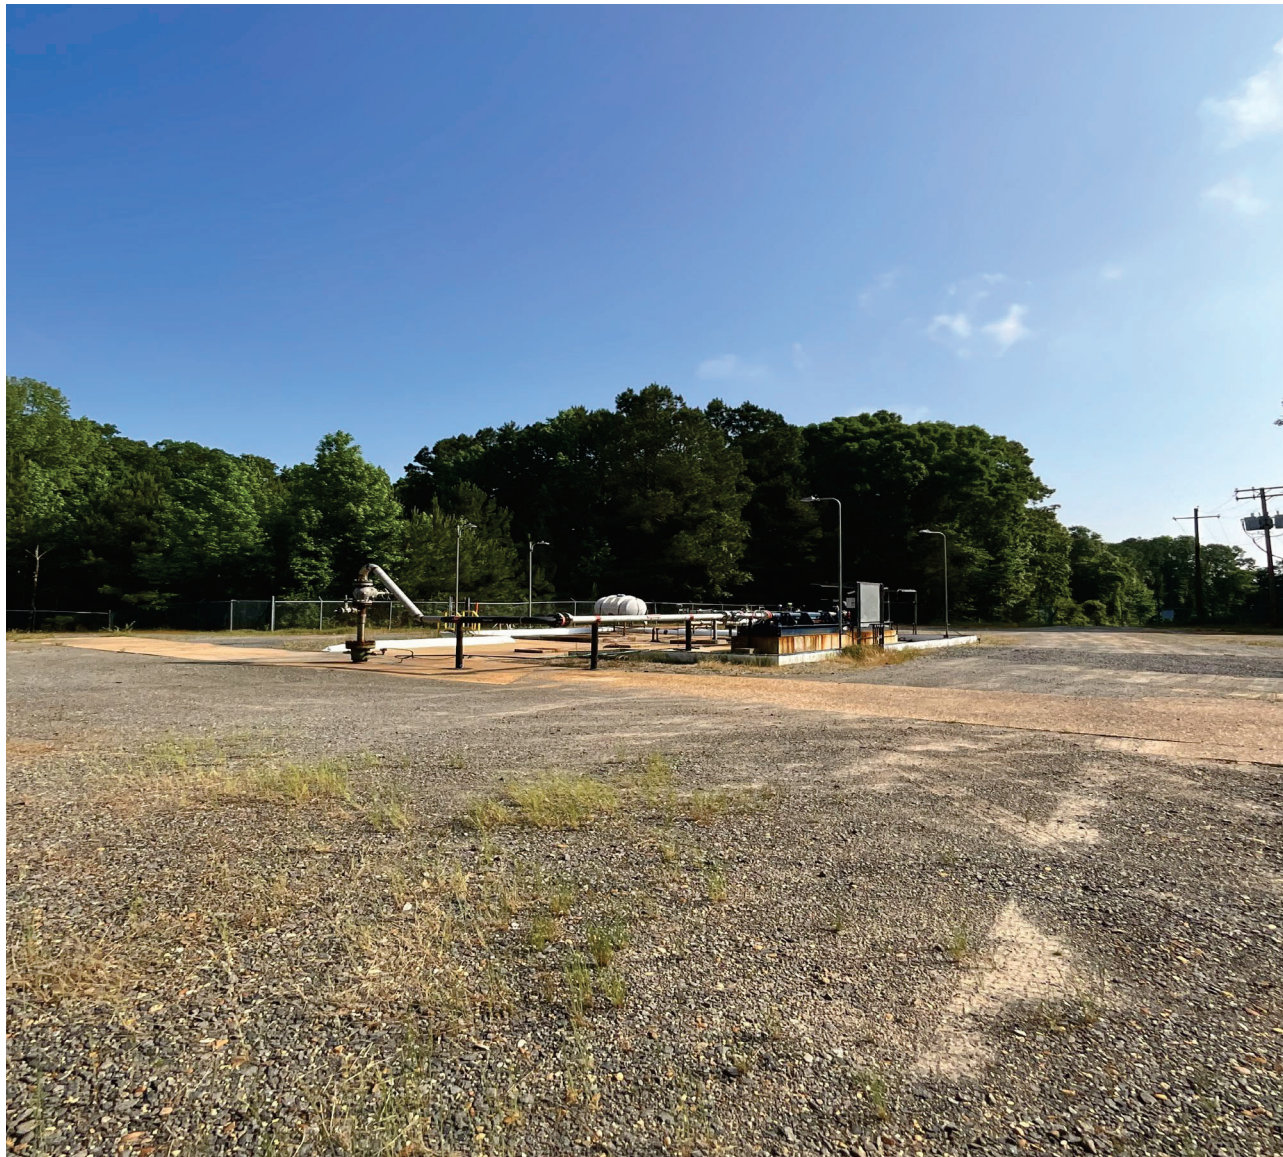
Photo No. 4

I observed the injection well pad, see Photo No. 4.

**Description:** Looking NE, this photo showed the overview of the tail brine injection well where the release had occurred.

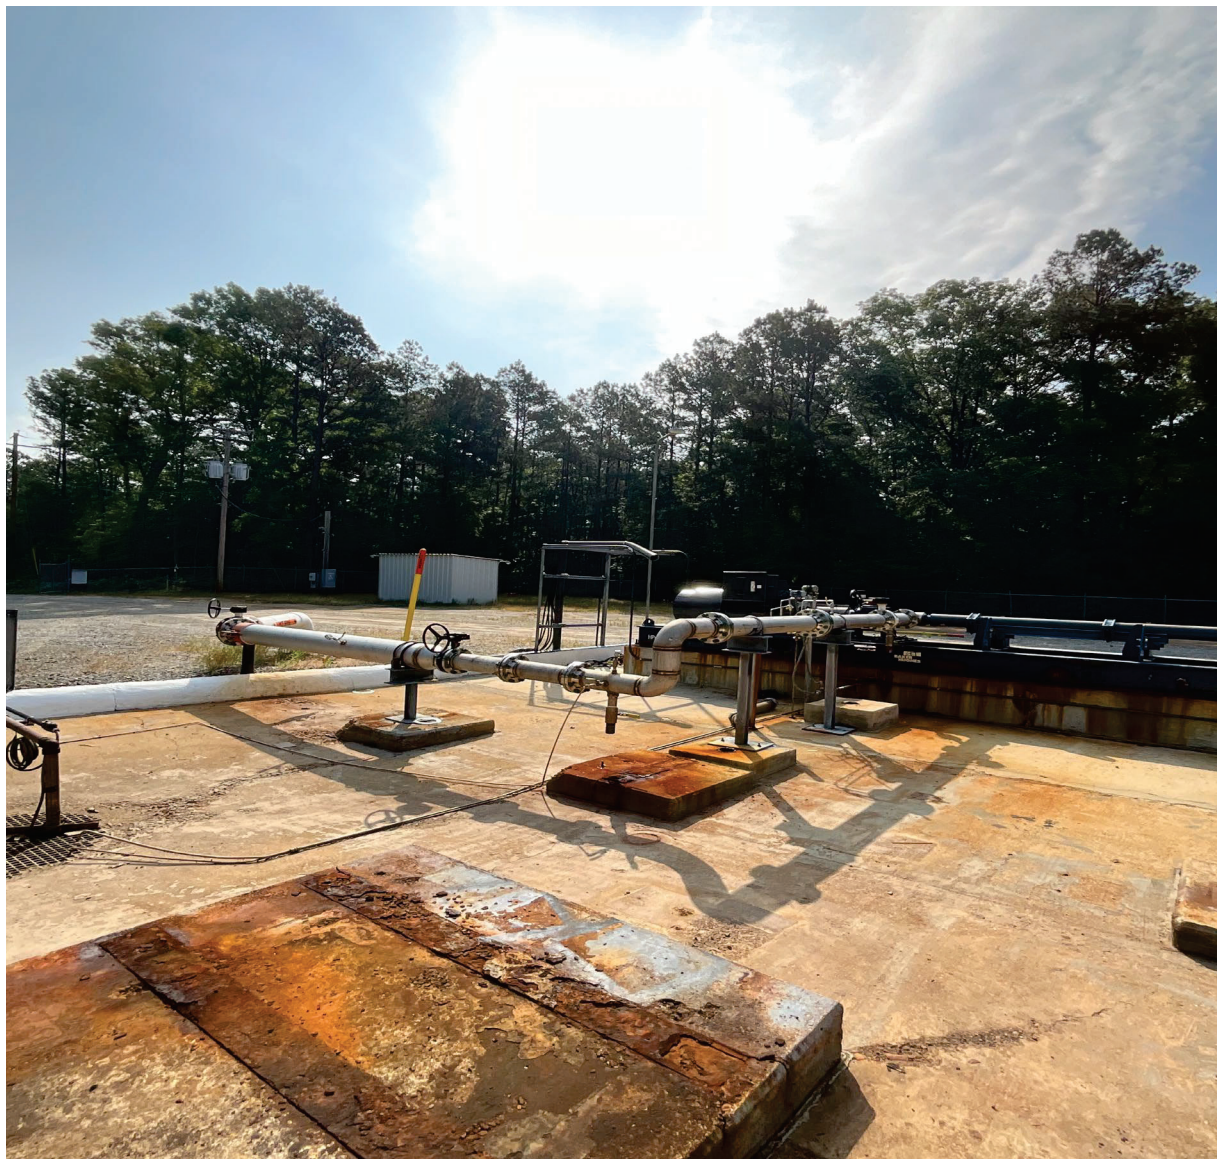
Photo No. 5

I observed the repaired section of line for the injection well, see Photo No. 5.

**Description:** Looking E, this photo showed the section of the line that was replaced after the release.

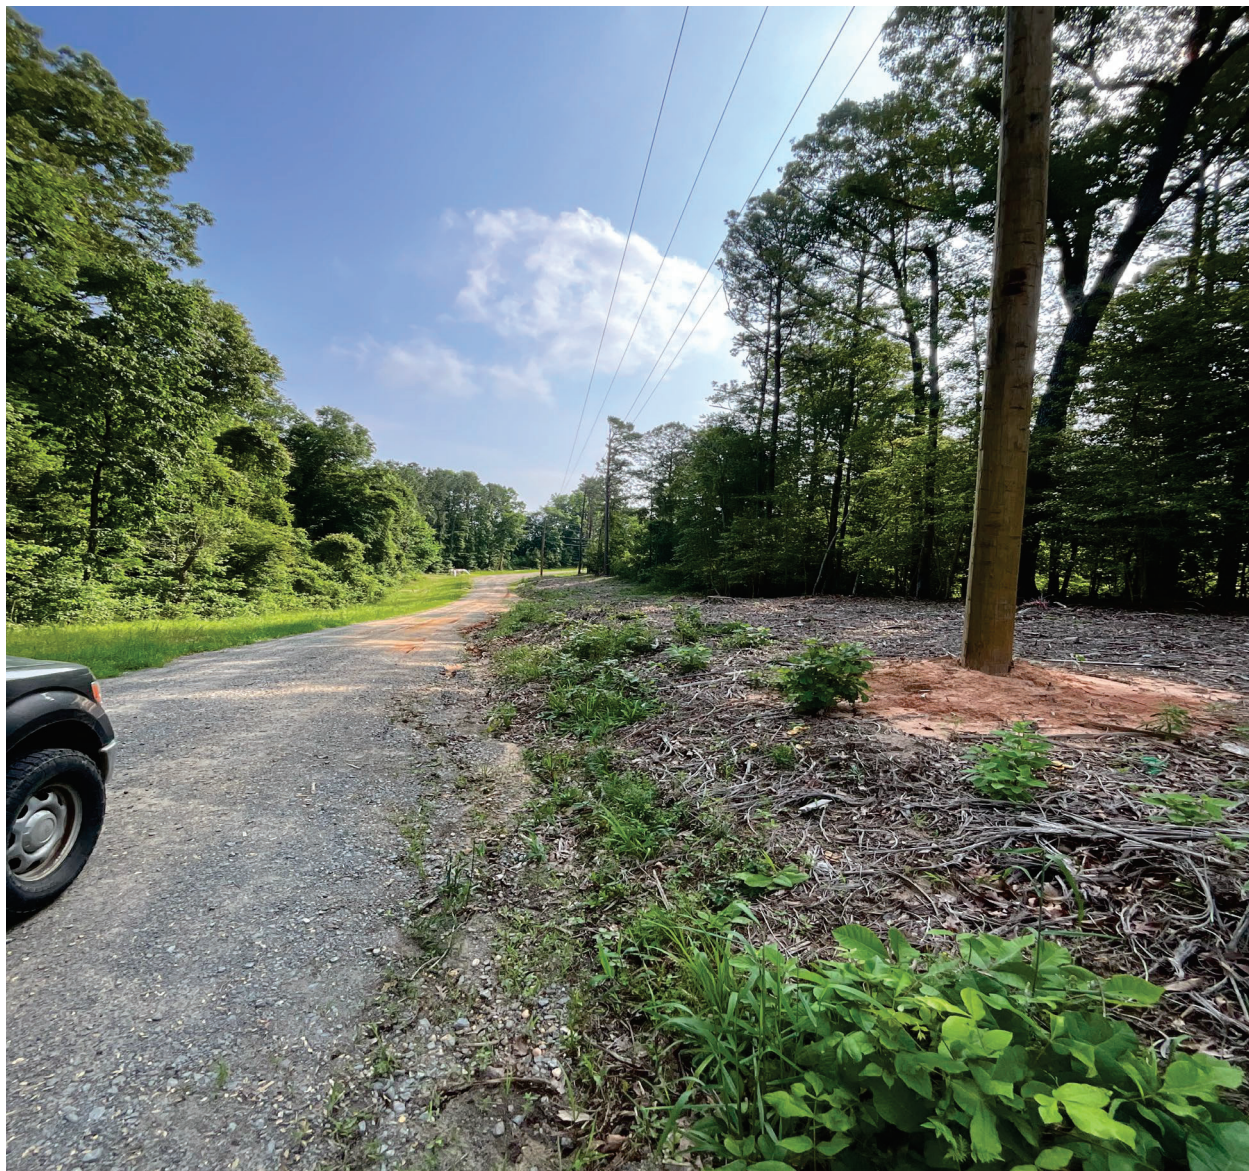
Photo No. 6

I observed a privately-owned utility Right of Way (ROW) that had been cleared of trees, see Photo No. 6.

**Description:** Looking NE, this photo showed the Right of Way (ROW) cleared by private utility company.
