## Region 6 - Enforcement & Compliance Assurance Division

### INSPECTION REPORT

| Company Name: | <b>Red Oak Operating, LLC</b> | |
| Facility Name: | <b>Minter A Tank Battery</b> | |

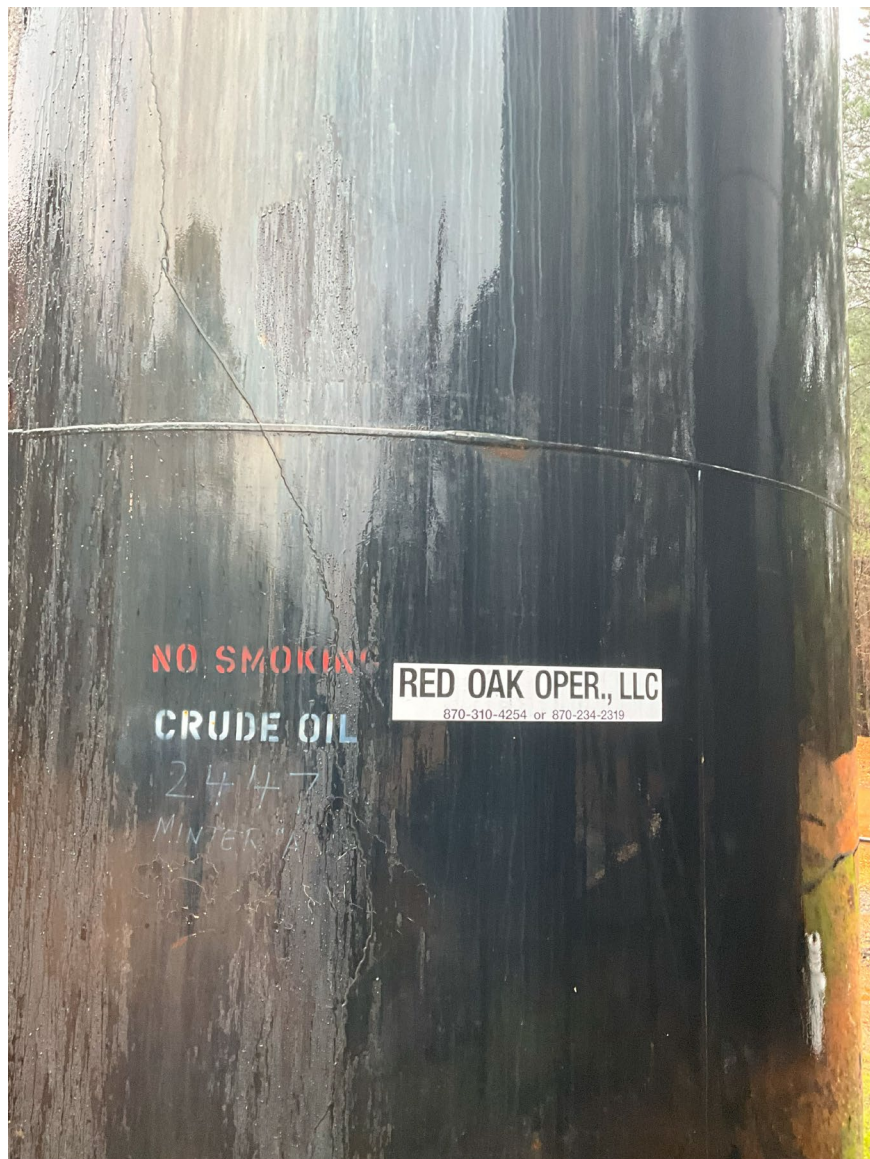
Photo No. 1

**Description:** This photo was taken looking south and shows the facility sign.

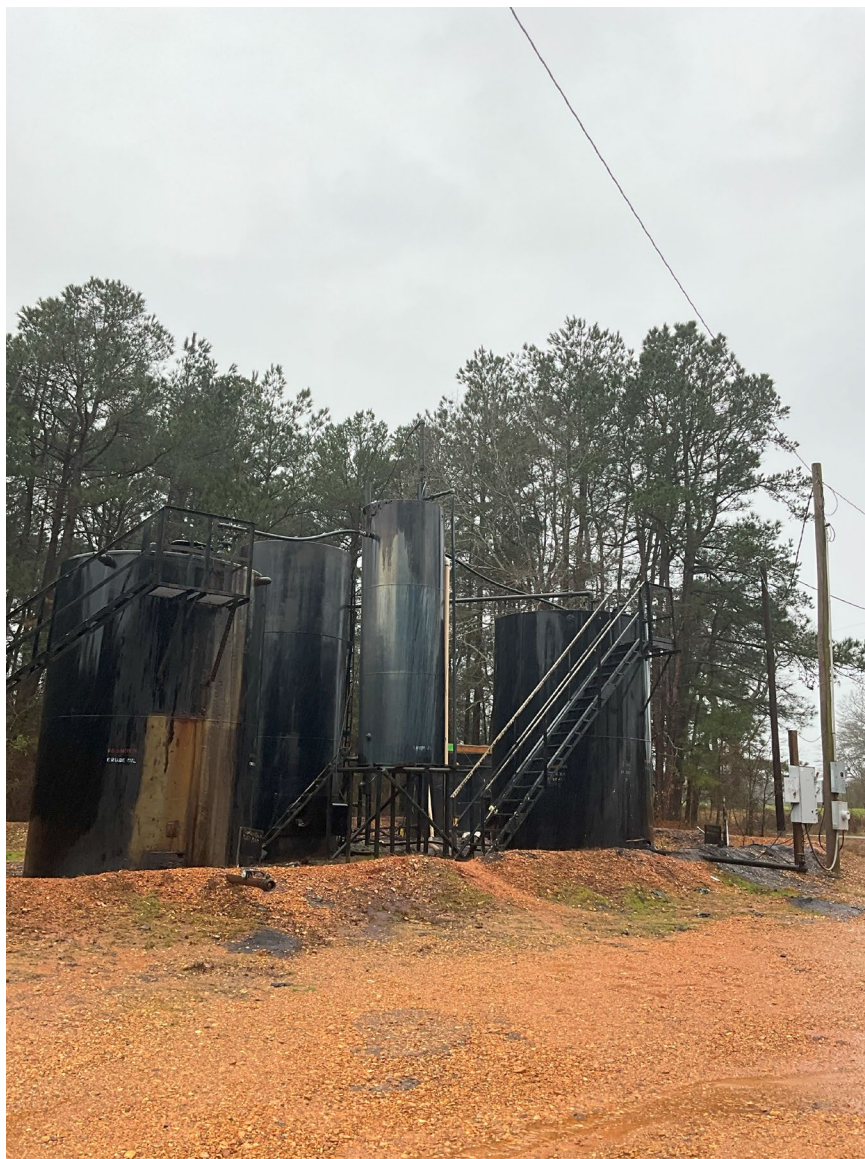
Photo No. 2

No closing conference was held due to no Red Oak Operating, LLC staff being present during the inspection. Areas of concern at the time of the inspection include one of the separators was out of service but was not marked out of service with a date and the load lines outside of secondary containment were missing catchment buckets.

**Description:** This photo was taken looking southwest and shows an overview of the facility. This photo also shows the missing catchment buckets for the load lines.

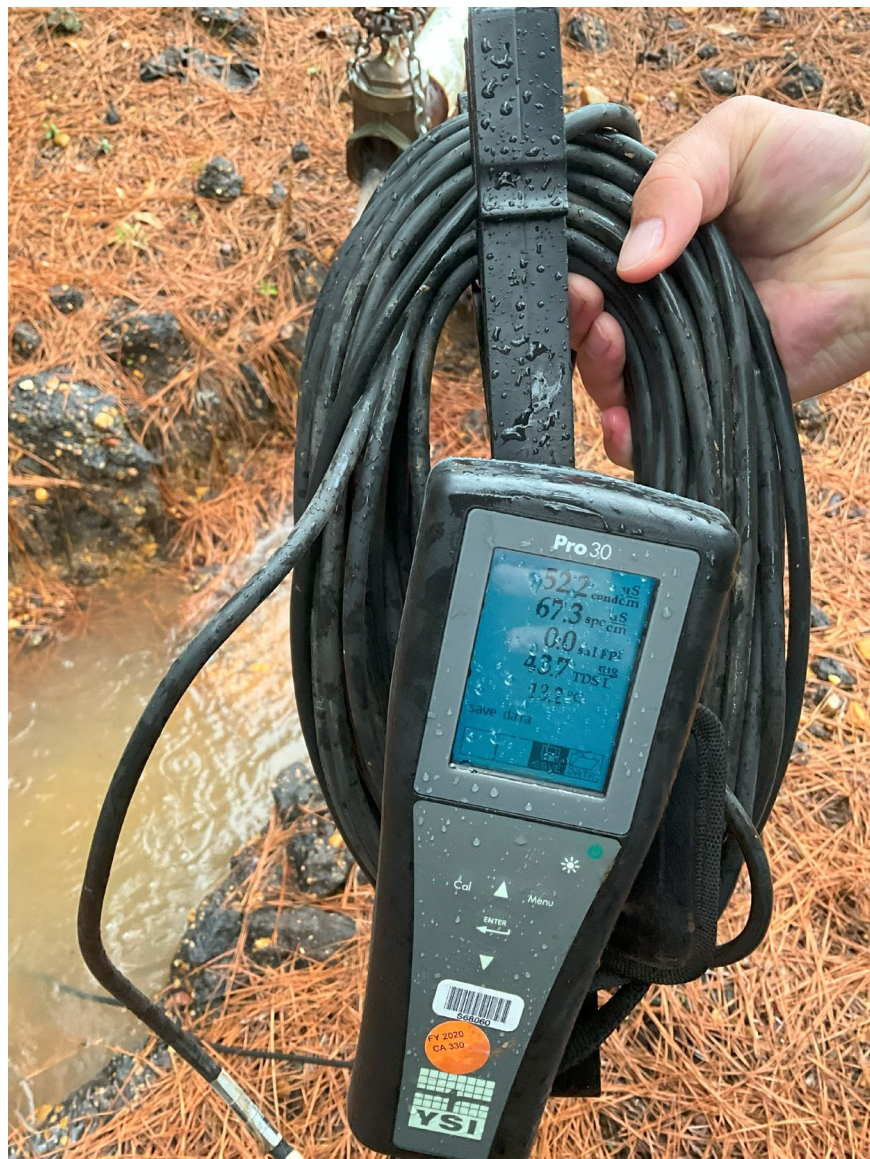
Photo No. 3

I observed a Total Dissolved Solids (TDS) reading of 43.7 mg/L from the secondary containment discharge pipe outside of secondary containment, see photo No. 3.

**Description:** This photo was taken showing the Total Dissolved Solids (TDS) reading of 43.7 mg/L at the discharge point from the secondary containment drainage pipe.
