**Region 6 - Enforcement & Compliance Assurance Division**  
**INSPECTION REPORT**

| Inspection Date(s): | 3/14/24 | |
| Company Name: | <b>John Sinclair Production, LLC</b> | |
| Facility Name: | <b>Emodell Murphy #1, 2, 3, 4 Tank Battery</b> | |

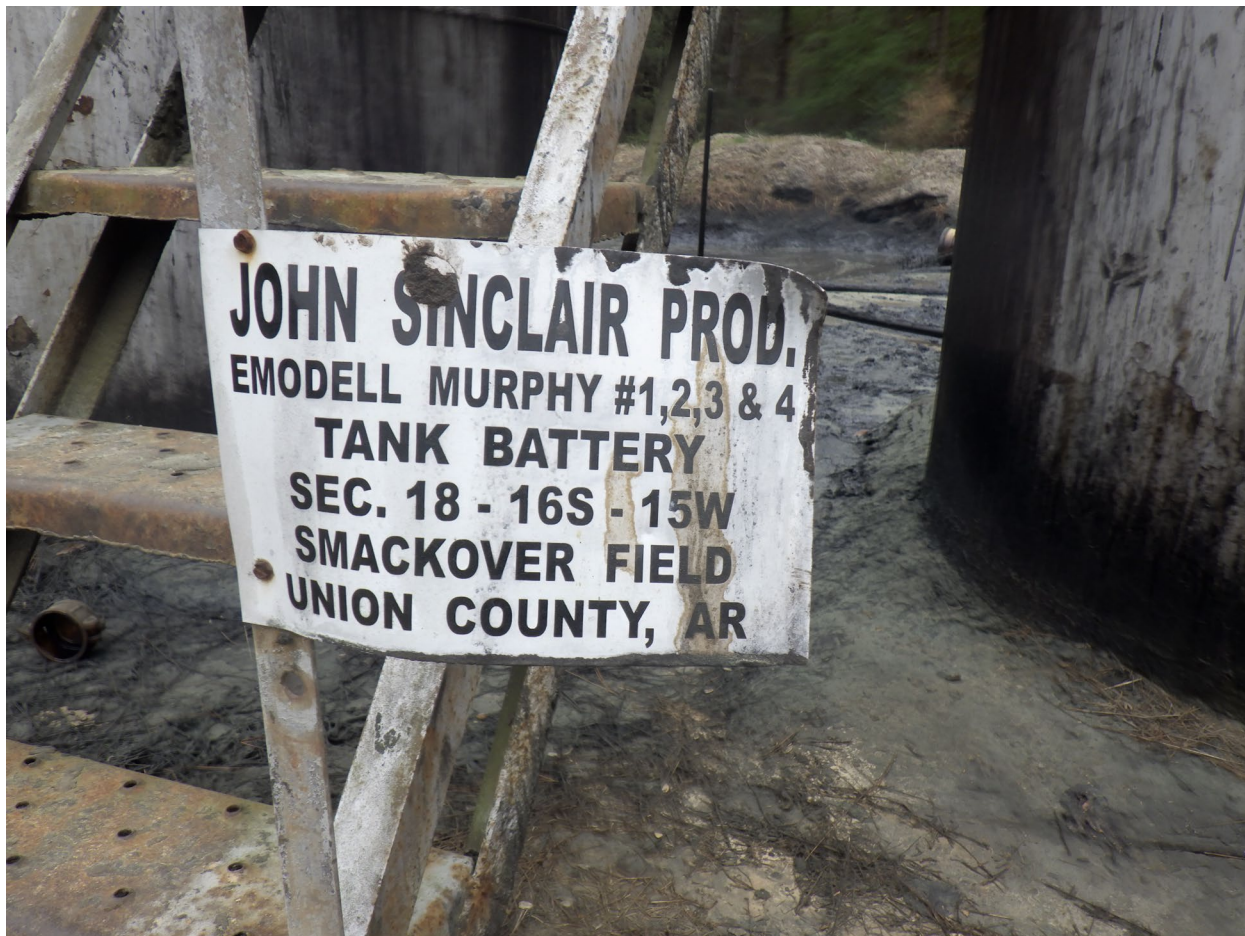
Photo No. 1

**Description:** This photo was taken looking S-SE at the facility showing the facility sign.

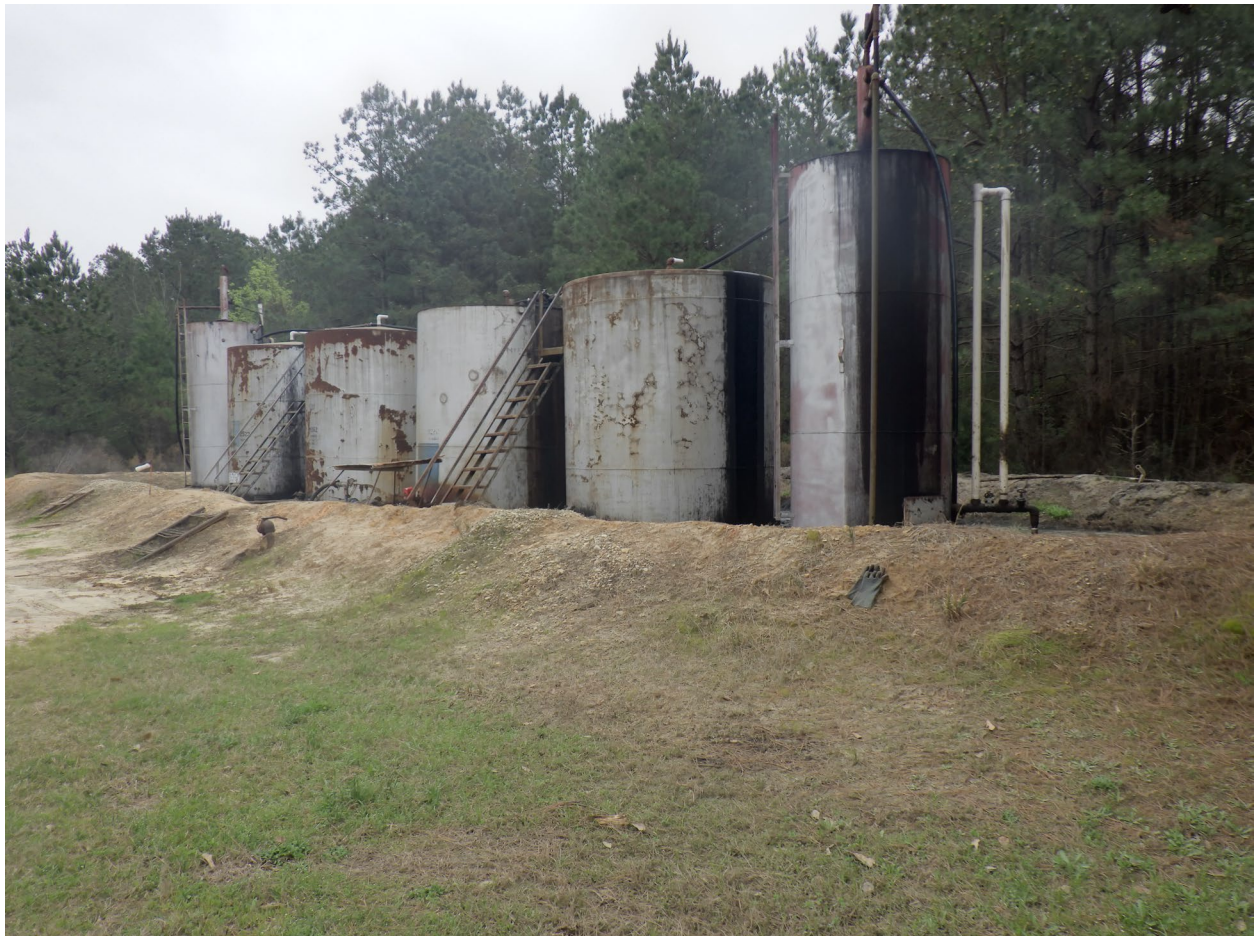
Photo No. 2

**Description:** This photo was taken looking SE at the facility showing the overview of the facility.

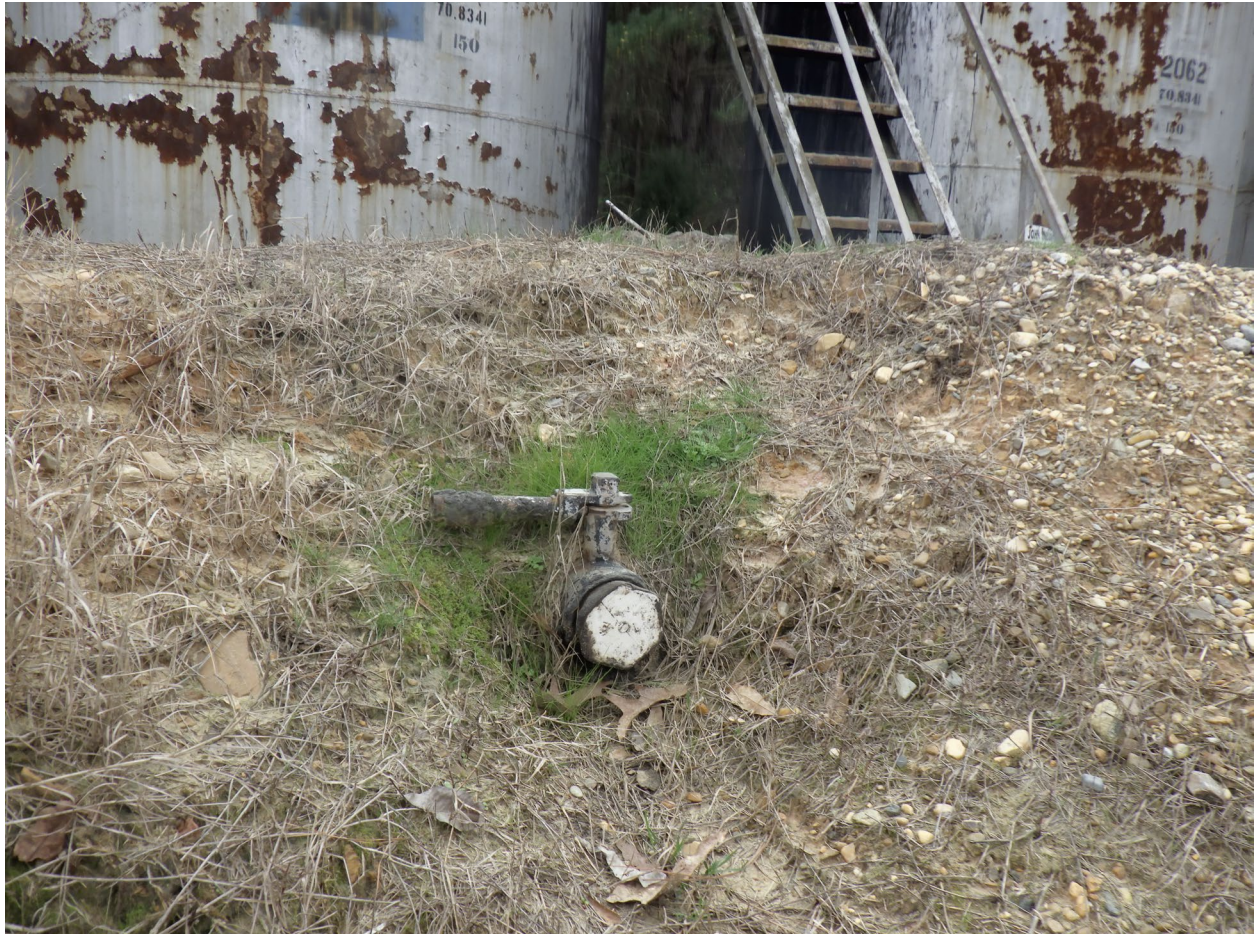
I observed transfer pipes through secondary containment with loose oil around the area and no catch buckets, see Photo No. 3 and No. 4.

**Description:** This photo was taken looking S-SW showing a closeup of a transfer pipe through the secondary containment without a catch bucket.

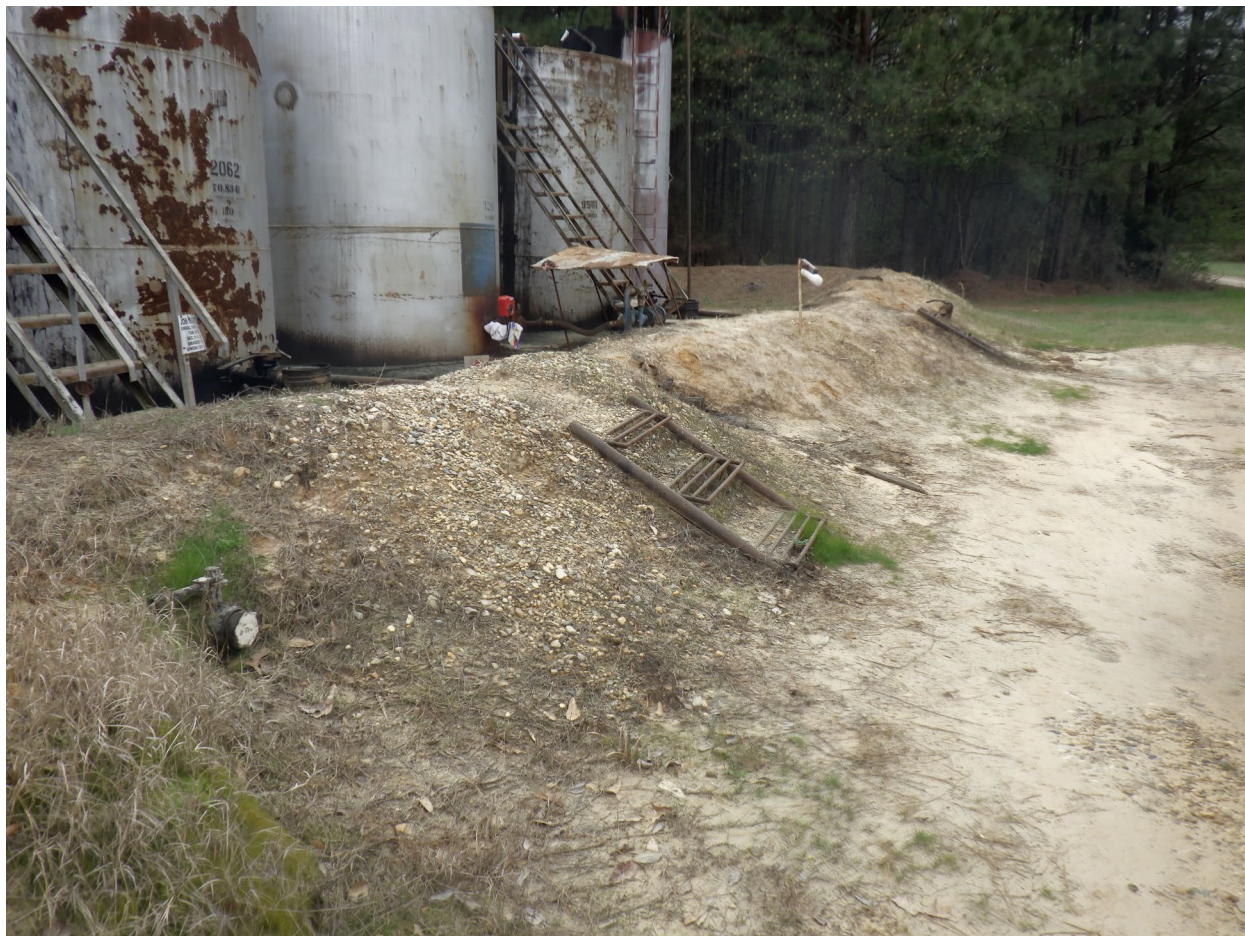
Photo No. 4

**Description:** This photo was taken looking W-SW showing transfer pipes through secondary containment without catch buckets.

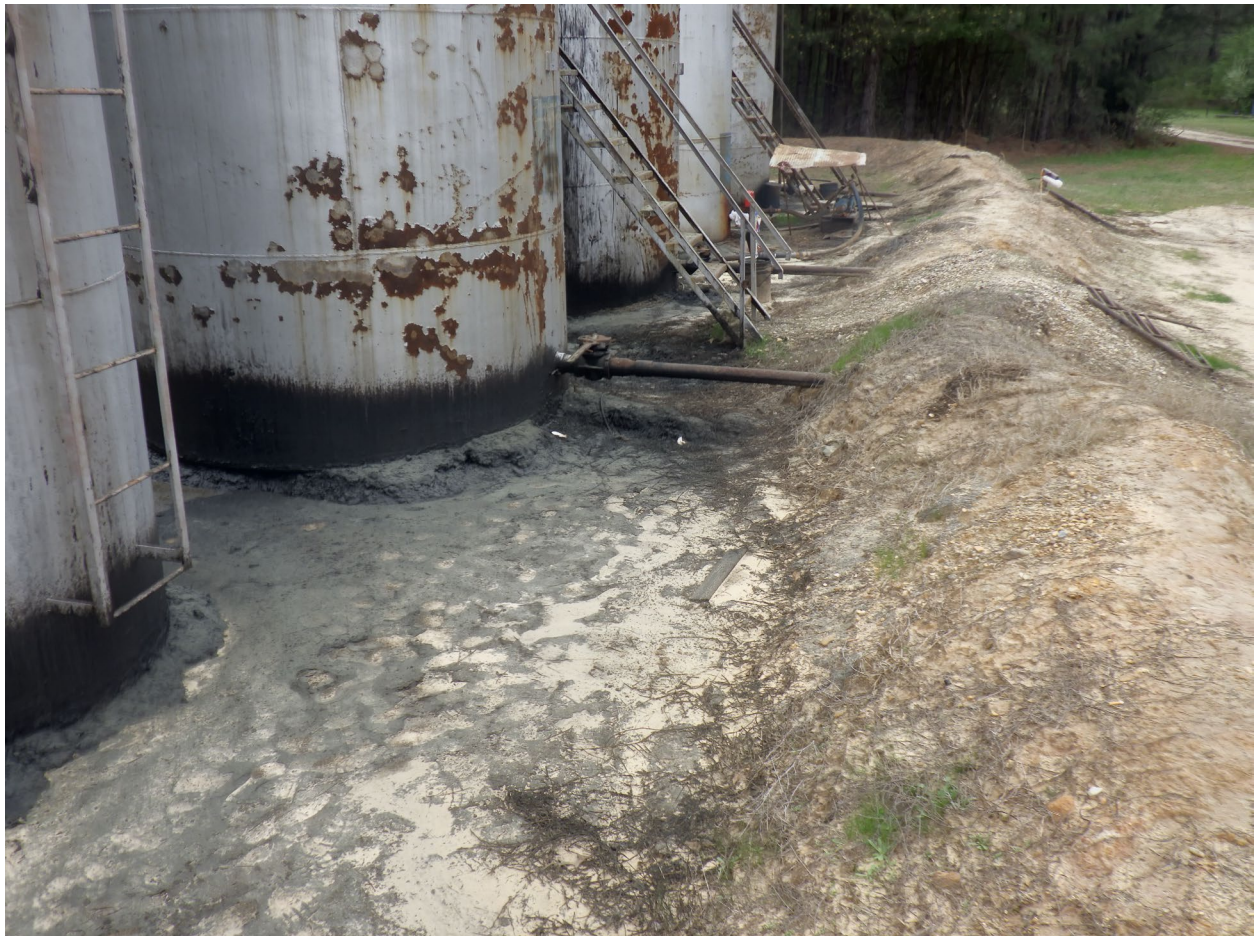
Looking W-SW and E from the top of secondary containment (front and back), I observed loose oil inside the secondary containment, see Photo No. 5 and No. 14.

**Description:** This photo was taken looking W-SW showing loose oil inside secondary containment (frontside).

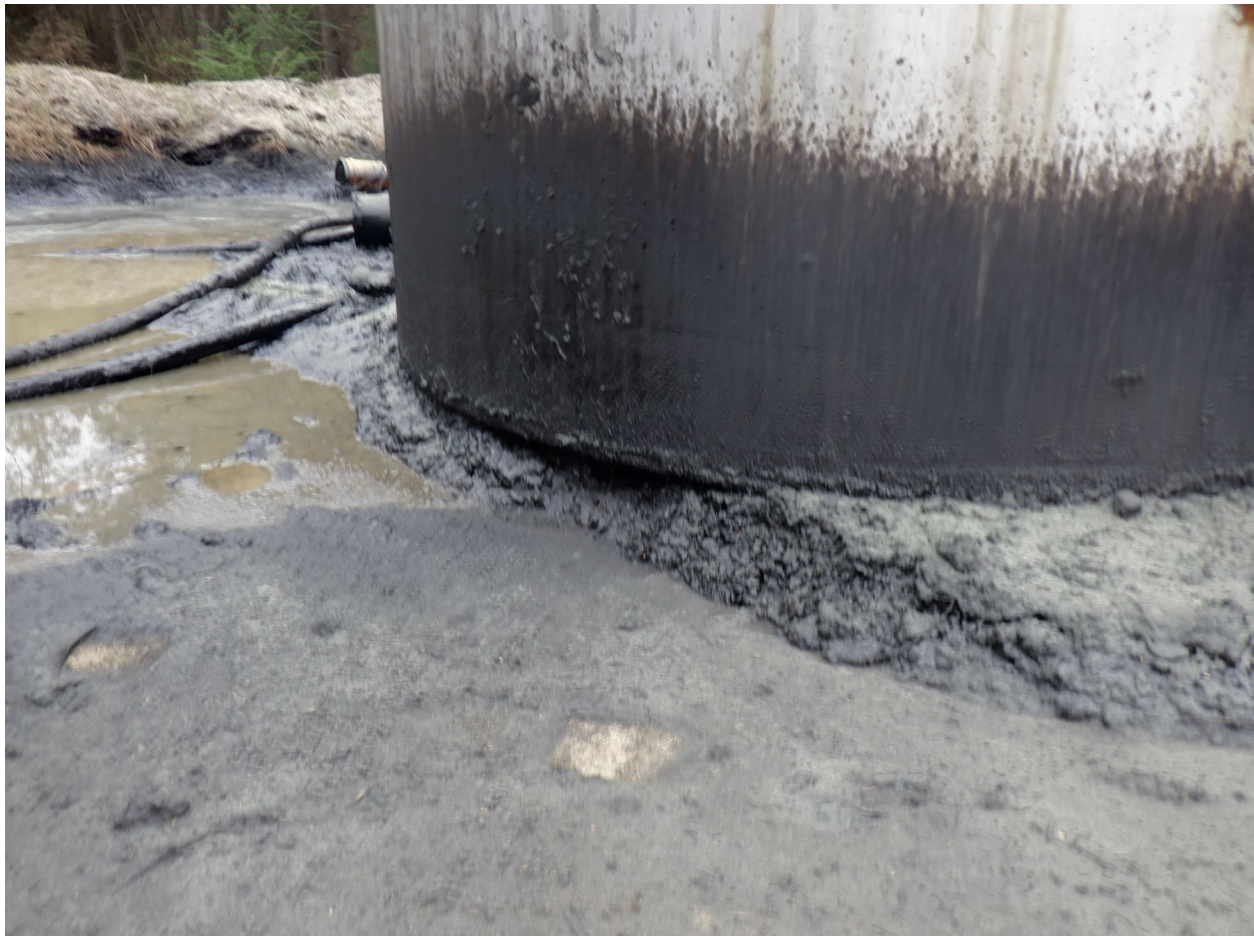
I observed a gap under a tank, identified as 2523, inside the secondary containment, see Photo No. 6 and No. 7.

**Description:** This photo was taken looking SW showing the gap under one of the tanks inside secondary containment.

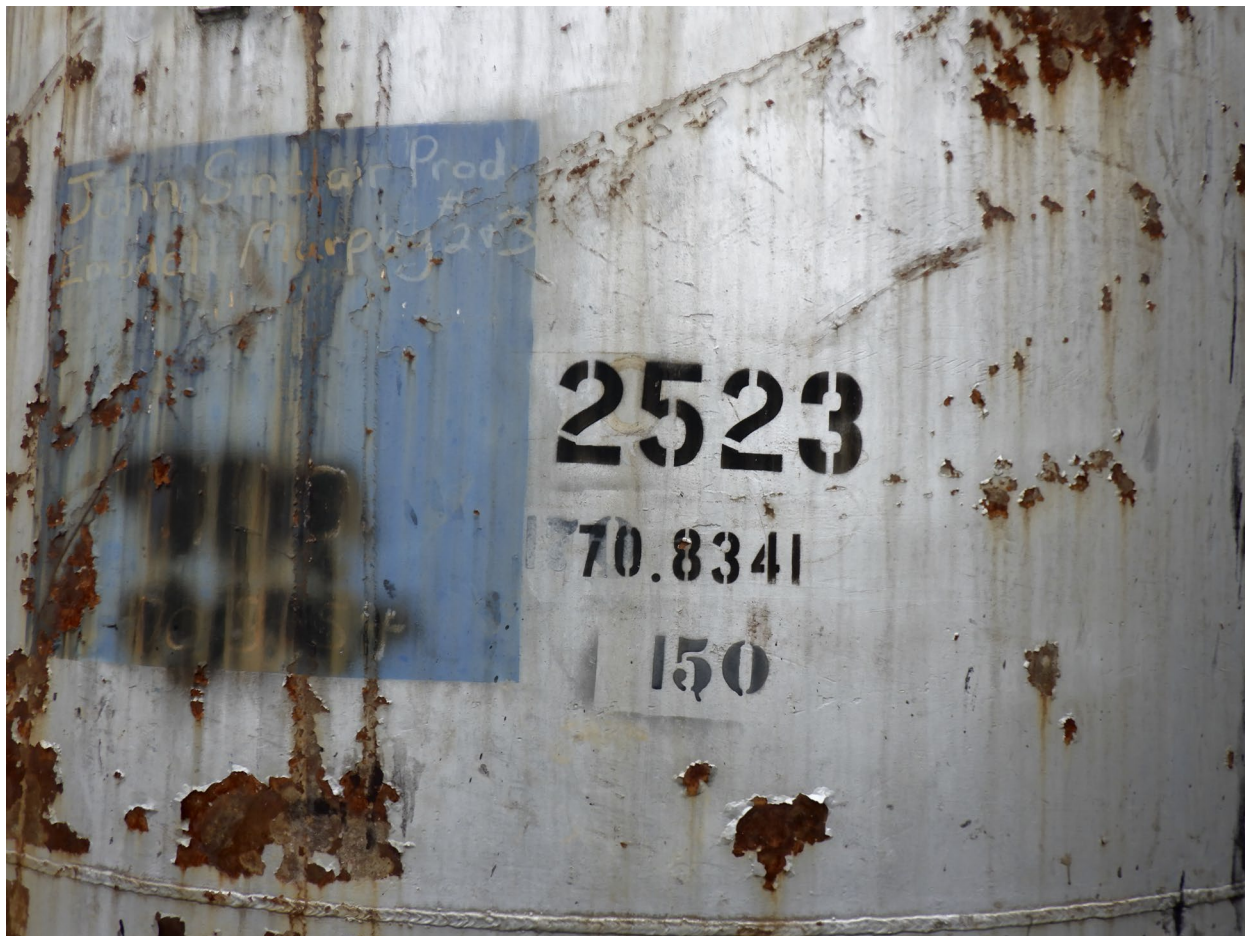
Photo No. 7

**Description:** This photo was taken looking S-SE showing the tank identification (2523) for the gap under the tank noted in Photo No. 6.

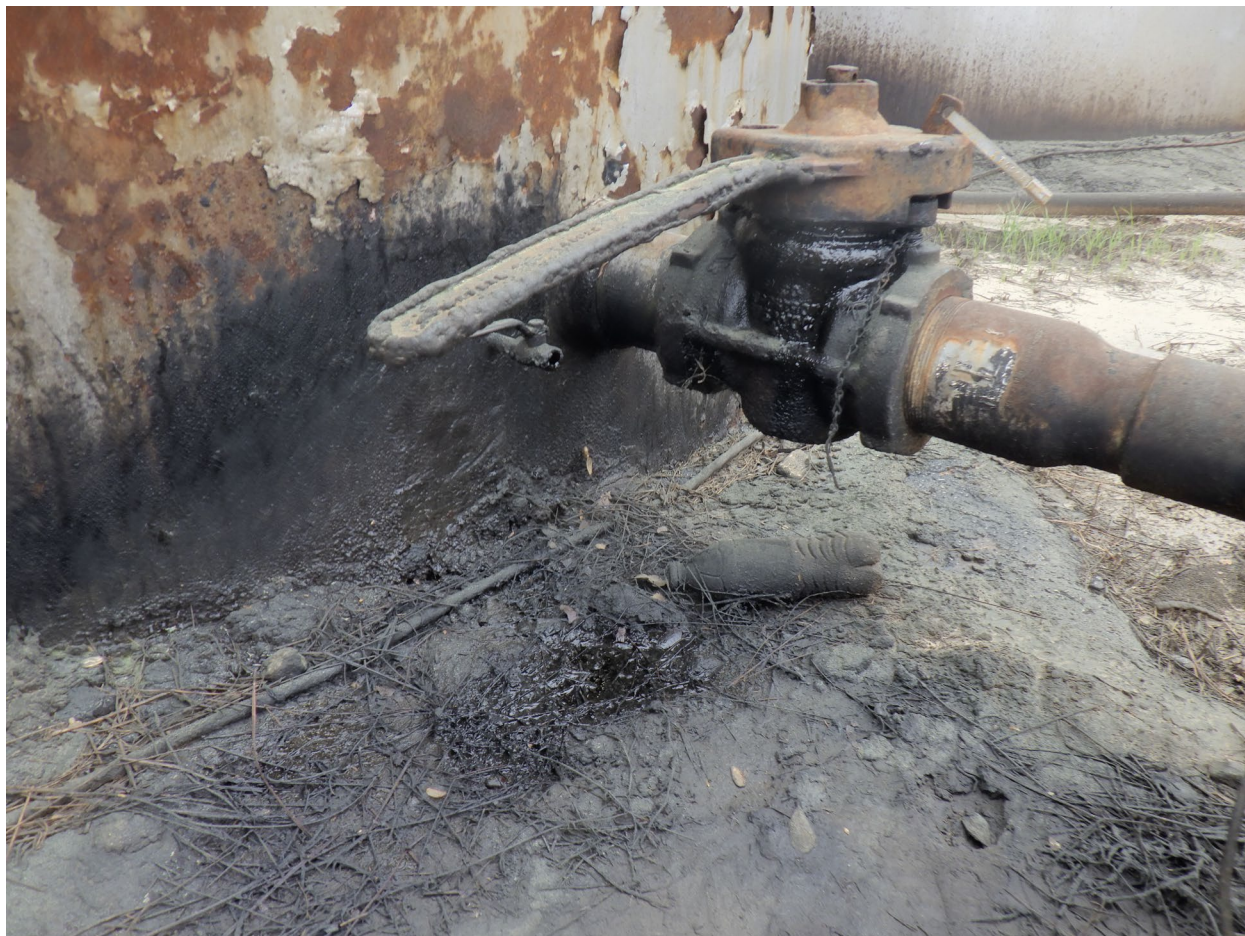
I observed an active leak from a valve from a tank, identified as 2062, inside the secondary containment, see Photo No. 8 and No. 9.

**Description:** This photo was taken looking SW showing an active leak from a valve for one of the tanks inside secondary containment.

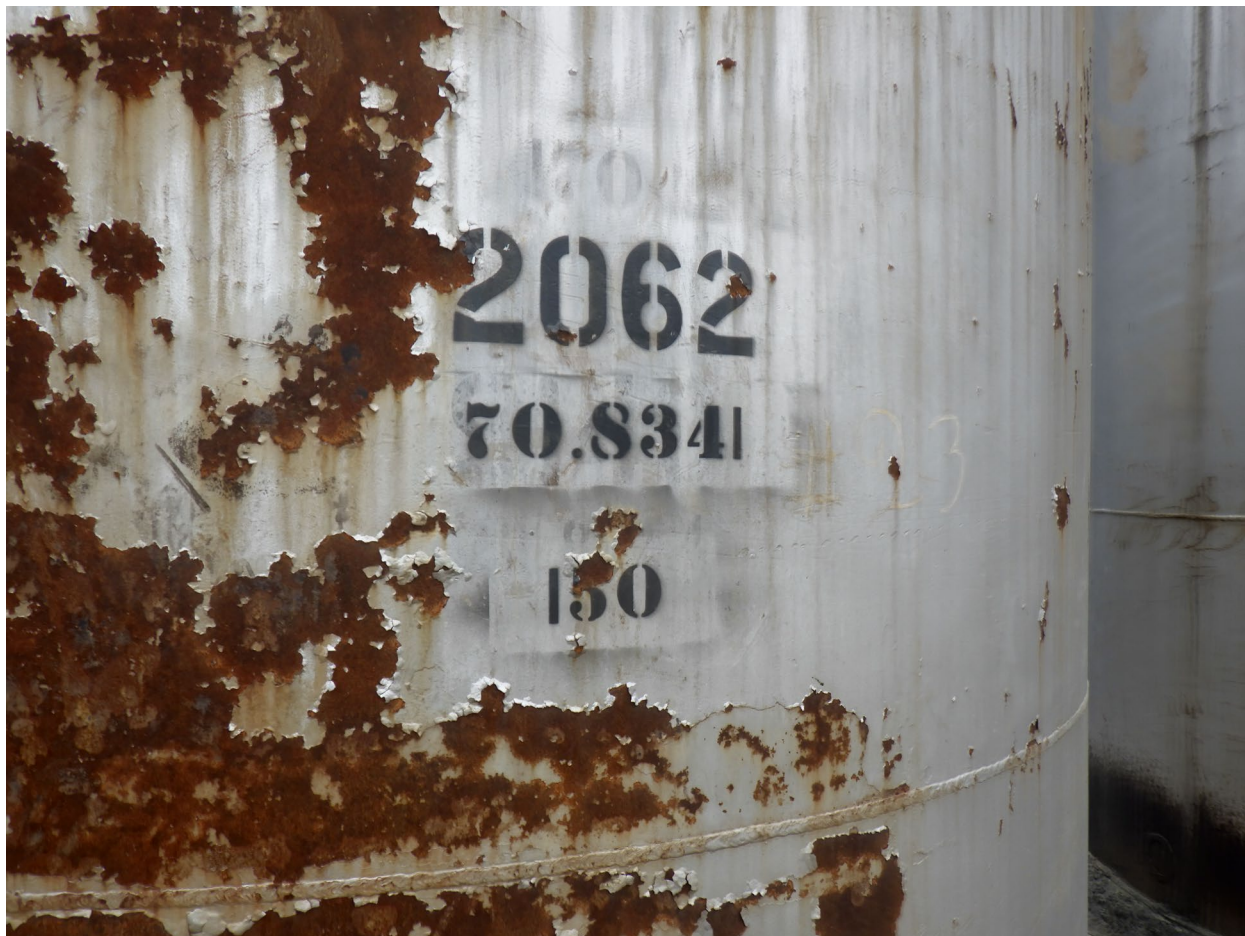
Photo No. 9

**Description:** This photo was taken looking S-SW showing the tank identification (2062) for the active valve leak for the tank in Photo No. 8.

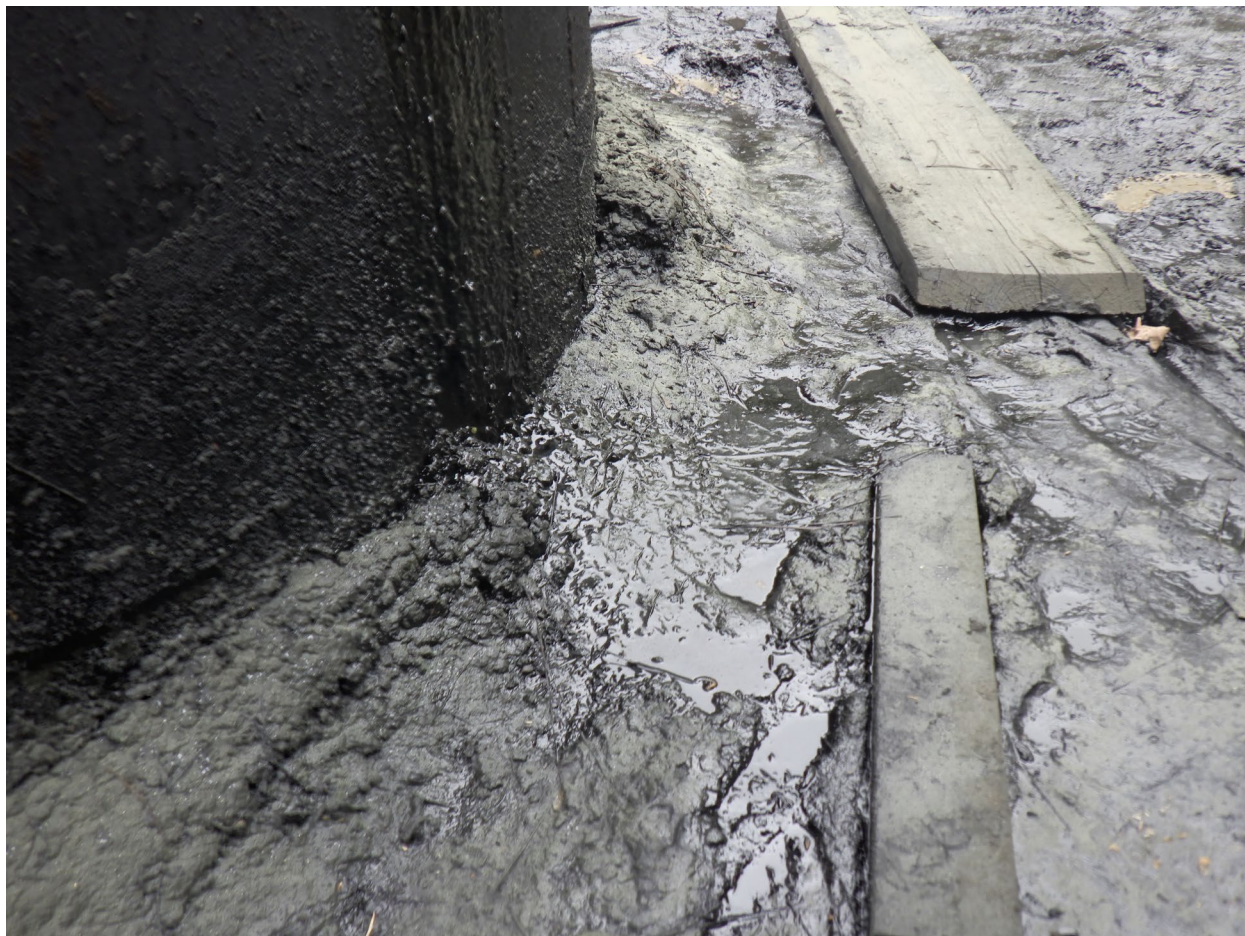
I observed an active leak from a tank, identified as 2523, inside secondary containment, see Photo No. 10 and No. 11.

**Description:** This photo was taken looking S-SW showing an active leak from a tank inside the secondary containment.

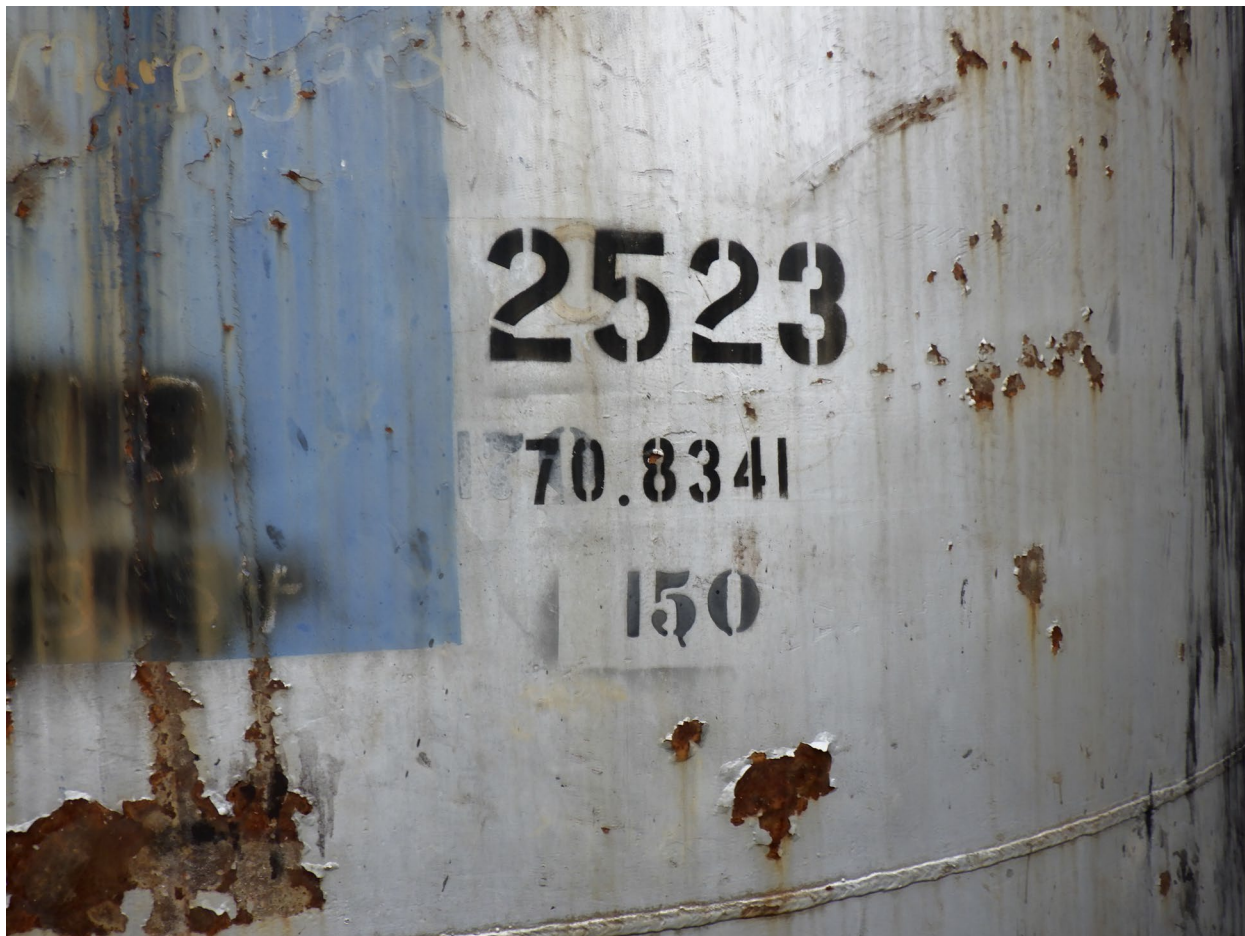
Photo No. 11

**Description:** This photo was taken looking S showing the tank identification (2523) for the leak from the tank inside secondary containment in Photo No. 10.

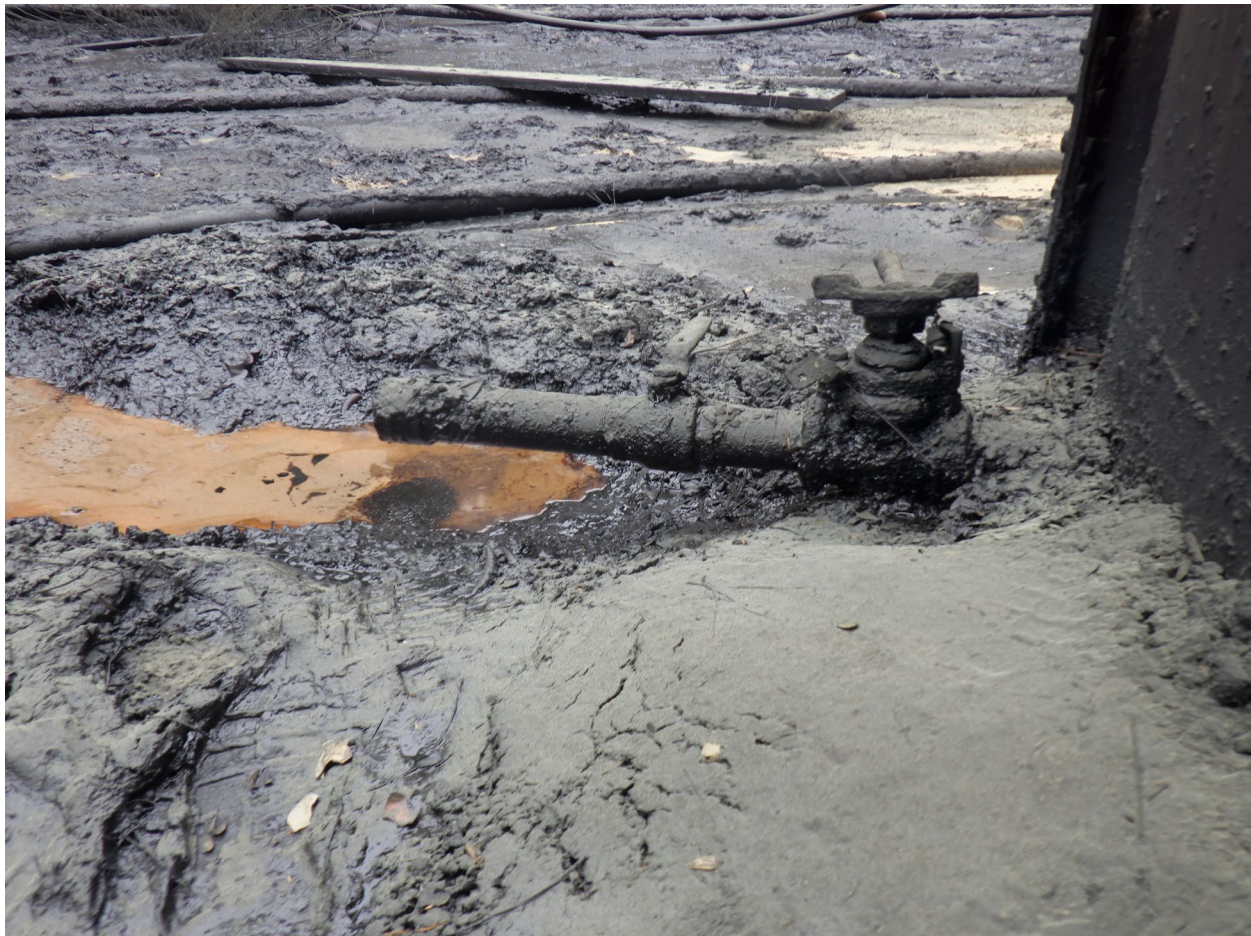
I observed an open pipe from a tank, identified as 2062, inside secondary containment, see Photo No. 12 and No. 13.

**Description:** This photo was taken looking W showing an open pipe from a tank inside secondary containment.

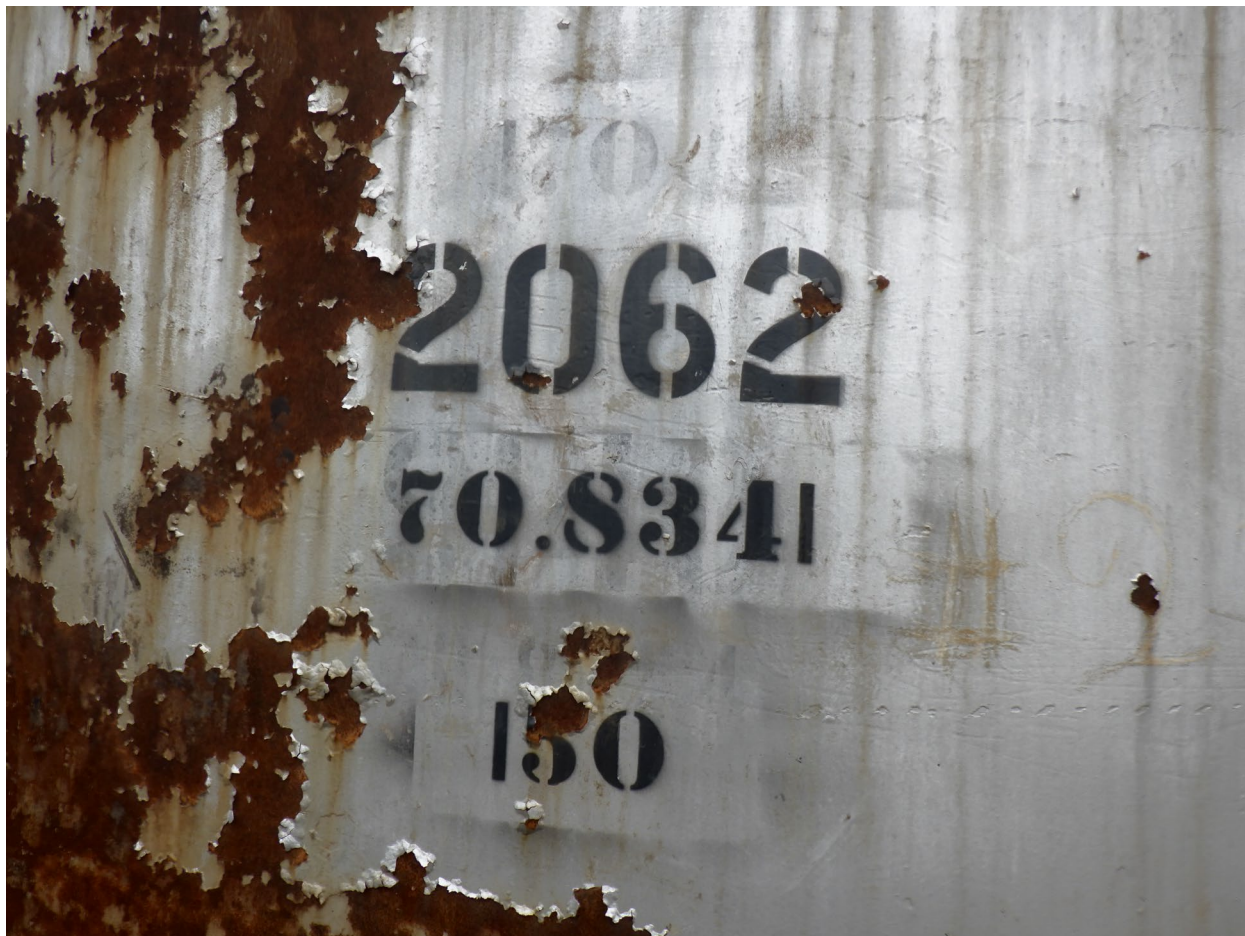
Photo No. 13

**Description:** This photo was taken looking S showing the tank identification (2062) of the tank with an open pipe inside secondary containment in Photo No. 12.

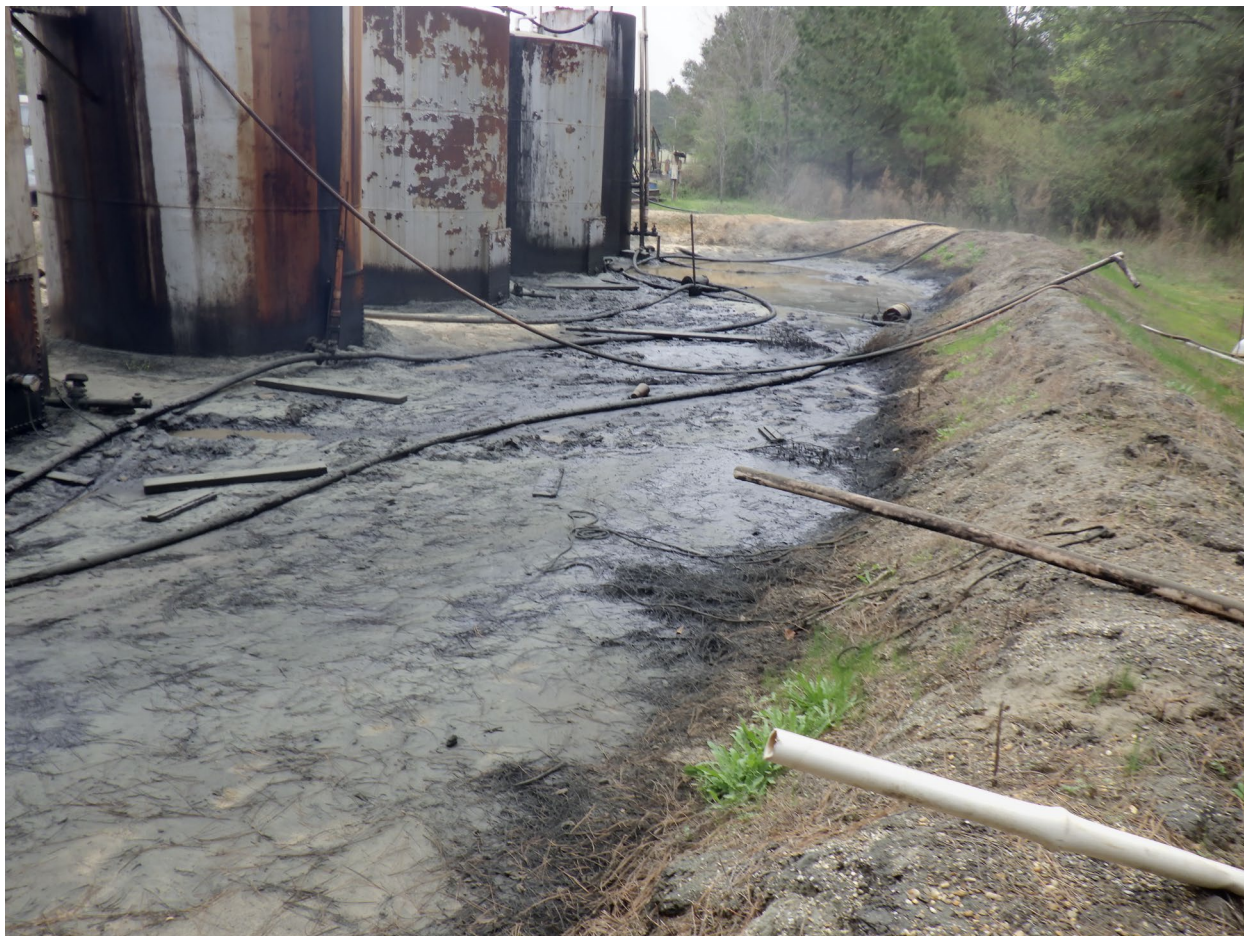
Photo No. 14

**Description:** This photo was taken looking E showing loose oil inside secondary containment (backside).

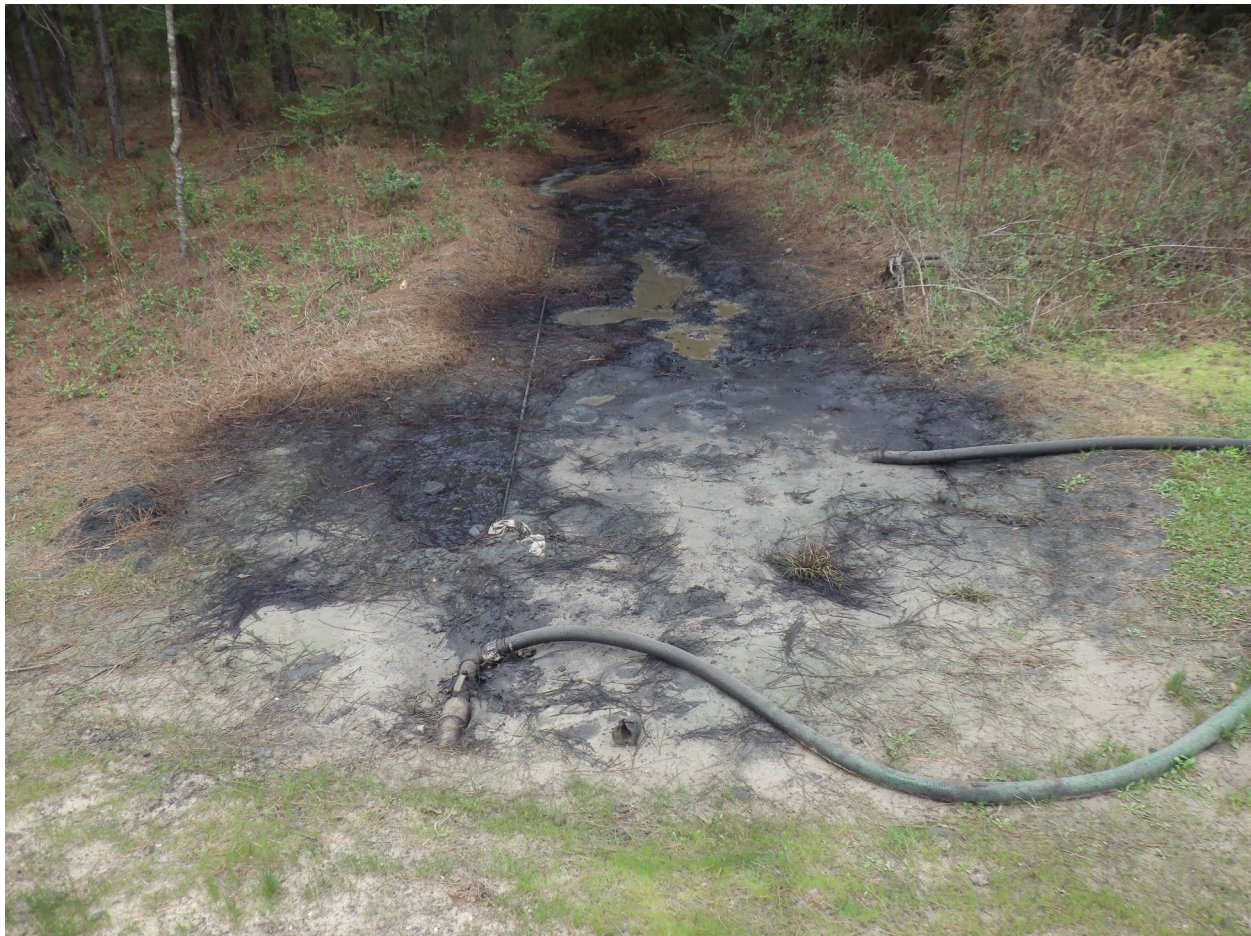
I observed a release of crude oil and saltwater from the drainpipe for secondary containment, see Photo No. 15 through Photo No. 17.

**Description:** This photo was taken looking S showing a release of crude oil and saltwater from drainage pipe through secondary containment.

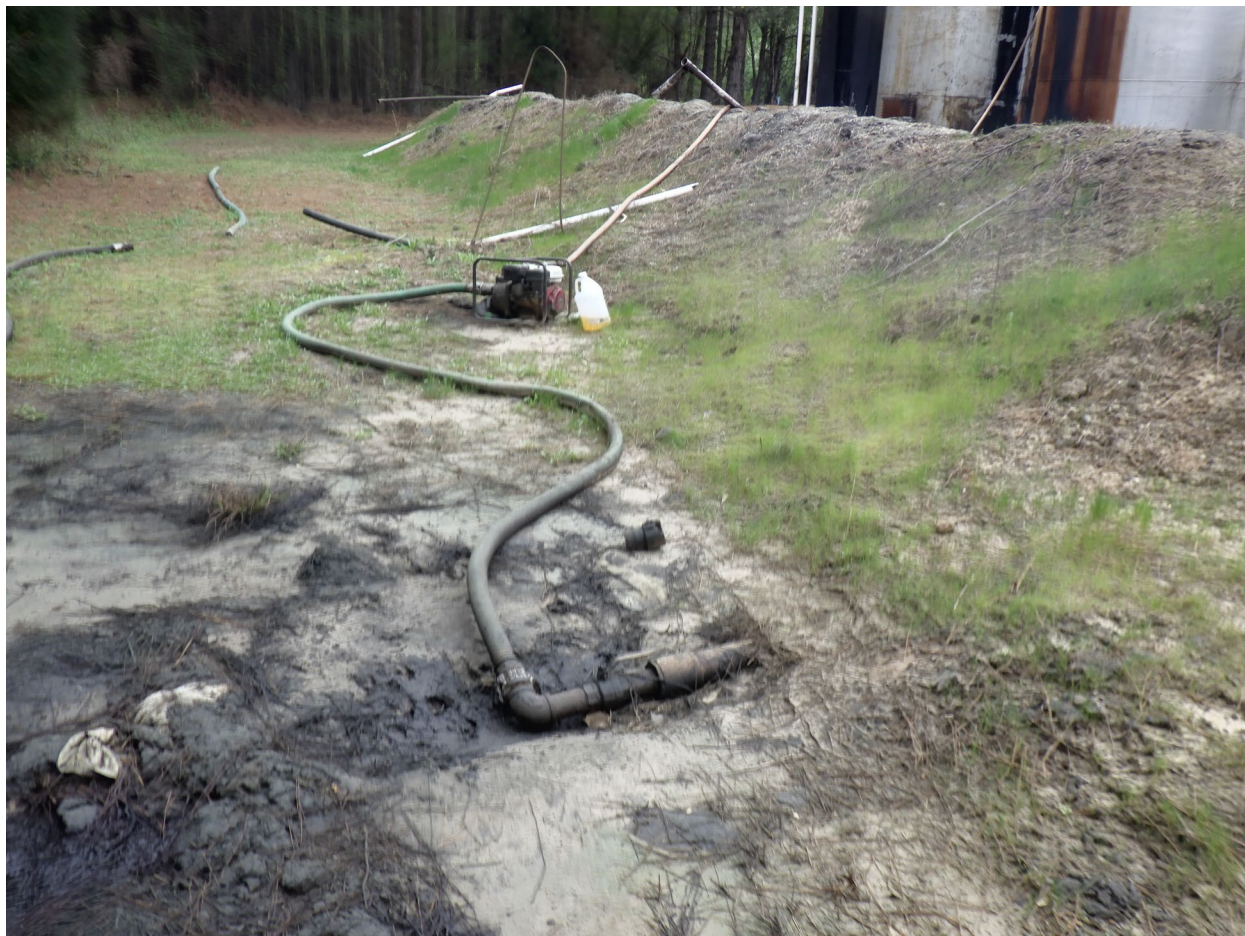
Photo No. 16

**Description:** This photo was taken looking W showing a pump and hosing connected to the drainage pipe that are used to transfer the contents inside the secondary containment back into the oil-water separator inside secondary containment.

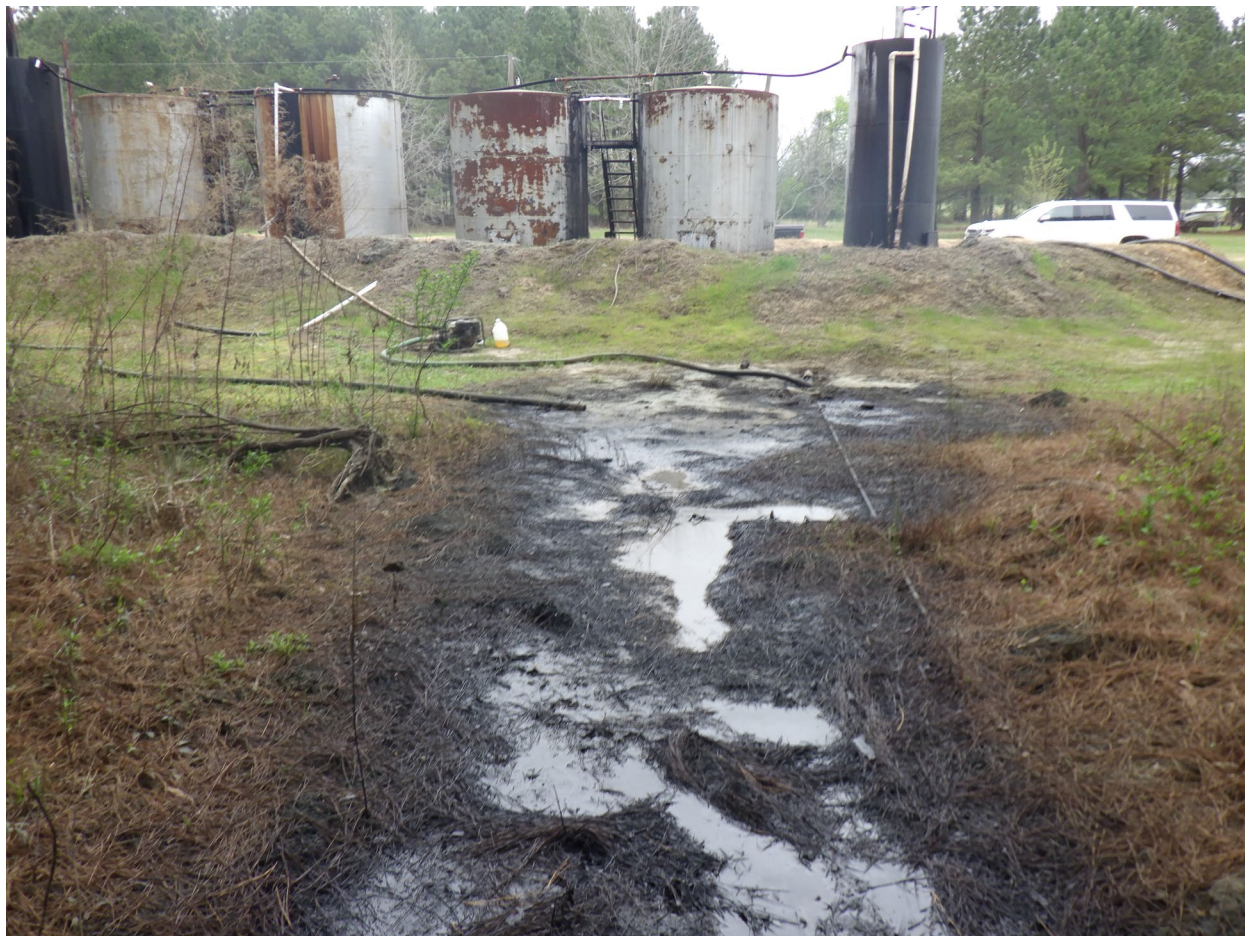
Photo No. 17

**Description:** This photo was taken looking N-NW showing the release of crude oil and saltwater from the drainage pipe through secondary containment.
