To Distribution  
From J. H. McCulley, Jr.  
Date March 16, 1984  
Subject 1983 Vinyl Chloride Safety Association Meeting Report

A report on the 1983 Vinyl Chloride Safety Association meeting is attached. As usual, the meeting was well worth attending. Several major incidents from the past were reviewed to prevent their lessons from being lost. Also a number of interesting audience surveys were made on various safety issues. The results from an industry questionnaire on controlling runaway PVC reactors were of particular interest. The BFG VCM storage tank safety standard and maintenance work standard that were developed as a result of a large (1 1/2 MM pound) VCM release from a sphere need to be evaluated.

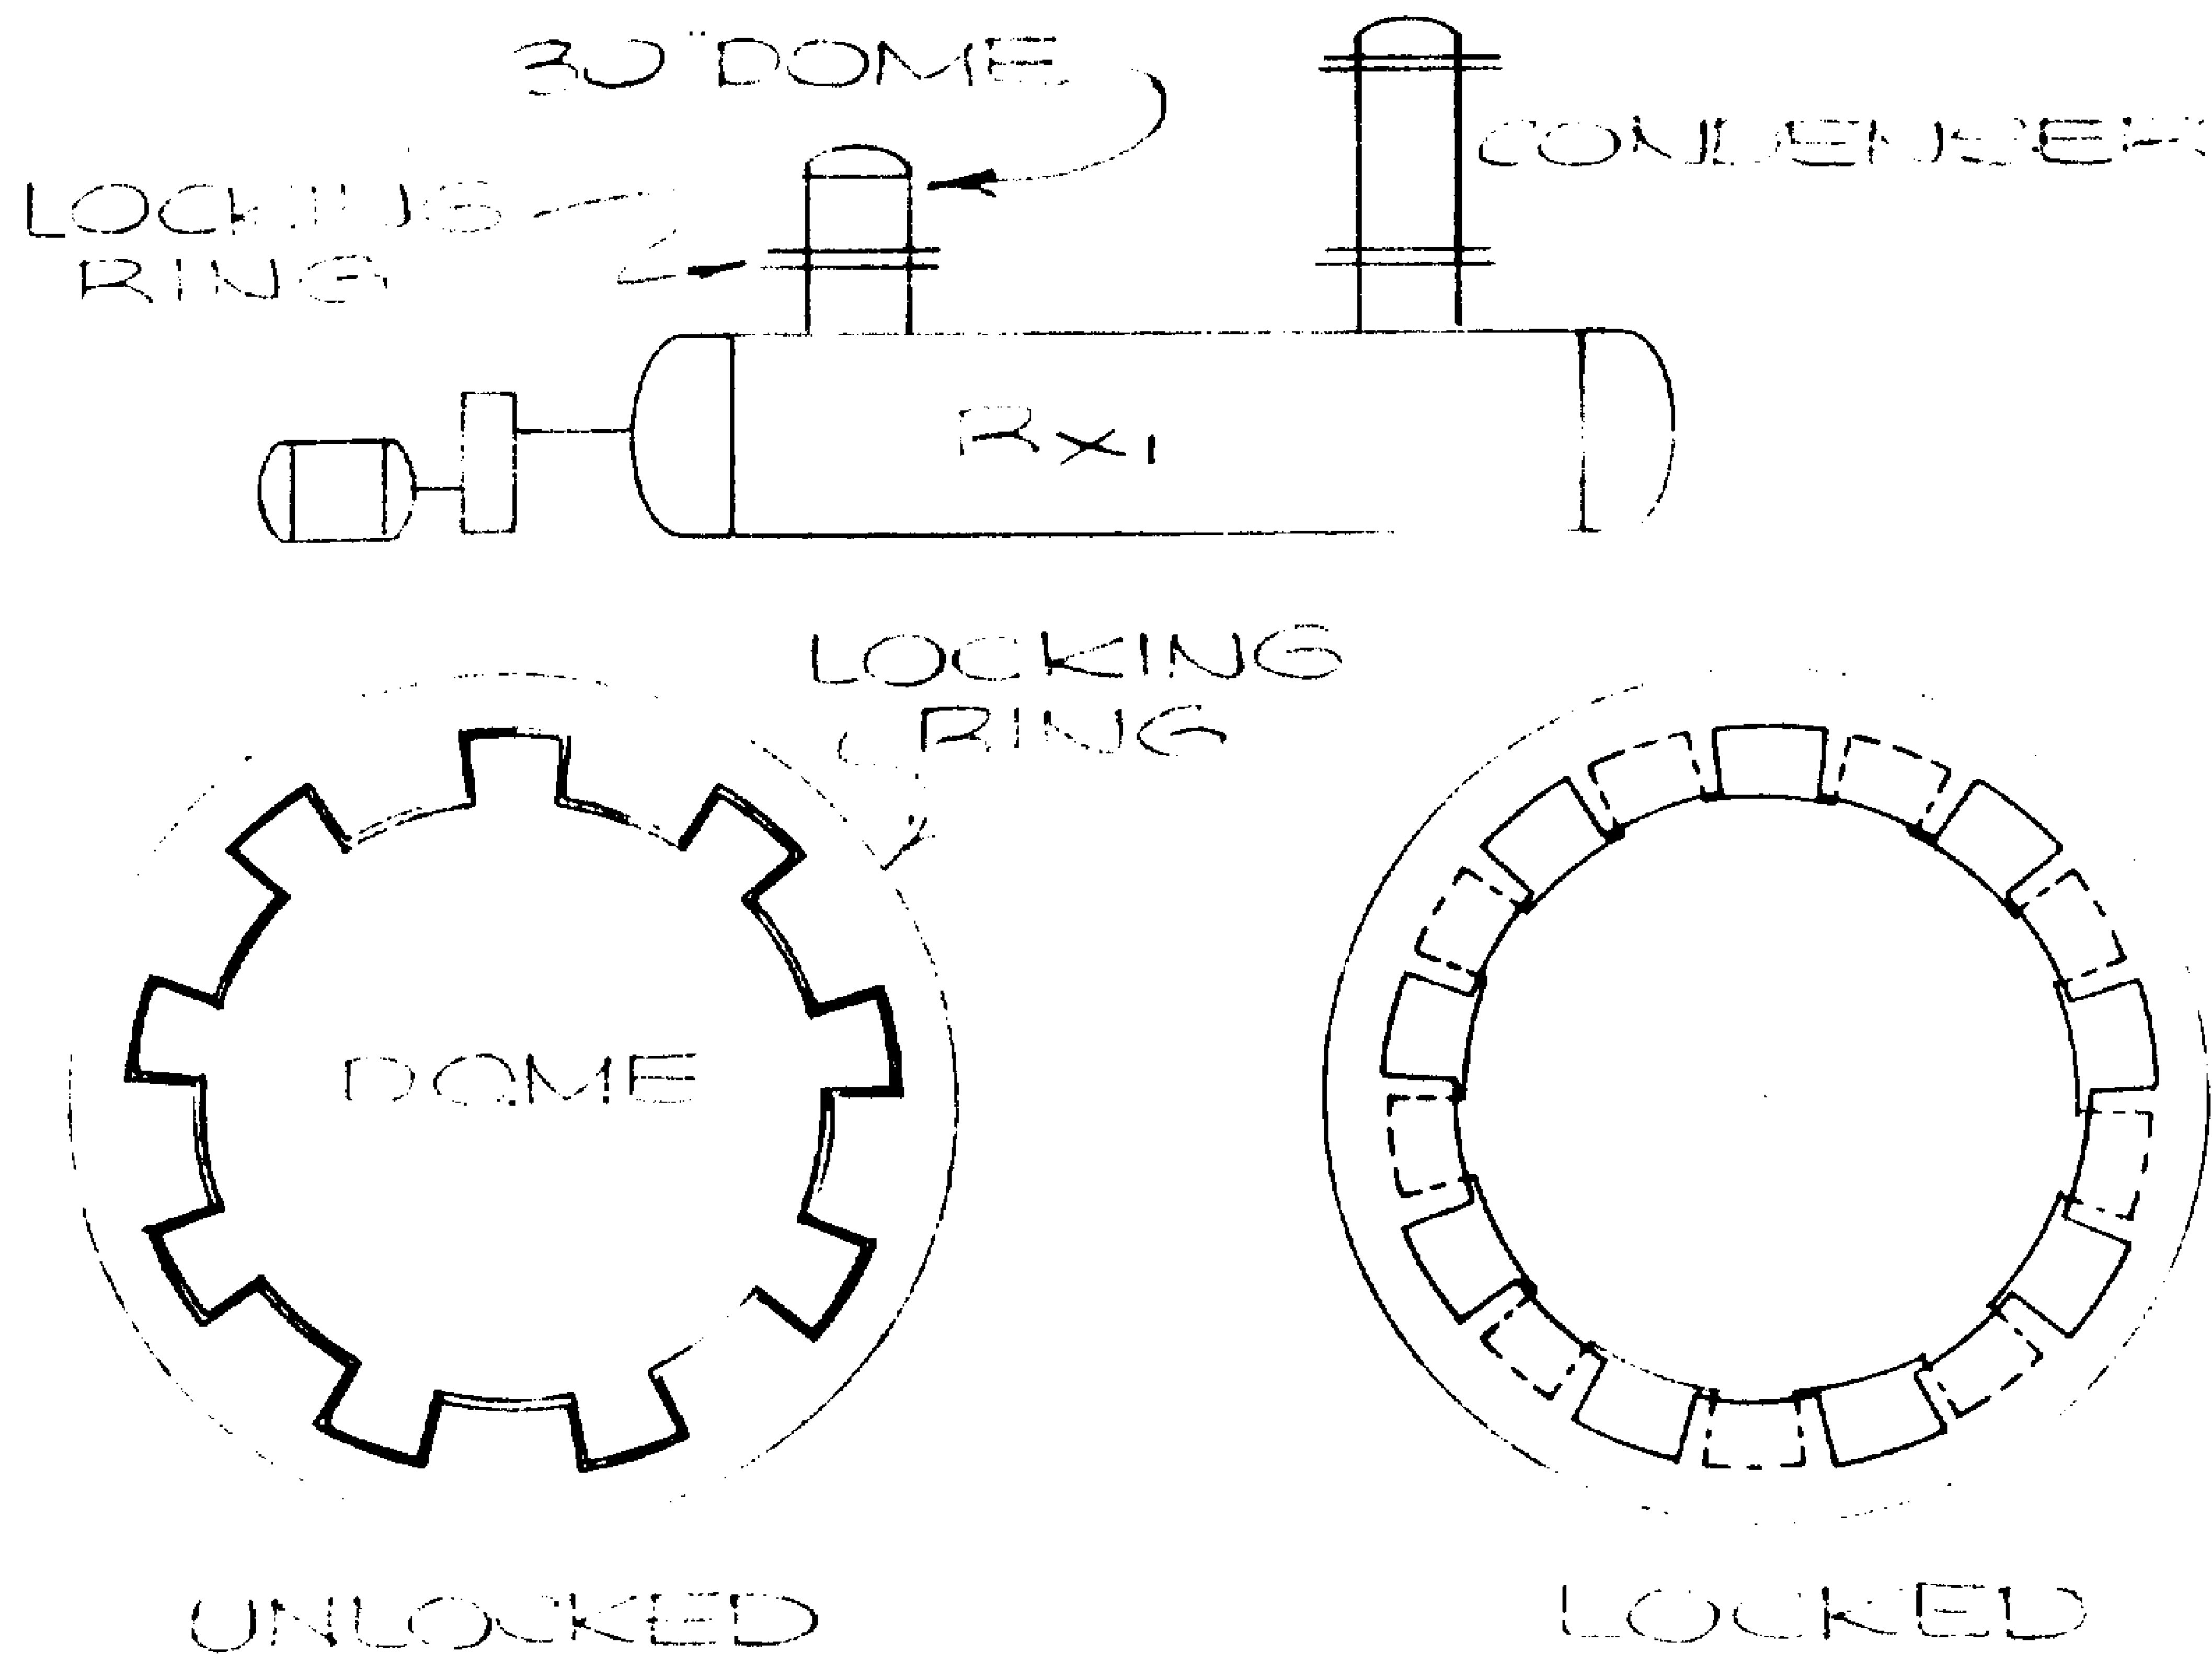
This fire occurred on the popo of Goodyear's bulk PVC plant. The reactor was charged and the pressure brought to 128 psig. Three minutes later the dome blew off releasing 19,000 pounds of VCM. The VCM cloud ignited, perhaps from a spark caused by the dome hitting a pipe. Three people were seriously burned but there were no fatalities. The fire burned for three hours.

The dome slipped out of the locking ring and broke a three-inch nozzle on the dome (or maybe vice versa). Perhaps the dome had not been tightened completely. Or the broken nozzle could have caused the dome to twist out of the locking ring. They don't know which happened first.

A steel wedge was made to insert in the locked dome flange to prevent it opening accidentally. A proximity switch was installed to confirm that the wedge was in place before charge would start. Alarms sound if the wedge is removed during operation. This has worked well.

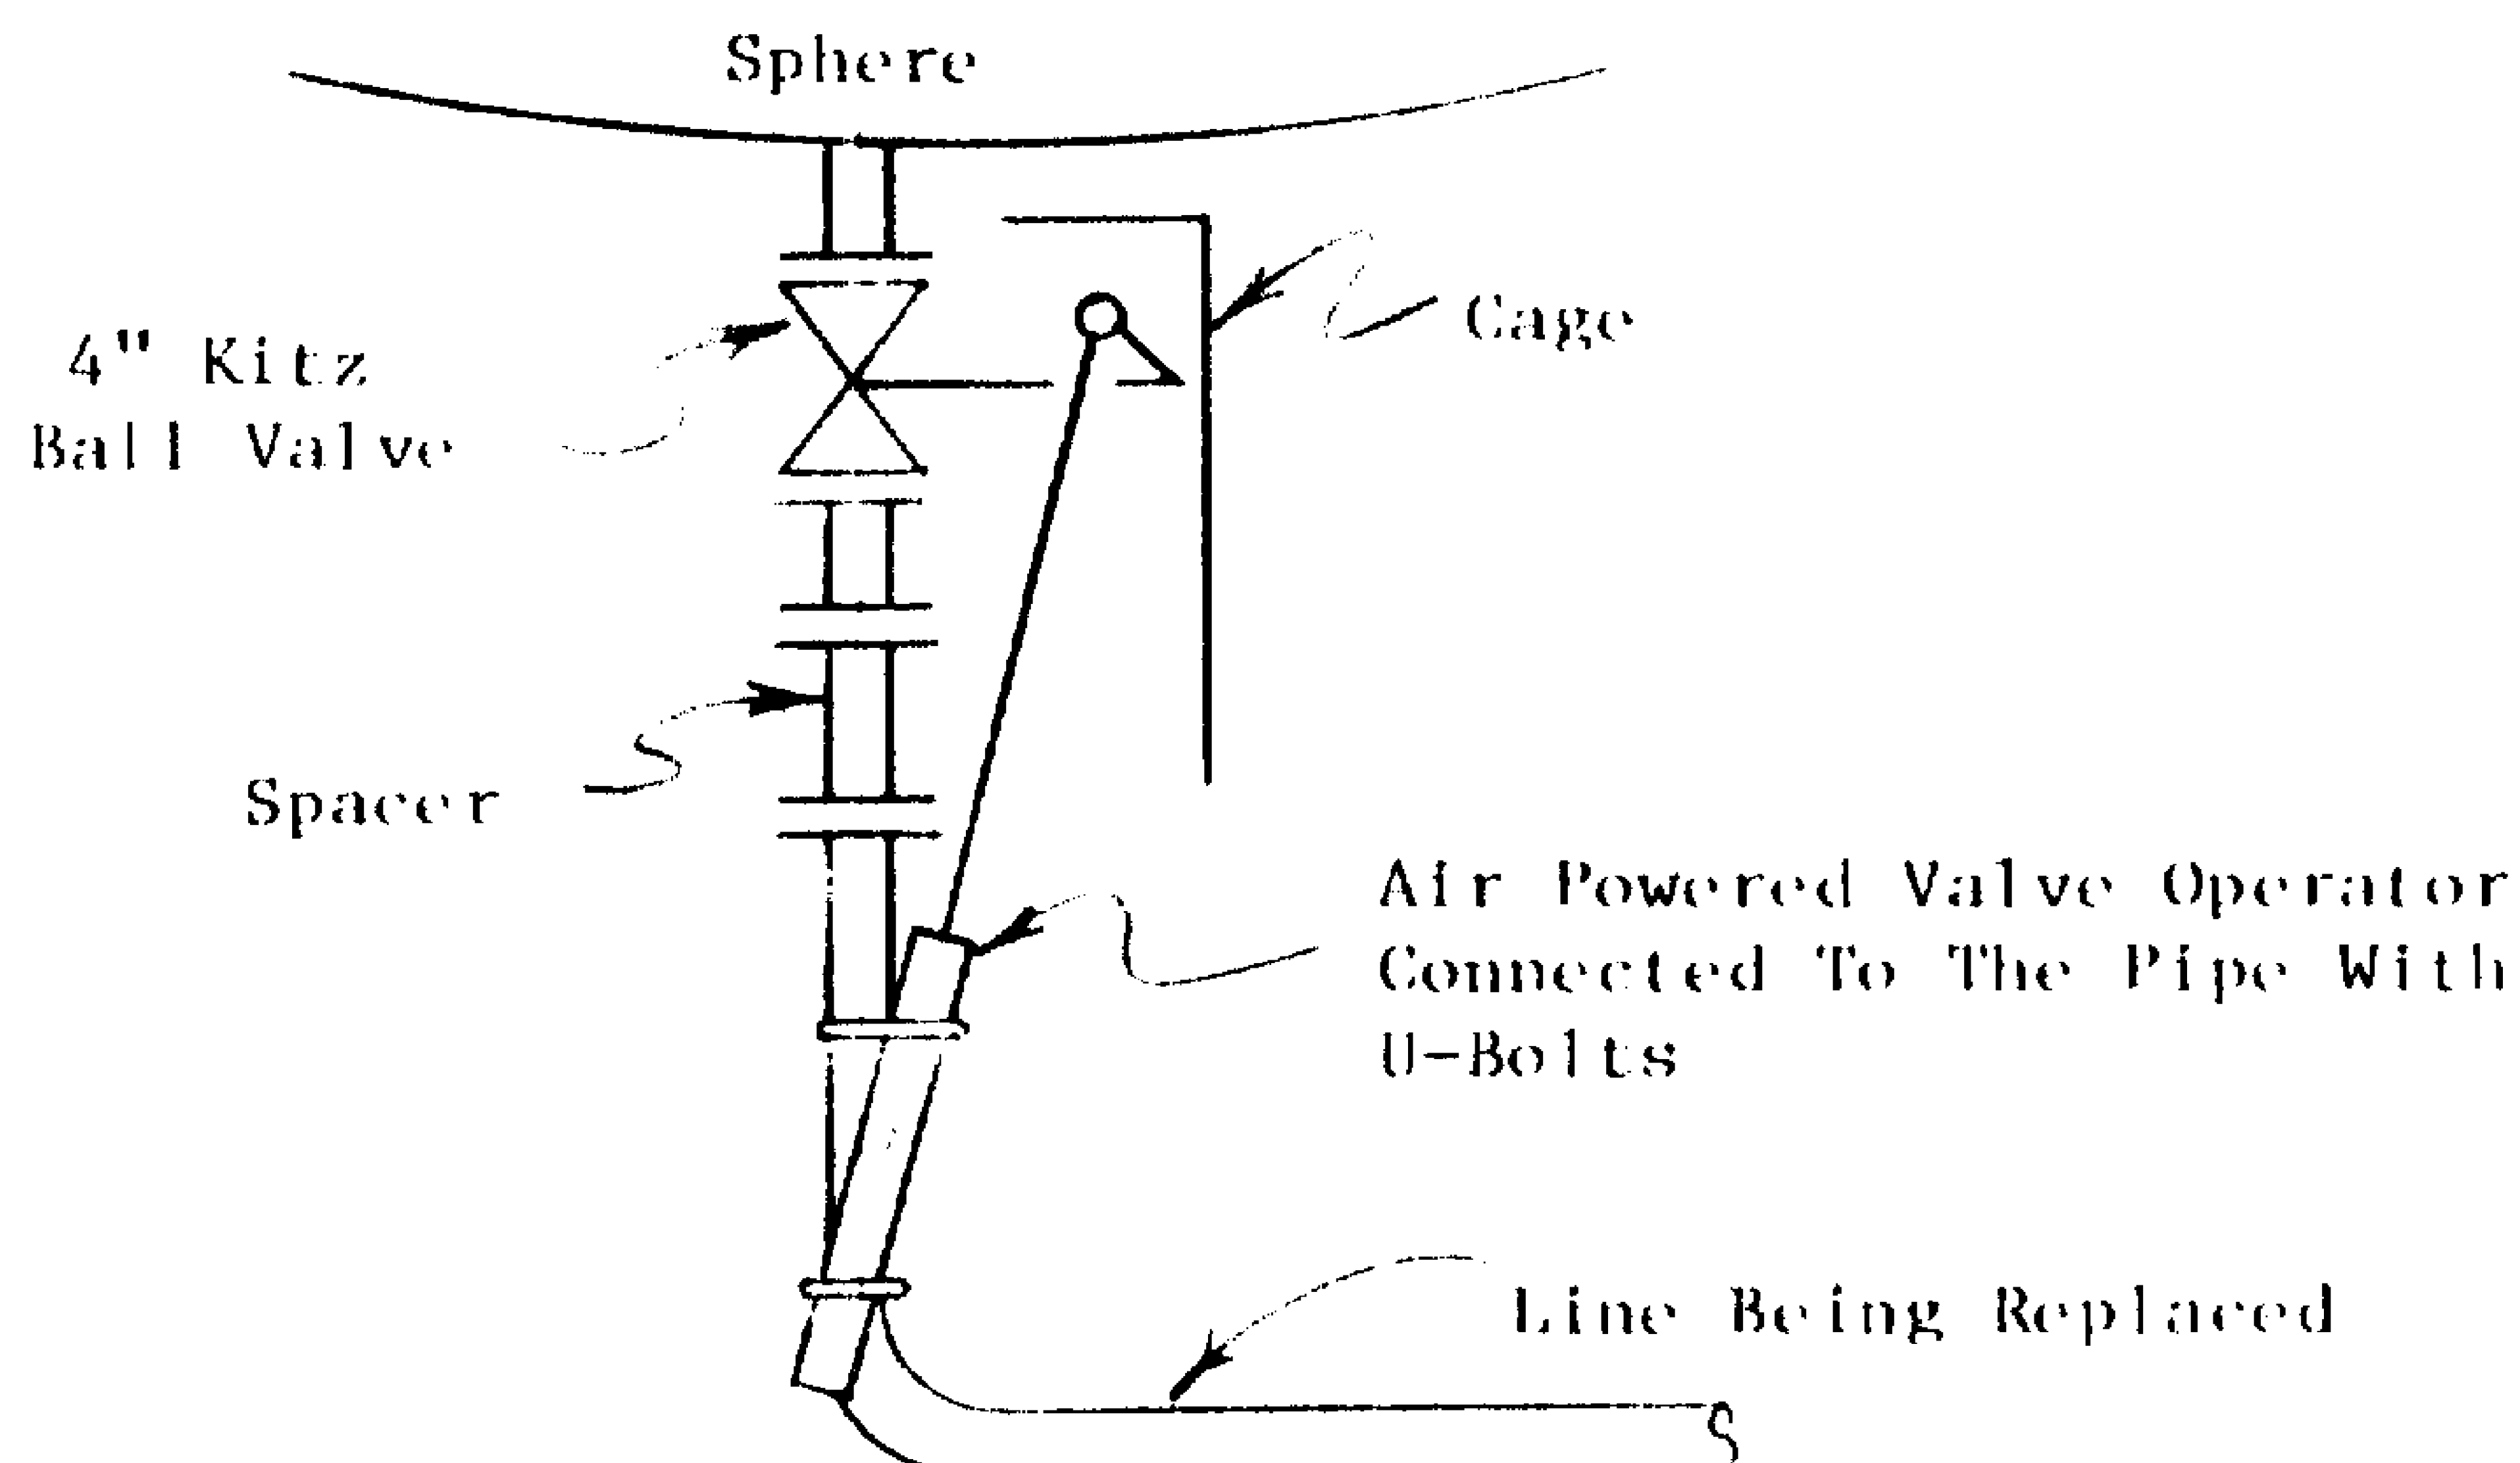
A four-inch liquid line off the bottom of a large VCM sphere was being replaced due to corrosion. There were seven other smaller lines connected to the bottom of the sphere. Only the four-inch line had a remote operated valve at the tank. None of the lines had excess flow check valves.

The valve was closed. The pipe fitter was not allowed to remove the expanded mesh cage around the valve or the operator. However, he did remove the operator's U-bolts, freeing it from the pipe. In the process of trying to move the unbolted line the line flange hooked the valve operator, partially opening the valve. Liquid VCM began to blow out. Operations could not close the valve with air pressure because the operator was only connected to the valve stem; it did not have anything to push against. They tried to use a long 2x4 to pry the valve operator and close the valve. However, the 2x4 snapped. Apparently the recoil caused the valve to go wide open. One and one half million pounds of VCM (the entire contents of the tank were lost over a six-hour period. There was no fire or explosion.

This incident was investigated thoroughly by BFG. They concluded that the accident was caused by a breakdown of their maintenance work order procedure. A new companywide maintenance work order standard was prepared (attached) which requires that the release by operations of hazardous equipment must be done at the job site in the presence of the craftsman, among other things. The release is valid for that shift only and must be repeated for the next shift. This helps to insure that both operations and maintenance understand the status and hazards of the work.

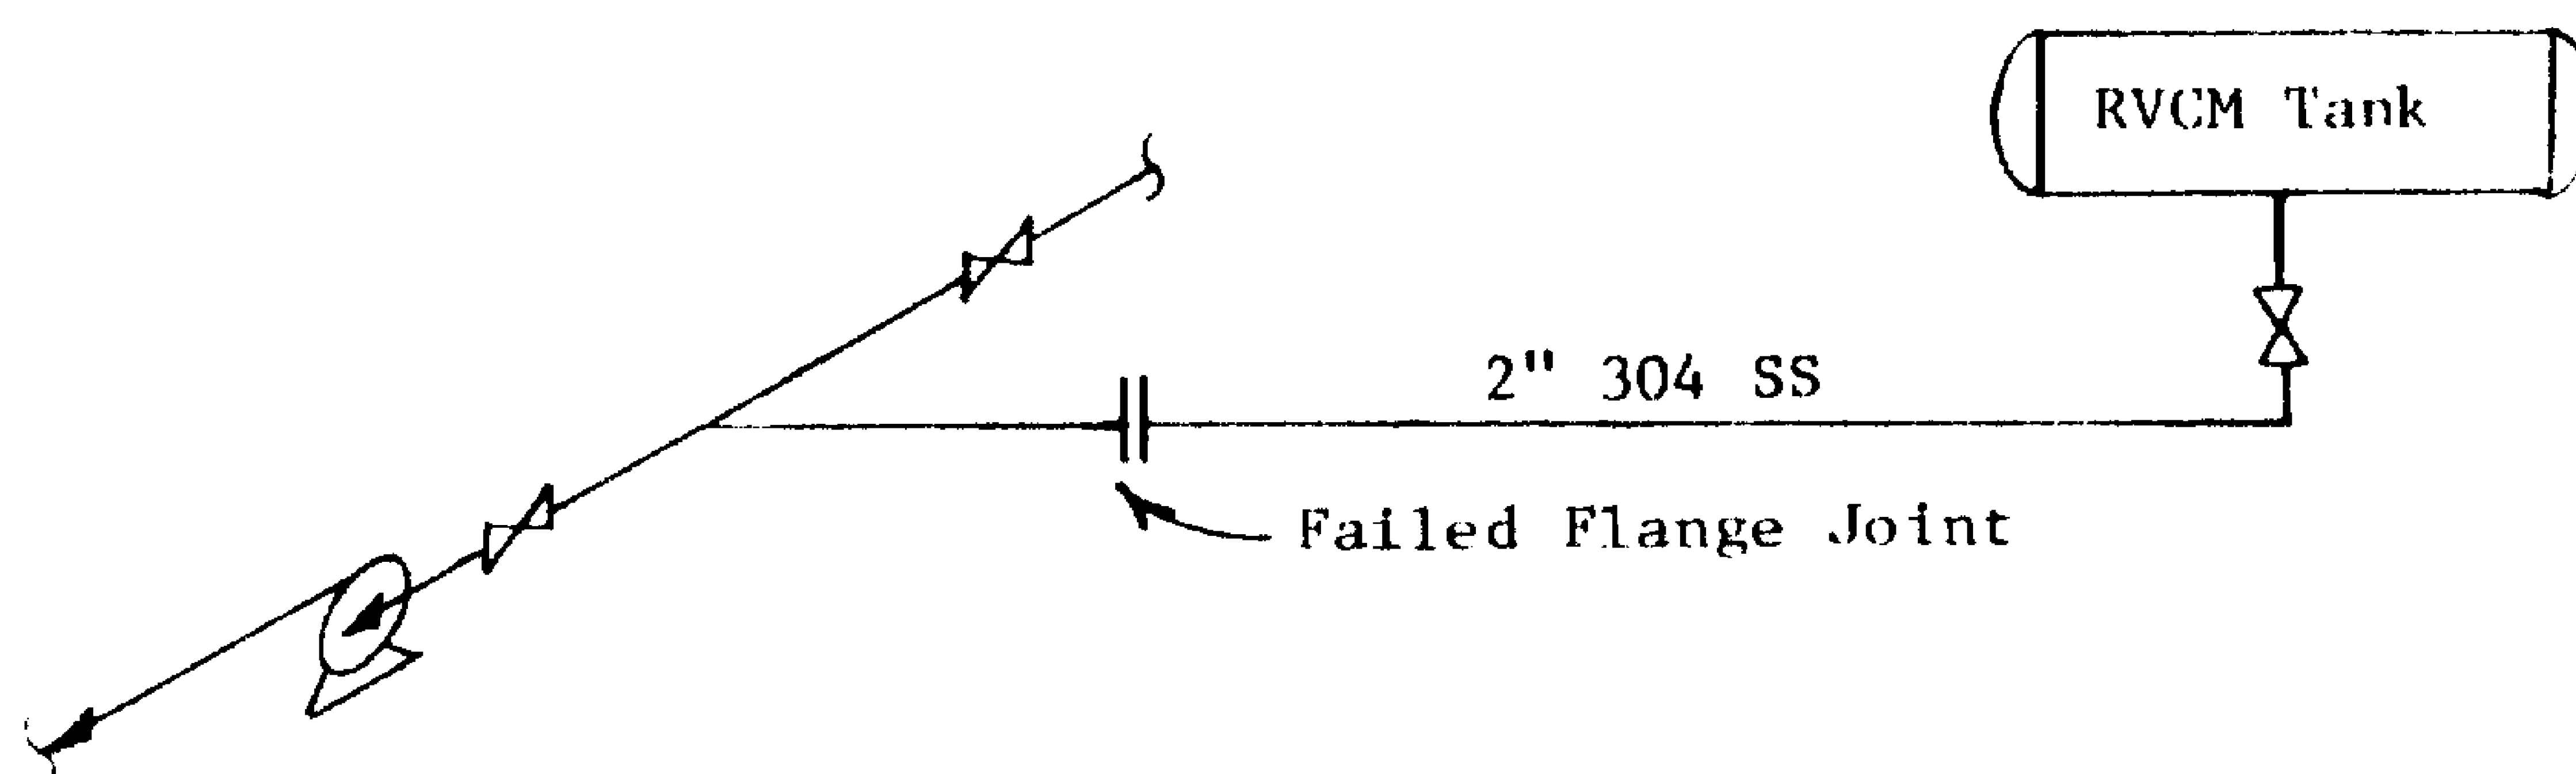
The fixed point monitors indicated a leak. They found the flange to pipe weld was leaking. They blocked in the leaking section of the line quickly. There was no fire or major release.

Afterwards someone kicked the line and the leaking flange to pipe weld completely failed. The flange was monel. The 304 stainless steel line had suffered galvanic corrosion at the weld.

Esso is now using more stringent inspection procedures to make sure the right metallurgy is used.

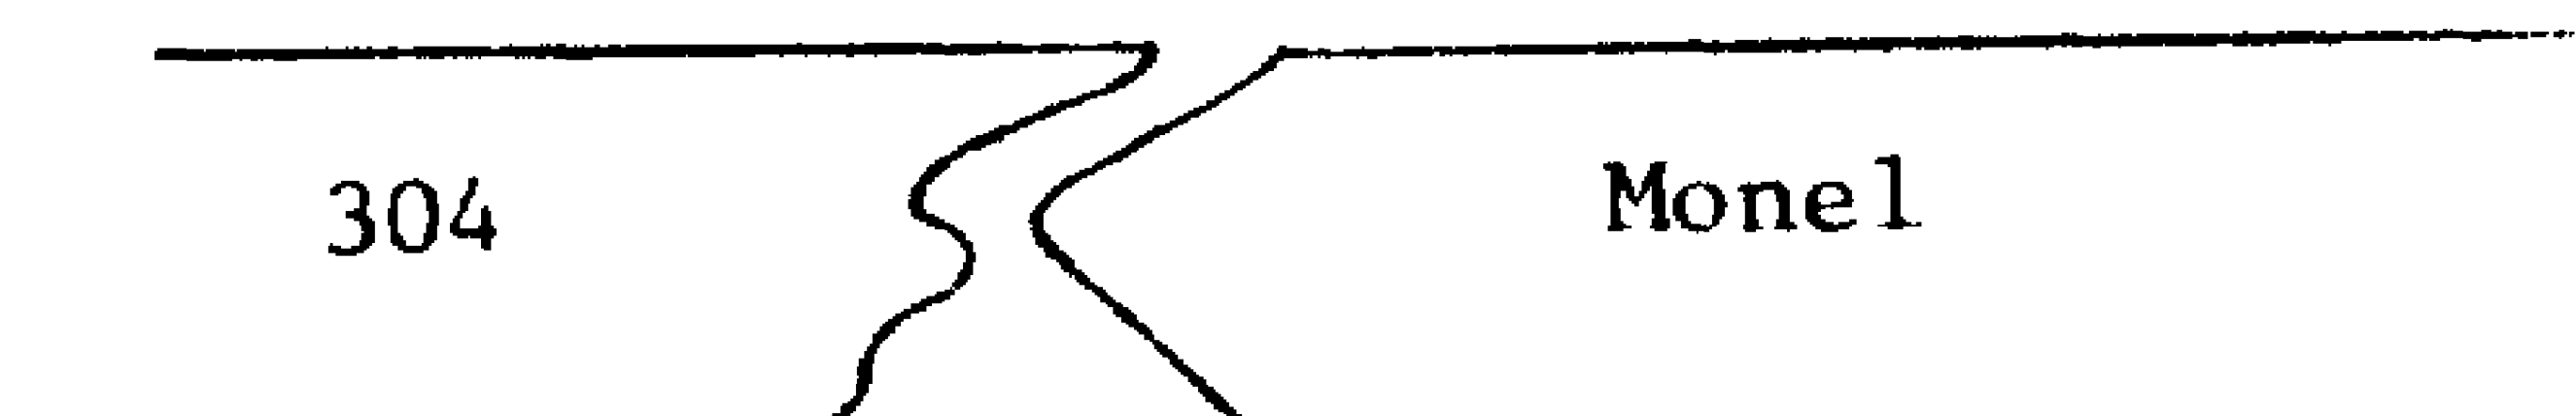
Cross Section of the Weld

The flange had been installed by a contractor. He did not have a two-inch flange so he used a monel flange figuring that it would be even better than stainless steel.

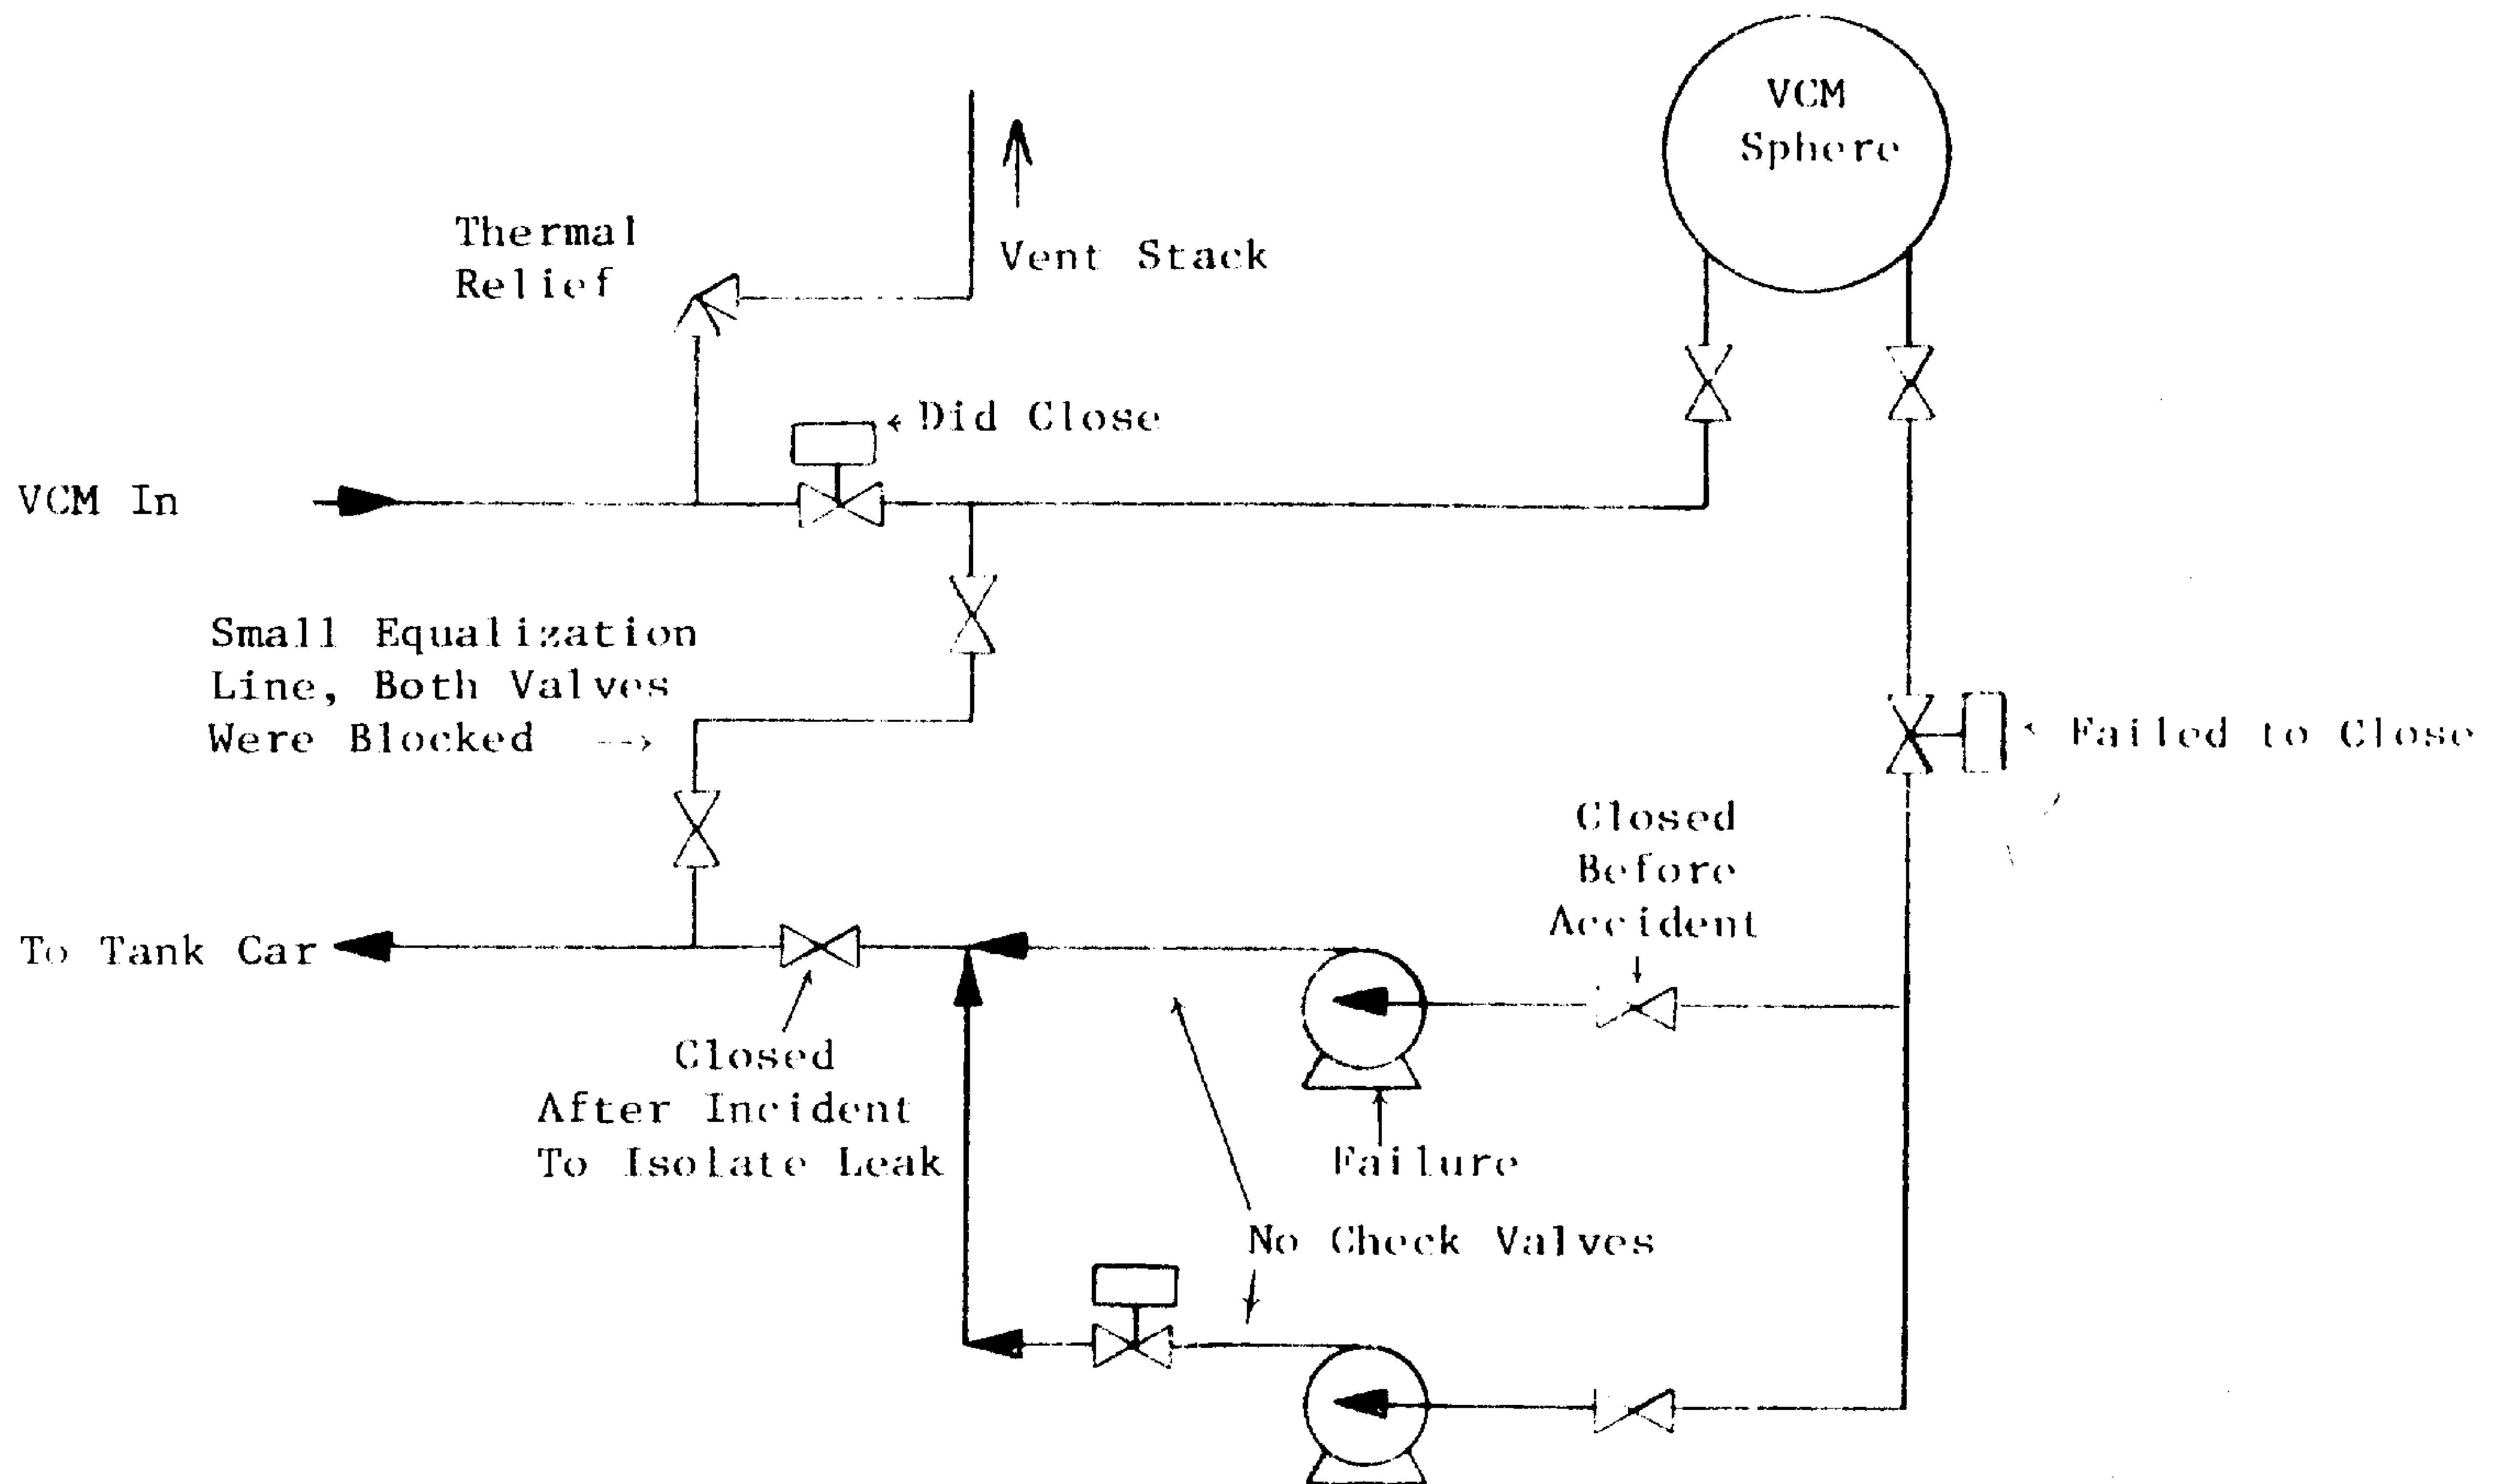
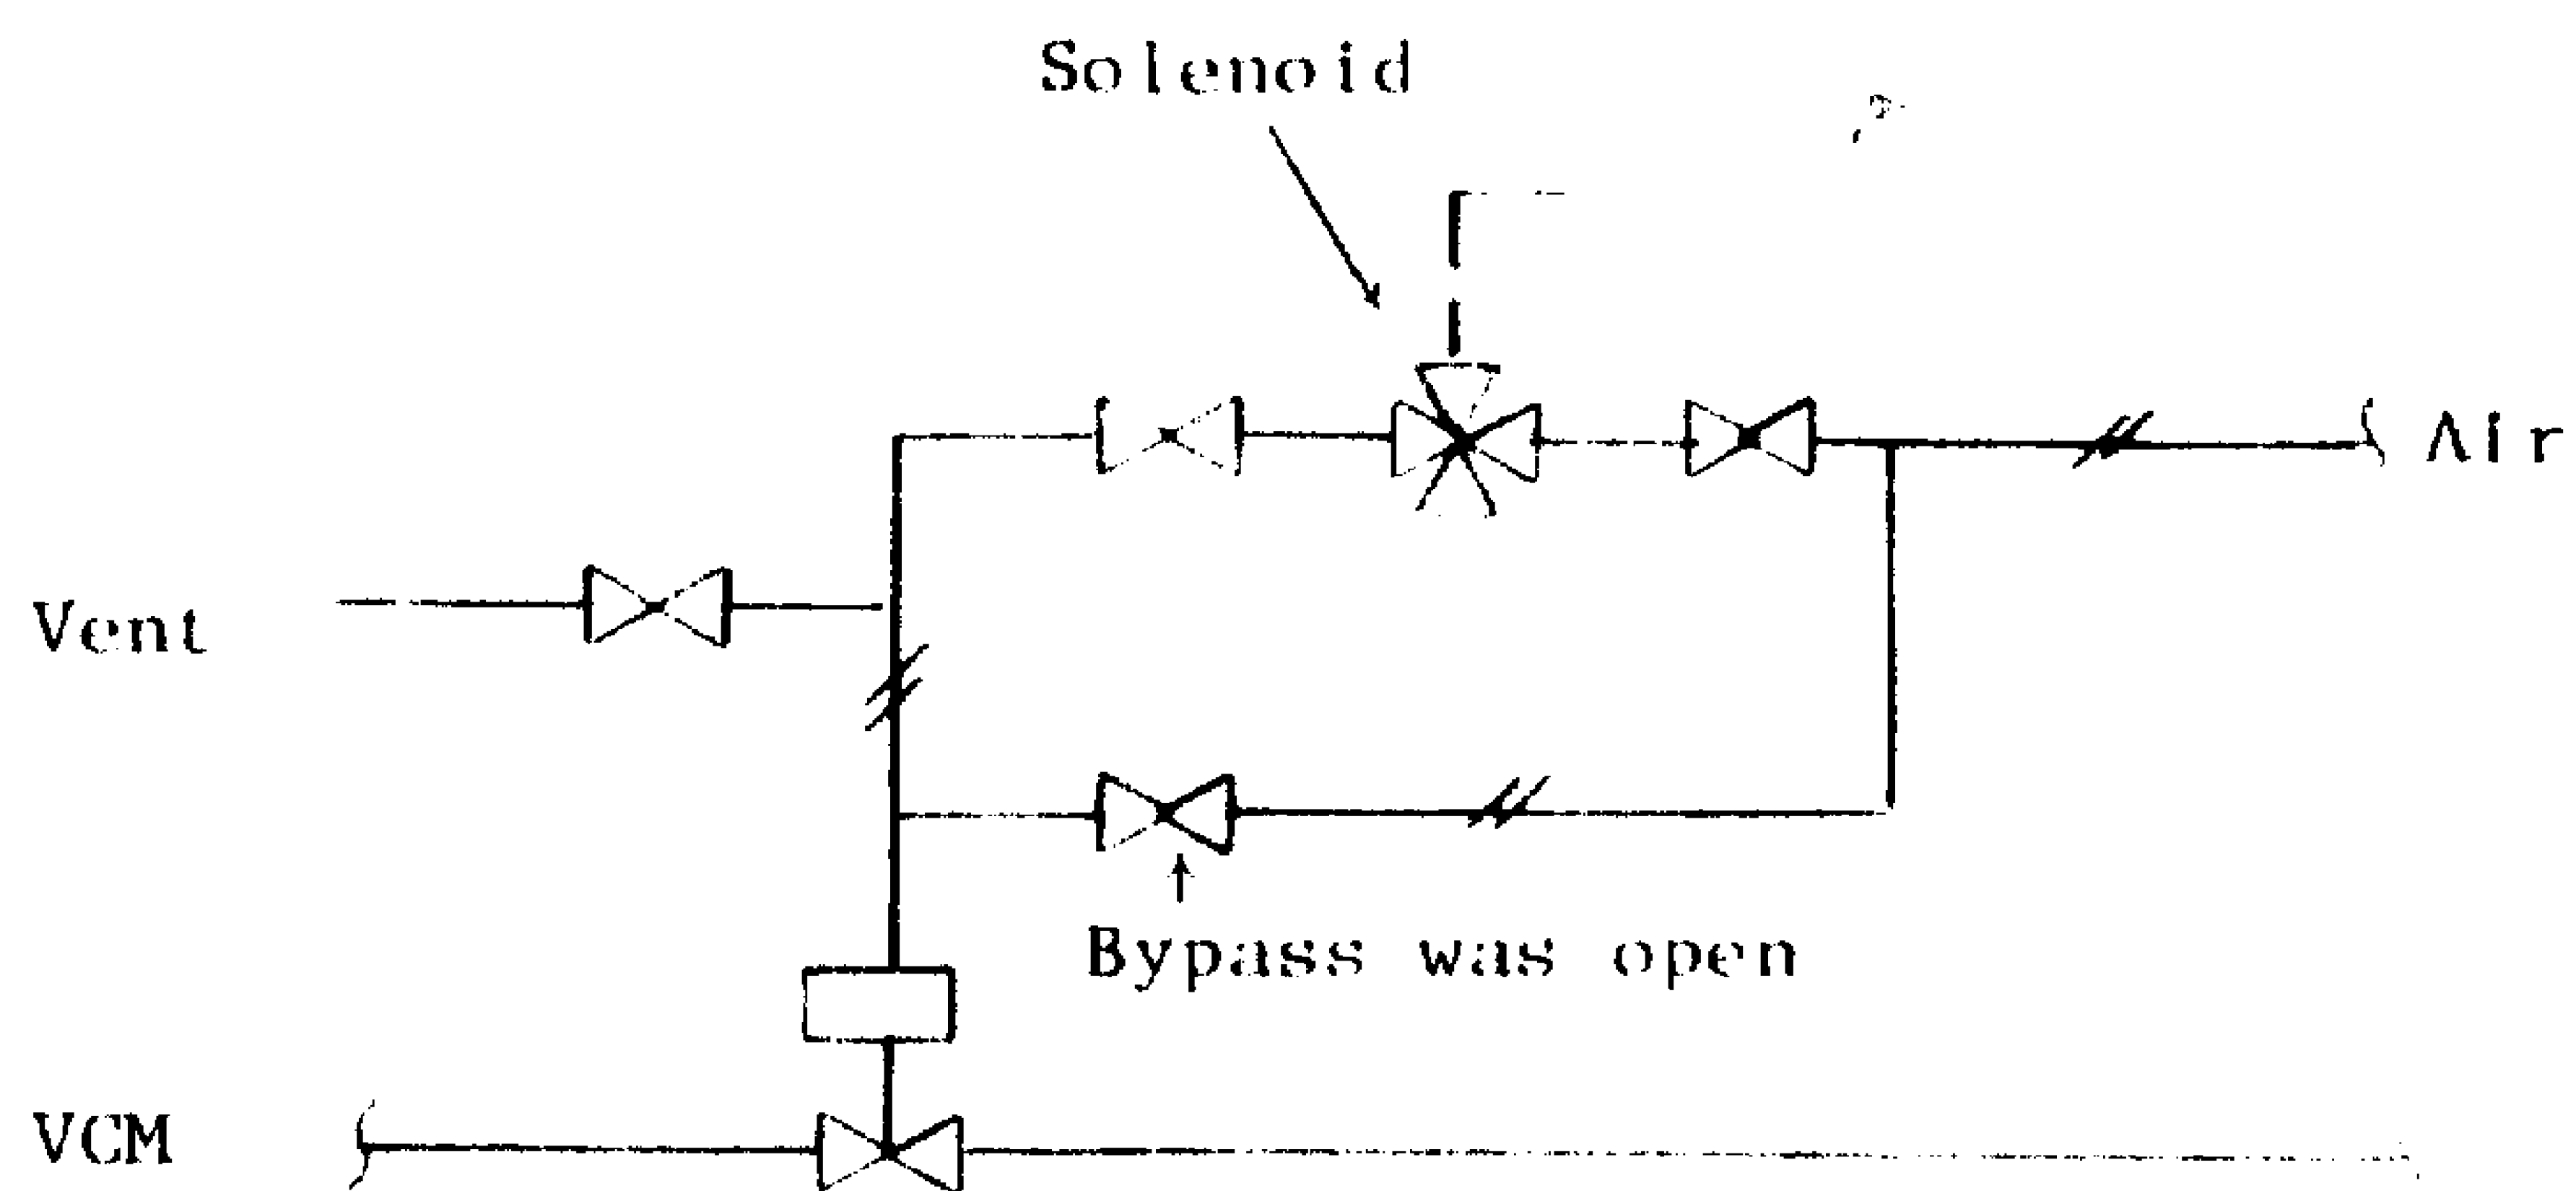
A blocked in loading pump in their VCM tank farm failed due to overpressure from thermal expansion of the VCM. The pump's parts in contact with VCM were steel, but the back of the pump was steel clad cast iron. The back failed 360° around its circumference. The force of the failure sheared the pump base and motor mounting bolts and bent the pump shaft. The pump seal did not blow out.

The pump is located in a VCM storage area that contains two 2,500 ton spheres and 8 bullets. See the sketch below.
