**Well Inspection**  
**Osage DNR / Environmental Protection Agency**  
**1201 Elm Street, Suite 500**  
**Dallas, Texas 75270**

| | | <b>Lease Name</b> | Burbank S | | |
| | | <b>Well ID</b> | J-W15 | | |
| <b>Inspection Reason</b> | Plugging Witnessed | <b>Responsible Company at Time of Inspection</b> | CapturePoint, LLC | | |

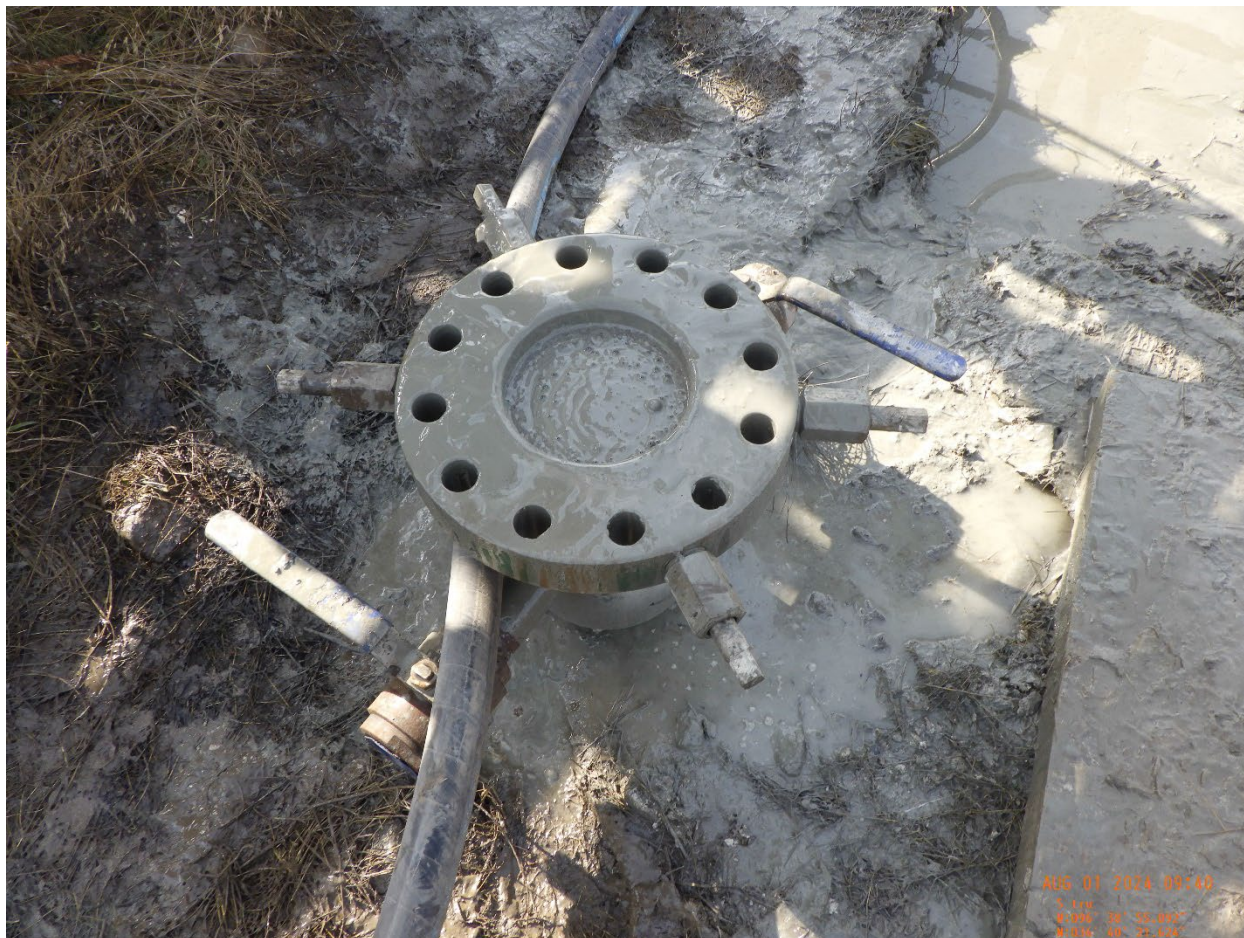
Photo No. 1

| <b>Inspection Comments</b> | Inspector observed CapturePoint, LLC run tubing in well OS4674000 to 450 feet below the surface and attempt to squeeze 100 sacks of cement. The well would not accept cement squeeze. 50 sacks of cement (2 % calcium) were circulated to the surface from 450 feet. Cement was observed standing at the surface with no fallback. | | | | |

**Description:** This was well OS4674000 full of cement to the surface with no fallback.
