## **PURPOSE OF INSPECTION**

The purpose of the inspection by the U.S. Environmental Protection Agency (USEPA) at Terminal Ready Mix, Inc. (Terminal or Facility) was to describe, evaluate, and document compliance with the Clean Water Act (CWA) and their National Pollutant Discharge Elimination System (NPDES) permit.

**Terminal Ready Mix  
EPA Inspection 6/22/2022  
All photos taken by Jake Berger, Physical Scientist, U.S. EPA  
Camera: Olympus Tough TG-6**

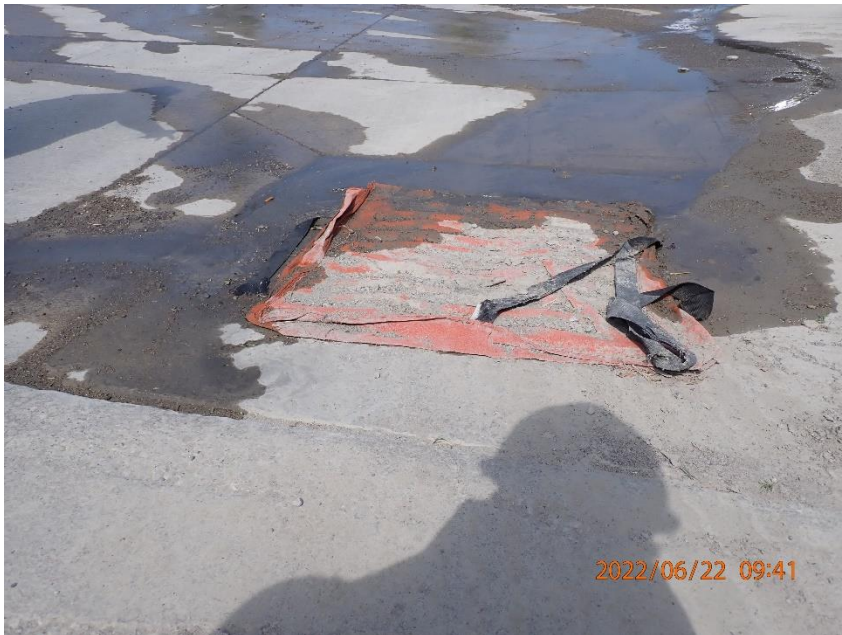
3: P6220003

- Dandy bags covering the inlets to the storm water basins appeared to not be regularly maintained, as sediment build-up has occurred (Photo 3, Photo 4, and Photo 13).

Description: Catch basin inlet sediment bag

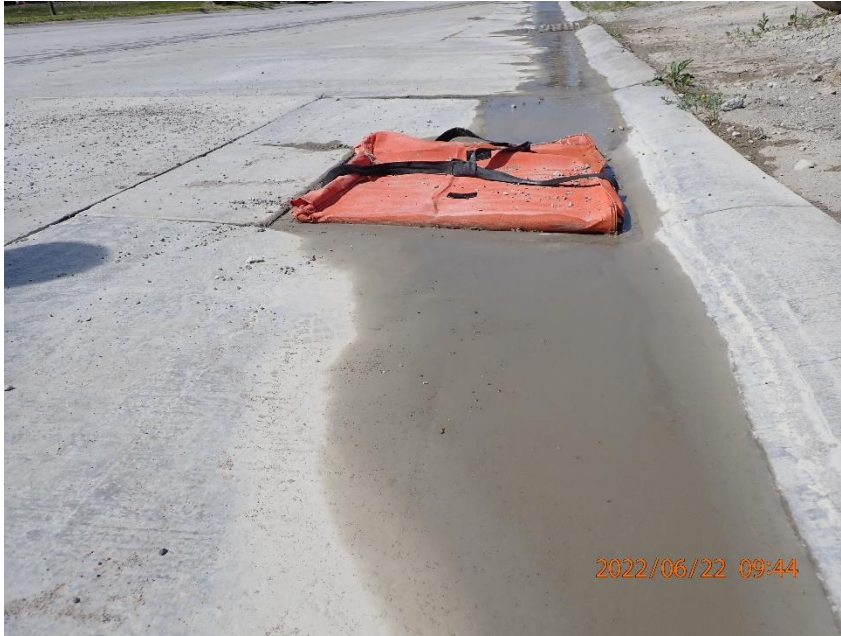
4: P6220004

Description: Catch basin inlet

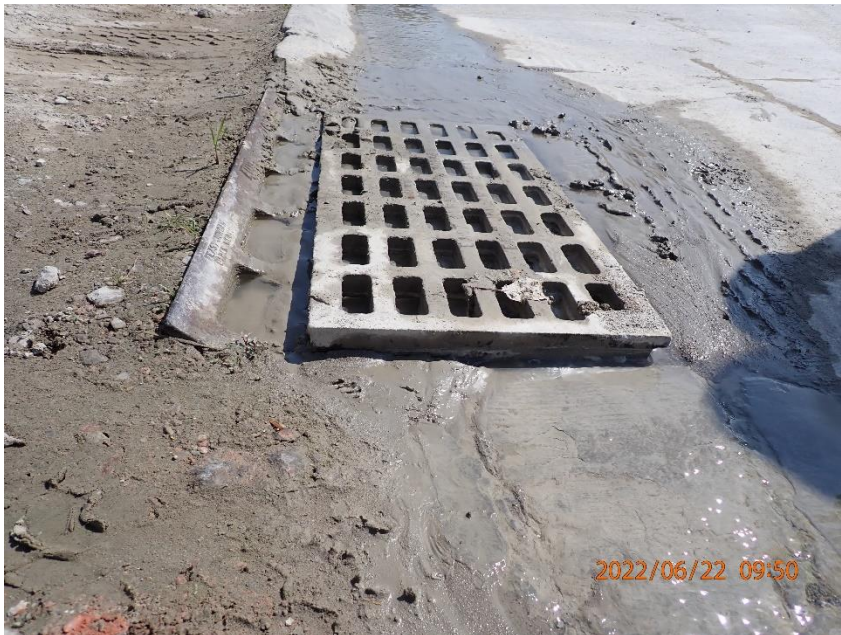
5: P6220005

- Excess sediment accumulation is occurring at the sediment trap (Photo 5).
- Material piles of stone and sand in the lower material storage area do not have any containment (Photo 8 and Photo 17).

Description: Sediment trap

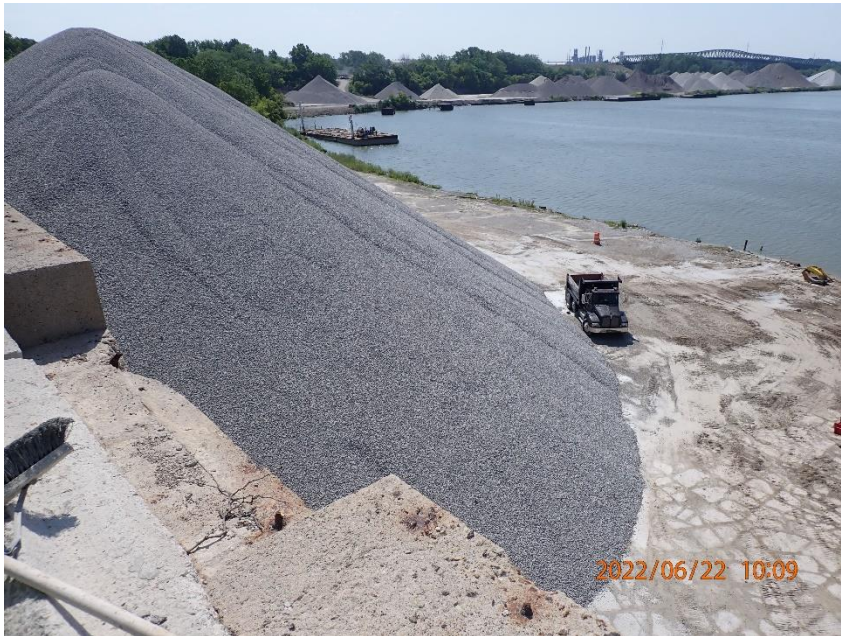
8: P6220008

Description: Property edge along Black River; lower material storage area

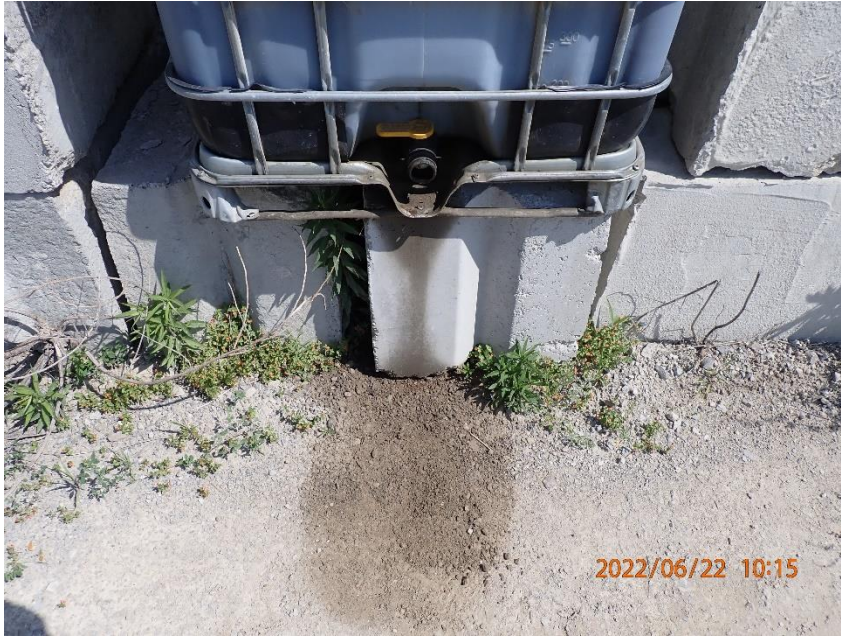
10: P6220010

- Containers of additive mixture and wash mix do not have secondary containment (Photo 10 and Photo 11).
- Water flowing from the rock channels near Basin A is coming from an unknown pipe and continues down to the lower material storage area (Photos 14 – 16).

Description: Tote of concrete additive mixture with no secondary containment

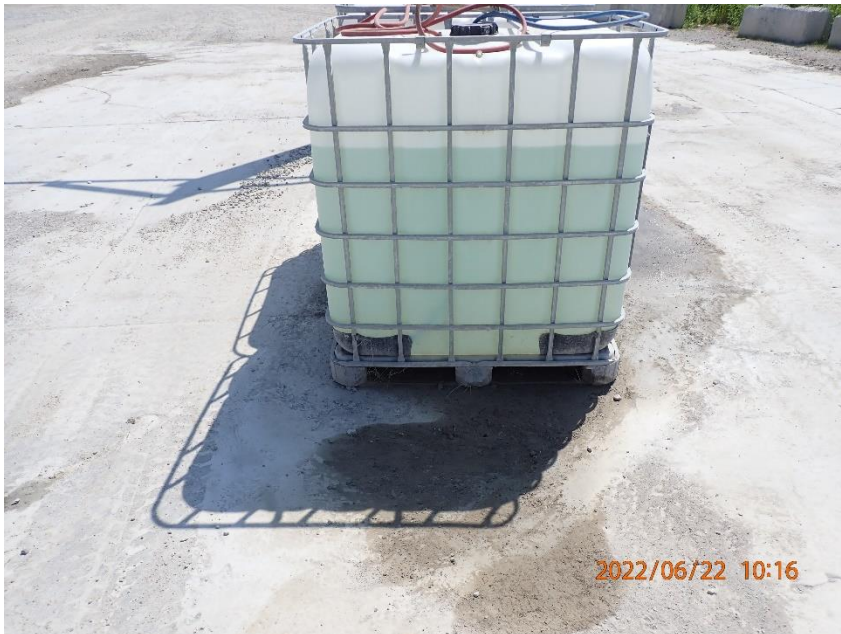
11: P6220011

Description: Wash water additives for truck exteriors

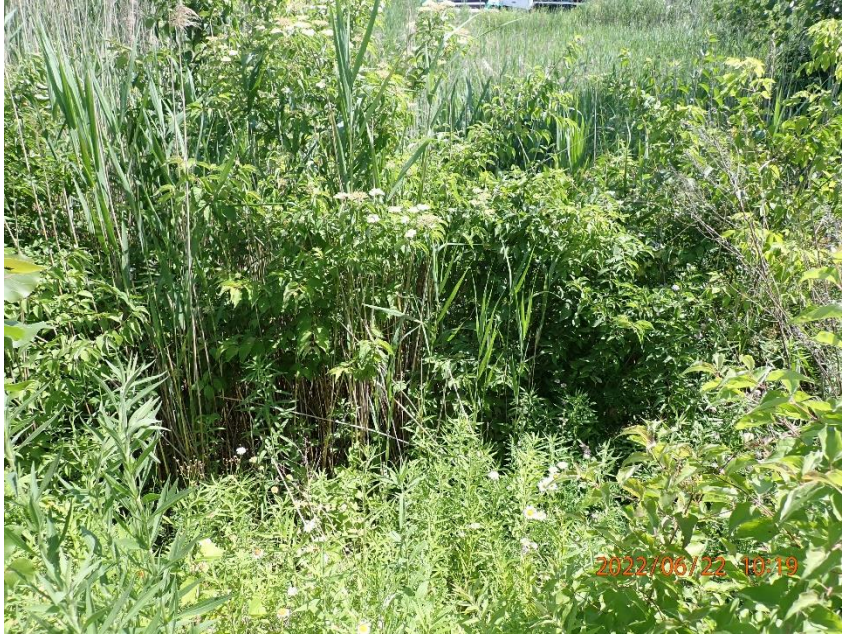
12: P6220012

Description: Basin B (overflow outlet is overgrown and not visible).

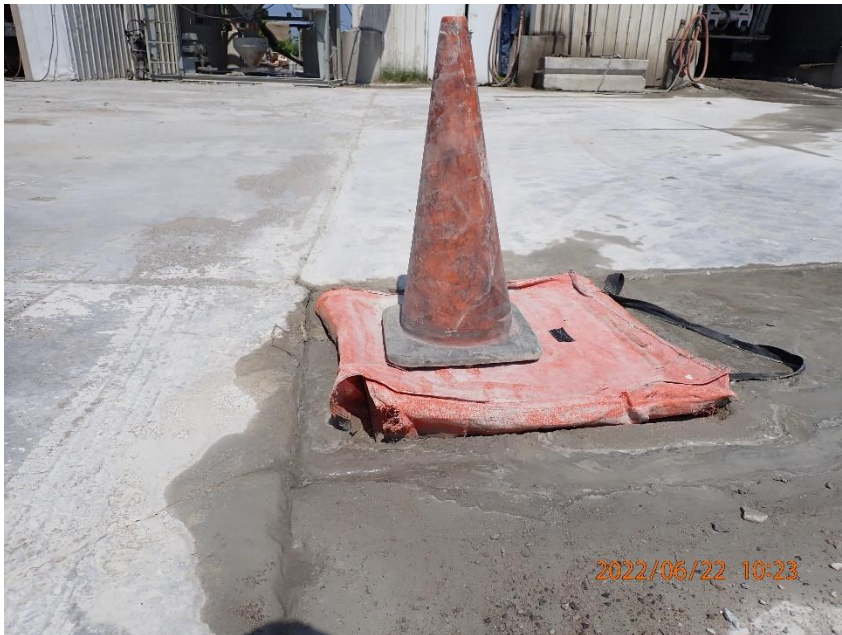
13: P6220013

Description: Dandy bag in catch basin

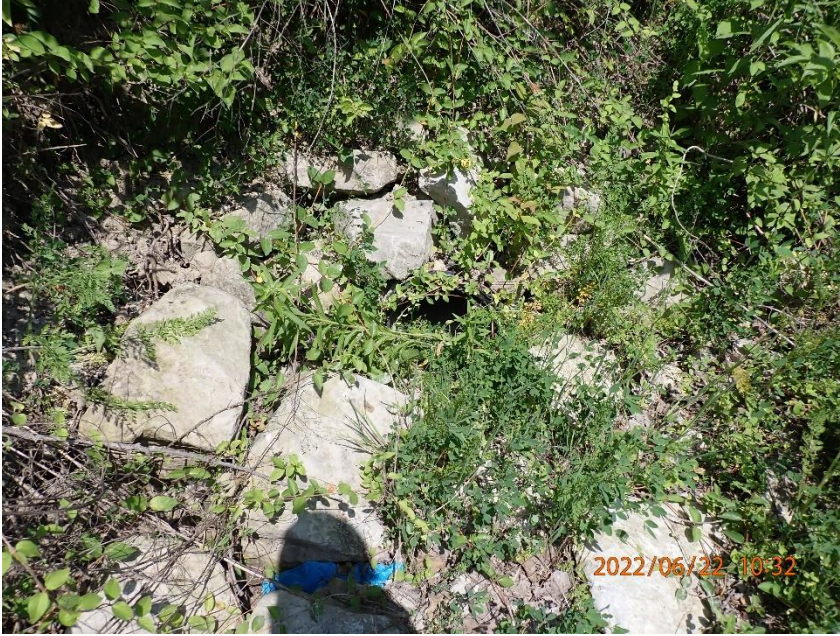
14: P6220014

Description: Basin A rock channel #1

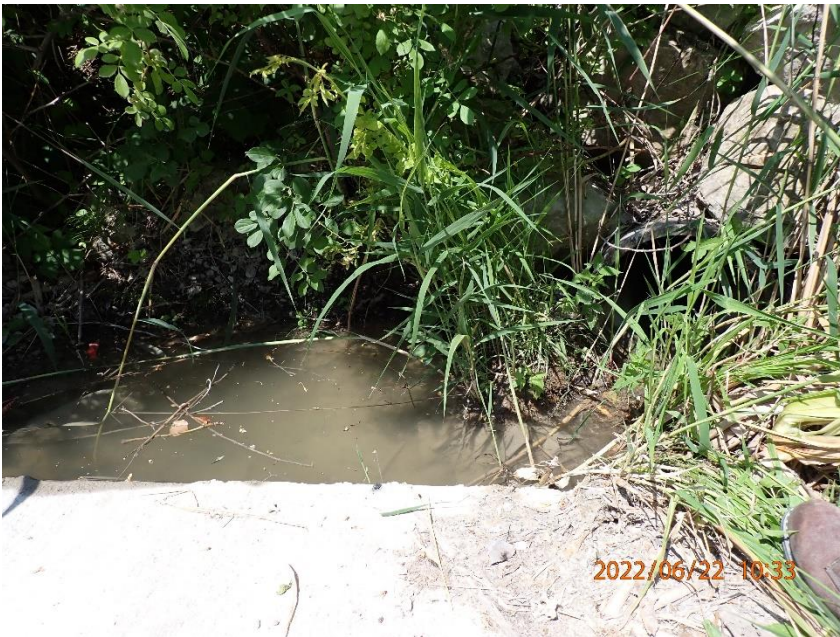
15: P6220015

Description: Basin A rock channel #2

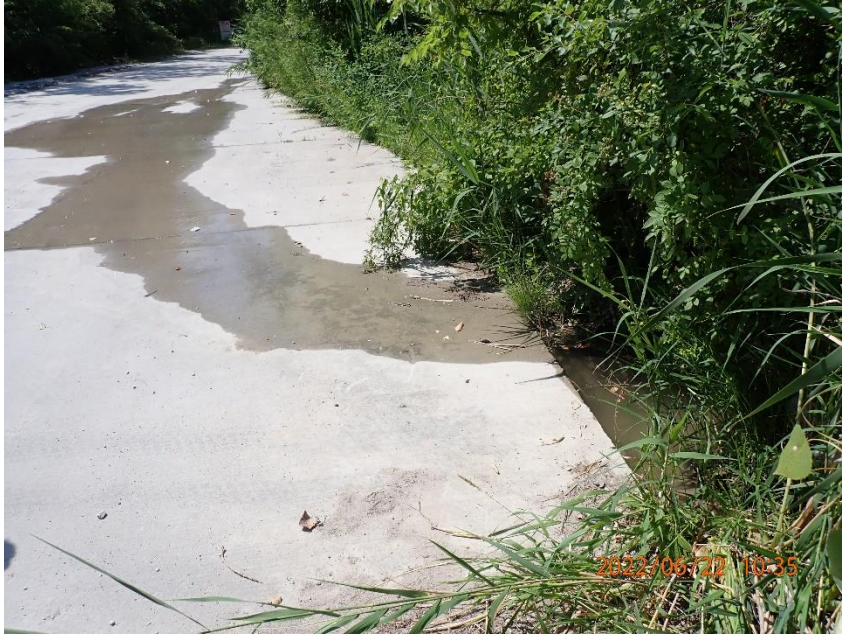
16: P6220016

Description: Flow path from rock channel #2

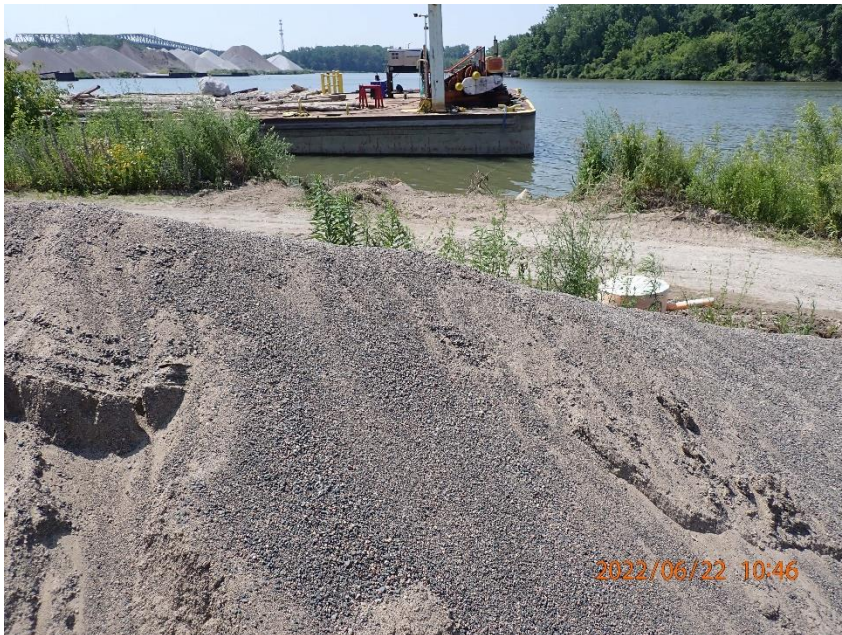
17: P6220017

- There is no containment or management of storm water that comes in contact with the stone and sand piles in the lower material storage area. Sediment runoff and erosion into the Black River is evident (Photos 17 – 20).

Description: Sand pile near the shoreline of the Black River

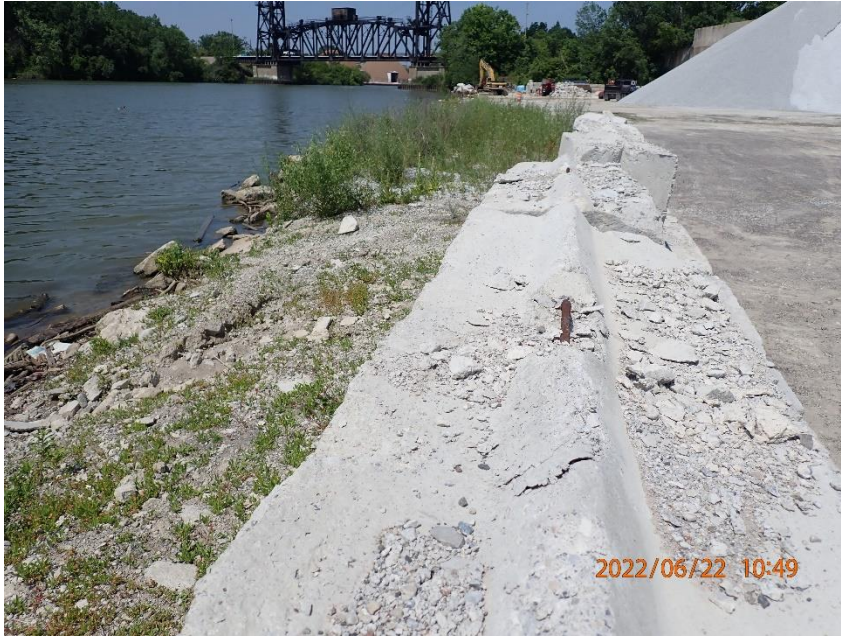
18: P6220018

Description: Stone pile and shoreline

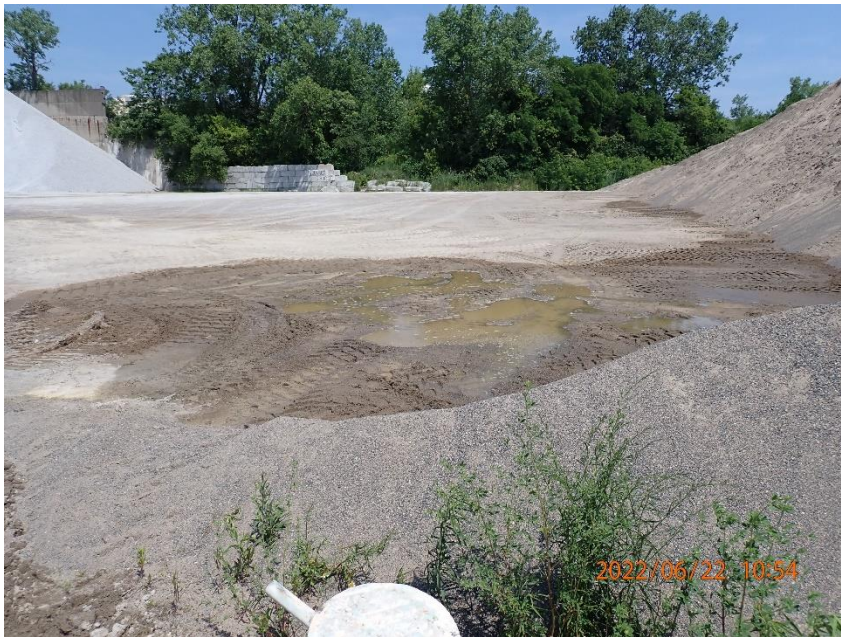
19: P6220019

Description: Lower material storage area along south side of property/Black River shoreline

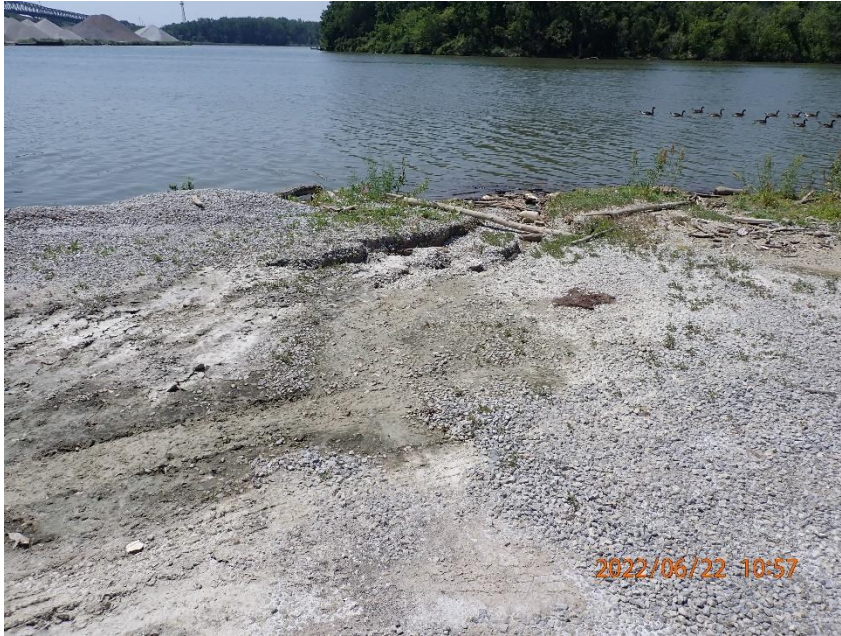
20: P6220020

Description: Erosion rills along south edge of property and the Black River shoreline

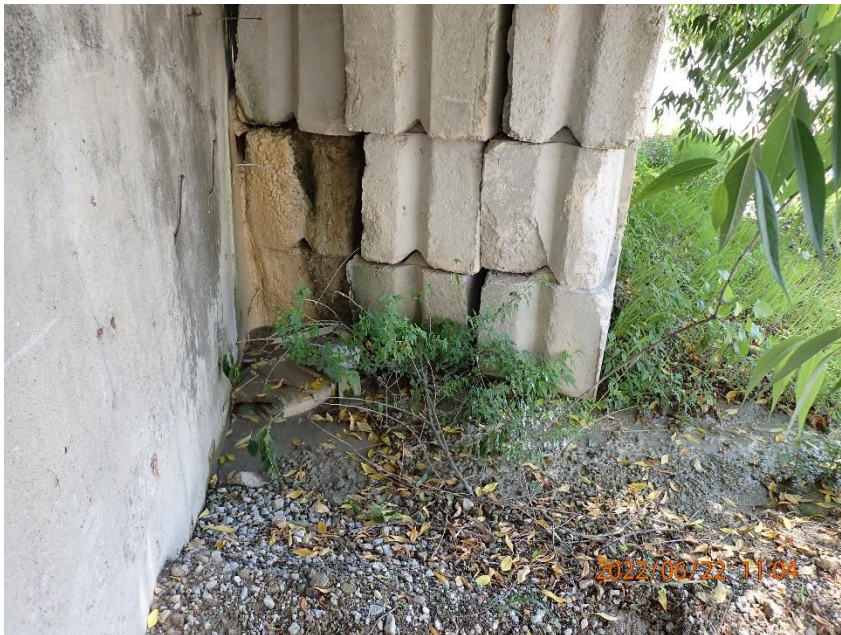
21: P6220021

- Storm water is seeping from the retaining wall beneath Basin B and is flowing across the lower material storage area towards the Black River.

Description: Retaining wall seepage below the backside of Basin B, located above/uphill

- The SWPPP must be reviewed, updated, and signed by a responsible corporate officer at least once per permit cycle.
- Benchmark Monitoring results are required to be averaged and compared to the benchmark concentration values to determine if additional actions are necessary.
- Terminal needs to submit their NOI to OEPA to receive continued coverage for industrial storm water discharges under Permit # OHR000007, if they have not done so already.
- Deficiencies were observed during the Facility walkthrough, such as general housekeeping of sediment and dandy bags, containment of materials, lack of secondary containment for liquid storage totes, the flow seeping out of the hillside near Basin A, the lack of erosion control and runoff prevention near the large material piles at the water level, and the failed retaining wall beneath Basin B.

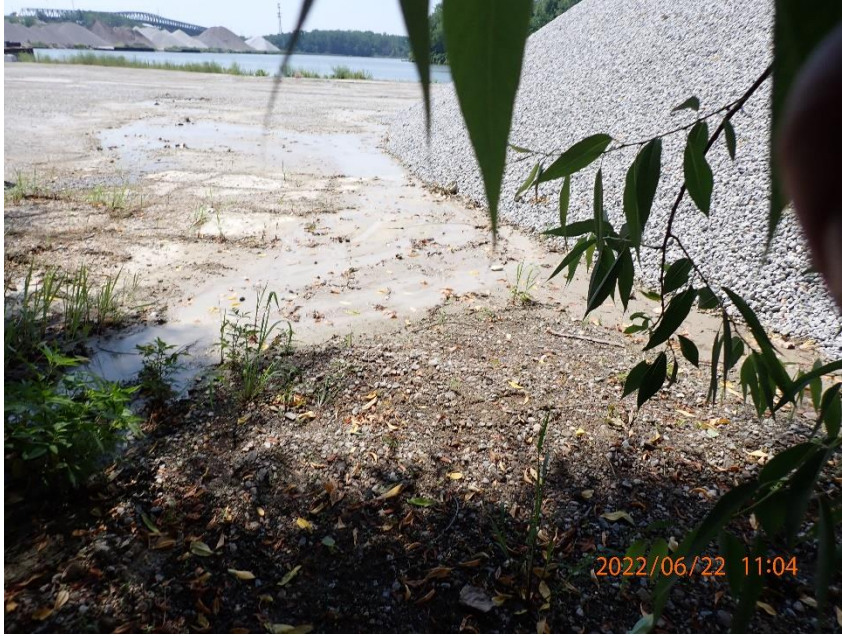
22: P6220022

Description: Flowpath of sediment seeping from retaining wall
