**Inspection Report Addendum for Well: MT20000-01073**  
**Inspection Date: 10/24/2023**

| <b>U.S. Environmental Protection Agency</b><br><b>Region 8</b> | | <b>UIC PHOTOGRAPHIC LOG</b> | |
| <b>Facility Location:</b><br>MT20000-01073 (61-W8), Glacier County, UT | | <b>Photographer:</b><br>Gary Wang | <b>Camera:</b><br>Ricoh WG-5 |

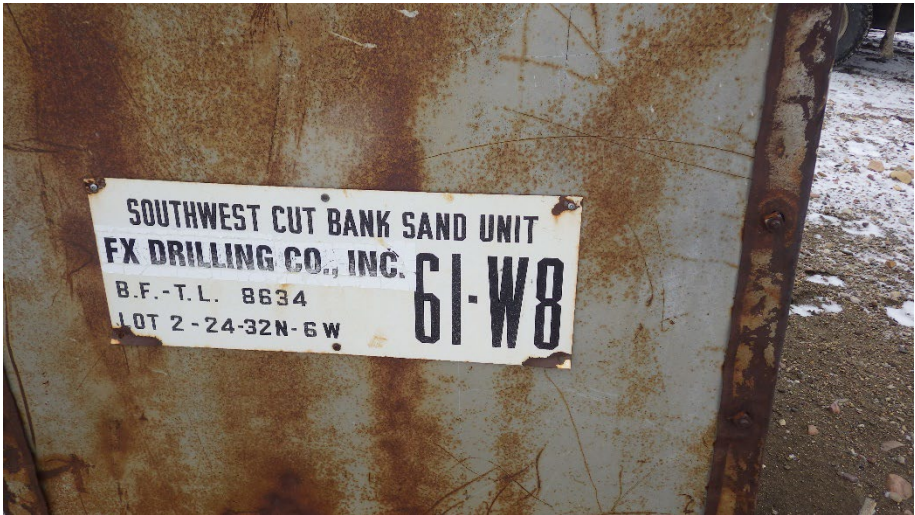
| <b>Photo No.</b><br>1 of 7 | <b>Time:</b><br>3:34 pm | | |

| <b>Photo Description:</b><br>Well sign by wellhead. | | | |

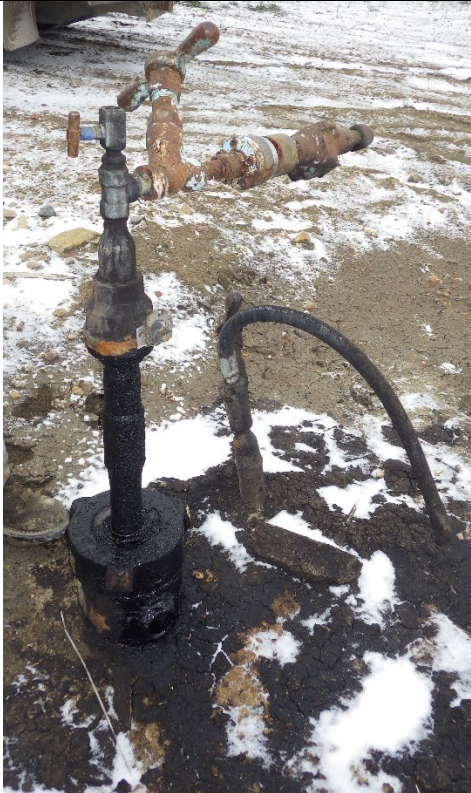
| <b>Photo Description:</b><br>Wellhead is observed to be disconnected from flowline (right of the wellhead).<br><br>Ground surrounding wellhead observed to have petroleum impacted soil. | | | |

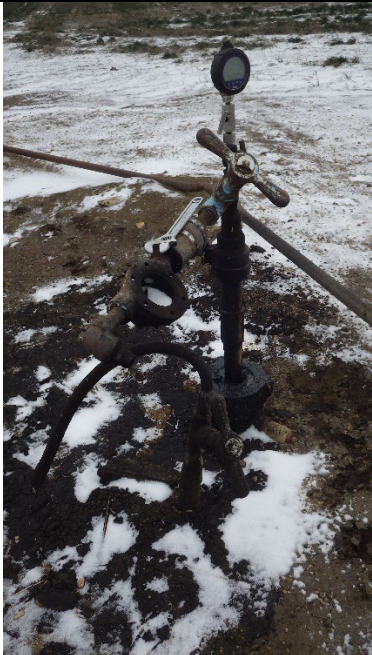
| <b>Photo No.</b><br>3 of 7 | <b>Time:</b><br>3:35 pm | | |

| <b>Photo Description:</b><br>Another angle of wellhead.<br>EPA's digital pressure gauge was installed onto well to check tubing pressure. | | | |

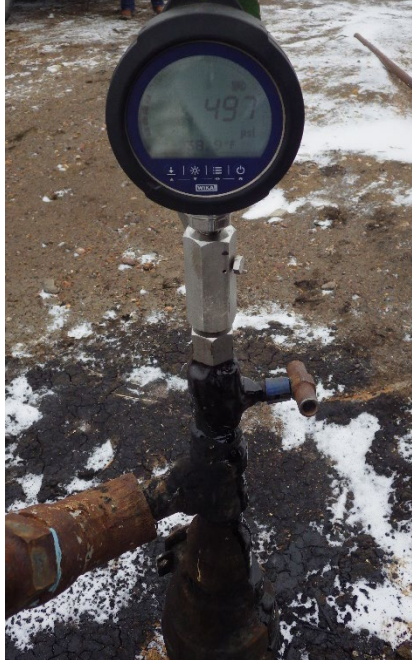
| <b>Photo No.</b><br>4 of 7 | <b>Time:</b><br>3:36 pm | | |

| <b>Photo Description:</b><br>EPA's digital pressure gauge on tubing read 497 psi on a 3000-psi range gauge.<br>MAIP for well is 2676 psi. | | | |

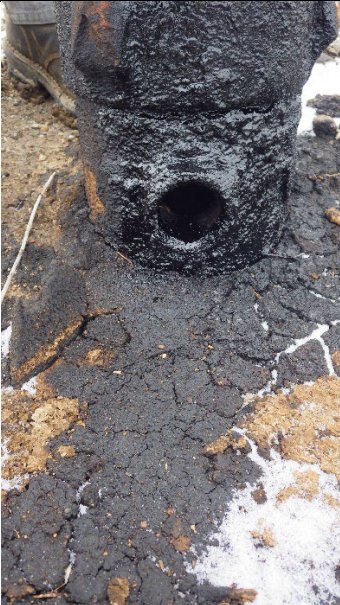
| <b>Photo No.</b><br>5 of 7 | <b>Time:</b><br>3:34 pm | | |

| <b>Photo Description:</b><br>Tubing-casing annulus observed to be maintained continuously open to atmospheric pressure. | | | |

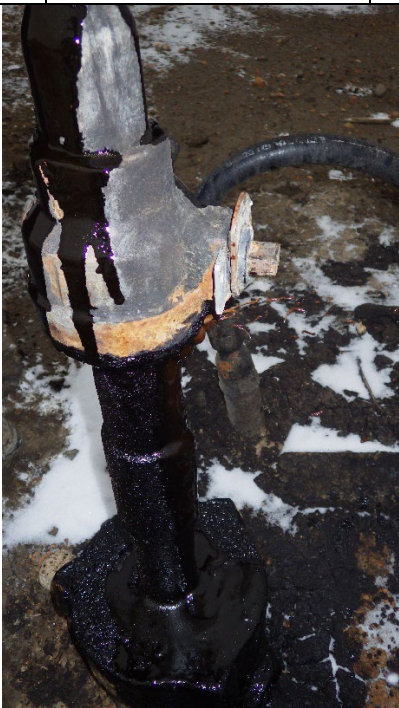
| <b>Photo Description:</b><br>A leak formed underneath the tubing's master ball valve when operator tried to close the stem on the ball valve during the inspection. | | | |

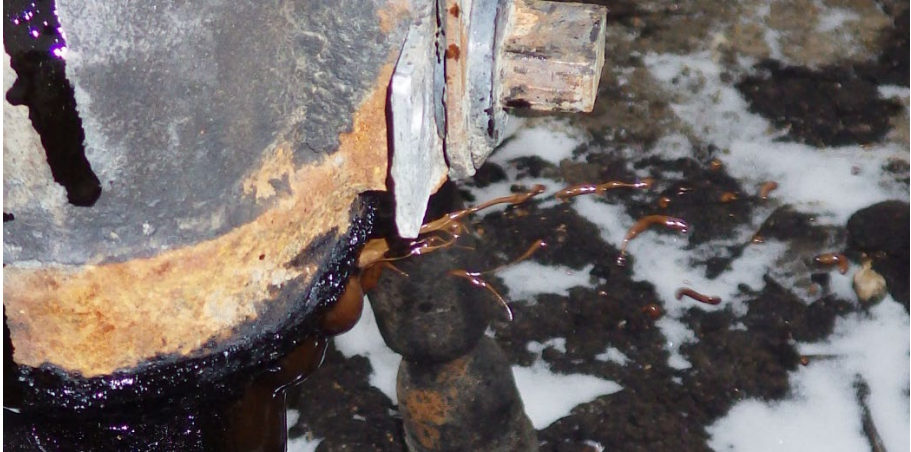
| <b>Photo Description:</b><br><p>A closeup of photo 6. A leak formed underneath the tubing's master ball valve when operator tried to close the stem on the ball valve during the inspection.</p> <p>Leak is observed to be streaming out (in brown) at the joint underneath ball valve on the tubing.</p> | | | |
