**Region 6 - Enforcement & Compliance Assurance Division**  
**INSPECTION REPORT**

| Company Name: | <b>CapturePoint, LLC</b> | |
| Facility Name: | <b>North Burbank Unit (NBU) 24 Battery</b> | |
| Identification/Permit Number: | OKU002197 | |

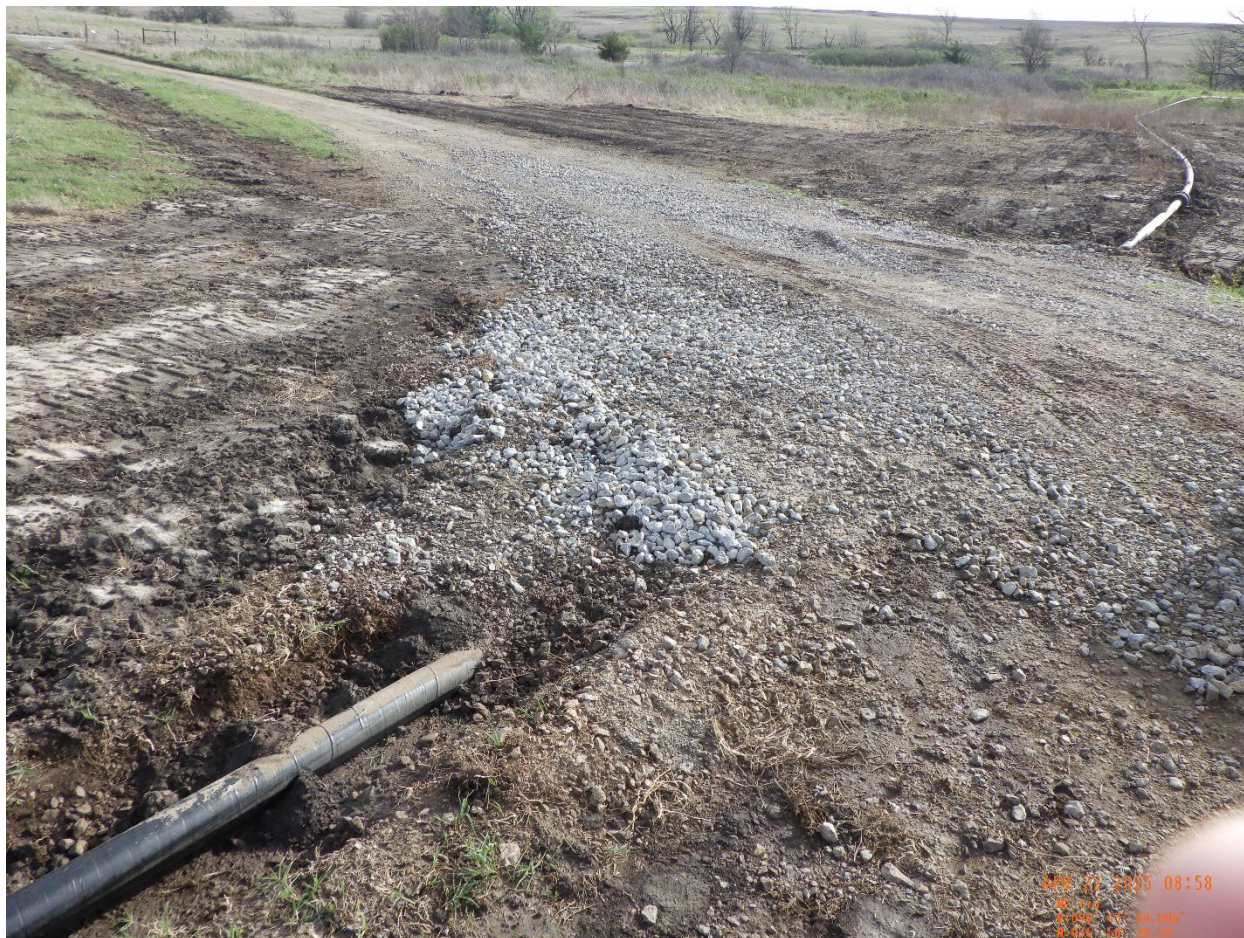
Photo No. 1

EPA conducted an inspection at the CapturePoint, LLC North Burbank Unit 24 Battery, where a 4" steel line connected to the NBU 24 battery failed, releasing a company estimated 350 barrels of saltwater to the land surface. Saltwater migrated generally northeast into an unnamed tributary of Haines Creek.

I observed the release point of the spill which was a 4" steel flowline. At the time of the inspection, the flowline had been repaired and returned to service. See photo No. 1, Appendix 1 (photo log). For additional GPS location information and photo metadata, see the attached photo log.

**Description:** This was the release point of the spill. At the time of the inspection the failed flowline had been repaired.

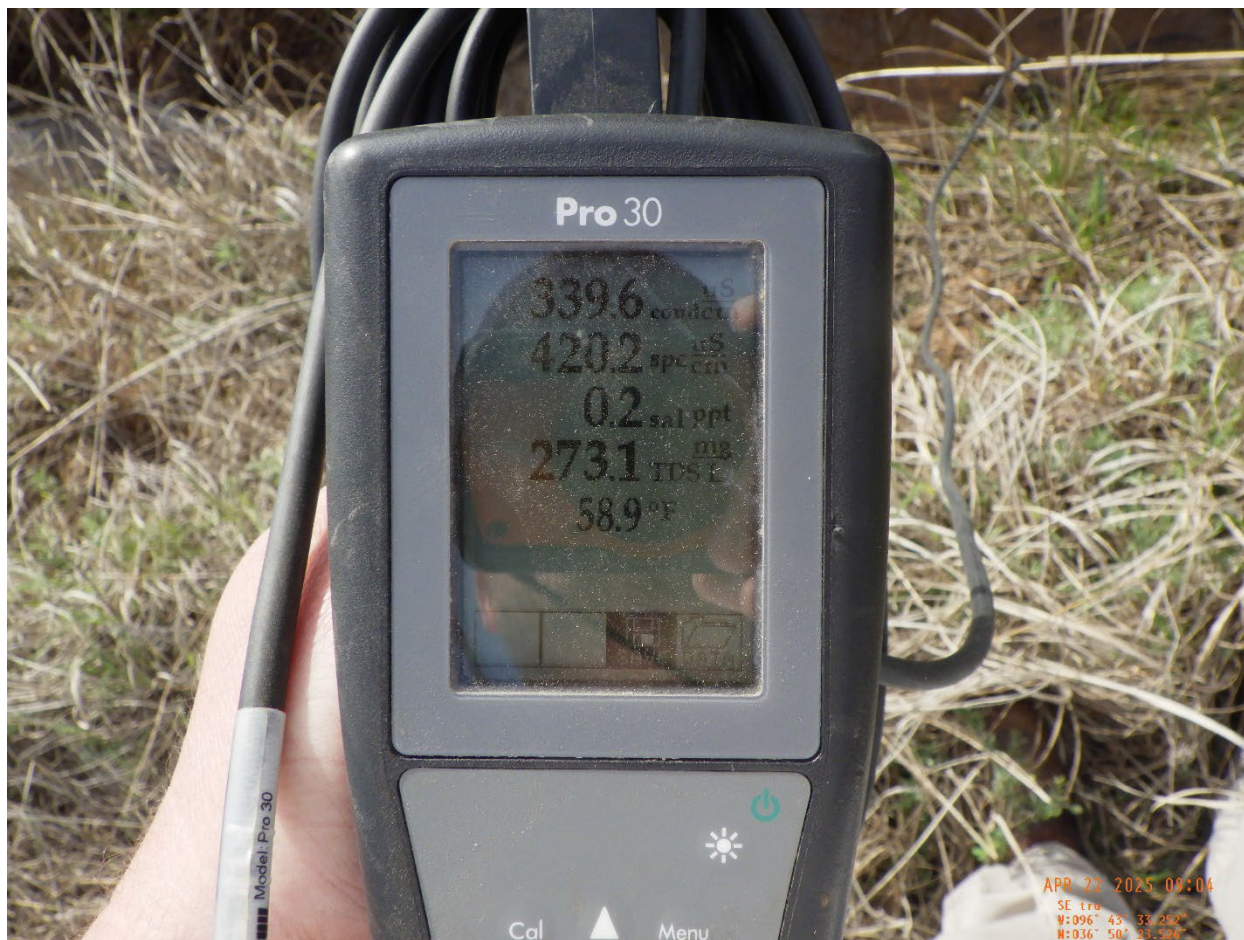
Photo No. 2

Immediately upstream from the point of entry (POE) into the unnamed tributary of Haines Creek, I observed a background TDS field reading of 273.1 mg/L. This reading should be used to when assessing background TDS levels in the area. See photo No. 2.

**Description:** This was a background TDS field reading of 273.1 mg/L observed immediately upstream from the point of entry (POE) into the impacted, unnamed tributary of Haines Creek.

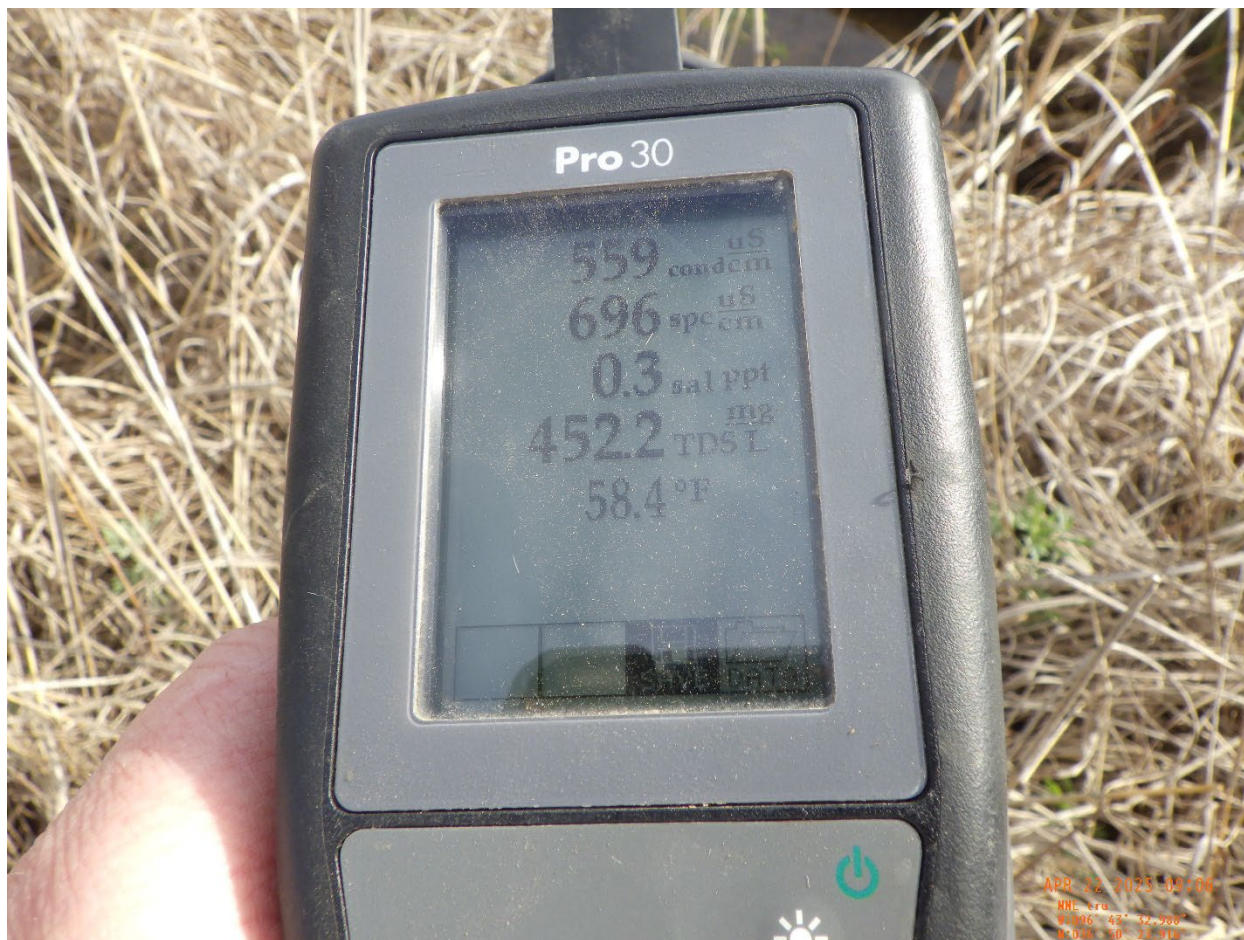
Photo No. 3

At the POE into the impacted tributary, I observed a TDS field reading of 452.2 mg/L in the main channel of the tributary. See photo No. 3.

**Description:** This was a TDS field reading of 452.2 mg/L observed at the POE into the unnamed tributary.

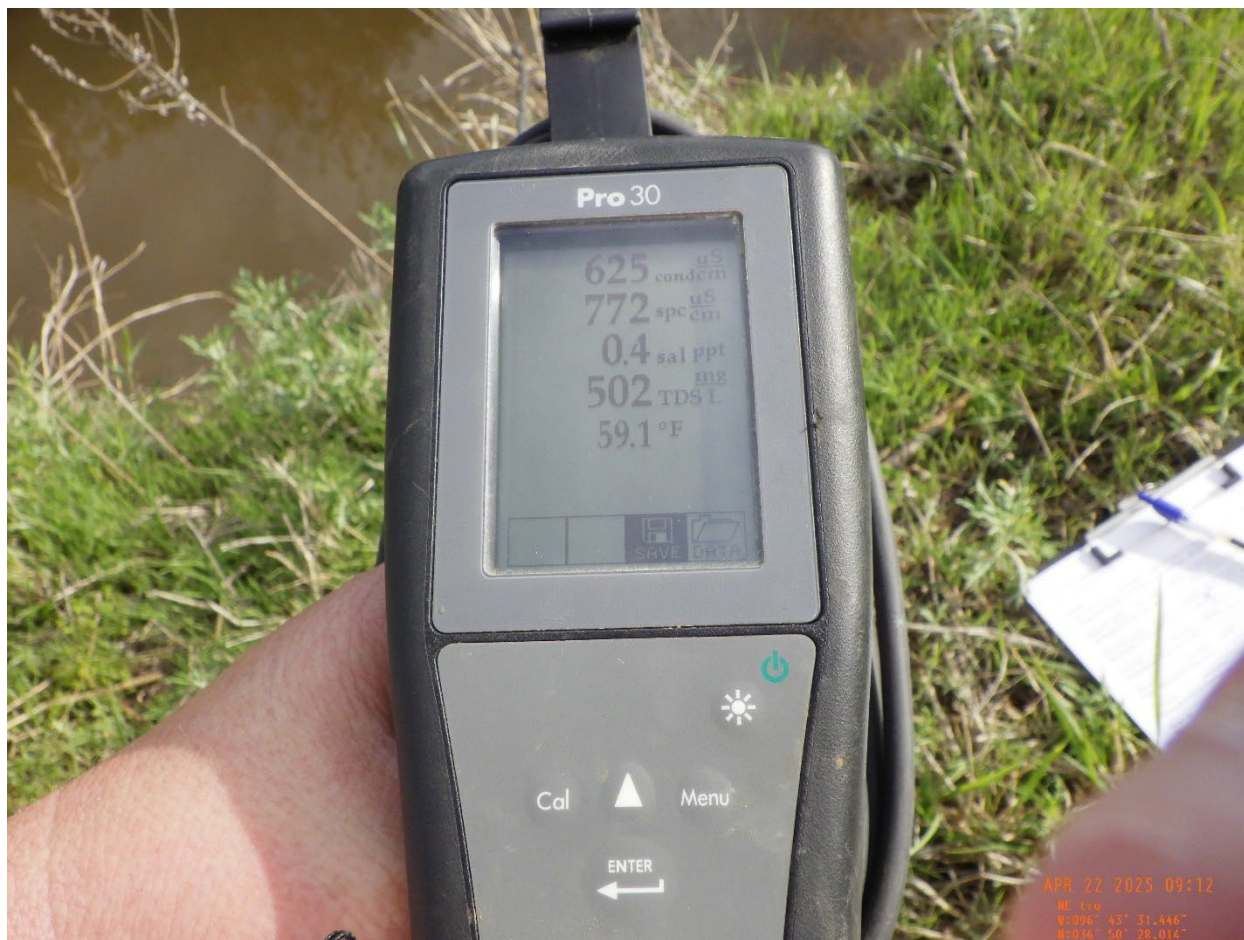
Photo No. 4

At the lowermost containment dam, which was also the end of observed spill impacts, I observed a TDS field reading of 502 mg/L. I also observed the bed and bank features of the impacted tributary at this same location. See photos No. 4 and 5.

**Description:** This was a TDS field reading of 502 mg/L taken at the end of spill impacts.

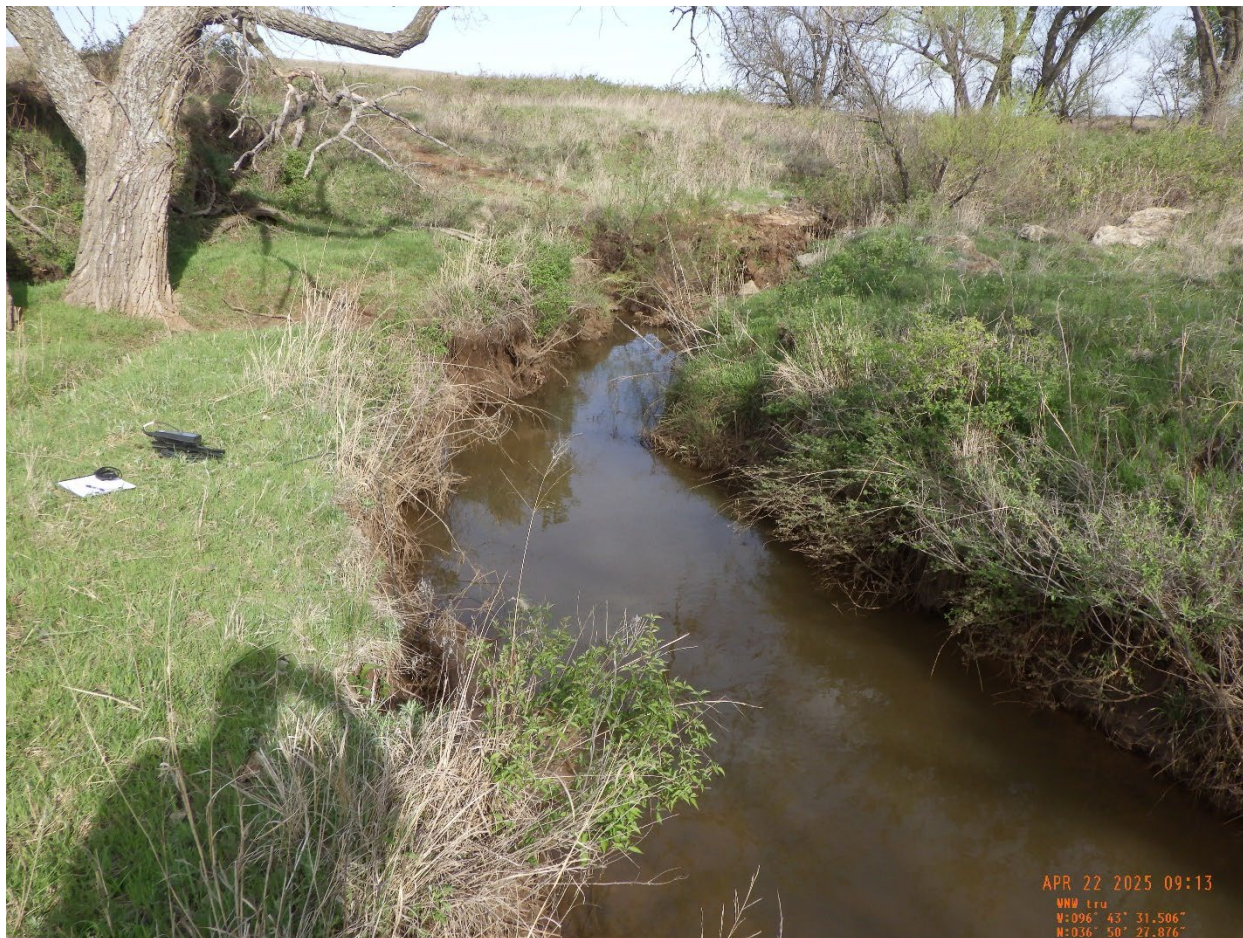
Photo No. 5

**Description:** This was a photo of the bed and bank features observed at the end of observed spill impacts.
