**UNITED STATES ENVIRONMENTAL PROTECTION AGENCY**  
**REGION 3**  
**Four Penn Center**  
**1600 JFK Blvd.**  
**Philadelphia, Pennsylvania 19103-2029**

**Report Title:** Clean Water Act Compliance Inspection Report  
**Inspection Date(s):** 12/12/2023  
**Regulatory Program(s):** National Pollutant Discharge Elimination System (NPDES)  
**Type of Activity:** Industrial Stormwater  
**Site/Facility Name:** Old Forge Power Equipment, Inc.  
**Permittee(s):** N/A  
**Site/Facility Operator:** Old Forge Power Equipment, Inc.  
**Site/Facility Address:** 5 Brookside Rd  
Carbondale, PA 18407  
**Latitude:** 41°33'30"N **Longitude:** 75°31'35"W  
**County/Parish:** Lackawanna County  
**Permit Number:** Unpermitted  
**NAICS Code:** 423140 **SIC:** 5015  
**Unique Project #:** ECAD-5485

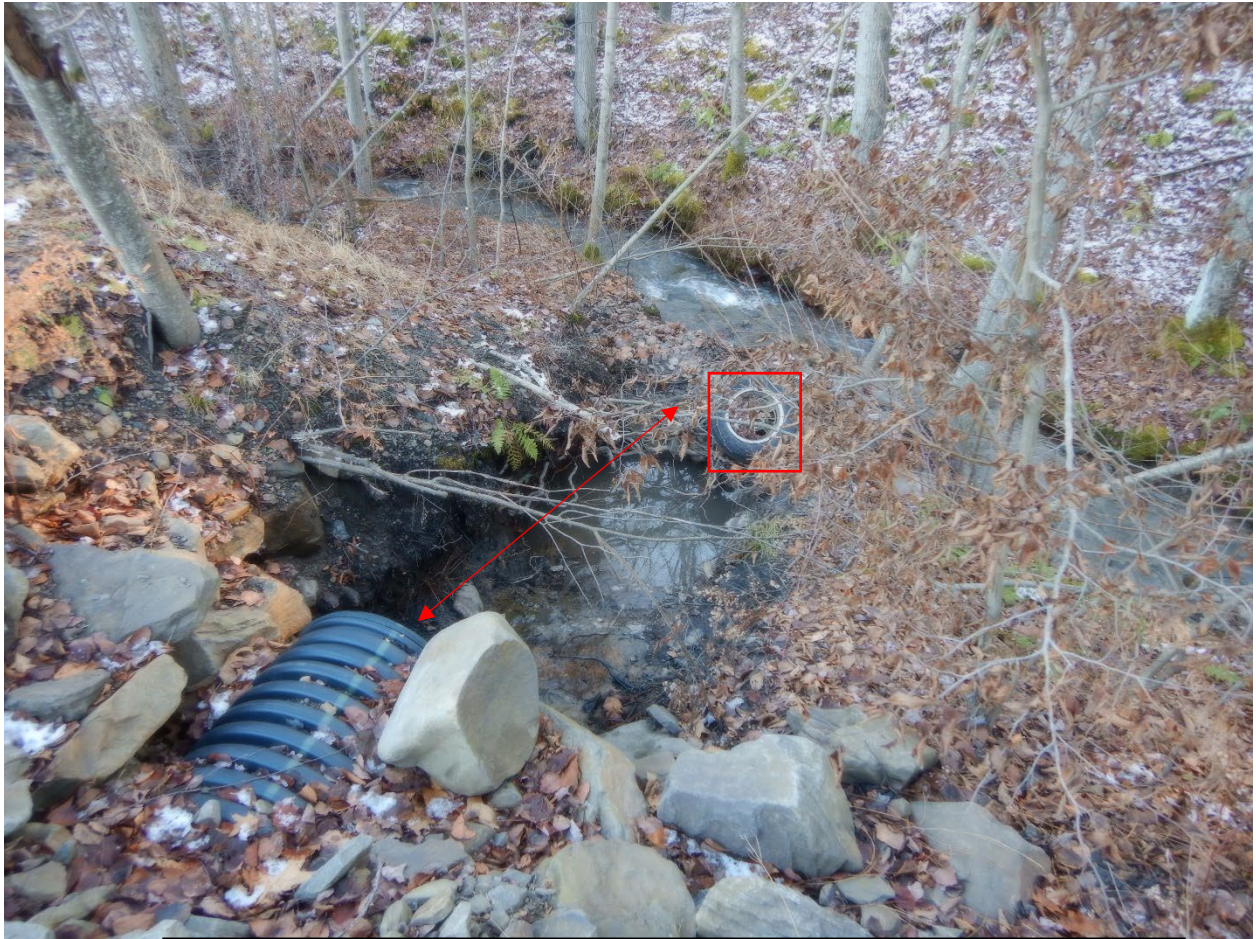
**Observation 1:** The EPA Inspection Team observed debris and erosion in several different areas around the facility. Erosion and a dumped tire were observed on the banks of a culvert approximately 20 feet from the facility entrance (DSCN4059). The EPA Inspection Team then observed erosion (DSCN4062) and debris (DSCN4063) on the east section of the facility to the north of the corner of Surface Drive and Brookside Road. The contours of the Facility appear to direct stormwater discharges towards Meredith Creek, which discharges into the Lackawanna River.

DSCN4059  
Meredith Creek – About 40 ft south, across from the entrance to facility yard (Note tire displaced (red box) into stream and erosion on banks upstream westwards surrounding pipe (red arrow))

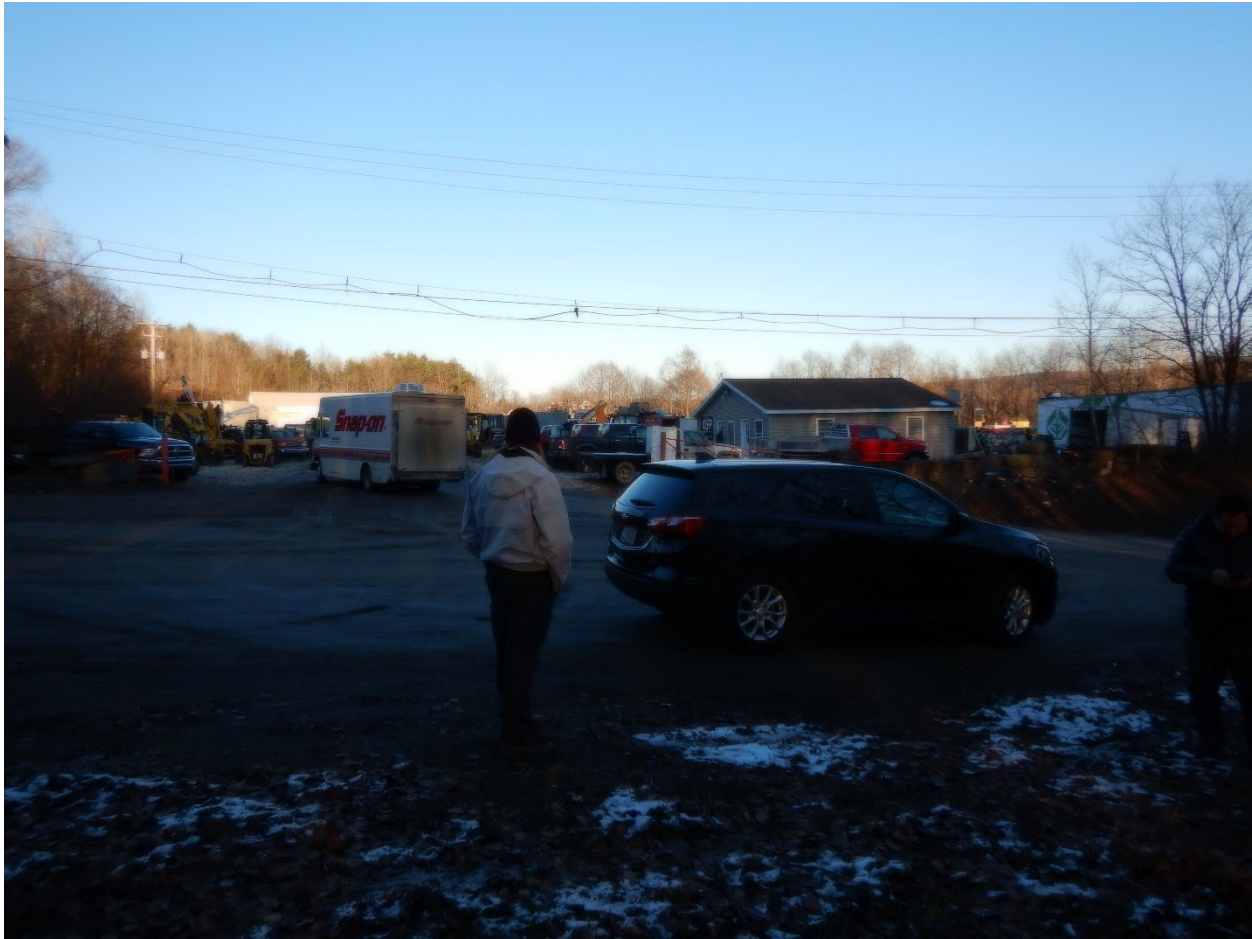
DSCN4060  
Driveway of facility – Note various cars and heavy  
equipment approximately 30ft to the north of road

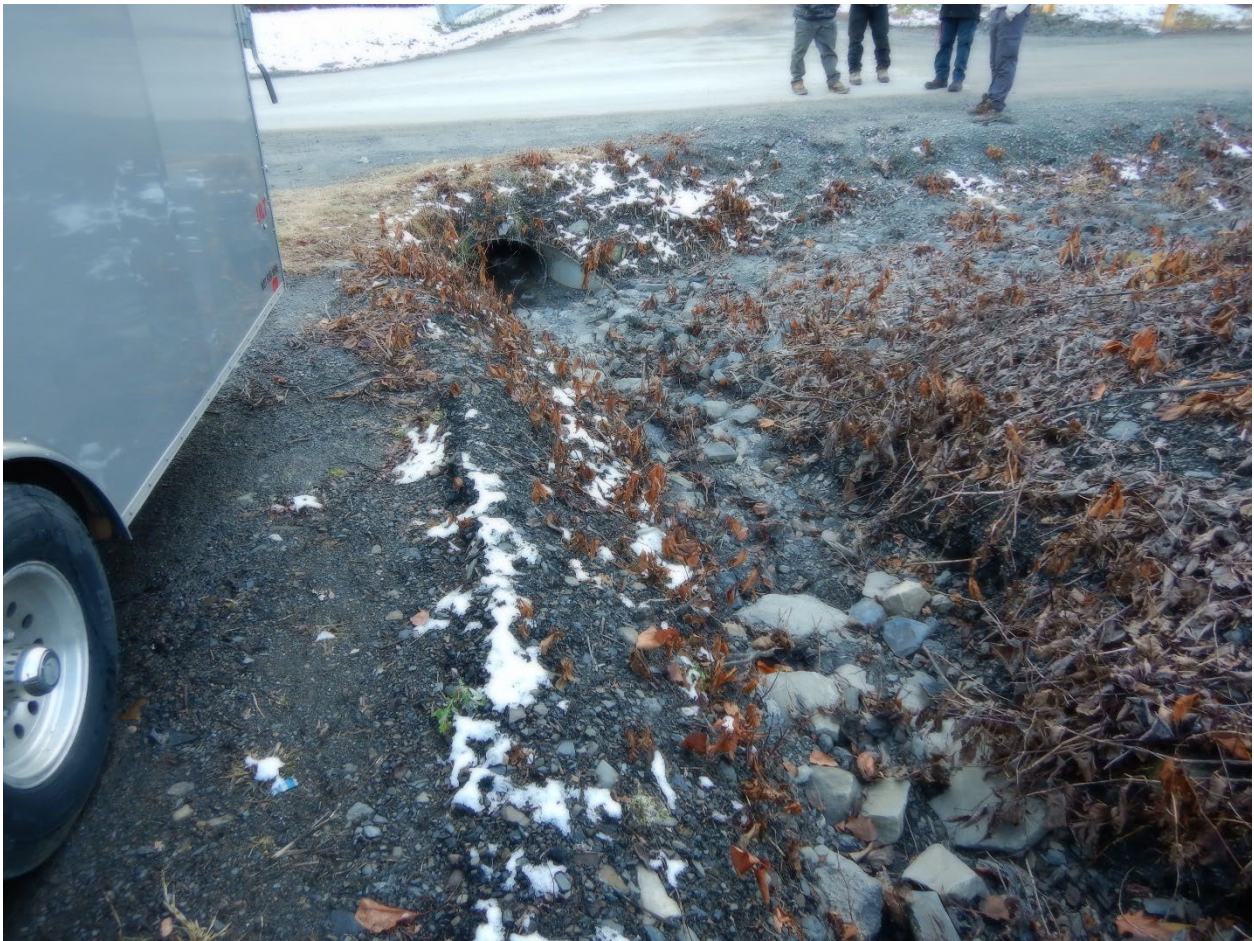
DSCN4065  
Meredith Creek (tributary of Lackawanna River) running  
eastwards through a culvert towards Main Street

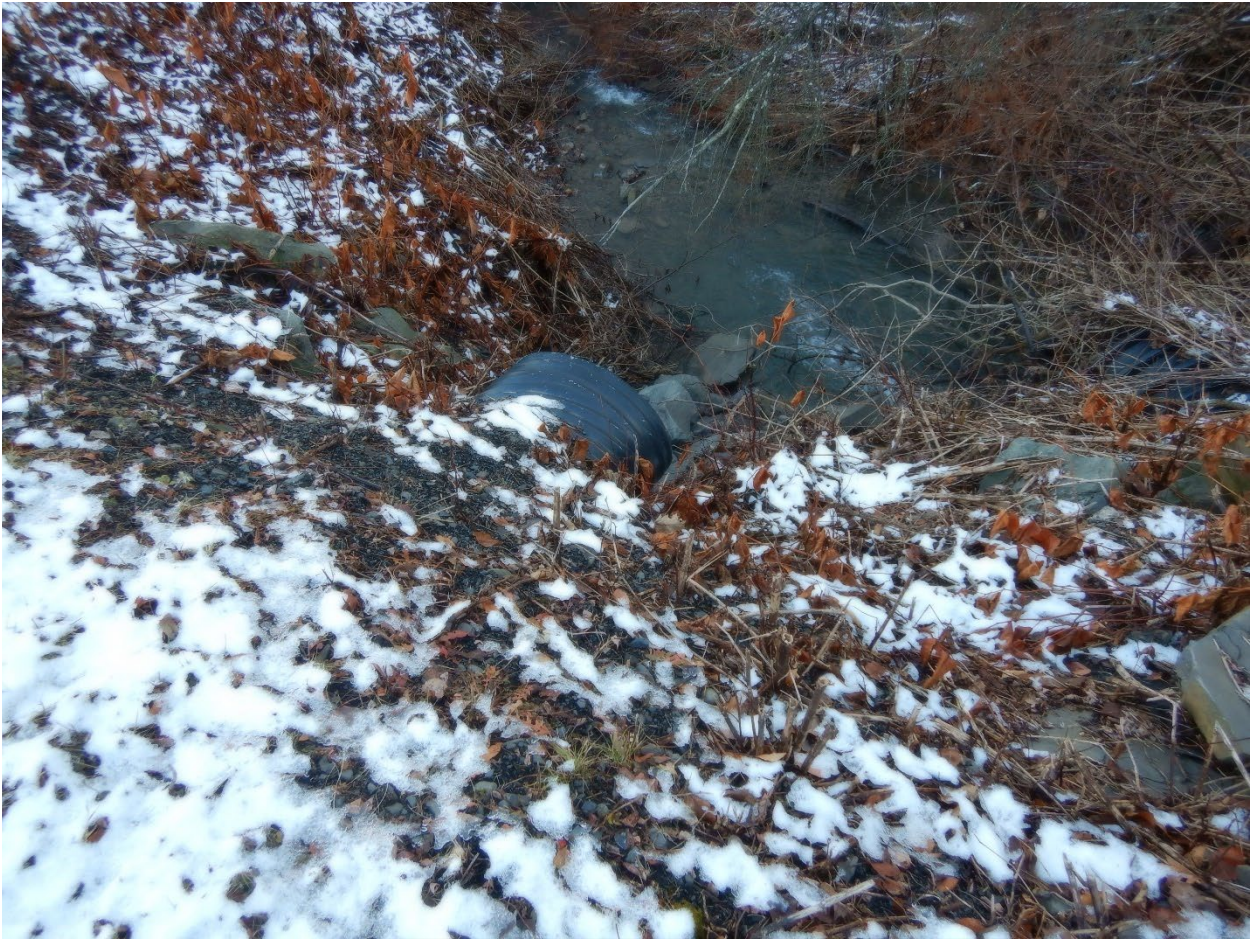
DSCN4066  
Meredith Creek Culvert (approximately 100 ft  
east downslope of driveway)

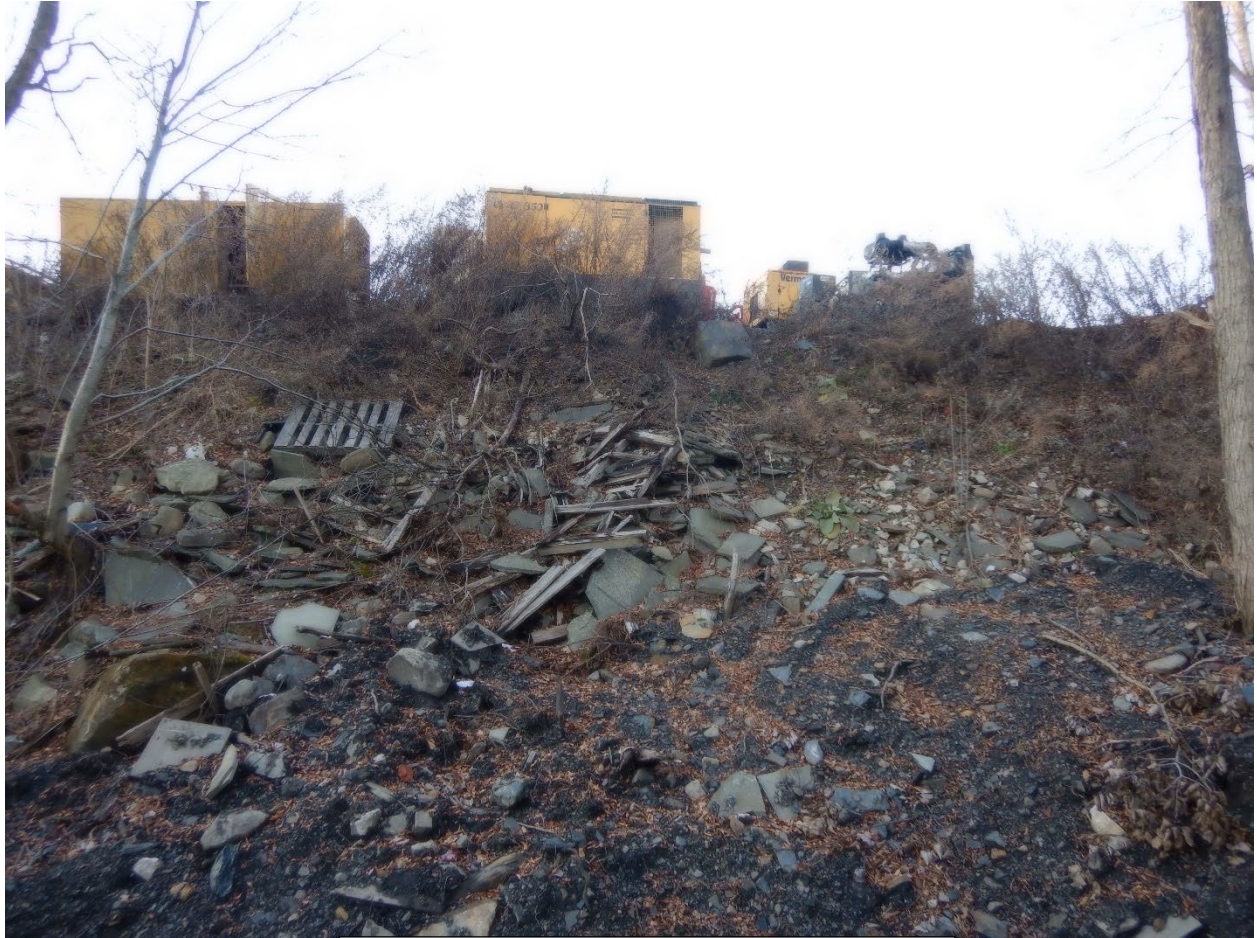
DSCN4063  
Edge of east boundary of facility  
approximately 50ft west of Main street and  
20ft north of driveway – Note debris  
scattering downslope.

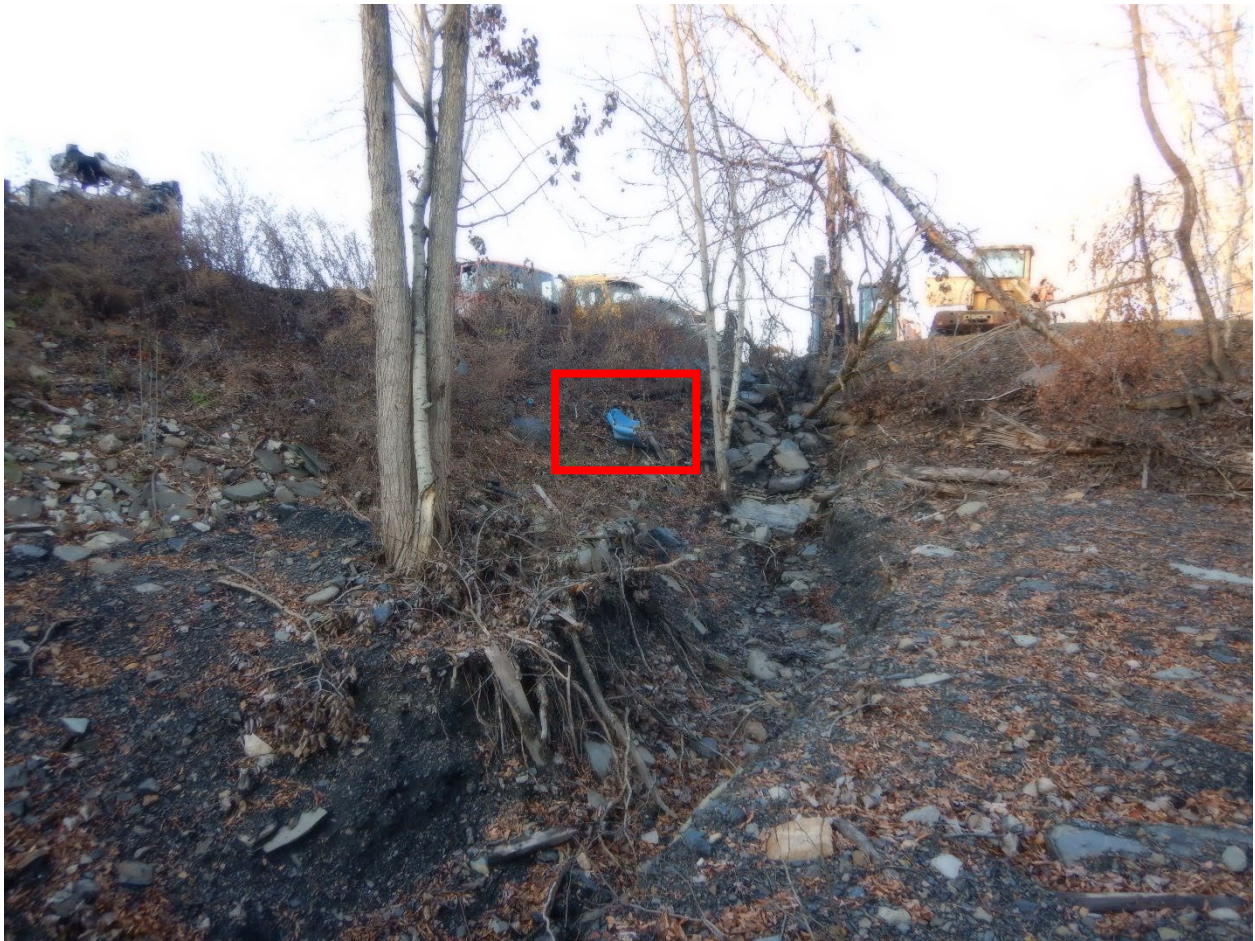
DSCN4062

Edge of east boundary of facility – note erosion and scattered debris about 550ft west of the Lackawanna River

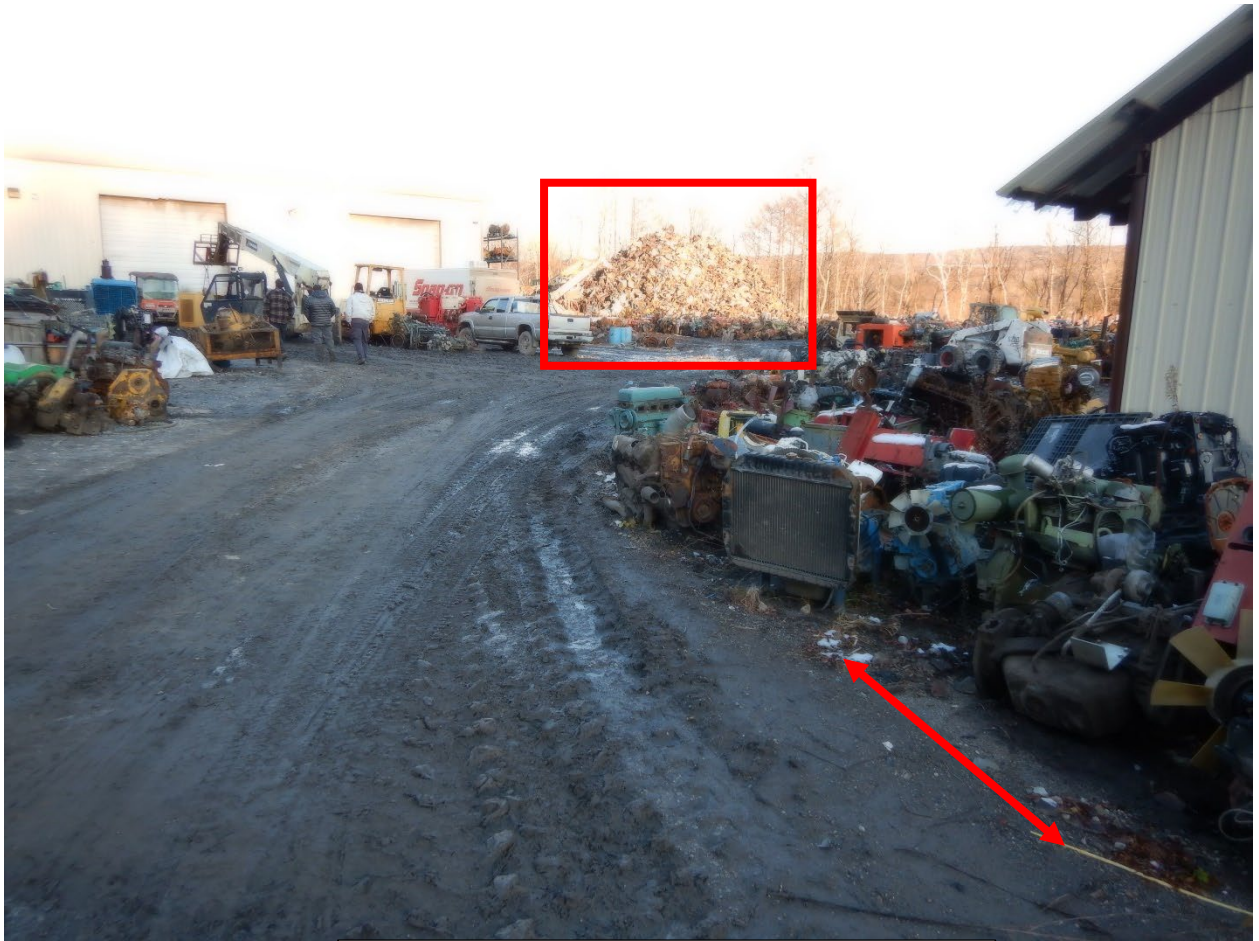
DSCN4068

**Observation 2:** Dark staining was observed in multiple areas surrounding engine parts scattered around facility yard (DSCN4067 – DSCN4068).

**Observation 3:** There was a large pile of scrap metal at the northeast corner of the Facility (DSCN4068). The large pile of scrap metal did not appear to have any stormwater management controls surrounding it.

Facility yard – note staining (red arrow) and  
pile of scrap metal parts in northeast (boxed)

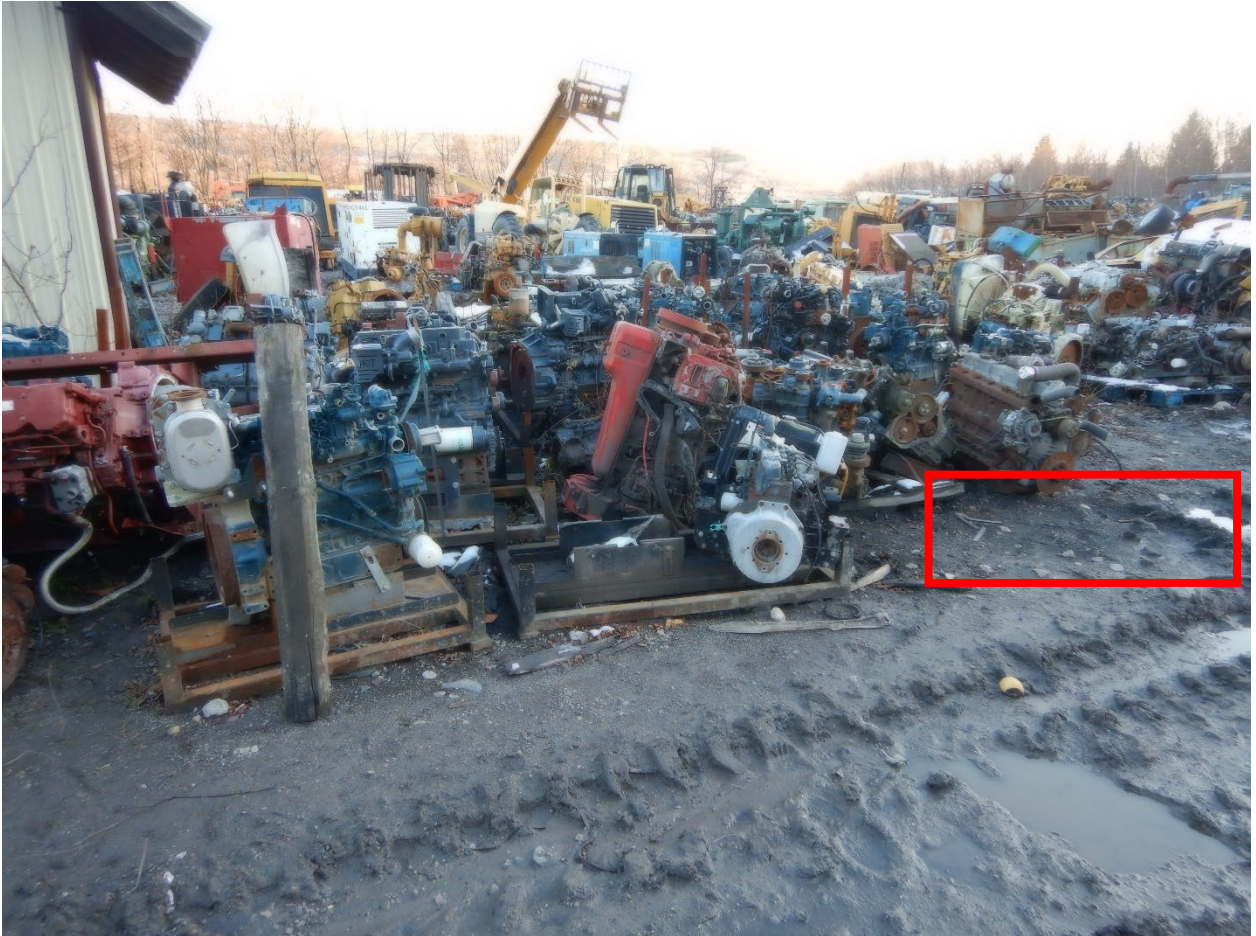
DSCN4067  
Pumps and engine parts in facility yard – note dark staining  
surrounding parts (red box)

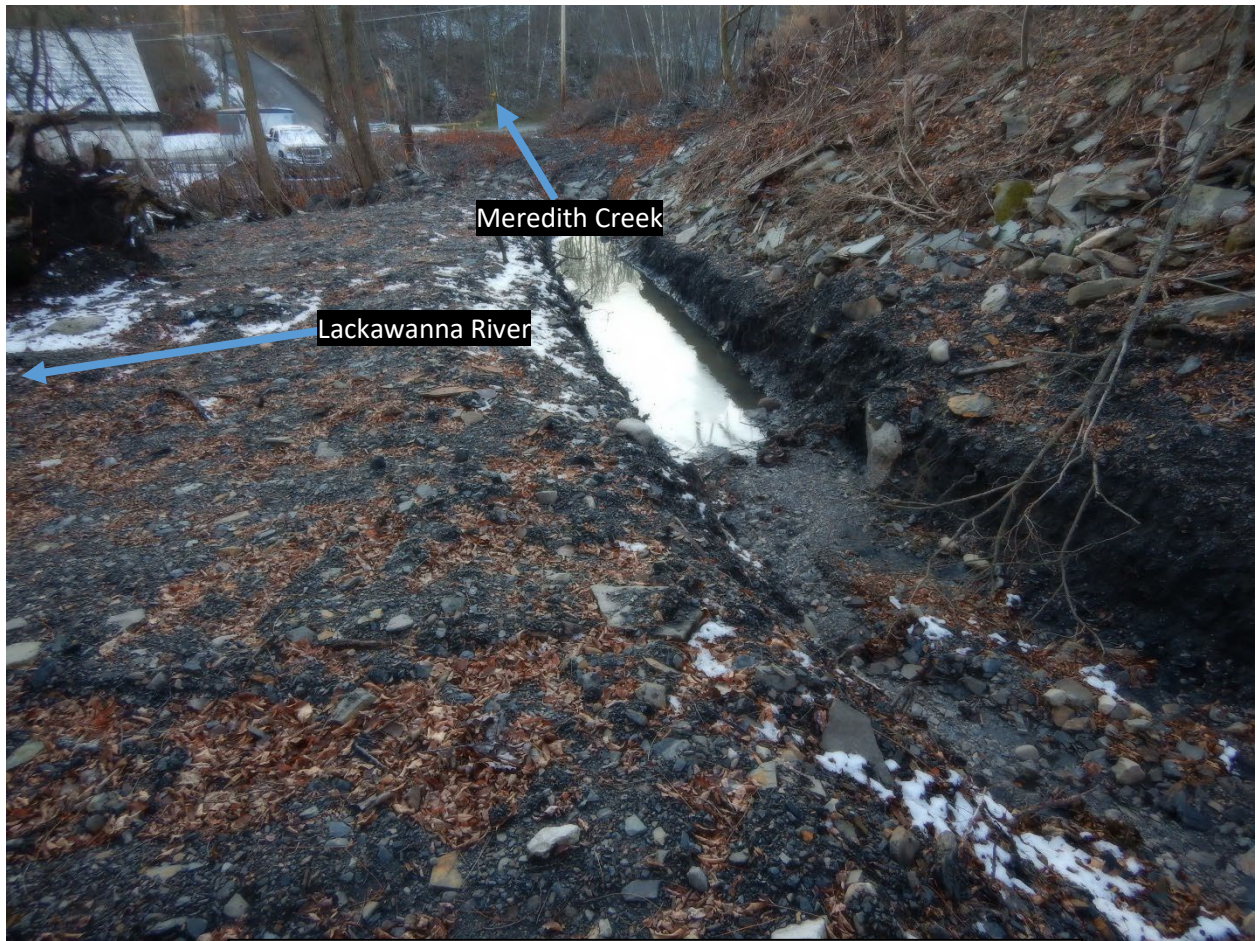
DSCN4064

Note Erosion and pooled water (Facility is uphill to the west,  
brookside road is 300ft south in photo)

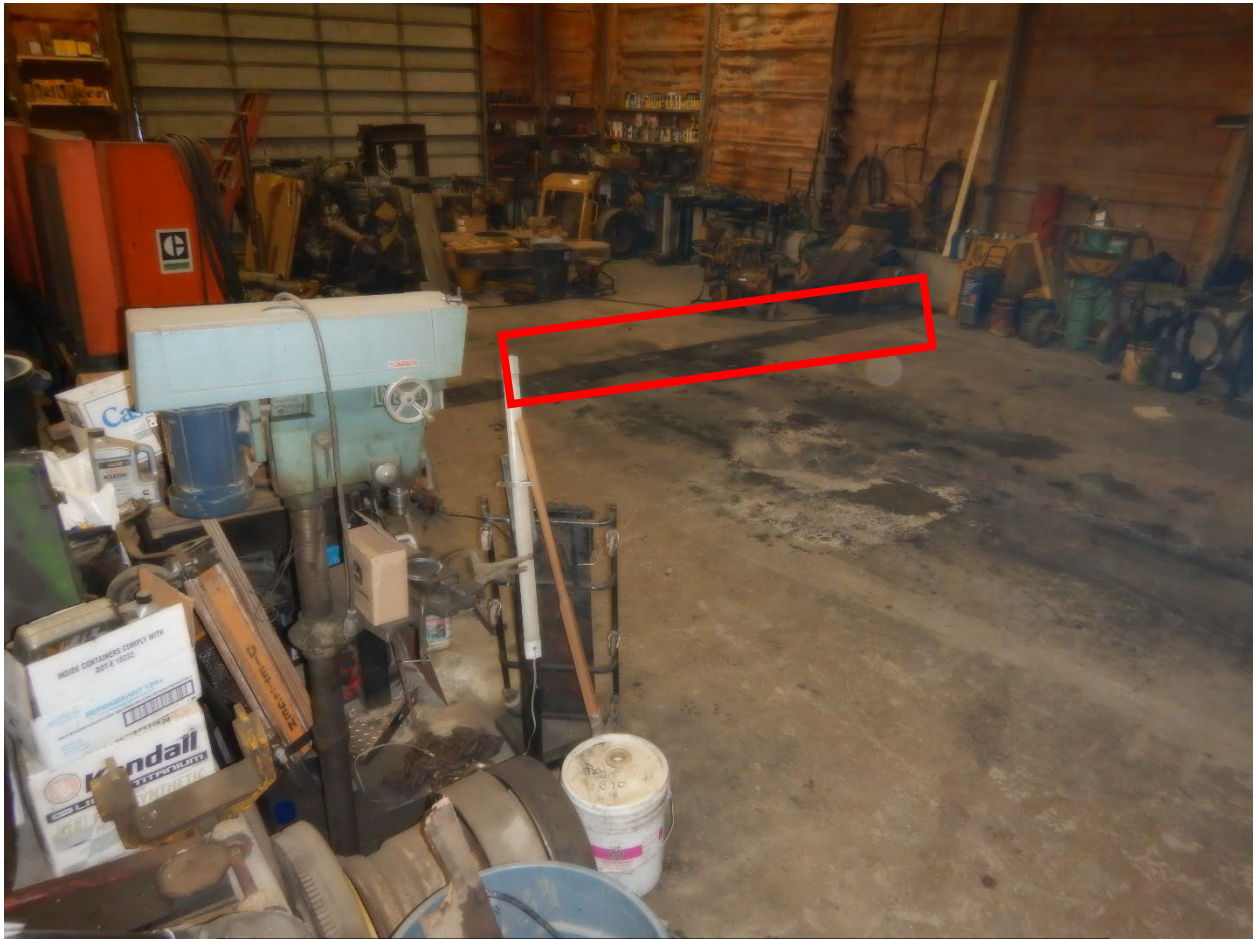
DSCN 4069  
Trench drain (red box) in maintenance garage – drain was plugged at time of inspection.
