## Region 6 - Enforcement & Compliance Assurance Division

### INSPECTION REPORT

| Company Name: | <b>Albuquerque Bernalillo County Water Utility Authority</b> | |

## **Section II - OBSERVATIONS**

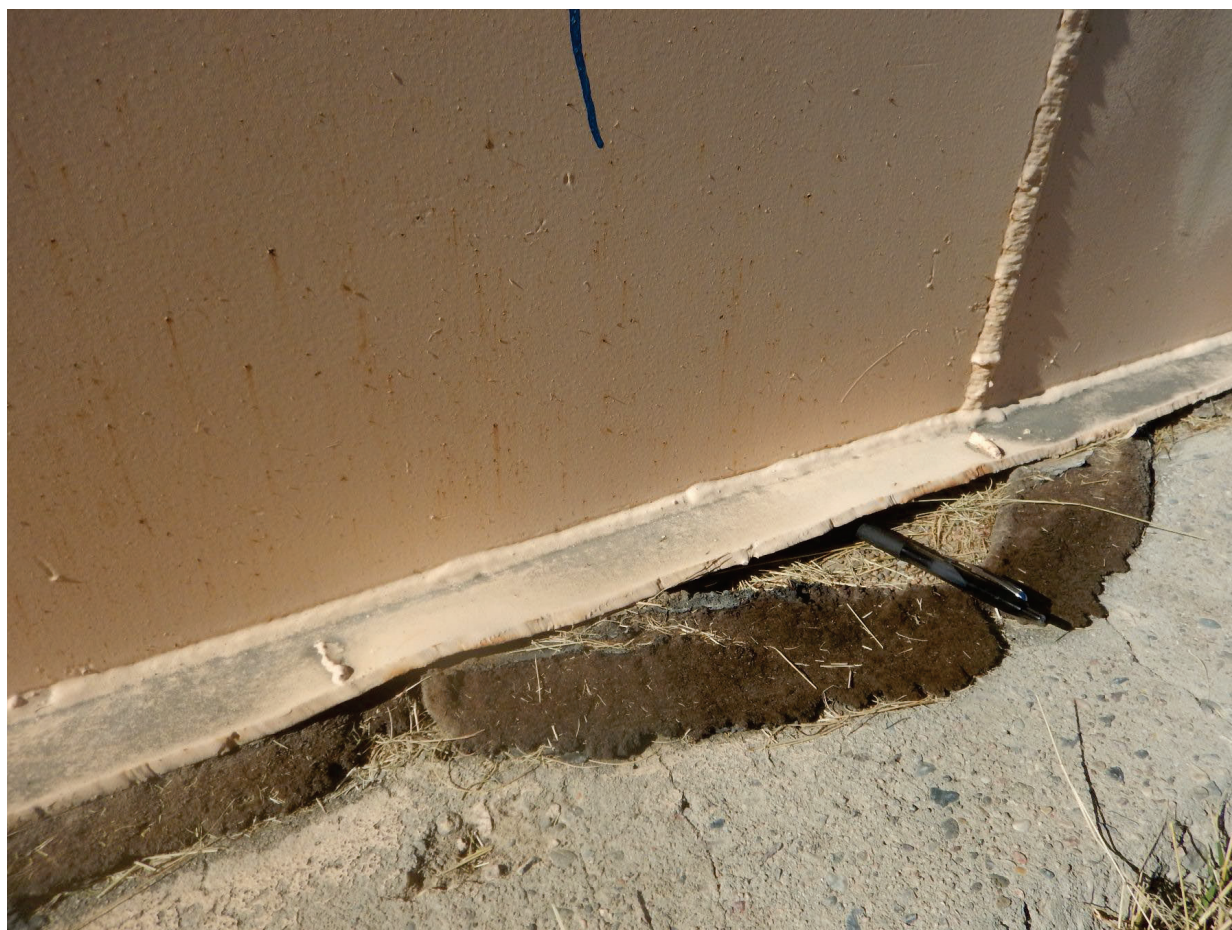
| Filename: | DSCN6012.JPG | Photo Date: | 10/20/2025 | Time: | 15:18:01 | | |

**Observation 3.** The EPA Inspection Team observed that the foundation seal for College Reservoir, Corrales Reservoir #3, Vol-Andia Reservoir #2, and Glenwood Reservoir was missing in areas. (refer to Appendix 2, Photographs 1, 3, 9 and 15). In the correspondence received on November 24, 2025, ABCWUA states that new felt material will be installed during the low water demand period between January and April 2026 (refer to Appendix 4).

| Description: | Close up view of the bottom of the College Reservoir. The sealing material had moved and there was a gap between the bottom plate and the concrete foundation. Note the pen inside the gap for scale. | | |

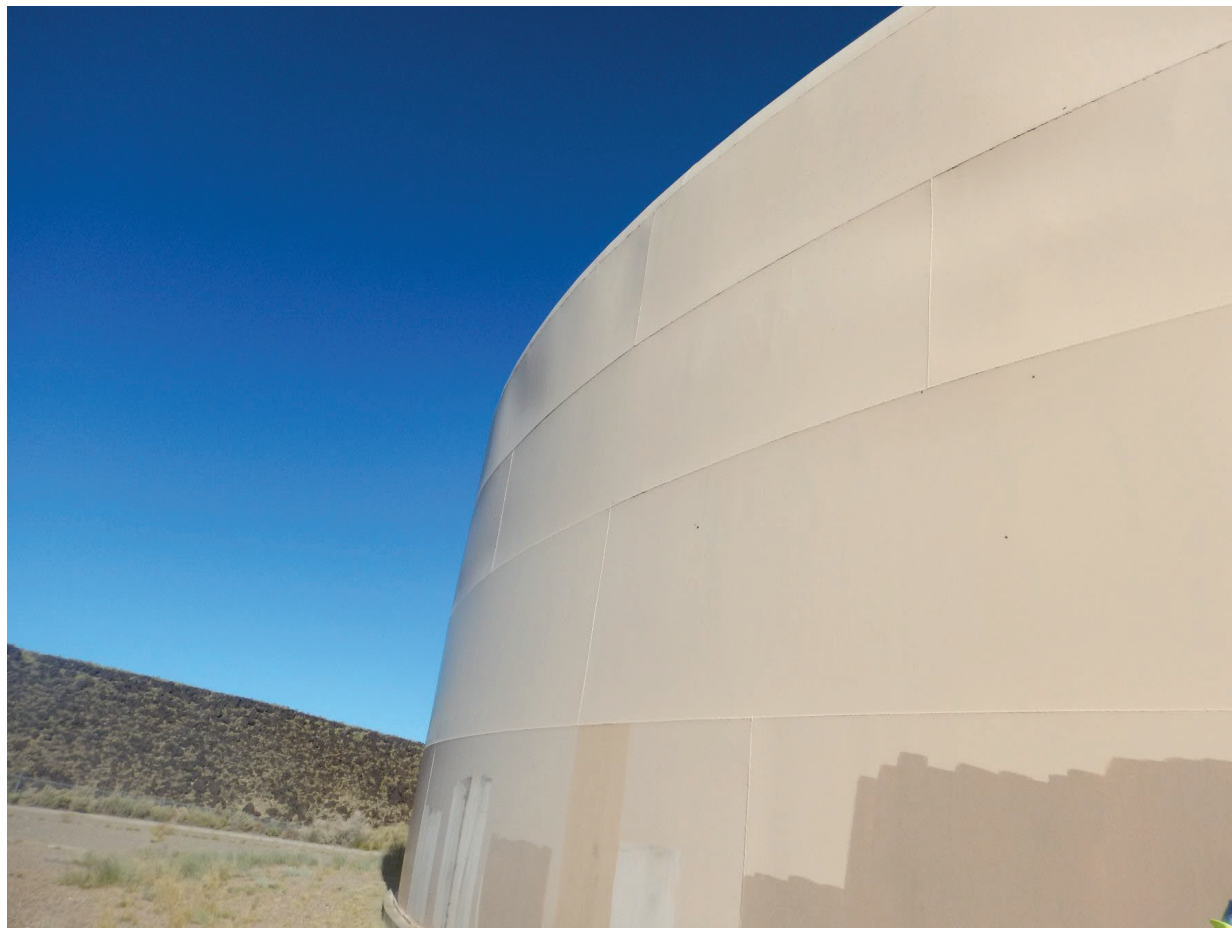
| Filename: | DSCN6015.JPG | Photo Date: | 10/20/2025 | | Time: | 15:20:16 | |

**Observation 4.** The EPA Inspection Team observed several dents on the College Reservoir outer walls (refer to Appendix 2, Photograph 2). The most recent storage tank inspection, completed on March 19, 2025, and submitted to the inspection team at the time of inspection, states that the structural elements and exterior coating of the tank are in fair condition.

| Description: | View of College Reservoir with a dent on the top. | | |

| EPA Inspection Observations | | | |
|---|---|---|---|
| College Storage Tank | There is evidence of a suction event of the storage tank that could have caused the integrity of the structure to decrease. | Inspection on the storage tank completed and emailed. | 10/23/2025 |

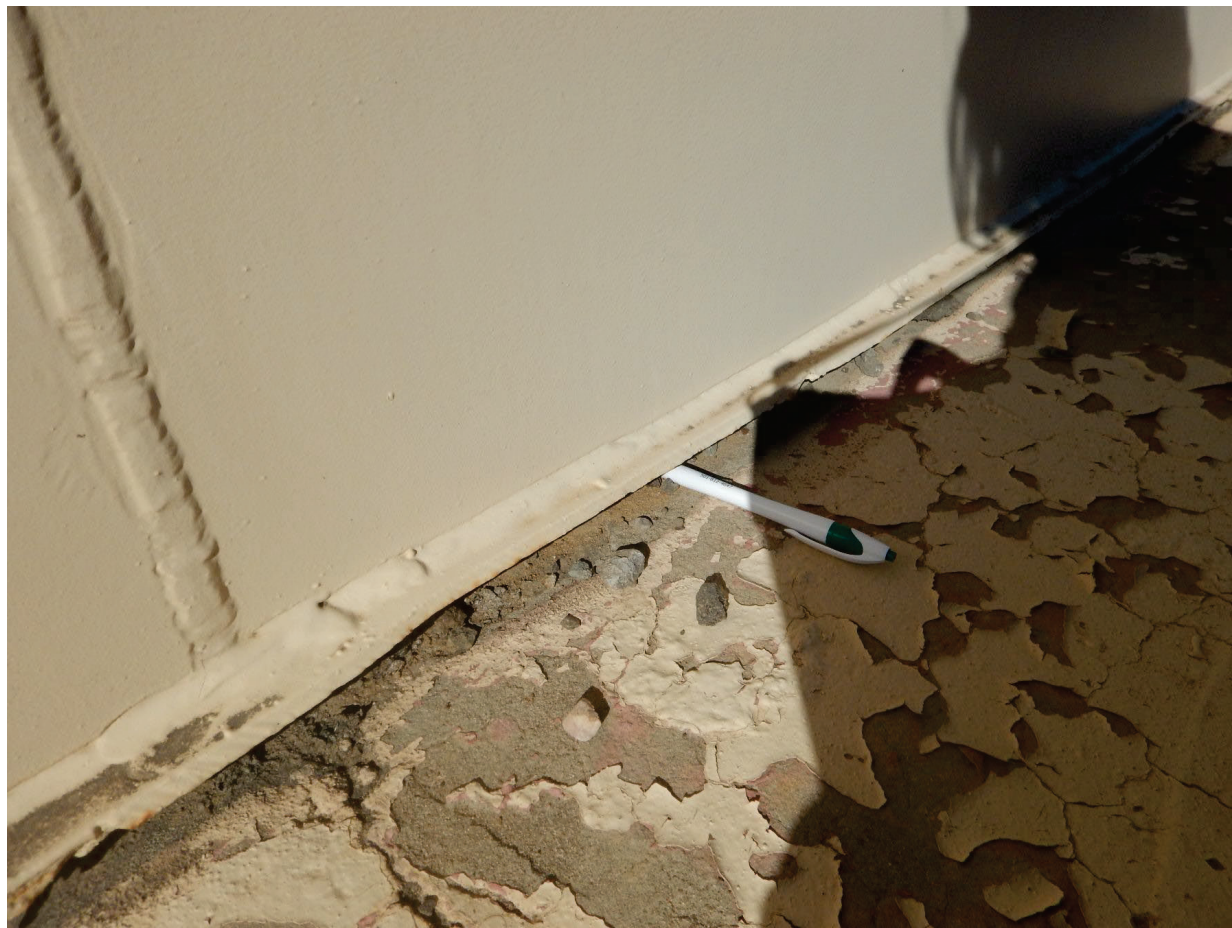
| Filename: | DSCN6019.JPG | Photo Date: | 10/21/2025 | | Time: | 15:25:58 | |

| Description: | Close up view of the bottom of the Corrales Reservoir #3. There was a gap between the bottom plate and the concrete foundation. Note the pen inside the gap for scale. | | |

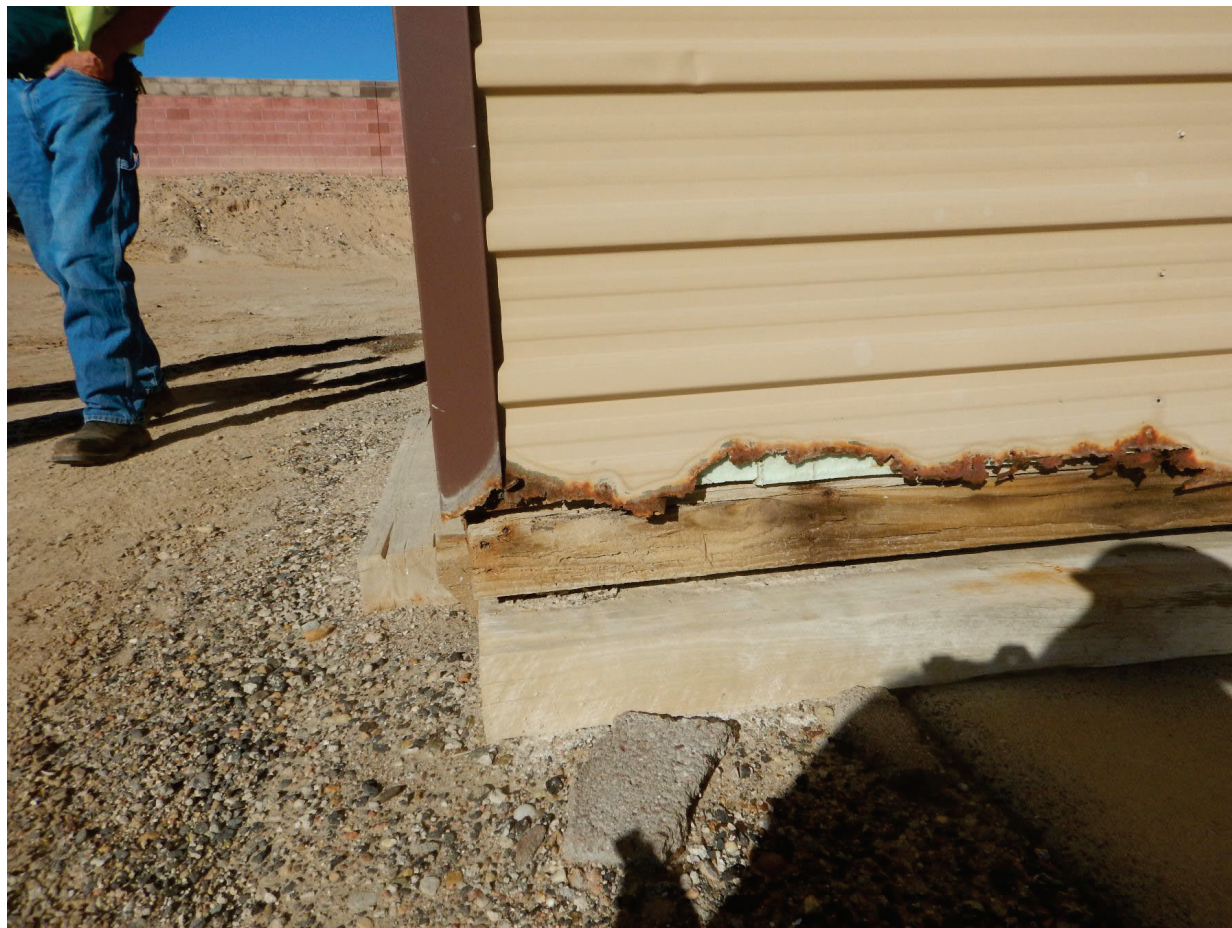
| Filename: | DSCN6023.JPG | Photo Date: | | 10/21/2025 | | Time: | 15:56:11 |

**Observation 11.** The EPA Inspection Team observed significant rust corrosion on the bottom of the salt storage tank at Corrales Well #8 (refer to Appendix 2, Photograph 4). In the correspondence received on November 24, 2024, ABCWUA states that the salt shed will be replaced at the end of its service life, which it has not yet reached (refer to Appendix 4).

| Description: | Close up view of the bottom of a storage shed at Corrales Well #8 with rust corrosion. | | |

| EPA Inspection Observations | | | |
|---|---|---|---|
| Corrales Well #08 | There was corrosion on the salt shed that could affect the integrity of the structure. | Salt sheds are replaced periodically at end of service life. This salt shed has several years of service life remaining. | TBD |

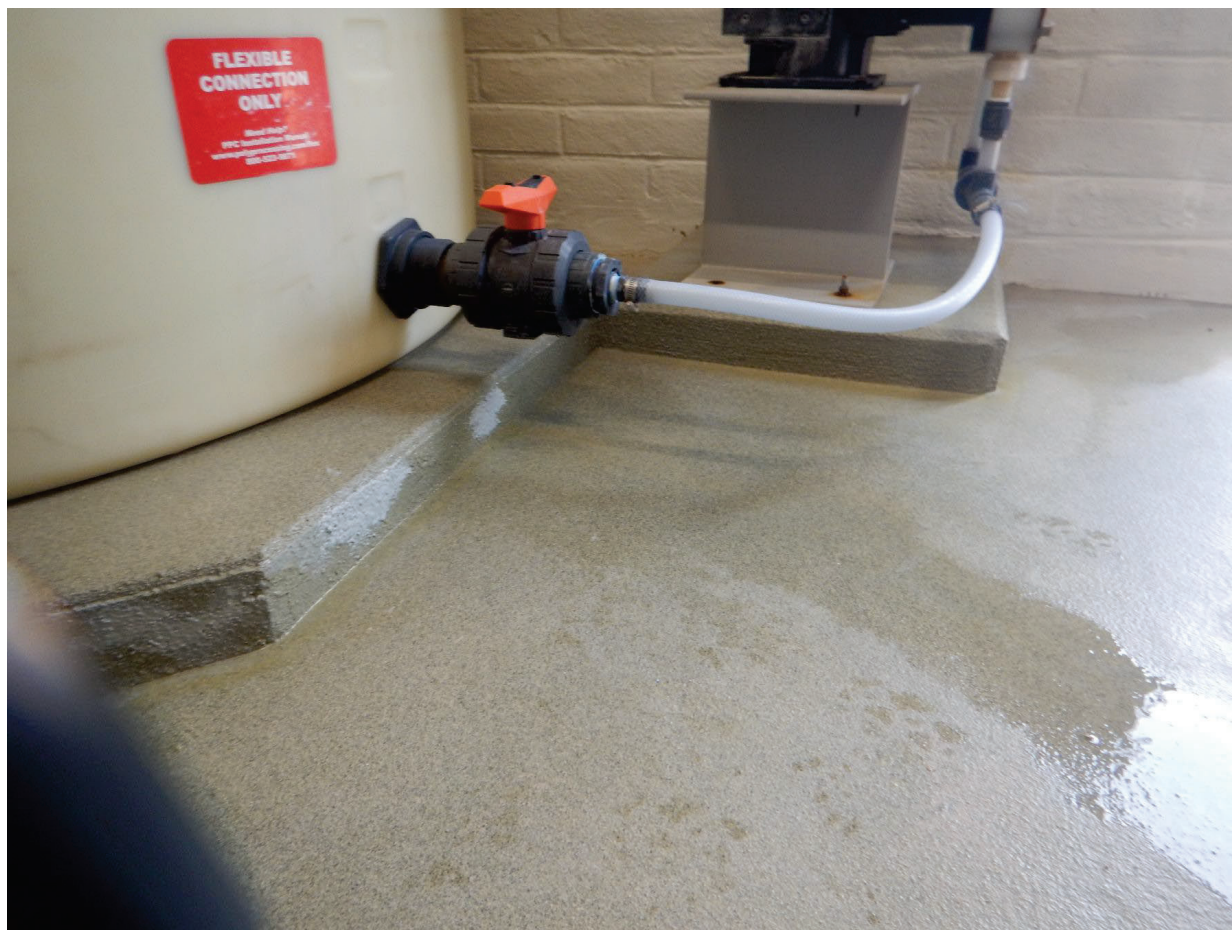
| Filename: | DSCN6024.JPG | Photo Date: | 10/22/2025 | Time: | 10:18:08 | | |

**Observation 13.** The EPA Inspection Team observed a leak in the discharge valve from the sodium hypochlorite tank (refer to Appendix 2, Photograph 5). It was immediately addressed by the facility.

| Description: | View of the discharge valve from the sodium hypochlorite tank that had an ongoing leak during the inspection. | | |

| EPA Inspection Observations | | | |
|---|---|---|---|
| Griegos Pump Station | There was a leak on the discharge valve from the sodium hypochlorite tank. | The leak was immediately addressed. | 10/22/2025 |

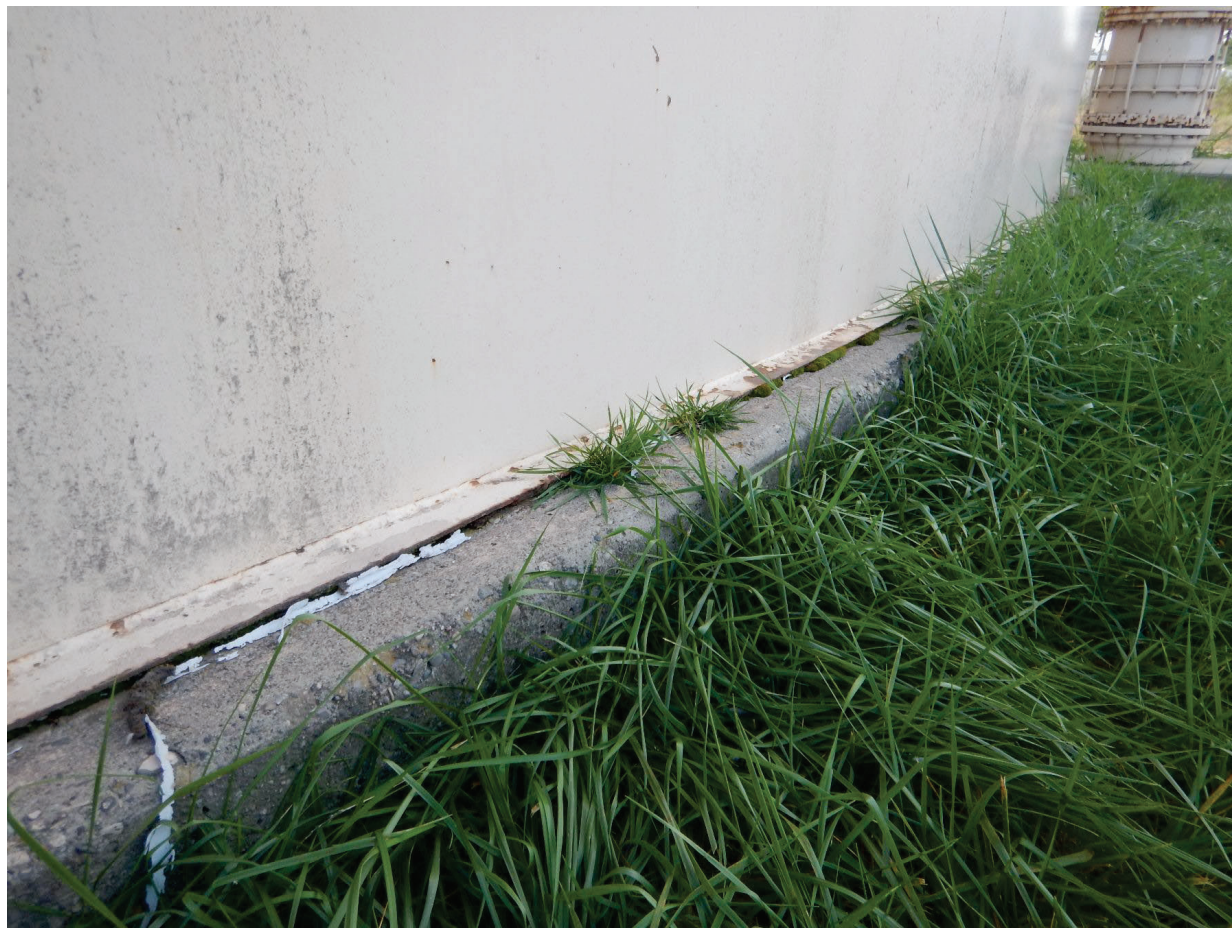
| Filename: | DSCN6026.JPG | Photo Date: | 10/22/2025 | | Time: | 10:20:23 | |

**Observation 6.** The EPA Inspection Team observed plant roots at the interface of the tank bottom plate and tank foundation at Griegos Reservoir and Glenwood Reservoir (refer to Appendix 2, Photographs 6 and 15). The vegetation was immediately removed, and photo documentation was submitted to EPA on October 23, 2025, as proof of completion (refer to Appendices 3 and 4).

| Description: | Close up view of the bottom of the Griegos Reservoir. There was vegetation growing on top of the concrete foundation and under the tank plate. | | |

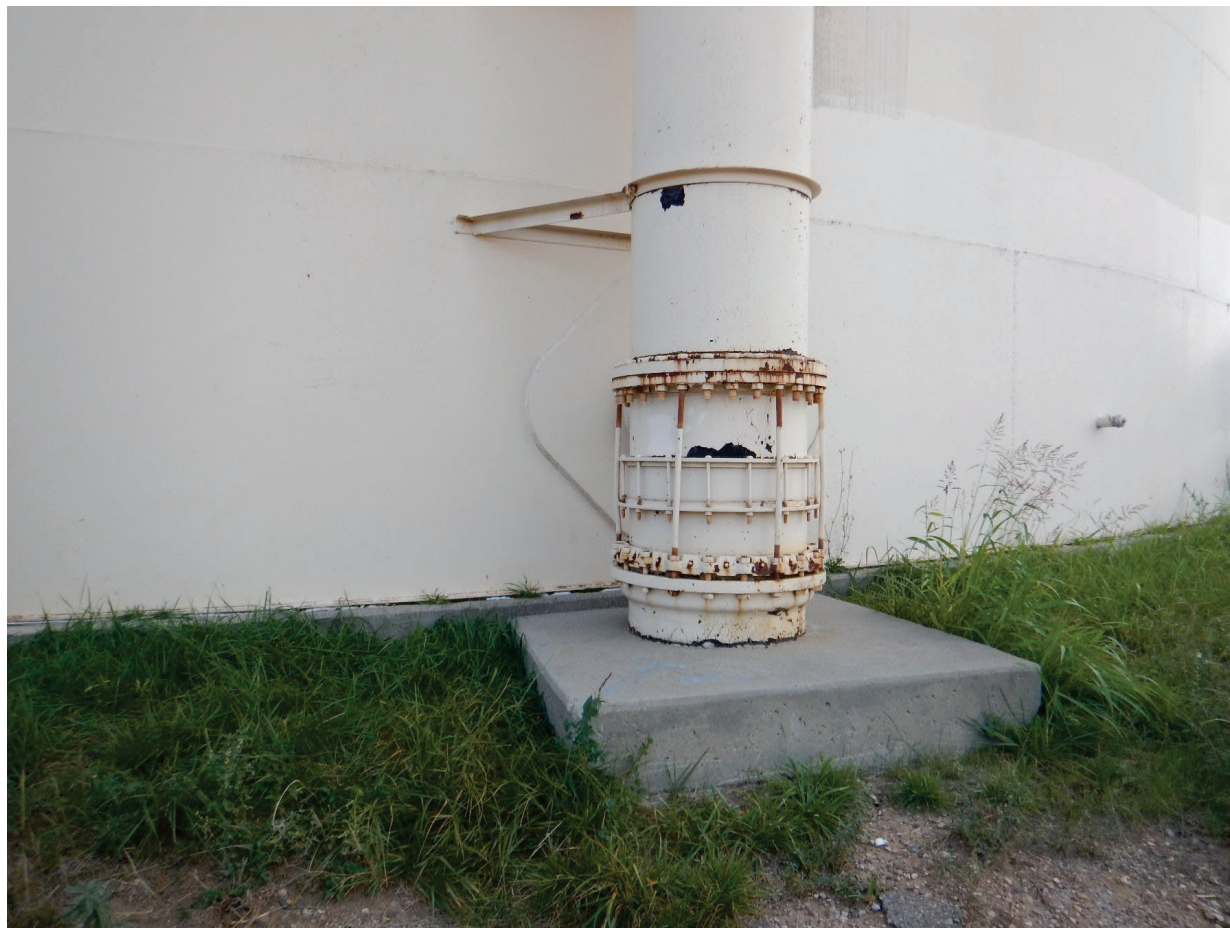
| Filename: | DSCN6027.JPG | Photo Date: | 10/22/2025 | | Time: | 10:21:37 | |

| Description: | View of the intake pipe at Griegos Reservoir showing rust on the intake pipe. | | |

| EPA Inspection Observations | | | |
|---|---|---|---|
| | There was evidence of rust on the intake pipe going into the storage tank. | Surface rust present does not impact the integrity of the exposed pipe or fitting. The exposed pipe and fitting will be recoated during the low water demand period between January and April 2026 | Jan-Apr 2026 |

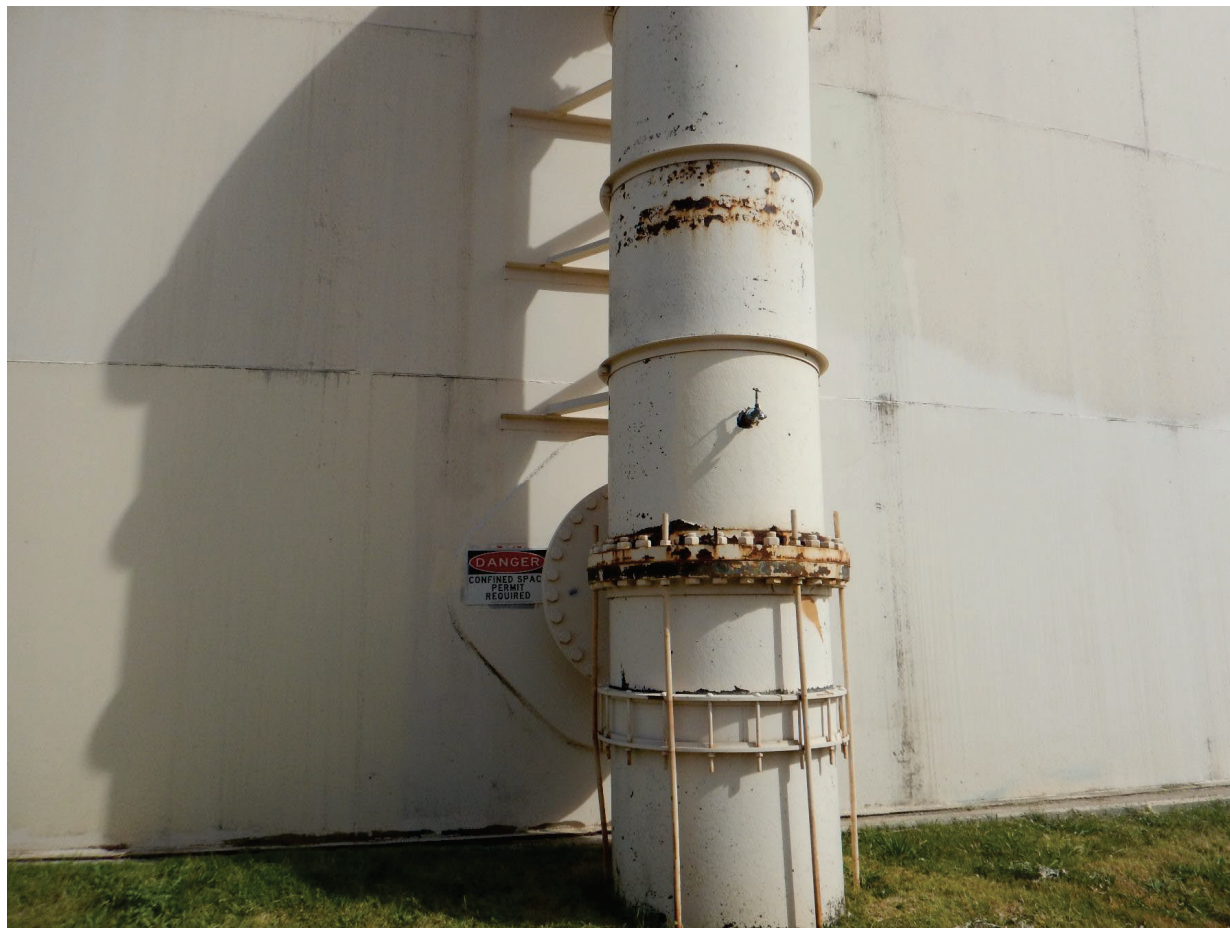
| Filename: | DSCN6028.JPG | Photo Date: | 10/22/2025 | Time: | 11:34:15 | | |

| Description: | View of the intake pipe at Vol-Andia Reservoir #1 showing rust on the intake pipe. | | |

| EPA Inspection Observations | | | |
|---|---|---|---|
| Vol Andia Storage Tank #01 | Has rust on intake pipe | Surface rust present does not impact the integrity of the exposed pipe or fitting. The exposed pipe and fitting will be recoated during the low water demand period between January and April 2026 | Jan-Apr 2026 |

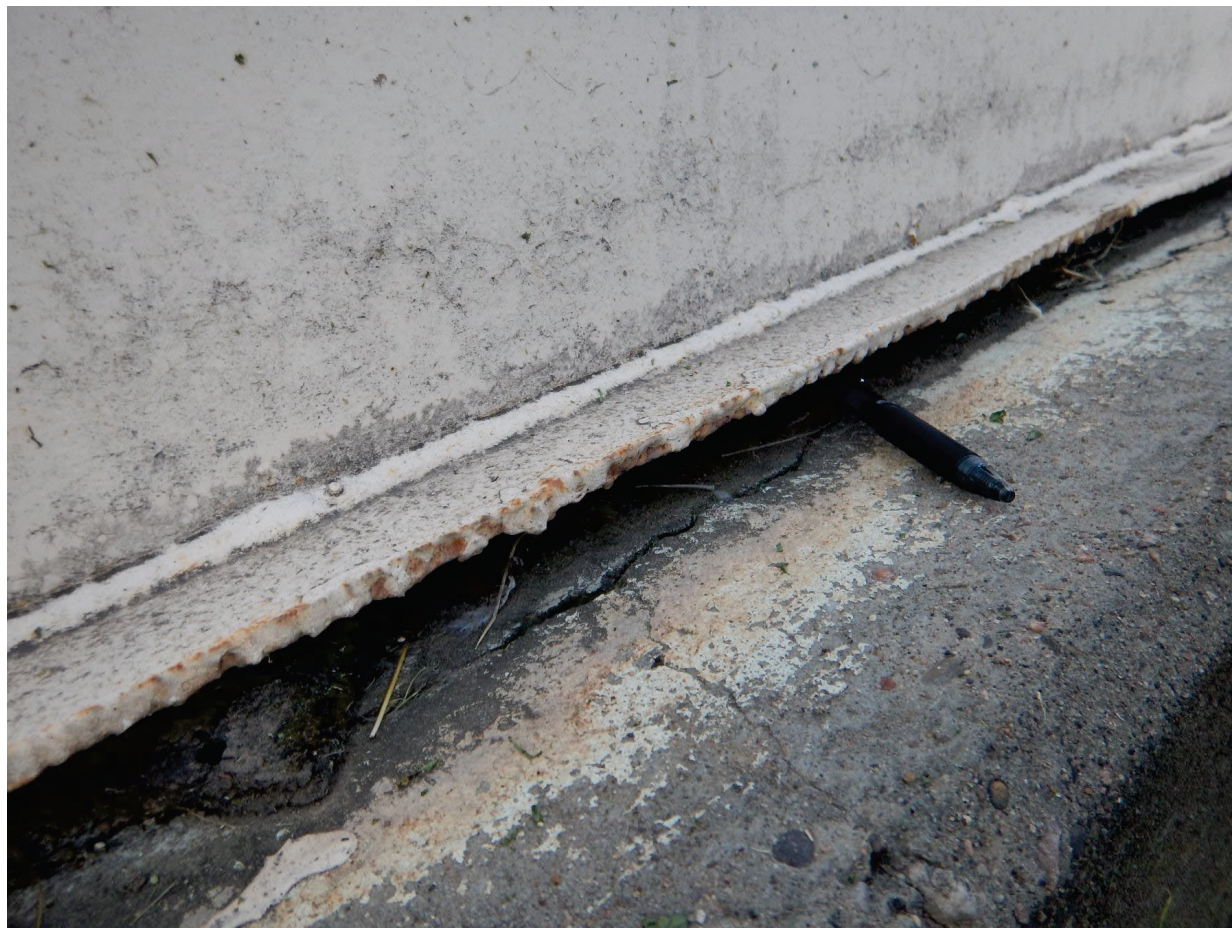
| Filename: | DSCN6030.JPG | Photo Date: | 10/22/2025 | | Time: | 11:36:53 | |

| Description: | Close up view of the bottom of the Vol-Andia Reservoir #2. The sealing material had moved and there was a gap between the bottom plate and the concrete foundation. Note the pen inside the gap for scale. | | |

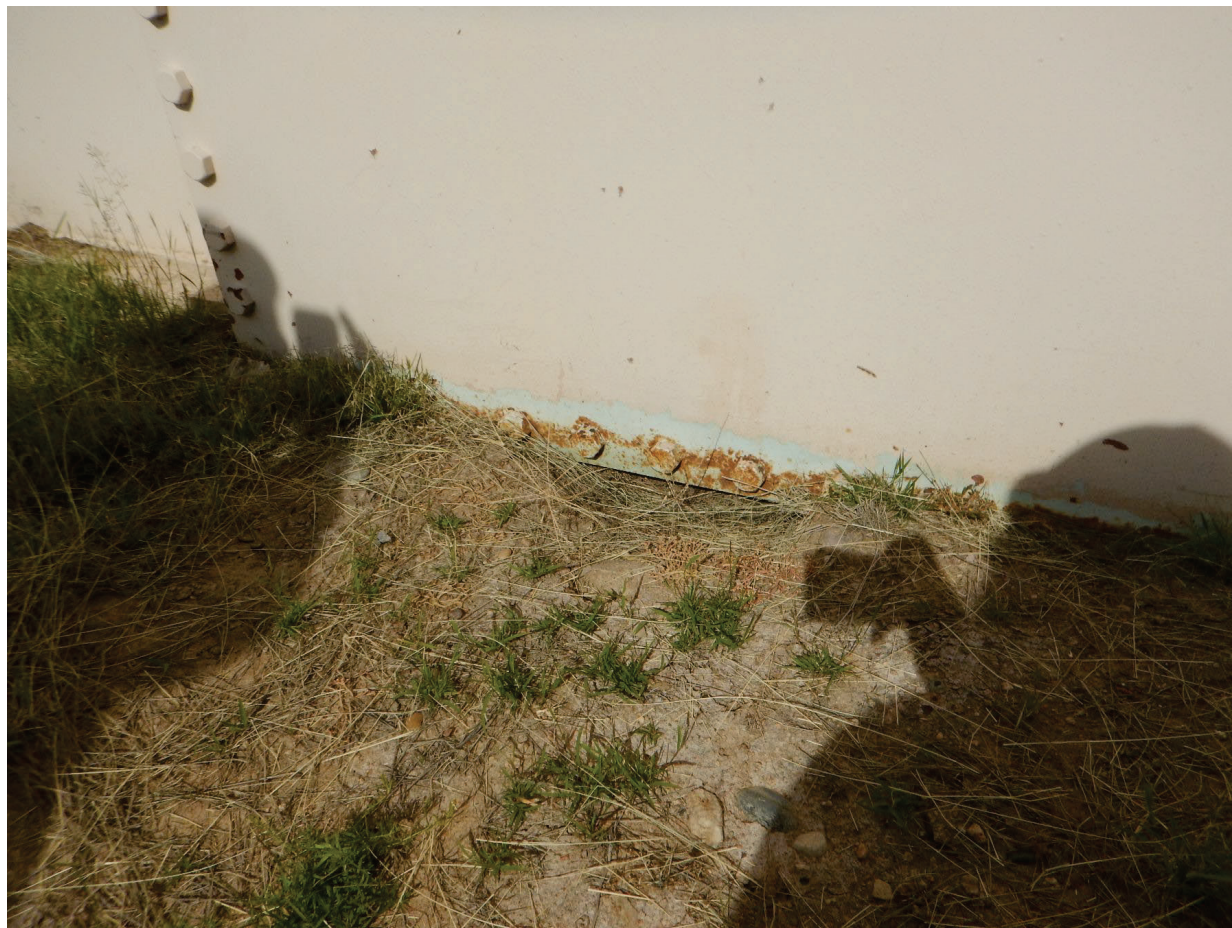
| Filename: | DSCN6032.JPG | Photo Date: | 10/22/2025 | | Time: | 11:39:14 | |

**Observation 5.** The EPA Inspection Team observed a hole under the Vol-Andria Reservoir #2 (refer to Appendix 2, Photograph 10). The hole was immediately covered up, and photo documentation was submitted to EPA on October 23, 2025, as proof of completion (refer to Appendices 3 and 4).

| Description: | Close up view of the bottom of the Vol-Andia Reservoir #2. There was a significant hole under the Reservoir that appeared to be a burrowing hole of an animal. | | |

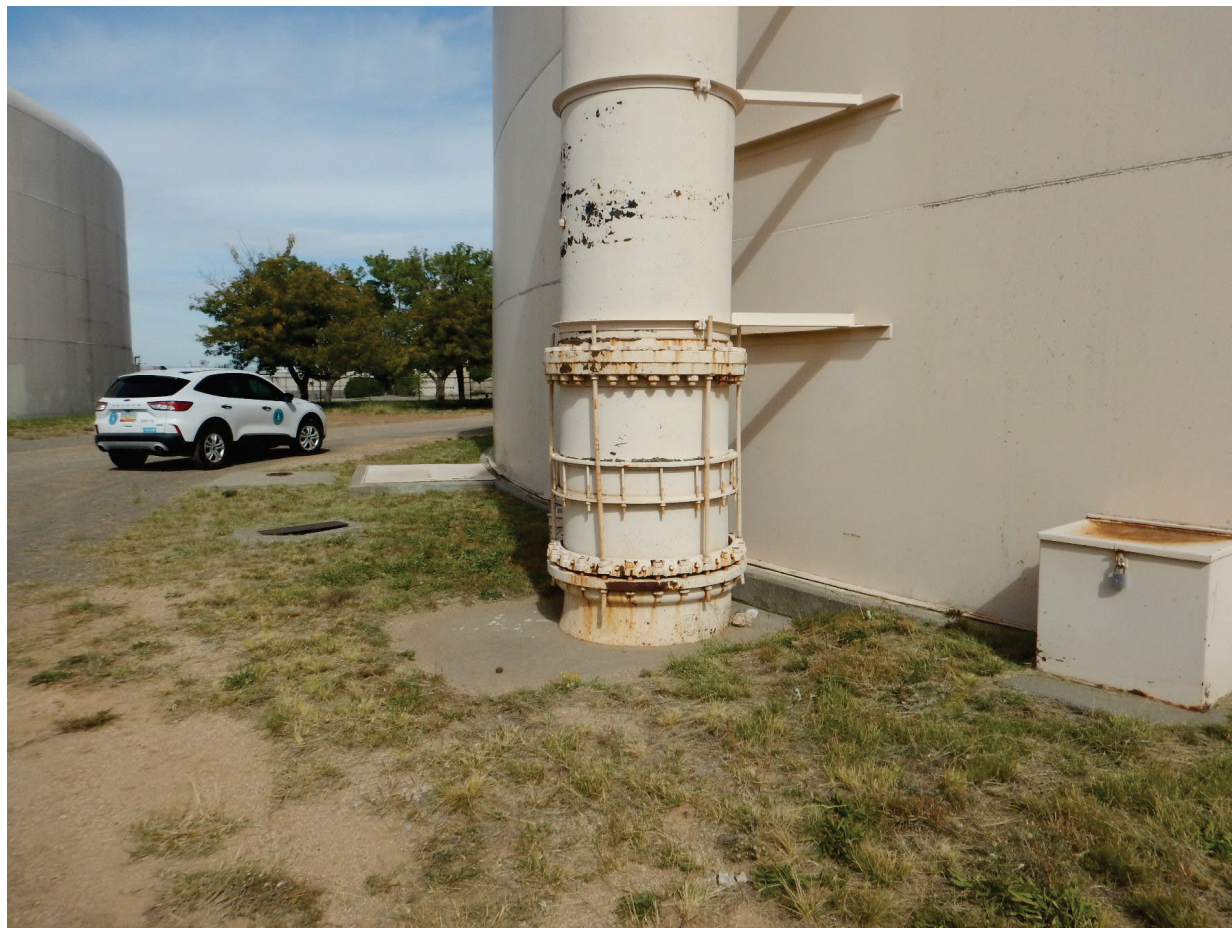
| Filename: | DSCN6034.JPG | Photo Date: | 10/22/2025 | | Time: | 11:42:09 | |

| Description: | View of the intake pipe at Vol-Andia Reservoir #2 showing rust on the intake pipe. | | |

| EPA Inspection Observations | | | |
|---|---|---|---|
| | There was evidence of rust on the intake pipe going into the storage tank. | Surface rust present does not impact the integrity of the exposed pipe or fitting. The exposed pipe and fitting will be recoated during the low water demand period between January and April 2026 | Jan-Apr 2026 |

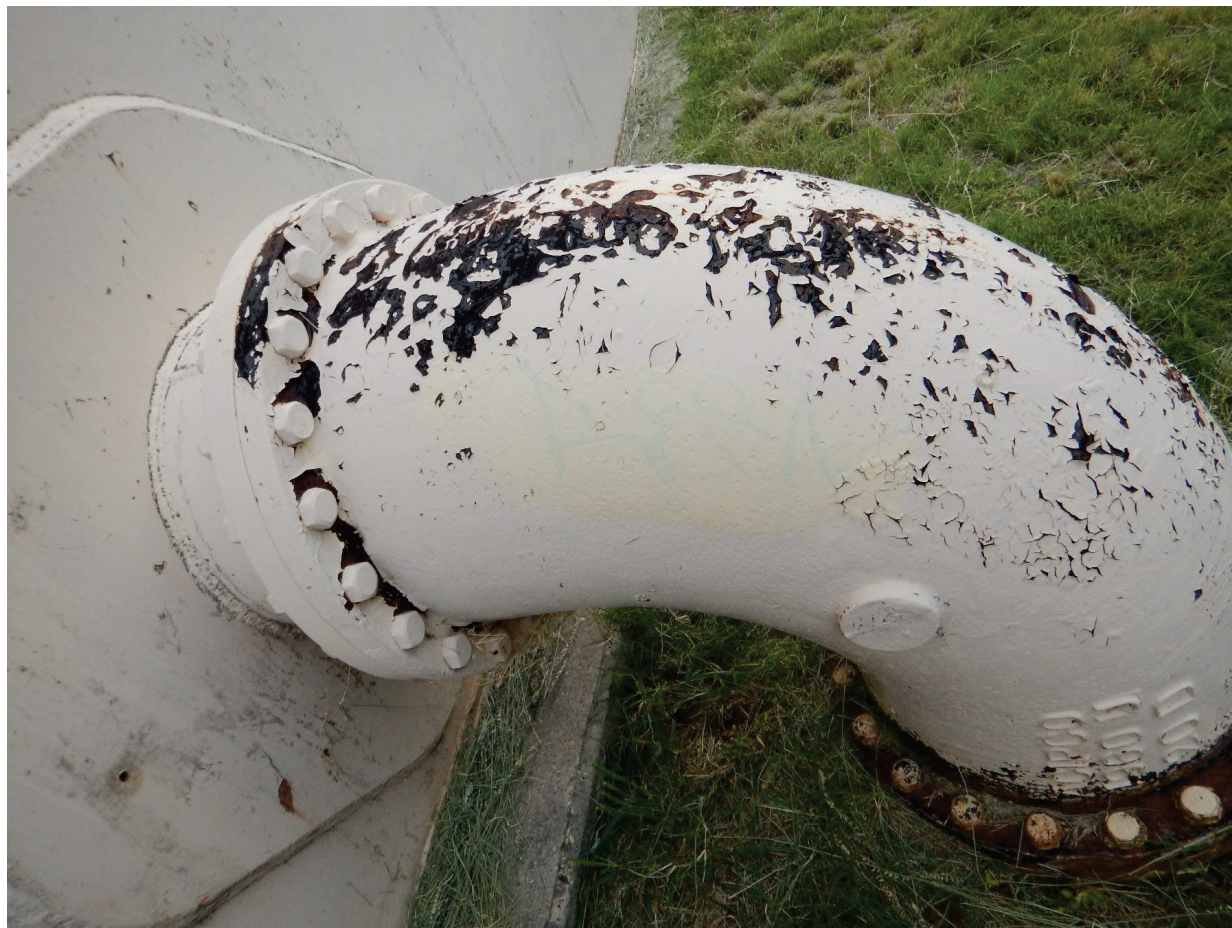
| Filename: | DSCN6035.JPG | Photo Date: | 10/22/2025 | | Time: | 13:49:29 | |

| Description: | View of the intake pipe at Leyendecker Reservoir showing rust on the outflow pipe. | | |

| Leyendecker Storage Tank | There was rust on the bottom of the tank, outflow pipe, and in circles going up the tank. | Surface rust present does not impact the integrity of the tank shell or the exposed pipe. The tank will be recoated in the future as part of the CIP Reservoir Rehabilitation program currently in the planning and budgeting stages | TBD |

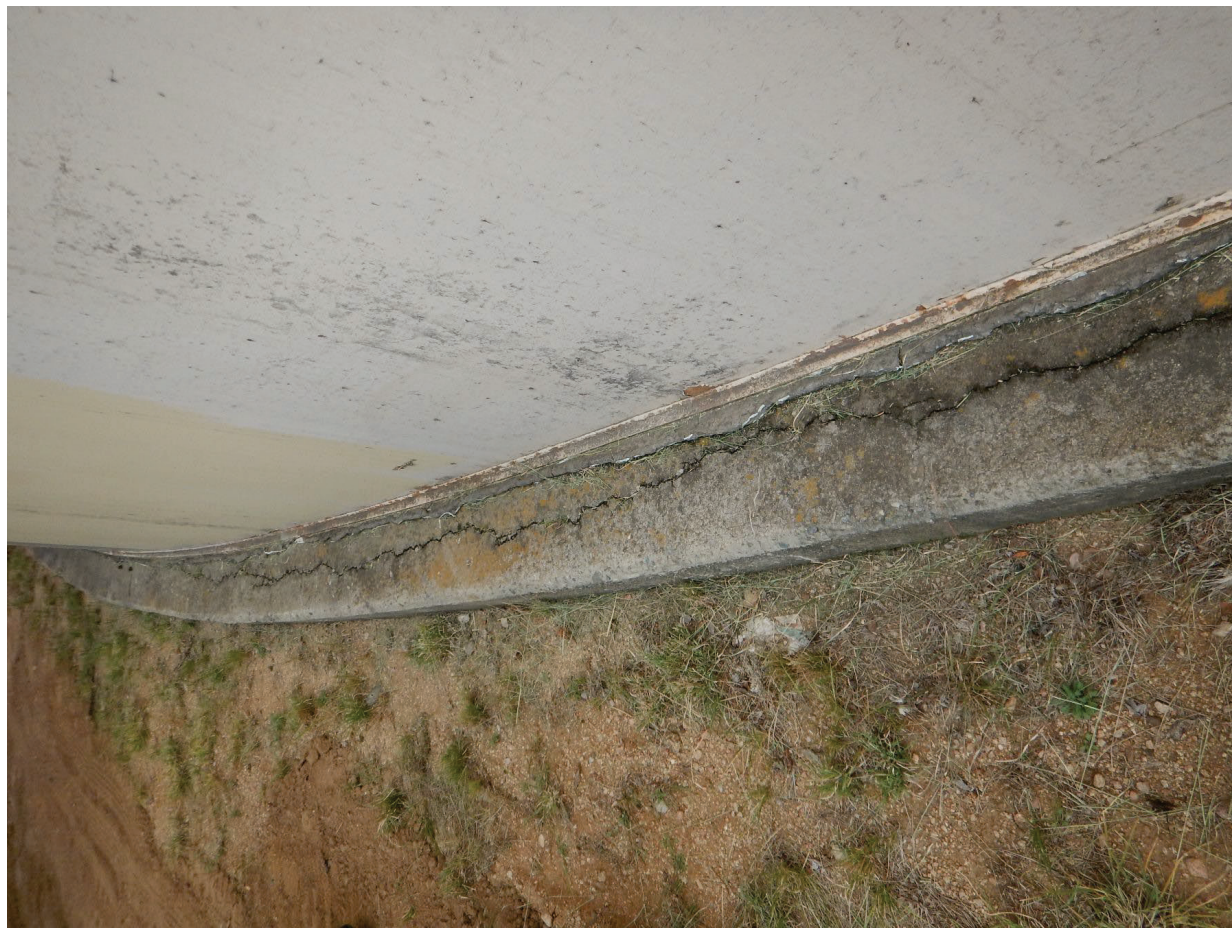
| Filename: | DSCN6036.JPG | Photo Date: | 10/22/2025 | | Time: | 13:50:50 | |

| Description: | Close up view of the bottom of the Leyendecker Reservoir showing a crack in the concrete base. | | |

| | There was crack on the concrete base. | The concrete ringwall integrity will be evaluated by a structural engineer in the Spring of 2026. | Spring of 2026 |

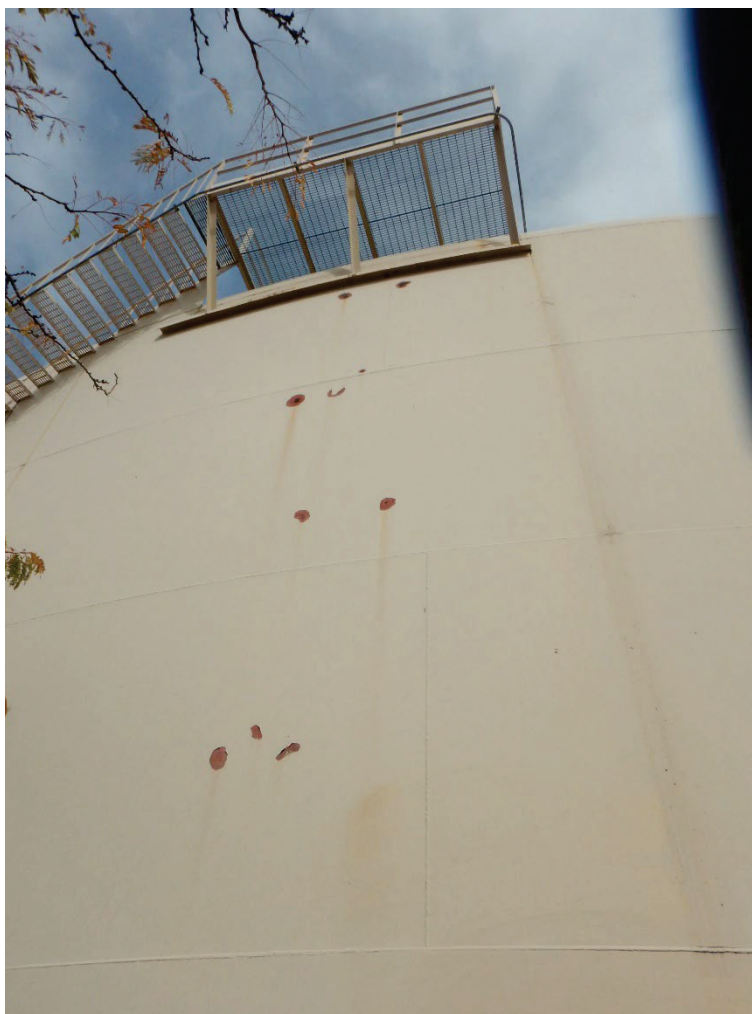
| Filename: | DSCN6038.JPG | Photo Date: | 10/22/2025 | | Time: | 13:56:32 | |

| Description: | View of the Leyendecker Reservoir outer wall with rust circles. | | |

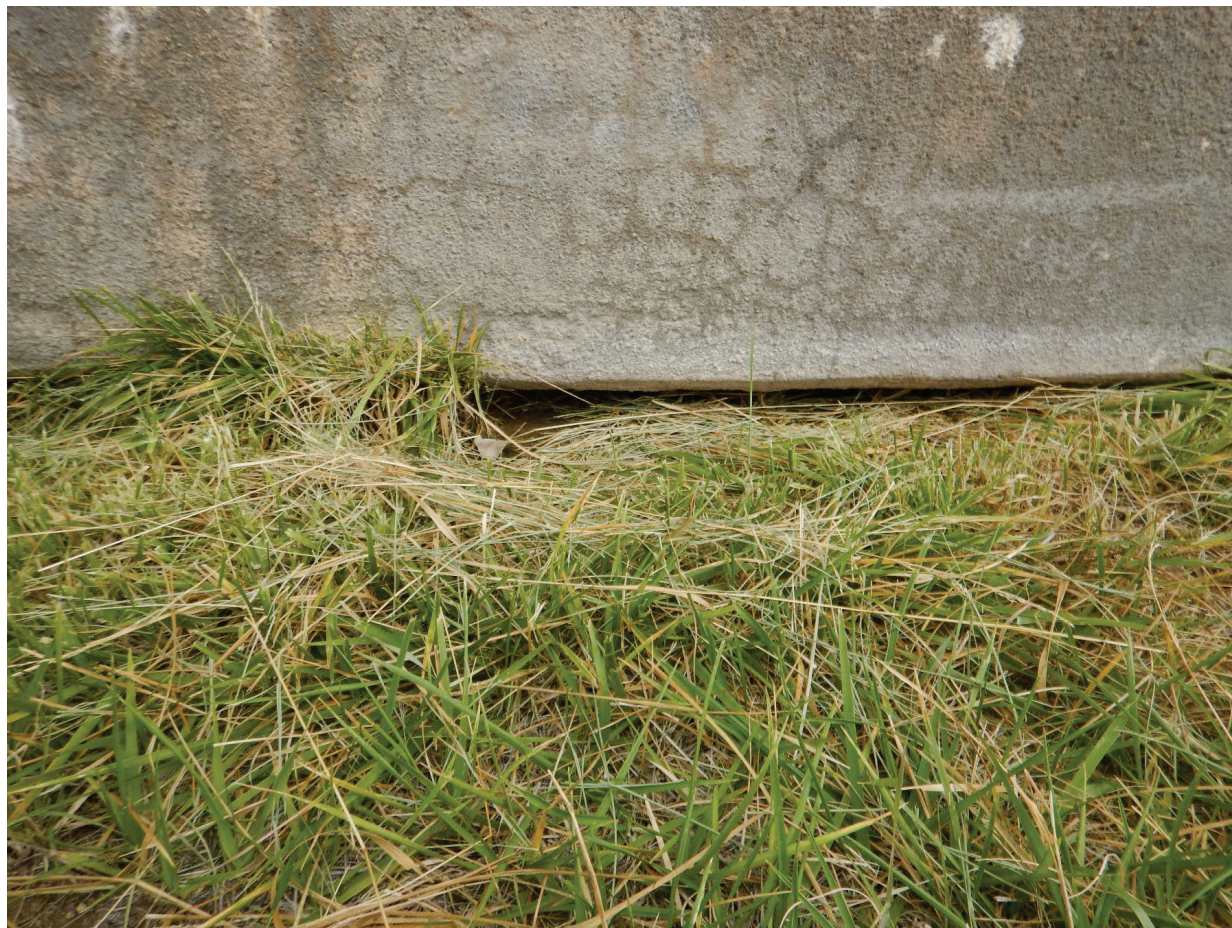
| Filename: | DSCN6039.JPG | Photo Date: | 10/22/2025 | | Time: | 14:19:29 | |

| Description: | Close up view of the bottom of the Glenwood Reservoir. There was a gap between the bottom plate and the concrete foundation and vegetation was growing on top of the concrete pad and under the reservoir. | | |

| Glenwood Reservoir #1 | The filling that was placed at the bottom of the reservoir has come out causing a gap between the concrete pad and the storage tank | Reservoir is scheduled for dry interior and exterior structural inspections in calendar year 2026. Subsequent repairs will be scheduled once a budget is developed and approved | TBD |

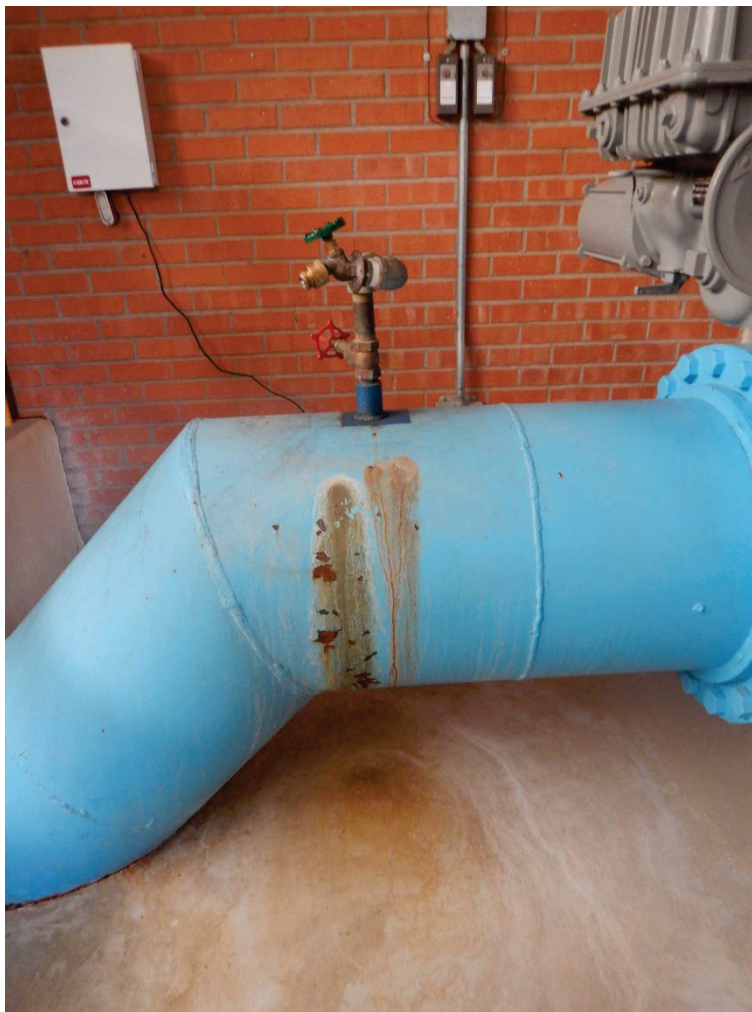
| Filename: | DSCN6042.JPG | Photo Date: | 10/22/2025 | | Time: | 14:29:11 | |

**Observation 10.** The EPA Inspection Team observed minor rust on one of the pipes connected to a booster pump at the Glenwood Pump Station (refer to Appendix 2, Photograph 16). In the correspondence received on November 24, 2024, ABCWUA states that the surface rust will be repaired between January and April 2026 (refer to Appendix 4).

| Description: | View of the pipes connected to one of the booster pumps at the Glenwood Pump Station with rust on it. | | |

| | One of the pumps was connected to a pipe with rust on it. | Surface rust will be repaired between January and April 2026 | Jan-Apr 2026 |

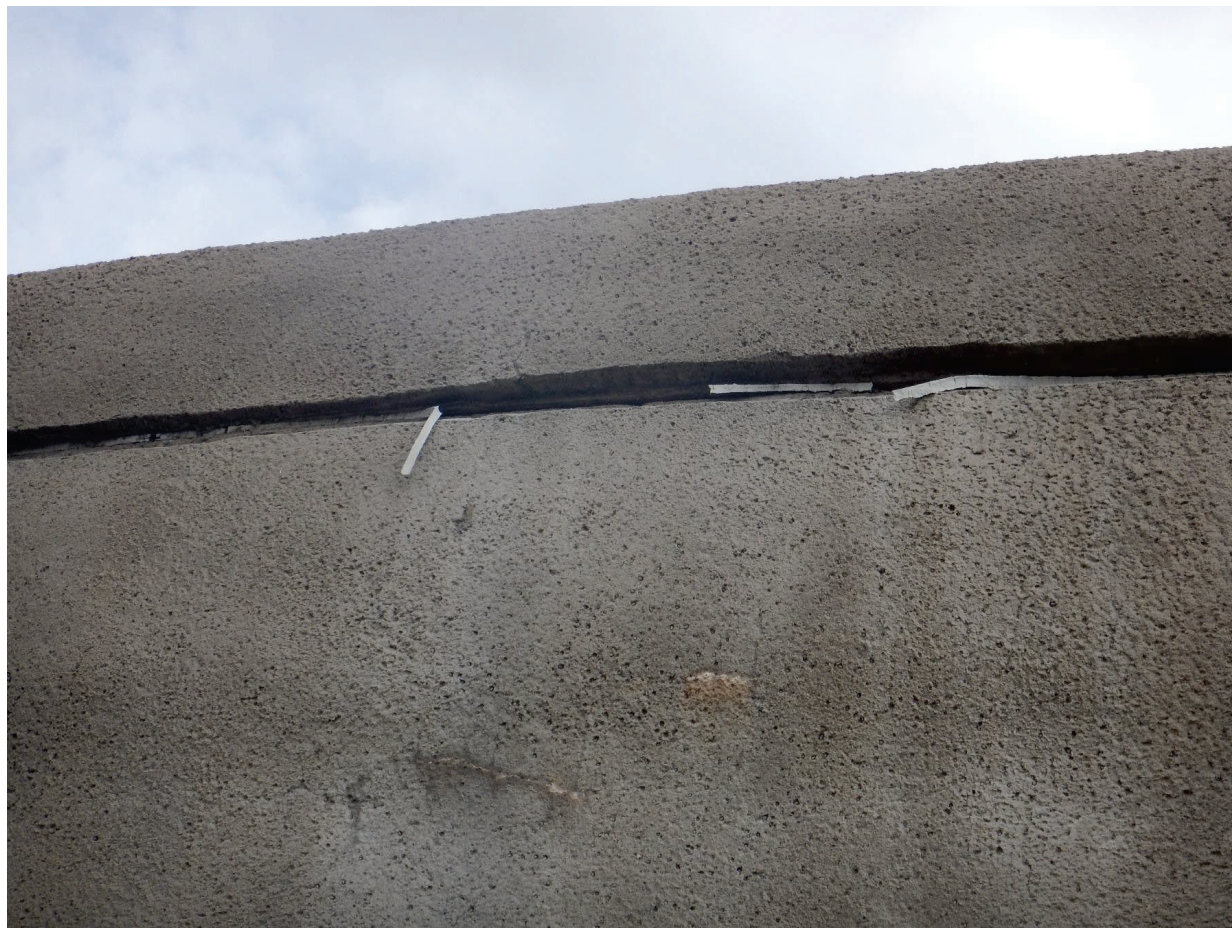
| Filename: | DSCN6046.JPG | Photo Date: | 10/22/2025 | Time: | 14:58:13 | | |

**Observation 12.** The EPA Inspection Team observed sealant peeling from the top of the Lomas Reservoir #1 (refer to Appendix 2, Photograph 17). In the correspondence received on November 24, 2025, ABCWUA states that the Lomas Reservoir #1 structural inspections and subsequent repairs are programmed to take place within the next five calendar years (2026-2030) (refer to Appendix 4).

| Description: | View of the top of Lomas Reservoir #1 showing sealant peeling from the top of the tank. | | |

| | Has sealant peeling from the top of the tank. | Reservoir structural inspections and subsequent repairs are programmed to take place within the next 5 calendar years (2026-2030) | 2026-2030 |
