## Region 6 - Enforcement & Compliance Assurance Division

### INSPECTION REPORT

| Company Name: | <b>Albuquerque Bernalillo County Water Utility Authority</b> | |

## **Section II - OBSERVATIONS**

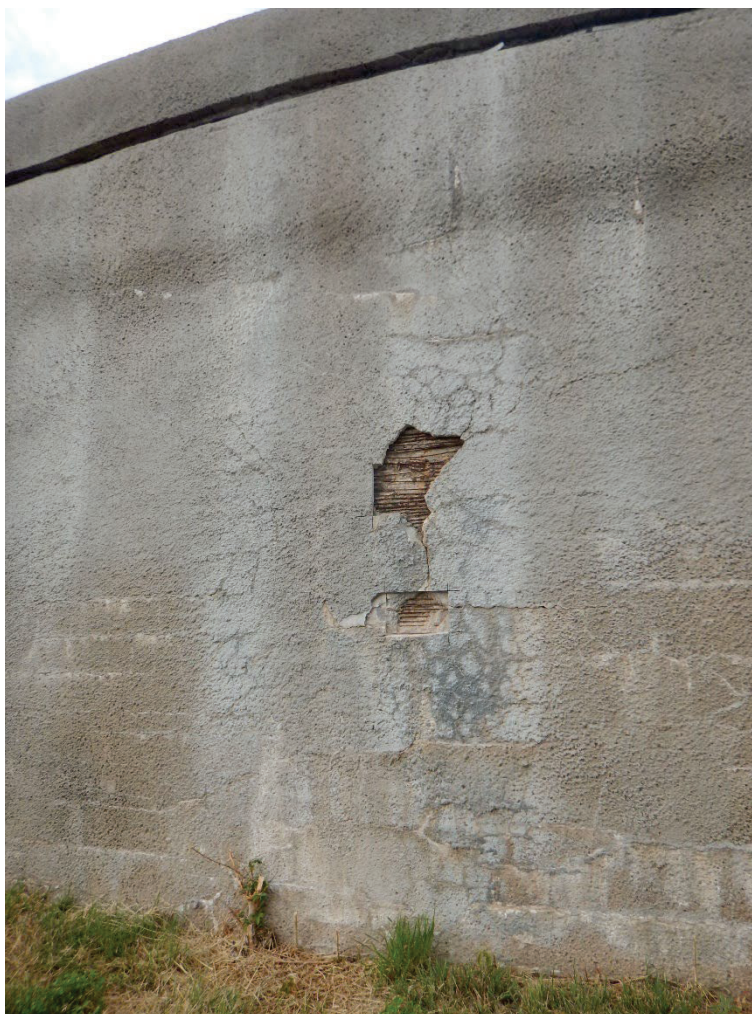
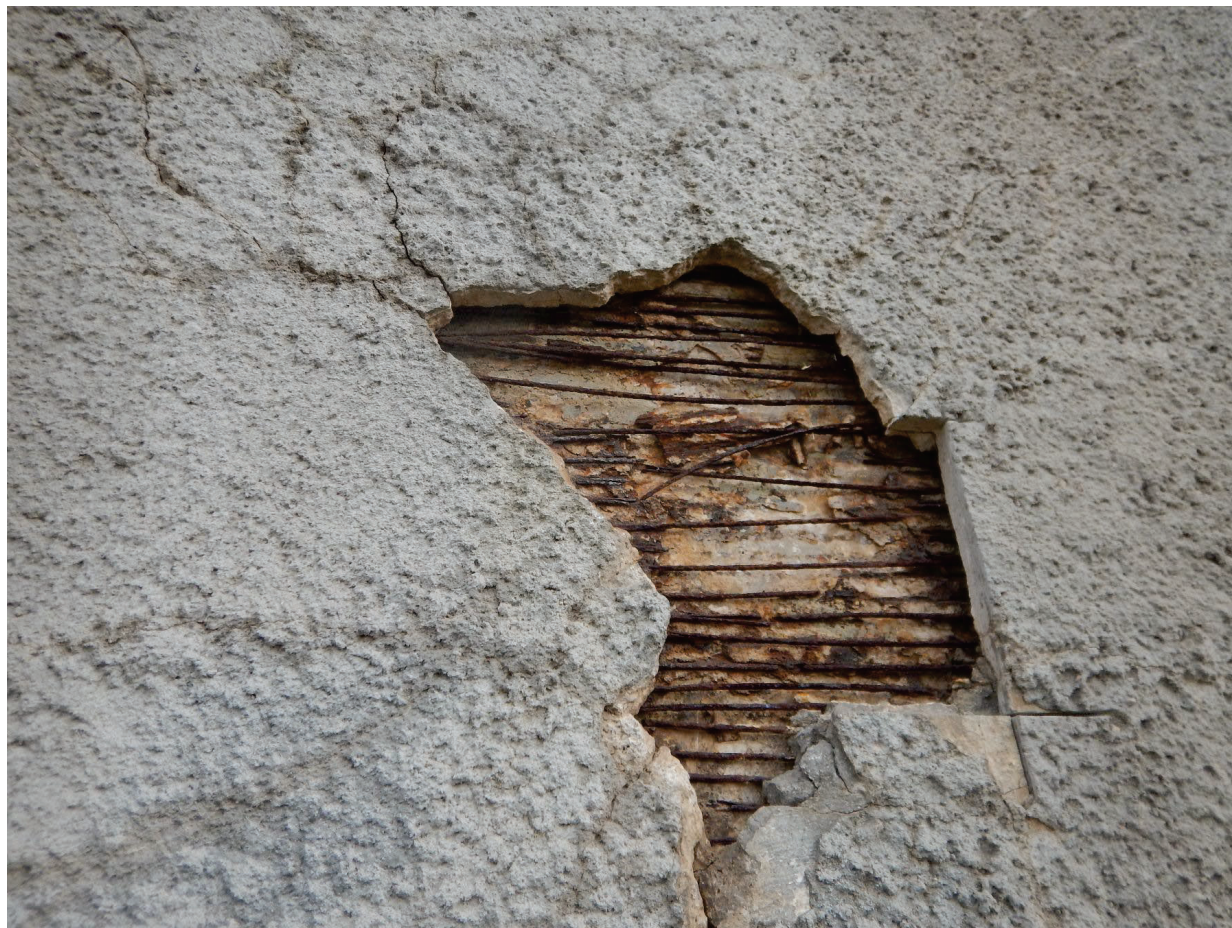
**Observation 8.** The EPA Inspection Team observed concrete patches missing from the outer wall of Lomas Reservoir #1 (refer to Appendix 2, Photographs 18 and 19). In the correspondence received on November 24, 2025, ABCWUA states the Lomas Reservoir #1 structural inspections and subsequent repairs are programmed to take place within the next five calendar years (2026-2030) (refer to Appendix 4).

| Description: | View of Lomas Reservoir #1 with concrete patches missing from its outer wall. | | |

| Description: | Close up view of Lomas Reservoir #1 with concrete patches missing from its outer wall. | | |

| Lomas Storage Tank #01 | Has concrete patches missing in its wall. | Reservoir structural inspections and subsequent repairs are programmed to take place within the next 5 calendar years (2026-2030) | 2026-2030 |

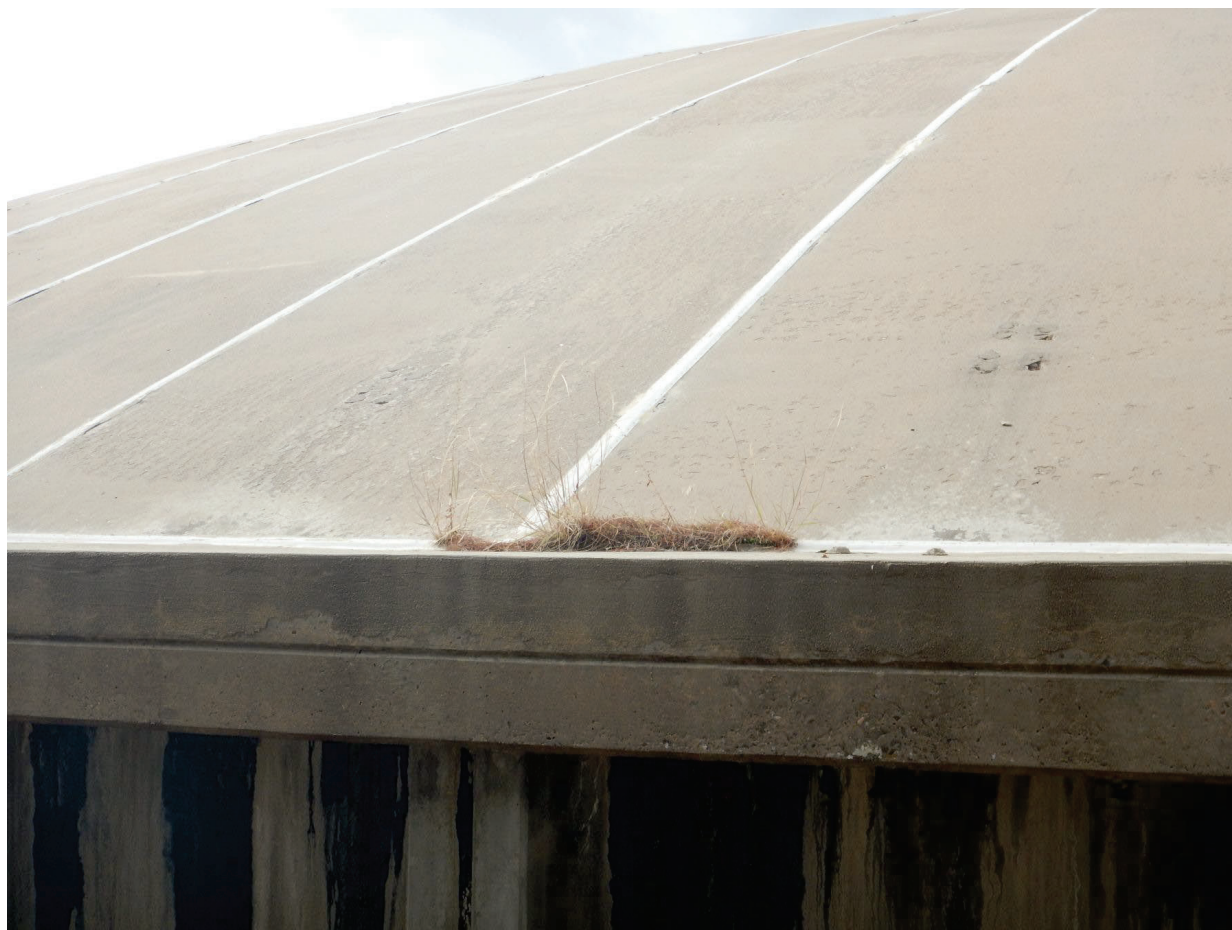
| Filename: | DSCN6053.JPG | Photo Date: | 10/22/2025 | | Time: | 14:59:16 | |

| Description: | View of the top of Lomas Reservoir #2 which shows vegetation growing on top of reservoir. | | |

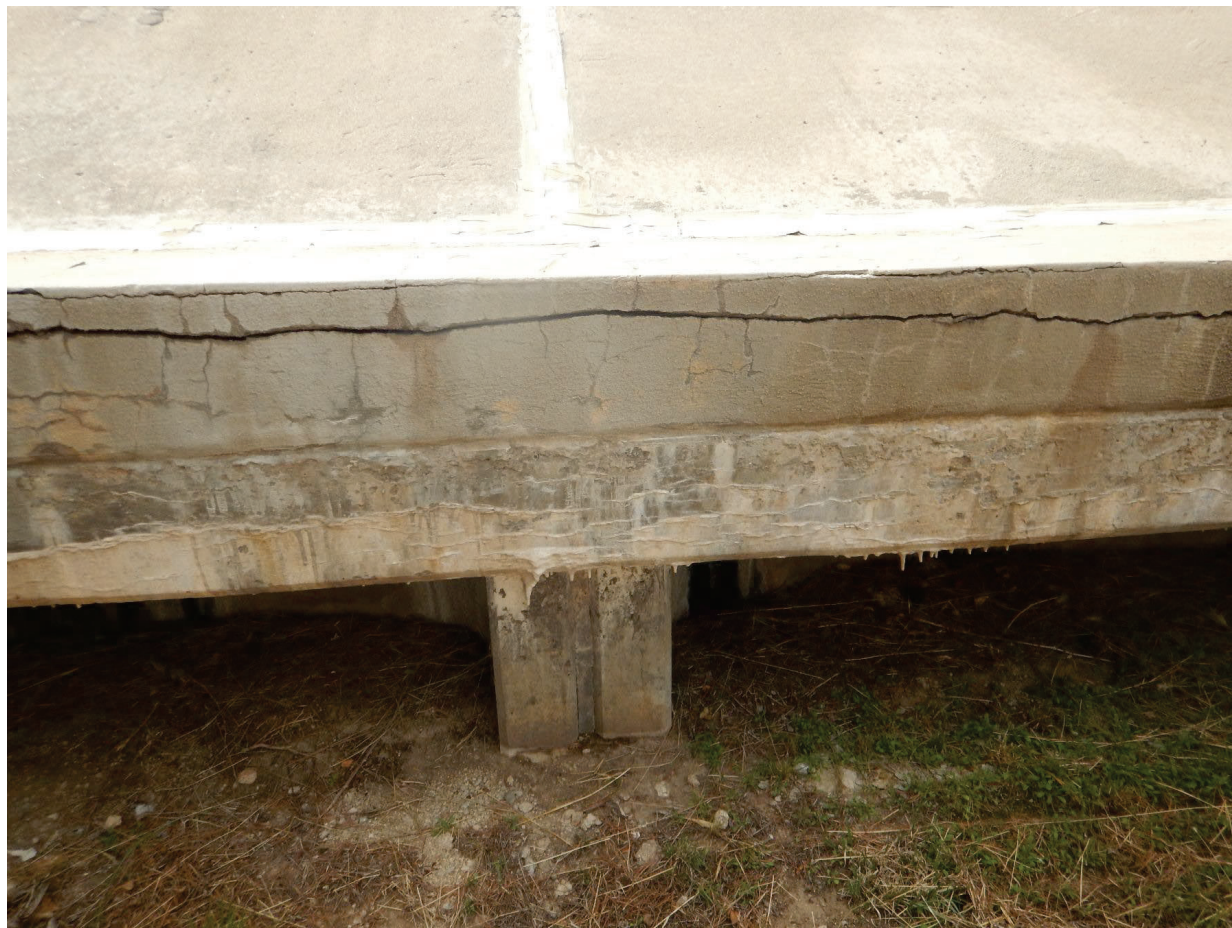
| Filename: | DSCN6056.JPG | Photo Date: | 10/22/2025 | | Time: | 15:07:13 | |

| Description: | View of the top of Lomas Reservoir #2 with a crack in the concrete. | | |

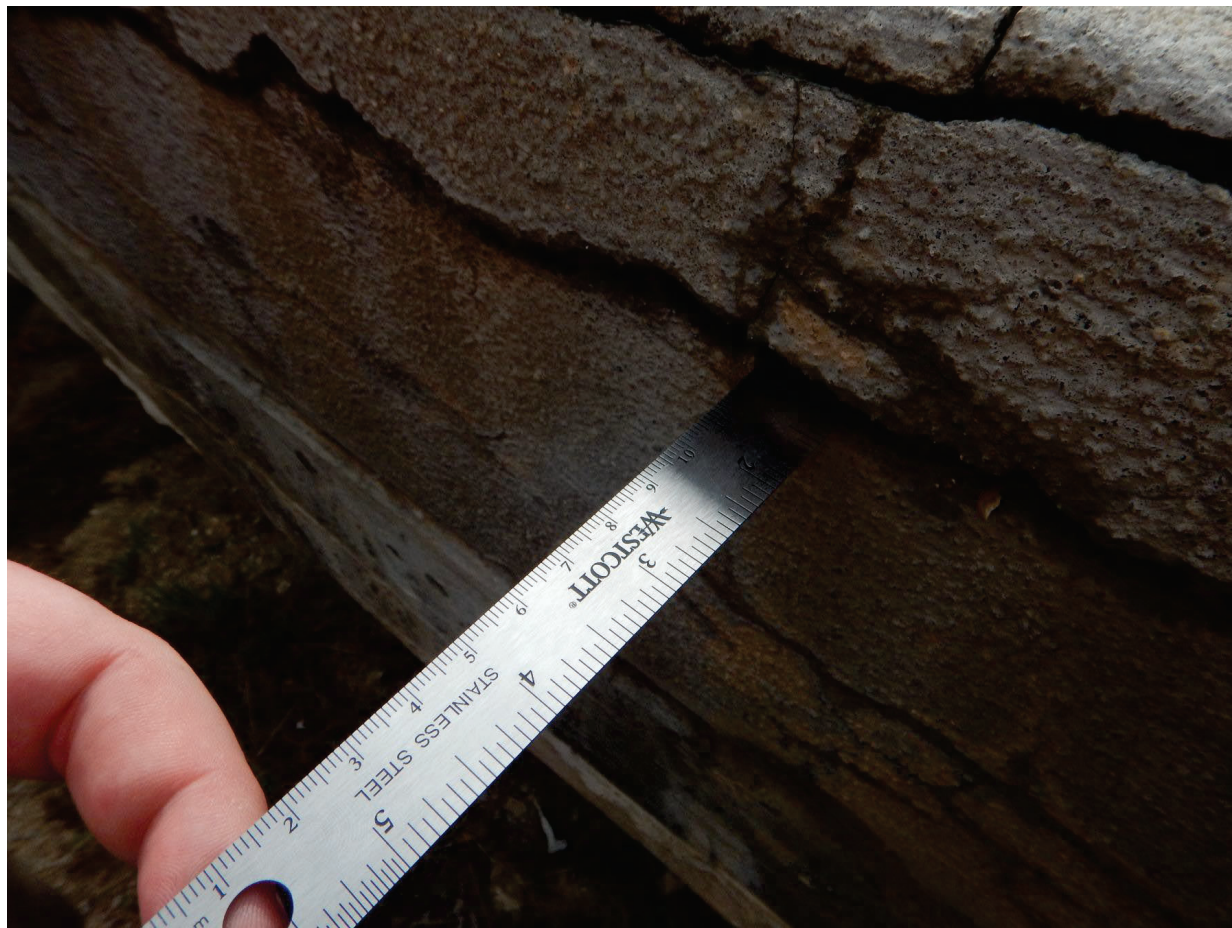
| Filename: | DSCN6063.JPG | Photo Date: | 10/22/2025 | | Time: | 15:08:47 | |

| Description: | Close up view of the crack of the concrete on Lomas Reservoir #2. Note the ruler for scale of the depth of the crack. | | |

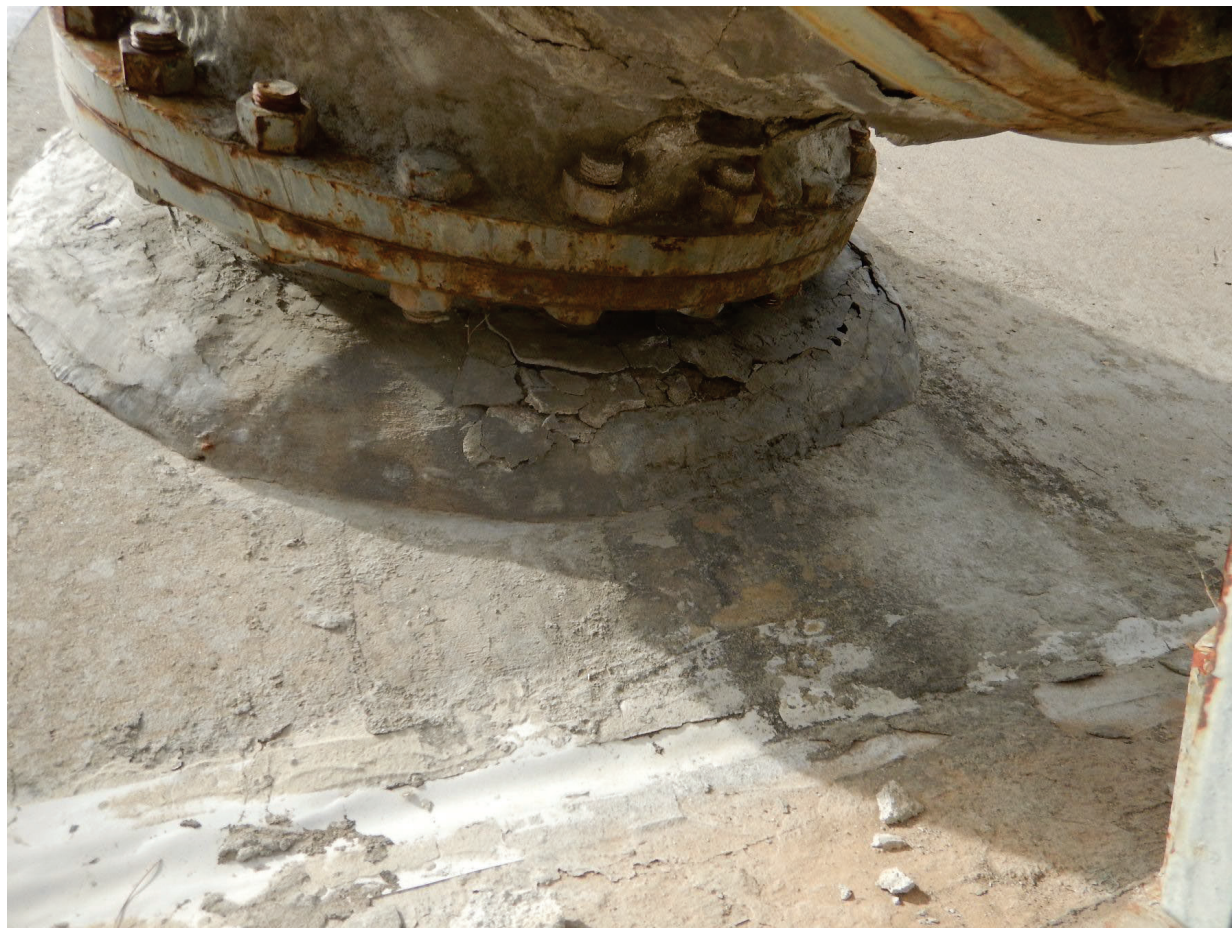
| Filename: | DSCN6062.JPG | Photo Date: | 10/22/2025 | | Time: | 15:08:08 | |

| Description: | View of one of the pipes of Lomas Reservoir #2 that shows cracks of the concrete. | | |

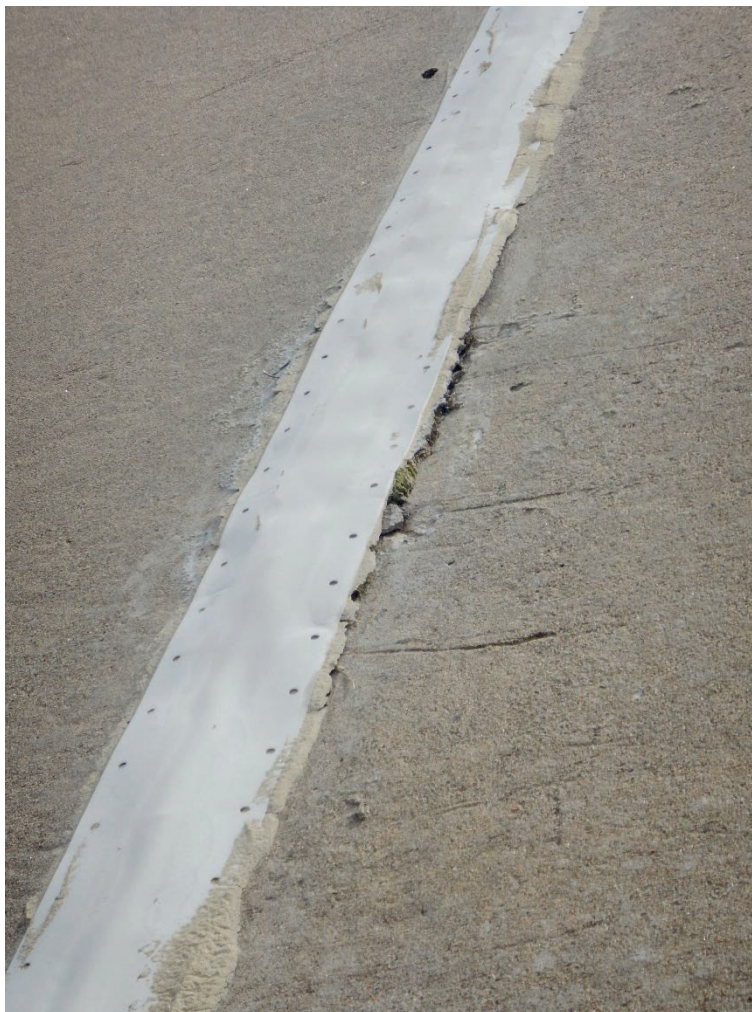
| Filename: | DSCN6065.JPG | Photo Date: | 10/22/2025 | | Time: | 15:09:55 | |

| Description: | Close up view of the top of Lomas Reservoir #2 that shows cracks of the concrete. | | |

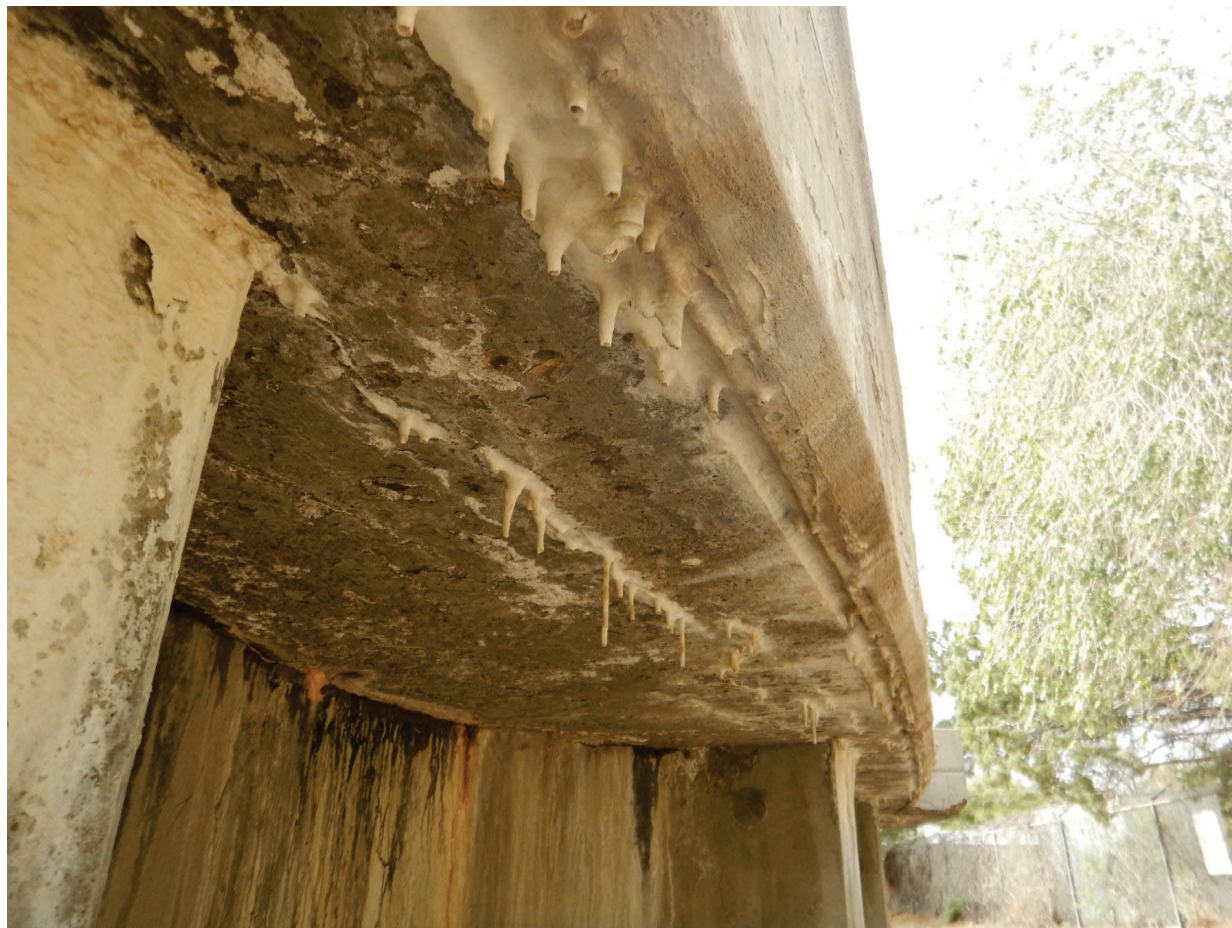
| Filename: | DSCN6066.JPG | Photo Date: | 10/23/2025 | | Time: | 10:19:09 | |

| Description: | View of the underside of Lomas Reservoir #2 that shows stalactites. | | |

| | Has calcium residue under tank lip. | Reservoir structural inspections and subsequent repairs are programmed to take place within the next 5 calendar years (2026-2030) | 2026-2030 |

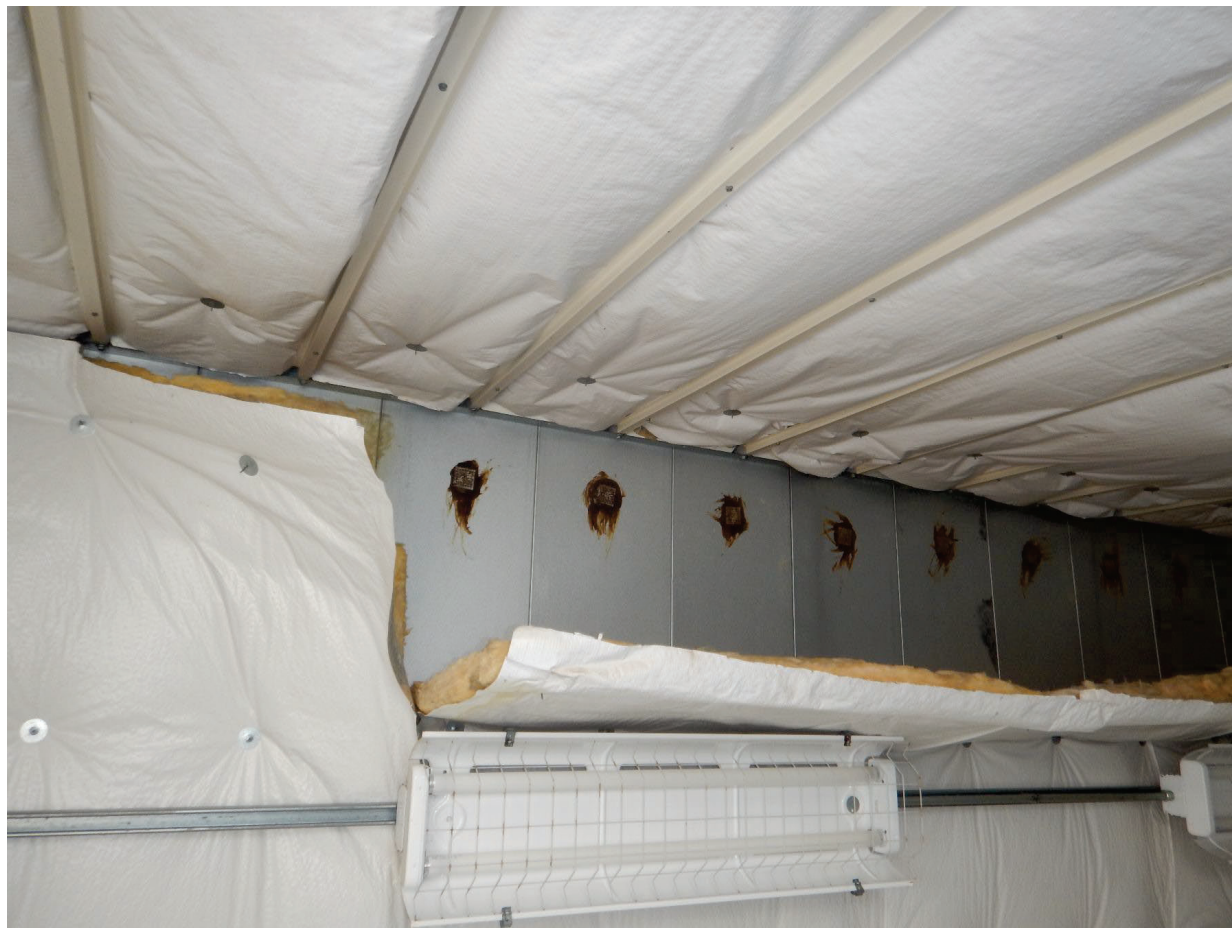
| Filename: | DSCN6068.JPG | Photo Date: | 10/22/2025 | | Time: | 15:10:58 | |

**Observation 14.** The EPA Inspection Team observed insulation peeling from the roof of the sodium hypochlorite building at the Burton Pump Station (refer to Appendix 2, Photograph 26). In the correspondence received on November 24, 2025, ABCWUA states, and shows through a photograph, that the insulation was reinstalled on November 21, 2025 (refer to Appendix 4).

| Description: | View of the ceiling of the sodium hypochlorite room at Burton Pump Station that shows the insulation peeling back. | | |

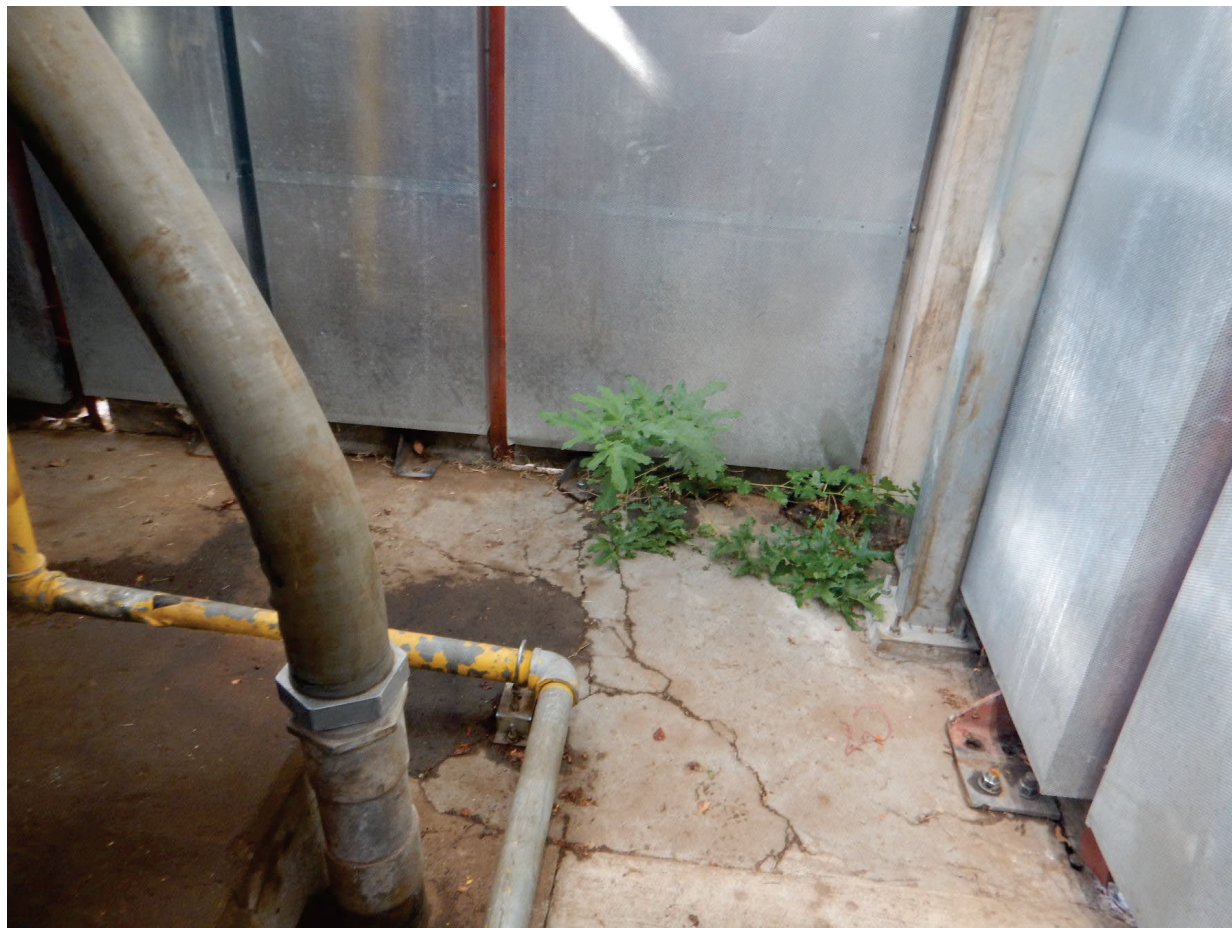
| Filename: | DSCN6069.JPG | Photo Date: | 10/23/2025 | | Time: | 10:46:11 | |

**Observation 15.** The EPA Inspection Team observed vegetation growing inside the Burton Well #3 wellhouse (refer to Appendix 2, Photograph 27). In the correspondence received on November 24, 2025, ABCWUA states, and shows through a photograph, that the vegetation was removed on November 21, 2025 (refer to Appendix 4).

| Description: | View of the inside of the wellhouse at Burton Well #3 that shows vegetation growing inside the building. | | |
