**Region 6 Compliance Assurance and Enforcement Division  
INSPECTION REPORT**

| Inspection Date(s): | 5/29/2019 | | |
| Facility Name: | Coleman Livestock Auction | | |
| Identification/Permit Number: | TXU011238 | | |

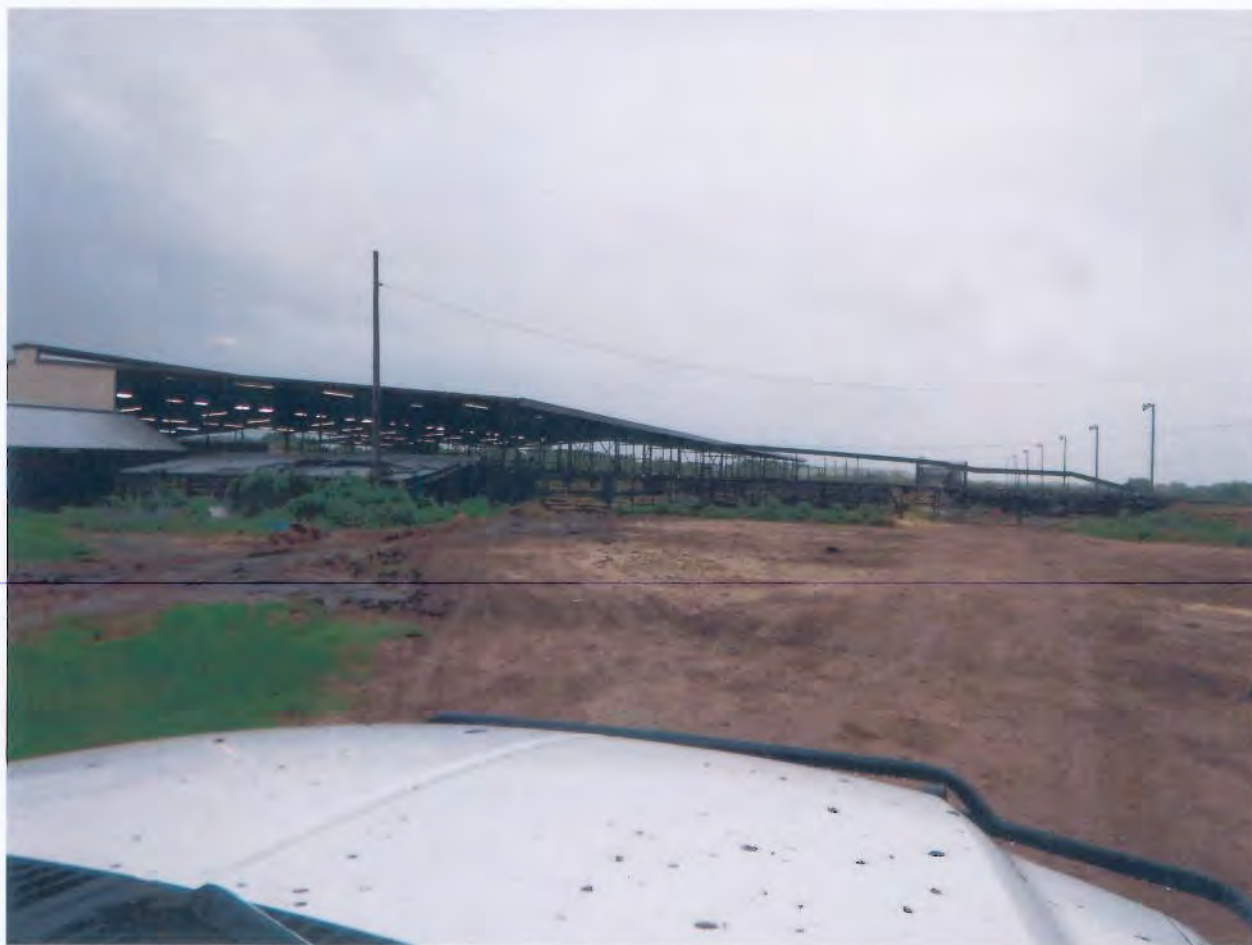
Photo No. 2

Description: Approximately 20% of the cattle pens (sorting yard) was covered by roof. The roof drained via an overhead metal channel to the right, outside of the open pens, but later this storm water commingled with the runoff from the open pens to the right of the roofed area thus generating process wastewater.

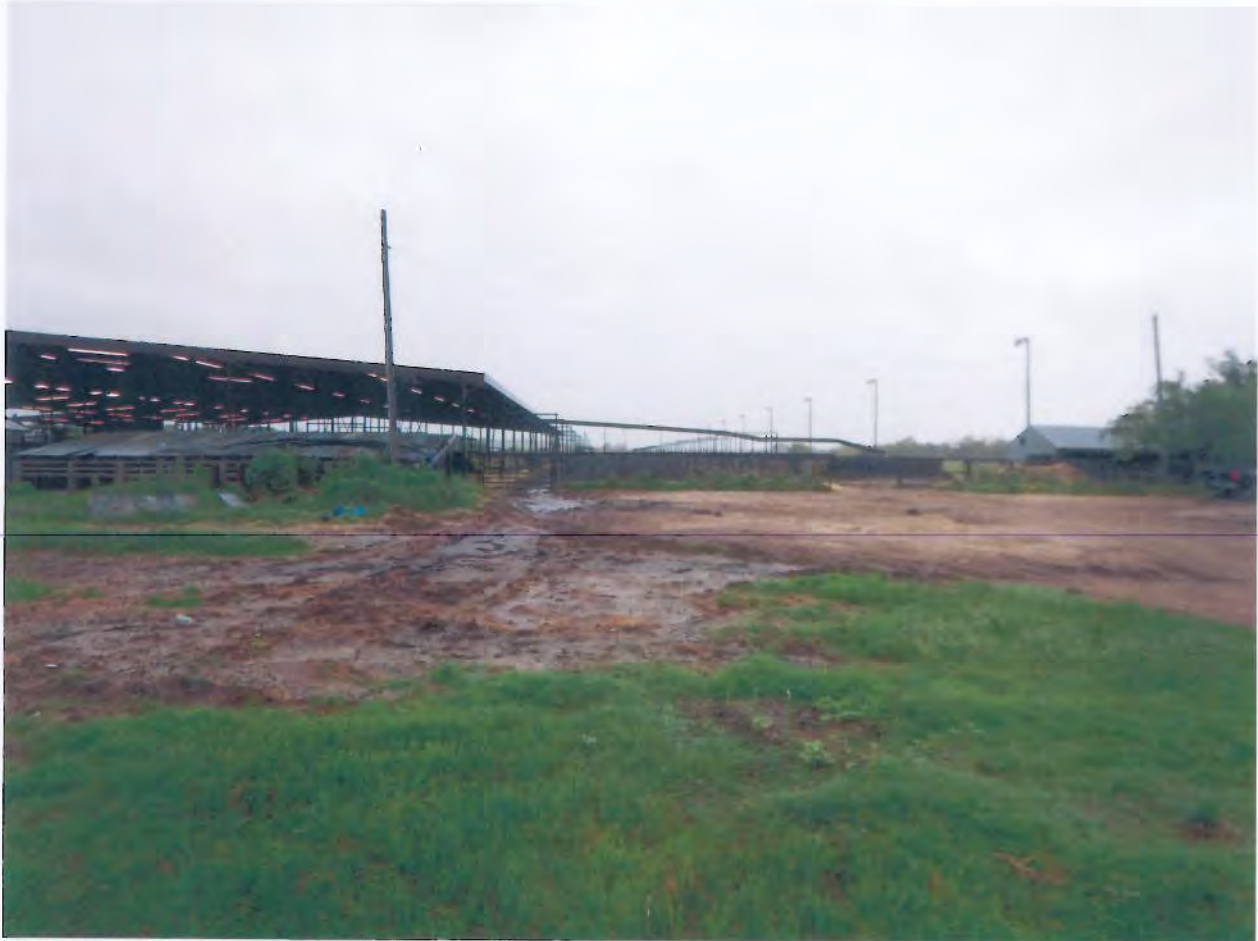
Photo No. 3

Description: Cattle pen runoff (process wastewater) from the east side of the cattle pens ran into an open area adjacent to the parking lot, thence toward a pasture (shown in photo 4).

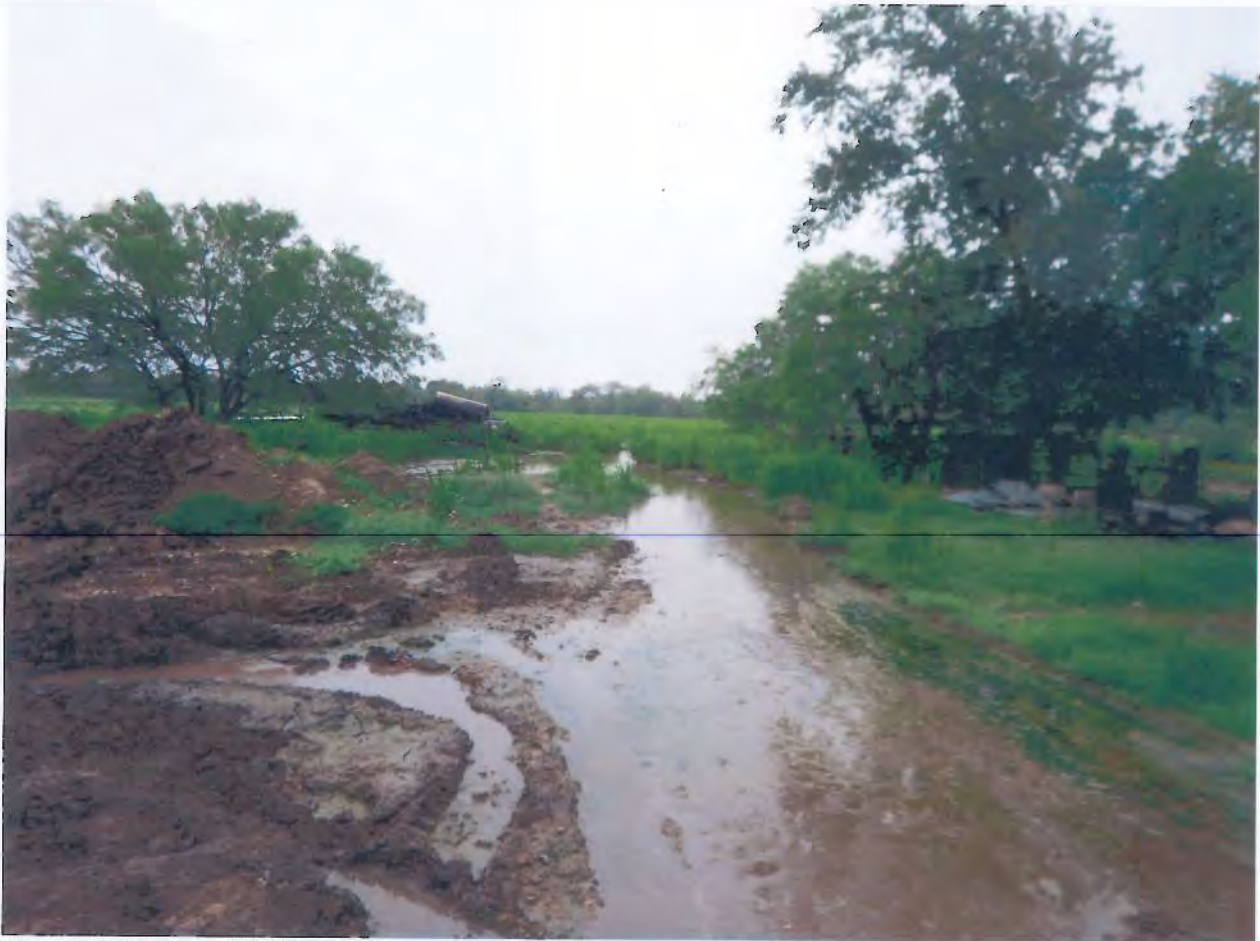
Photo No. 4

Description: Cattle pen runoff (process wastewater) from the east side of the cattle pens ran north into an open area adjacent to the parking lot, thence toward a pasture where it had pooled as shown. Also, note the pile of manure on the left side of the photo. Numerous piles of manure were haphazardly stored around the entire pen perimeter.

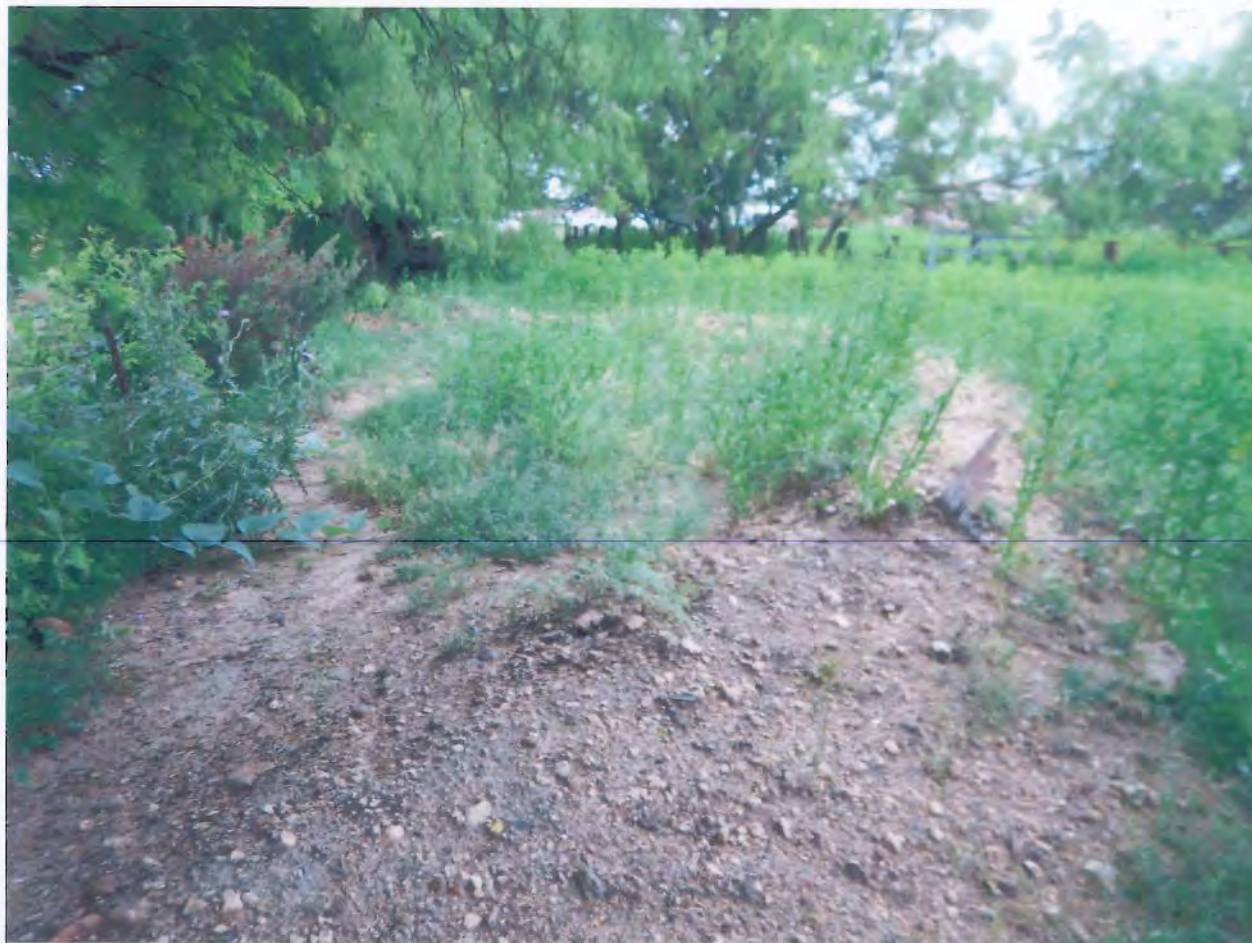
Photo No. 5

Description: The facility constructed a berm in their pasture (as seen in the foreground), located north of the auction barn parking lot to help prevent the ponded production area process wastewater (that discharged from the pens into the pasture) from entering the bar ditch located next to Hwy 84. Hwy 84 was located approximately 50 feet to the left of this photo and the view was toward the south.

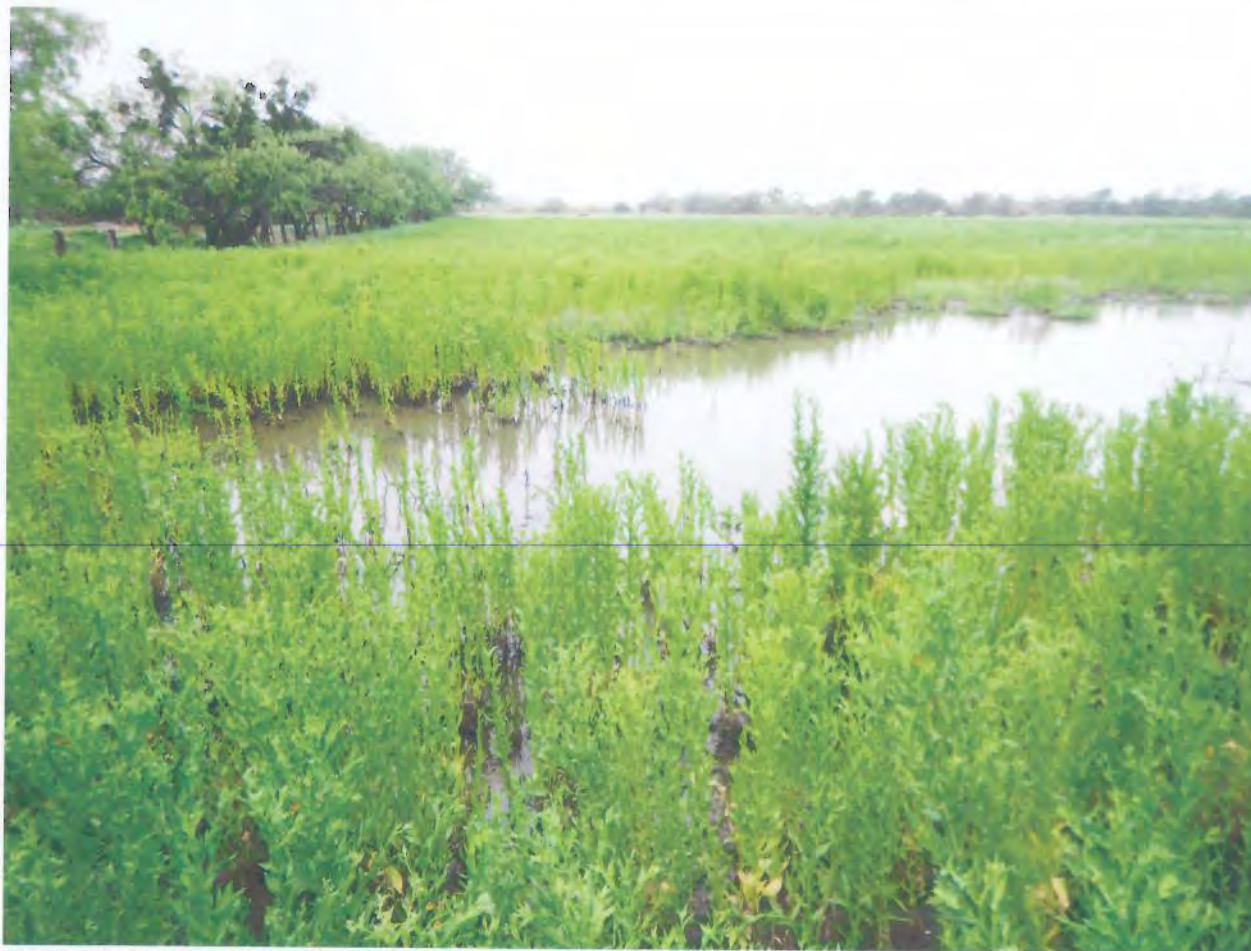
Photo No. 6

Description: The ponded production area process wastewater (that discharged from the pens into the pasture) that was contained by the constructed berm shown in photo 5. The view was toward the west.

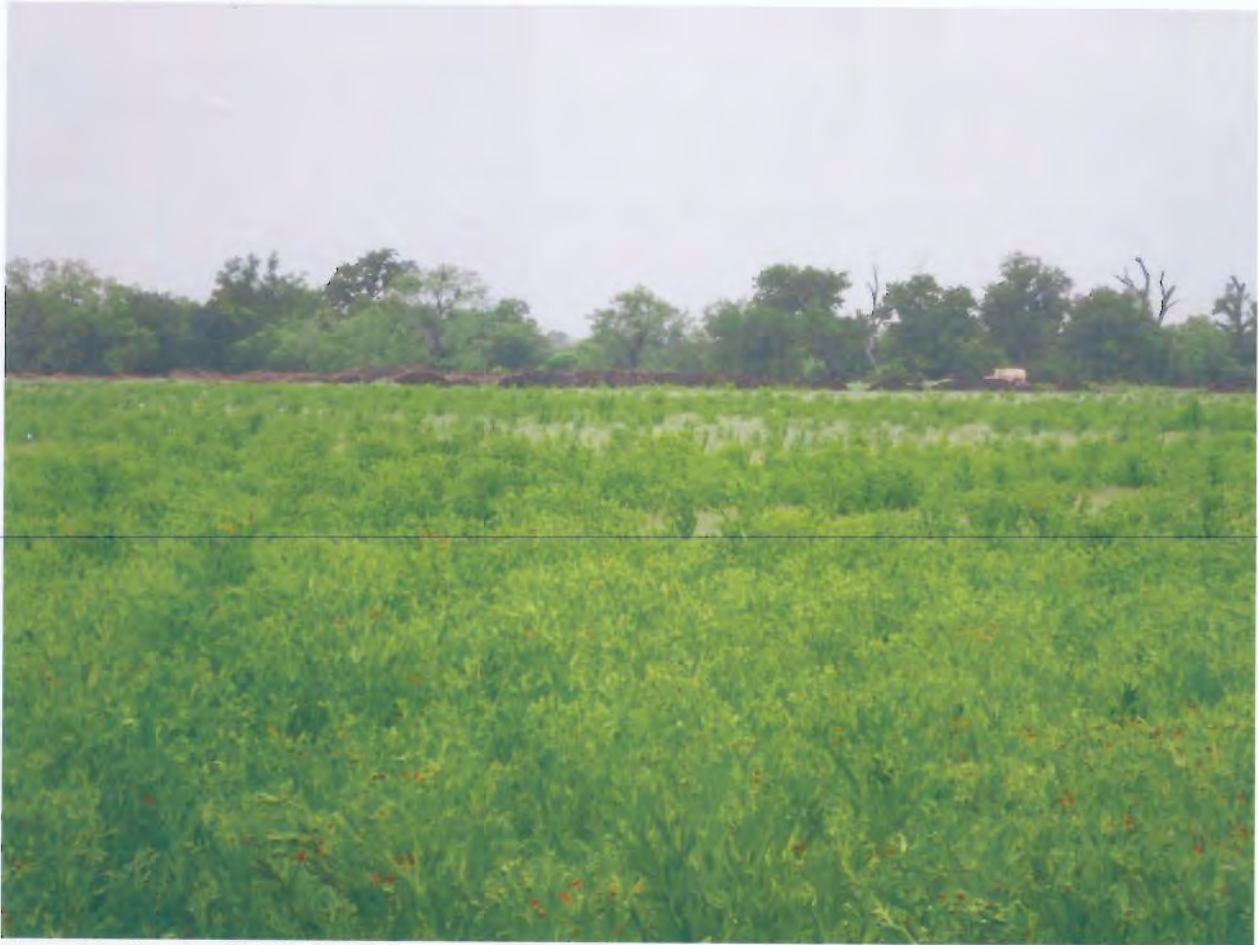
Photo No. 7

Description: A close-up photo of the piles of manure located in the pasture to the north of the cattle pens. A significant amount of lot scrapings (manure) was stored in this area. The view was toward the west.

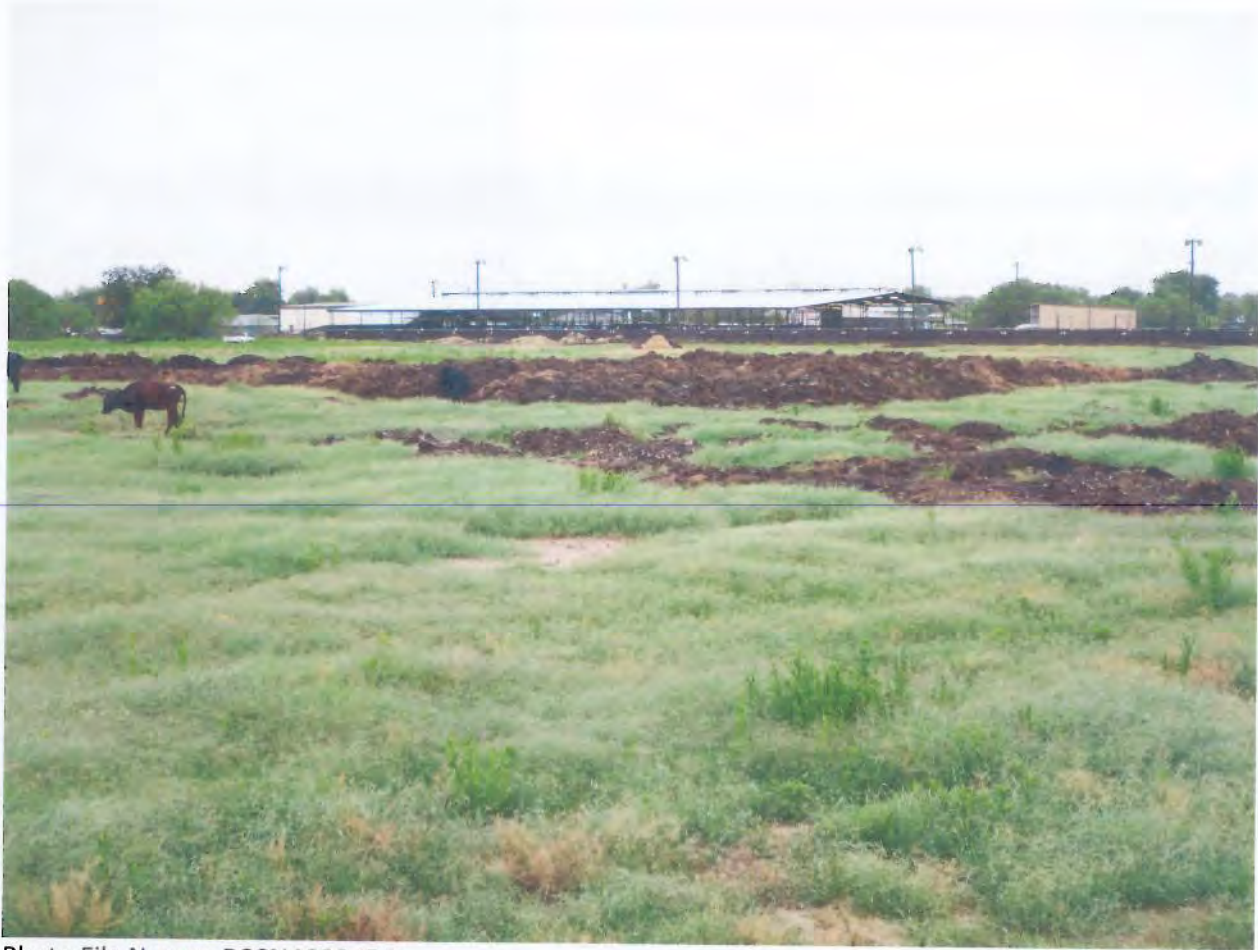
Photo No. 8

Description: A close-up photo of the piles of manure located in the pasture to the north of the cattle pens. A significant amount of lot scrapings (manure) was stored in this area. Note the Coleman Livestock Auction pens in the background. The view was toward the southeast.

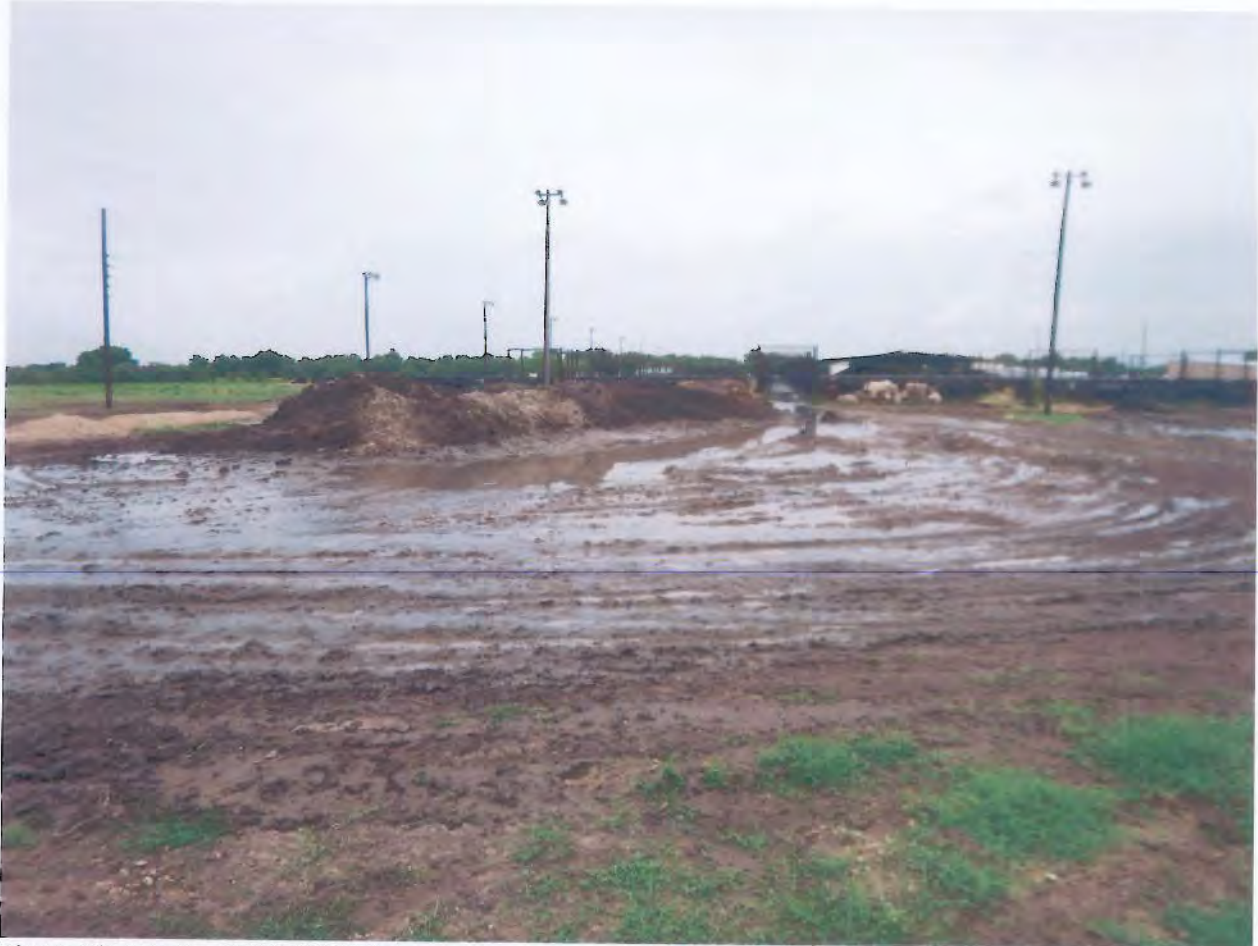
Photo No. 9

Description: Standing at the far west end of the pens (looking east) where the process wastewater had ponded. No discharge of process wastewater to navigable waters was observed at the time of the inspection. Note the manure piles stored in this area and the cattle pens in the background.
