Purpose: NPDES SSO Inspection Report

Facility: City of Chicago Heights, Illinois

Dates of Inspection: March 23, 2022

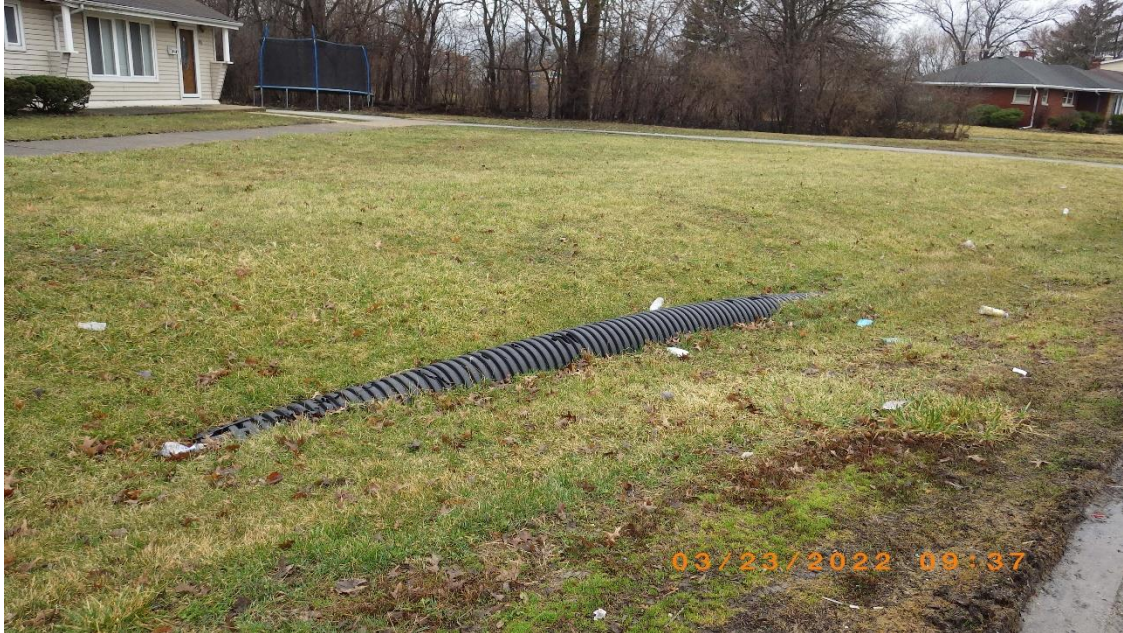
1: RIMG0052

EPA inspectors arrived at a manhole at the intersection of South Coolidge Street and Broadway Avenue at 9:33 AM. According to City records, there have been complaints of water exiting a manhole in the backyard of a residence near this intersection. EPA inspectors did not observe an overflow. EPA inspectors did observe a section of piping that appeared to belong to the storm sewer above ground. The pipe had visible damage and appeared to not be laid at a grade which would effectively convey storm water. See Photos 1 and 2.

Description: Storm sewer pipe protruding from the ground. Note damage to the pipe and the inconstant grade at which the pipe is laid.

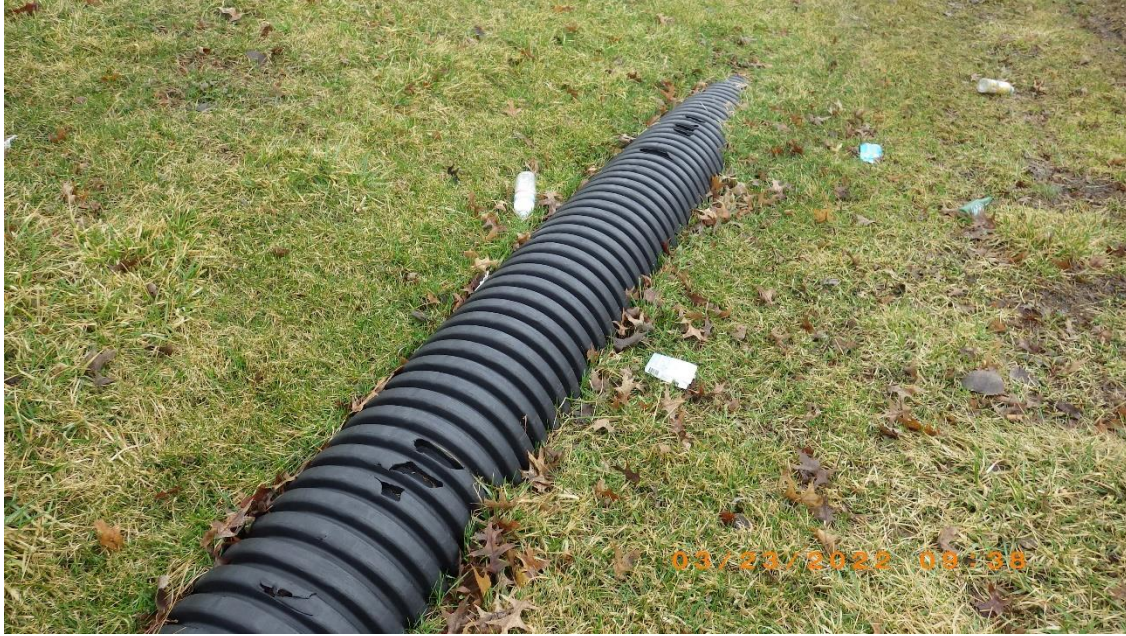
2: RIMG0053

Description: Visible damage to storm sewer pipe protruding from the ground.

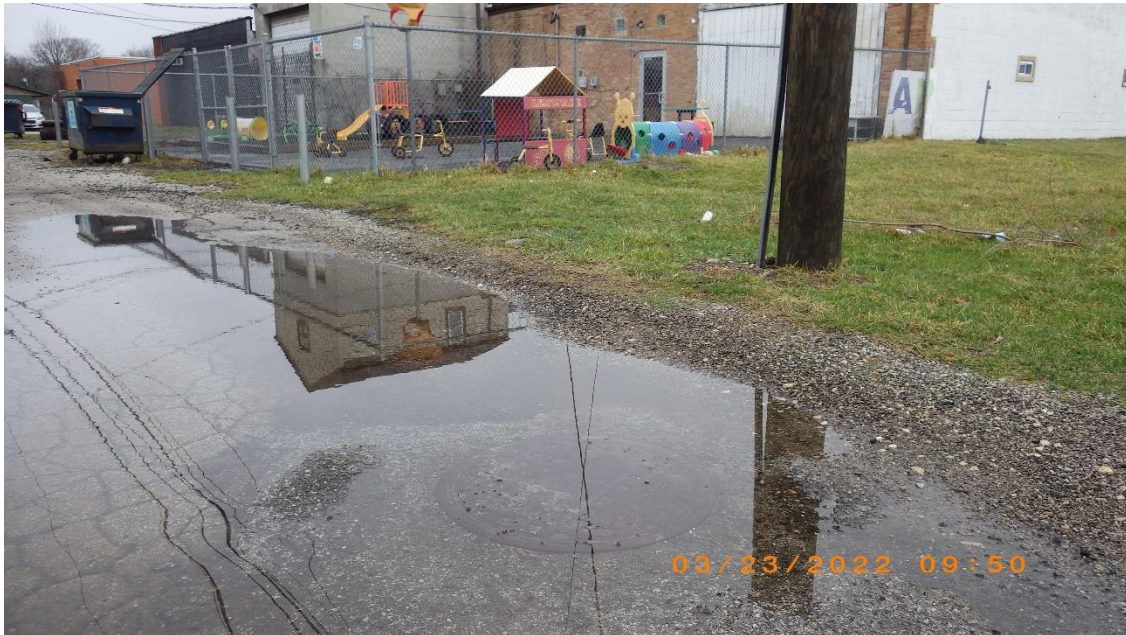
3: RIMG0054

EPA inspectors arrived at a manhole in an alley near the intersection of Hillcrest Avenue and South Halsted Street at 9:45 AM. According to City records there have been complaints of water exiting a manhole in the alley behind a residence near this intersection. EPA inspectors did not observe an overflow. Inspectors did observe what appeared to be a sanitary sewer manhole in the alley behind the address submerged underwater. The manhole appeared to be sealed and was not letting any standing water flow through at the time of the inspection. This manhole is adjacent to a child-care facility. See Photo 3.

Description: Manhole submered underwater. Note proximity to child-care facility.

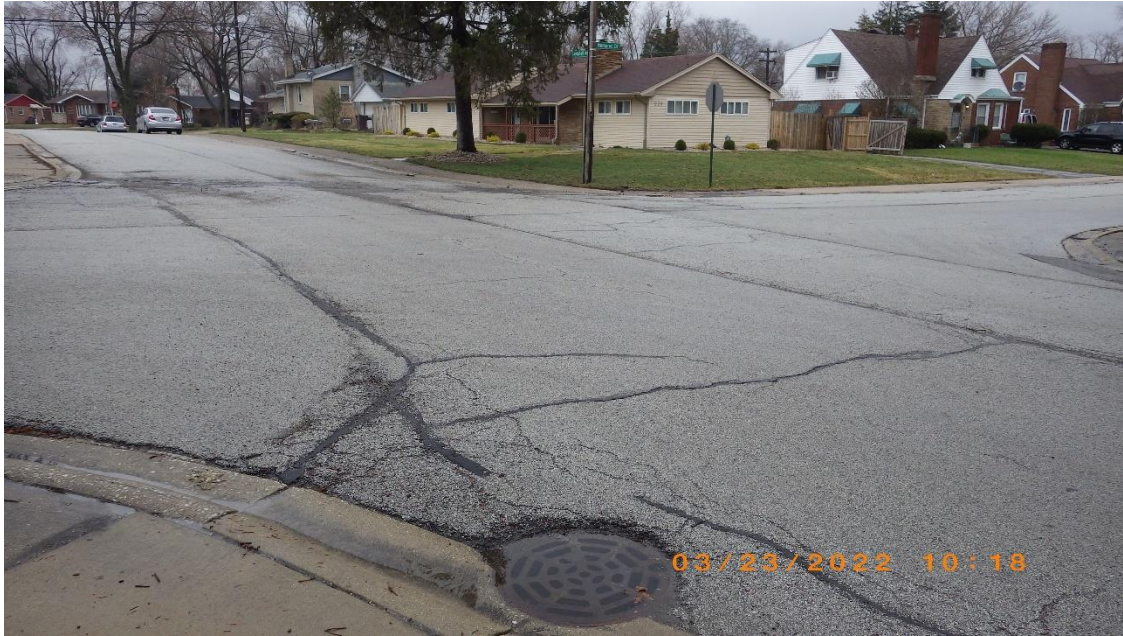
4: RIMG0055

EPA inspectors arrived at a manhole near the intersection of Hillcrest Avenue and Memorial Drive at 10:17 AM. According to City records, there have been complaints of water exiting a manhole in front of a residence near this intersection. EPA inspectors did not observe an overflow. EPA inspectors did observe a storm sewer inlet that was holding stagnant water. See Photo 4.

Description: Storm sewer inlet holding stagnant water.

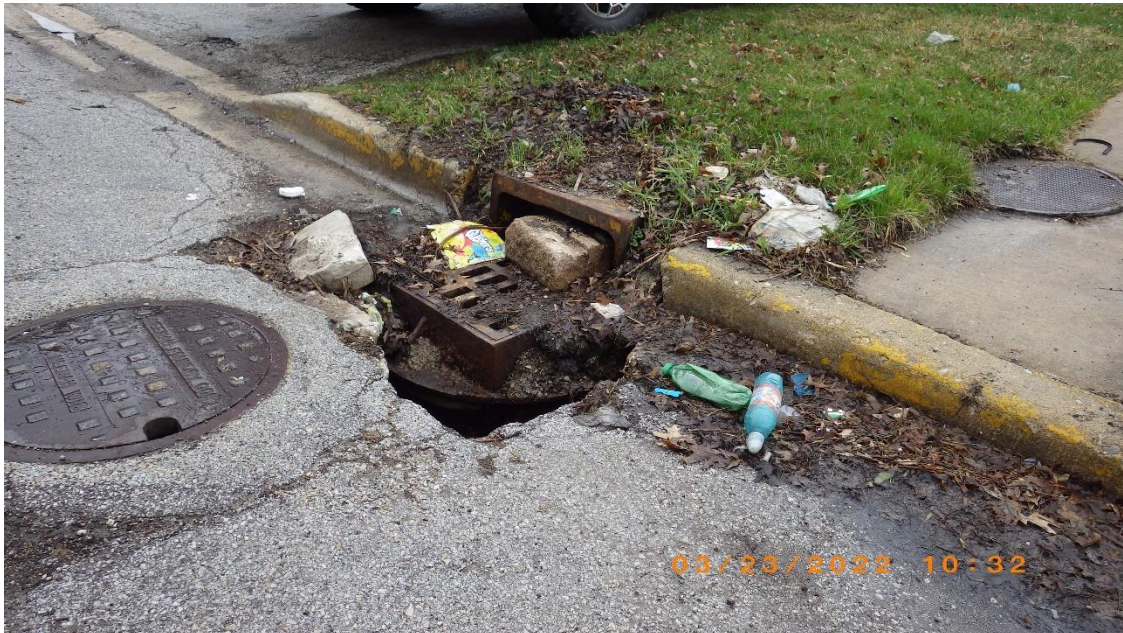
5: RIMG0056

Description: Collapsed storm sewer inlet.

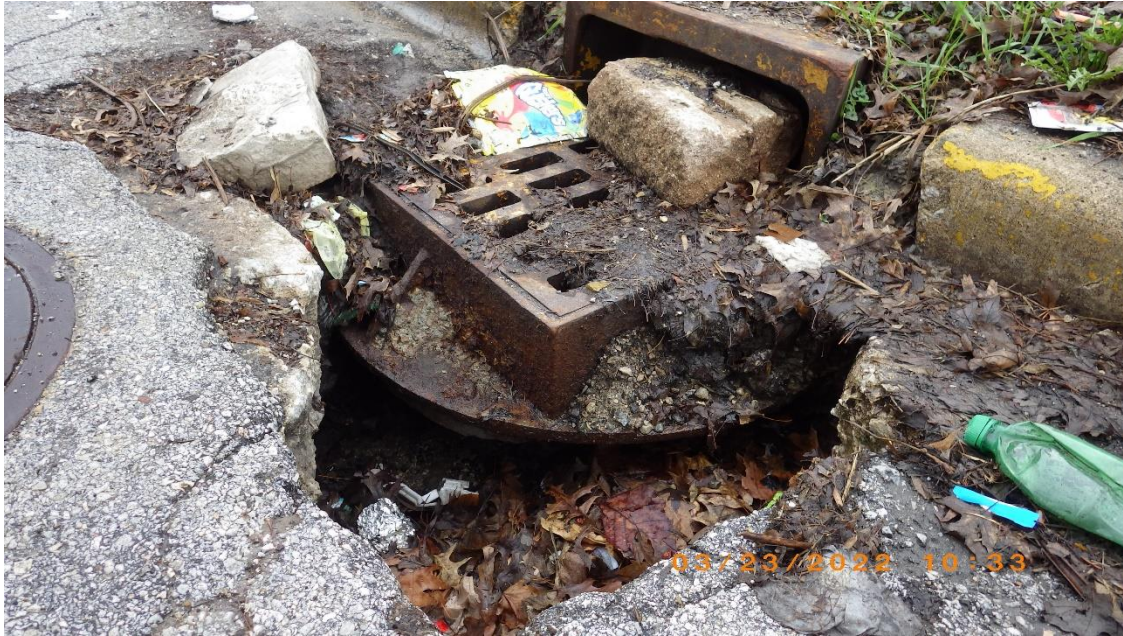
6: RIMG0057

Description: Second photo of collapsed storm sewer inlet depicted in Photo 5.

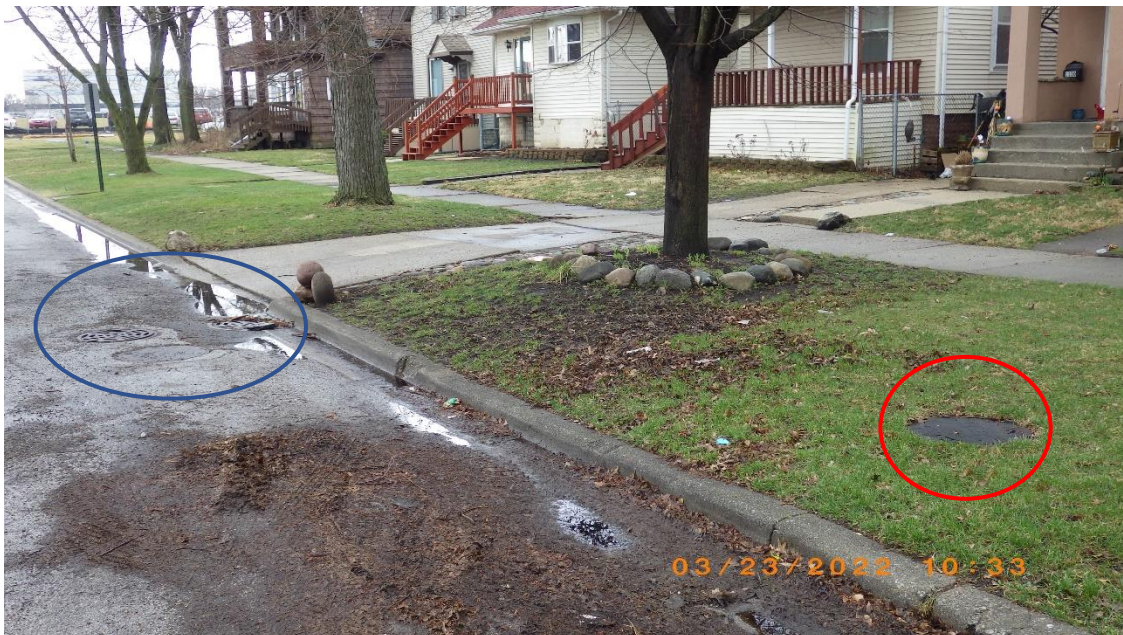
7: RIMG0058

EPA inspectors arrived at a manhole near the intersection of Vincennes Avenue and Lincoln Highway at 10:32 AM. According to City records, there have been complaints of water exiting a manhole in front of a residence near this intersection. EPA inspectors did not observe an overflow. EPA inspectors did note that the manhole of interest was next to a gutter with a storm sewer inlet approximately 15 feet downstream. EPA inspectors also observed a collapsed storm sewer inlet. See Photos 5 – 7.

Description: Sanitary sewer manhole with a history of overflow complaints (red circle) is approximately 15 feet from a storm sewer inlet (blue circle).

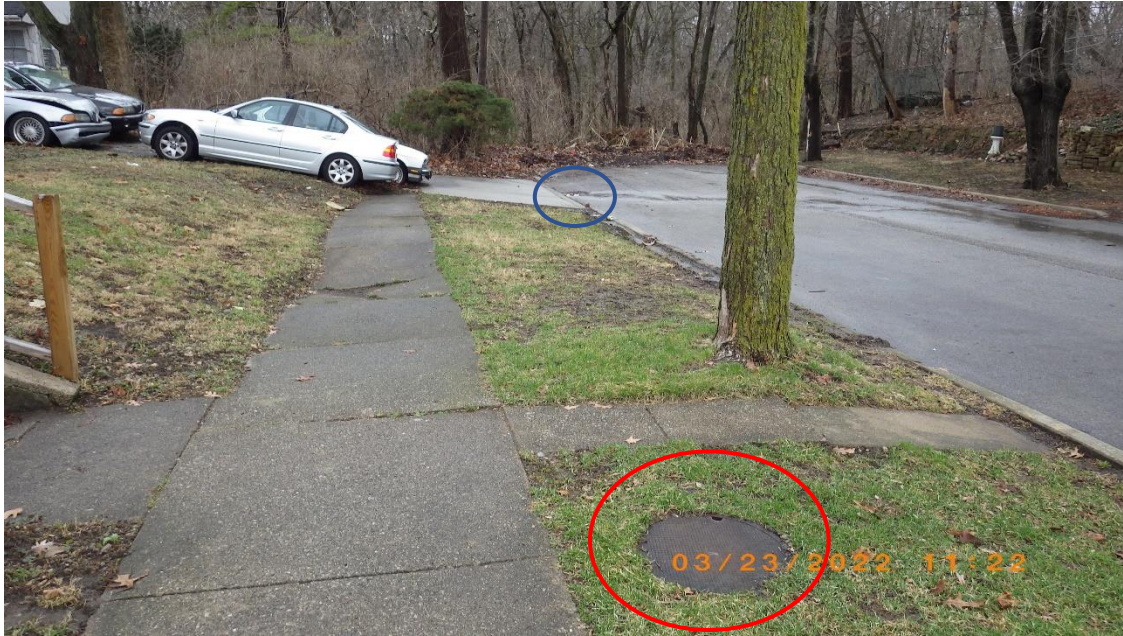
8: RIMG0059

EPA inspectors arrived at a manhole near the intersection of West Hickory Street and Buena Vista Circle at 11:22 AM. According to City records, there have been complaints of water exiting a manhole in front of a residence near this intersection. EPA inspectors did not observe an overflow. EPA inspectors did note that the manhole of interest was next to a gutter with a

Description: Sanitary sewer manhole with a history of overflows complaints (red circle) is approximately 20 feet from a storm sewer inlet (blue circle).

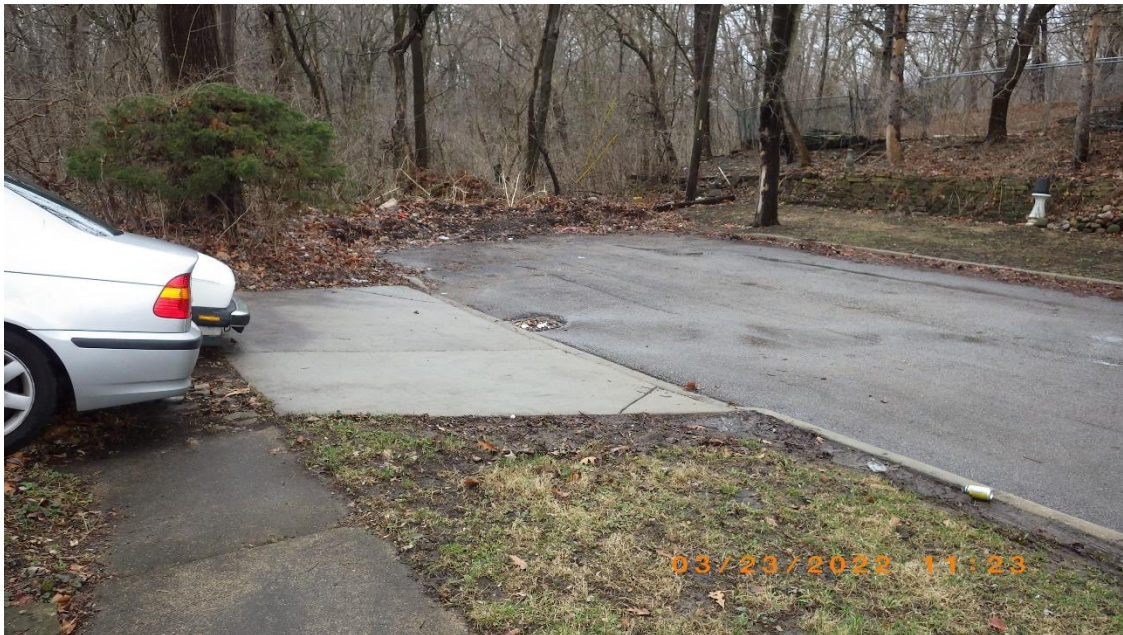
9: RIMG0060

Description: Second picture of the storm sewer inlet depicted in Photo 8.

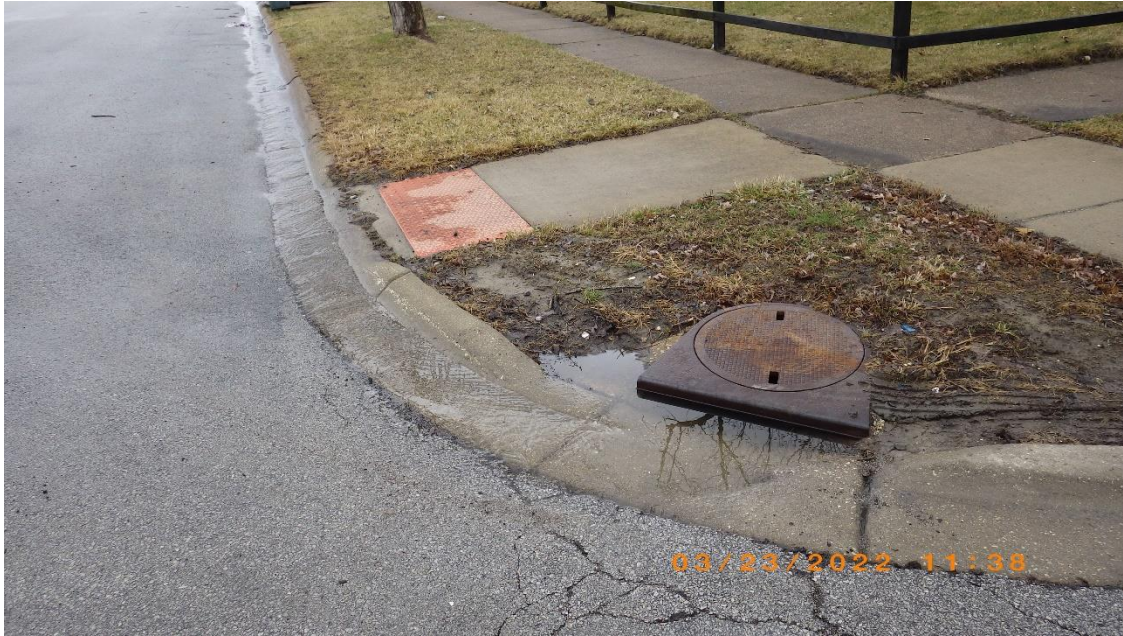
10: RIMG0061

EPA inspectors arrived at a manhole at the intersection of Bunker Street and Concord Drive at 11:35 AM. According to City records, there have been complaints of a manhole holding water near this intersection. EPA inspectors did observe one storm sewer inlet holding water at the northeast corner of the intersection and a second storm sewer inlet with water flowing out of the inlet and into a gutter on the southeast corner of the intersection. See Photos 10 and 11.

Description: Storm sewer inlet with water flowing out of it and flowing down the gutter to the lefthand side of the photo.

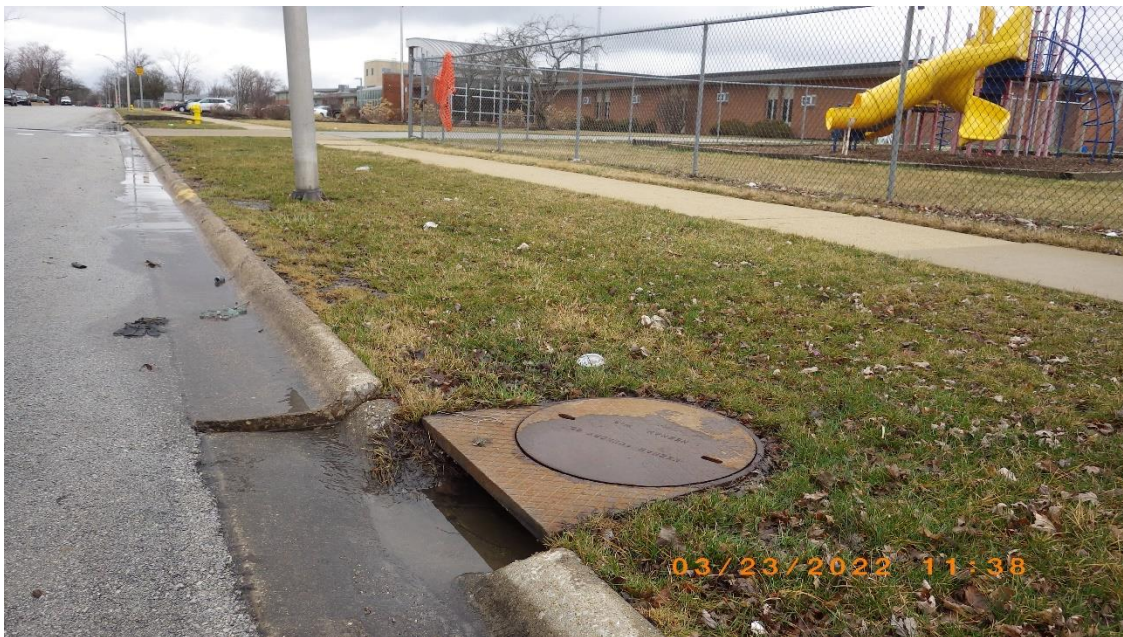
11: RIMG0062

Description: Storm sewer inlet holding stagnant water.

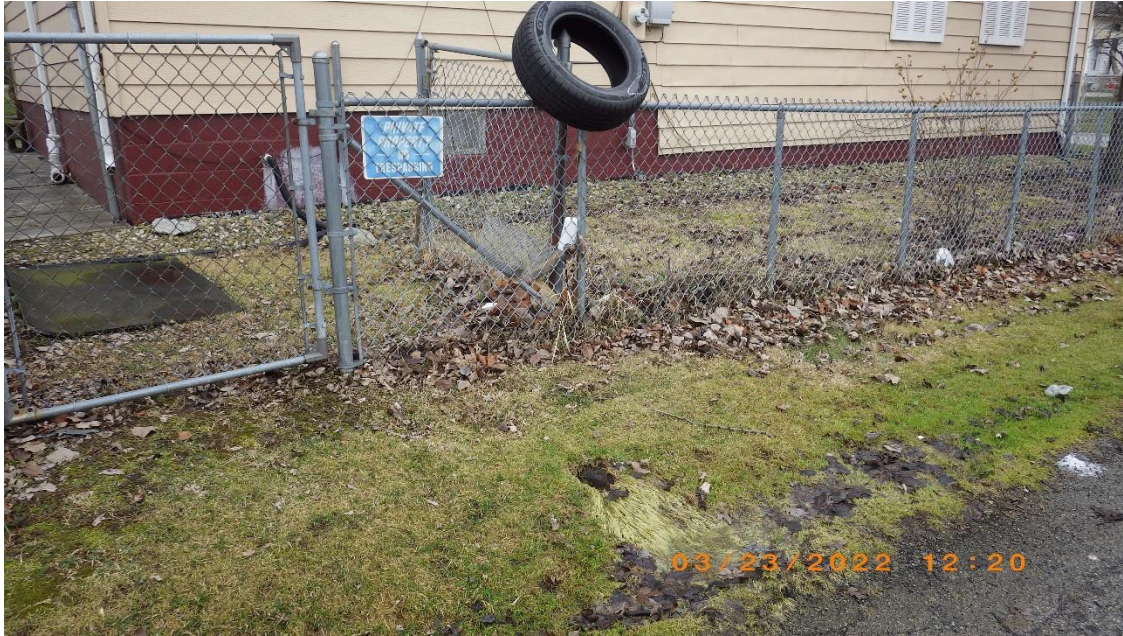
12: RIMG0063

EPA inspectors arrived at a manhole in an alley near the intersection of Wallace Avenue and East 26th Street at 12:05 PM. According to City records, there have been complaints of water exiting a manhole in the alley behind a residence near this intersection. EPA inspectors did observe a discharge of water from a pipe in the alley which appeared to come from a residence. The source of this water was not immediately apparent but the water itself was free from odor, color, turbidity, and debris. See Photos 12 and 13.

Description: Pipe with water flowing out. Water was free from odor, color, turbidity, and debris.

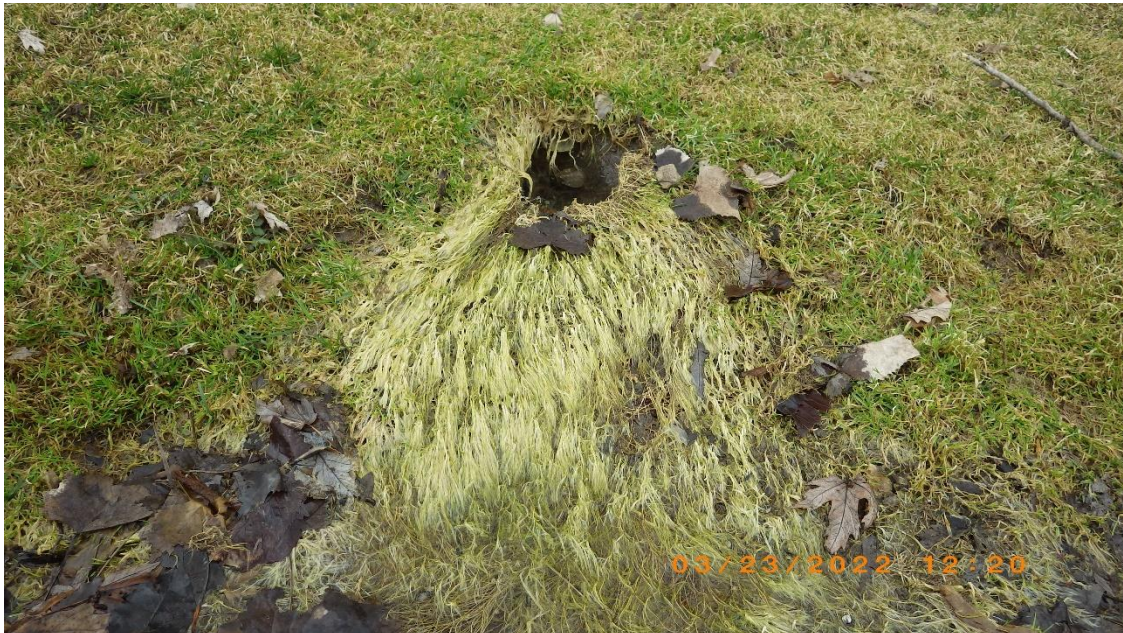
13: RIMG0064

Description: Secondary photo of pipe with water flowing out depicted in photo 12. Water was free from odor, color, turbidity, and debris.
