INSPECTION REPORT

| Type of Inspection | Compliance Evaluation Inspection | | |
| Permittee Name | Swanson Group Manufacturing, LLC | | |
| Facility or Site Name | Springfield Plywood & Veneer | | |

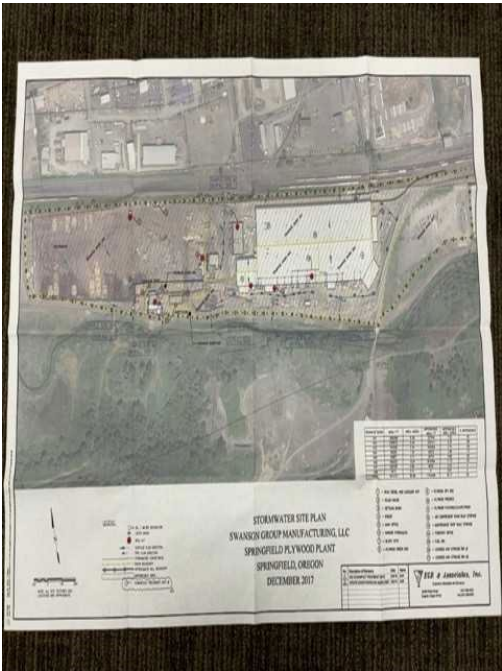
| Site Map, photo 1 | | | IMG-20241119104817481797970.jpg |

At the time of inspection, I reviewed the facility's Stormwater Pollution Control Plan (SPCP), dated June 2021. The SPCP shows the facility is under SIC code 2421 (Sawmills and Planing Mills, General) but based on activities, SIC code 2436 (Softwood Veneer and Plywood) should probably be added as a secondary activity. The facility is no longer monitoring or discharging from Outfall 5, so the map should be updated. The site plan does not indicate when packaged products are stored outside. The site plan does not show the loading and offloading areas. The site plan is missing the immediate access roads and rail lines used or traveled by carriers of raw materials, manufactured products, waste material, or by-products used or created by the facility.

| <b>AOC:</b><br>The facility is no longer monitoring or discharging from Outfall 5, so the map should be updated. | |
| <b>AOC:</b><br>The site plan does not indicate where packaged products are stored outside. | |
| <b>AOC:</b><br>The site plan did not show the loading and offloading areas. The site plan is missing the immediate access roads and rail lines used or traveled by carriers of raw materials, manufactured products, waste material, or by-products used or created by the facility. | |

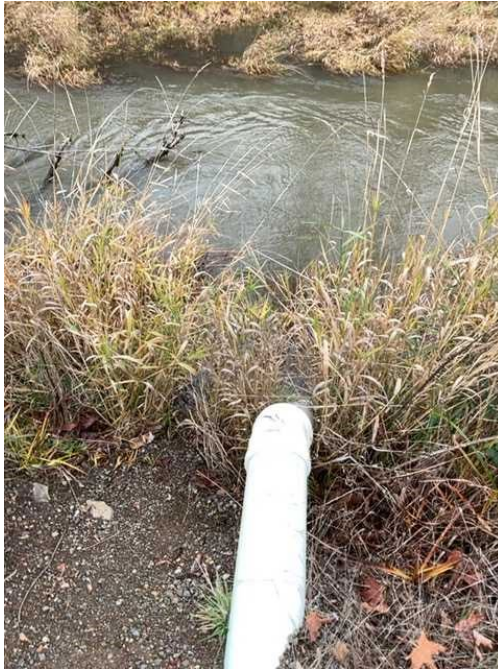
| Outfalls 002 | | | IMG-20241119130531531179340.jpg |

| Outfall 002 discharge pipe. | | | |

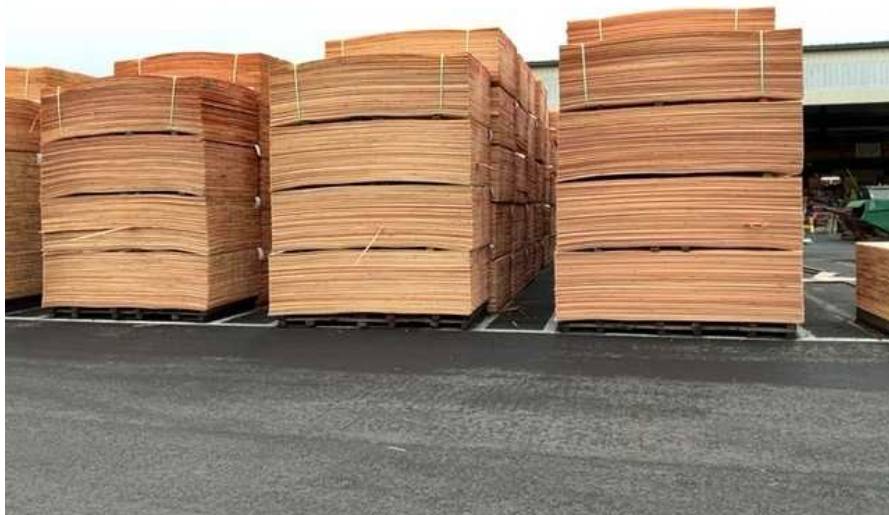
| Outside Storage | | | IMG-2024111913100510584894.jpg |

| Material waiting for processing. | | |

| Raw material waiting outside for processing. | | | |

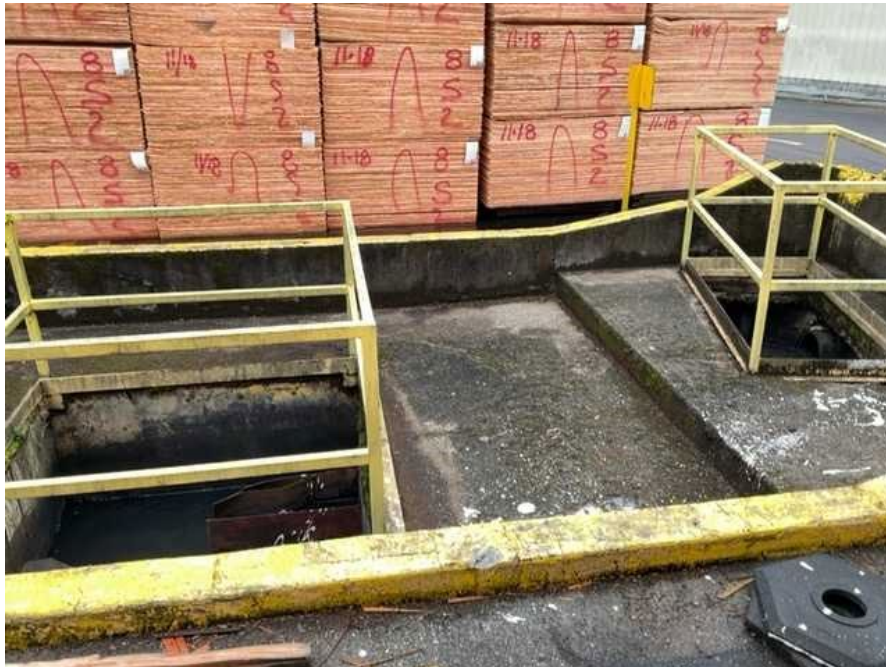
| Catch Basin 003 | | | IMG-202411191312321232135324.jpg |

| Catch basin 003 with oil/water separator on right. | | | |

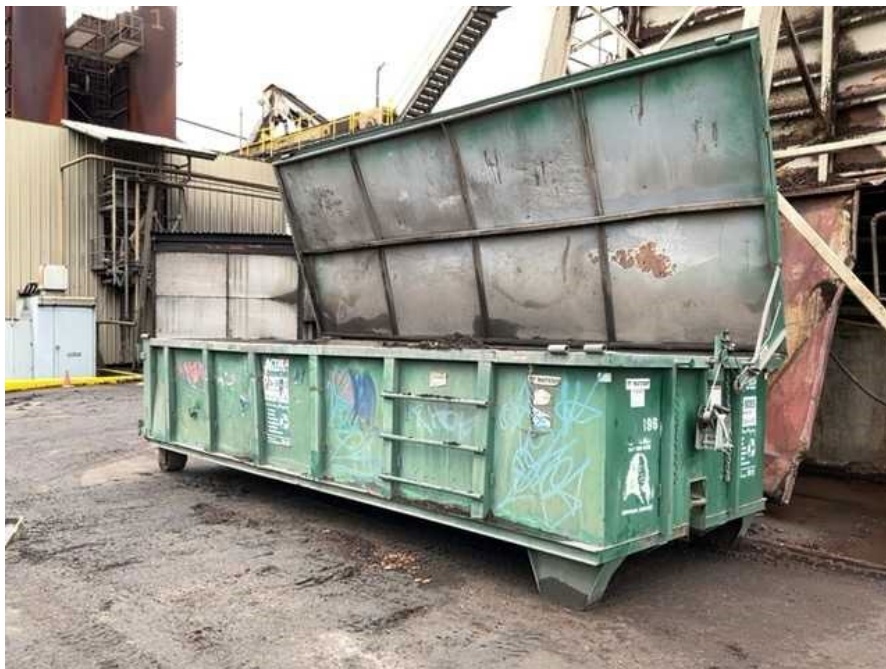
| Outside Boiler | | | IMG-202411191320572057121497.jpg |

| At the time of inspection, I observed an open dumpster that contained ash from the boiler. It did not appear the dumpster was being actively loaded or unloaded. | | |

| <b>Permit Requirement</b><br>Schedule A.1.c of the permit states, in part, "Cover all waste contained in bins or dumpsters where there is a potential for drainage of stormwater through the waste to prevent exposure of stormwater to these pollutants. Acceptable covers include, storage of bins or dumpsters under roofed areas or use of lids or properly secured temporary covers such as tarps." | |
| <b>AOC:</b><br>There was open dumpster that contained ash from the boiler. It did not appear the dumpster was being actively loaded or unloaded. | |

| Open dumpster with ash from boiler. | | | |

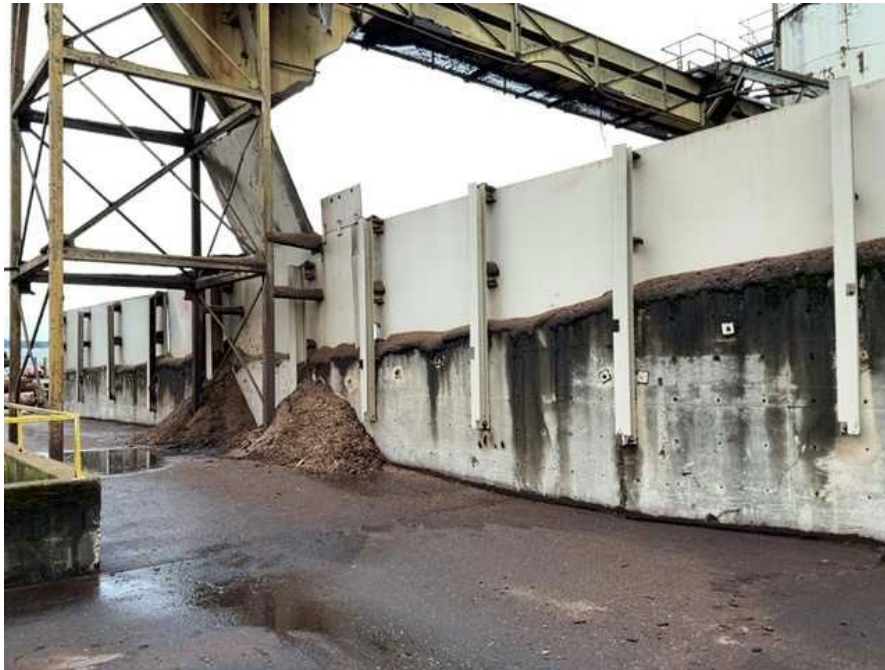
| Outside Boiler | | | IMG-202411191327502750113399.jpg |

| At the time of the inspection, I observed piles of sawdust accumulated on the walls and ground outside the boiler building. | | |

| <b>Permit Requirement</b><br>Schedule A.1.g of the permit states, in part, "Routinely clean all exposed areas that may contribute pollutants to stormwater with measures such as sweeping at regular intervals..." | |
| <b>AOC:</b><br>Piles of sawdust were accumulated on the walls and ground outside the boiler building. | |

| Sawdust piles outside of boiler area. | | | |

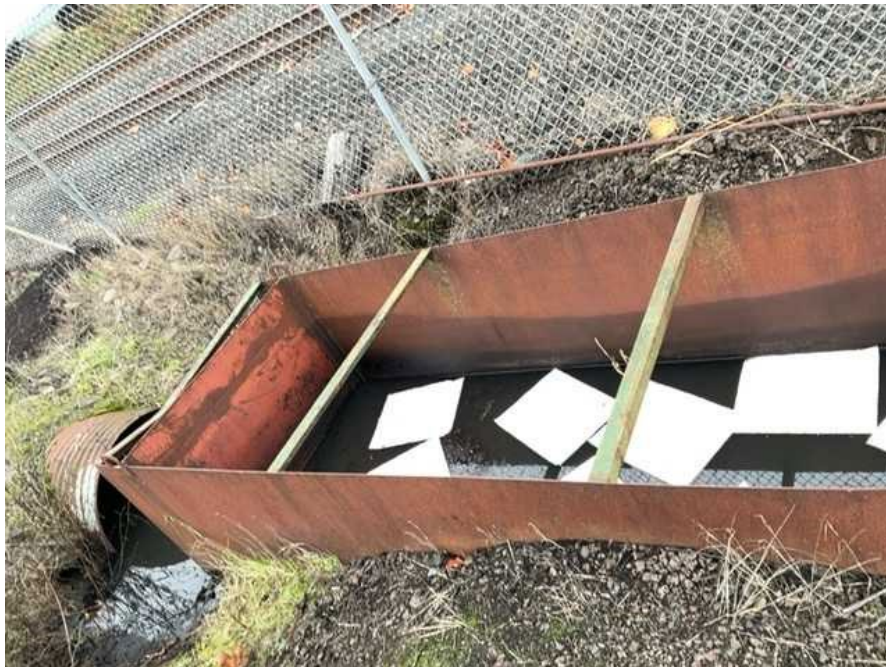
| Outfall 001 | | | IMG-202411191334233423154693.jpg |

| Outfall 001 with oil absorbent pads. | | | |

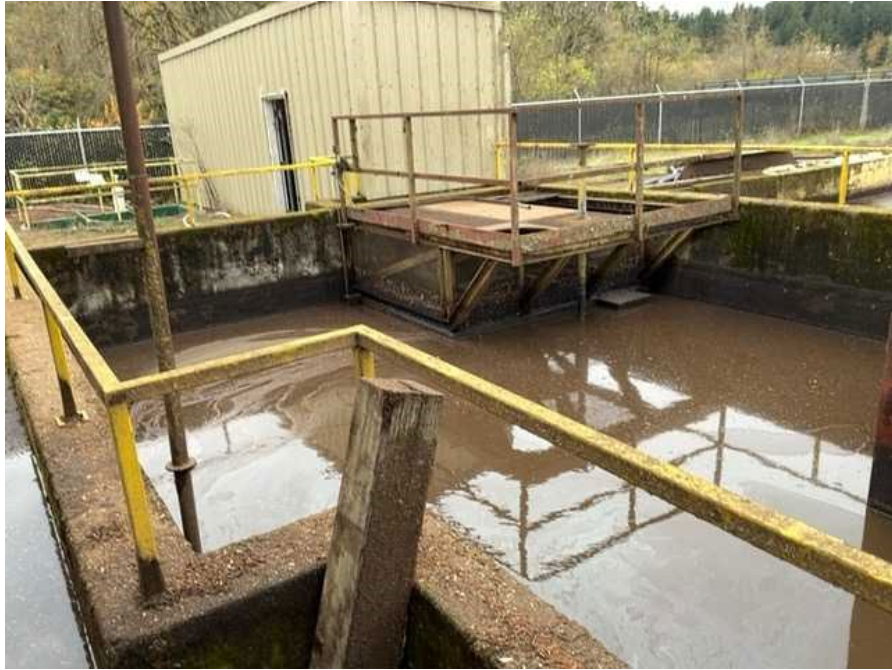
| Catch Basin 006 | | | IMG-20241119134007407123578.jpg |

| Catch basin 006, photo 1. | | | |

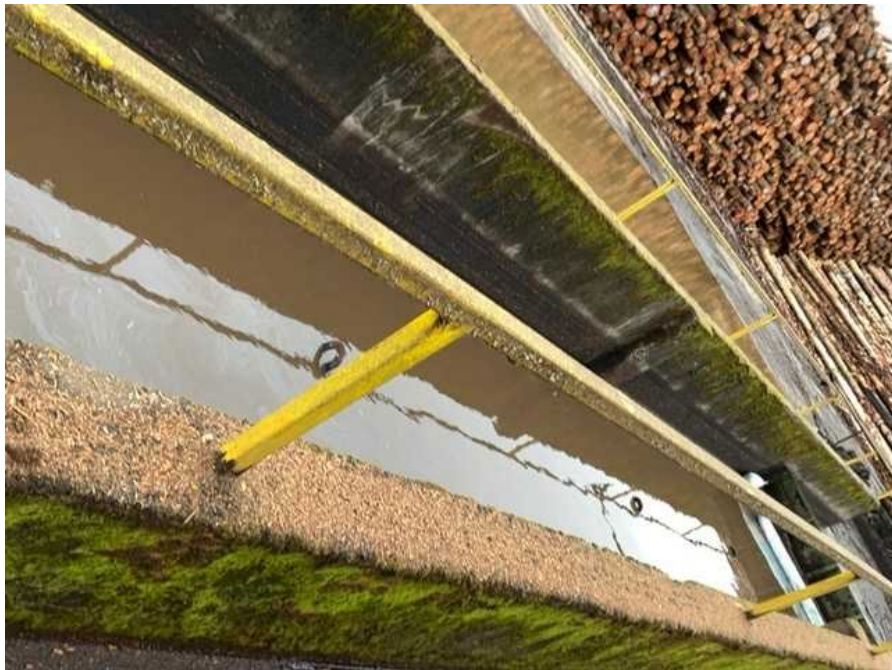
| Catch Basin 006 | | | IMG-202411191340134013130039.jpg |

| Catch basin 006, photo 2. | | | |

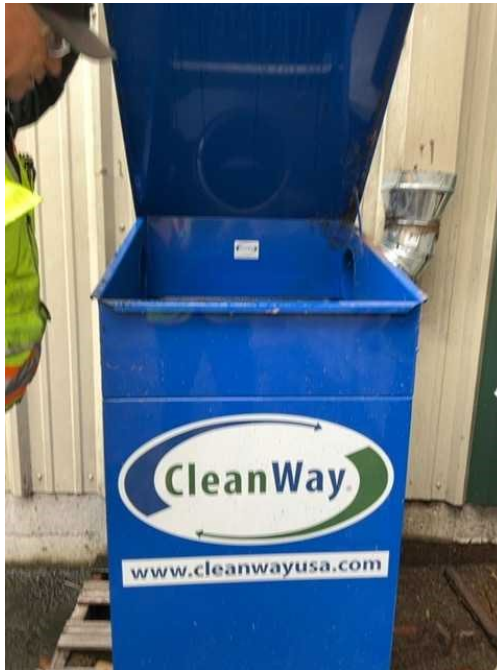
| The above photo is the Storm Clean® downspout filter system which collects and filters runoff from the facilities rooftops. Every roof downspout has its own Storm Clean® filter. Inside the filter system is the MetalZorb® metals filtration media, which filters a variety of metals including the target metal, zinc. | | | |

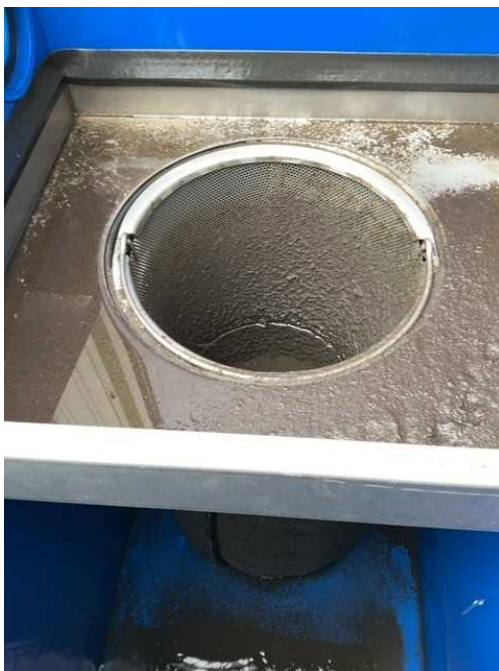
| Storm Clean® Downspout Filter System, Interior | | | IMG-20241119134544454489323.jpg |

| Filter for runoff from building roof, interior | | | |

| <p>Post Inspection, I reviewed two Tier II Corrective Action Response (CAR) SPCP Addendums, dated February 9, 2023 (Addendum 1), and November 15, 2023 (Addendum 2). The Responses were prepared for the facility by the contract engineering firm EGR &amp; Associates, Inc.</p> <p>The Addendum 1 CAR was in response to exceedance of the benchmark geometric mean for total suspended solids (TSS) at Outfall 006. The corrective action plan required the facility to retrofit the settling basin in the log grading and storage area with baffles to improve settling efficiency of sediment in the stormwater.</p> <p>The Addendum 2 CAR was in response to exceedance of the benchmark geometric mean for zinc (Zn) at Outfall 004. The facility and the contract engineer determined the most likely cause of the excessive zinc in the stormwater was runoff from the rooftops. To mitigate the discharge of zinc, the corrective action plan required the facility to install a self-contained downspout filter treatment unit at each of the roof downspouts. The filters use a filter media that specifically targets dissolved metals including zinc. The facility selected the Storm Clean® assembled downspout filter system manufactured by CleanWay® Environmental Partners with MetalZorb® metals filtration media. The downspout pipes were connected to an individual filter unit, which has an internal high-flow bypass. The filter units will discharge onto adjacent pavement as currently occurs with the roof downspouts.</p> | | |

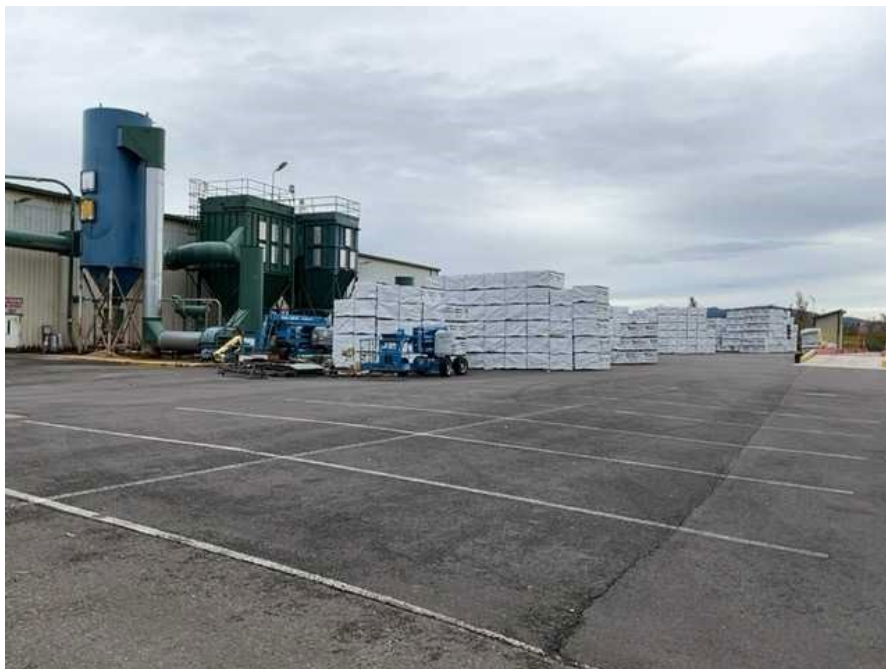
| Outside Storage | | | IMG-20241119135223522383817.jpg |

| Packaged finished product. | | |

| Packaged finished product waiting for ship out. | | | |
