**UNITED STATES ENVIRONMENTAL PROTECTION AGENCY**  
**REGION 5**  
**77 WEST JACKSON BOULEVARD**  
**CHICAGO, ILLINOIS 60604**

**SUBJECT:** CLEAN WATER ACT INSPECTION REPORT  
*United Mobile Homes of Ohio, Inc – Wood Valley MHP, 1493 N. Whetstone River Rd, Caledonia, Ohio, Marion County*

**Facility Type:** *Extended aeration treatment plant (privately-owned mobile home park)*

**Date of Inspection:** September 5, 2024

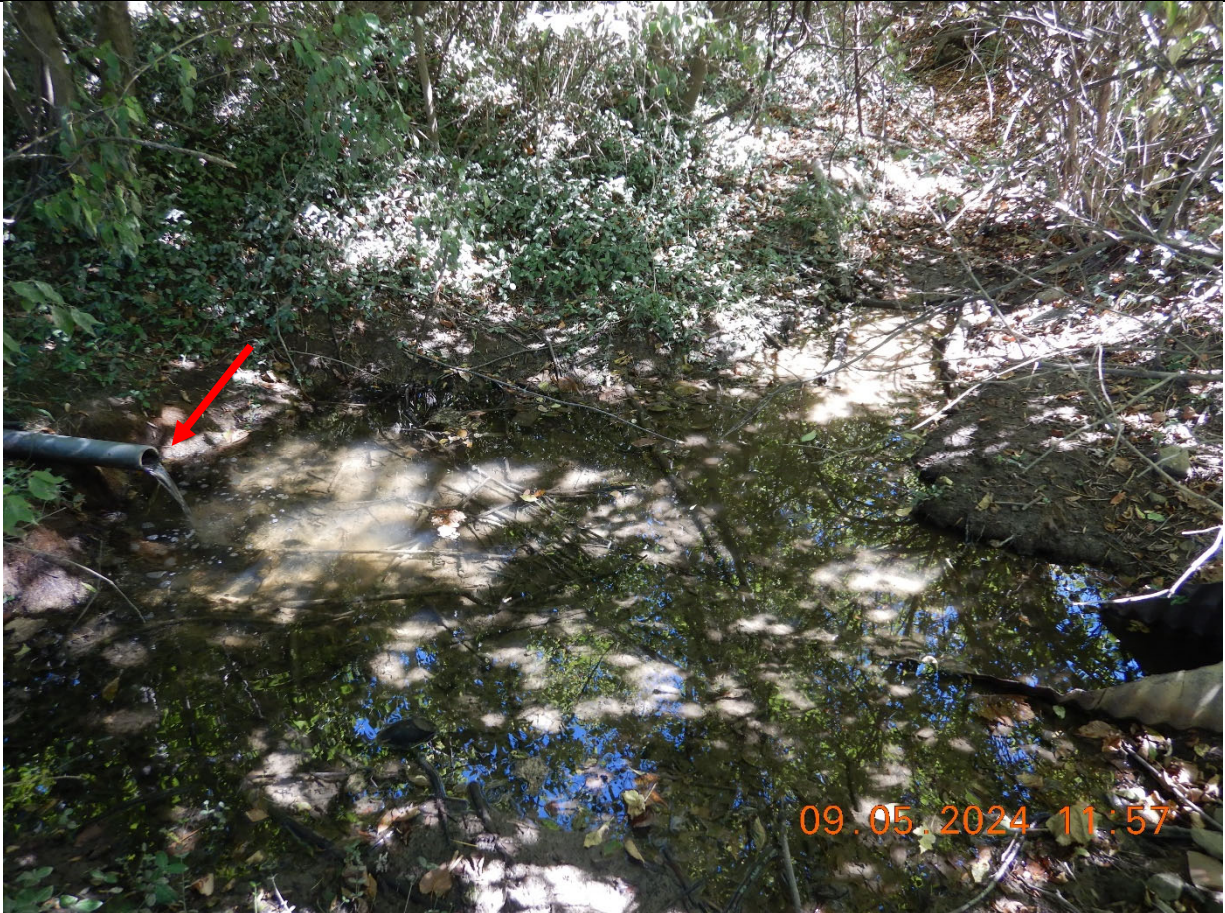
1: DSCN2266.JPG

Description: Outlet from the discharge pipe to the small tributary to the Olentangy River. End of discharge pipe is marked with a red arrow.

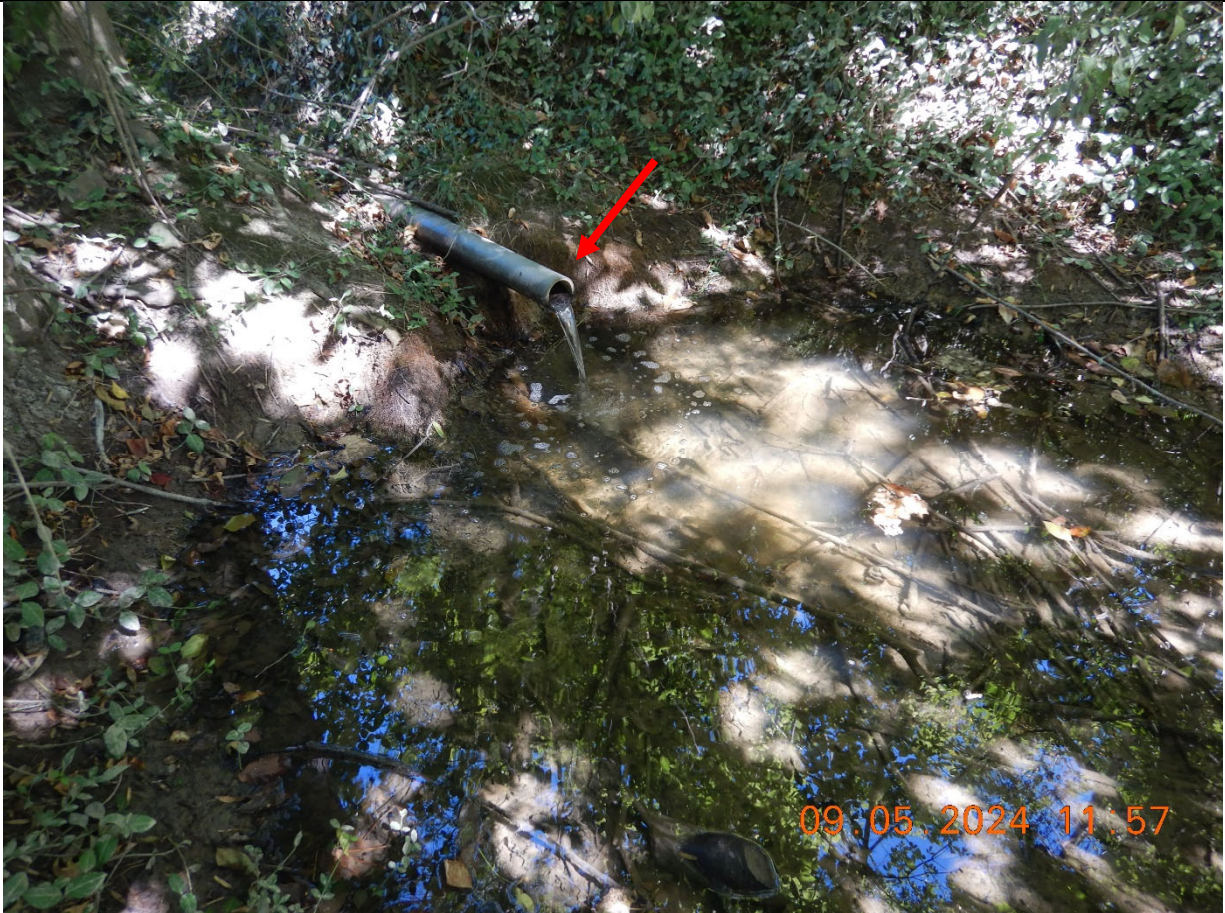
[2: DSCN2267.JPG](#)

Description: Outlet from the discharge pipe to the small tributary to the Olentangy River. End of discharge pipe is marked with a red arrow.

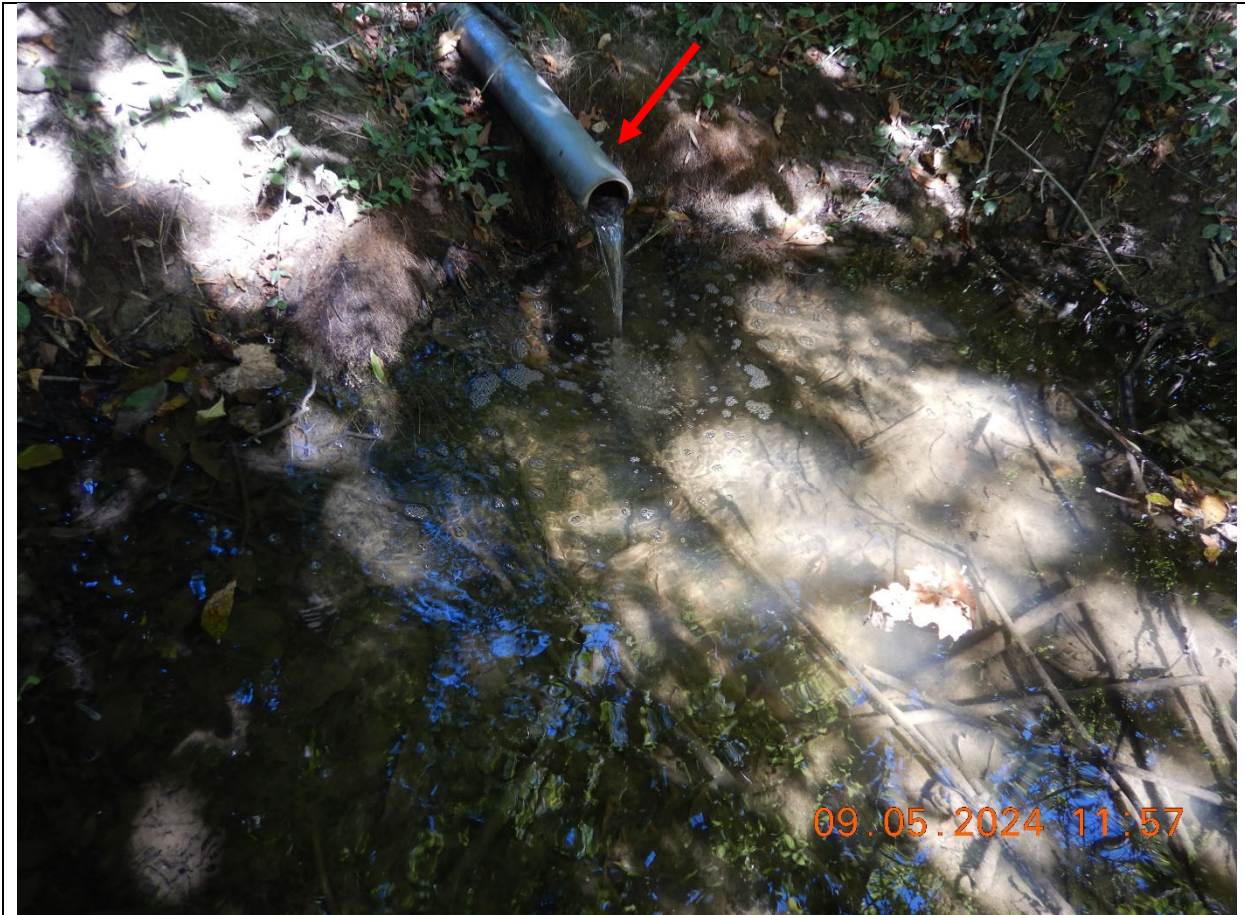
3: DSCN2268.JPG

Description: Outlet from the discharge pipe to the small tributary to the Olentangy River. End of discharge pipe is marked with a red arrow.

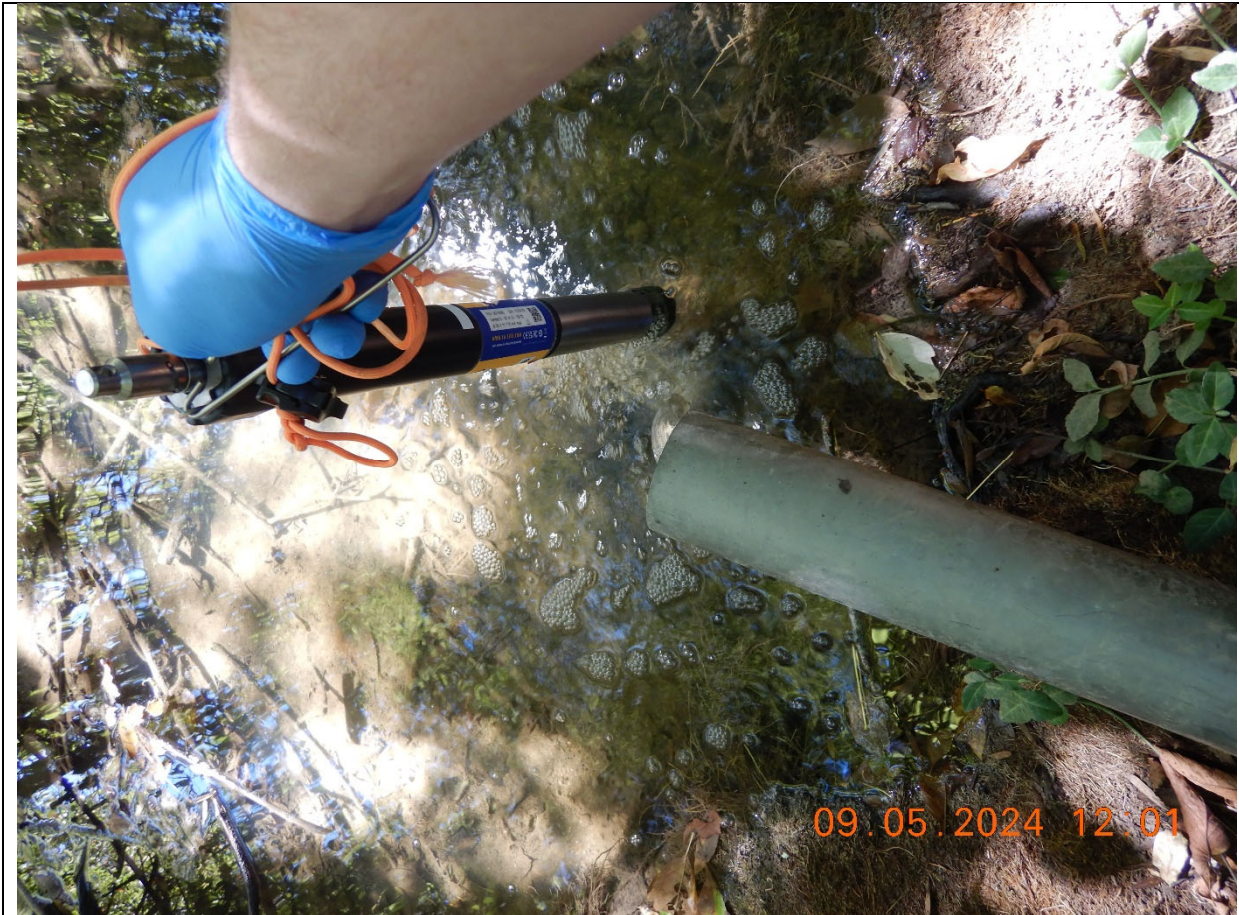
4: [DSCN2269.JPG](#)

Description: Outlet from the discharge pipe to the small tributary to the Olentangy River.

Location where field monitoring was conducted.

| <b><i>Date/Time</i></b> | <b><i>Ref. #</i></b> | <b><i>Location</i></b> | <b><i>Cond<br/>(ug/cm)</i></b> | <b><i>pH (SU)</i></b> | <b><i>RDO<br/>(mg/l)</i></b> | <b><i>Turbidity<br/>(NTU)<br/>equivalent</i></b> |
|---|---|---|---|---|---|---|
| 9/5/2024<br>12:00 | MP-03 | End of pipe on the discharge line from Outfall 001, in stream measurement, see Photo 4 | 873 | 6.53 | 3.93 | 0.5 |

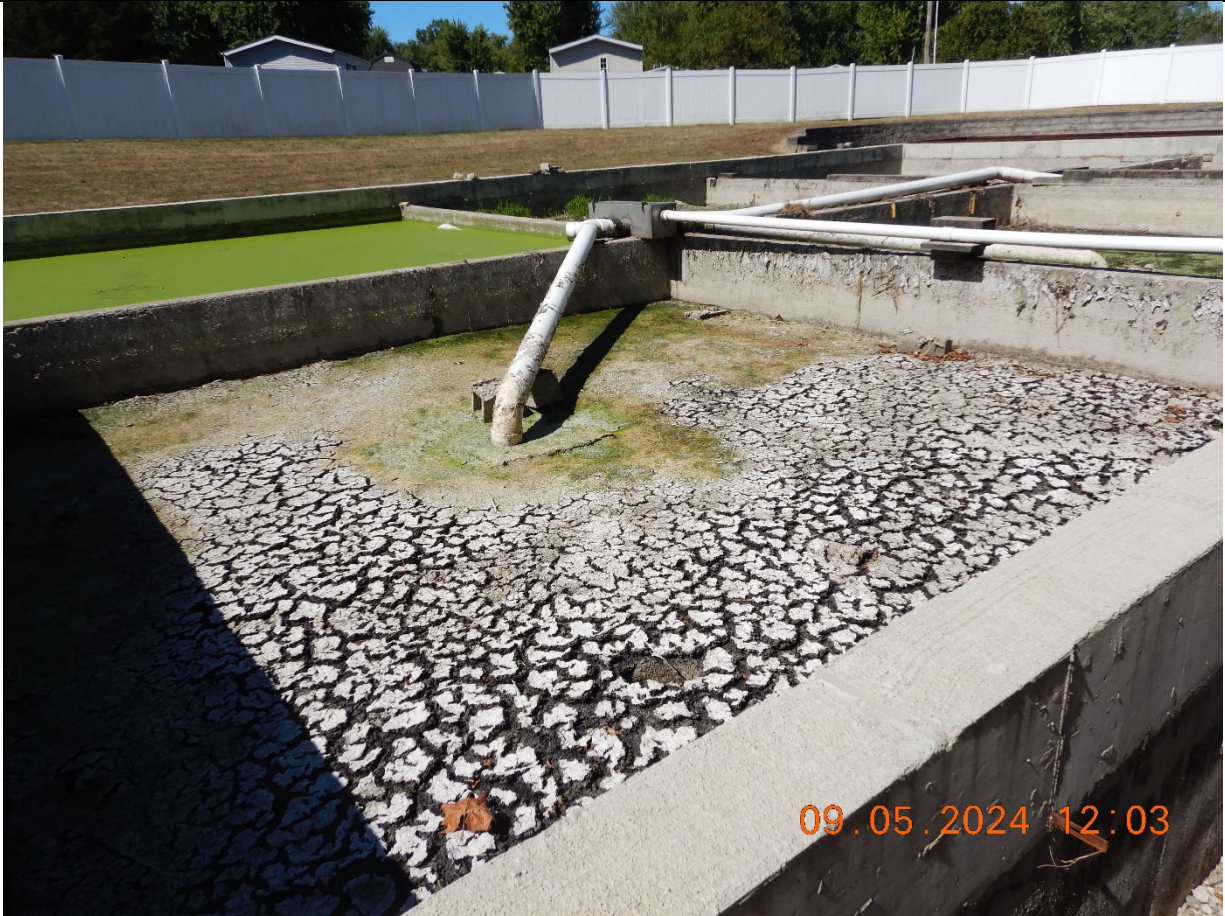
5: DSCN2270.JPG

The sand filters were filled with vegetation, algae and other materials as shown in Photos 5 through 13.

At the time of the inspection, five of the six cells in the slow sand filter contained either excessive plant grown, algae and/or dried material resembling dried sludge. One filter cell was in operation. This cell was flooded, holding standing water and covered with bright green algae.

Description: Filter cell at the southwest corner of the filters. At the time of the inspection the surface of the filter was covered with dried, non-sand, material resembling dried sludge.

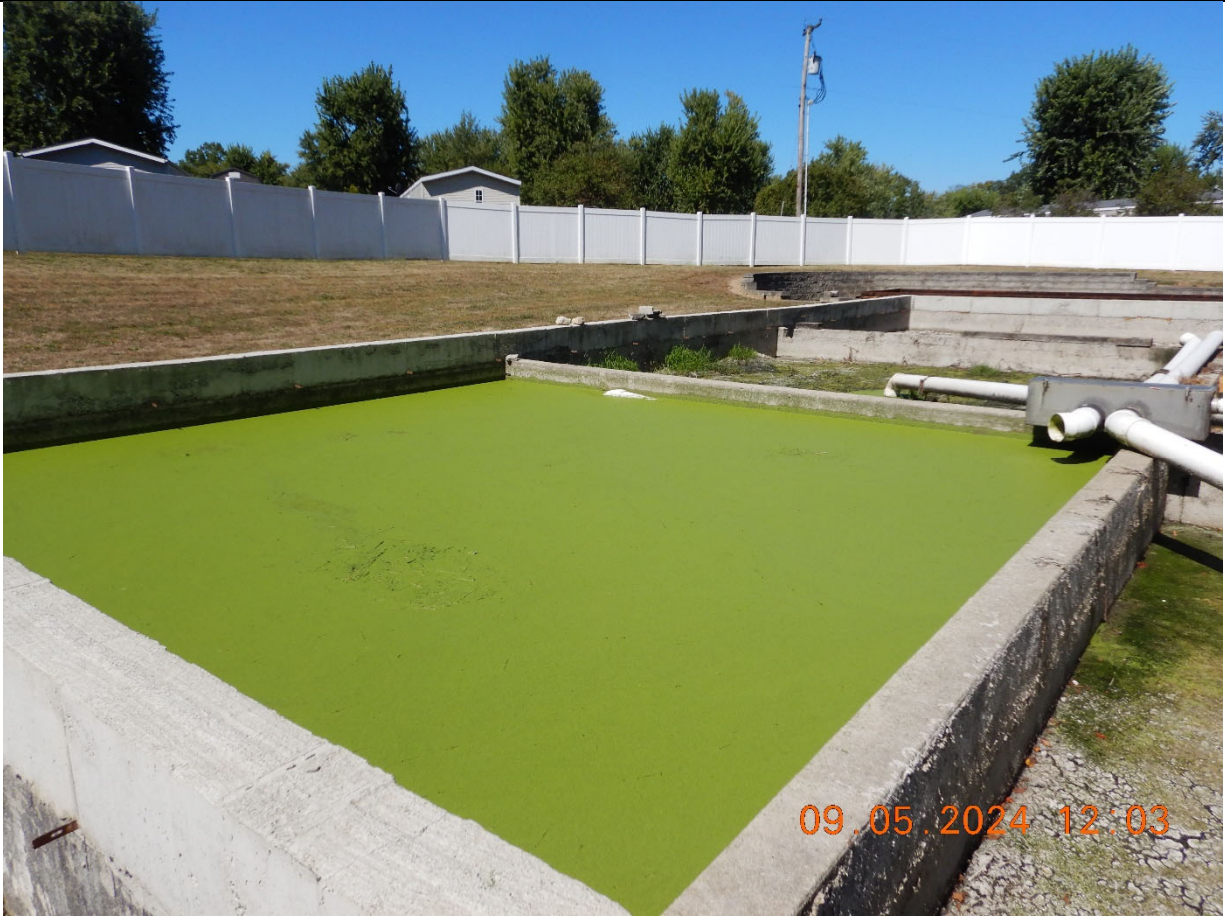
6: DSCN2271.JPG

Description: Filter cell at the southeast corner of the filters. At the time of the inspection the surface of the filter was covered with water and a layer of green algae.

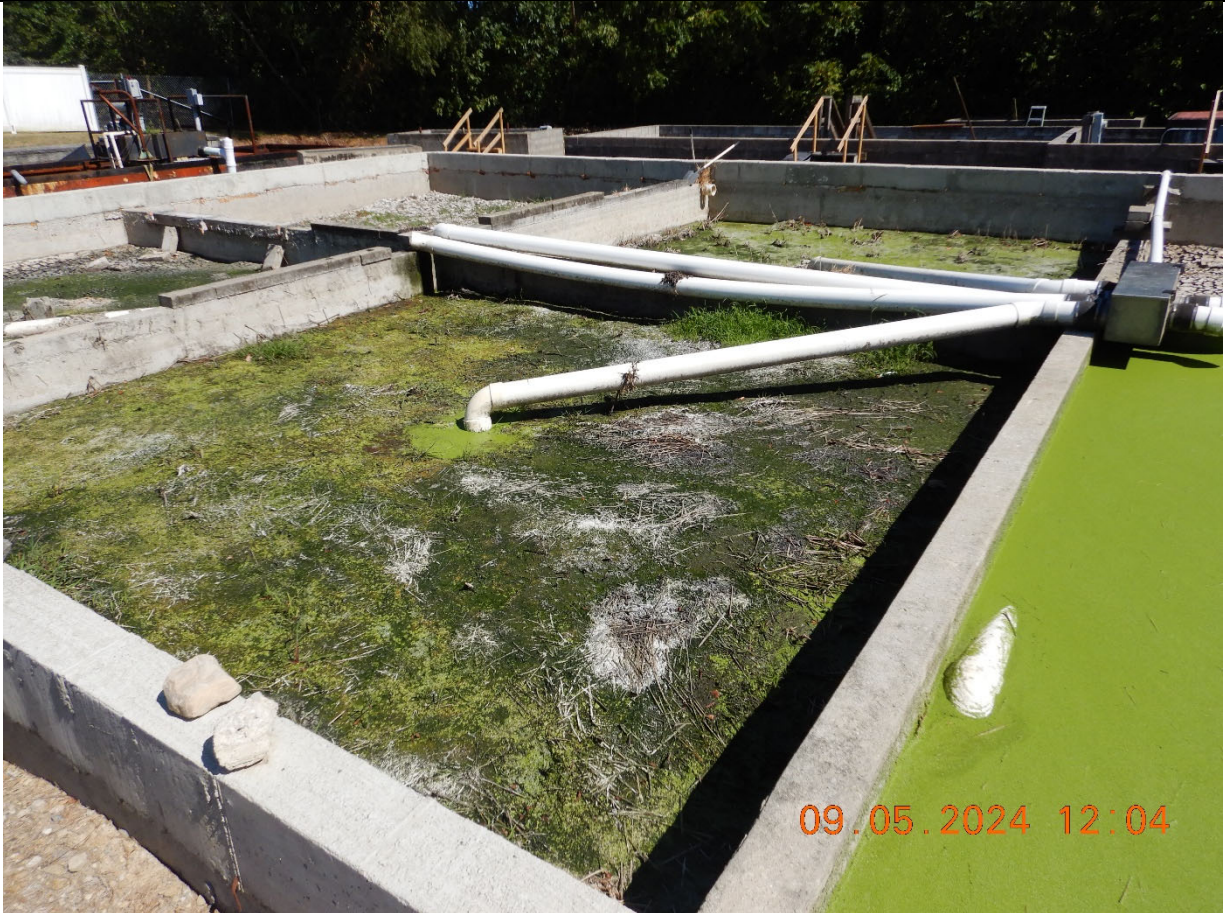
7: DSCN2272.JPG

Description: Filter cell at the middle west side of the filters. At the time of the inspection the surface of the filter was covered with vegetation.

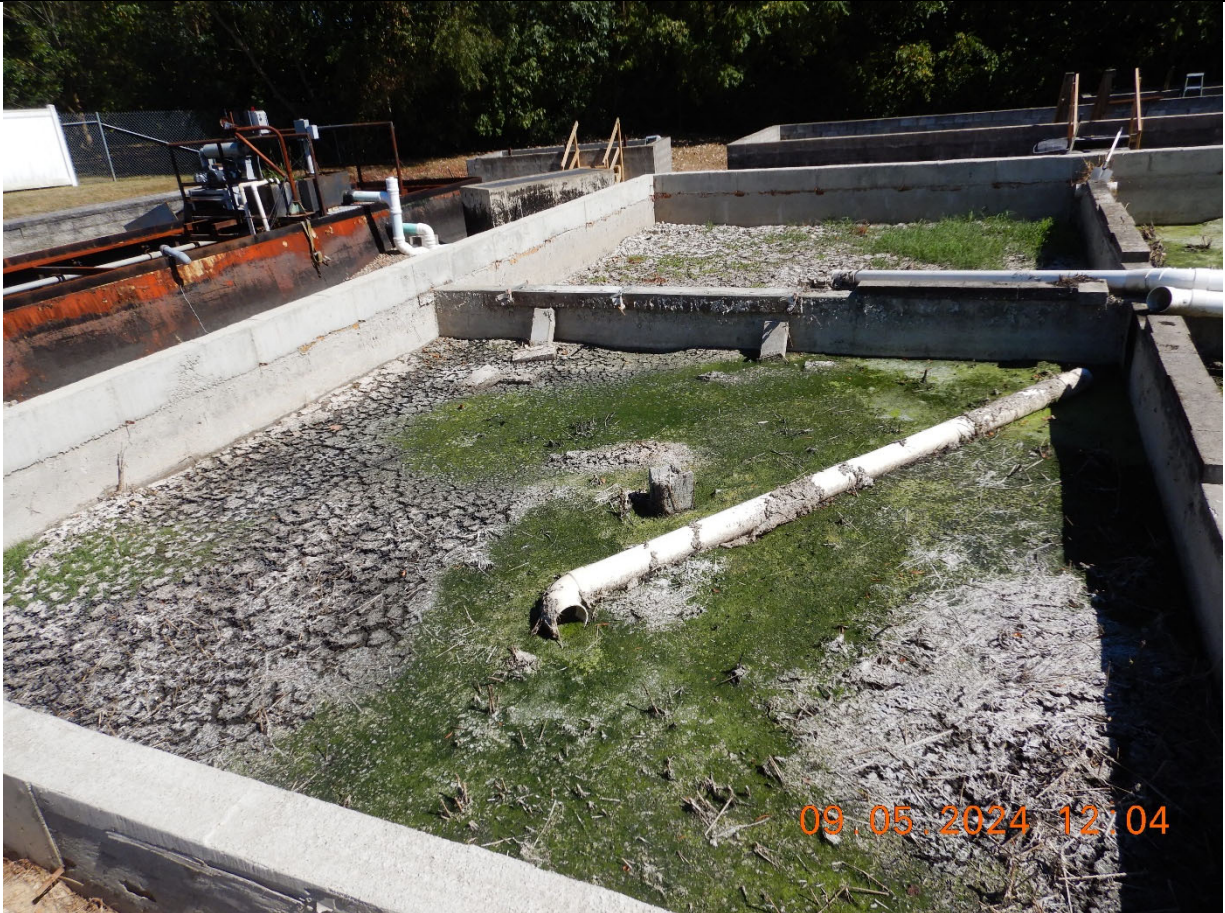
8: [DSCN2273.JPG](#)

Description: Filter cell at the northwest corner of the filters. At the time of the inspection the surface of the filter was covered with vegetation and dried material that resembled dried sludge.

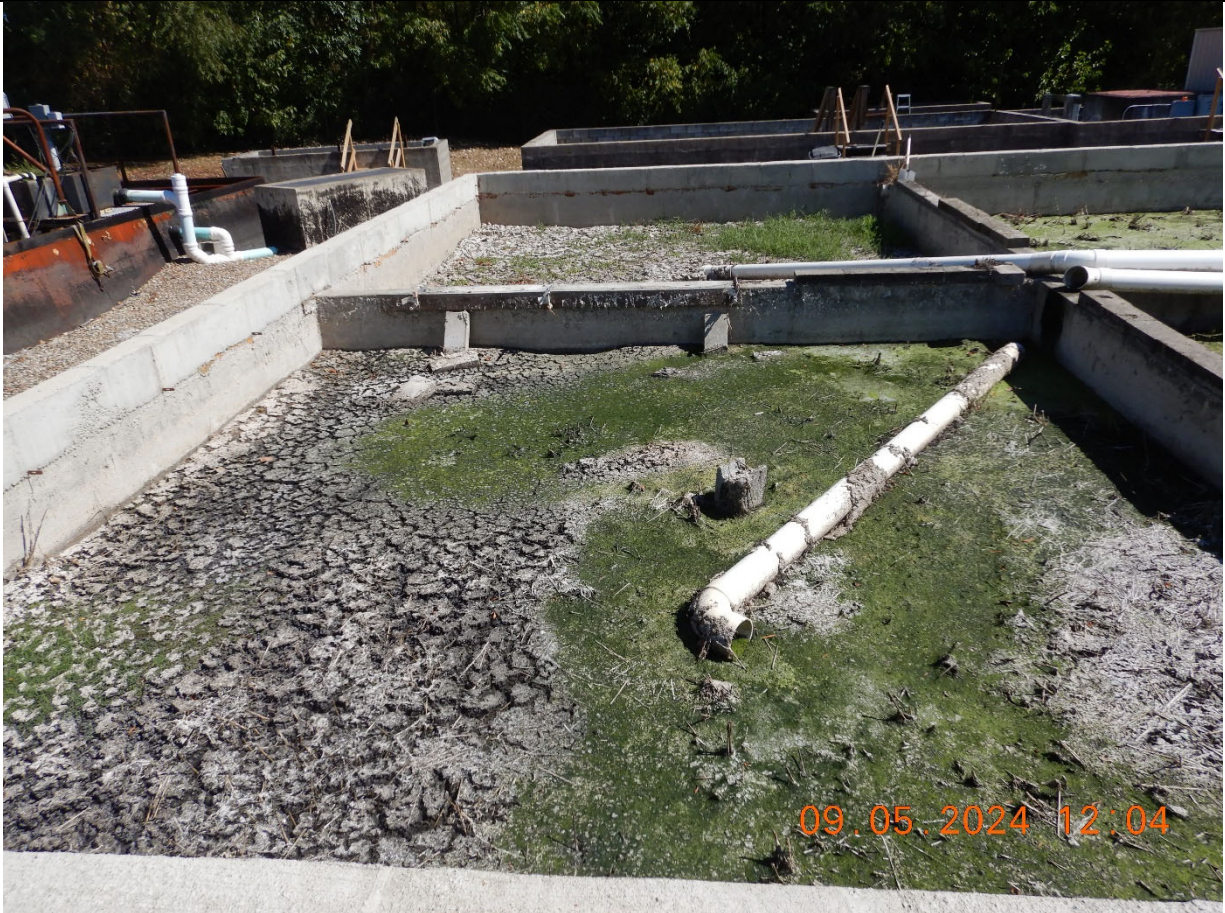
10: [DSCN2275.JPG](#)

Description: Filter cell at the northwest corner of the filters. At the time of the inspection the surface of the filter was covered with vegetation and dried material that resembled dried sludge.

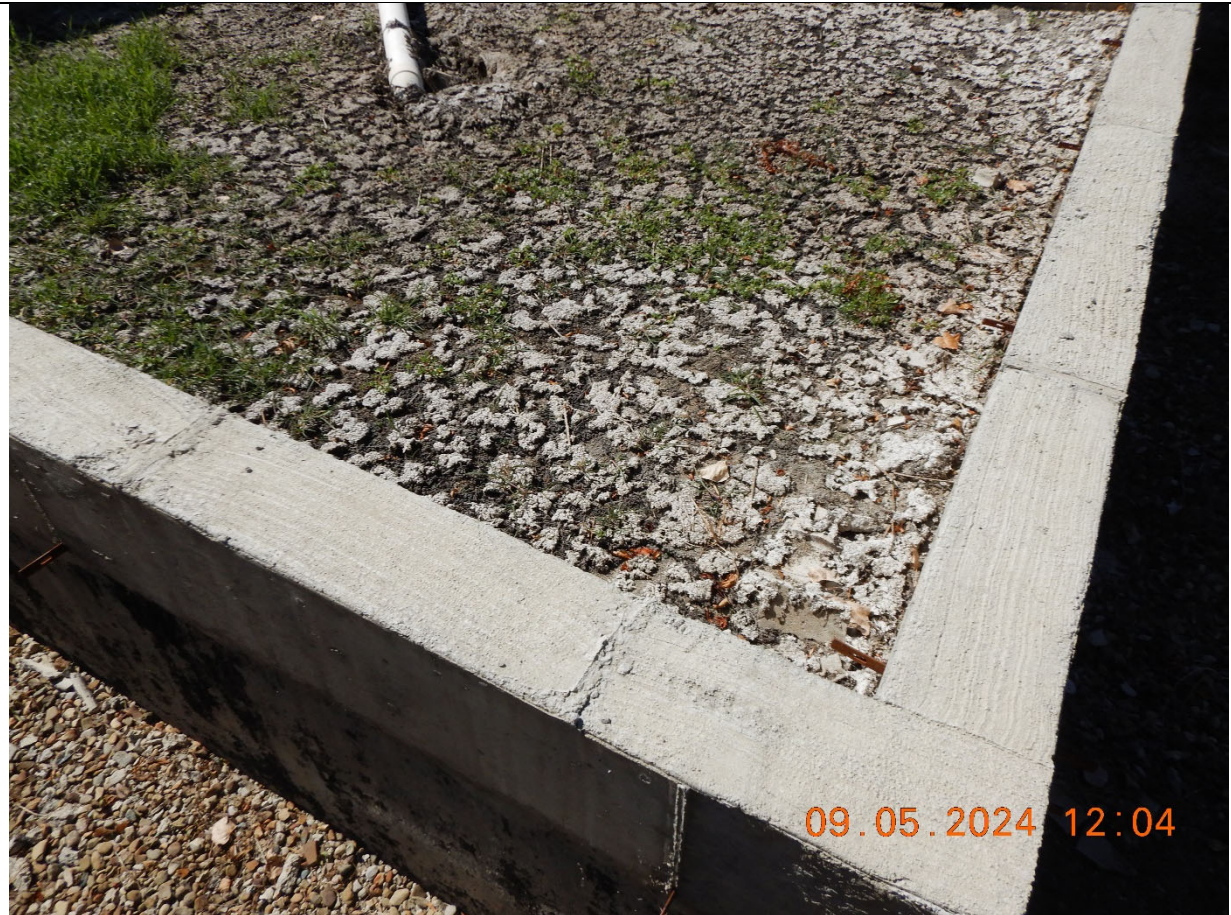
11: [DSCN2276.JPG](#)

Description: Filter cell at the northeast corner of the filters. At the time of the inspection the surface of the filter was covered with vegetation and dried material that resembled dried sludge.

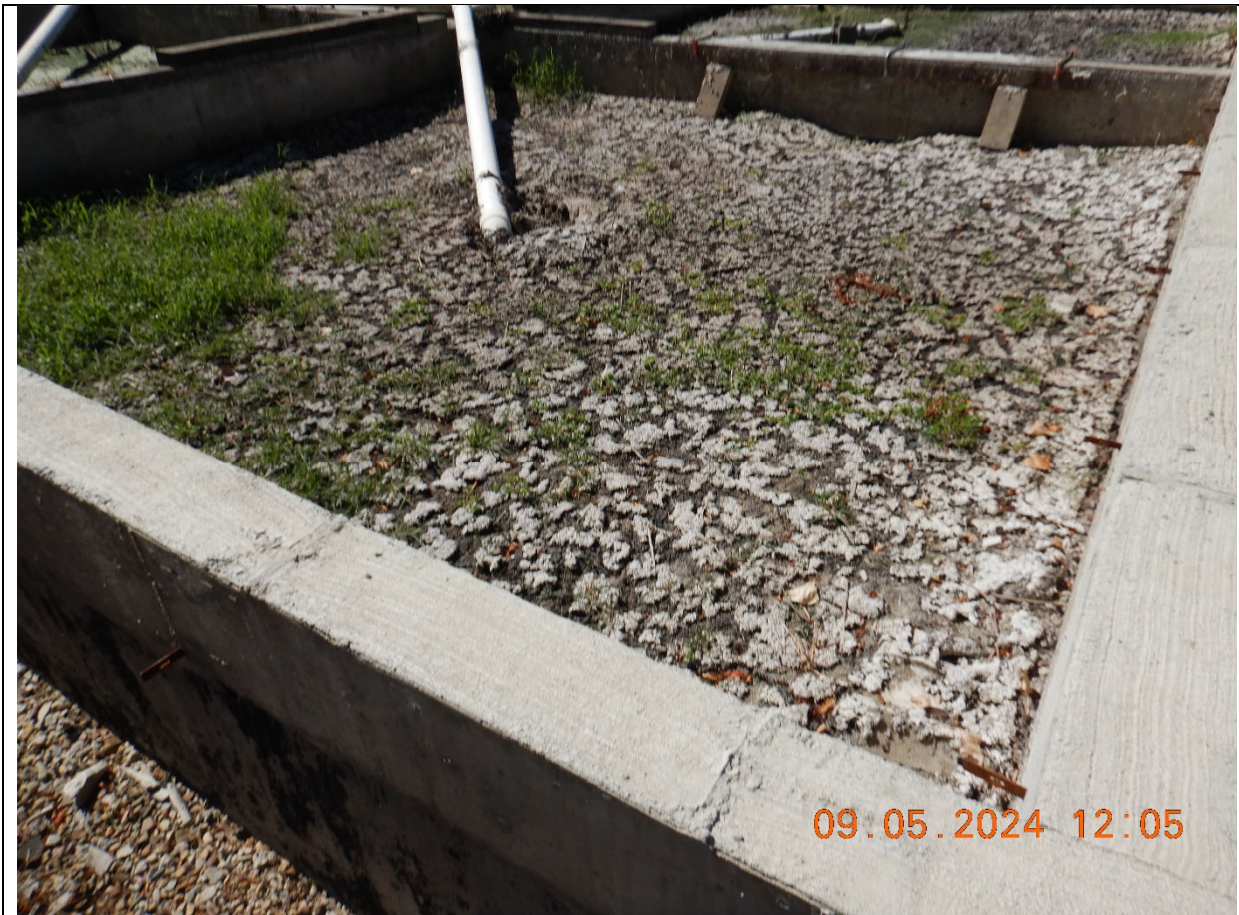
[12: DSCN2277.JPG](#)

Description: Filter cell at the northeast corner of the filters. At the time of the inspection the surface of the filter was covered with vegetation and dried material that resembled dried sludge.

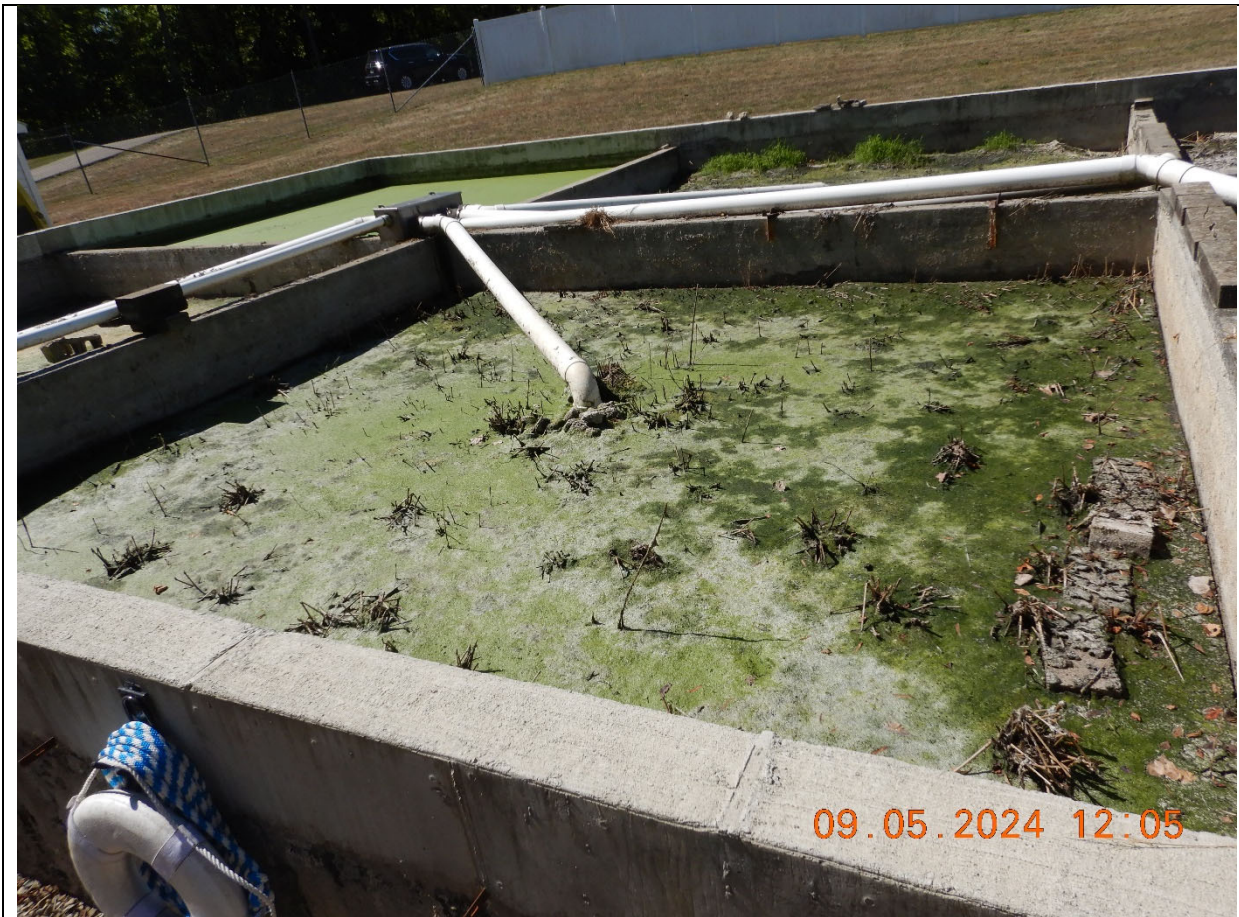
13: DSCN2278.JPG

Description: Filter cell at the middle east side of the filters. At the time of the inspection the surface of the filter was covered with vegetation and debris.

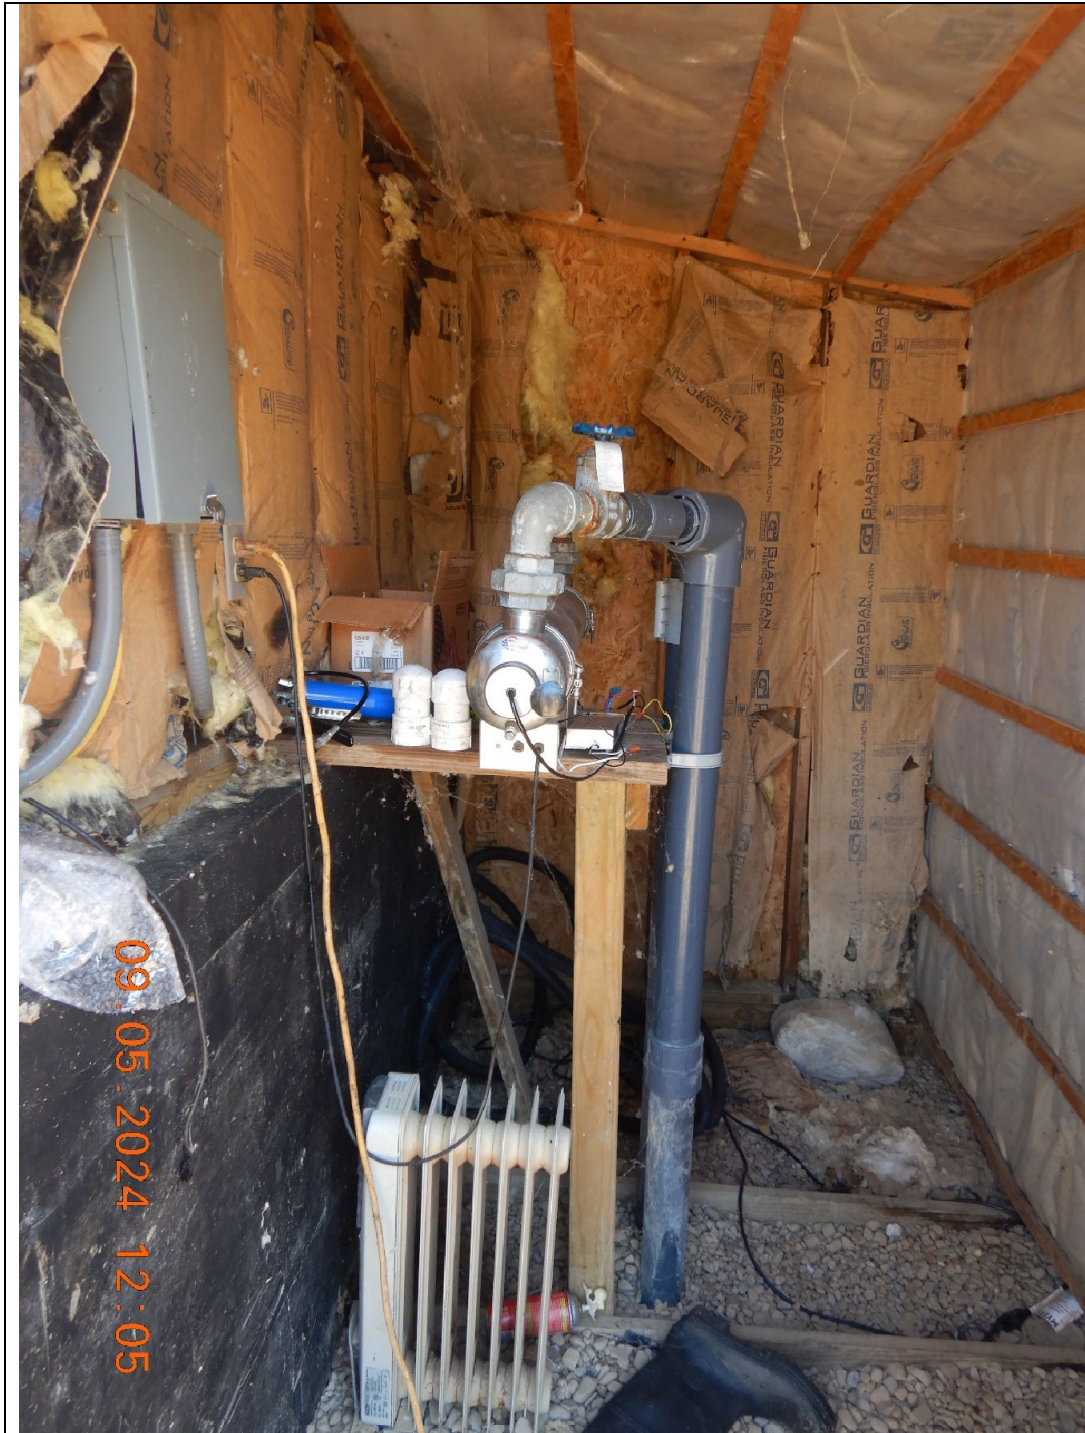
14: DSCN2279.JPG

Description: Looking into the room with the UV system and the compliance sampling tap.

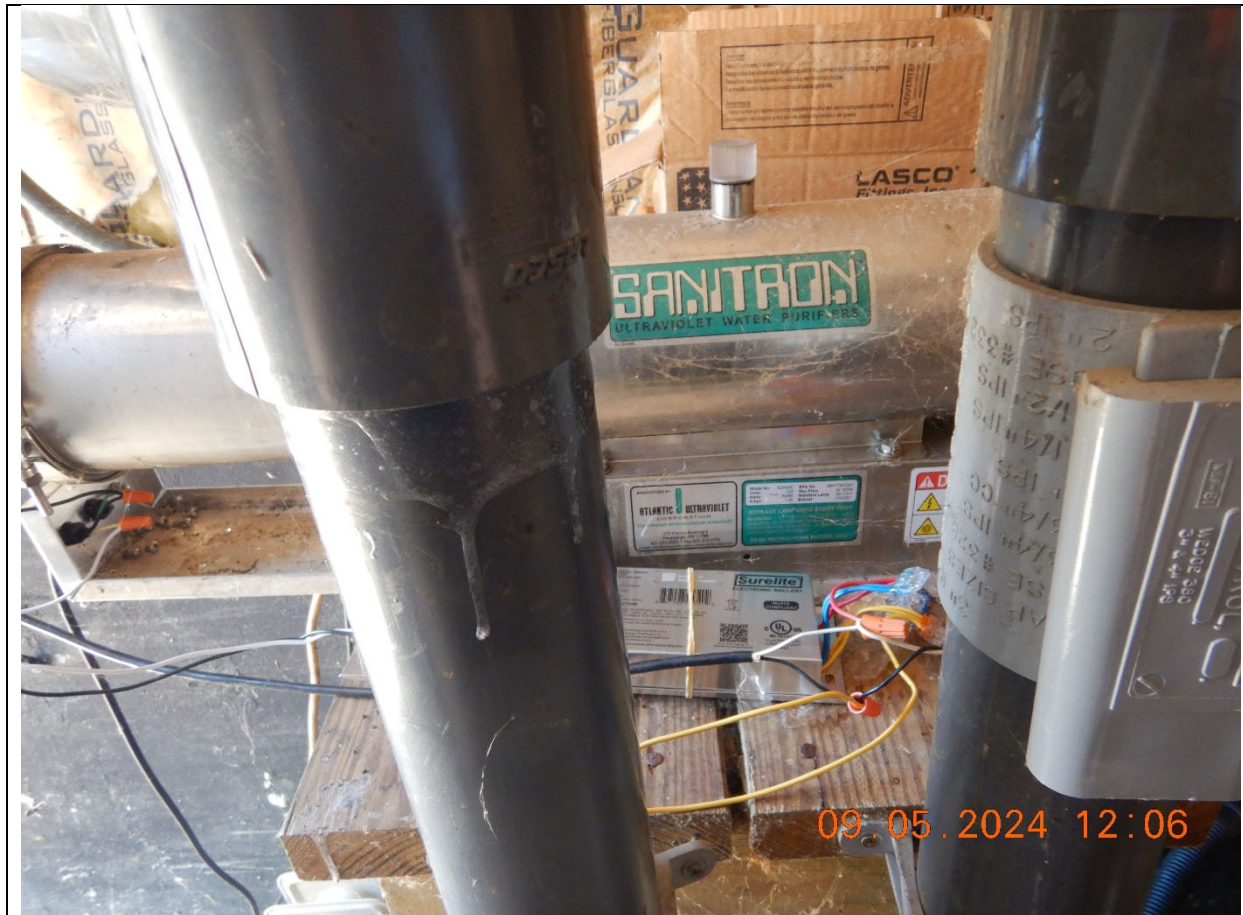
15: DSCN2280.JPG

Description: The Sanitron UV treatment system. At the time of the inspection, the system was on and the lamp was illuminated.

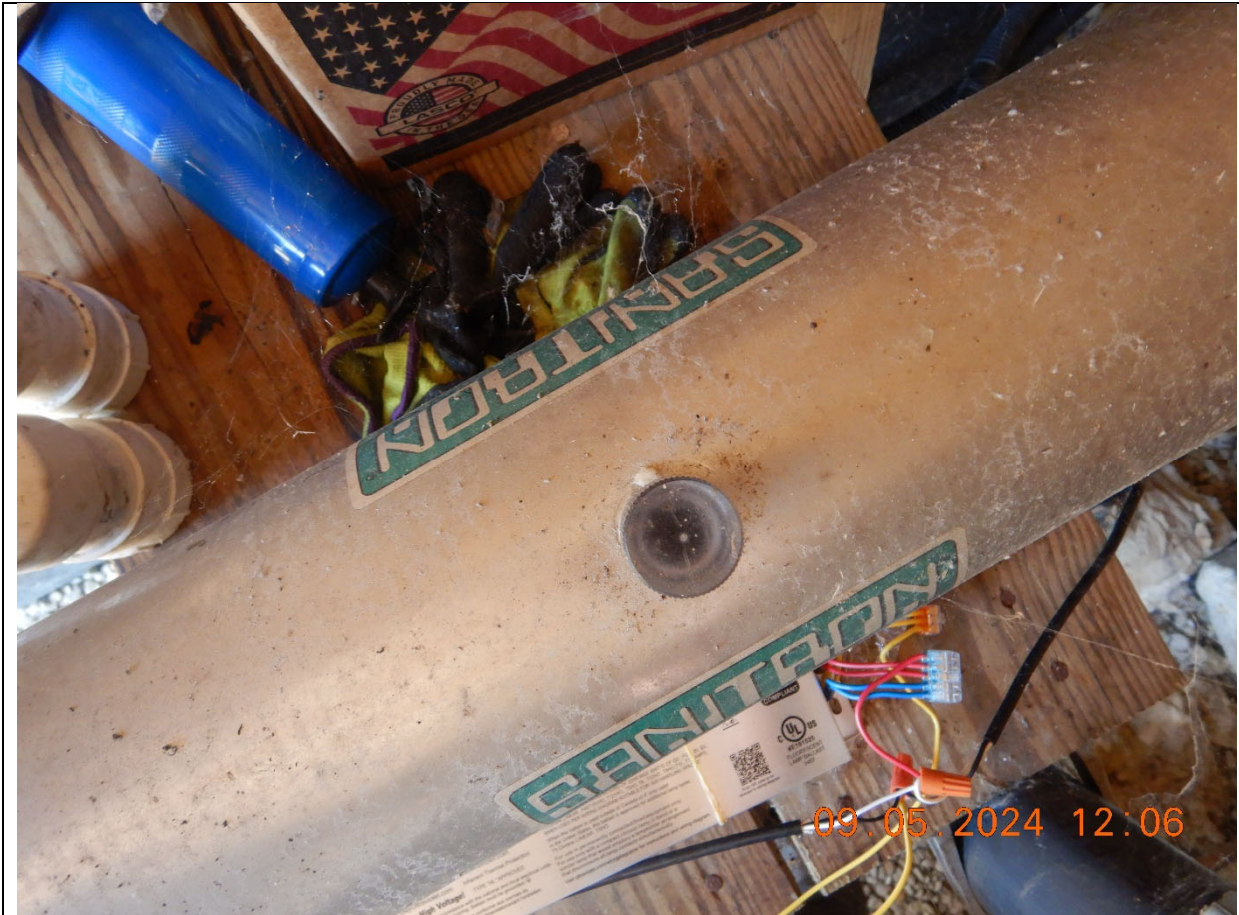
16: DSCN2281.JPG

Description: The Sanitron UV treatment system. At the time of the inspection, the system was on and the lamp was illuminated.

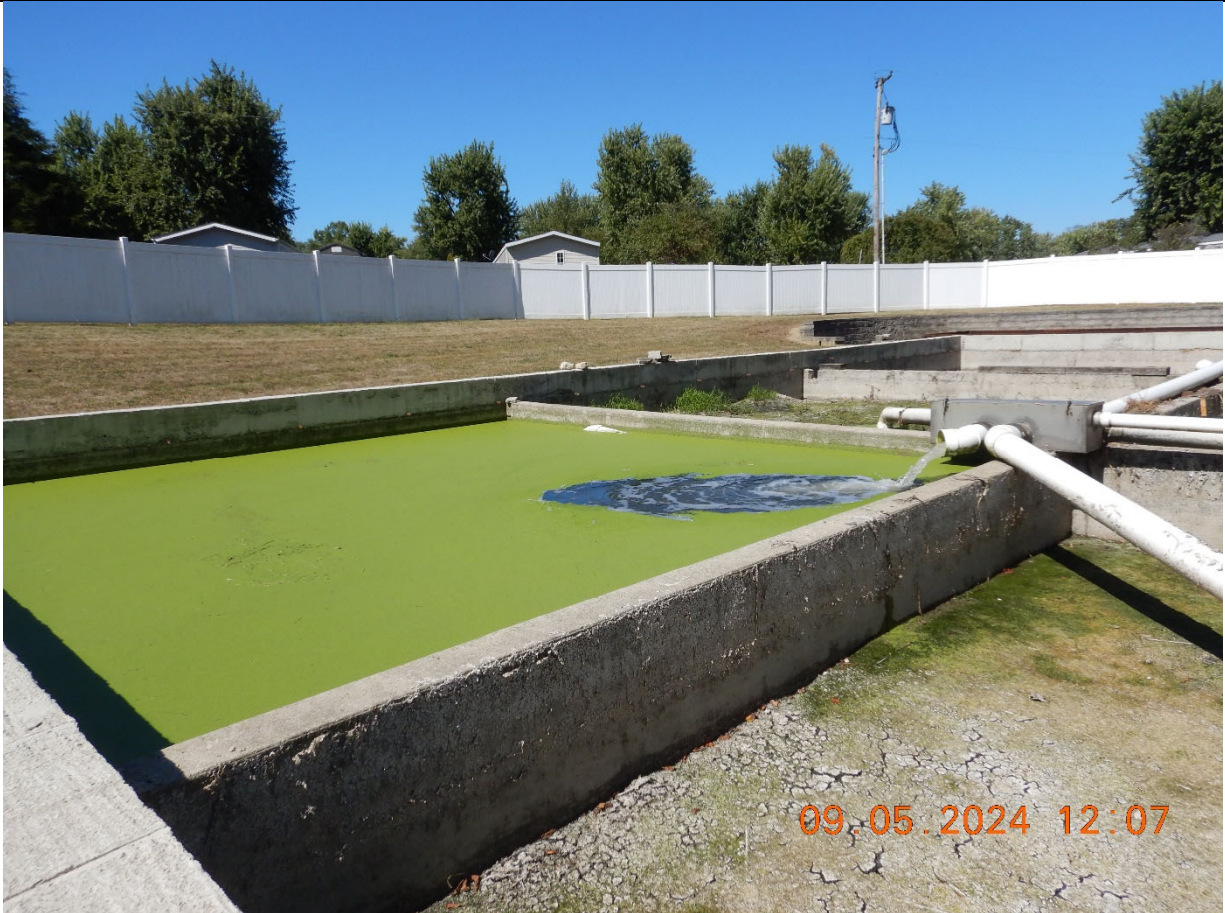
17: DSCN2282.JPG

Description: During the inspection, the dosing pump for the filters activated. Flow was observed into the cell at the southeast corner of the filter cells. This was the only cell that appeared to be in use.

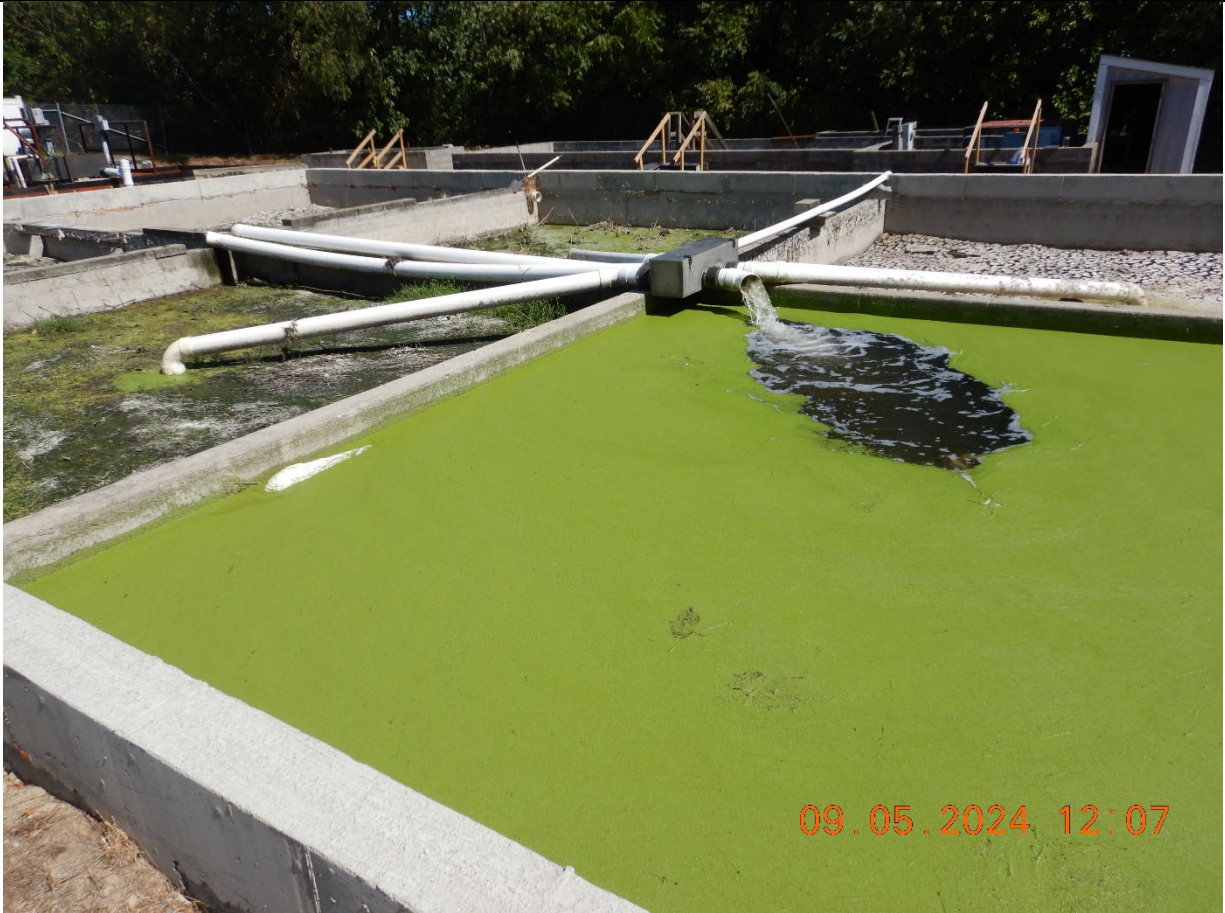
18: [DSCN2283.JPG](#)

Description: During the inspection, the dosing pump for the filters activated. Flow was observed into the cell at the southeast corner of the filter cells. This was the only cell that appeared to be in use.

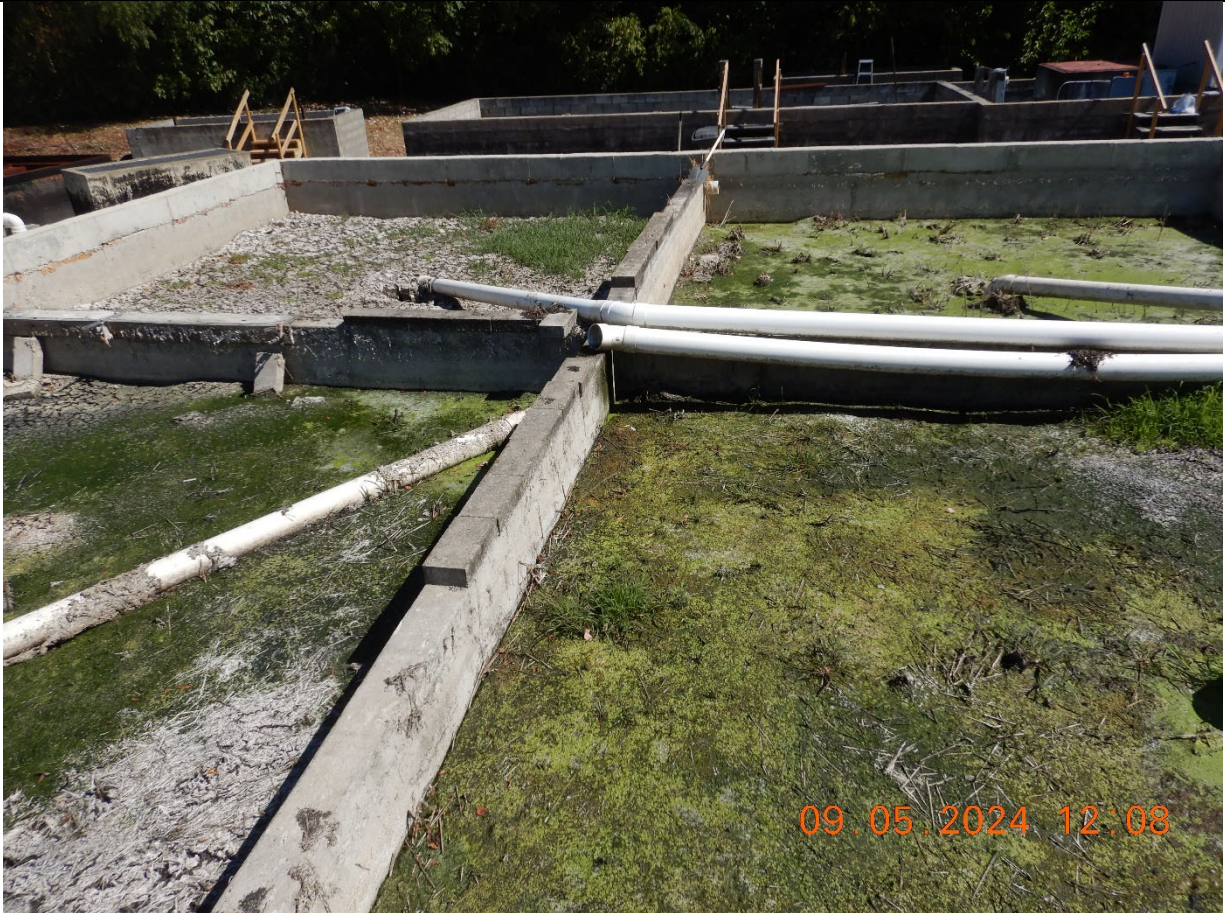
19: [DSCN2284.JPG](#)

Description: Looking at the four filter cells on the north end of the filters. Photo was taken while water was flowing into the cell at the southeast corner.

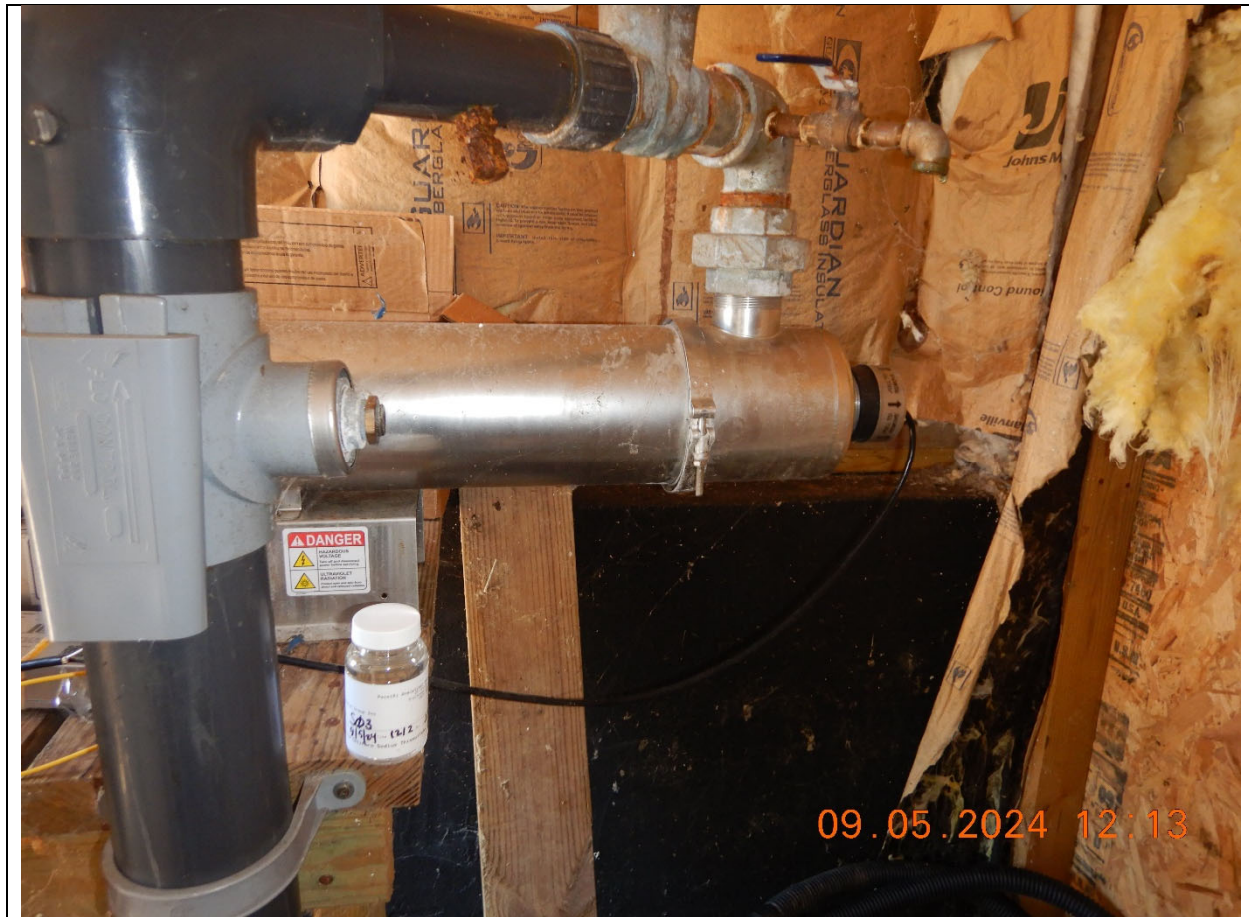
20: DSCN2285.JPG

Result of the E. coli sample taken during the inspection was 866 which is higher than the weekly and monthly averages. At the time of writing of this report, the other weekly and monthly values were not known.

Description: Sample tap and sample S03 at the compliance monitoring location for Outfall 001.
