**UNITED STATES ENVIRONMENTAL PROTECTION AGENCY**  
**REGION 5**  
**77 WEST JACKSON BOULEVARD**  
**CHICAGO, ILLINOIS 60604**

**SUBJECT:** CLEAN WATER ACT INSPECTION REPORT  
*United Mobile Homes of Ohio, Inc – Wood Valley MHP, 1493 N. Whetstone River Rd, Caledonia, Ohio, Marion County*

**Facility Type:** *Extended aeration treatment plant (privately-owned mobile home park)*

**Date of Inspection:** September 5, 2024

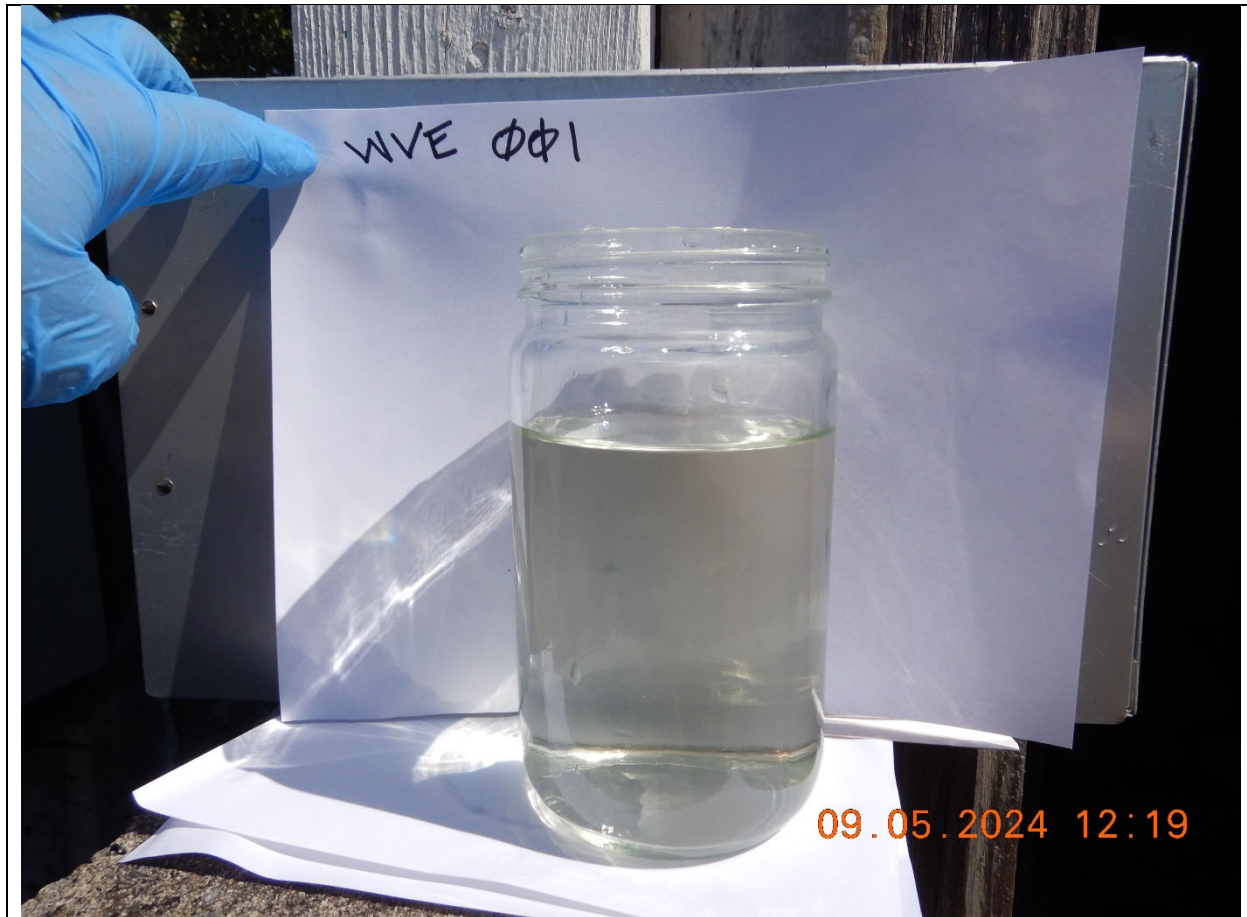
21: DSCN2286.JPG

Field monitoring conducted during the inspection showed dissolved oxygen less than the permit limitation. This was observed at the NPDES compliance sampling tap where the measurements were 4.61 mg/L, and 4.78 mg/L and also from a sample taken from the end of the discharge pipe where the value was 3.93 mg/L. The instream concentration in the tributary to the Olentangy River, immediately downstream of the confluence with the effluent from the Outfall 001 was 3.69 mg/L and below the permit limit.

Description: Visual grab of the water from the tap used for compliance sampling at Outfall 001.

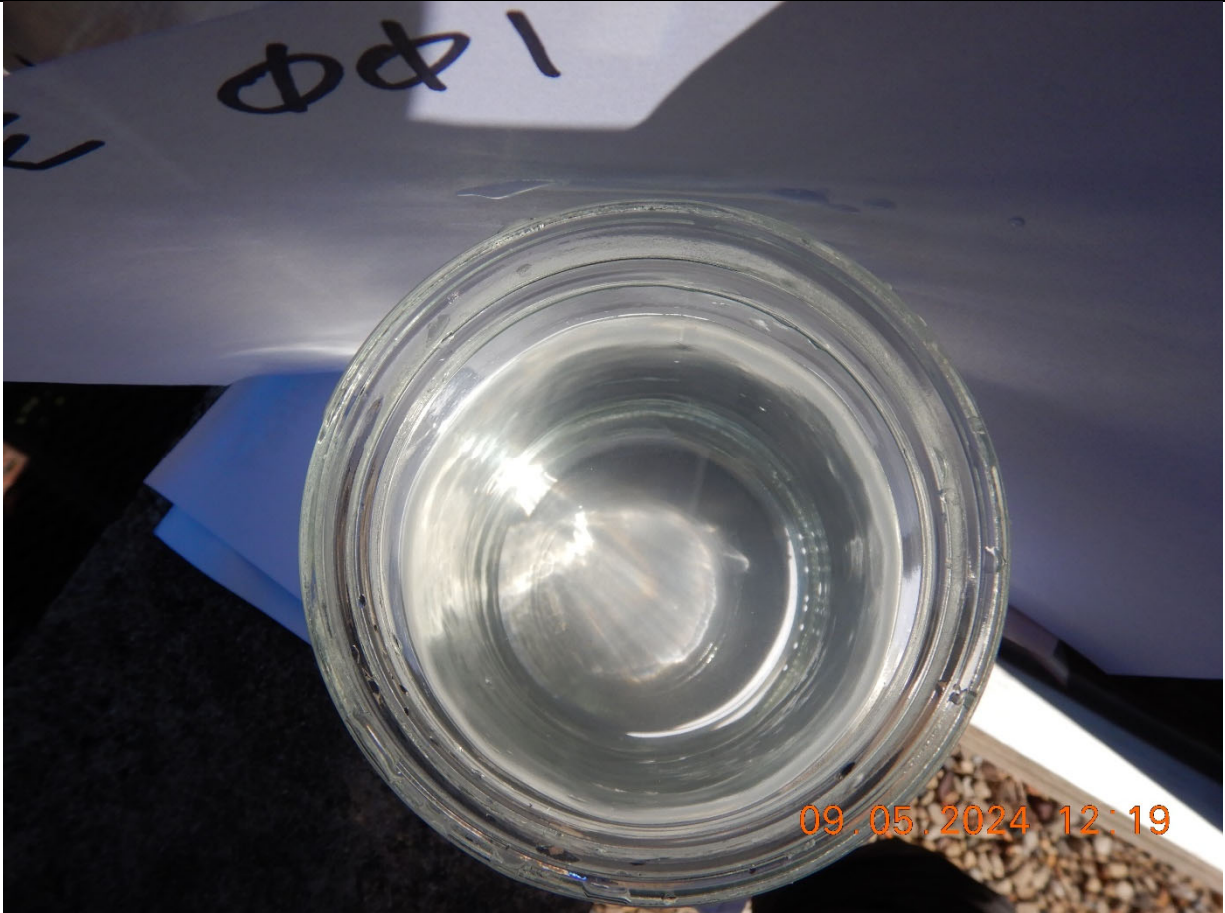
22: DSCN2287.JPG

Description: Visual grab of the water from the tap used for compliance sampling at Outfall 001.
