SUBJECT: CLEAN WATER ACT INSPECTION REPORT
Calumet Specialty Products Partners, L.P., Burnham, Illinois

Facility Type: Petroleum Products Transfer Terminal

Date of Inspection: May 28, 2021

Inspection Type: Industrial Stormwater

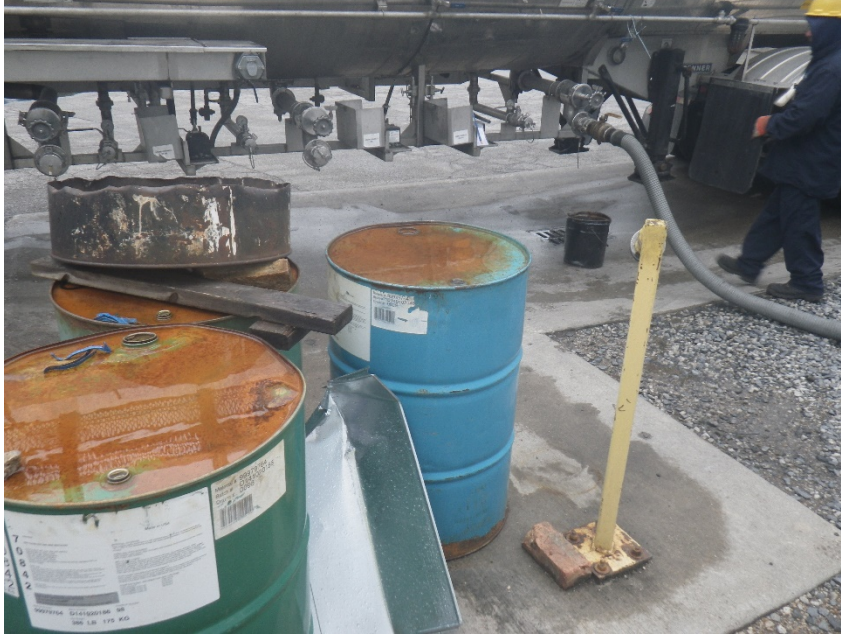
4: IMGP0004

The facility walkthrough focused on the site perimeter controls and internal stormwater sewer system. Stormwater on site gravity drains to a series of inlets which are all on an internal sewer. The internal sewer is gravity fed to a pump room and then pumped to an oil water separator, prior to being held, and then discharged to MWRD. MWRD samples at a manhole located directly to the east, off property, of the site (see image 23). The facility also has a surge wall which protects stormwater from going off site where rail cars unload (see image 1). Multiple inlets with standing water were observed, and it was noticeable that these inlets were well maintained but draining water slowly where the gravity elevation was higher (see images 2, 3, 6, 6, 8, 11, 15, 16, 17, 25, 28, 32). No trains were active on site, but trucks were present loading product near inlets (see image 4, 14). General maintenance on site was good as evidence by lack

Description: Hose and Bucket Below Tank Truck

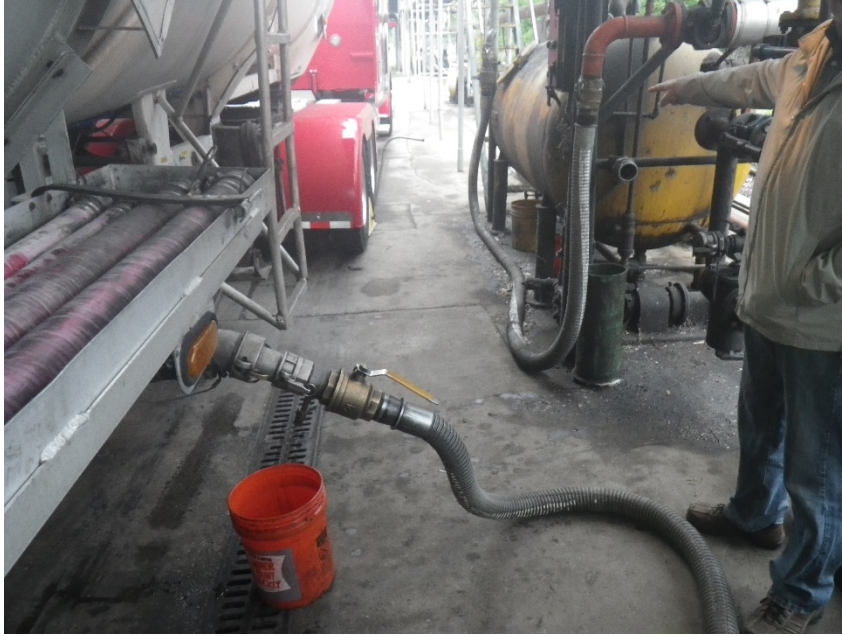
14: IMG0014

Description: Truck over Trench Drain

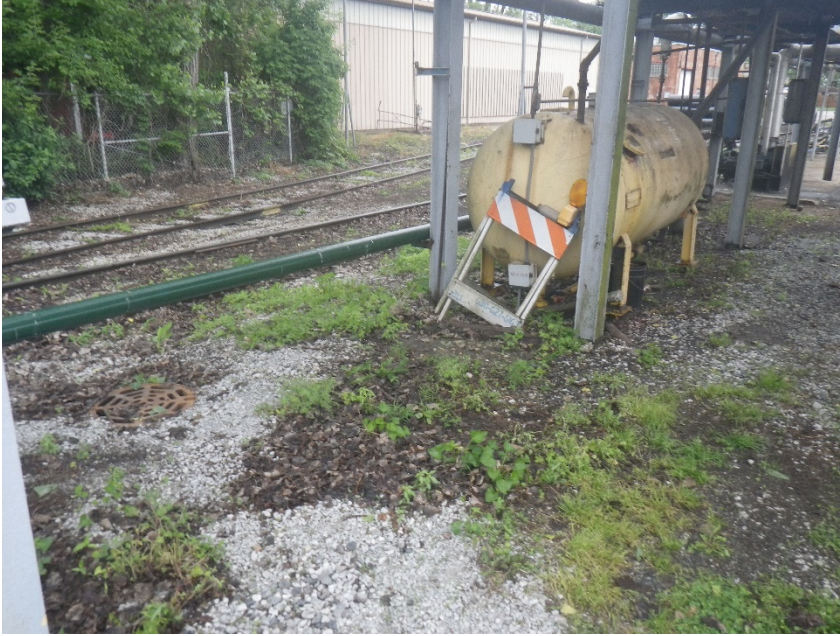
16: IMGP0016

of sheen at most inlets, although sheen was present at the most low lying area (see image 28), and site flow characteristics were acting as designed with no evidence of water leaving the site or pooling in areas without inlets. One area of the site (see image 16) upper elevation east side, may not have had the necessary elevation gradient to ensure stormwater from heavy rainfall would stay on site, but this was not verified. All industrial waste and storage containers not actively being used were enclosed in the Inside storage Building on the North end of the site (see image 13). The pump room appeared in good working order (see images 18, 19, 20), and there was no evidence of issues with the oil/water separator (see image 21).

Description: Catch Basin and Tank

It is recommended that the site conditions around the inlet identified in image 16 be checked to confirm they are to the correct gradient to keep water gravity flowing away from the property line of the site.

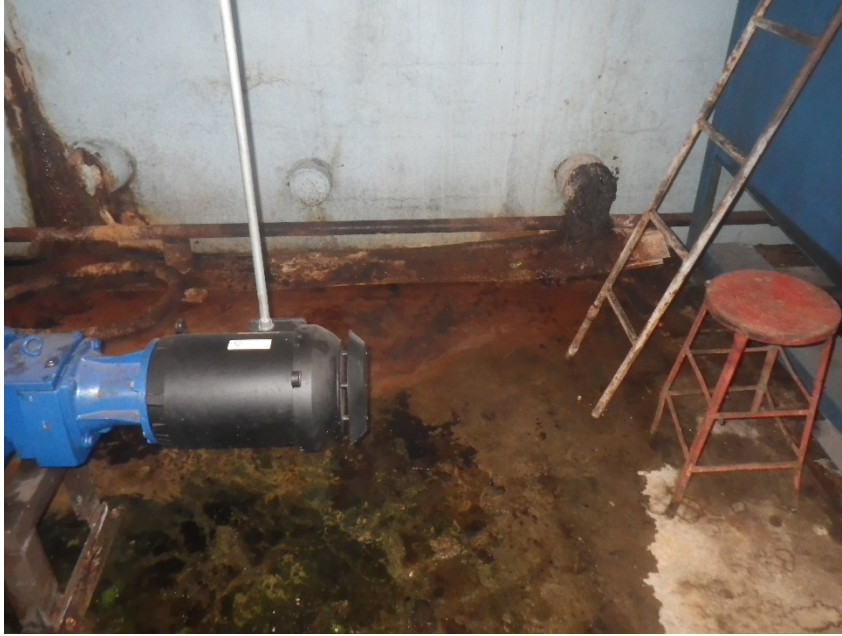
18: IMG0018

Description: Pump Room with Progressive Cavity Pump

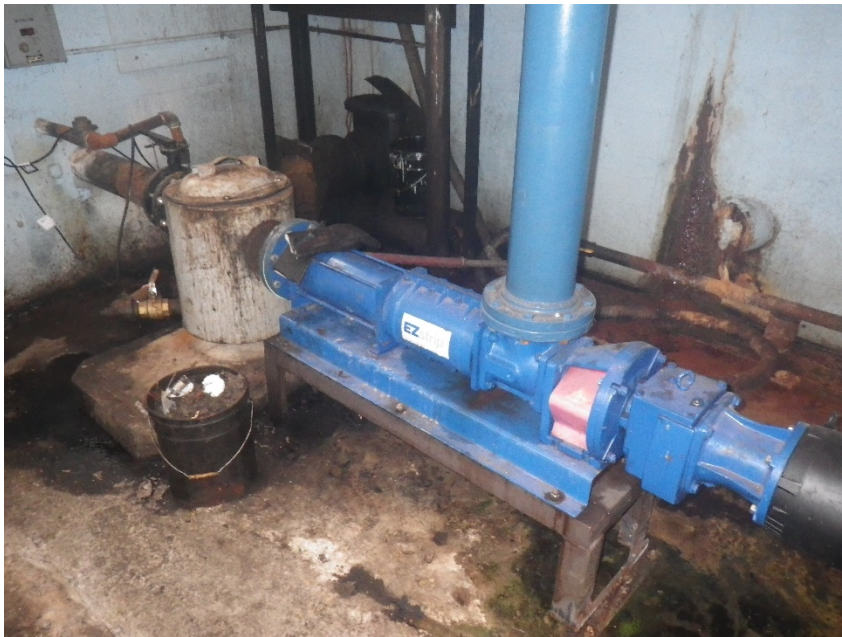
19: IMG0019

Description: Pump Room with Progressive Cavity Pump

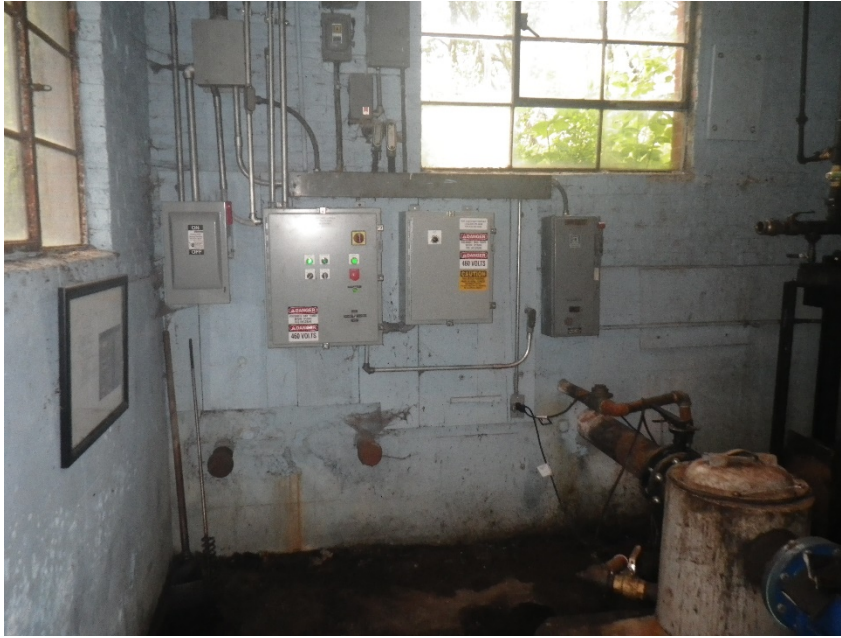
20: IMG0020

Description: Pump Room with Progressive Cavity Pump

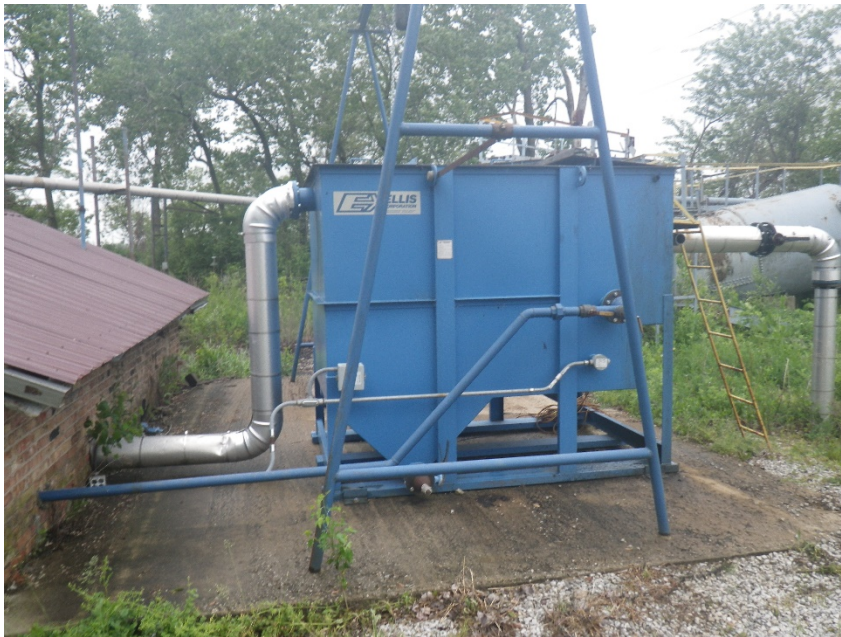
21: IMG0021

Description: Oil/Water Separator, Flow to POTW

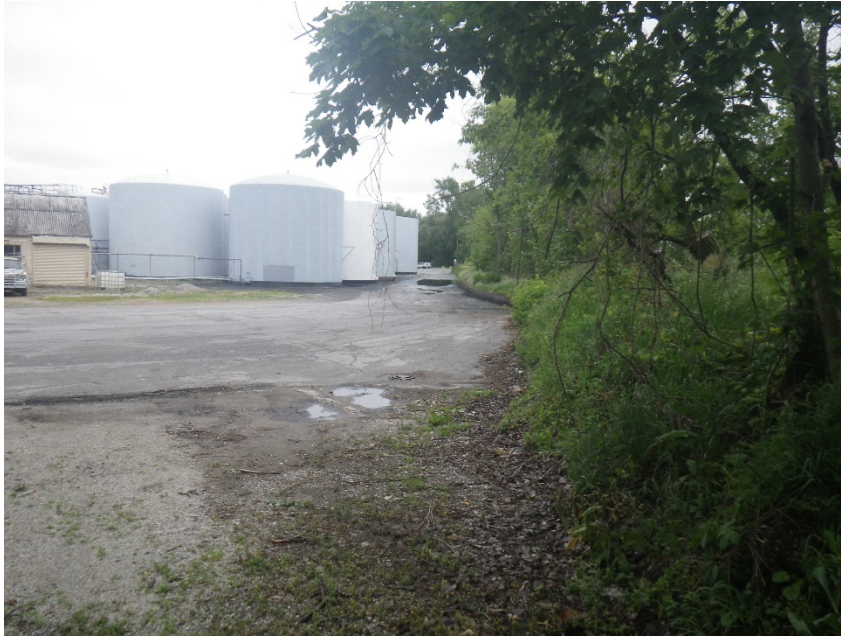
24: IMGP0024

Focusing on the low-lying areas of the site. It was evident that the height of the berm was sufficient to contain stormwater on the site (see images 24, 27, and 31) and there was no evidence of any petroleum product above the berm in the vegetation (see image 29, 30, 33, 34) or in the Grand Calumet (see image 26, 35). Also in the low lying area, the facility has a dry hydrant (see image 29 and 30) which is a non-pressurized permanent pipe system installed to allow the withdrawal of water from the Grand Calumet River to provide a water source for fire suppression close to potential areas of concern.

Description: Berm and Standing Water on Low End of Site

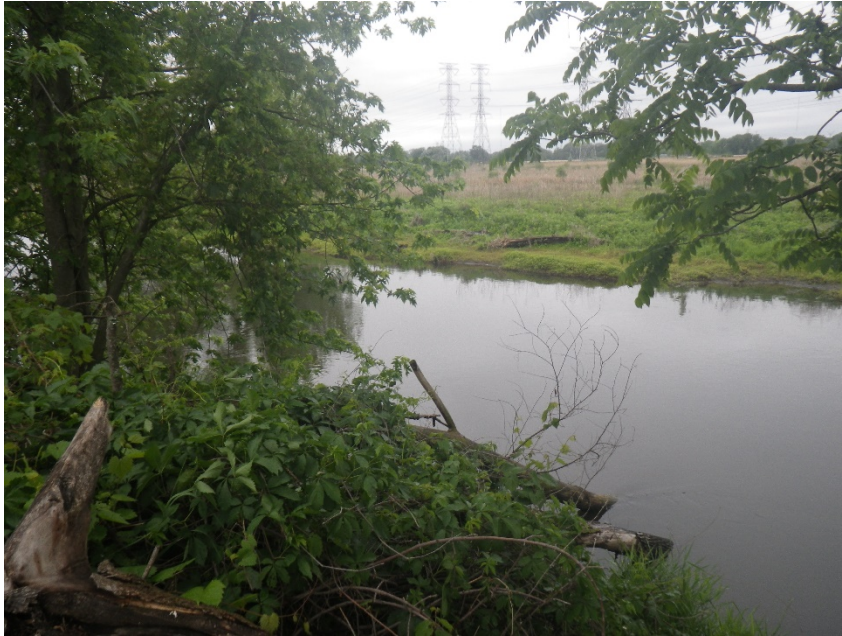
26: IMGP0026

Description: Grand Calumet Directly Adjacent to Site

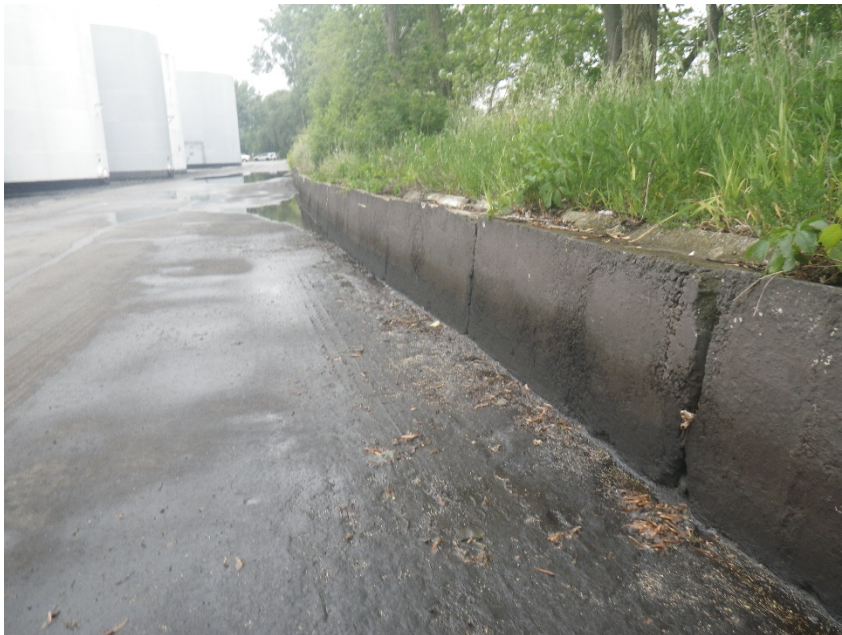
27: IMGP0027

Description: Low End of Site Berm

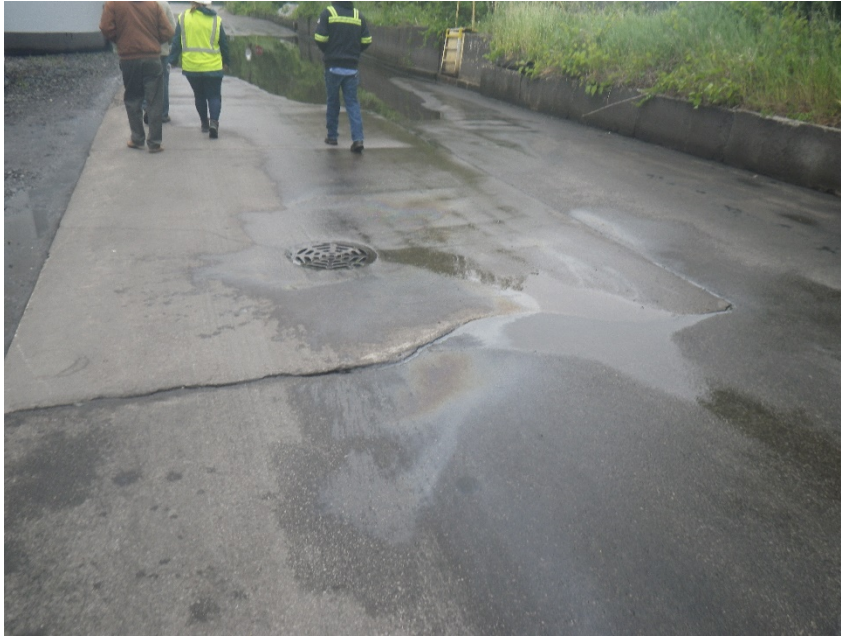
28: IMGP0028

Description: Catch Basin with Oil Sheen

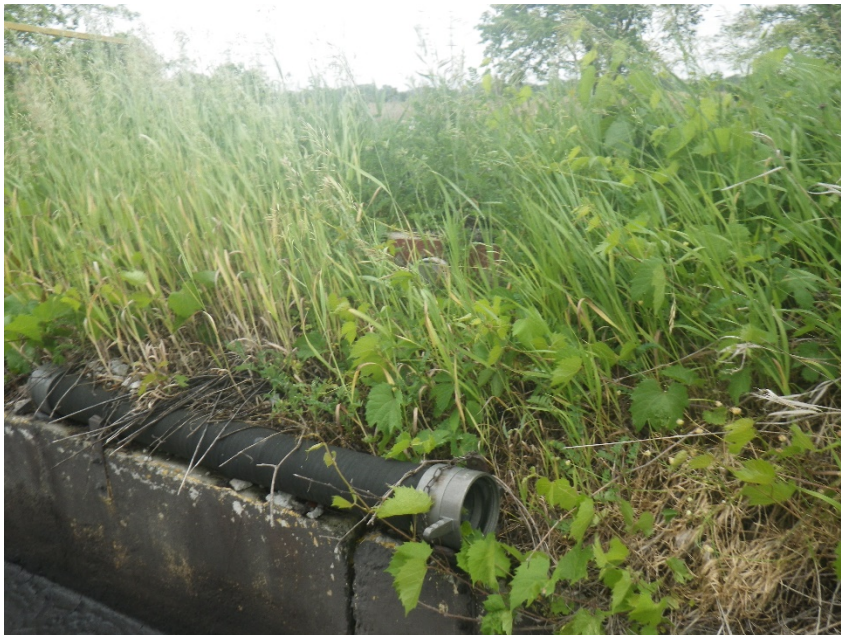
29: IMGP0029

Description: Dry Hydrant on Berm

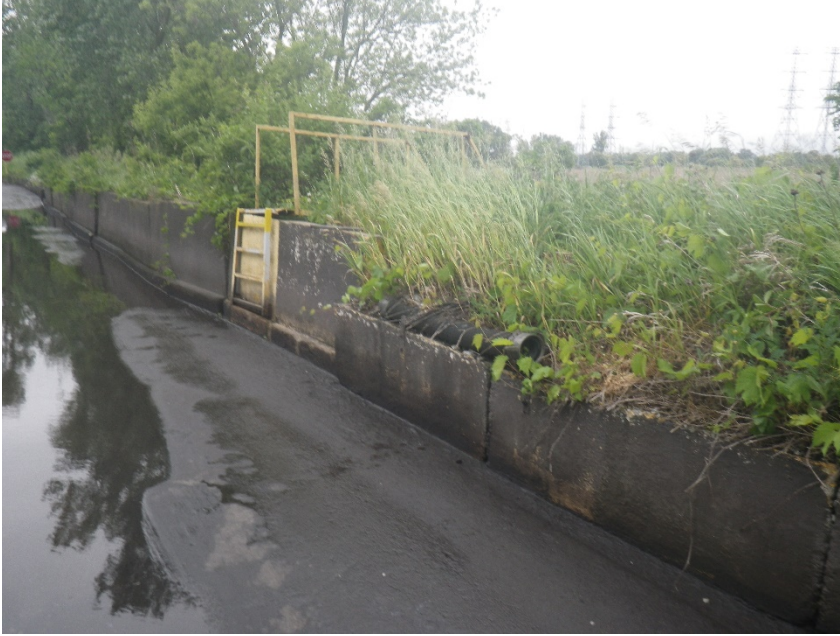
30: IMGP0030

Description: Dry Hydrant on Berm

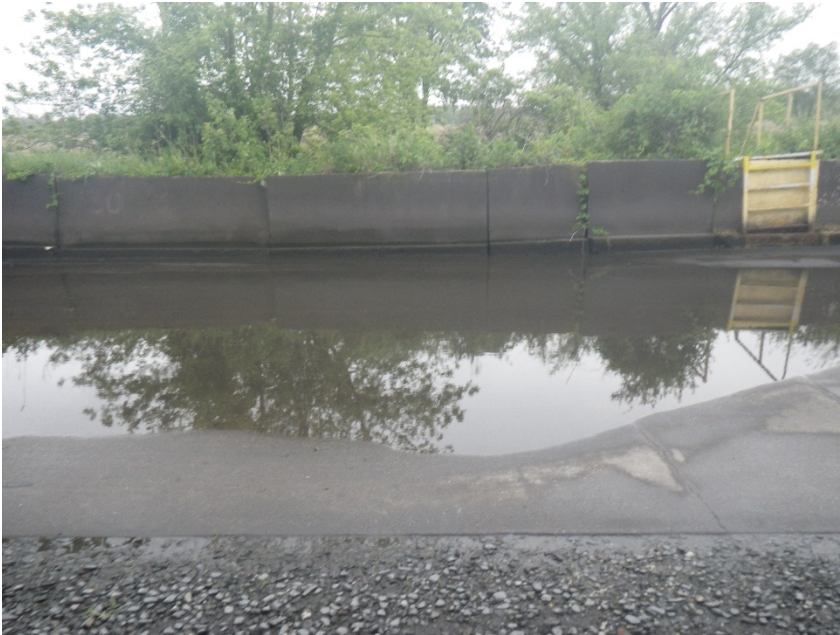
31: IMGP0031

Description: Standing water by Berm on Road

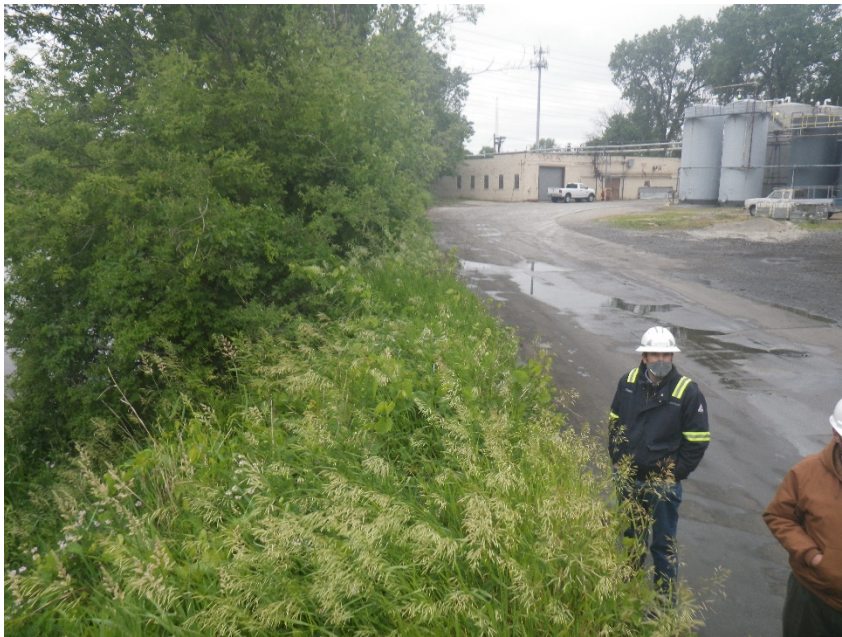
33: IMGP0033

Description: Dense Vegetation Along Top of Berm

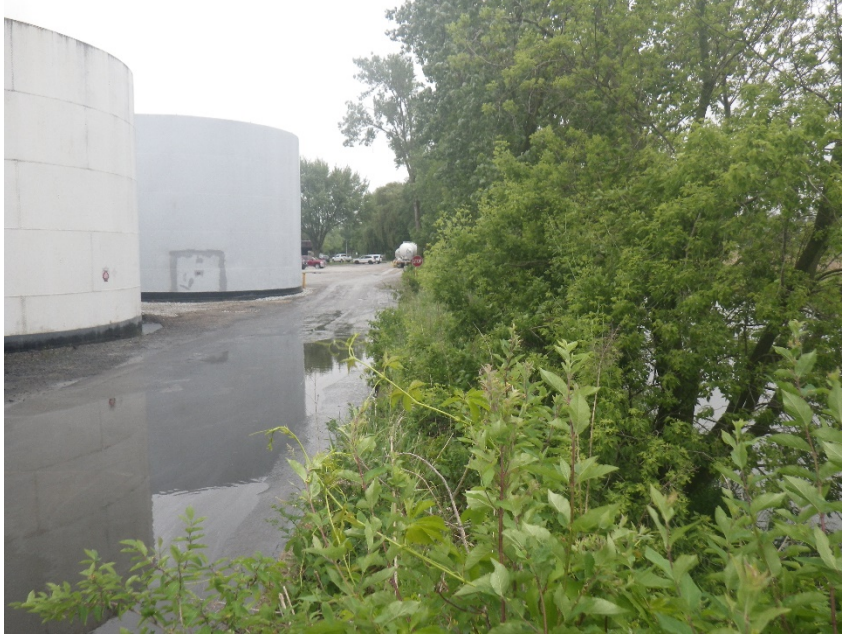
34: IMGP0034

Description: Top of Berm
