**CWA COMPLIANCE EVALUATION INSPECTION REPORT  
U.S. ENVIRONMENTAL PROTECTION AGENCY, REGION 5**

Compliance Sampling Inspection

Schwieterman Farms  
4339 County Road 716A  
Celina, Ohio  
Mercer County, Ohio  
40.476569, -84.526512

**Date of Inspection:** 4/21/2023

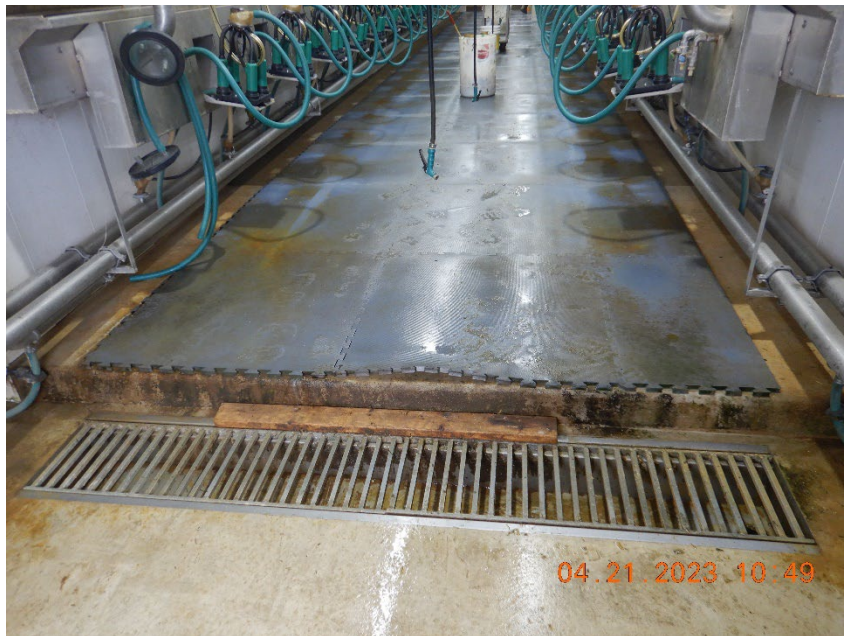
1: DSCN4167

Description: The milking parlor floor is sloped to drain used parlor wash water to the floor drains which are connected to the flush flume reception pit.

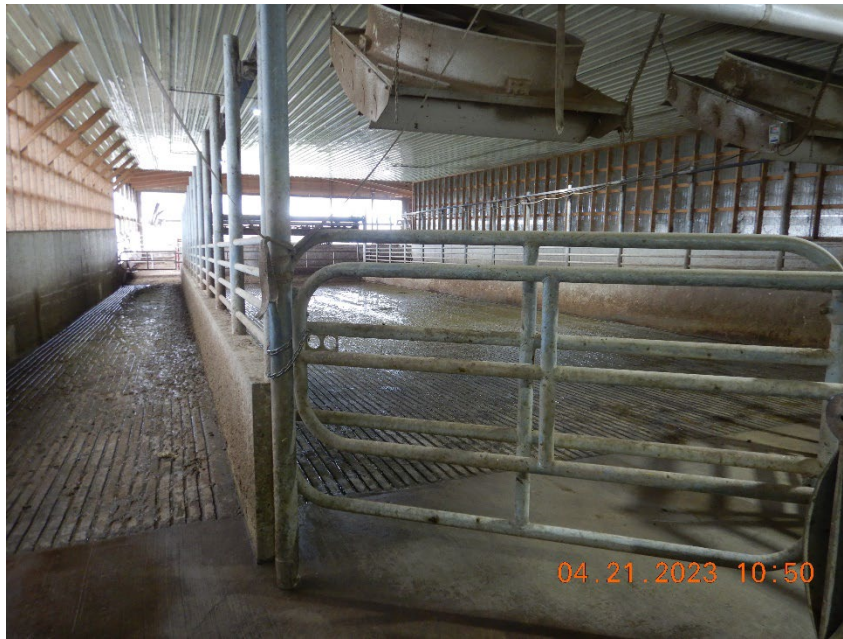
2: DSCN4168

Description: Overview of holding area adjacent to the west end of the Milking Parlor. An automatic squeegee system in the holding area scrapes manure to the west end of the holding area into the flush flume. The cow lane to the left of the holding area in the photograph is scraped with the skid steer and the manure solids are placed in the Manure Storage Barn.

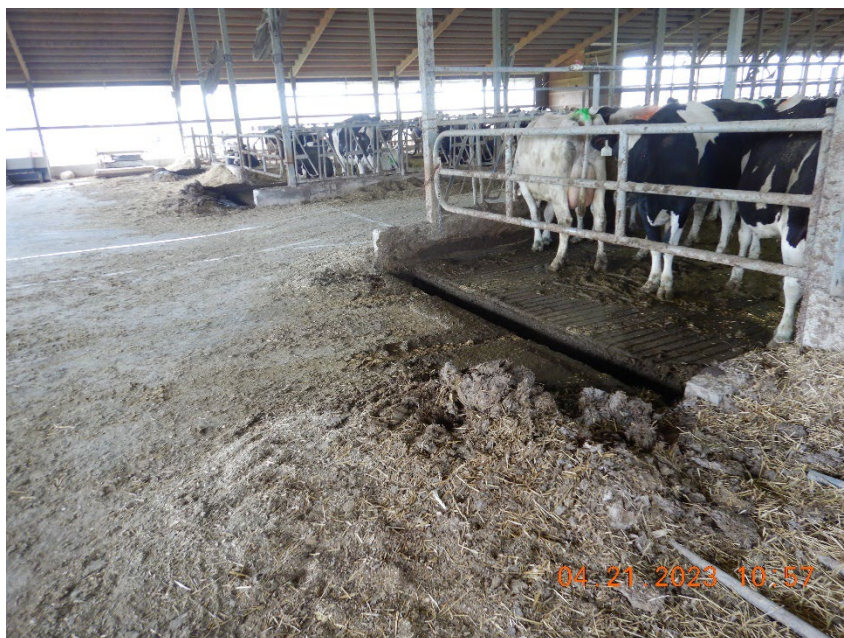
3: DSCN4169

Description: Freestall Barn

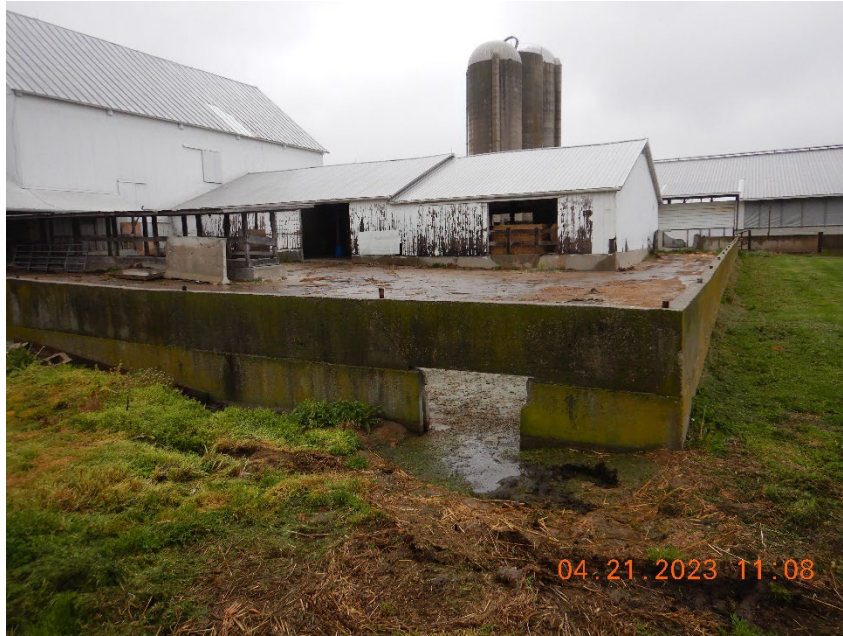
5: DSCN4171

The walkthrough proceeded around the exterior of the south and west sides of the abandoned unroofed cow lot from the original dairy design. EPA observed that the concrete containment wall around the unroofed cow lot had a cut out opening in its southwest corner that allowed manure and straw solids to collect in a surface depression on the outside of the containment wall in the grass (Photograph 5:DSCN4171). EPA did not observe evidence that the manure/straw solids had migrated from the surface depression further into the grassed area towards Prairie Creek. From the west side of the unroofed cow lot, the walkthrough continued north towards the main corn and soybean grain bins and then west over the creek crossing towards the west side of the farm where the Manure Lagoon and Silage Storage Pad are located. EPA observed concrete placed along the east bank of Prairie Creek adjacent to the driveway's creek crossing that connects the east and west sides of the farm (Photograph 6:DSCN4172). According to Mr. Schwieterman IV, the concrete along the bank in this area was added to mitigate erosion of the bank caused by stormwater run-off from the driveway flowing southwest off the driveway, past the western-most corn grain bin and into the creek. EPA did not observe evidence of manure or corn along the run-off pathway or on the bank of the creek where stormwater would flow into the creek.

| <b>Specific Areas of Concern Discussed:</b> EPA discussed four specific areas of concern. EPA observed manure solids collecting in the southwest corner of the abandoned unroofed cow lot where there is also an opening in the concrete containment wall from which contaminated stormwater/process wastewater would flow west overland, through the grass, and enter Prairie Creek which is approximately 170 feet west of the opening in the concrete containment wall (Photographs 5:DSCN4171 and 15:DSCN4181). The grass in this area was sparsley vegetated in some areas. A second area of concern was the accumulation of bedding on the exterior of the Freestall Barn that had been pushed over the knee wall to the outside of the Freestall Barn by the animals (Photograph 4:DSCN4170). EPA discussed the use of regular housekeeping in these areas to better manage manure/bedding materials. A third area of | |

Description: The concrete containment wall around the unroofed cow lot was observed to have a cut out opening in its southwest corner that had allowed manure and straw solids to collect in a depression on the outside of the wall in the grassed area to the west. EPA did not observe evidence that the manure/straw solids had migrated further into the grassed area to the west towards Prairie Creek. Stormwater that comes into contact with the manure and straw can continue to flow west into Prairie Creek.

On May 10, 2023, Mr. Schwieterman IV provided EPA with an e-mail detailing the actions taken to address areas of concern identified during the inspection based on the recommendations provided by the MCSWCD when they visited the farm. The implemented actions included: removing the bedding that had been pushed to the outside of the sides Freestall Barn by the animals, placing gravel along that area, and installing lumber along the top of the freestall wall to increase the height by approximately 8 inches to prevent the bedding from being pushed outside by the animals. Mr. Schwieterman IV verified with the dairy's nutritionist that the added height would not block or decrease ventilation to the cows while resting. The farm also has implemented increased housekeeping along the Freestall Barn exterior. In regards to the abandoned cow lot, the cow lot area was cleaned and an additional board was installed across the opening at the southwest corner of the lot to slow the water down. In addition, improved housekeeping would be implemented where they mix supplements into the feed outside of the commodity barn. The grass area adjacent to the cow lot opening in the southwest corner, was prepared and seeded with fescue, oats and spring barley as a cover crop. This vegetation will be maintained at 6 to 8 inches tall to provide filtration of waters leaving through the boards across the cow lot opening. To address the run-off wash-out area around the western-most corn grain bin, the farm used 8-inch stone (which they purchased) and additional concrete pieces in the wash-out area to level the area to address the run-off issues. Mr. Schwieterman IV also provided EPA with photographs of the areas addressed including: the added lumber to the freestall wall, the exterior side of the freestall where pushed-out bedding was removed and gravel was installed, the concrete area of the abandoned unroofed cow lot where housekeeping was conducted to remove residual manure, the added board across the containment wall opening in the southwest corner of the

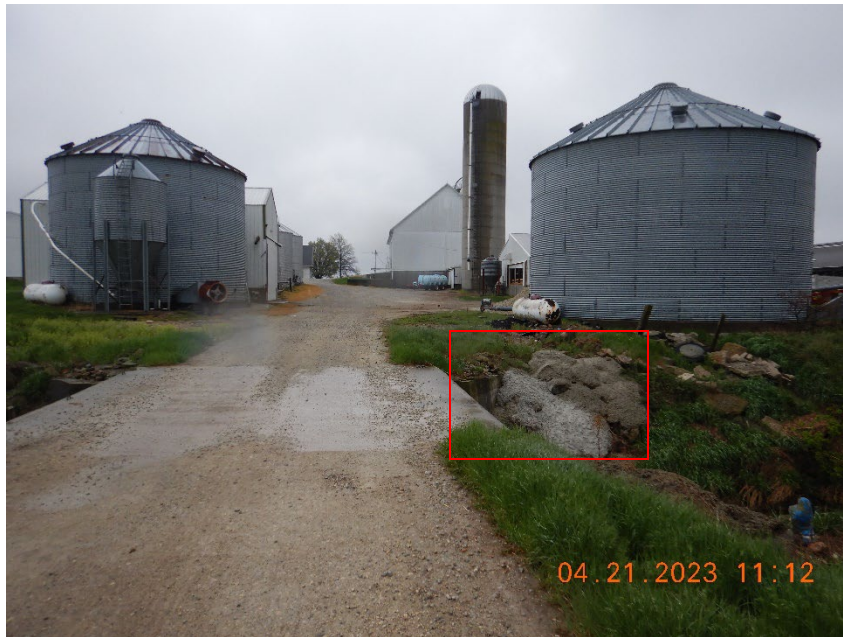
6: DSCN4172

concern was the area of stormwater run-off erosion located along the east bank of Prairie Creek between the western-most corn grain bin and the creek crossing (Photograph 6:DSCN4172). EPA did not observe evidence of residual manure or corn along the run-off pathway or on the bank of the creek. Housekeeping measures around the grain bins and along the driveway should be maintained to prevent precipitation run-off from transporting corn/soy beans or manure to the creek. The fourth area of concern was that EPA observed pooling of silage leachate in tire ruts just off the east end of the Silage Storage Pad; however, the leachate was not observed to be reaching Prairie Creek, approximately 600 feet east of the Silage Storage Pad. There was a well established vegetated buffer (approximately 600 feet long) between the east side of the Silage Storage Pad and Prairie Creek.

Description: Inside the red outlined box, Operators have placed concrete along the east bank of Prairie Creek adjacent to the driveway creek crossing that connects the east and west sides of the farm. The concrete along the bank in this area was added to mitigate erosion of the bank caused by stormwater run-off from the driveway flowing southwest off the driveway, past the corn grain bin and into the creek. EPA did not observe evidence of manure or corn along the run-off pathway or on the bank of the creek where stormwater would enter the creek.

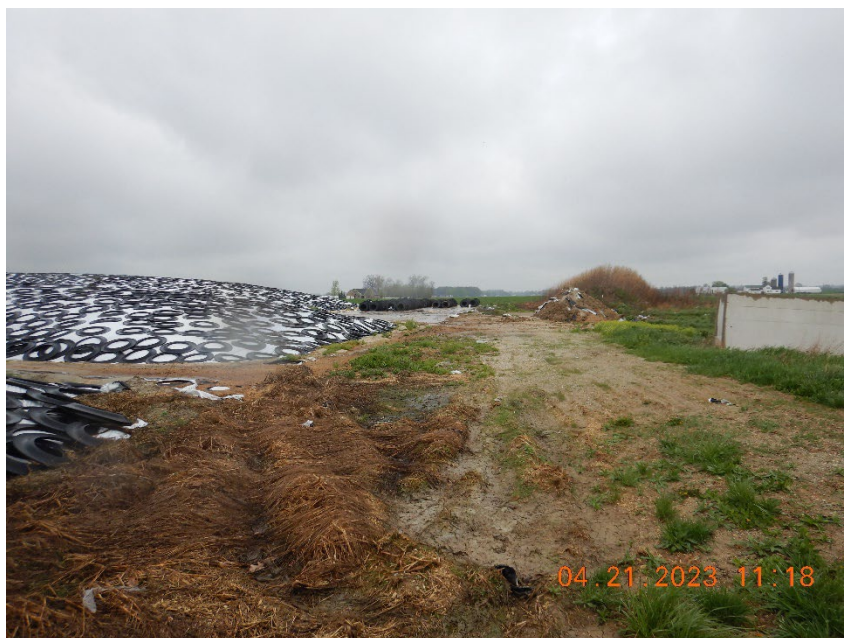
7: DSCN4173

The walkthrough continued west along the access driveway to the Silage Storage Pad which is located approximately 600 feet west of Prairie Creek. EPA observed the silage piles to be covered with plastic sheeting that was secured by crushed limestone at the base and tire rounds on top. The Silage Storage Pad is a concrete pad with no curbing along the sides of the pad. According to Mr. Schwieterman IV, the Silage Storage Pad is sloped to the east and southeast to direct leachate and run-off to a perforated drain tile that collects those liquids from along the eastern edge of the pad (Photograph 7:DSCN4173) and directs the leachate and/or stormwater run-off toward a general collection area at the southeast corner of the Silage Storage Pad. The general collection area at the southeast corner is a depression on the ground surface that has an inlet tile that directs leachate and/or stormwater run-off via gravity through an underground tile into the Manure Lagoon. EPA observed the tile inlet that directs leachate and stormwater run-off to the Manure Lagoon (Photograph 8:DSCN4174). EPA observed leachate pooled in tire ruts and surface depressions on the ground on the east side of the Silage Storage Pad, adjacent to the pile of re-used crushed limestone (Photograph 10:DSCN4176). EPA also observed the vegetated grassed buffer area that is maintained on the east side of the Silage Storage Pad (Photograph 9:DSCN4175). EPA did not observe evidence of silage leachate, silage or other materials from the storage pad within the grassed buffer area. The vegetated buffer area extends approximately 570 feet east to the natural vegetation strip (35 feet) along the west bank of Prairie Creek.

Description: View from the southeast corner of the Silage Storage Pad looking along its eastern edge. Silage piles were covered with plastic sheeting secured by crushed limestone at the base and tire rounds on top. The Silage Storage Pad is a concrete pad with no curbing along the sides of the pad. The pad is sloped to the east and southeast to a perforated drain tile that collects liquids from along the eastern edge of the pad and directs them towards a general collection area at the southeast corner of the Silage Storage Pad. The general collection area at the southeast corner is a depression on the ground surface that has an inlet tile that directs any leachate or stormwater run-off via gravity through an underground tile into the Manure Lagoon.

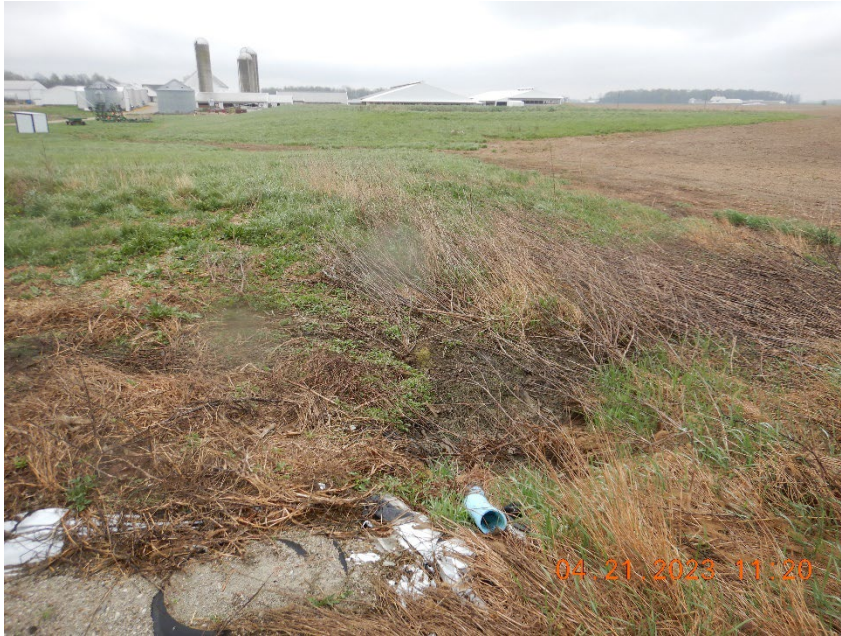
8: DSCN4174

Description: This inlet tile off the southeast corner of the Silage Storage Pad directs leachate and stormwater run-off from the Silage Storage Pad general collection area at the southeast corner to the Manure Lagoon.

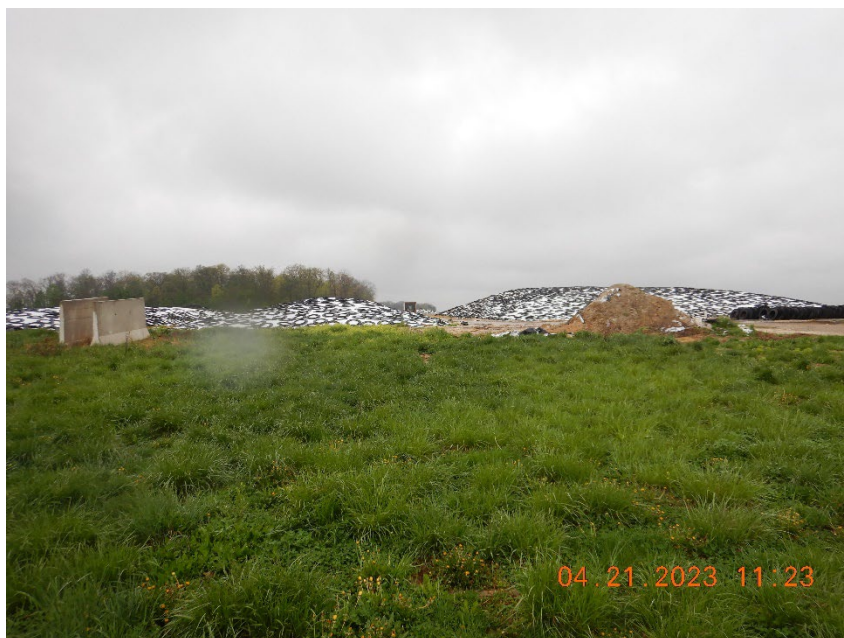
9: DSCN4175

Description: A vegetated grassed buffer area is maintained on the east side of the Silage Storage Pad. EPA did not observe evidence of silage leachate, silage or other materials from the silage pad within the grassed buffer area.

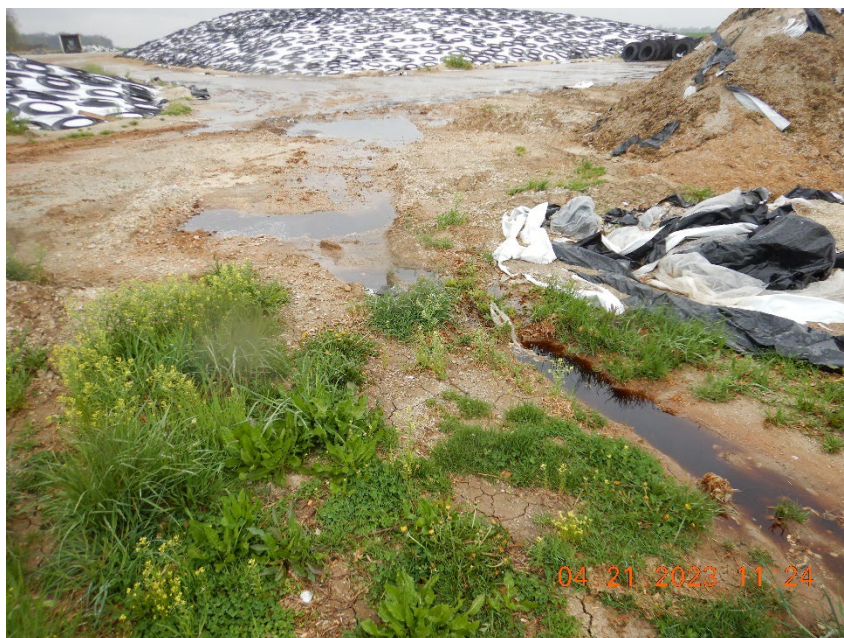
10: DSCN4176

Description: EPA observed several shallow puddles of dark colored leachate collecting along the east edge of the Silage Storage Pad, adjacent to the pile of re-used crushed limestone. Crushed limestone is used along the base of the plastic coverings over the silage piles to keep the covers in place. The leachate was not observed within the grassed buffer area east of the Silage Storage Pad.

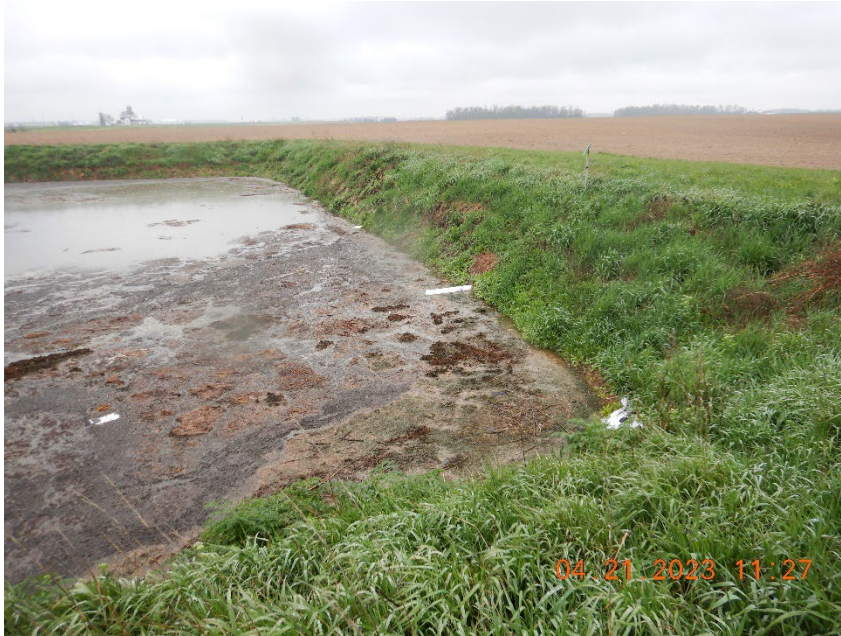
11: DSCN4177

The walkthrough continued to the manure storage lagoon. EPA observed the white PVC inlet pipe on the west side of the Manure Lagoon that directs leachate and stormwater flow from the Silage Storage Pad into the Manure Lagoon (Photograph 11:DSCN4177). EPA also observed the T-handle for the knife valve associated with the inlet pipe. According to Mr. Schwieterman IV, the valve is always closed unless the operators need to drain leachate and/or stormwater from the Silage Storage Pad collection area into the Manure Lagoon. The flush flume reception pit discharge pipe that directs manure from the flush flume reception pit into the Manure Lagoon is

Description: The white inlet pipe on the west side of the Manure Lagoon directs leachate flow from the Silage Storage Pad into the Manure Lagoon. The T-handle for the knife valve associated with the pipe is located above the inlet pipe on the top of the berm. The valve is always closed unless the operators need to drain leachate from the Silage Storage Pad collection area into the Manure Lagoon.

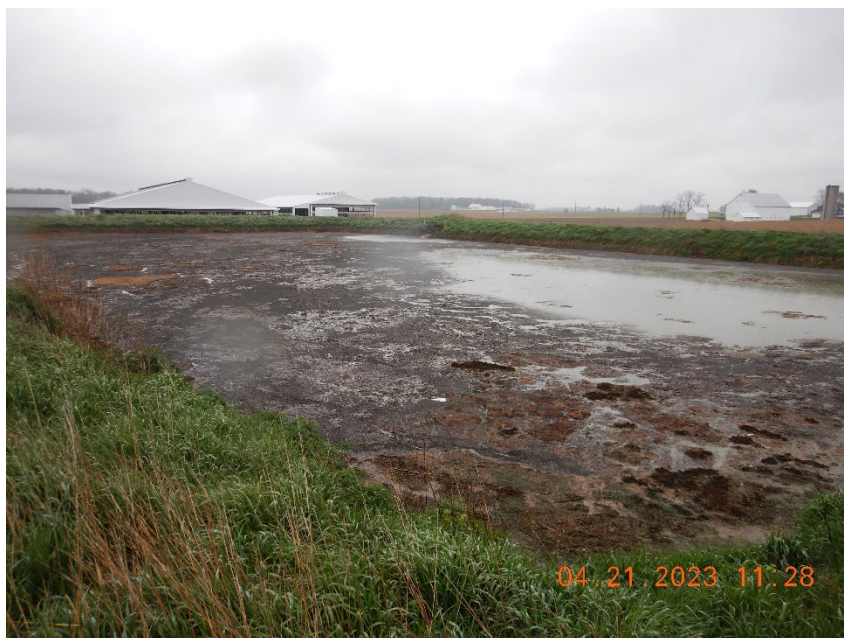
12: DSCN4178

Description: View of the Manure Lagoon looking southeast towards the flush flume reception pit discharge pipe that directs manure into the Manure Lagoon. A concrete spillway is present under the discharge pipe to prevent bank erosion as manure from the flush flume reception pit is pumped into the lagoon.

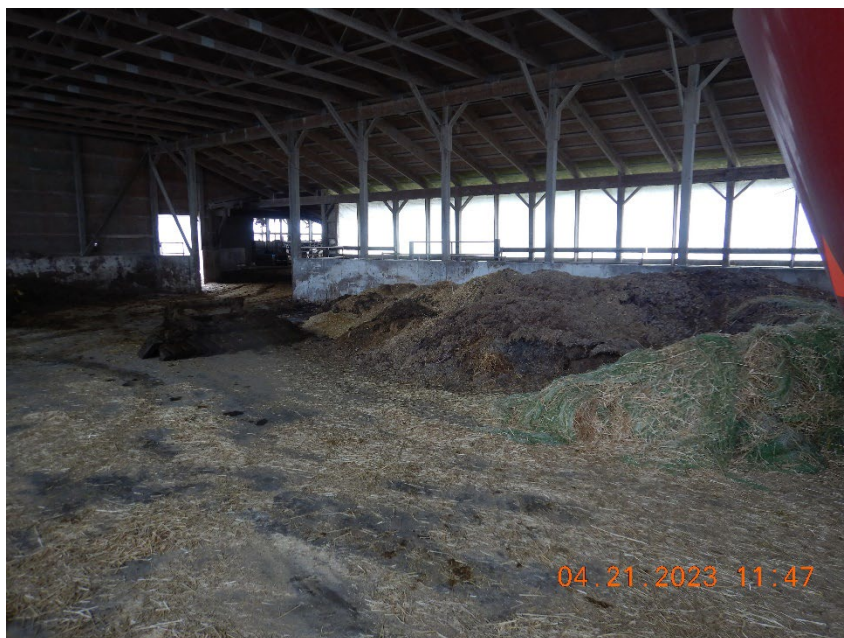
13: DSCN4179

EPA observed the flush flume reception pit structure and its associated pump shed and then continued on the walkthrough to the Manure Storage Barn. EPA observed the mortality composting pile (Photograph 13:DSCN4179) and piled pen pack/manure solids (Photograph 14:DSCN1480) maintained within the Manure Storage Barn. The last stop during the walkthrough was to the abandoned, unroofed cow lot, to view the southwest corner of the cow lot from inside the lot. EPA observed manure solids collected in the southwest corner of the cow lot where the cut-out opening was located (Photograph 15:DSCN4181). The walkthrough ended at approximately 11:55 a.m.

Description: Mortality composting pile located inside the Manure Storage Barn.

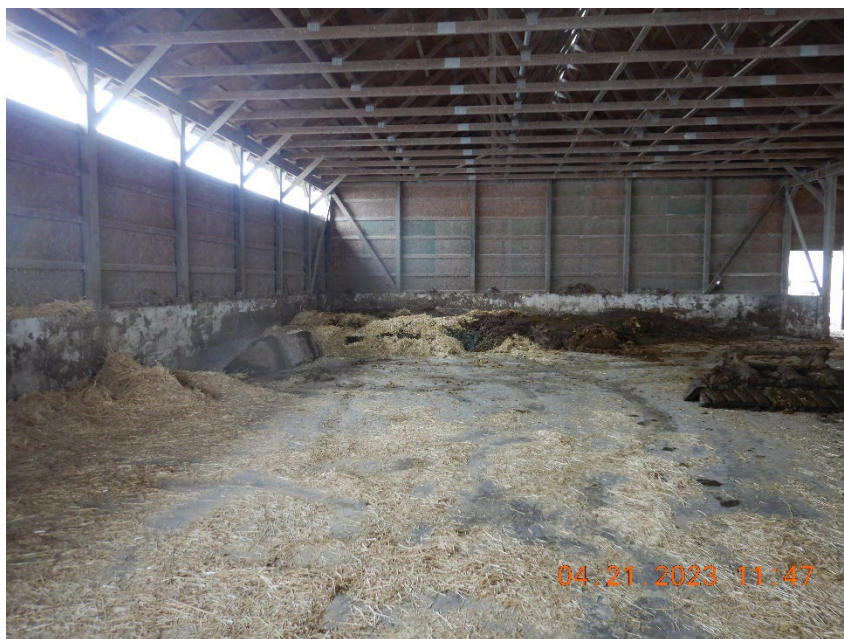
14: DSCN4180

Description: The Manure Storage Barn is also used for storage of used pen pack and drier manure solids.

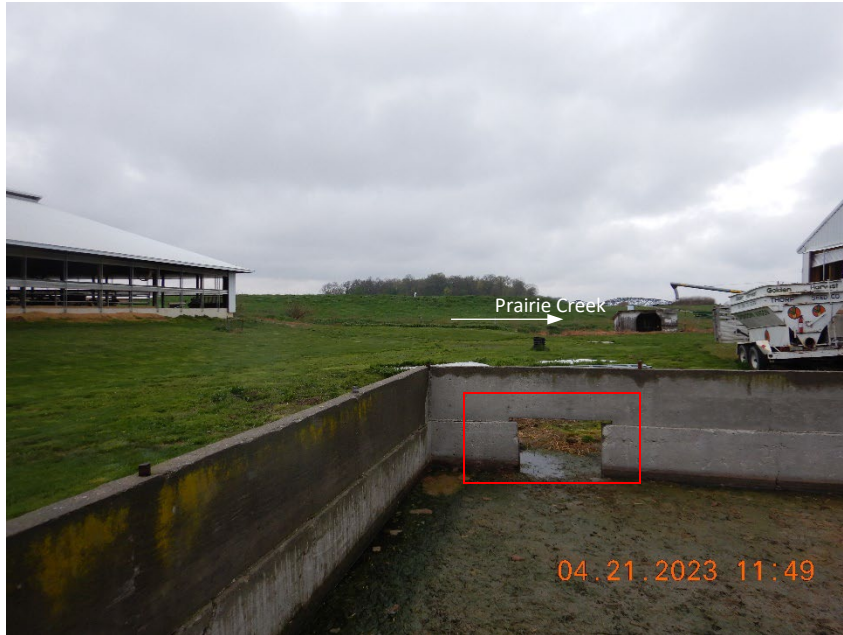
15: DSCN4181

Description: Inside the red outlined box is the cut-out opening in the southwest corner of the containment wall around the abandoned unroofed cow lot that allows manure solids, straw and contaminated run-off from the lot to pool in a depressed grassed area adjacent to the opening. EPA did not observe evidence that the manure/straw solids had migrated further into the grassed area to the west or to Prairie Creek. The east bank of Prairie Creek runs along the west edge of the grassed area in this photograph just behind the wooden shed in the background.
