**Region 6 - Enforcement & Compliance Assurance Division**  
**INSPECTION REPORT**

| <b>Inspection Date(s):</b> | 06/04/2024 through 06/06/2024 | |
| <b>System Name:</b> | City of Stillwater Public Water System (PWS) | |
| <b>PWS ID:</b> | OK1021220 | |

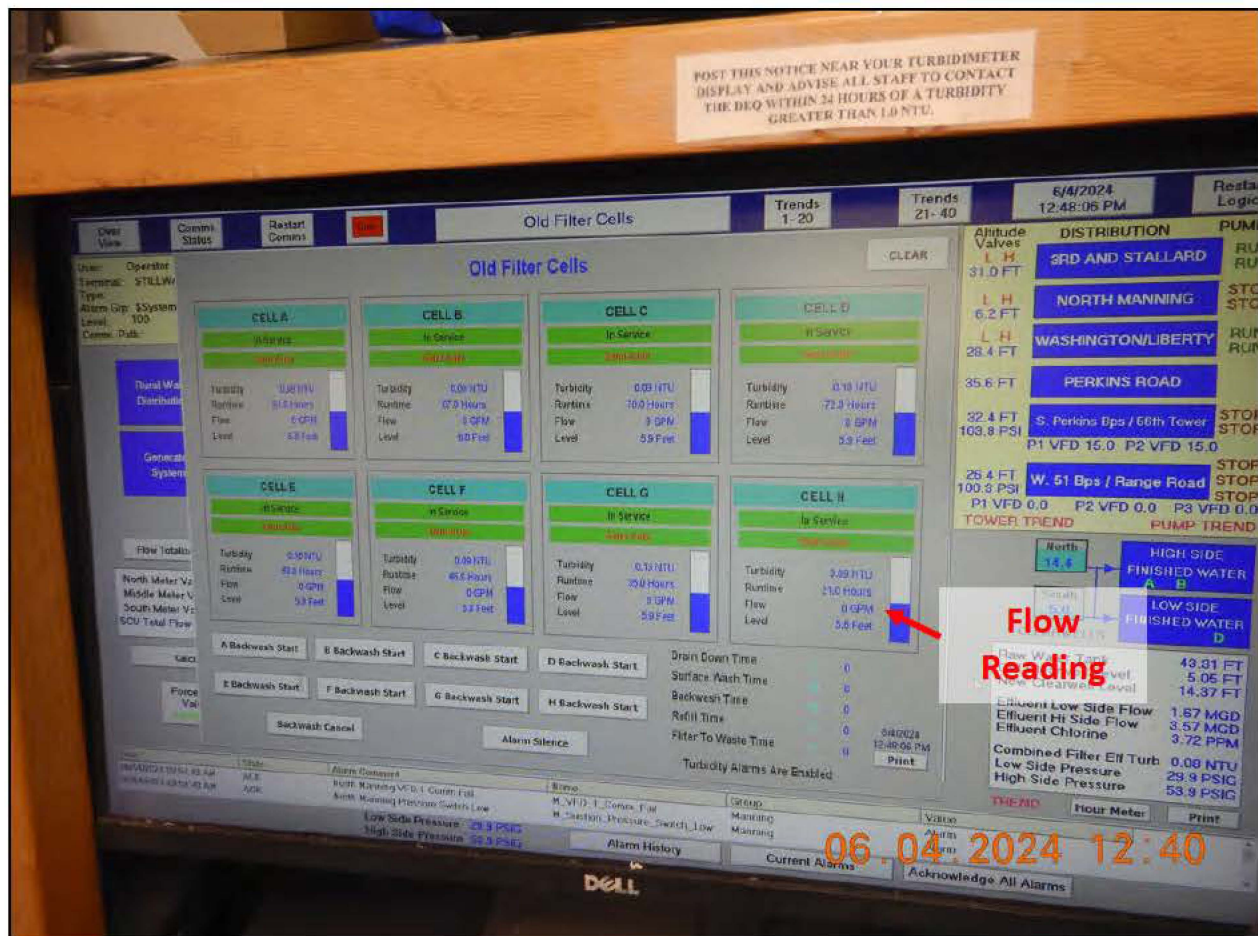
Photograph 1. 6/4/2024 12:40 PM DSCN0657.JPG

WTP SCADA Screen View of the City's SCADA screen showing the status of the eight older filters at the WTP. Turbidity, runtime, and level of the filters was being monitored, but flow was not monitored or recorded.

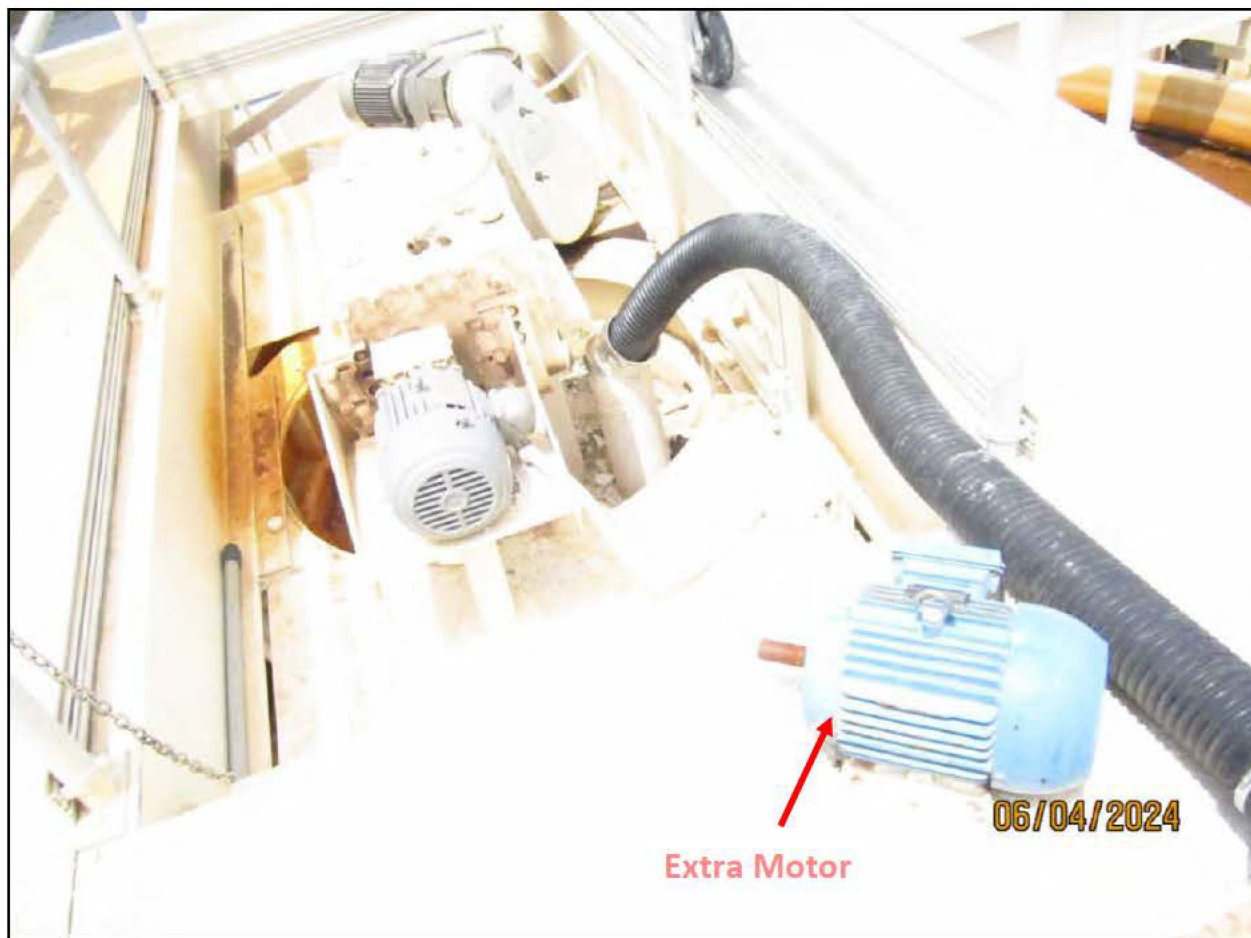
**Photograph 4. 6/4/2024 2:15 PM IMG\_0051.JPG**

**WTP, North SCU** View of the deck in the middle of the North SCU. There was an extra motor positioned on the operational deck, and System representatives stated that the motor had been changed a few months before the date of the inspection. Following the inspection, System representatives stated via email that the pump motor had been removed from the deck.

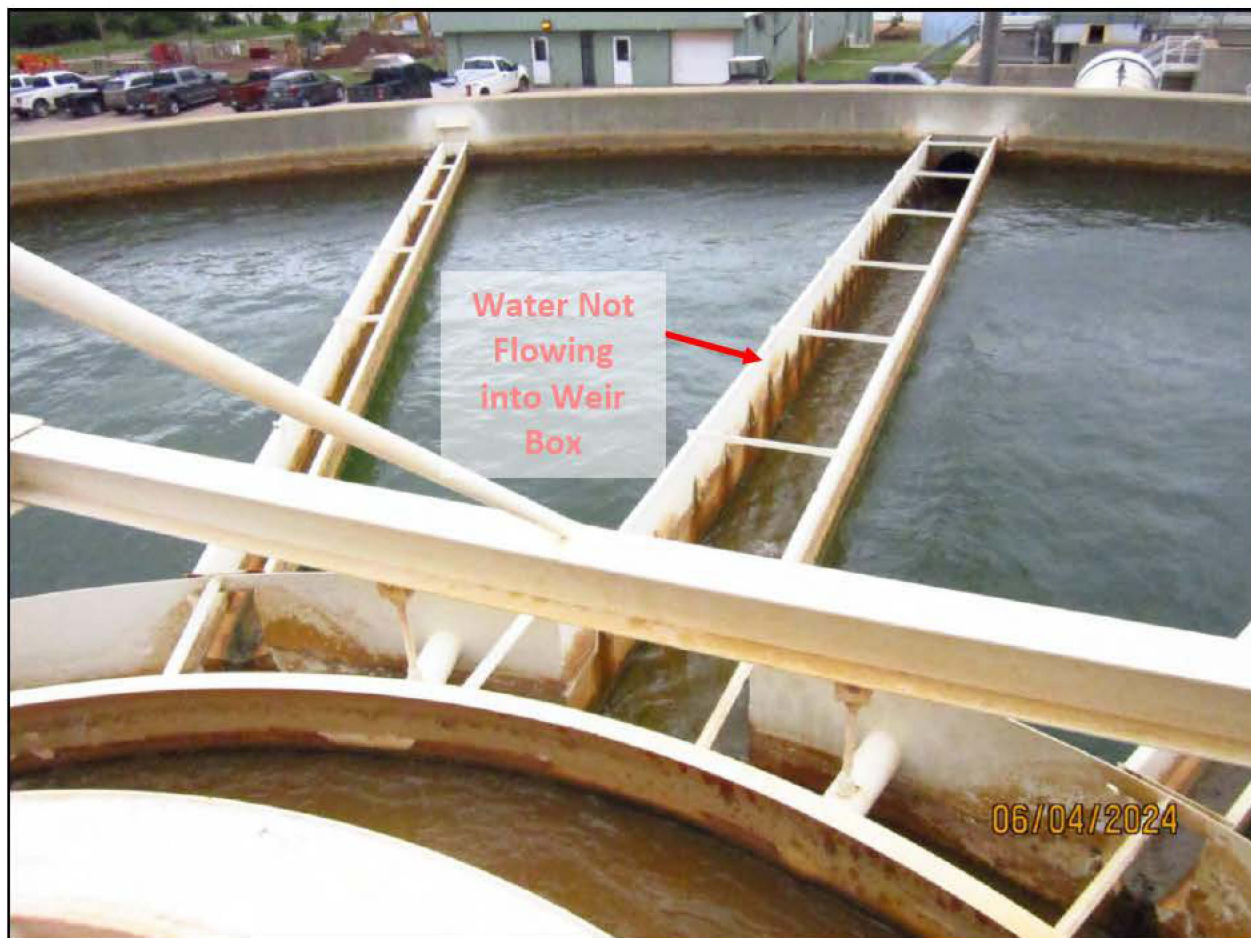
Photograph 6. 6/4/2024 2:04 PM IMG\_0063.JPG

WTP, South SCU View of one of the effluent troughs of the South SCU. The South SCU was offline during the inspection. A small volume of water was entering the unit due to a faulty valve. This water was not treated with lime and was blended with treated waters from the Northern and Central SCUs.

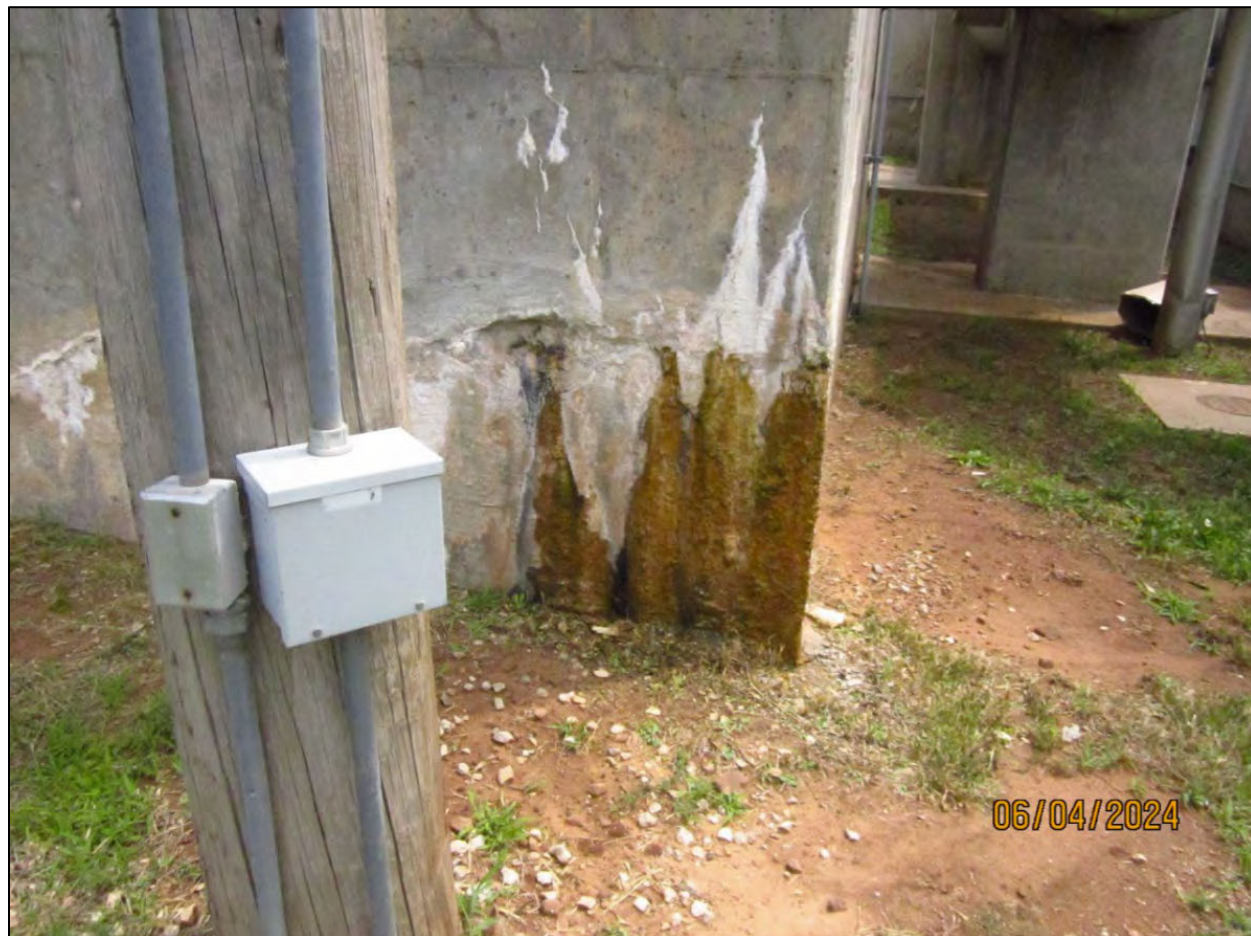
**Photograph 8. 6/4/2024 2:21 PM IMG\_0069.JPG**

**WTP, Recarbonization Basin** View of water weeping through concrete cracks in the northwest corner of the recarbonization basin.

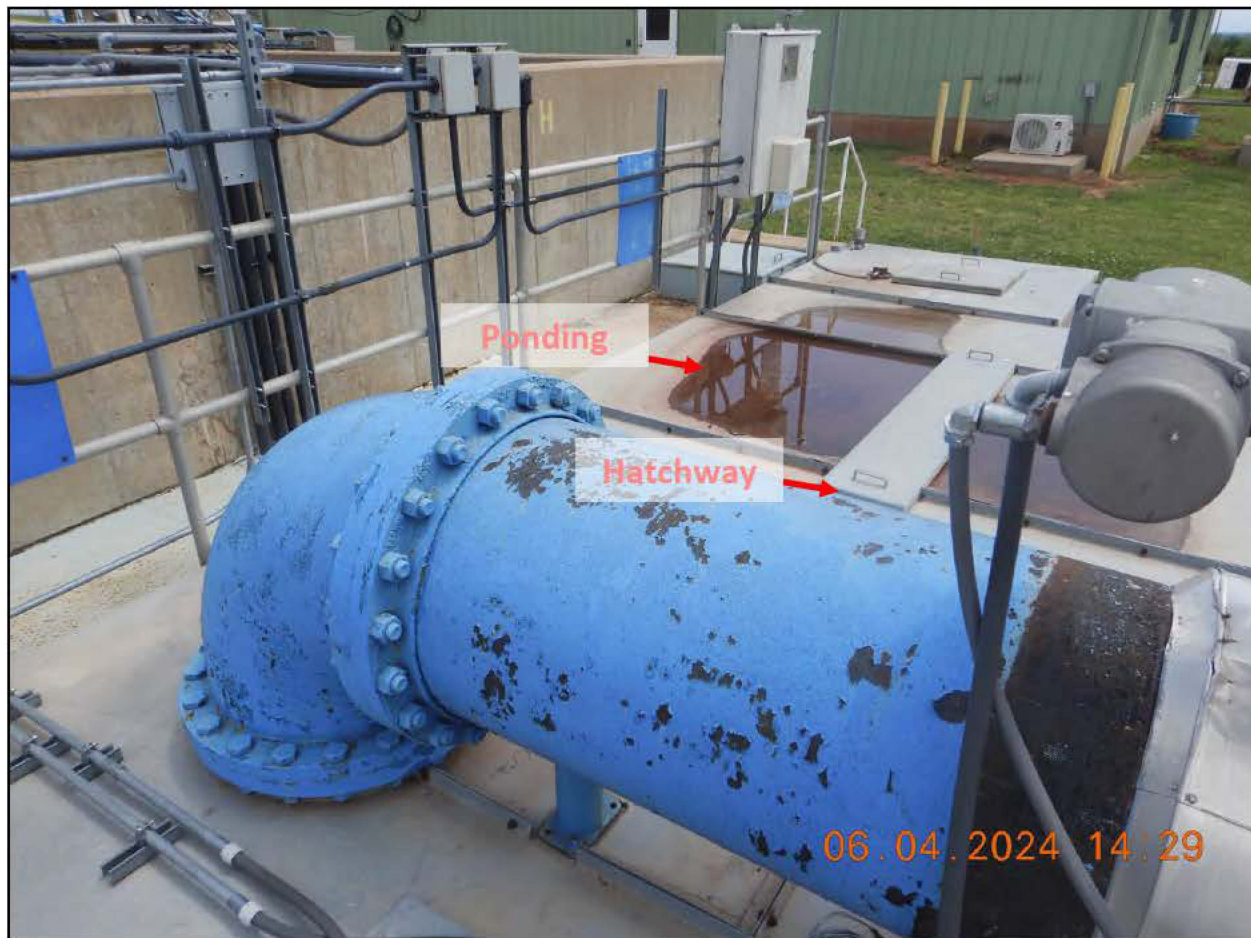
Photograph 9. 6/4/2024 2:29 PM DSCN0722.JPG

**WTP, Filter Effluent Wet Well** View of the effluent wet well that was positioned after the filters. The hatchways to the wet well lacked sanitary seals, and there was water ponding on the roof near the hatchways.

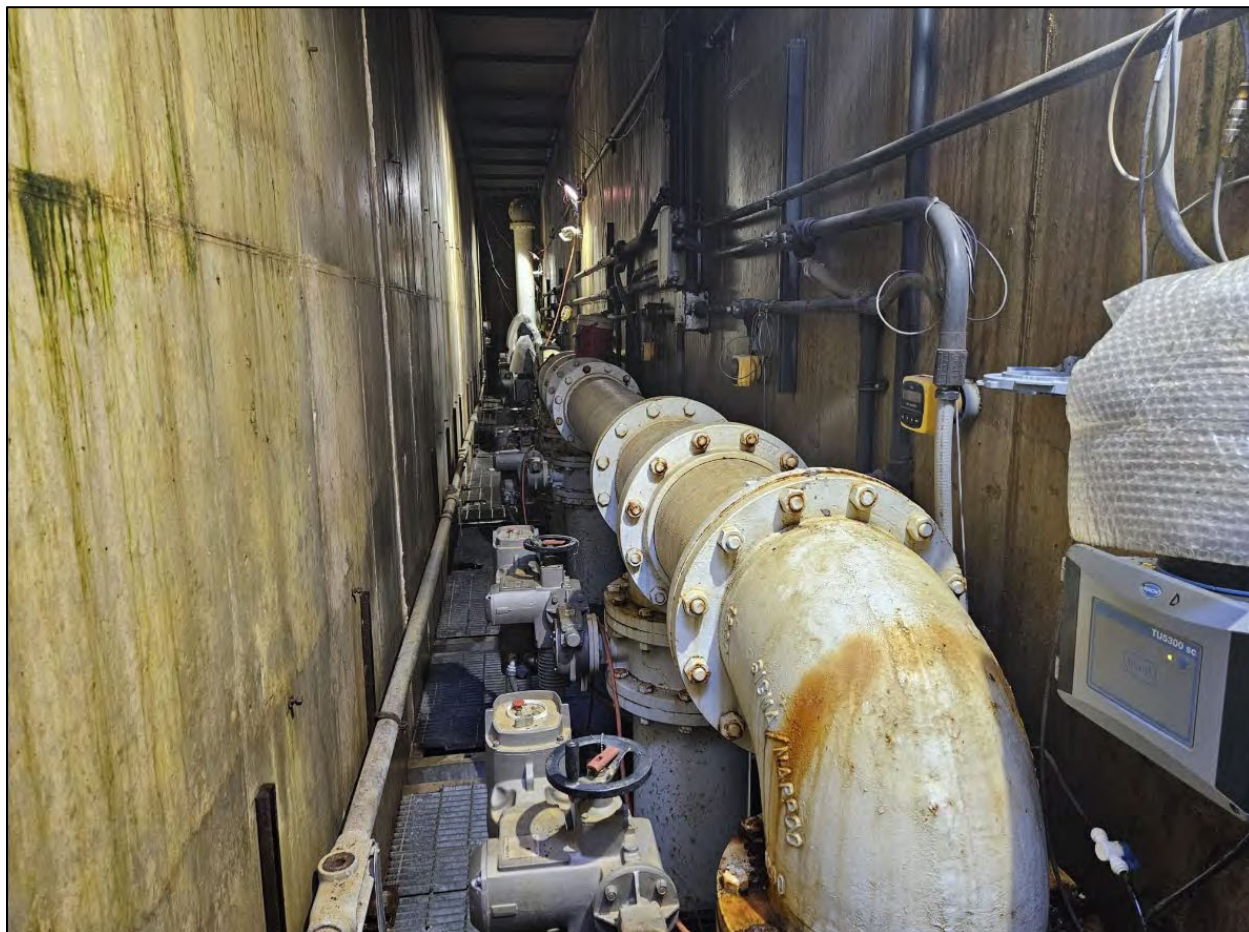
**Photograph 10. 6/5/2024 5:21 PM 20240605\_172110.JPG**

**WTP, Filter Pipe Gallery Vault (Confined Space, photo taken by System representatives)** View of the inside of filter pipe gallery vault. The IFE turbidimeters were positioned inside of the vault. The vault was unable to be entered by the EPA Inspection Team due to confined space requirements. System representatives stated that the vault was only entered once per month due to confined space conditions making the vault difficult to access. (Photo provided by System representatives following the inspection).

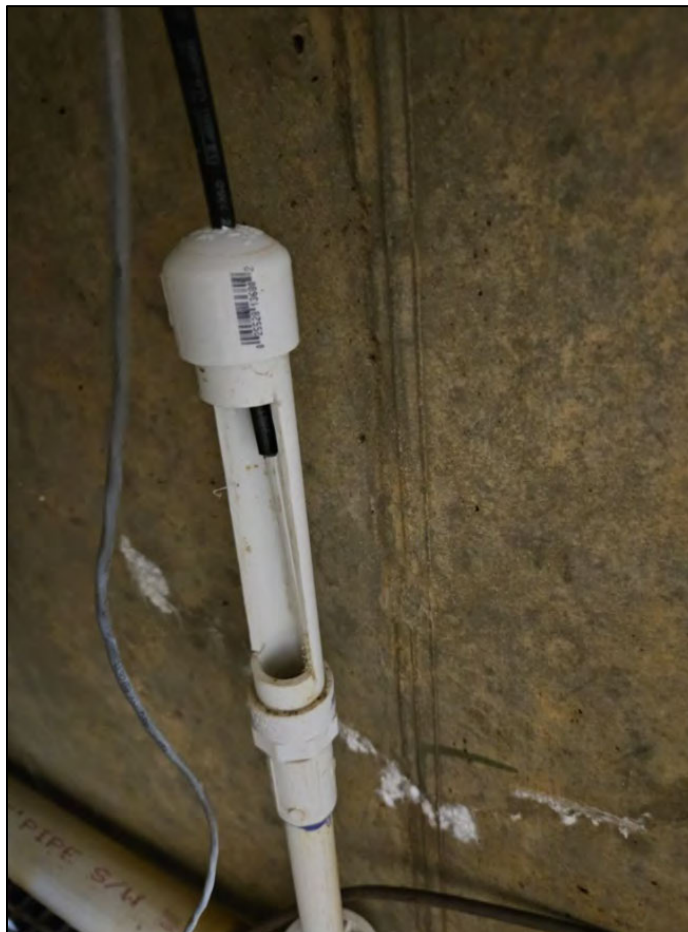
**Photograph 11. 6/5/2024 5:33 PM 20240605\_173323.JPG**

**WTP, Filter Pipe Gallery Vault (Confined Space, photo taken by System representatives)** View of one of the IFE turbidity meter sample hoses that had an air gap, resolving a deficiency identified in the 2019 OK DEQ sanitary survey. (Photo provided by System representatives following the inspection).

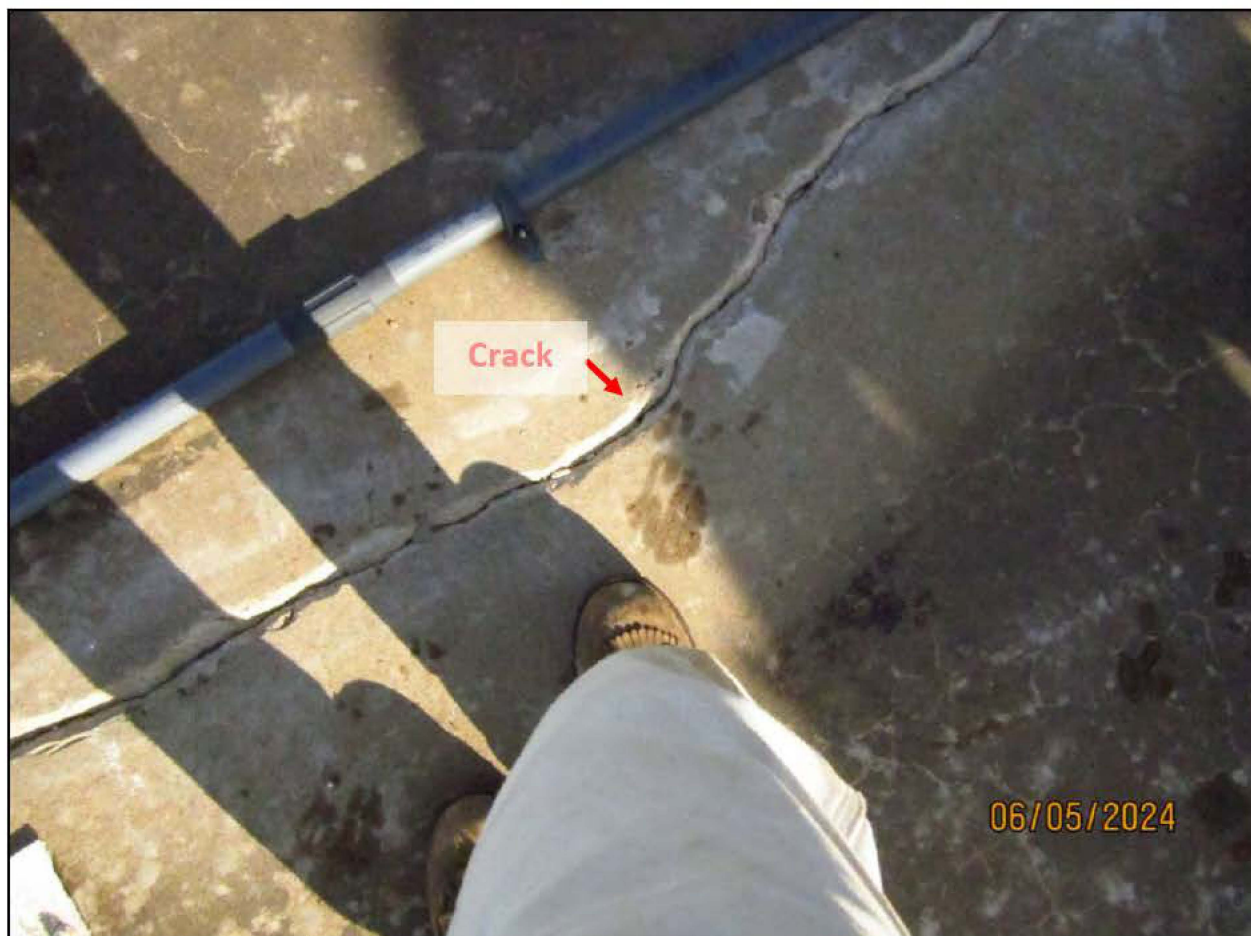
Photograph 12. 6/5/2024 8:16 AM IMG\_0003.JPG

- d. There were numerous cracks in the concrete roof of the ozone basin (refer to Appendix 1, Photograph 12). It appeared that the cracks had been filled at a point in time, but there were cracks in the caulking as well.
- e. The chemical injection vault where ammonia is injected into the produced water line (downstream of the ozonation process) was completely flooded, submerging the injection port (refer to Appendix 1, Photograph 13). There was a strong ammonia smell coming from the vault.

**WTP, Ozone Basin** View of a crack on the concrete roof of the ozone basin at the WTP. There were multiple cracks on the roof of the basin, and it appeared that the cracks had been filled in the past, but there were failures in the new caulking as well.

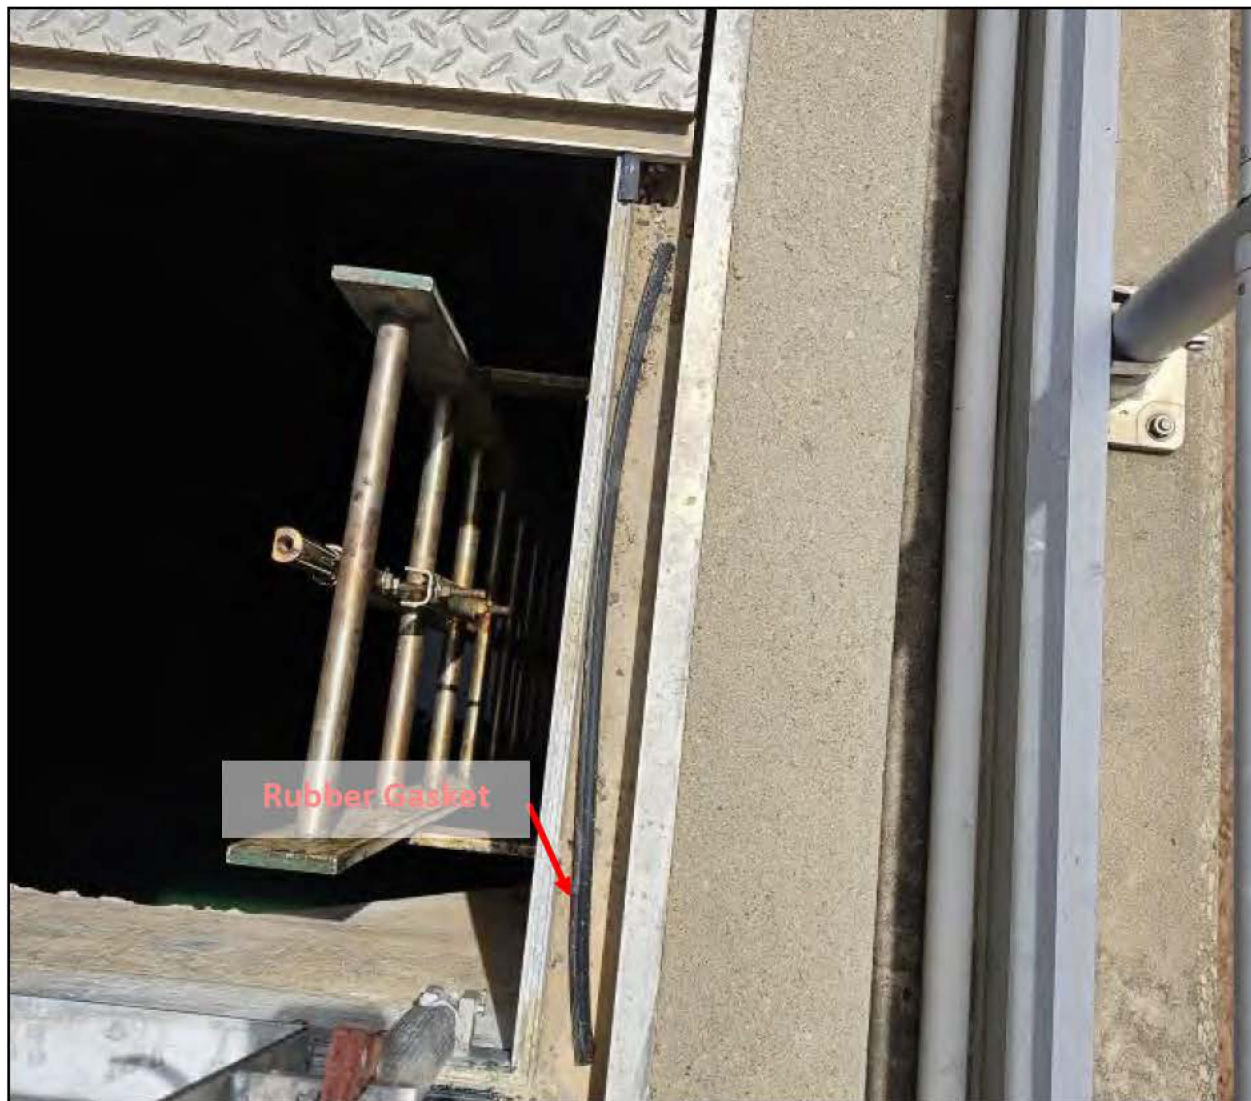
Photograph 14. 6/11/2024 2:07 PM 20240611\_140751.JPG

**WTP, Clearwell** View of a hatchway on the roof of the 4.0 MG clearwell. The hatchways were not “shoe box” design, rather they were utility vault entry type design. The rubber gasket around the outside of the hatchway had fallen off in places, and it is unknown if a watertight seal exists. (Photo provided by System representatives following the inspection).

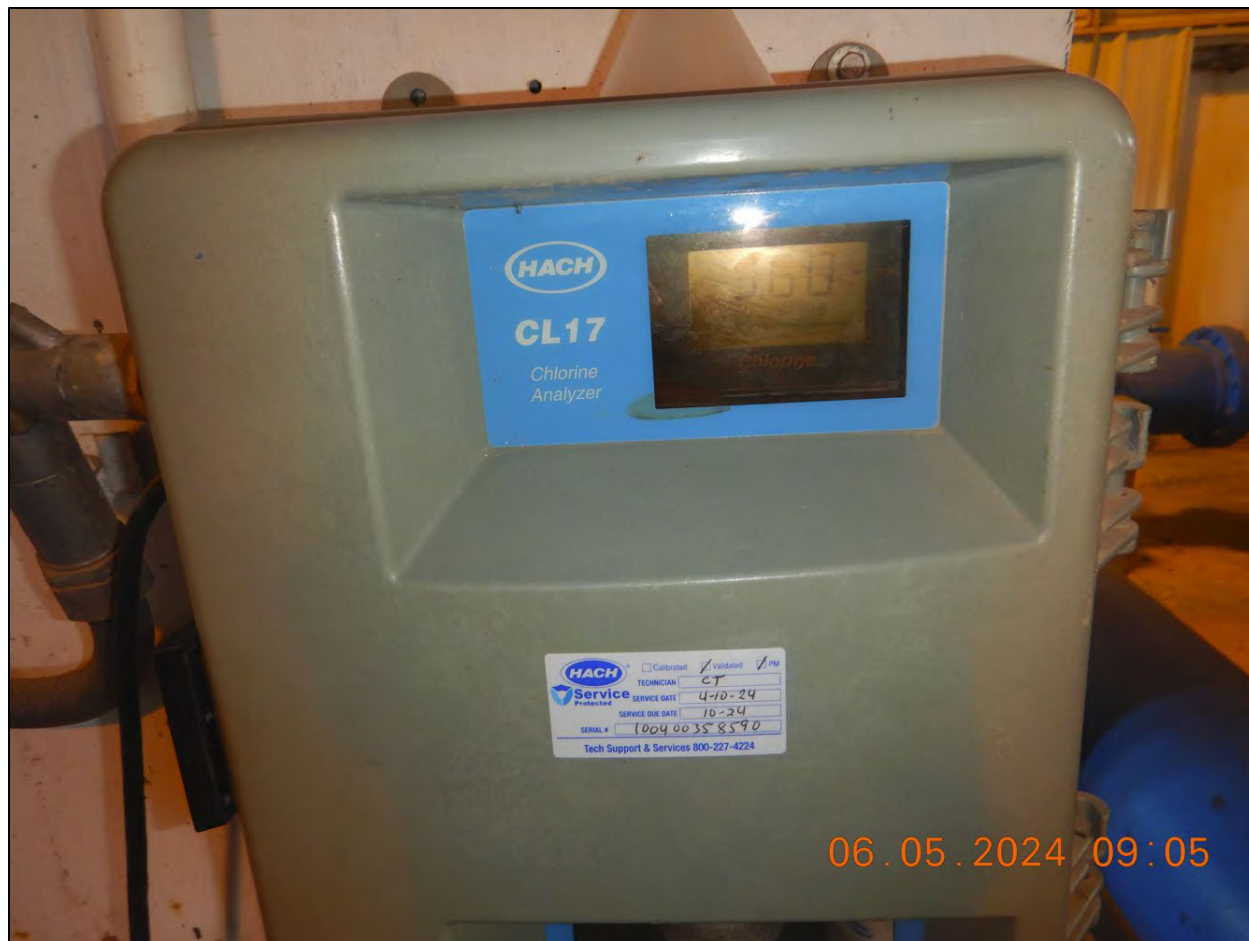
**Photograph 16. 6/5/2024 9:05 AM DSCN0777.JPG**

**WTP, High Service Pump Station** View of the POE chlorine analyzer. The analyzer was reading 3.60 mg/L at 9:05 a.m. on the morning of June 5, 2024. There was a preventative maintenance sticker from Hach on the analyzer that showed that it was last serviced on April 10, 2024.

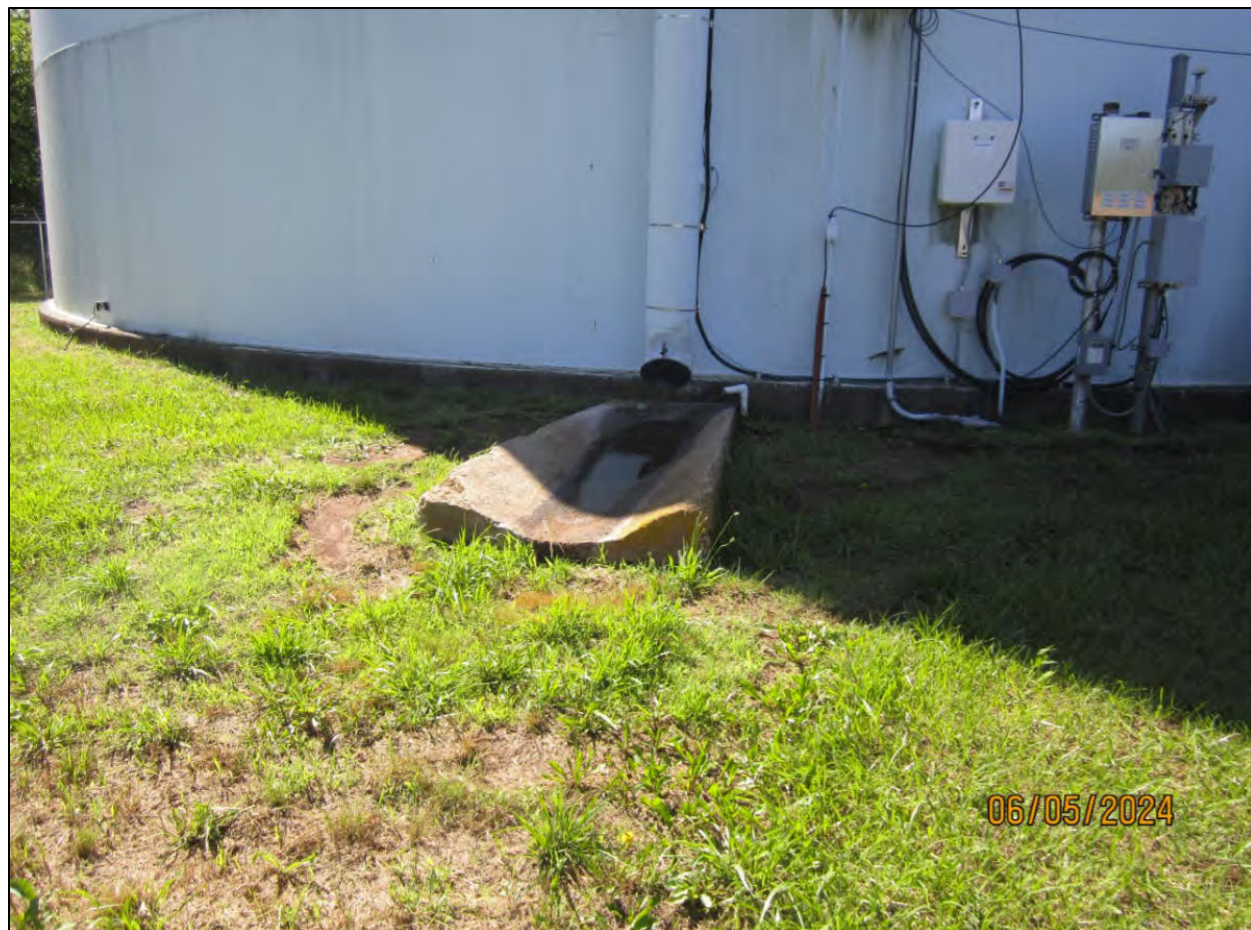
**Photograph 17. 6/5/2024 9:55 AM IMG\_0057.JPG**

**North Perkins Water Tower** View of the concrete splash pad next to the overflow at the North Perkins Water Tower. The pad was offset, and water appeared to be draining toward the foundation of the tank.

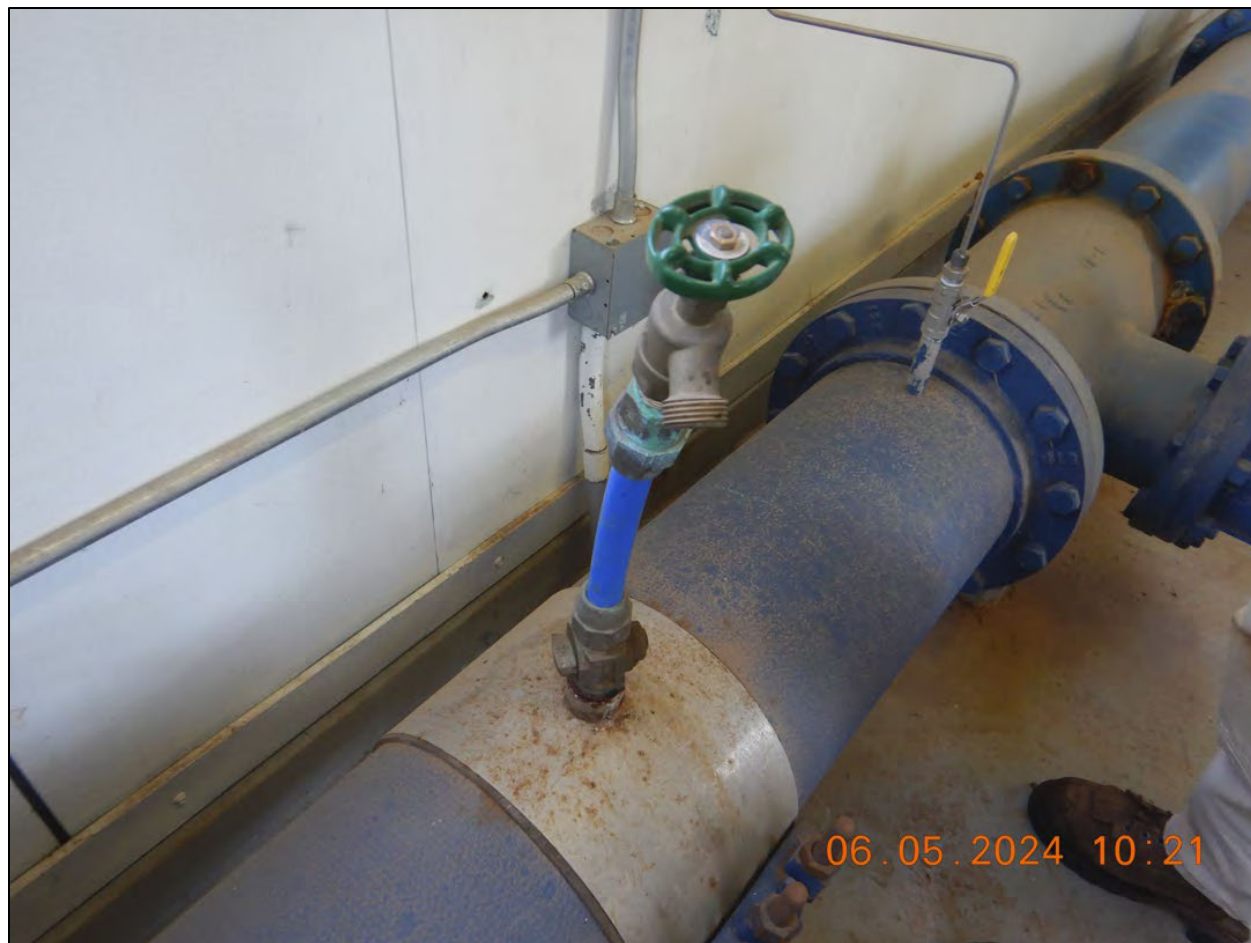
**Photograph 19. 6/5/2024 10:21 AM DSCN0804.JPG**

**Manning Pump Station** View of a threaded hose tap without backflow prevention extending on the pump line at the Manning Pump Station. The pump station was offline during the inspection.

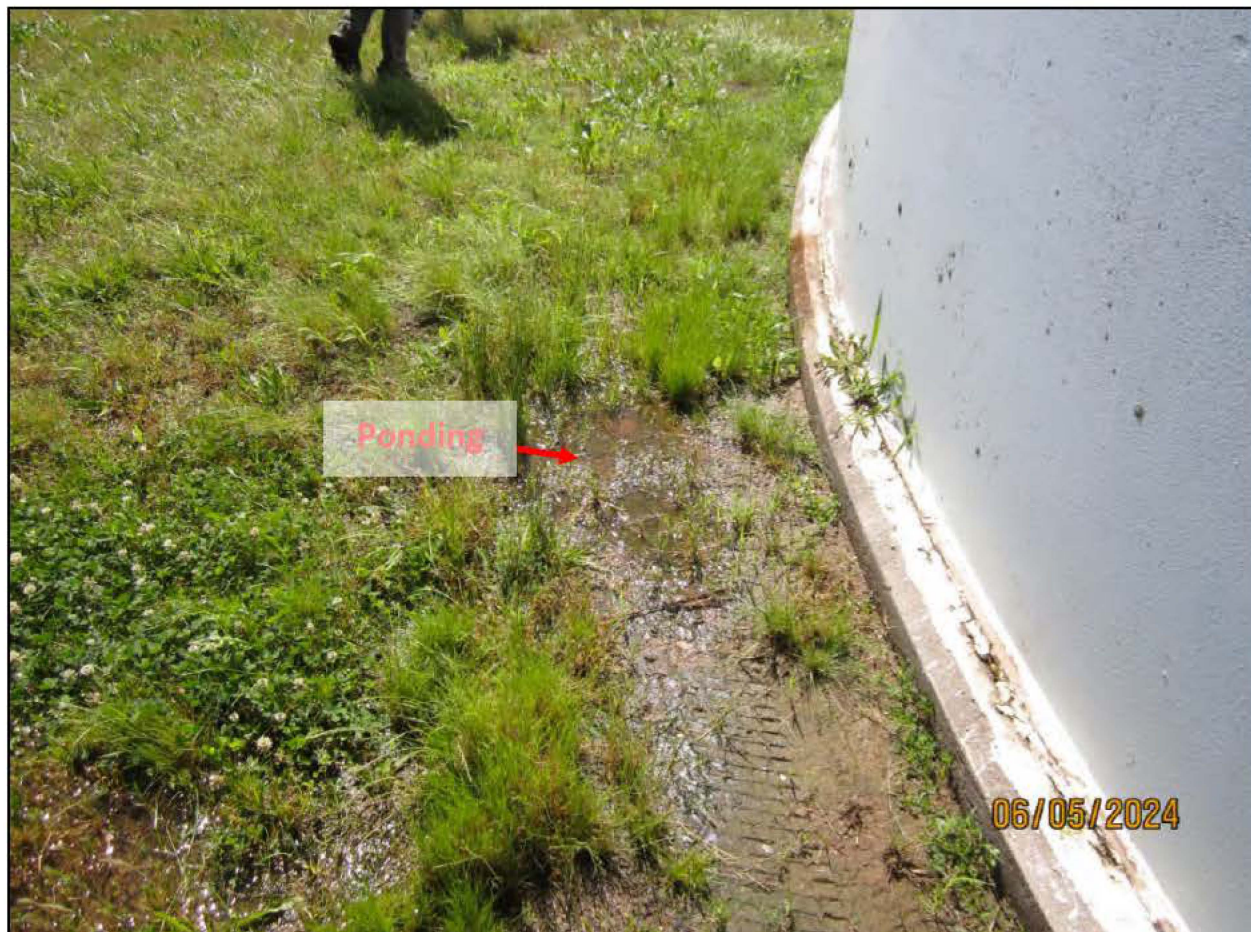
Photograph 22. 6/5/2024 10:45 AM IMG\_0094.JPG

Third and Stallard Water Tower View of ponding water next to the base of the Third and Stallard Water Tower. The ground sloped toward the tank foundation in places. Areas of the caulking between the tank bottom plate and foundation had failed.

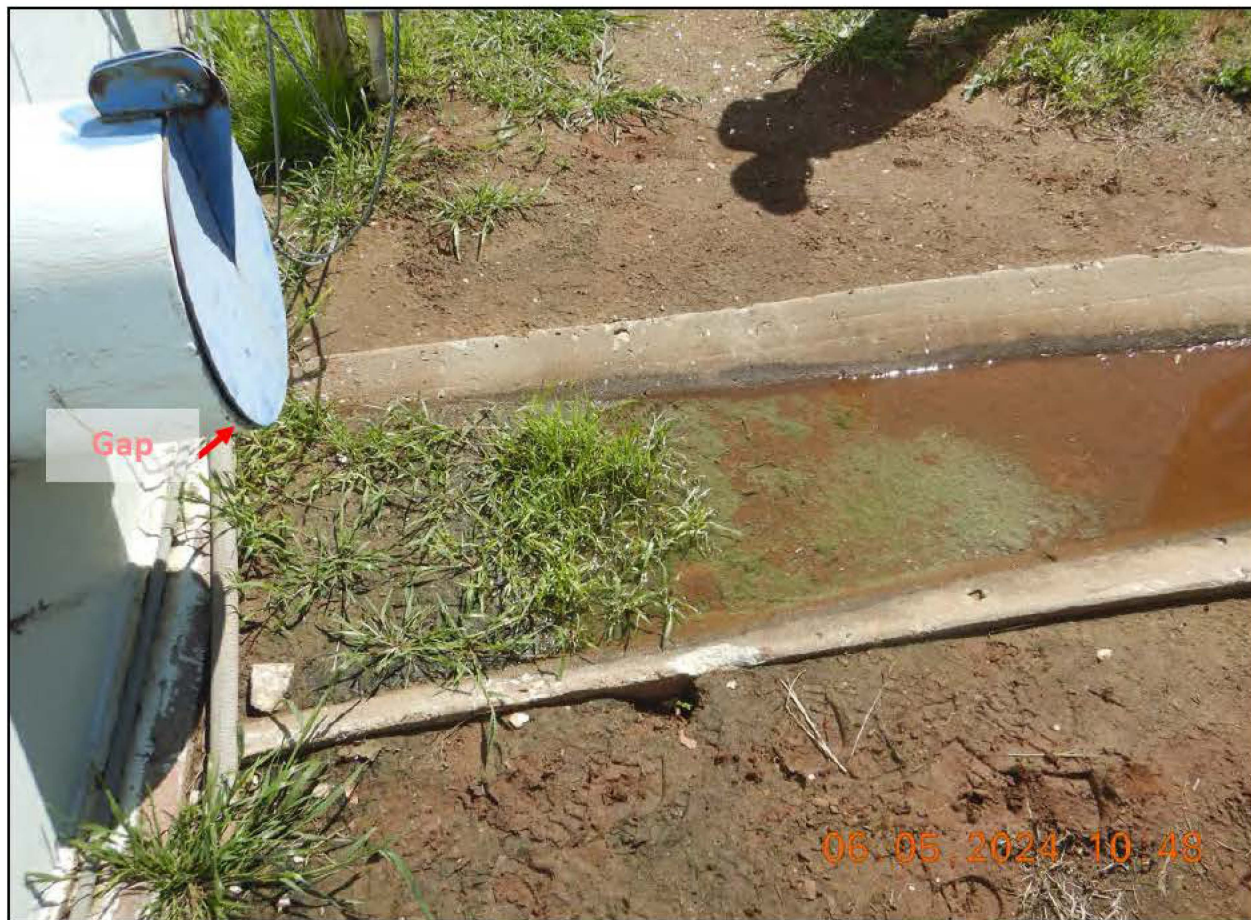
Photograph 23. 6/5/2024 10:48 AM DSCN0828.JPG

**Third and Stallard Water Tower** View of the concrete splash pad next to the end of the overflow pipe at the Third and Stallard Water Tower. The pad was offset, and water appeared to be draining toward the foundation of the tank. Also visible in this image is the flex gate at the end of the overflow pipe. The flex gate did not form a tight seal, and there was an approximately 1-inch gap between the end of the pipe and the flex gate.

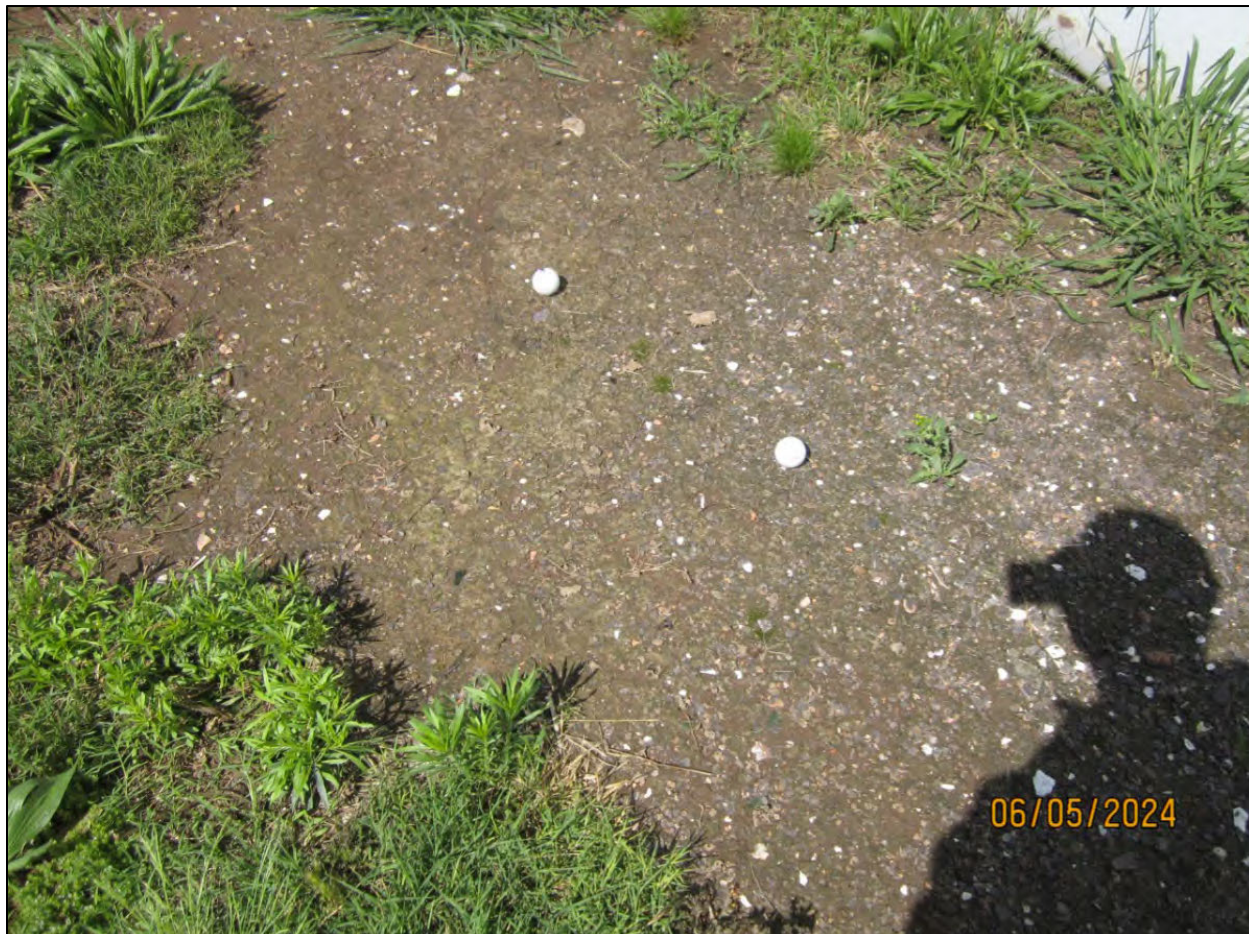
**Photograph 24. 6/4/2024 10:50 AM IMG\_0098.JPG**

**Third and Stallard Water Tower** View of golf balls and broken glass next to the base of the Third and Stallard Water Tower. System representatives stated that the residents of the house directly next to the tank would throw bottles over the fence against the side of the tank, and that people would hit golf balls toward the tank. System representatives also stated that the police had dealt with the security issues coming from the house next to the tank.

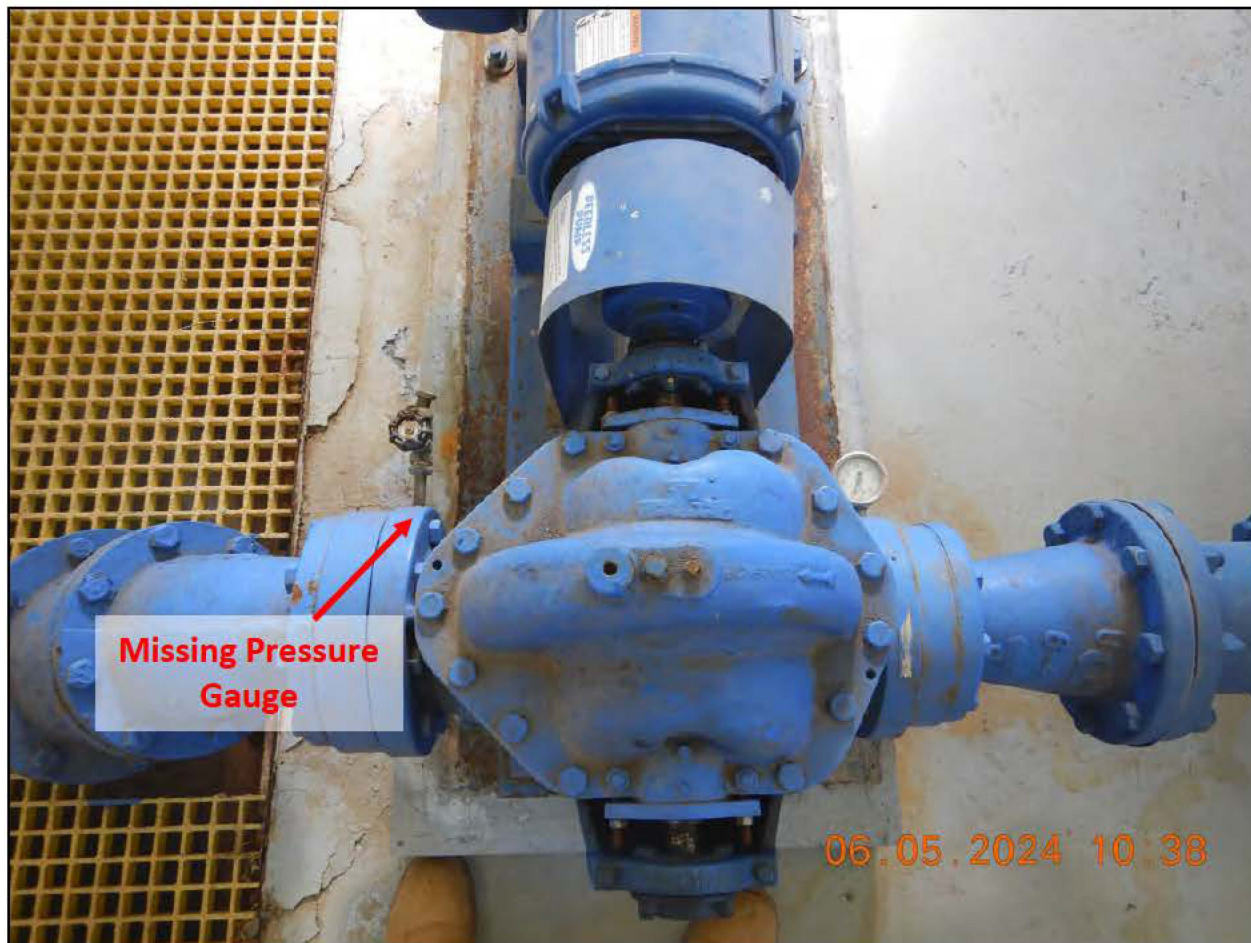
Photograph 28. 6/5/2024 10:38 AM DSCN0820.JPG

Third and Stallard Pump Station View of one of the pump lines inside of the Third and Stallard pump station. A suction side pressure gauge was missing from the line.

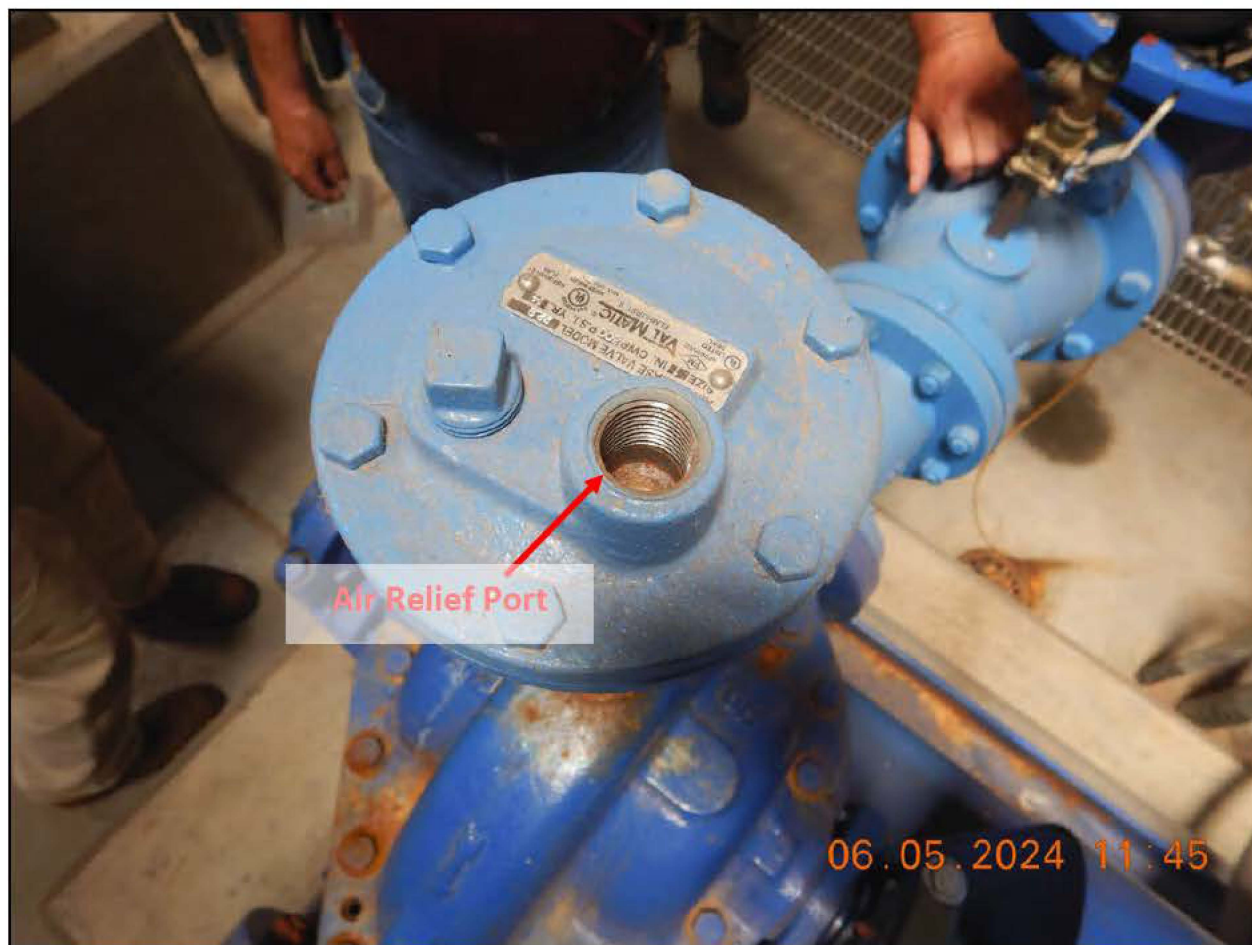
Photograph 29. 6/5/2024 11:45 AM DSCN0838.JPG  
South Perkins Road Pump Station View of an air relief port that was missing a downturned exhaust line.

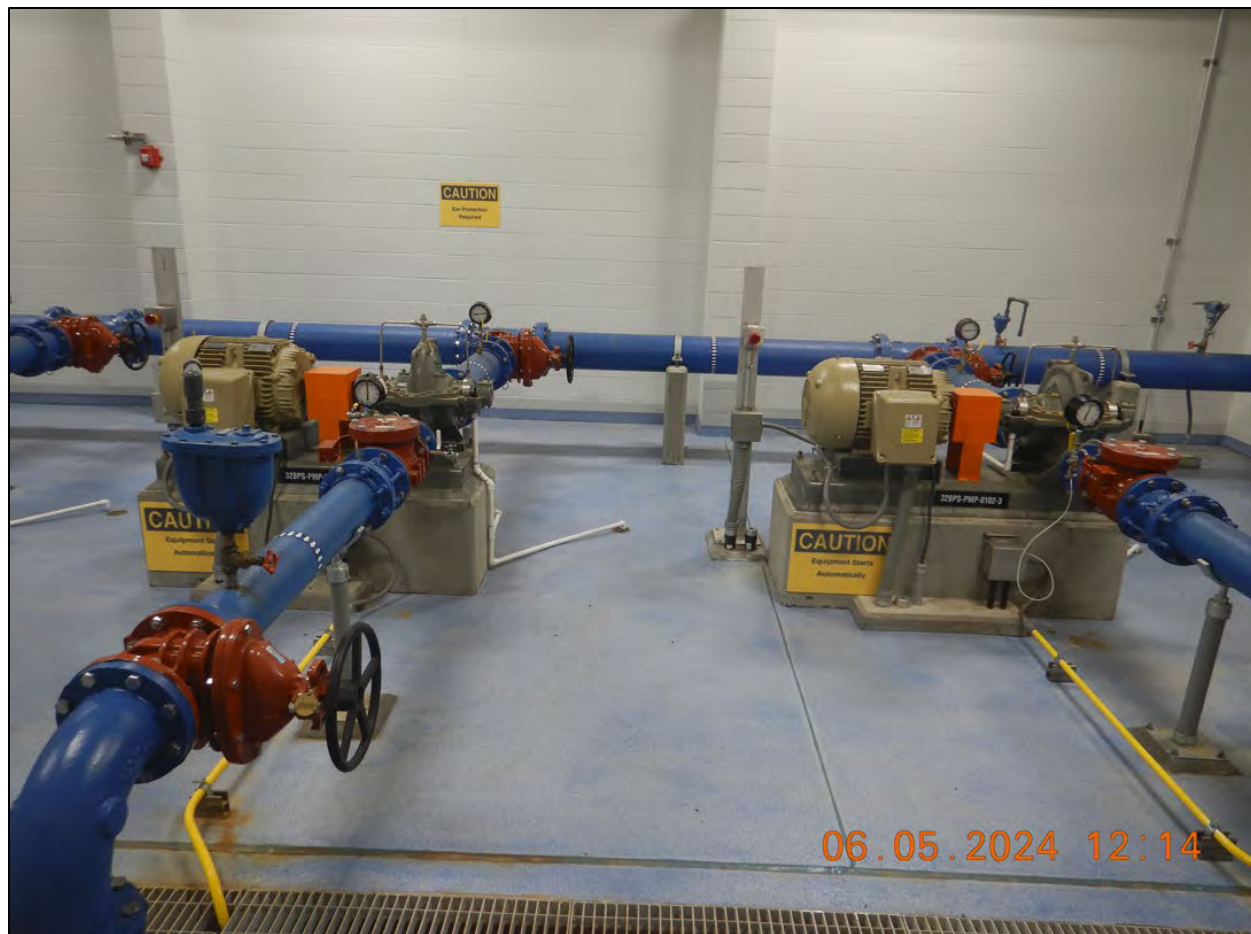
**Photograph 30. 6/5/2024 12:14 PM DSCN0845.JPG**

- a. One of the impellers associated with one of the pumps at the 32<sup>nd</sup> St. Pump Station was spinning in reverse when the EPA Inspection Team arrived onsite (refer to Appendix 1, Photograph 30). The SCADA system indicated that the pump was not running at the time. After the observation was made, operators found that the seal of the check valve on the pump discharge line had deteriorated and needed to be replaced. The pump and discharge line were taken offline while repairs were being made. A second check valve at the pump station was making a periodic clicking noise; it was unknown what was causing the noise. It appeared that the check valve was not seated properly. System representatives stated that operators were planning to take the pump and discharge line offline to evaluate the extent of the issue.

**32<sup>nd</sup> St. Pump Station** View of two of the pumps inside of the 32<sup>nd</sup> St. Pump Station. The impellers of the pump on the right were spinning in reverse when the EPA Inspection Team arrived, and it was discovered that there was a failure with the check valve on the pump discharge line. The check valve on the discharge pump line to the left of the image was making a periodic clicking noise, and the reason was unknown.
