**Region 6 - Enforcement & Compliance Assurance Division**  
**INSPECTION REPORT**

| <b>Inspection Date(s):</b> | 06/04/2024 through 06/06/2024 | |
| <b>System Name:</b> | City of Stillwater Public Water System (PWS) | |
| <b>PWS ID:</b> | OK1021220 | |

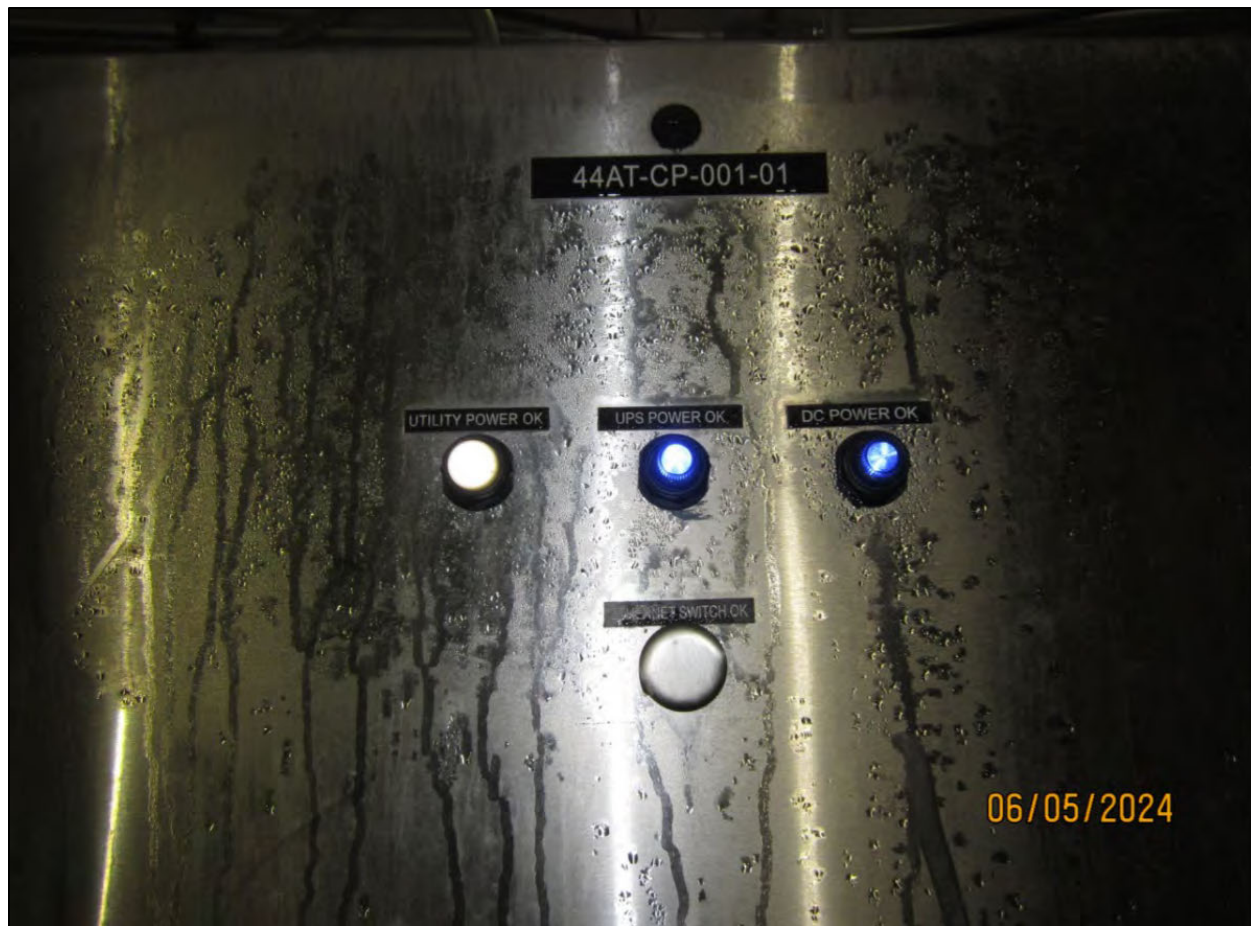
**Photograph 52. 6/5/2024 1:58 PM IMG\_0182.JPG**

- e. There was a heavy buildup of moisture on the control panel inside of the 44<sup>th</sup> St. Water Tower base due to humidity within the base (refer to Appendix 1, Photograph 52). The EPA Inspection Team had the City representatives check the inside of the panel, which did not contain moisture.

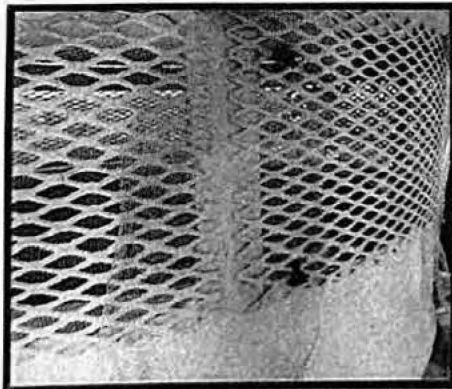
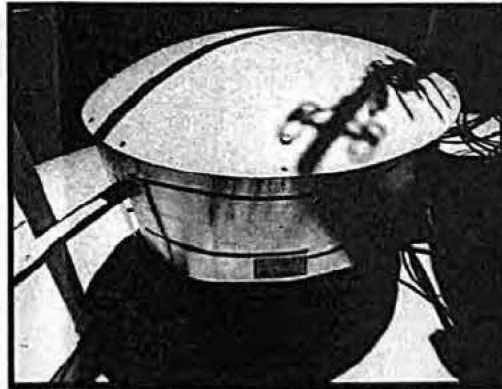
*The Range Road Tower vent was upgraded with a retrofit cover that completely covers the mesh screening on May 29, 2020. Please see below pictures of the upgrade:*

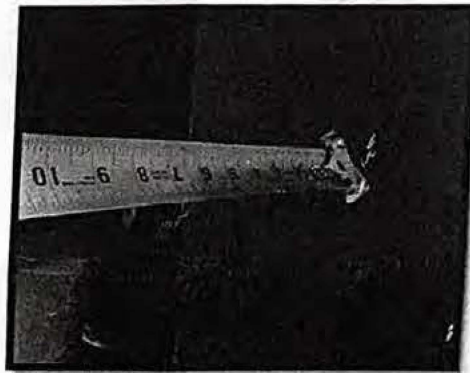
*Below is a picture of inside of the fluoride mixing tank. The water has been turned off to show the 6" gap between the end of finished pipe and the top of the water. The adjustment to the float valve was completed January 23, 2020.*

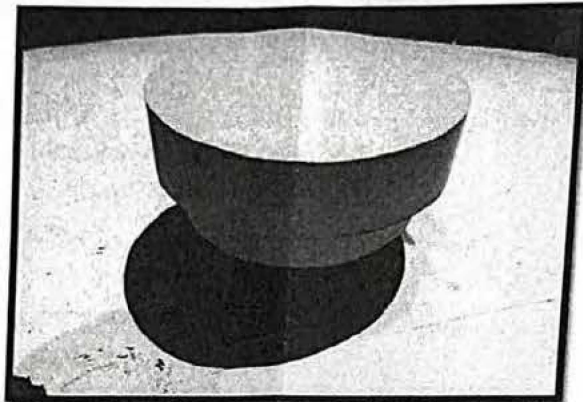
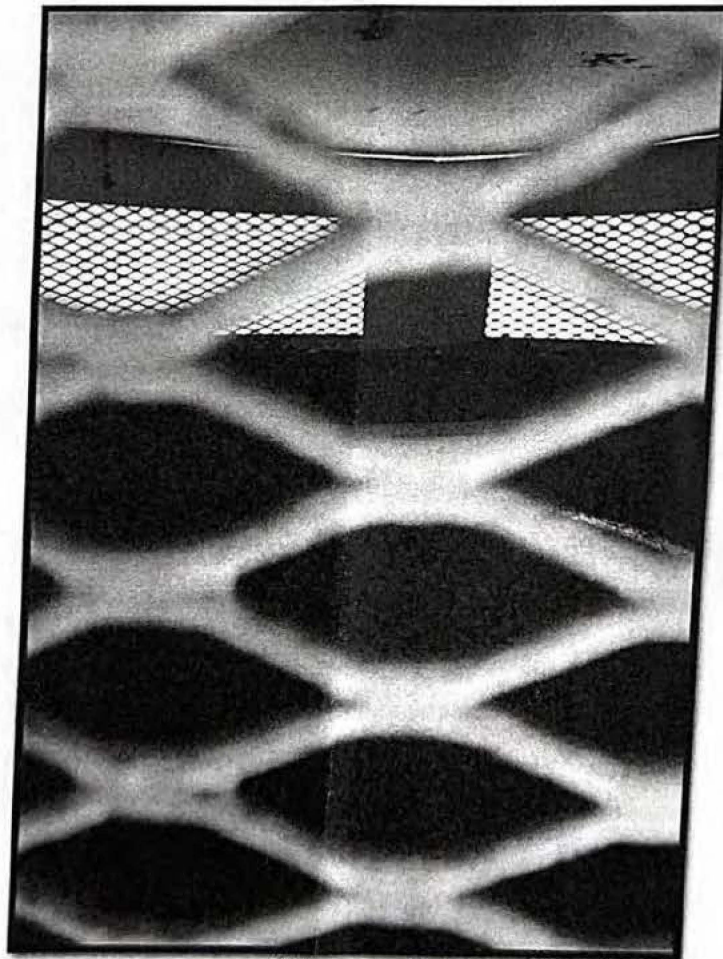
*Please see the pictures below of the Stallard Tank vent's confirmation of 24-mesh screen inside and below outer expanded metal screen:*

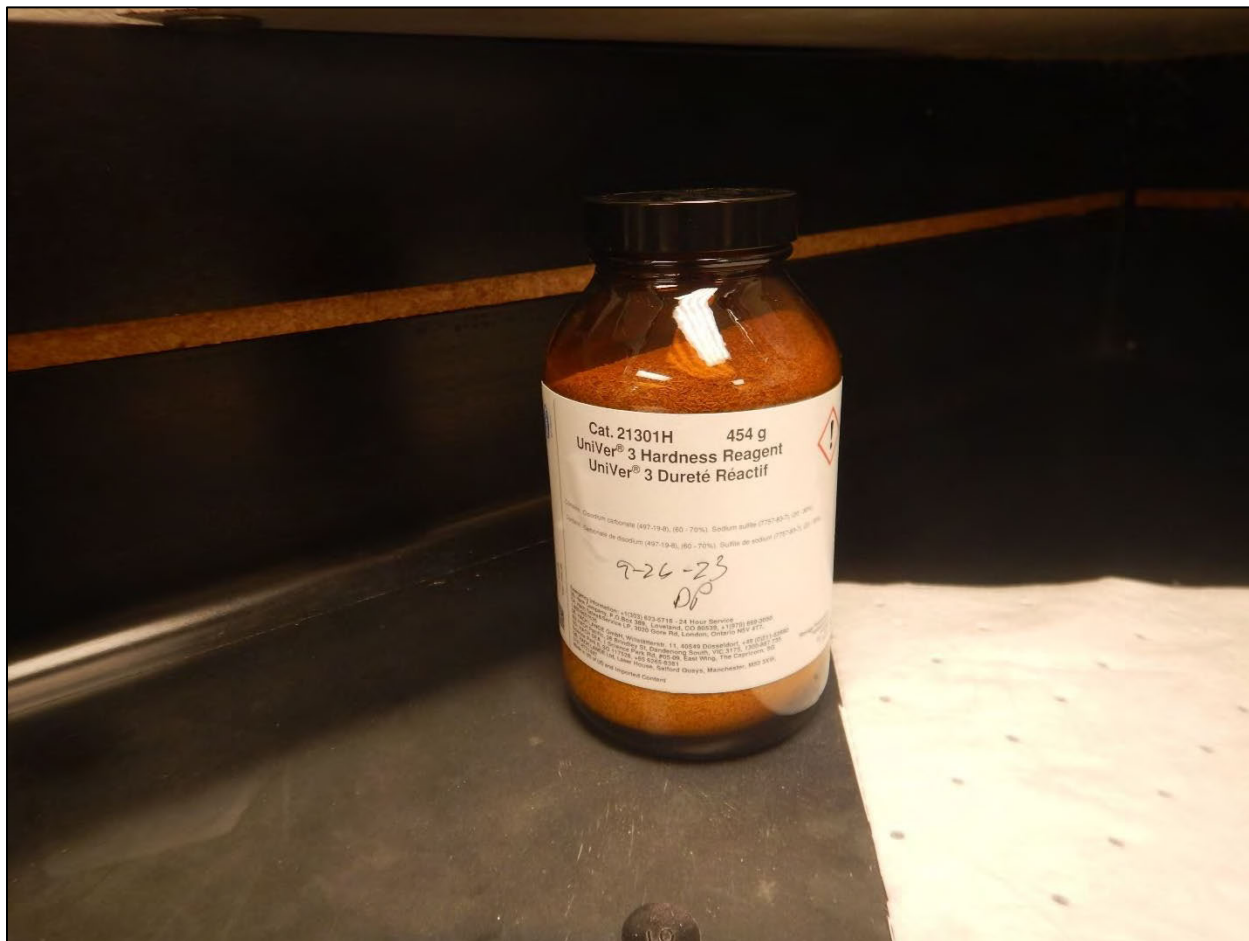
Description: Reagents in cabinet without date opened properly labeled.

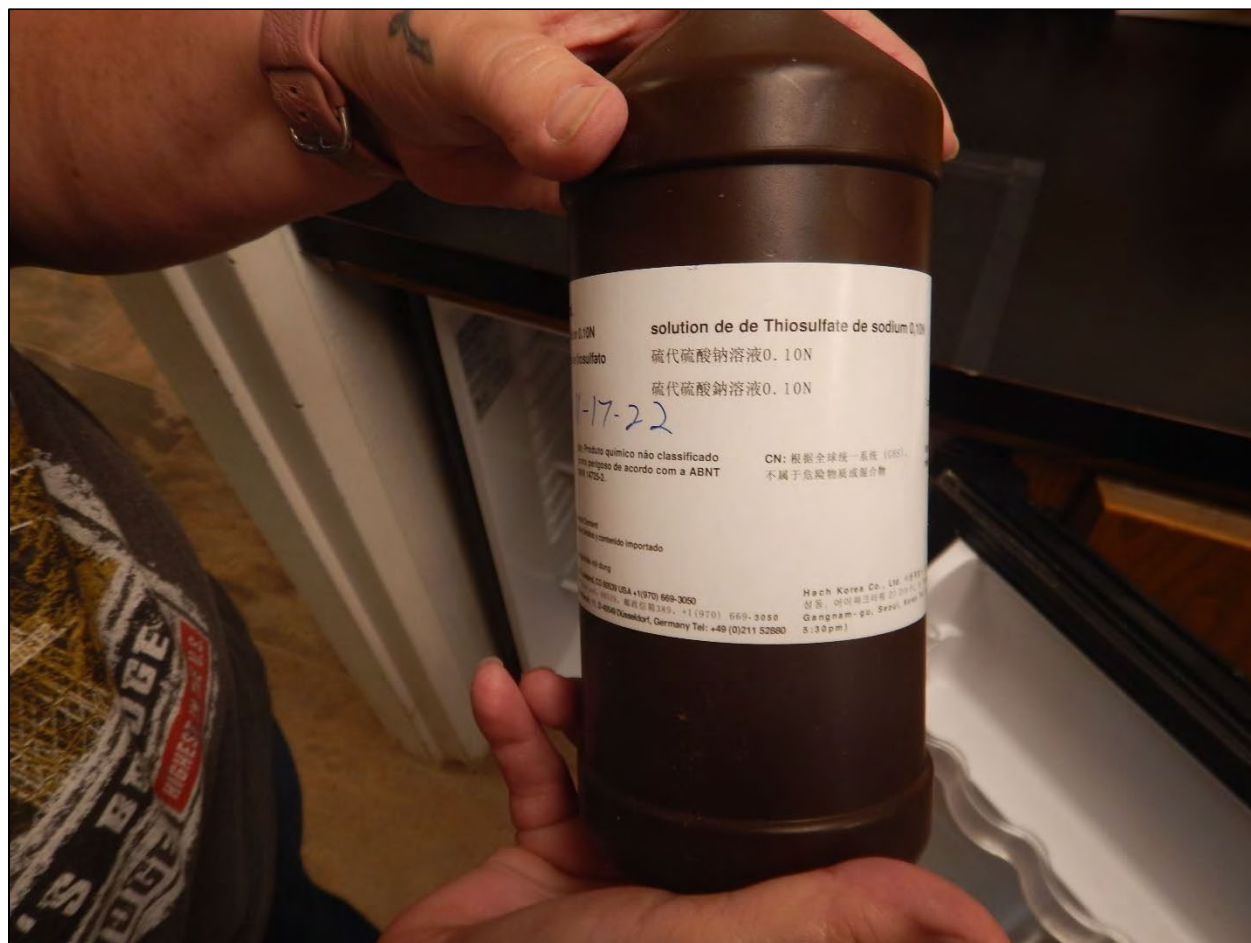
Description: Reagent on counter with only date received labeled and without date opened labeled.

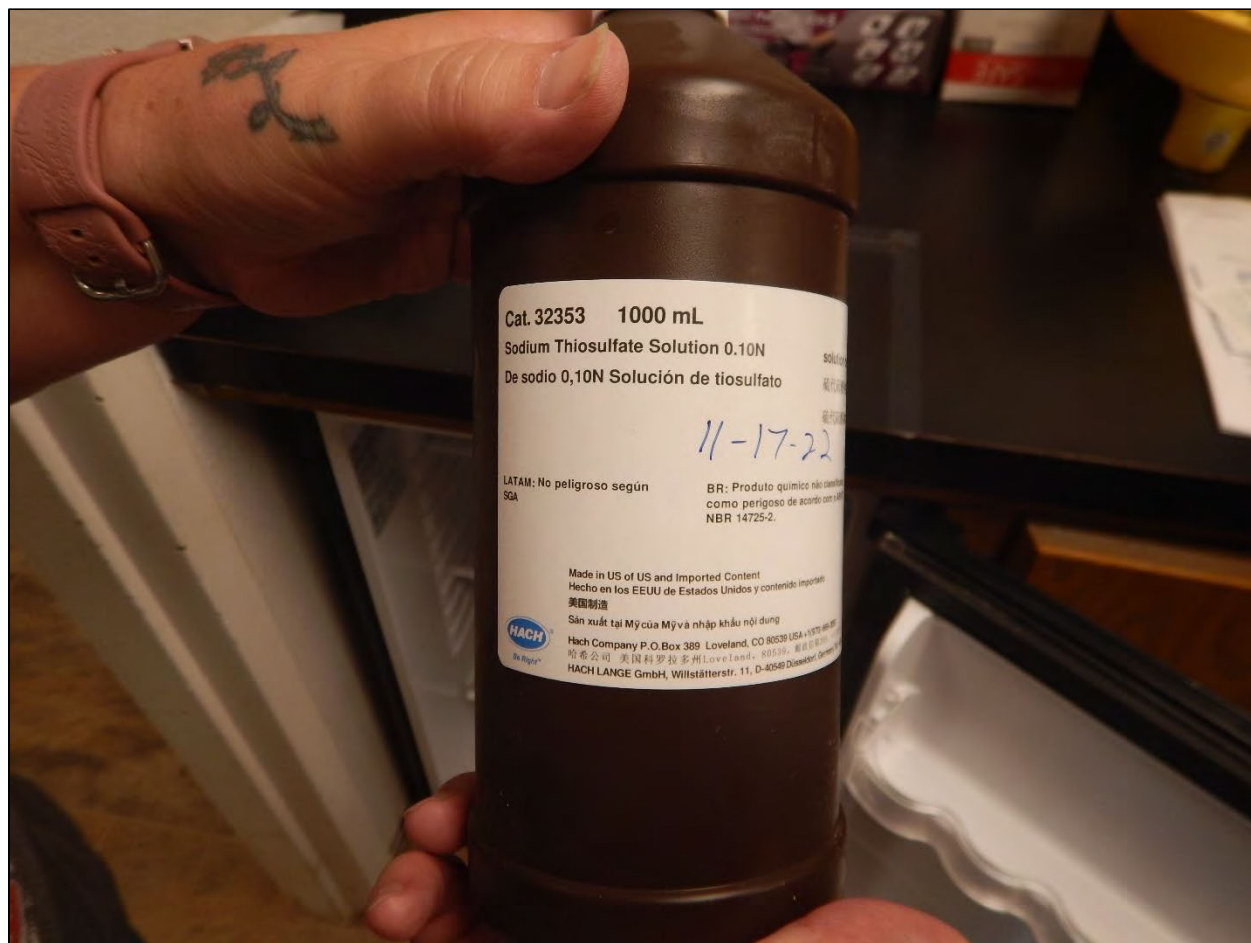
Description: Reagent in refrigerator with only date received labeled and without date opened labeled.

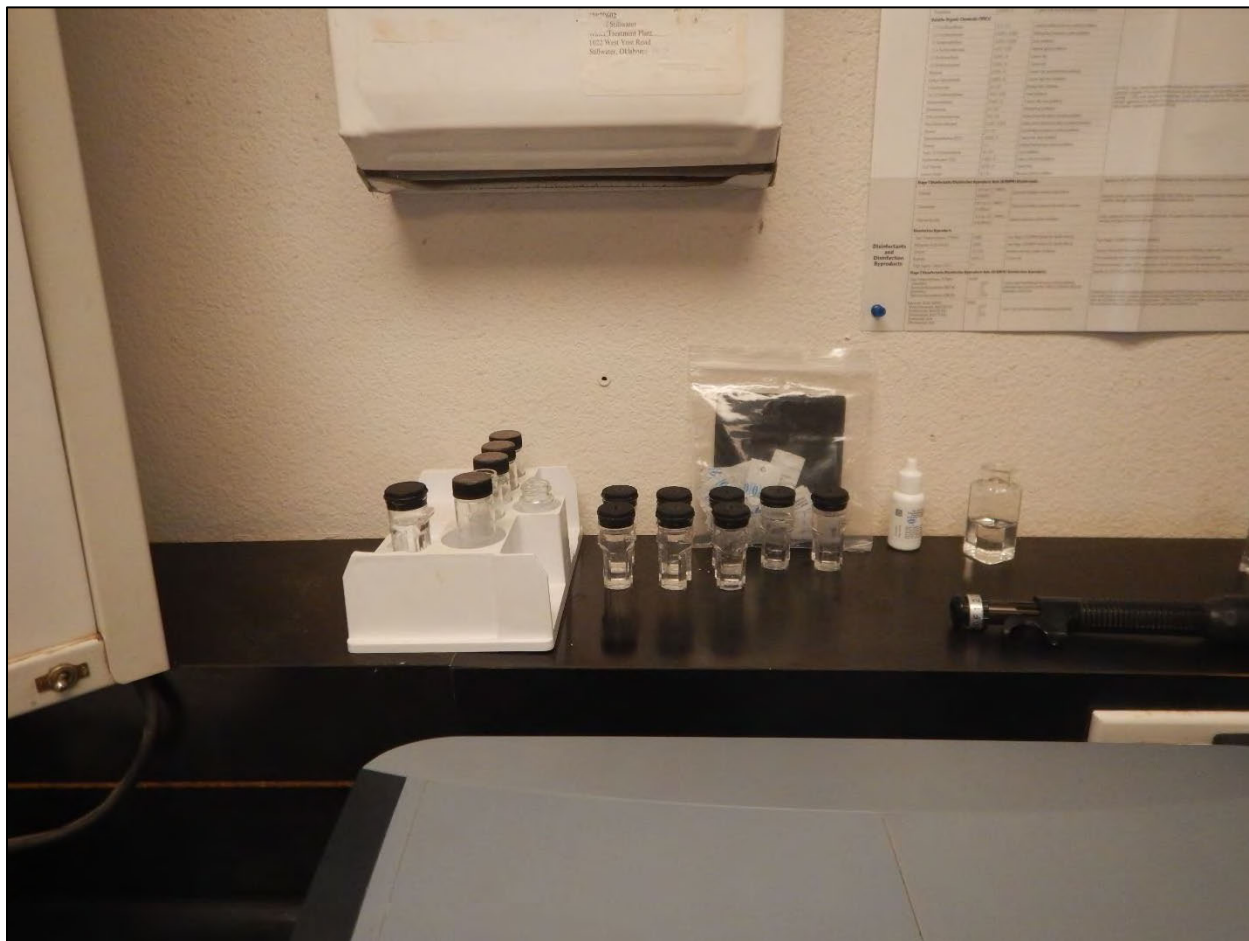
Description: Bottles on counter containing a clear reagent not labeled with any identifying information.

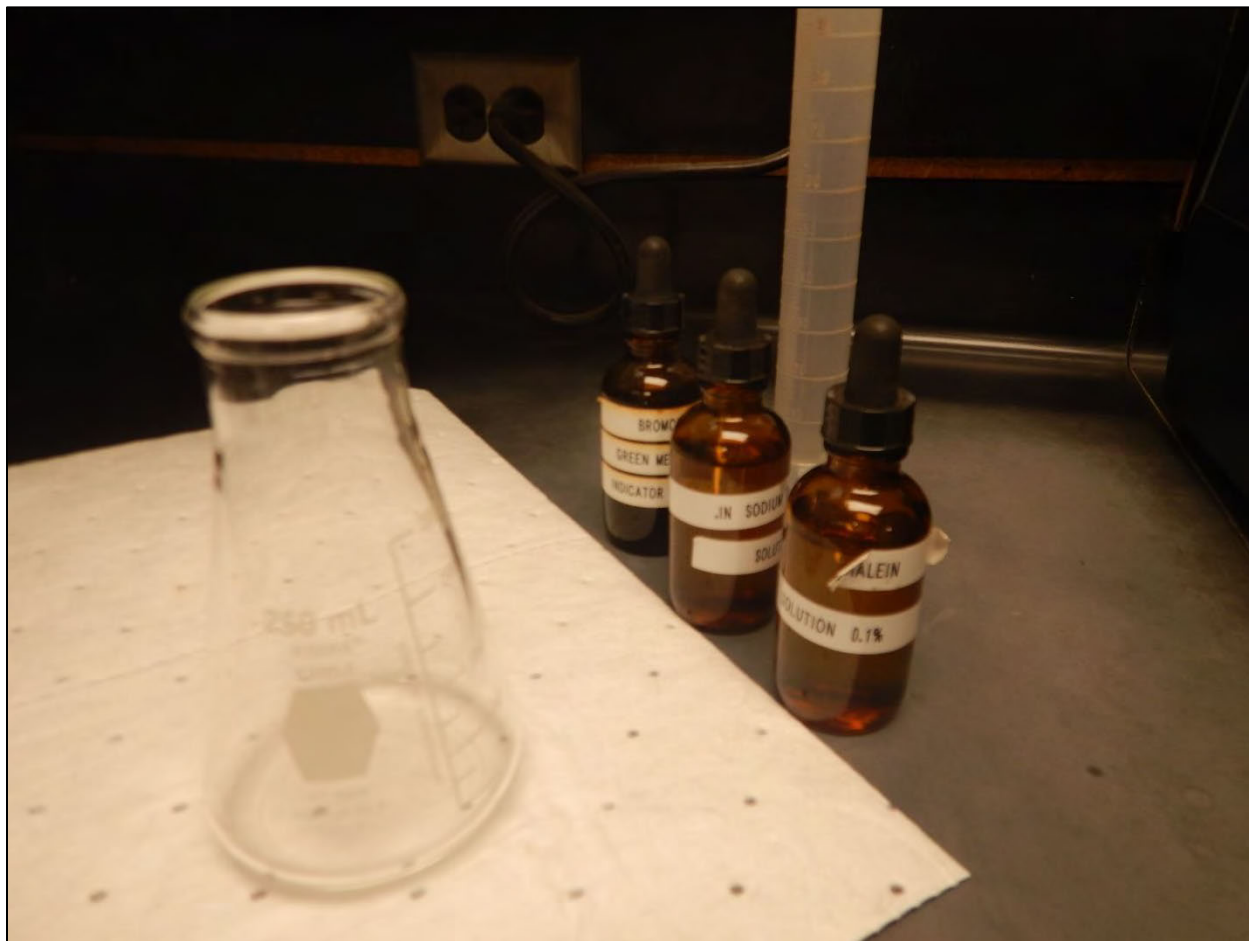
Description: Bottles on counter used for chlorine blanks and chlorine testing without identifying labels.

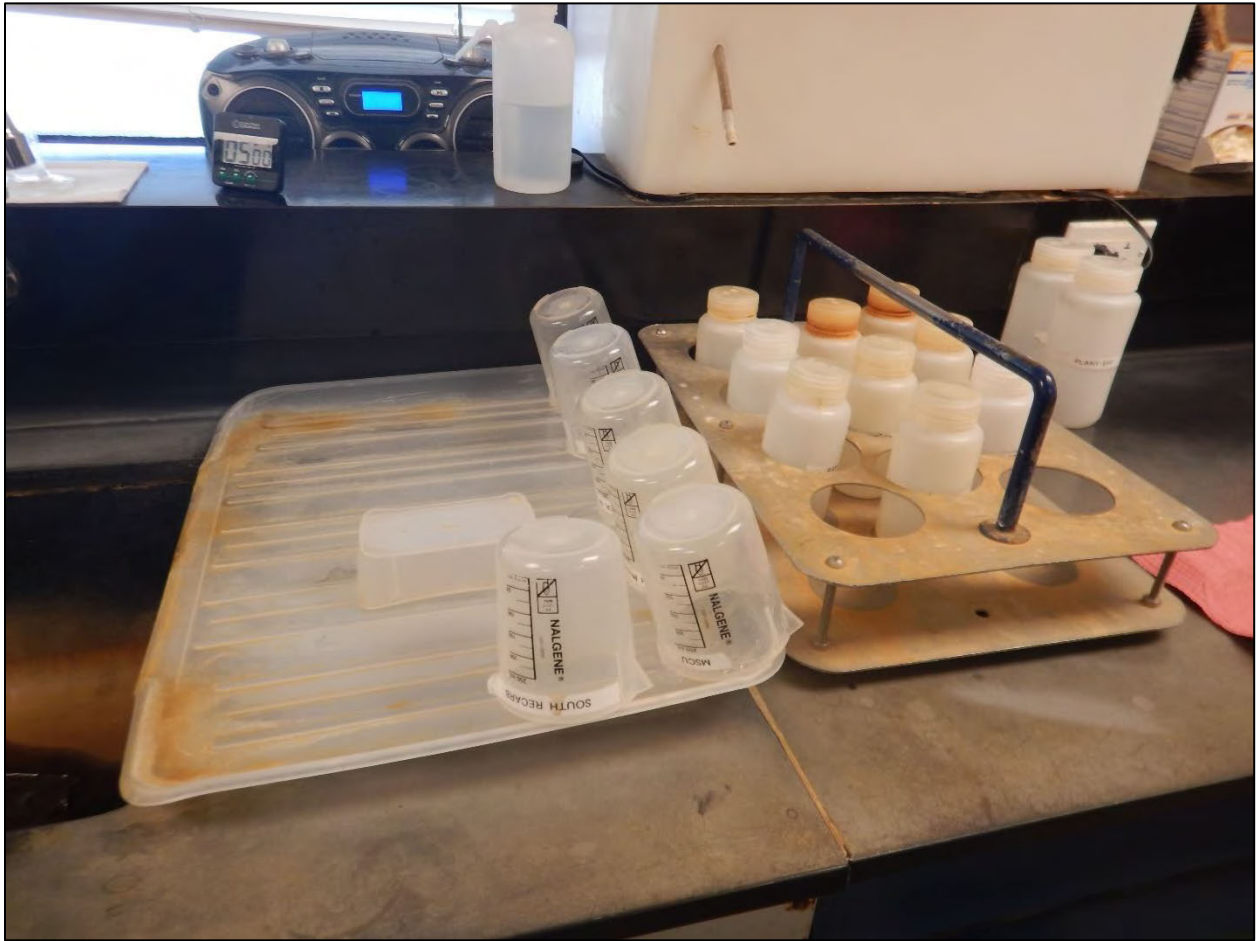
Description: Bottles on counter that were refilled with reagents from original reagent bottles not labeled with the expiration date of their contents.

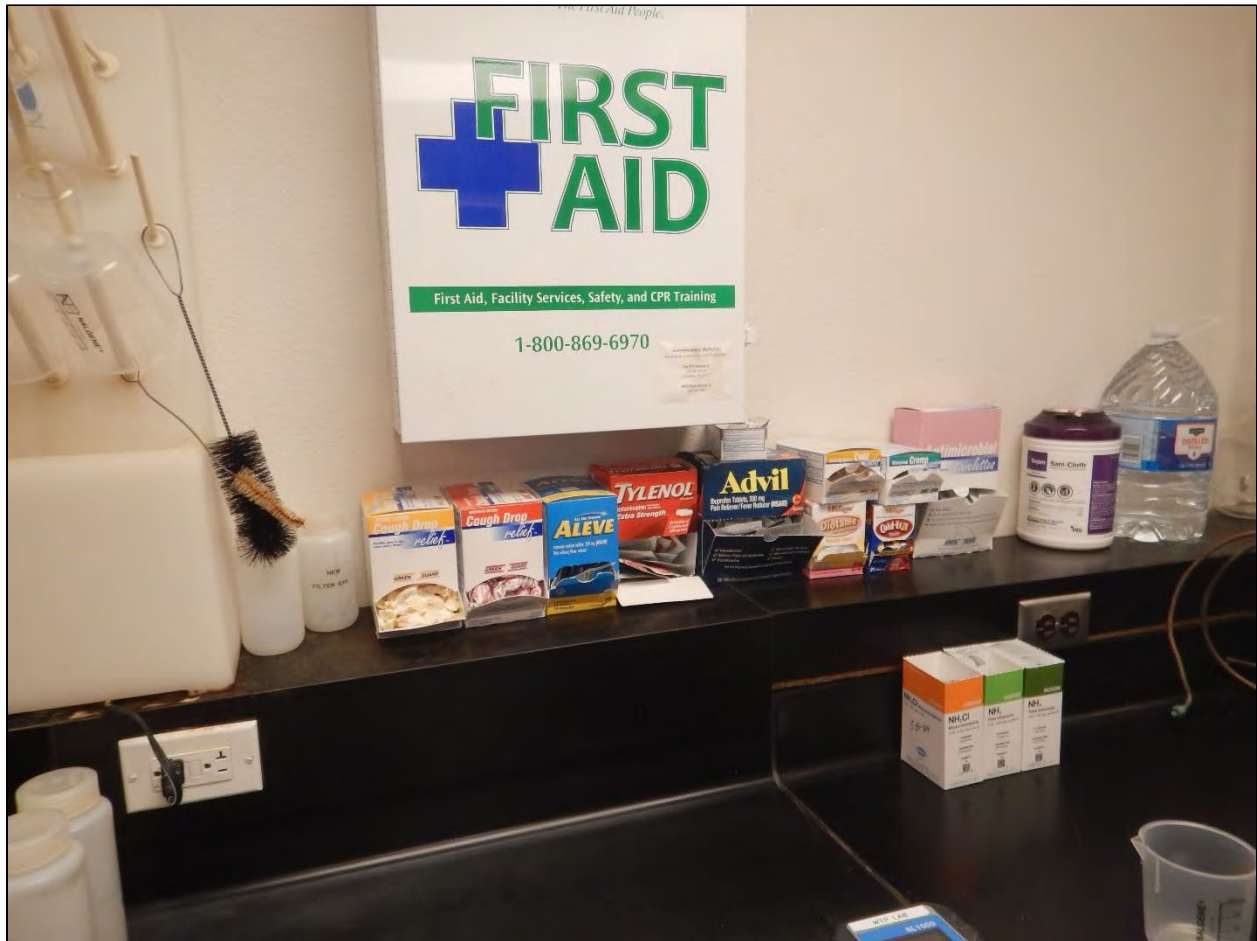
Description: Commercial distilled water purchased from a grocery store or similar general store on laboratory counter.
