**Class I and II Well Inspection Form**  
**US Environmental Protection Agency – Region 4**  
**Underground Injection Control Program**  
61 Forsyth Street SW, MC 9T25, Atlanta, Georgia, 30303  
Phone: (404)562-9424

Facility Name: *Blackjack Plant* \_\_\_\_\_  
Street Address: *4940 Blackjack Plant Road* \_\_\_\_\_  
City: *Jay* \_\_\_\_\_ County: *Santa Rosa* \_\_\_\_\_ State: *FL* \_\_\_\_\_ Zip: *32535* \_\_\_\_\_  
Nature of Business: *Oil and gas production* \_\_\_\_\_  
Facility Owner/Operator: *Black Creek Energy, LLC* \_\_\_\_\_ Phone: *(601) 431-5386* \_\_\_\_\_  
Email: *harris.butler@butlerroyals.com* \_\_\_\_\_  
Facility Contact (if different): *Michael Wetzel* \_\_\_\_\_ Phone: *(850) 324-6271* \_\_\_\_\_  
O/O Mailing Address: *140 Virginia Street, Suite 402* \_\_\_\_\_  
City: *Richmond* \_\_\_\_\_ County: *NA* \_\_\_\_\_ State: *VA* \_\_\_\_\_ Zip: *23209* \_\_\_\_\_

Well Name & #: *R. L. Moore #23-E* \_\_\_\_\_  
Well Type (see table): *Enhanced Recovery (EOR)* \_\_\_\_\_ State Permit: API # *0911320121* \_\_\_\_\_  
Latitude (°N): *30.84106039* °N \_\_\_\_\_ Longitude (°W): *-87.1119759* °W \_\_\_\_\_ Elevation (ft): *NA* \_\_\_\_\_  
Injection Method (check ap

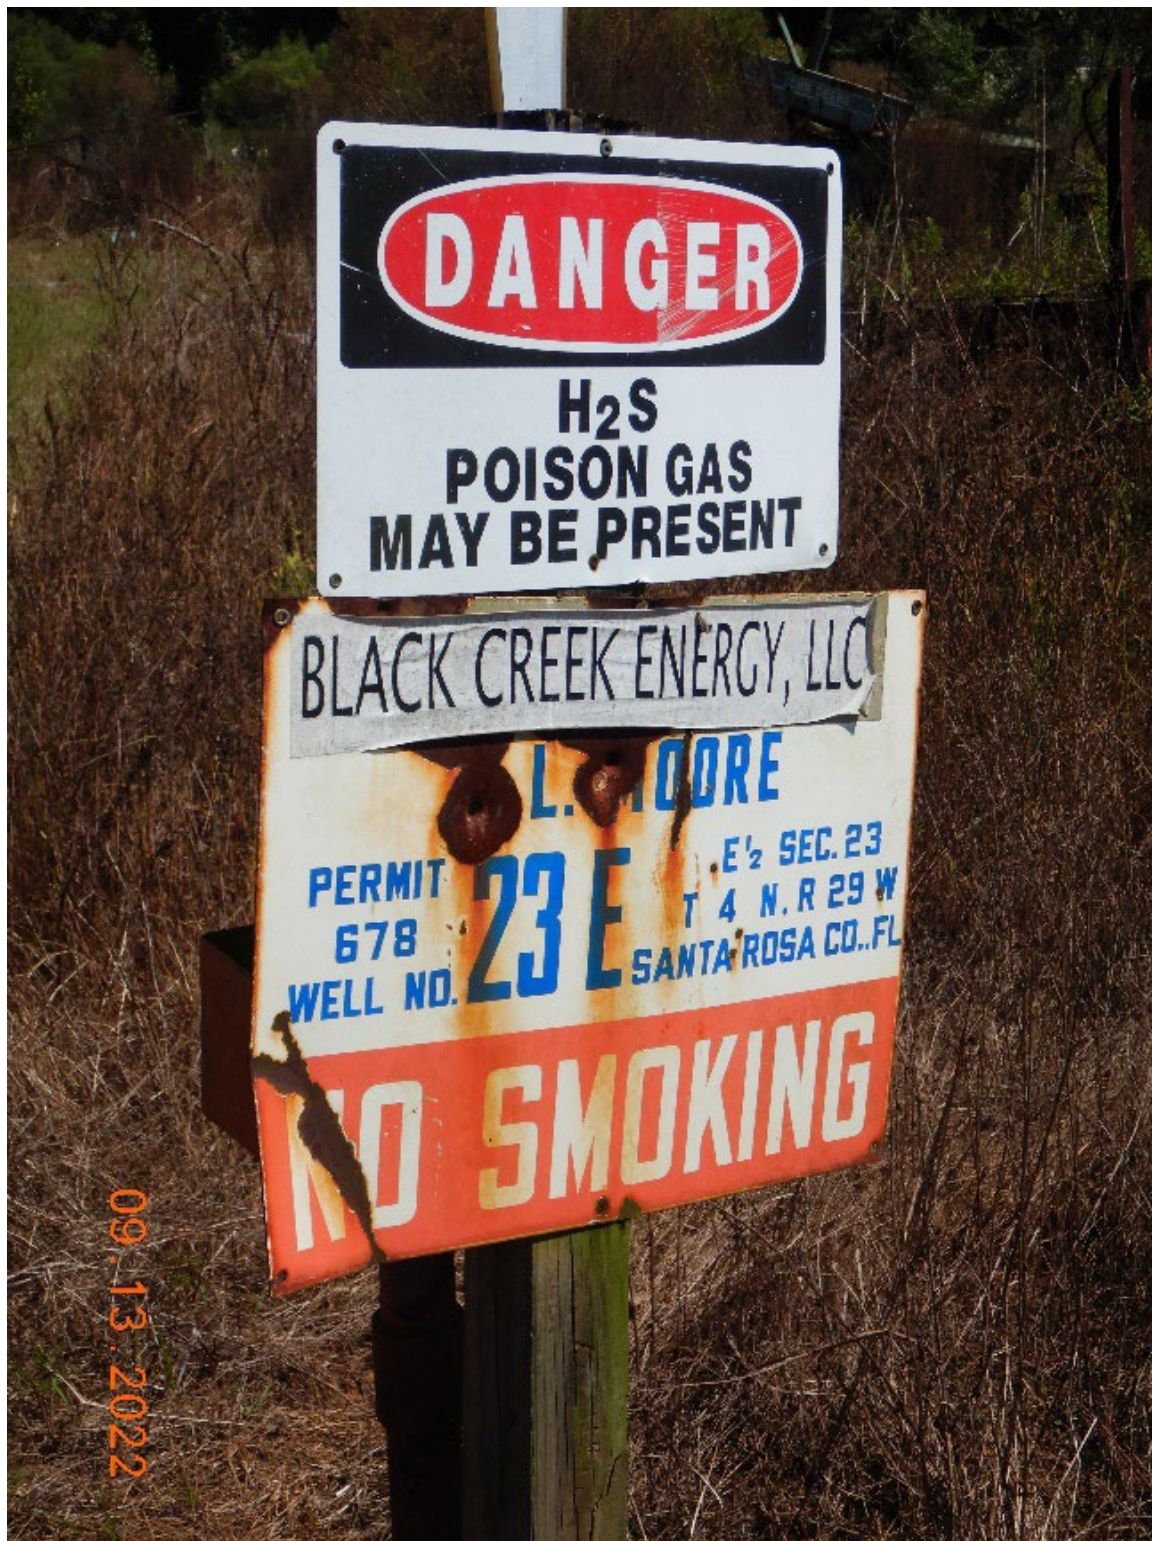
Description: *Looking north, R.L. Moore #23-E sign alongside access road.* \_\_\_\_\_

Photograph 1: Looking north, R.L. Moore #23-E sign alongside access road.

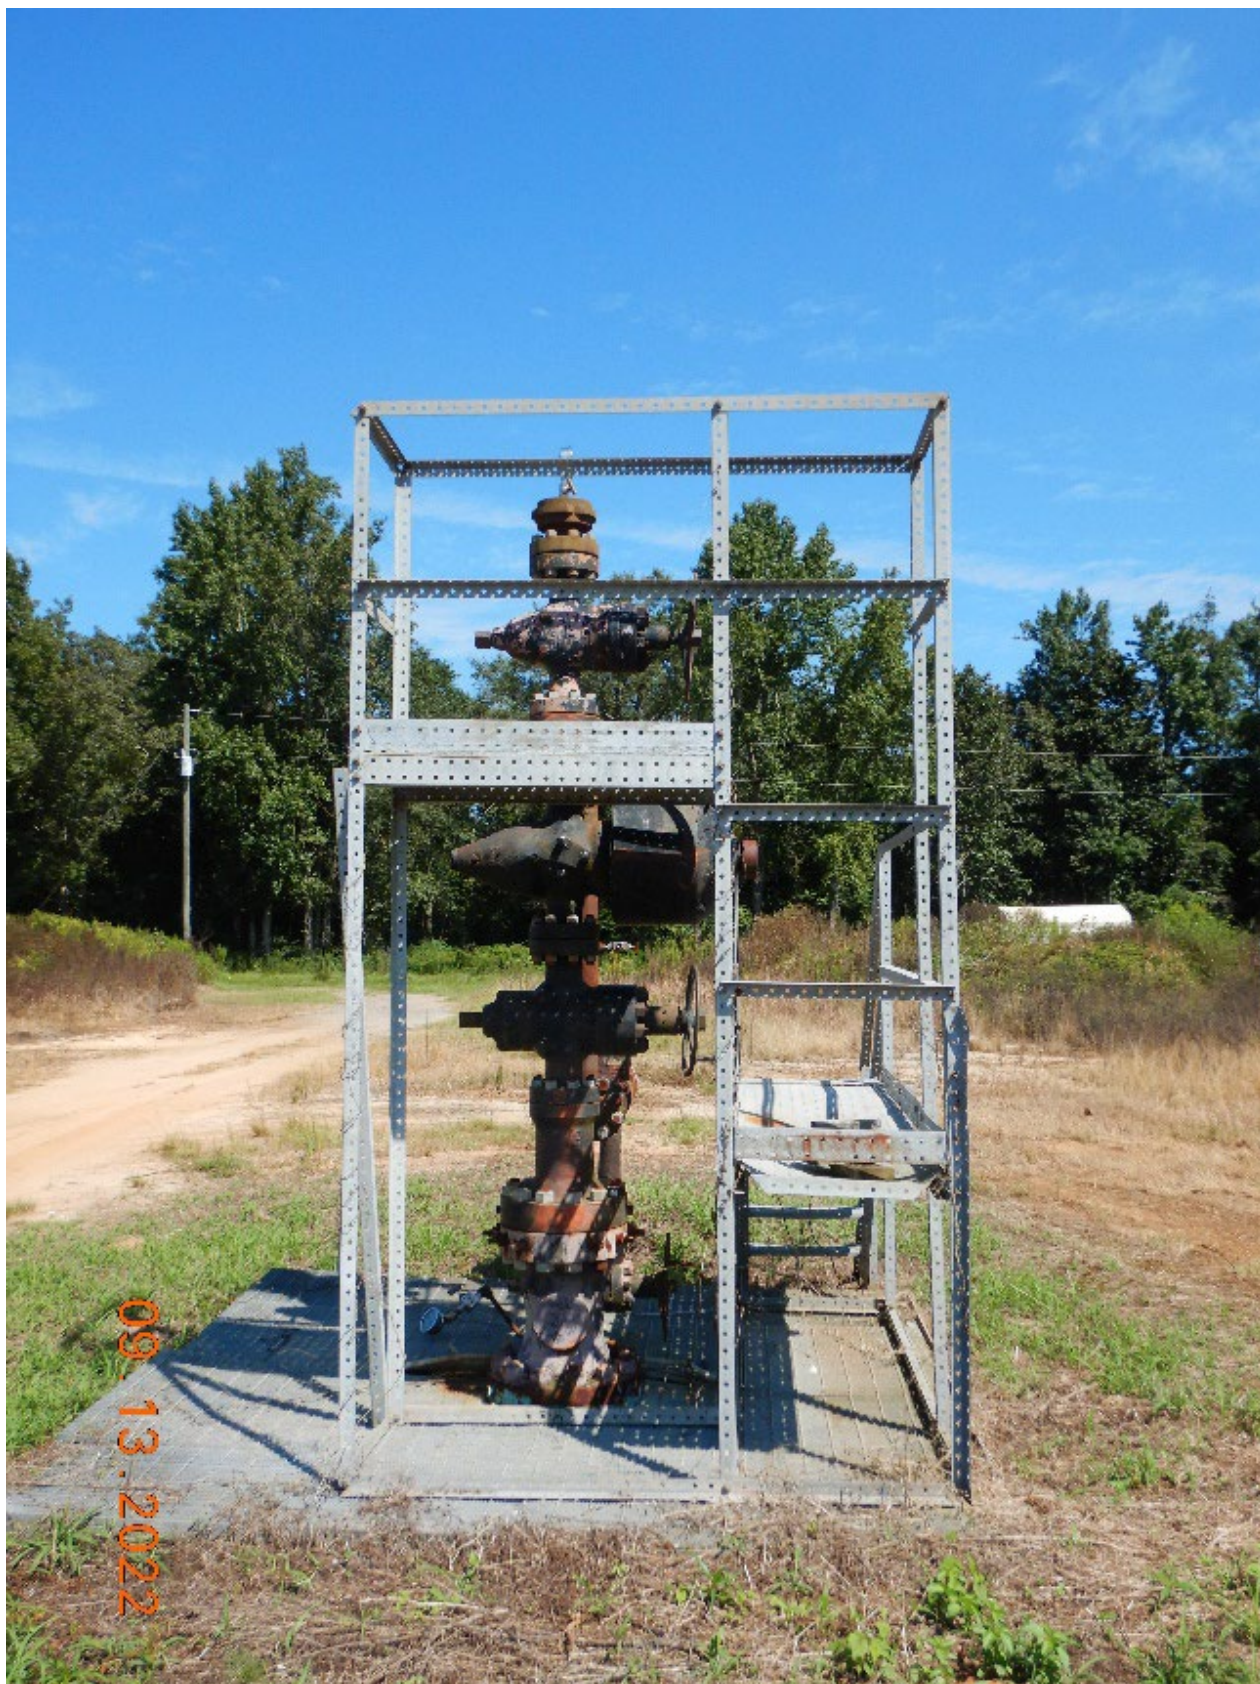
Description: *Looking north, site overview showing well head, pressure gauges, valves, and as stairway.* \_\_\_\_\_

**Photograph 2:** Looking north, site overview showing well head, pressure gauges, valves, and access stairway.

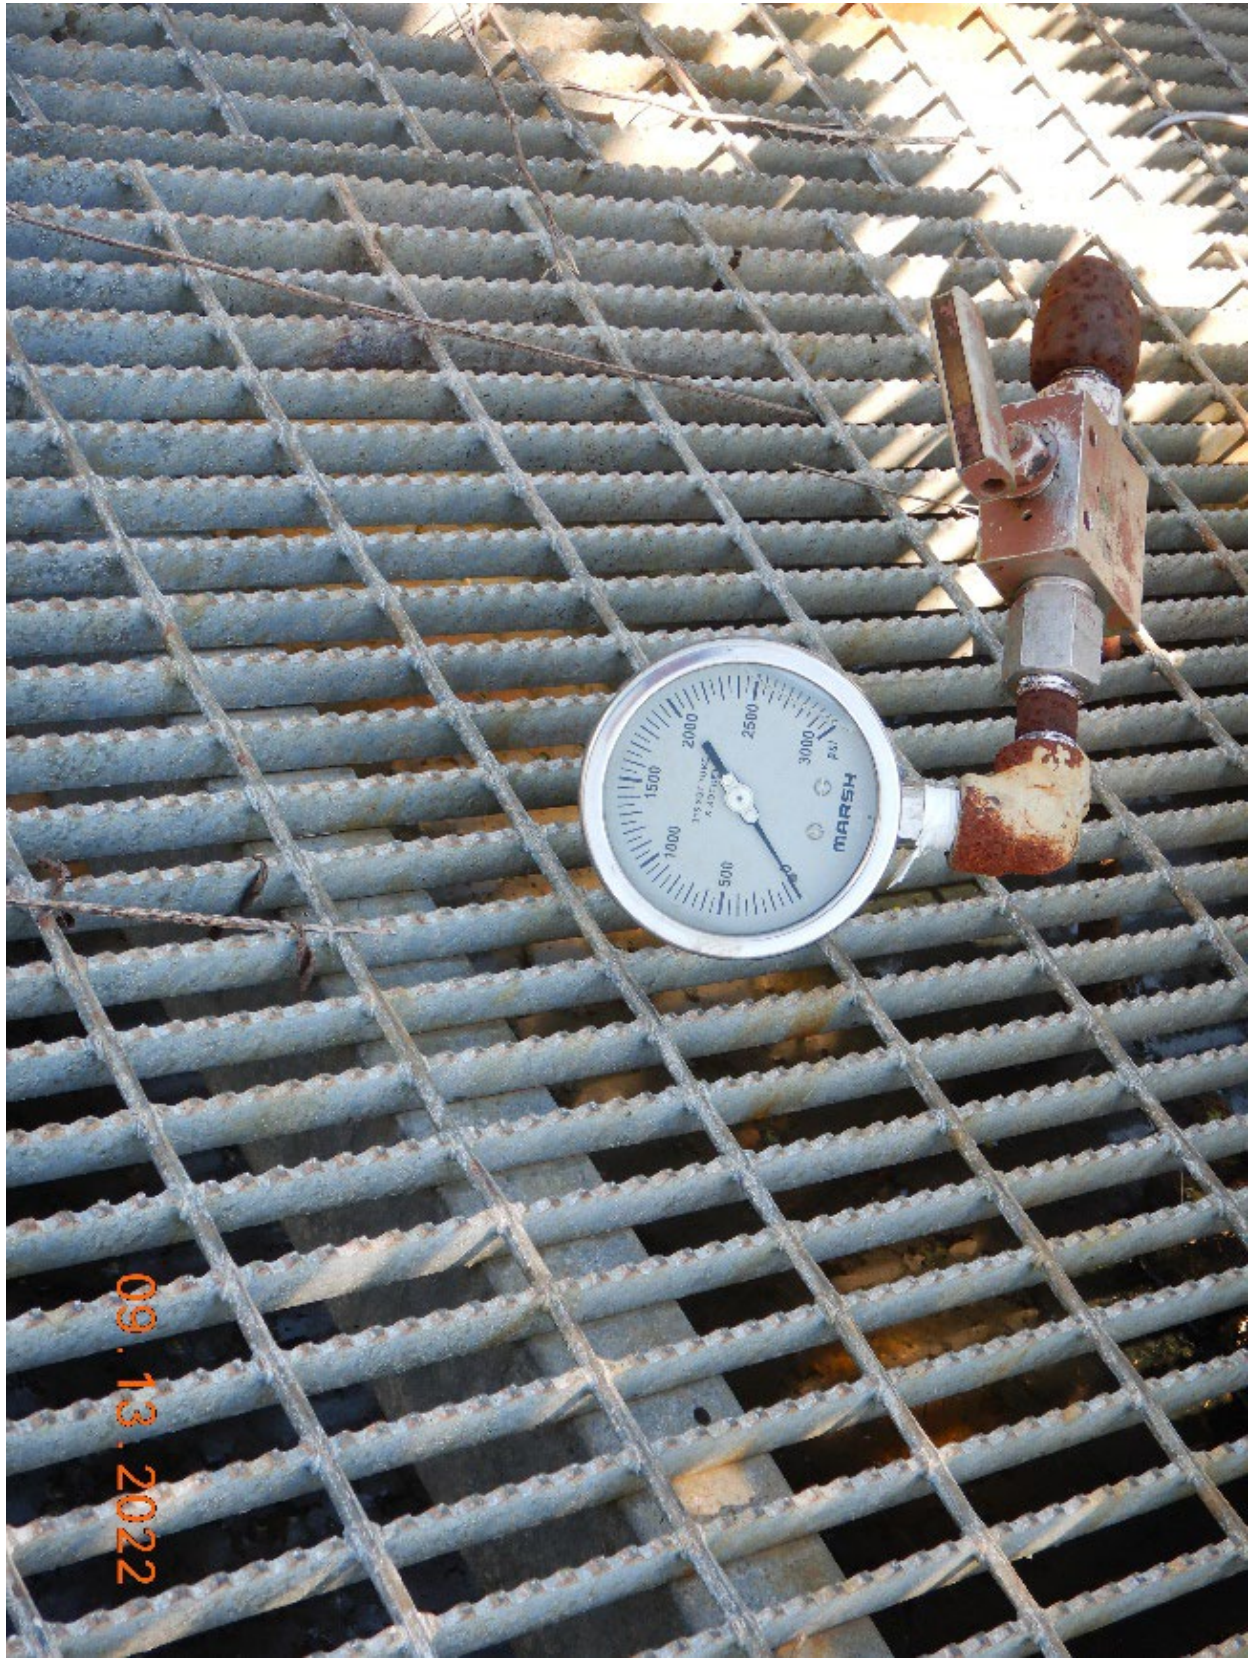
Description: *Looking east, closeup view of surface pressure gauge reading 0 psi.* \_\_\_\_\_

**Photograph 3:** Looking east, closeup view of surface pressure gauge reading 0 psi.

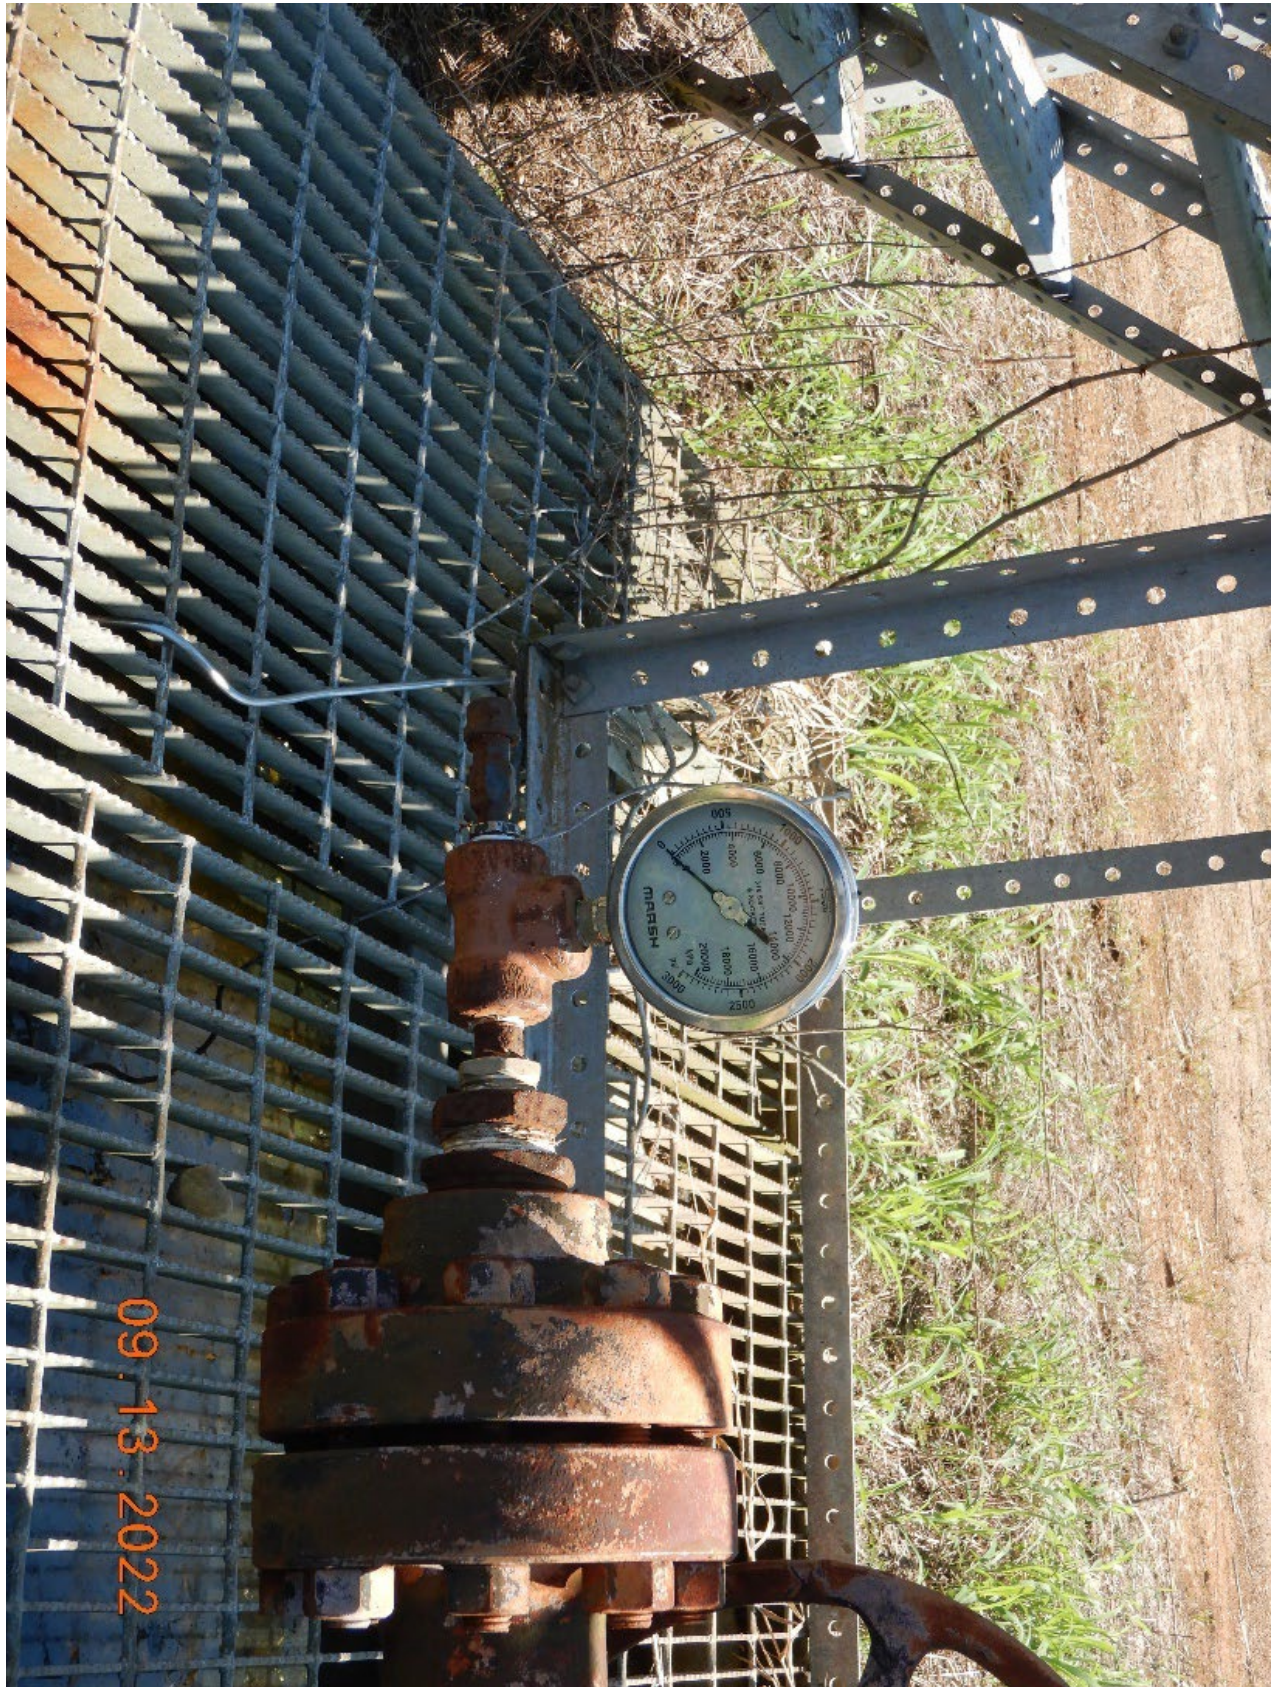
Description: *Looking east, closeup view of production casing pressure gauge reading 0 psi.* \_\_\_\_\_

**Photograph 4:** Looking east, closeup view of production casing pressure gauge reading 0 psi.

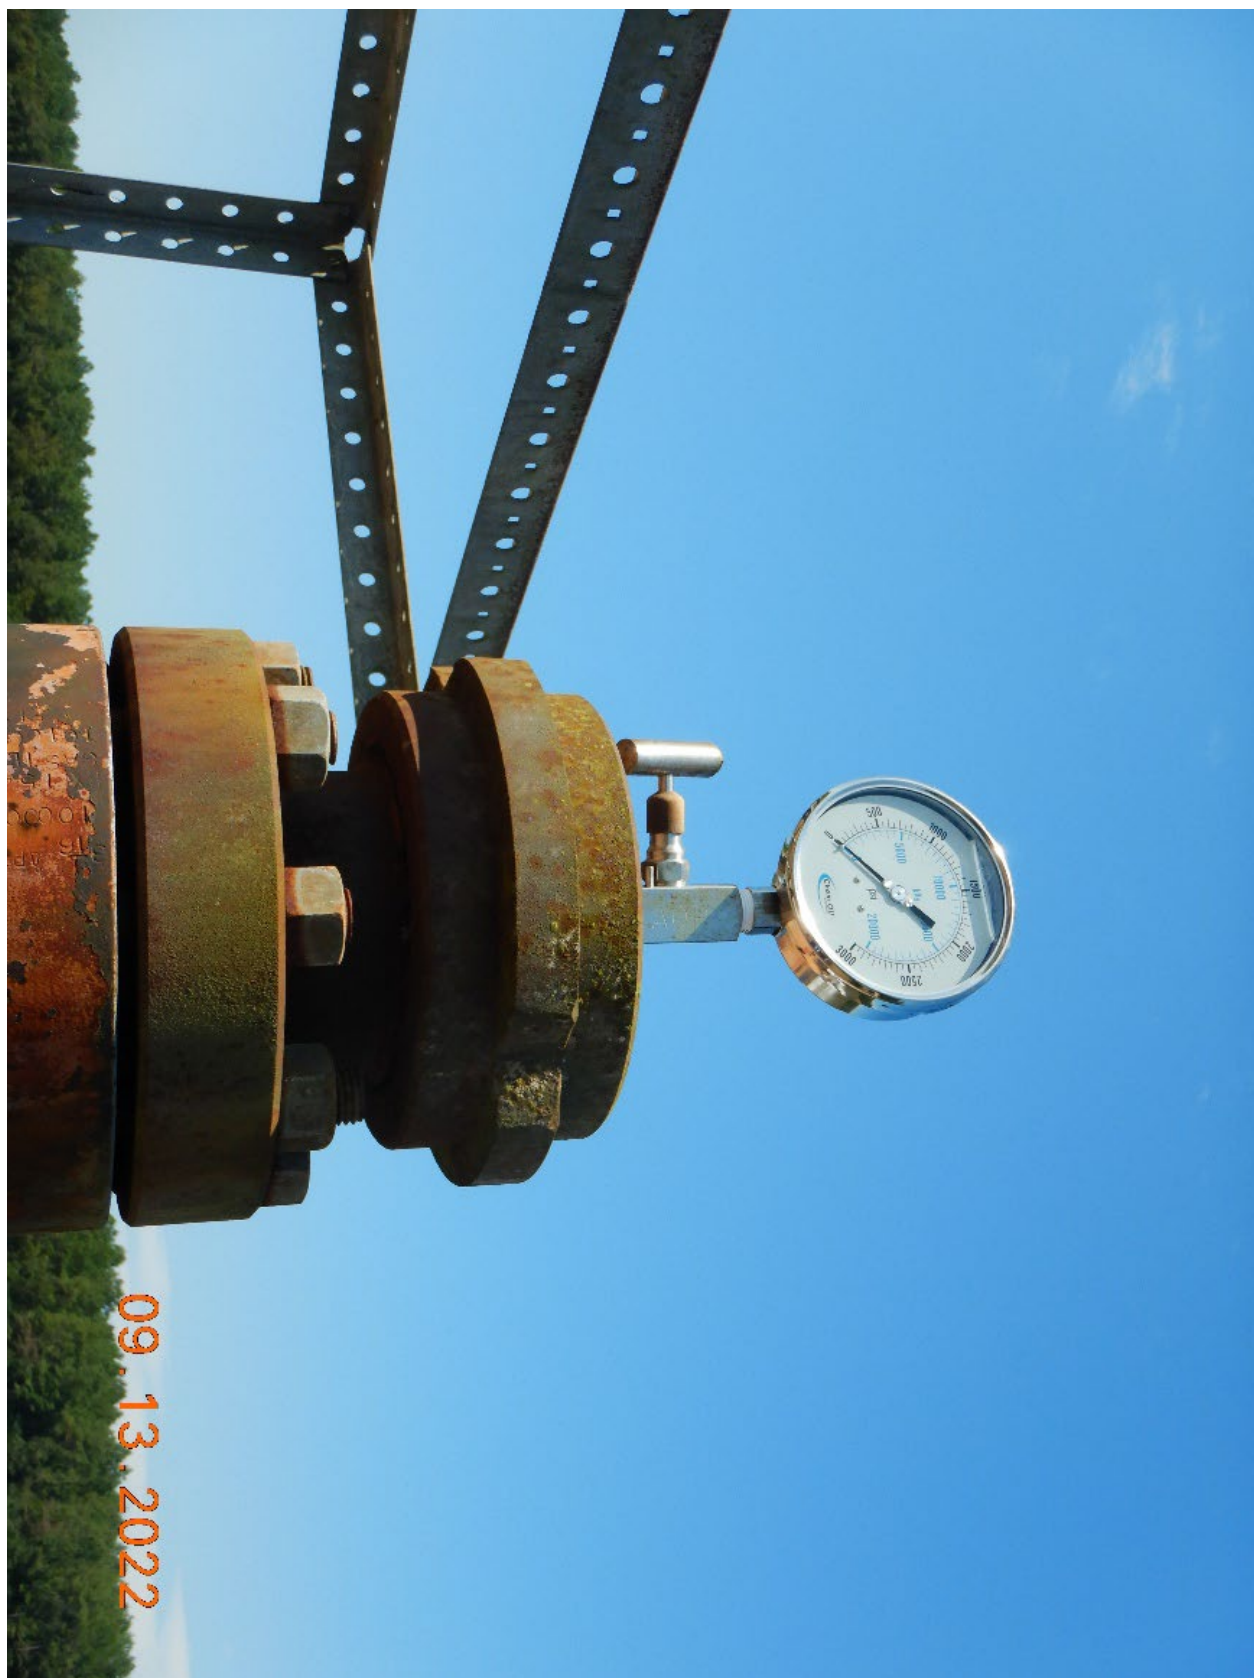
Description: *Looking west, closeup view of internal pressure gauge reading 0 psi.* \_\_\_\_\_

**Photograph 5:** Looking west, closeup view of internal pressure gauge reading 0 psi.

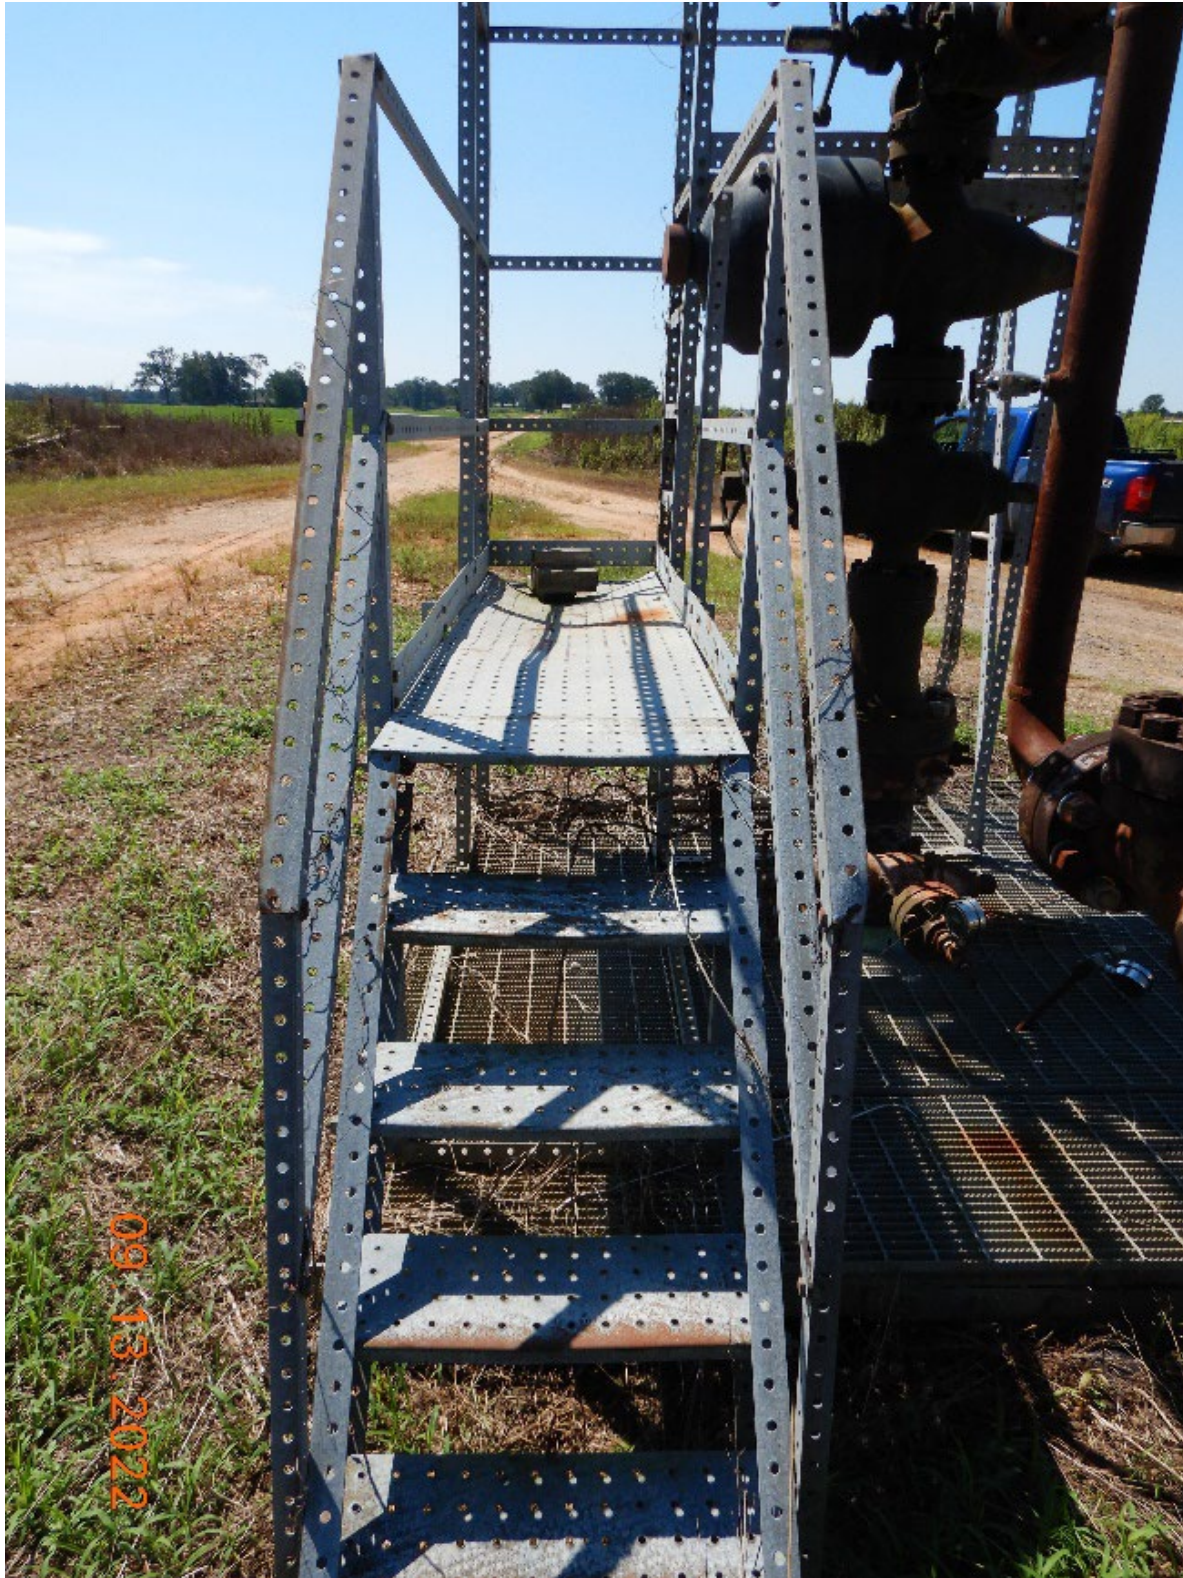
*DEP indicated this well has been temporarily plugged and abandoned, meaning that it is no longer in use, and all perforations have been plugged with cement. The site was clean and well-maintained. There was no evidence of leaks or excessive corrosion. The stairway was unstable, in need of repairs/upgrades.*  
Perfs (see well schematics):  
*8/20/1975 4SPF, 12/3/77 2SPF 15,928-15,940' GR*  
*10/13/79 4SPF 15,954-15,976' GR*

Description: *Looking south, access stairway with sagging platform.* \_\_\_\_\_

**Photograph 6:** Looking south, access stairway with sagging platform.
