**Region 6 Compliance Assurance and Enforcement Division  
INSPECTION REPORT**

| Inspection Date(s): | August 28, 2018 | | |
| Company Name: | <b>Special Energy Corporation</b> | | |
| Facility Name: | <b>Ramsey</b> | | |

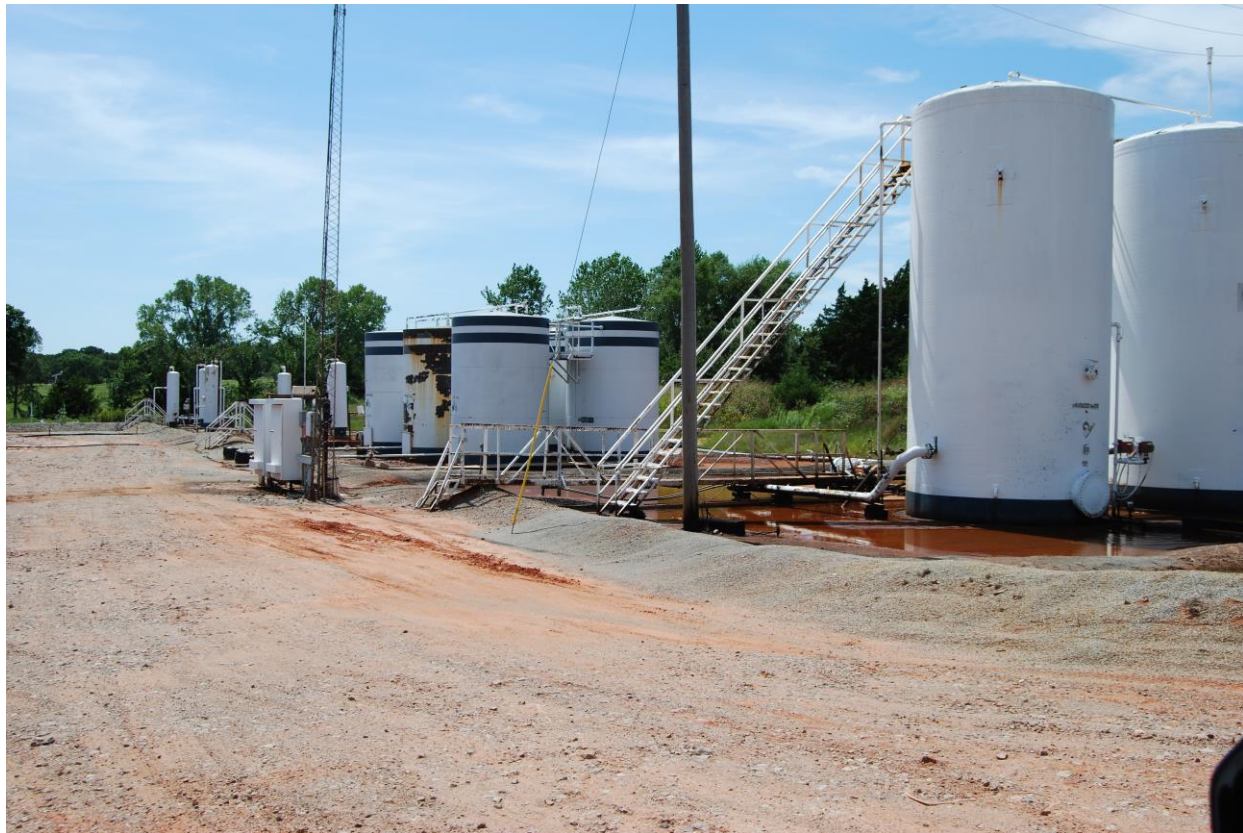
Photo No. 1

Description: The discharge originated from an injection line near this tank battery.

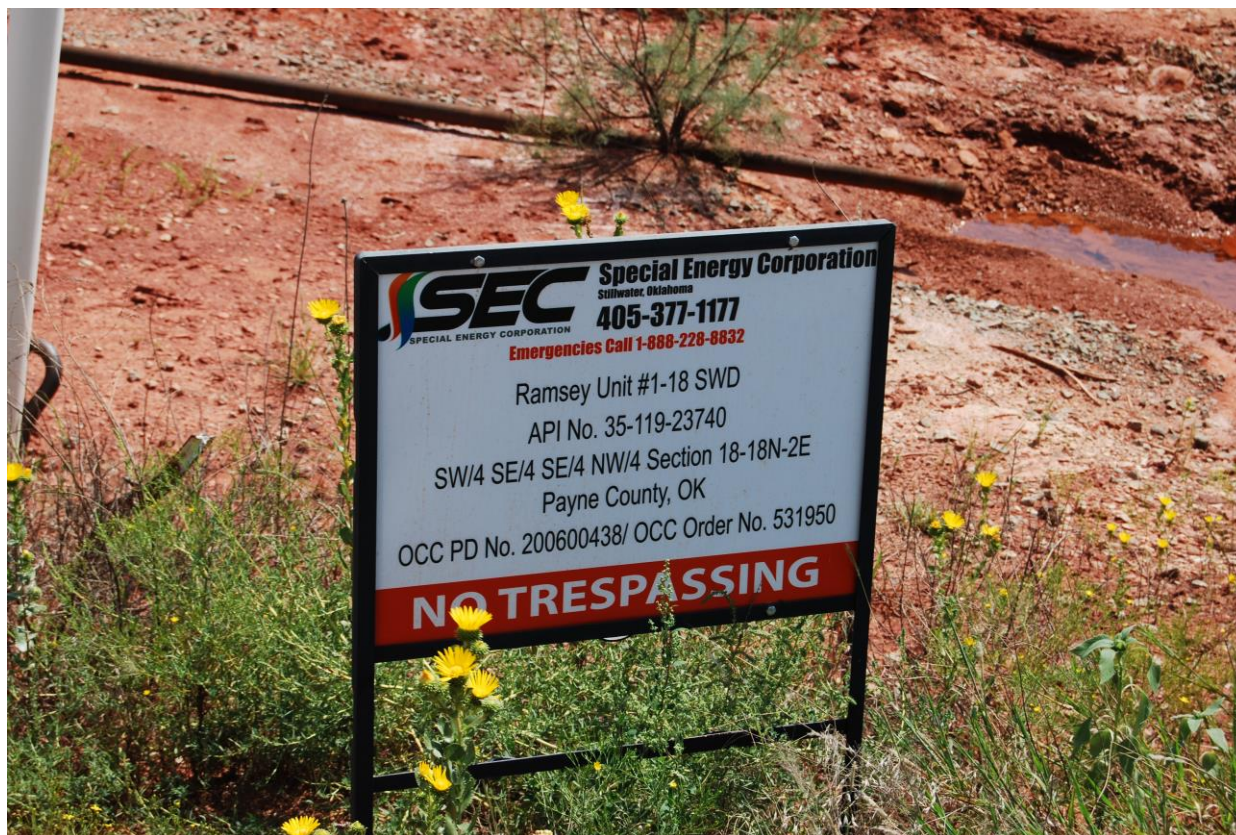
Photo No. 2

Description: This photo shows the sign which identifies the lease at the spill site.

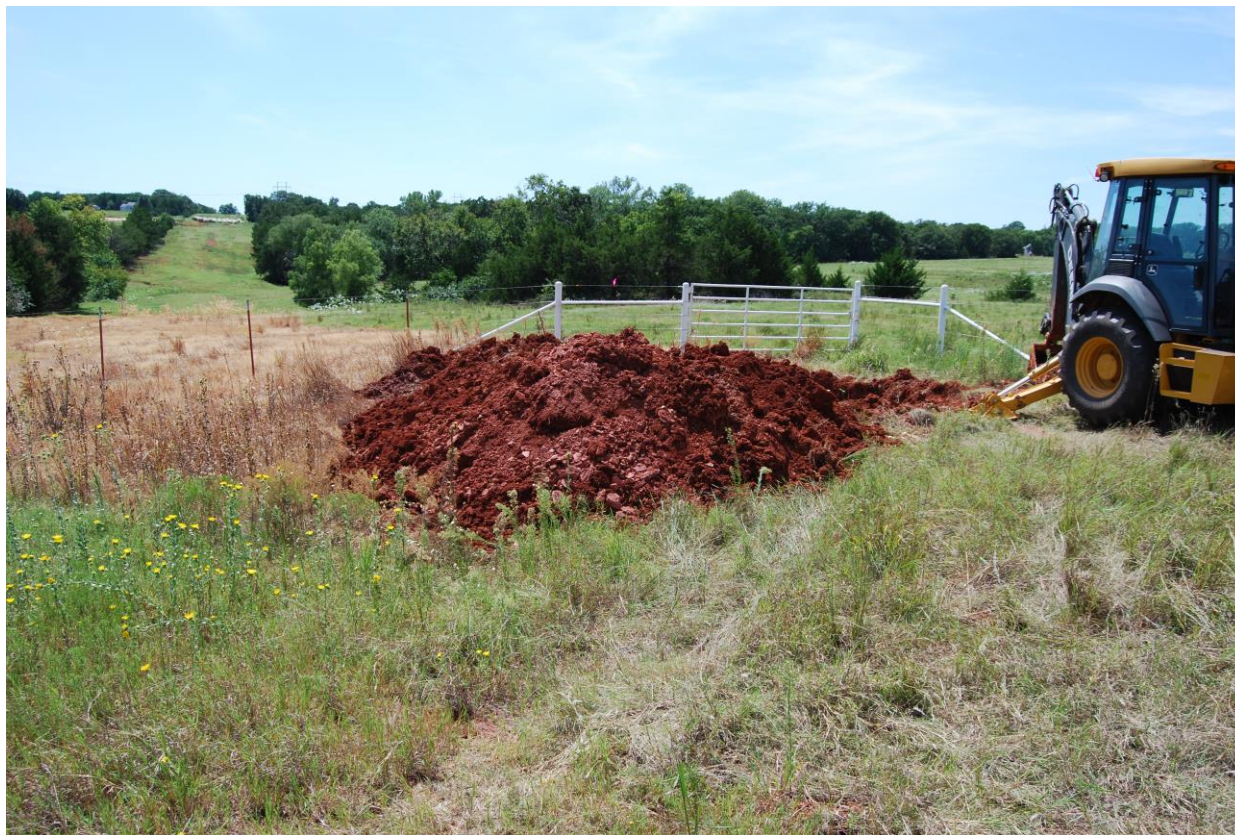
Photo No. 3

Description: Brine fluids were discharged from an injection flow line near the tank battery, which was the point of discharge. The flow line was buried during the inspection.

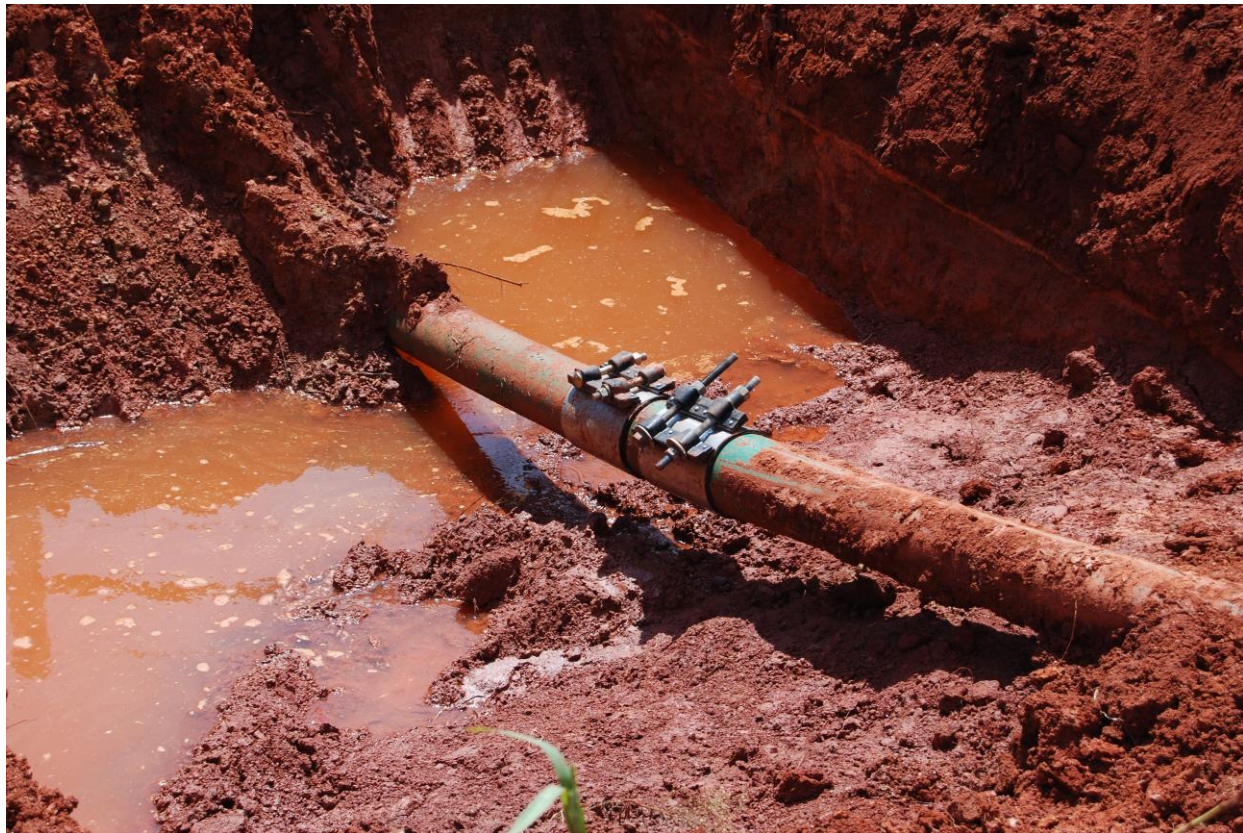
Photo No. 4

The facility included storage tanks, flow lines and other equipment associated with oil and gas operations. The origination point of discharge was a 6-inch buried fiberglass injection line. The line appeared to have sustained damage when it was installed and buried.

Description: The 6-inch fiberglass injection line had been clamped at the time of the inspection and was the source of the discharge of produced water, or brine. The pipe appeared to be damaged on the bottom and was still leaking slightly during the inspection.

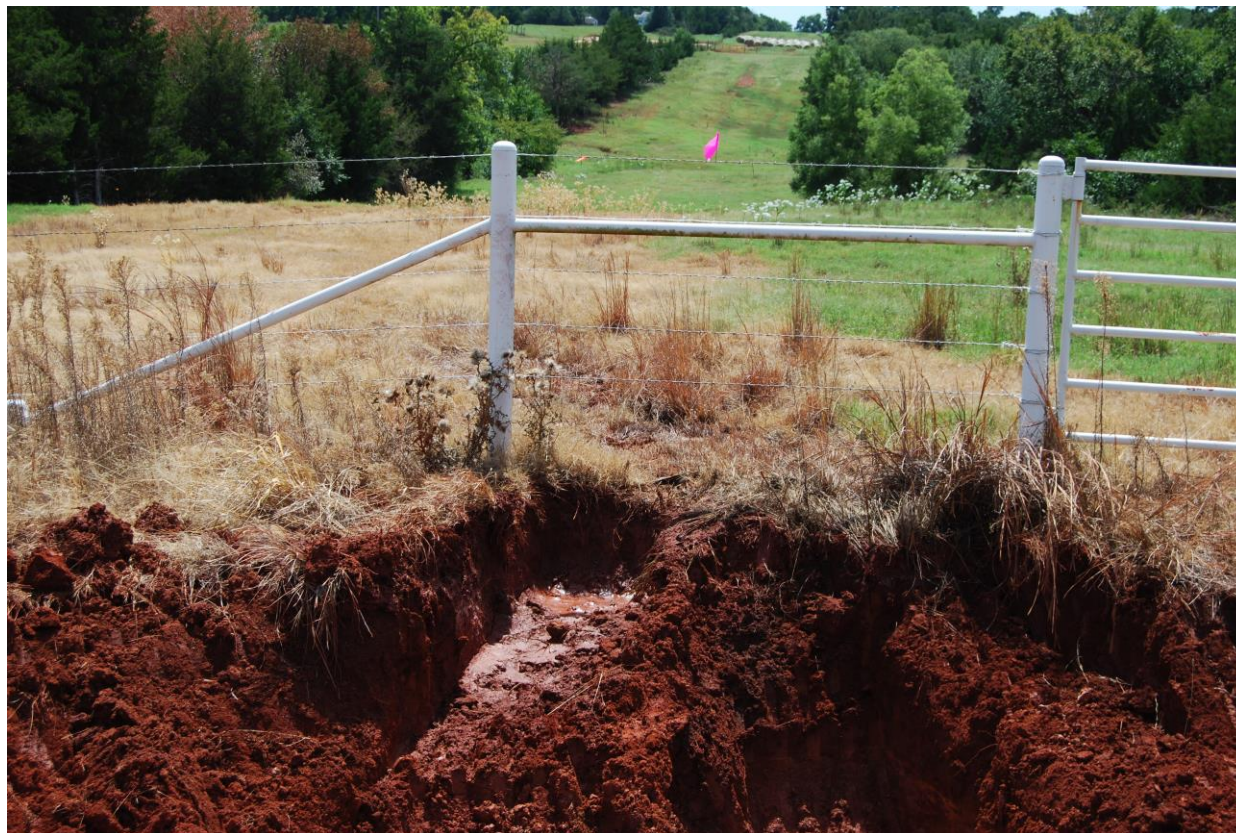
Photo No. 5

Description: The produced water or brine from the line bubbled out of the ground here from the leaking flow line and flowed south down the hill.

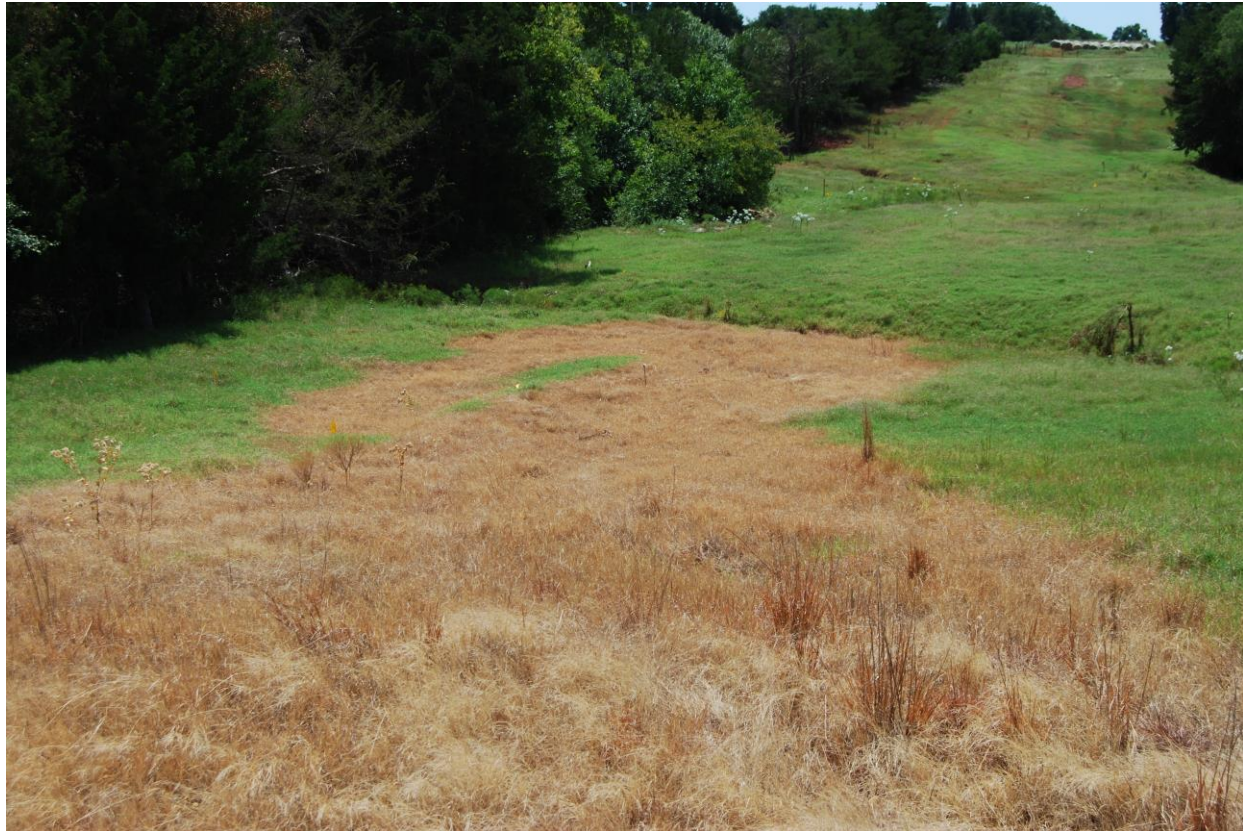
Photo No. 6

Description: The brine flowed down the hill here toward the tributary of Wild Horse Creek. I observed dead grass and salt staining along the flow path during the inspection.

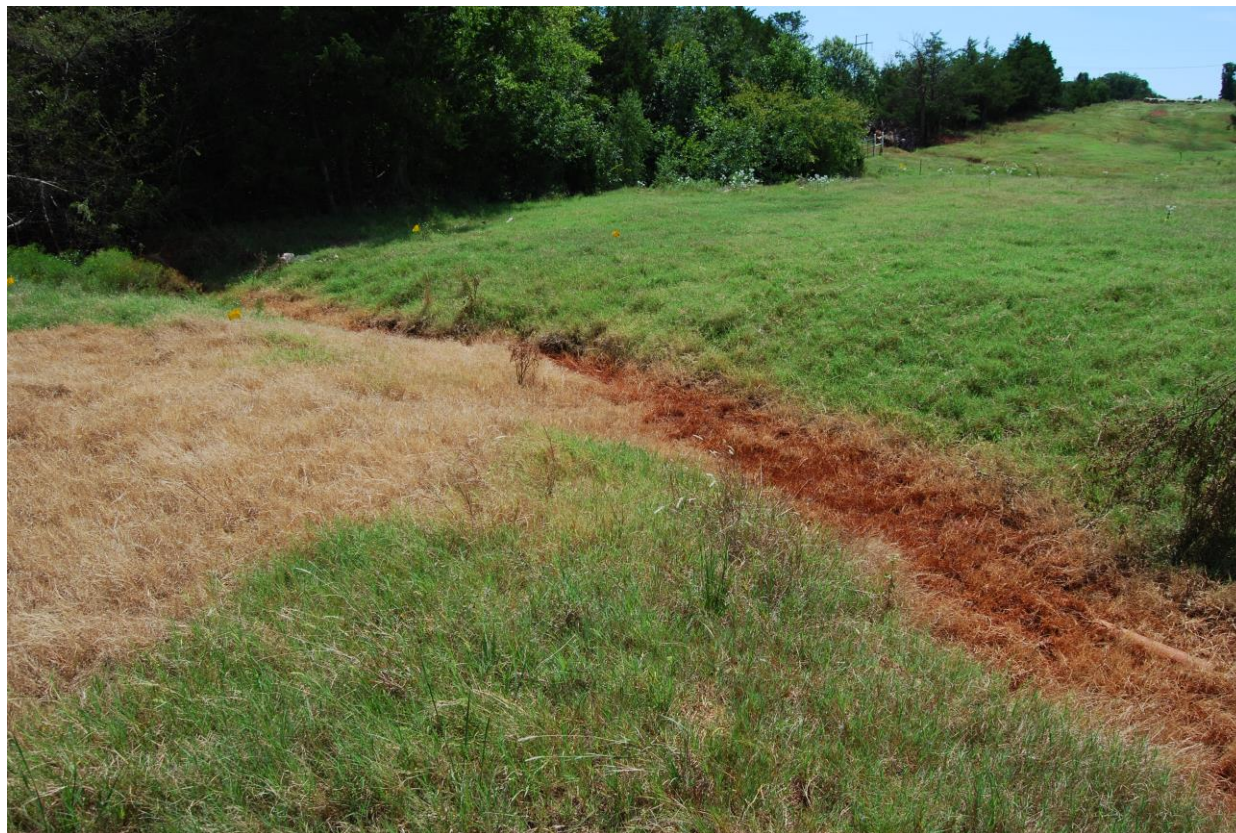
Photo No. 7

Description: This is the point of entry to tributary of Wild Horse Creek The tributary was dry upstream from this location.

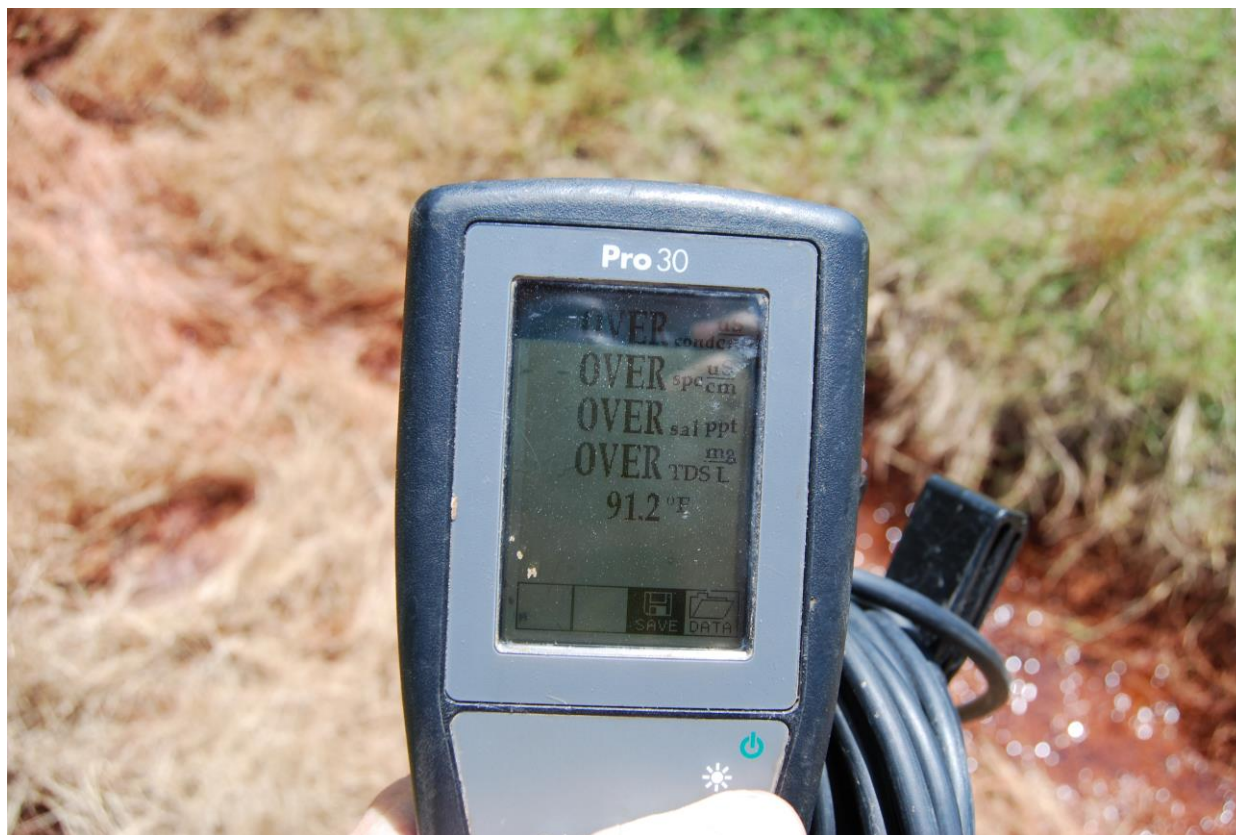
Photo No. 8

Description: With a calibrated YSI Pro 30 Conductivity meter, the Total Dissolved Solids (TDS) reading was over the meter limit at the point of entry. This indicated that the TDS reading at the point of entry was over 125,000 milligrams per liter (mg/L).

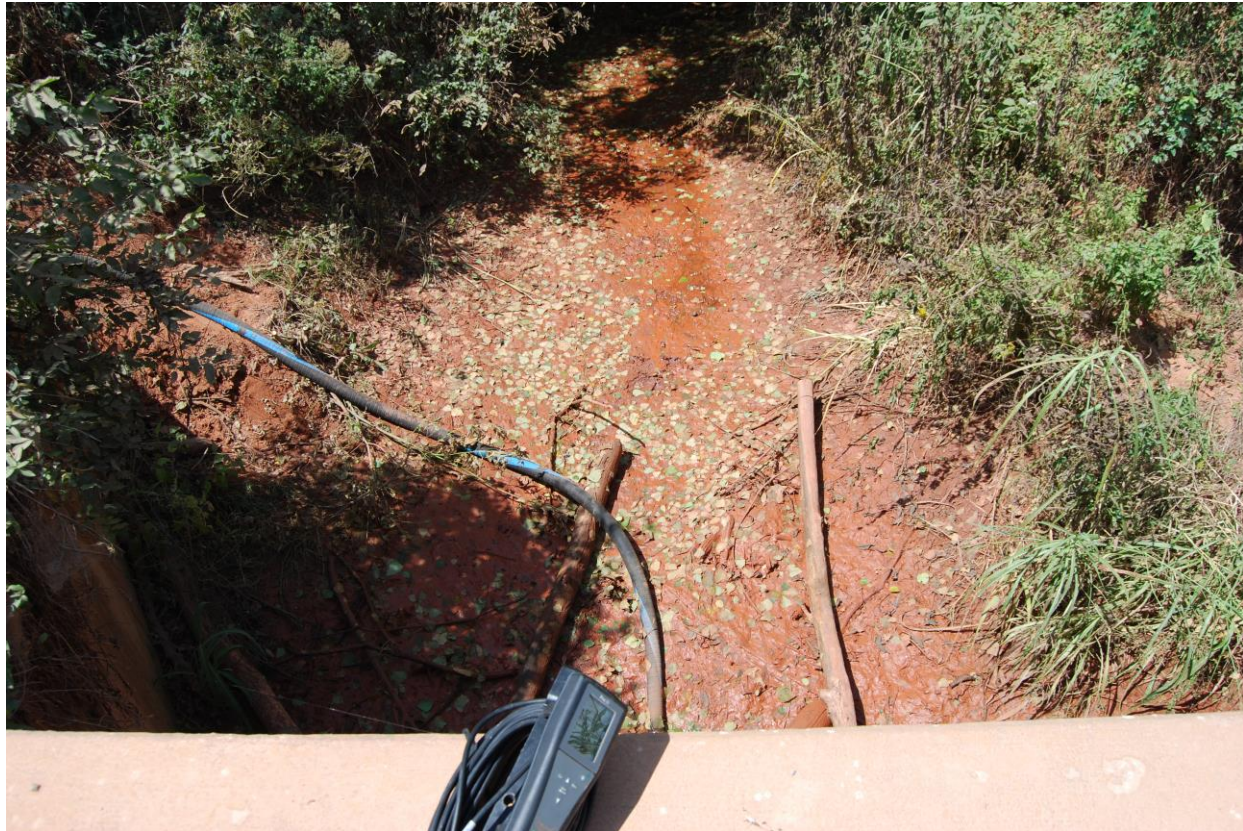
Photo No. 9

Description: This bridge southeast of the spill site had been pumped out prior to the inspection. The tributary continued south from this point.

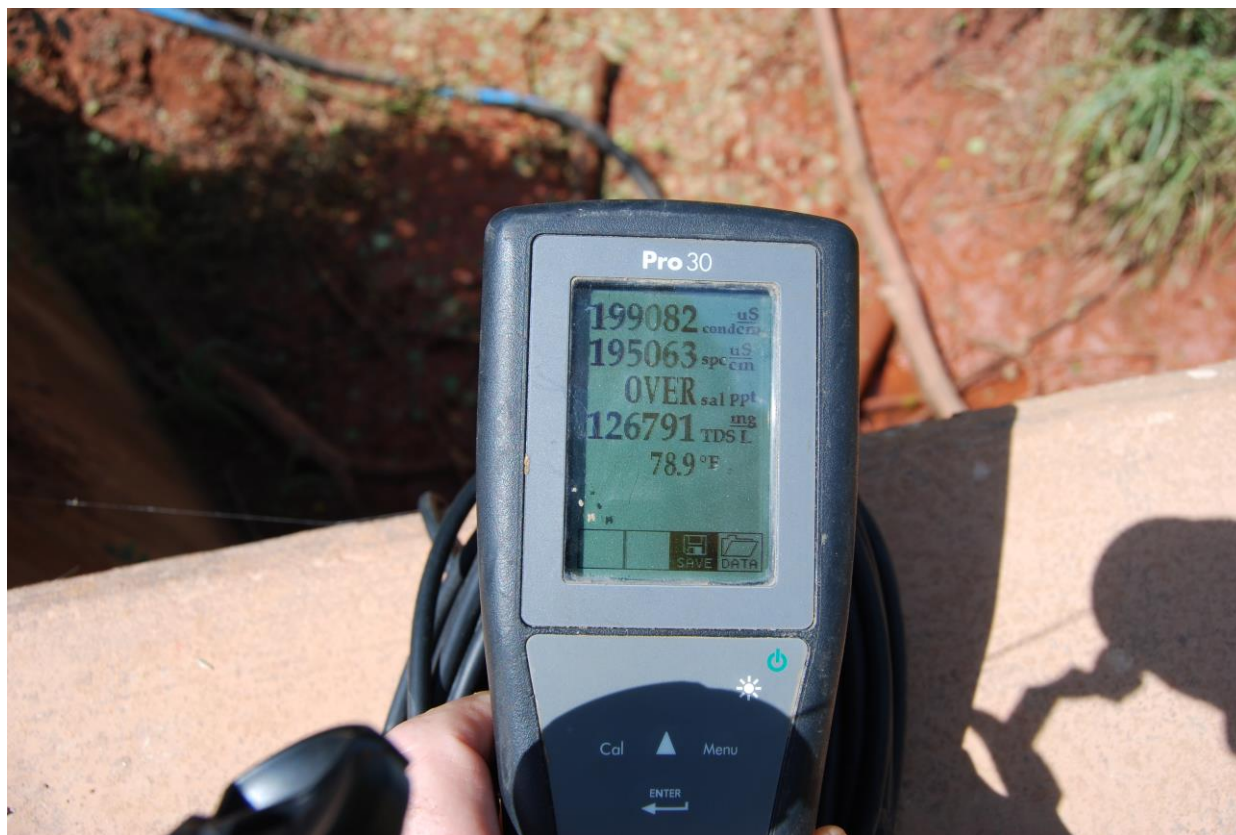
Photo No. 10

Description: I took a TDS reading at the bridge crossing that was 126,791 mg/L.

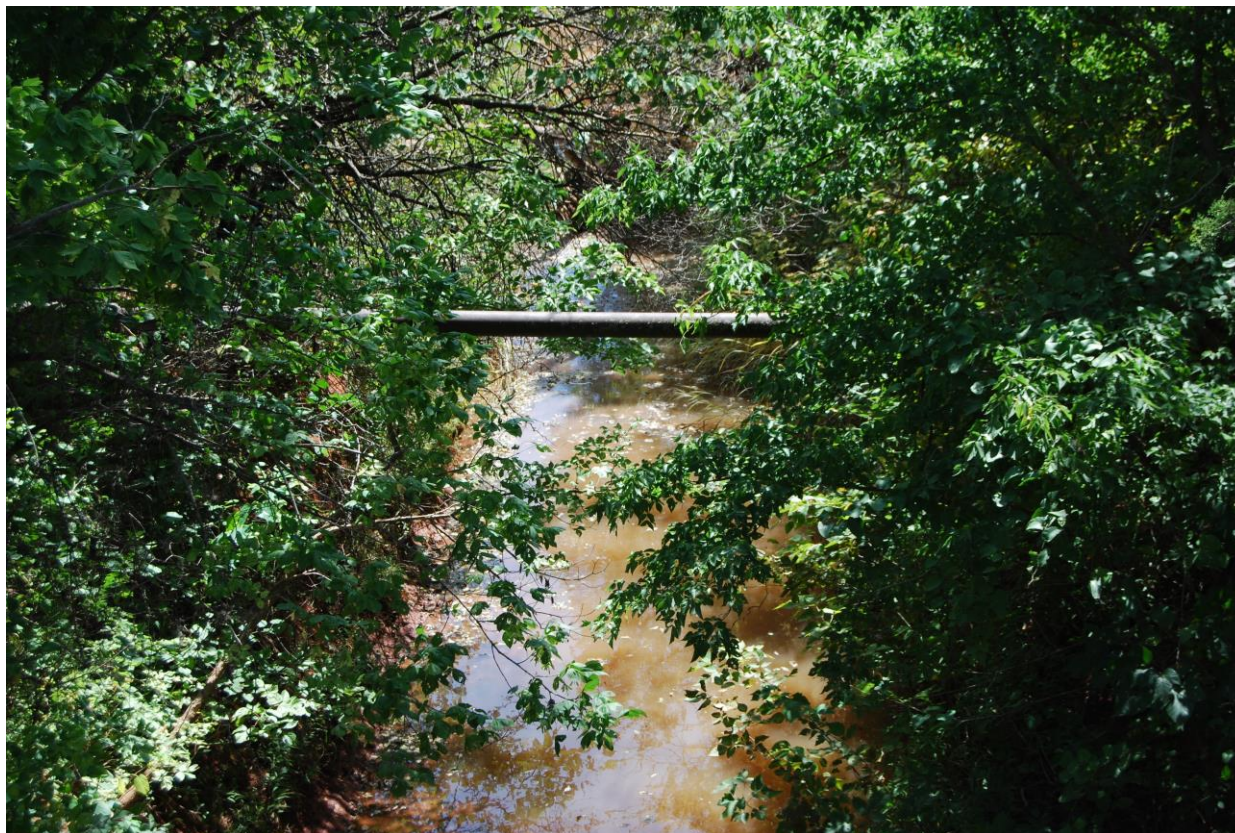
Photo No. 11

Description: This was the view from another County Road bridge farther southeast of the spill, downstream along the tributary of Wild Horse Creek. I observed defined banks at this location.

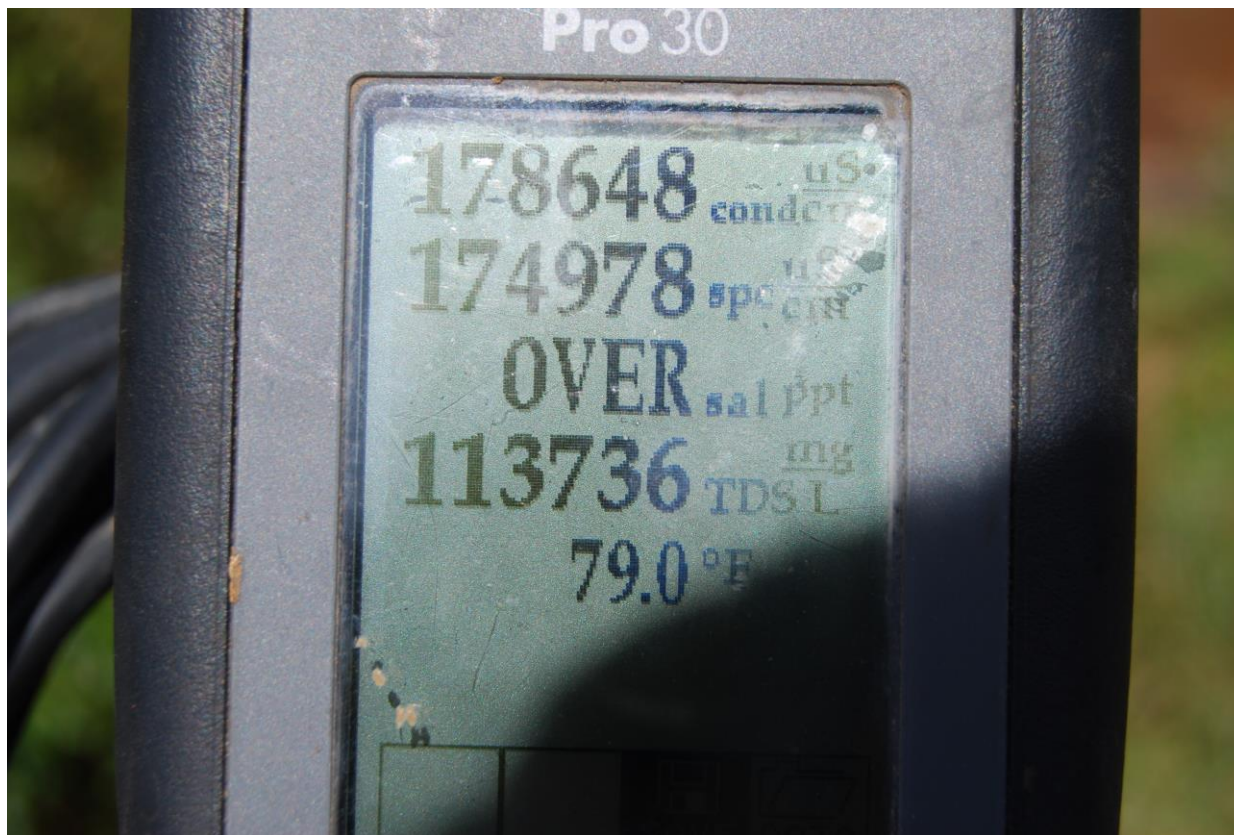
Photo No. 12

Description: The TDS at the location shown in Photo 11 was 113,736 mg/L.

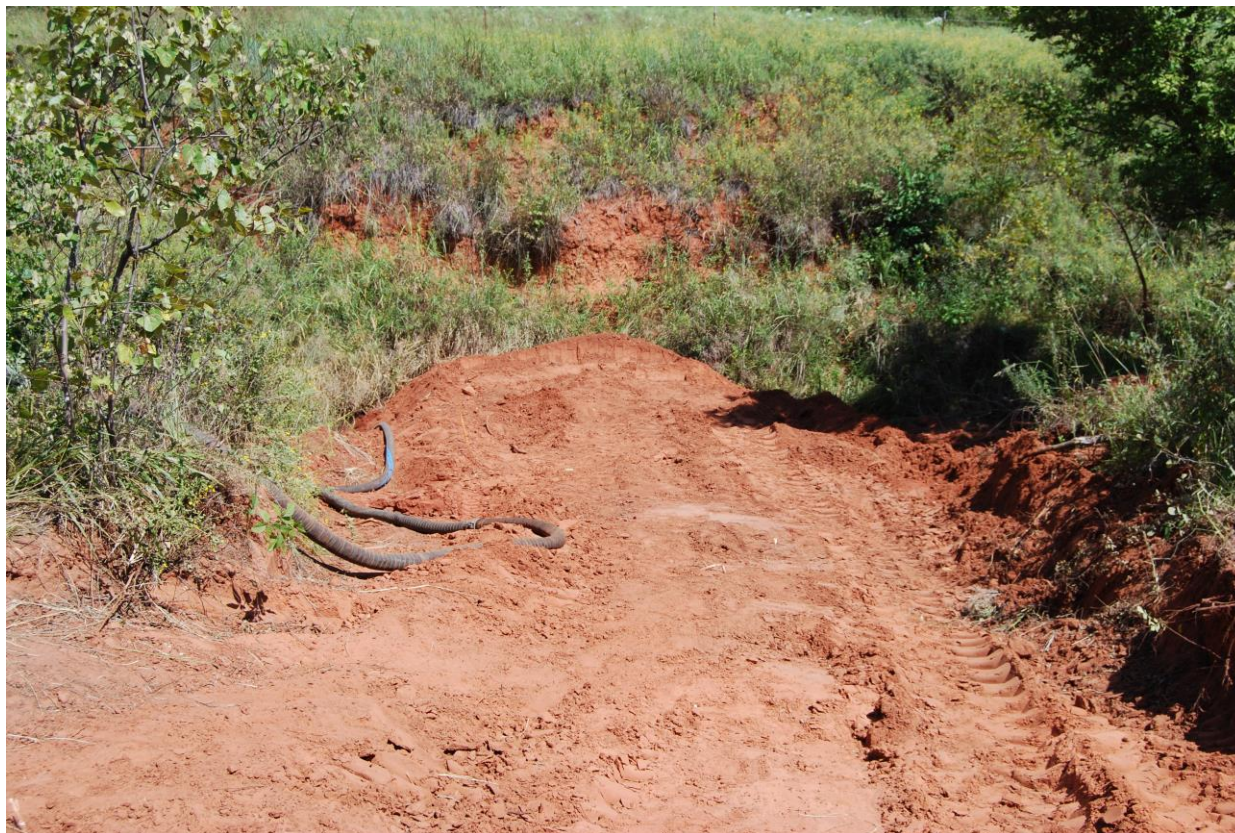
Photo No. 13

Description: A dam had been built south of the location in Photo 11. I observed brine was still leaking through the base of the dam along the tributary of Wild Horse Creek.

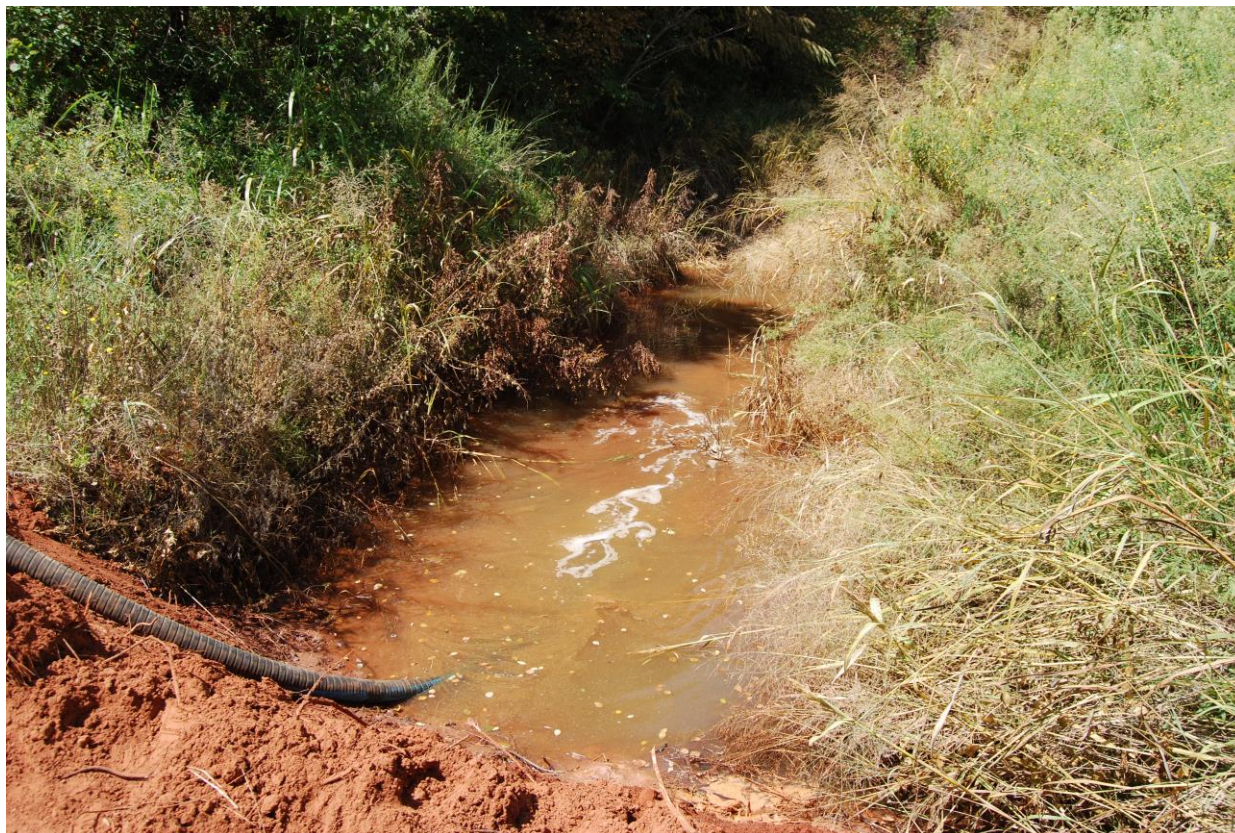
Photo No. 14

Description: A truck was removing brine from the tributary shown here on the upstream side of the dirt dam, seen in Photo 13.

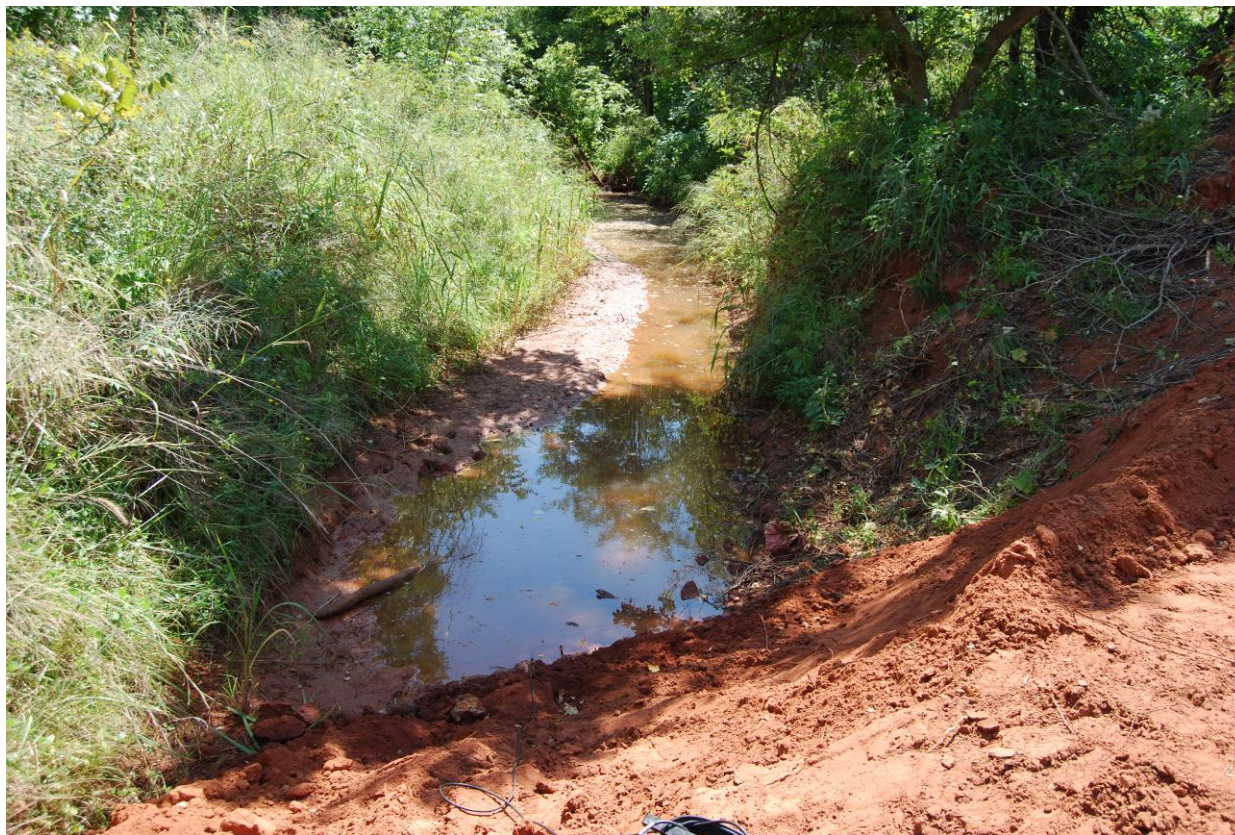
Photo No. 15

Description: This was a view downstream on the tributary of Wild Horse Creek from the dam location.

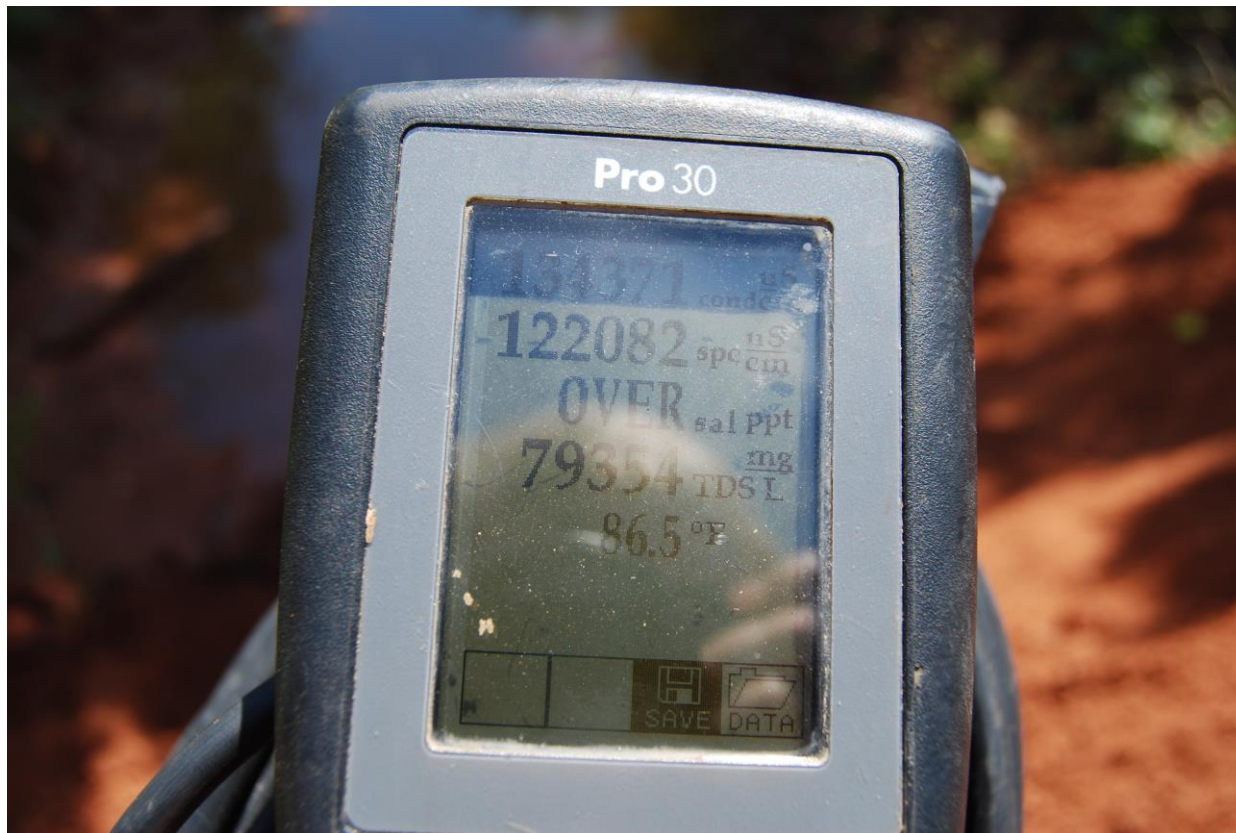
Photo No. 16

Description: The TDS on the downstream side of the dam was 79,354 mg/L.

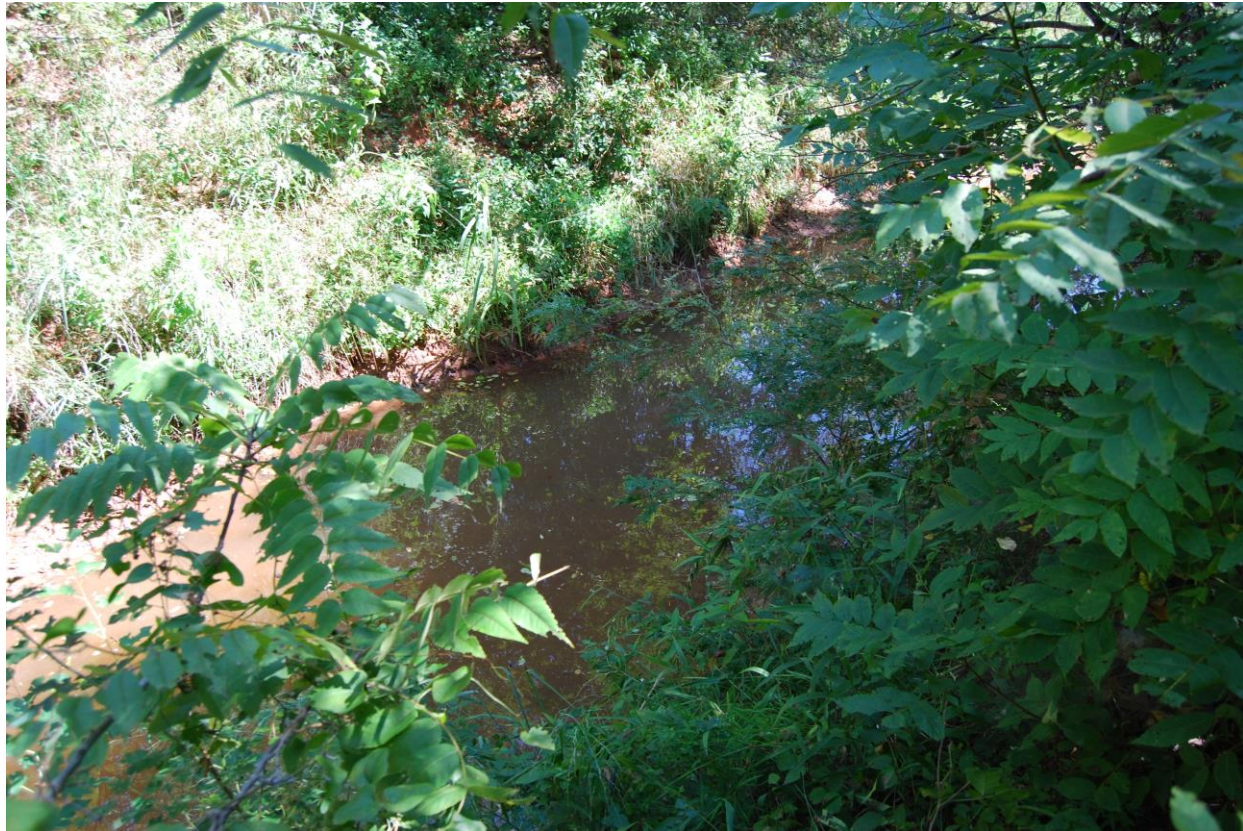
Photo No. 17

Description: The tributary was shown here downstream of the dam. I observed defined banks at this location along the tributary.

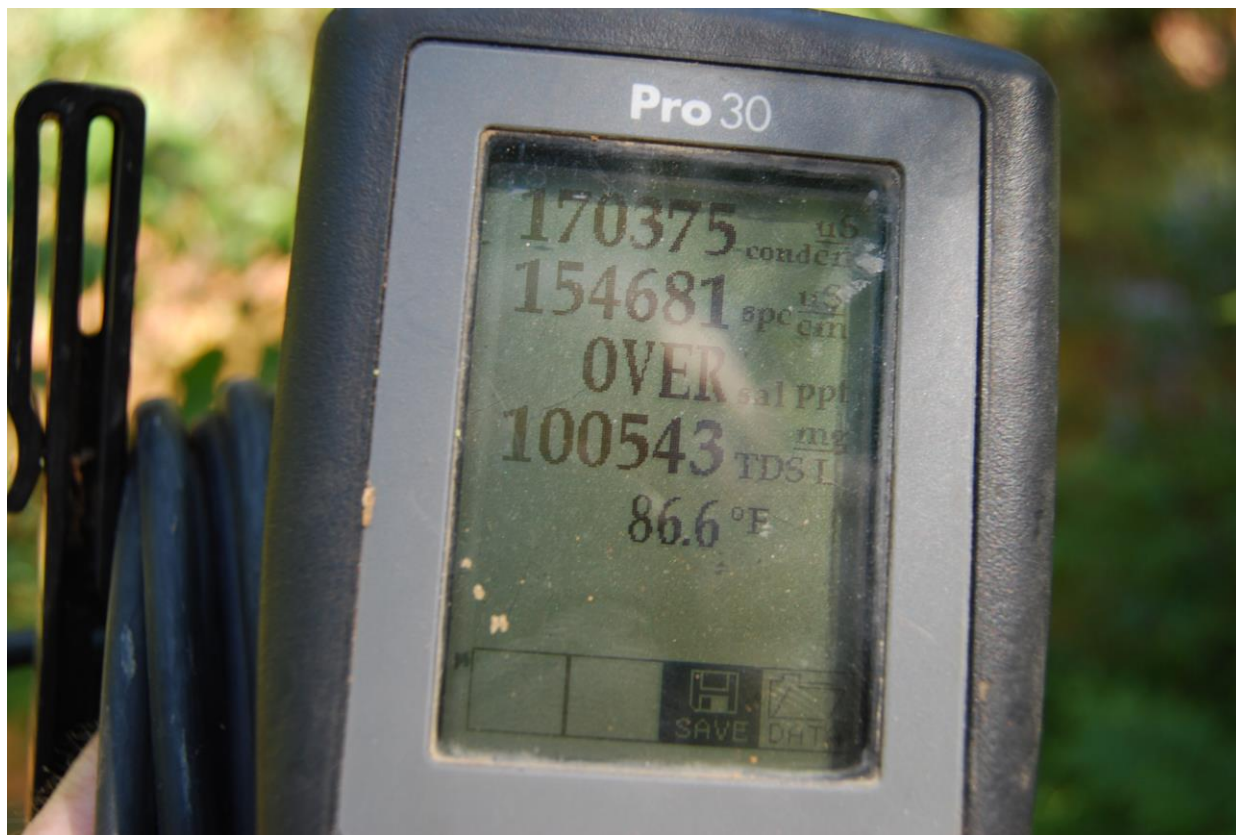
Photo No. 18

Description: The TDS of the tributary shown in Photo 17 was 100,543 mg/L.

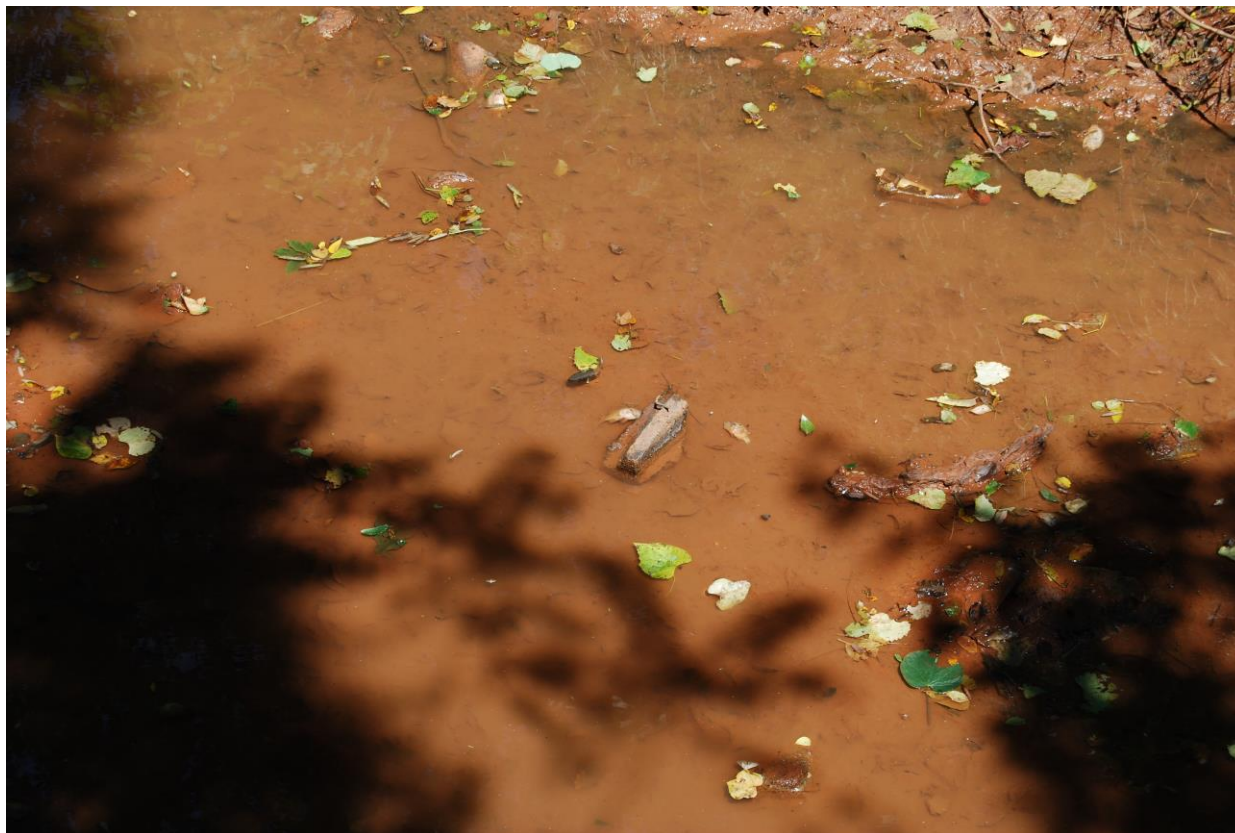
Photo No. 19

Description: I observed dead fish at the location in Photo 17, in the tributary of Wild Horse Creek.

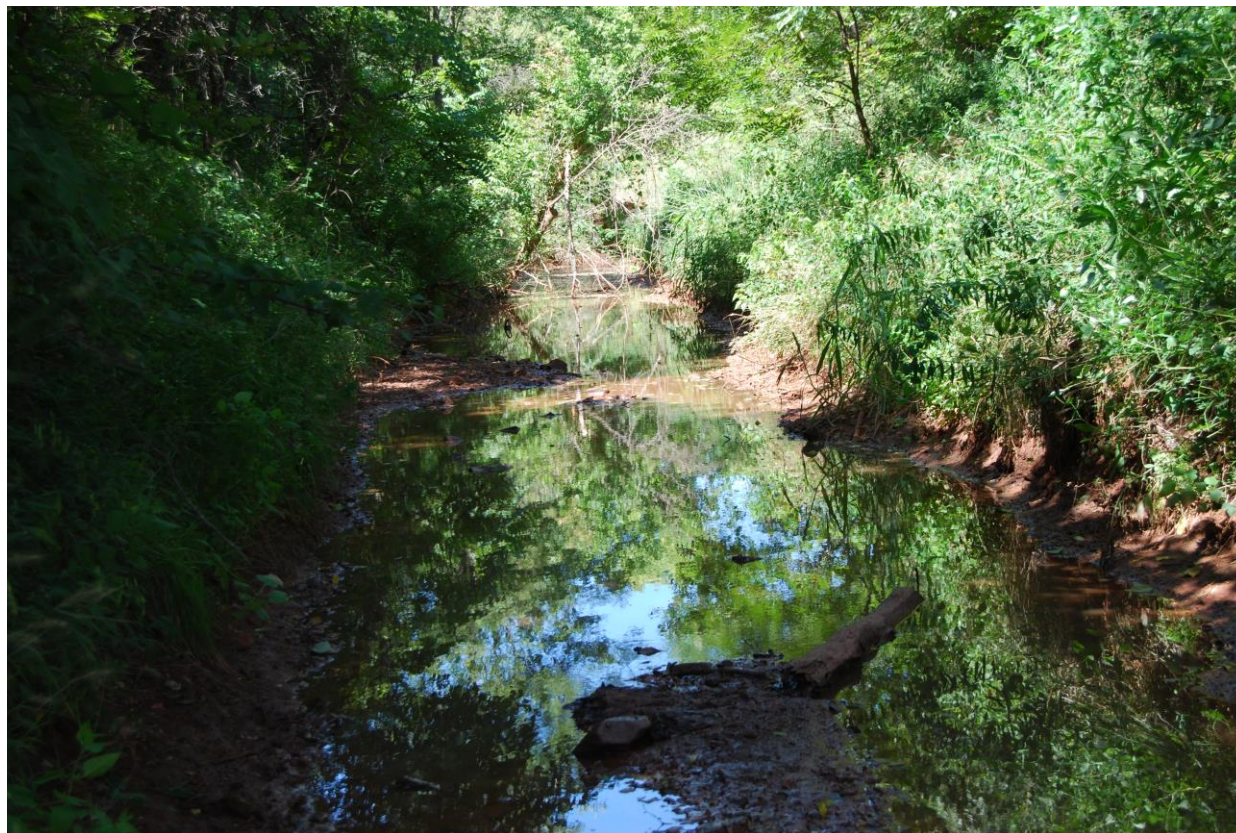
Photo No. 20

Description: This was the tributary of Wild Horse Creek south of the location in Photo 17.

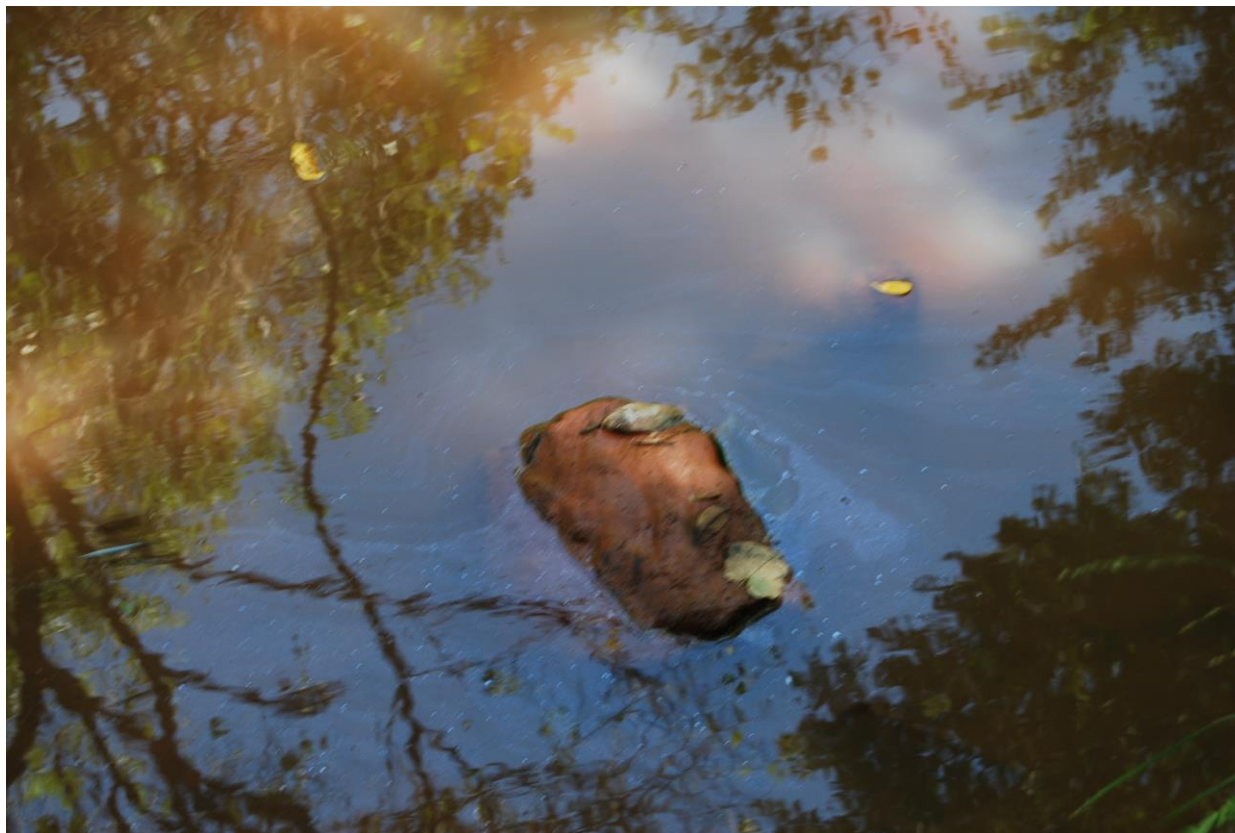
Photo No. 21

Description: I observed more dead fish in the tributary of Wild Horse Creek near the location in Photo 20.
