**Region 6 Compliance Assurance and Enforcement Division  
INSPECTION REPORT**

| Inspection Date(s): | August 28, 2018 | | |
| Company Name: | <b>Special Energy Corporation</b> | | |
| Facility Name: | <b>Ramsey</b> | | |

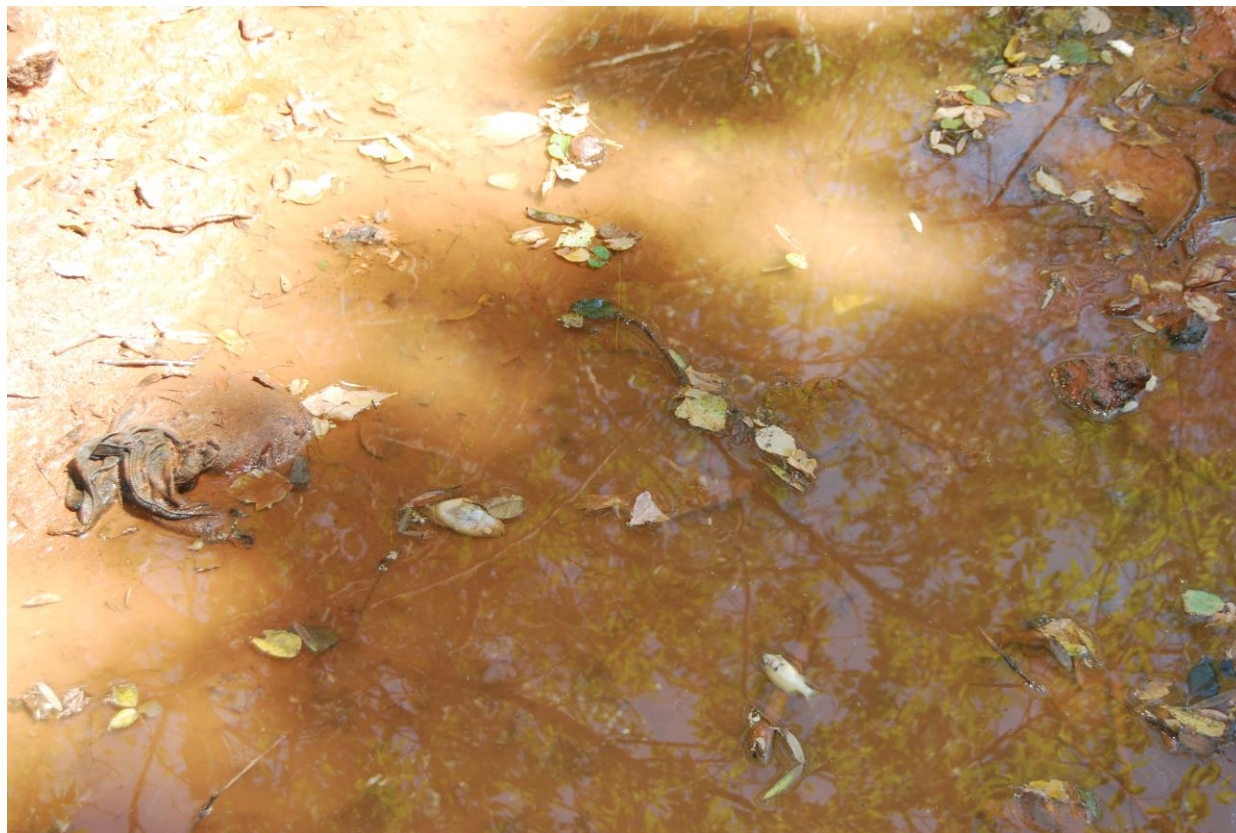
Photo No. 22

Description: I observed more dead fish in the tributary at the location in Photo 20.

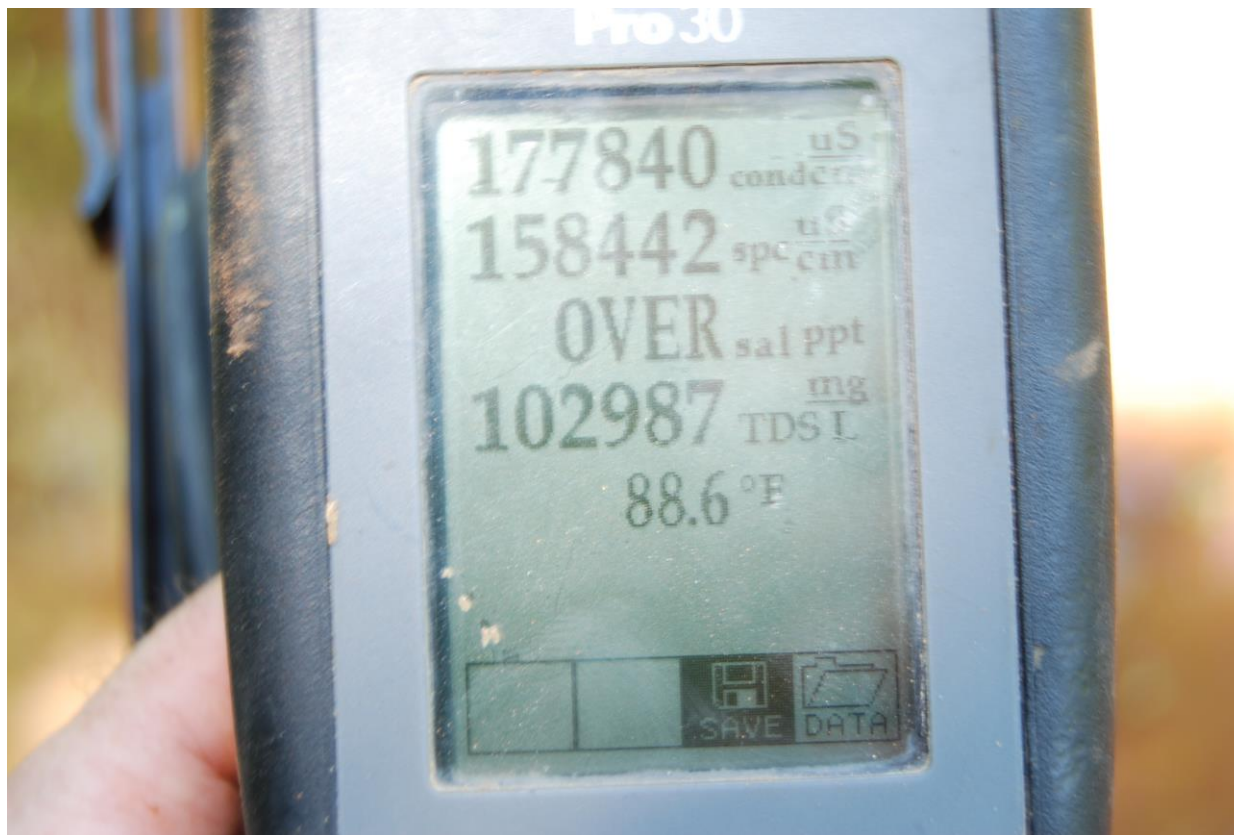
Photo No. 23

Description: The TDS of the tributary at Photo 20 location was 102,987 mg/L.

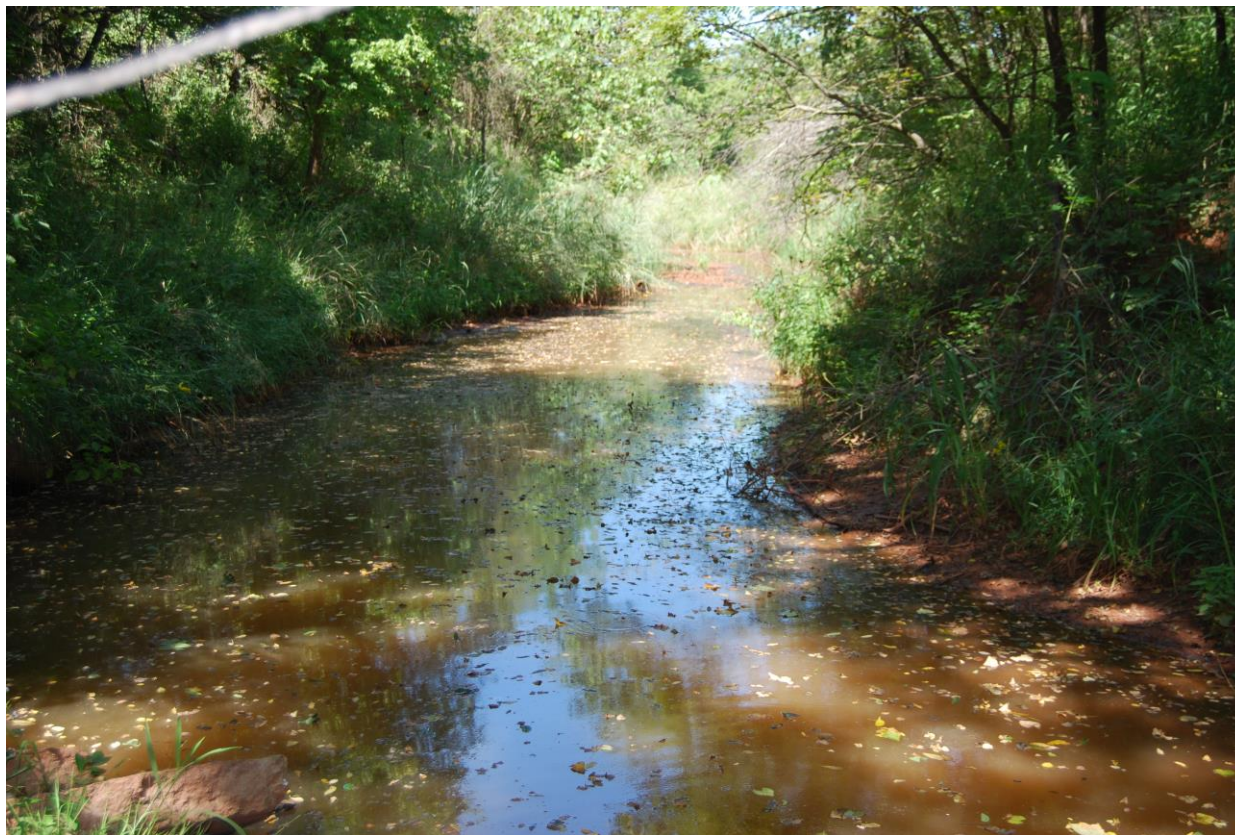
Photo No. 24

Description: The tributary was observed farther south as shown here. I observed defined banks and some riparian vegetation along the tributary.

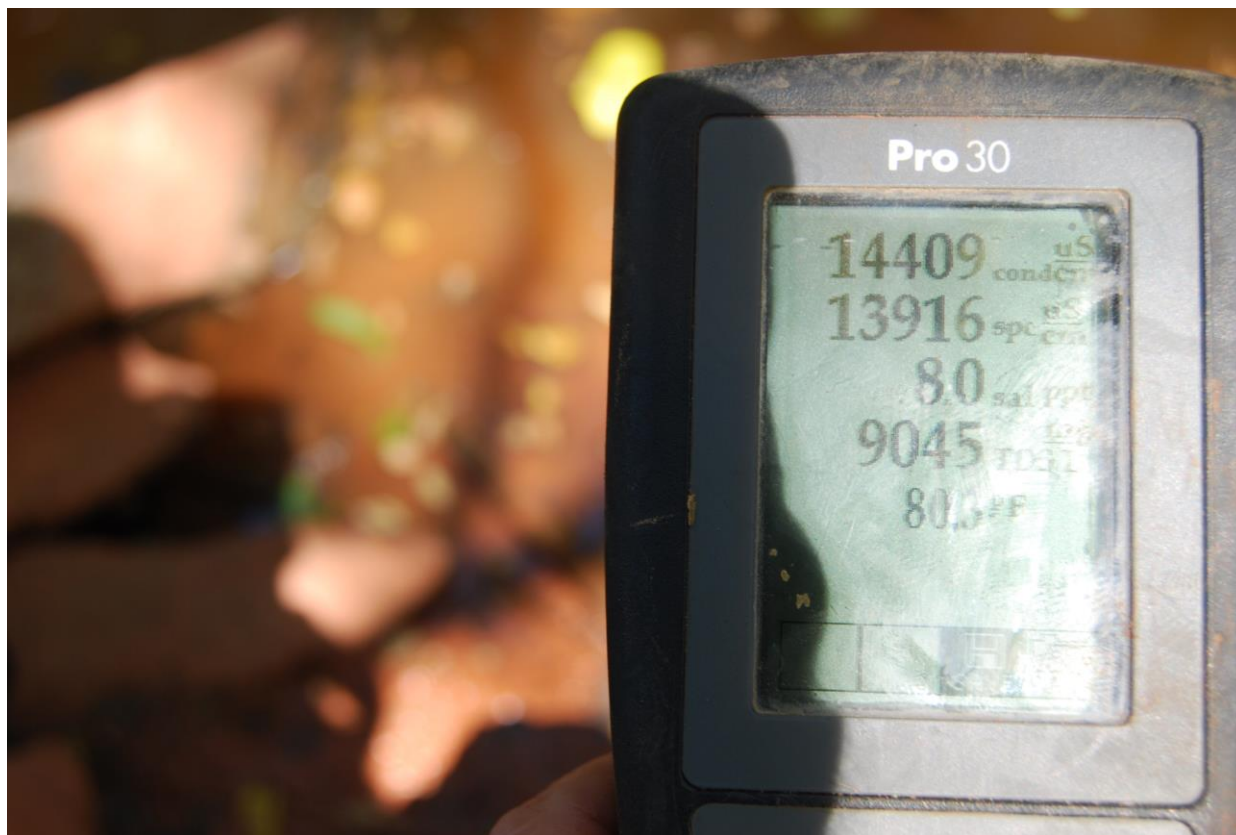
Photo No. 25

Description: The TDS of the tributary shown in Photo 24 was 9,045 mg/L.

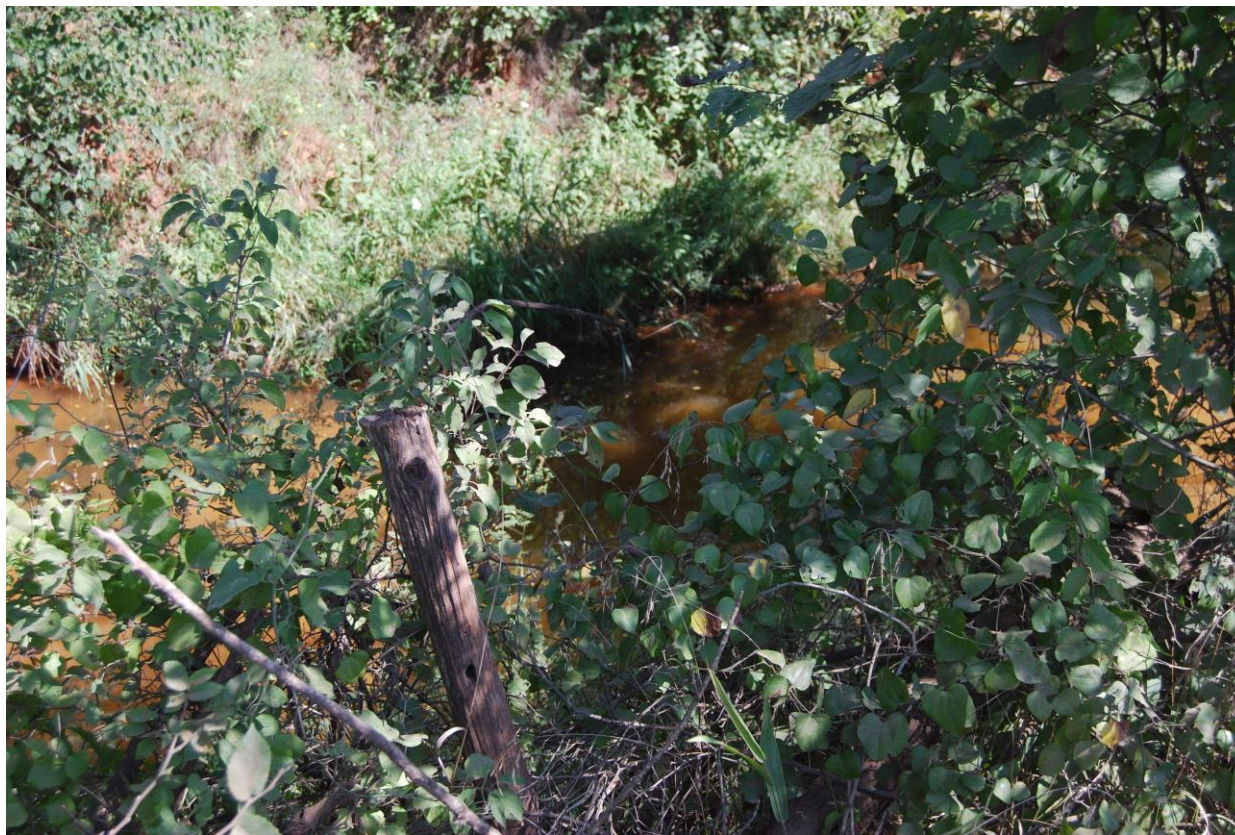
Photo No. 26

Description: Another observation of the tributary south of Photo 24 location, showed the defined banks of the tributary.

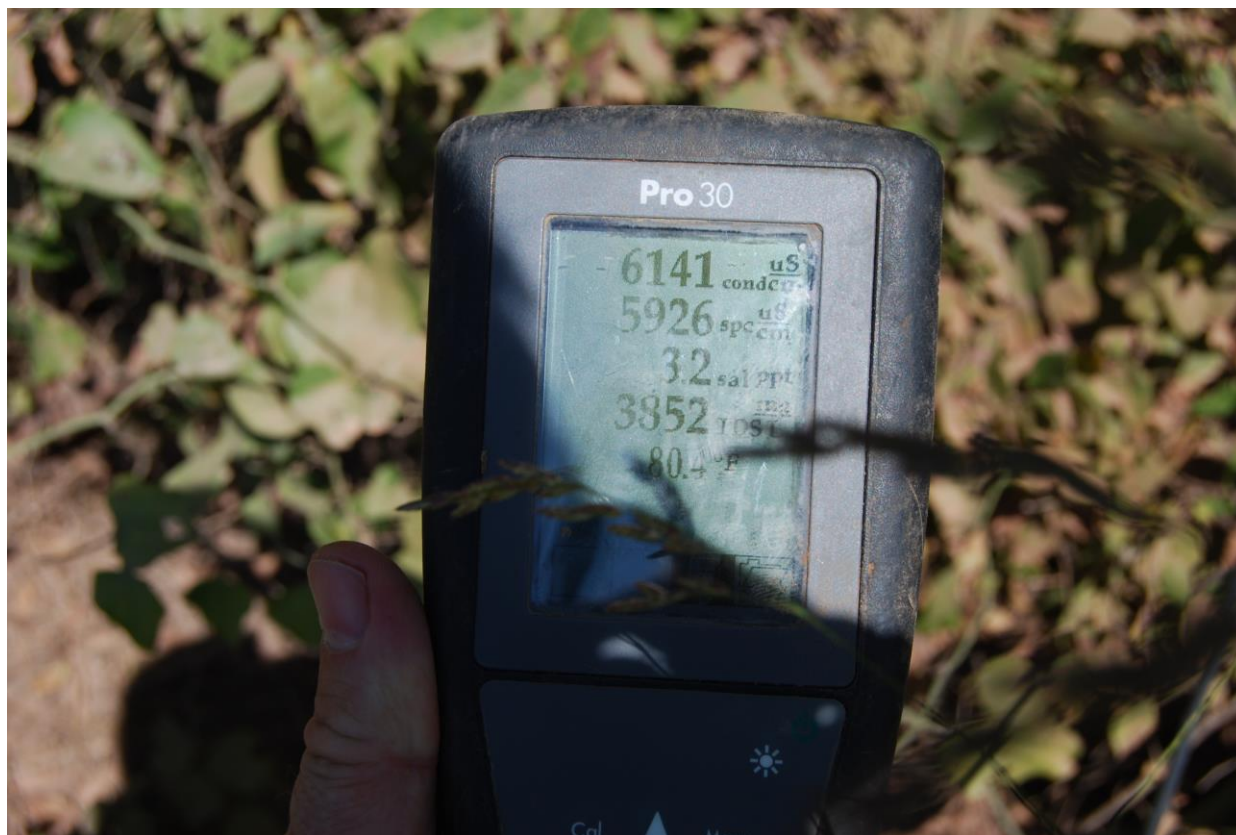
Photo No. 27

Description: The TDS of the creek at the Photo 26 location was 3,852 mg/L.

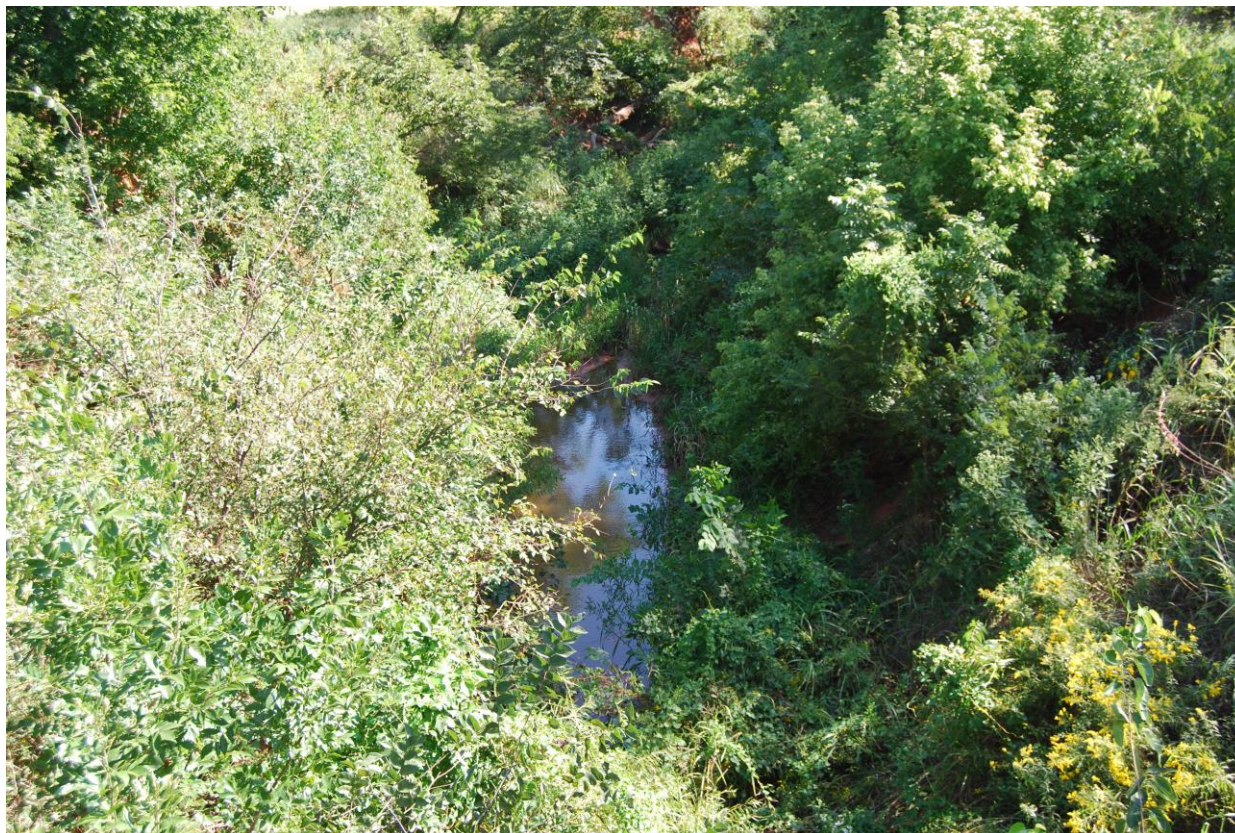
Photo No. 28

Description: This was the tributary of Wild Horse Creek south of the spill site, but not along the flow path of the brine spill into the tributary. I observed that water at this location was a representation of background water quality.

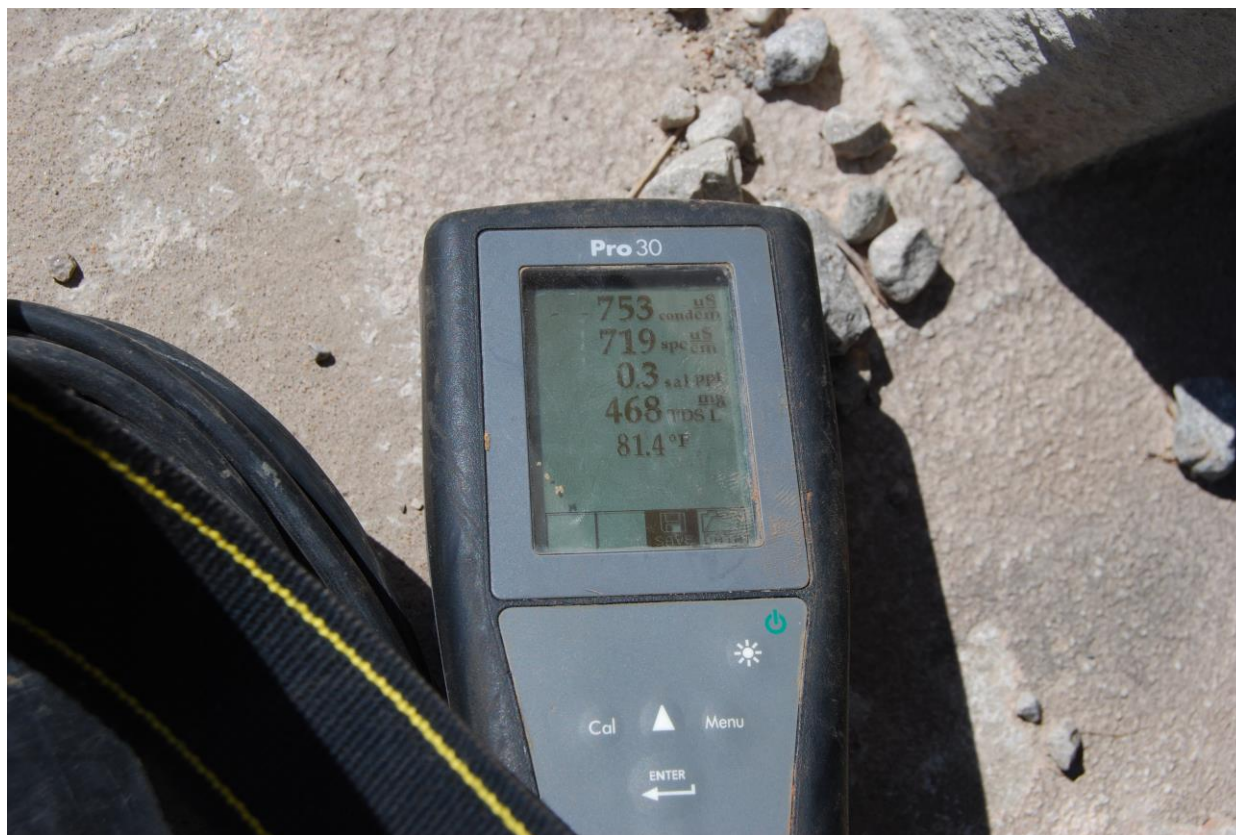
Photo No. 29

Description: The TDS of background water in the tributary of Wild Horse Creek in the area was 468 mg/L.
