Region 6 Compliance Assurance and Enforcement Division  
**INSPECTION REPORT**

| Inspection Date(s): | June 7, 2016 | | |
| Facility Name: | Dulce Wastewater Treatment Plant | | |
| | Subject: | Dulce WWTP Compliance Evaluation Inspection Report (CEI) | |

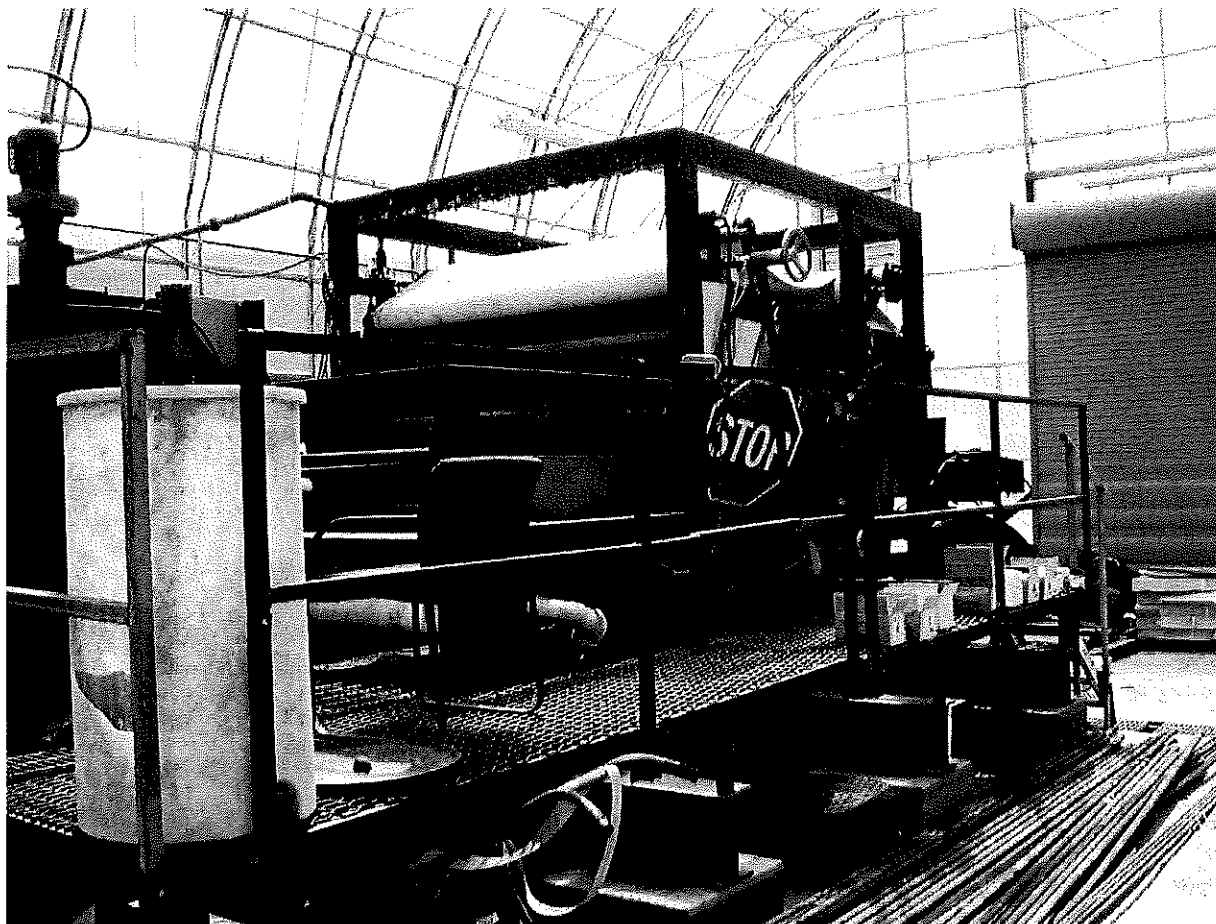
Photo File Name: P6070585

- A. Grit removal system – six months non-operational
- B. Belt press – Over 12 months non-operational
- C. Filter system prior to UV disinfection – more than six months non-operational
- D. Two of Five SBR blower motors were non-operational, with one being repaired during the inspection
- E. Decant valve in SBR #2 was also being replaced at the time of inspection
- F. Power was down to the facility's UV disinfection system and discharge flow meter, but would be operational once power was re-established in that part of the plant

Description: Sludge belt press has been out of operation for the past 12 months

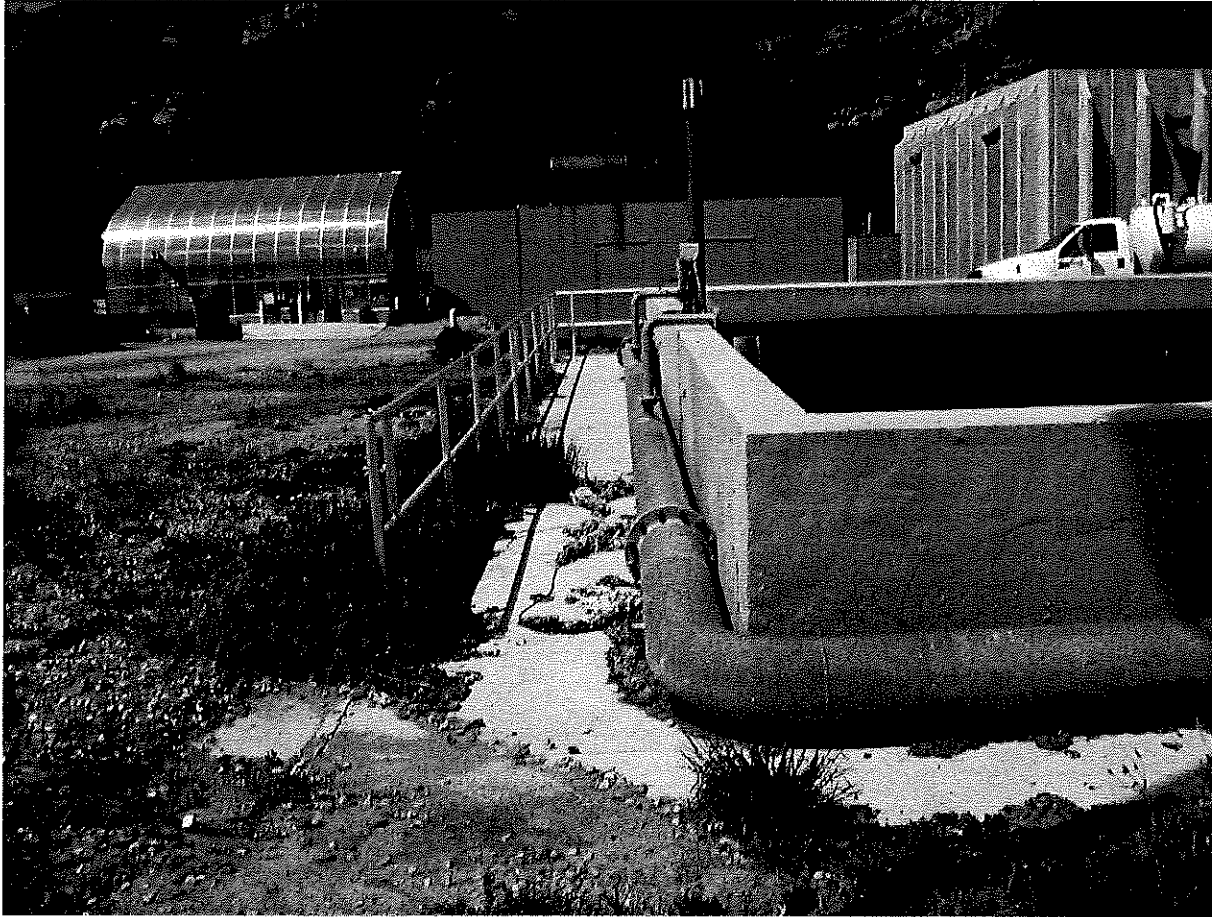
Photo File Name: P6070588

4. Good housekeeping at the facility is lacking as noted by the presence of dried solids on the ground adjacent to both the lift station, SBR Basins and sludge press. Additionally, during the inspection it was noted that wash water was being discharged to the storm sewer system and allowed to flow offsite. Finally, the security fence surrounding the facility was breached and had not been repaired

Description: Spilled or overflowed sludge from SBR#2

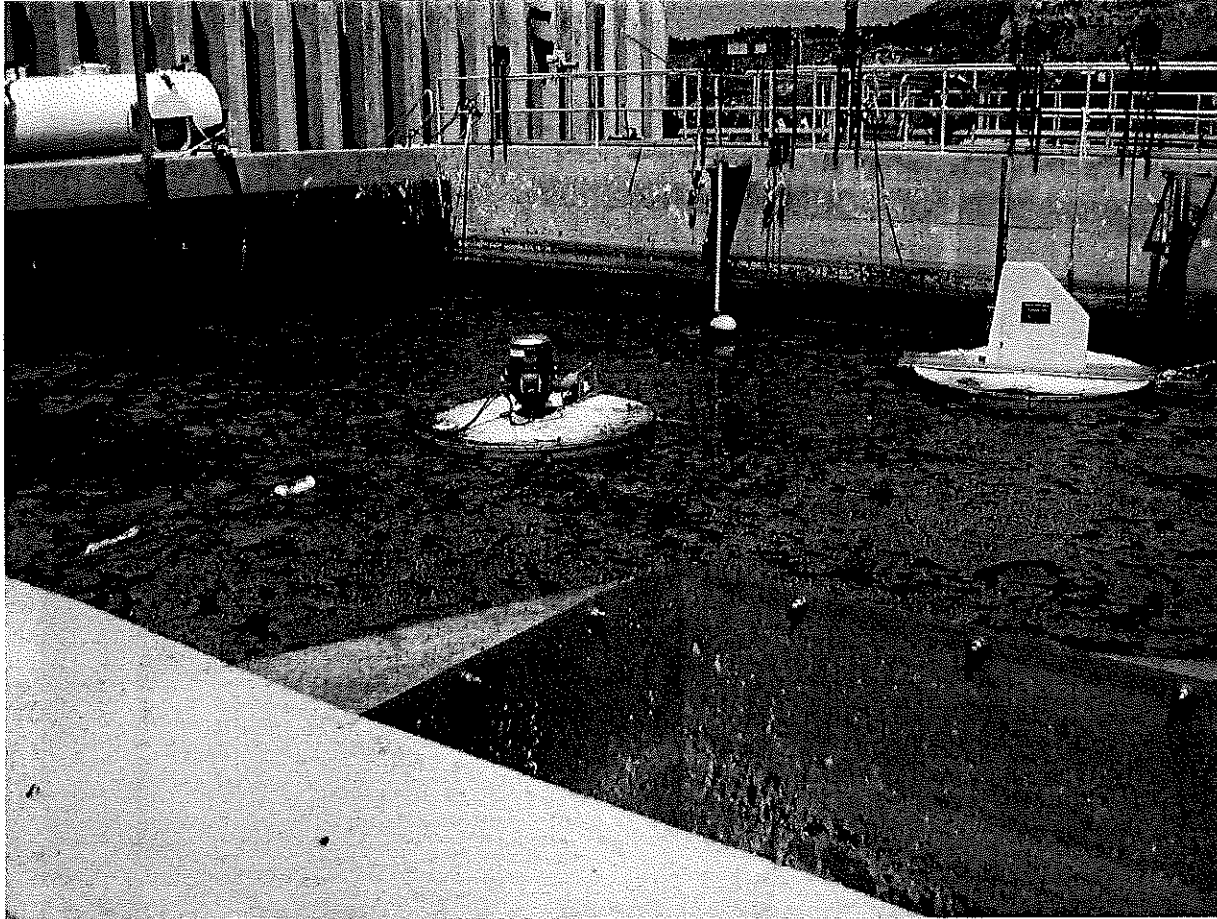
Photo File Name: P6070590

Description: SBR #1 with pumps off

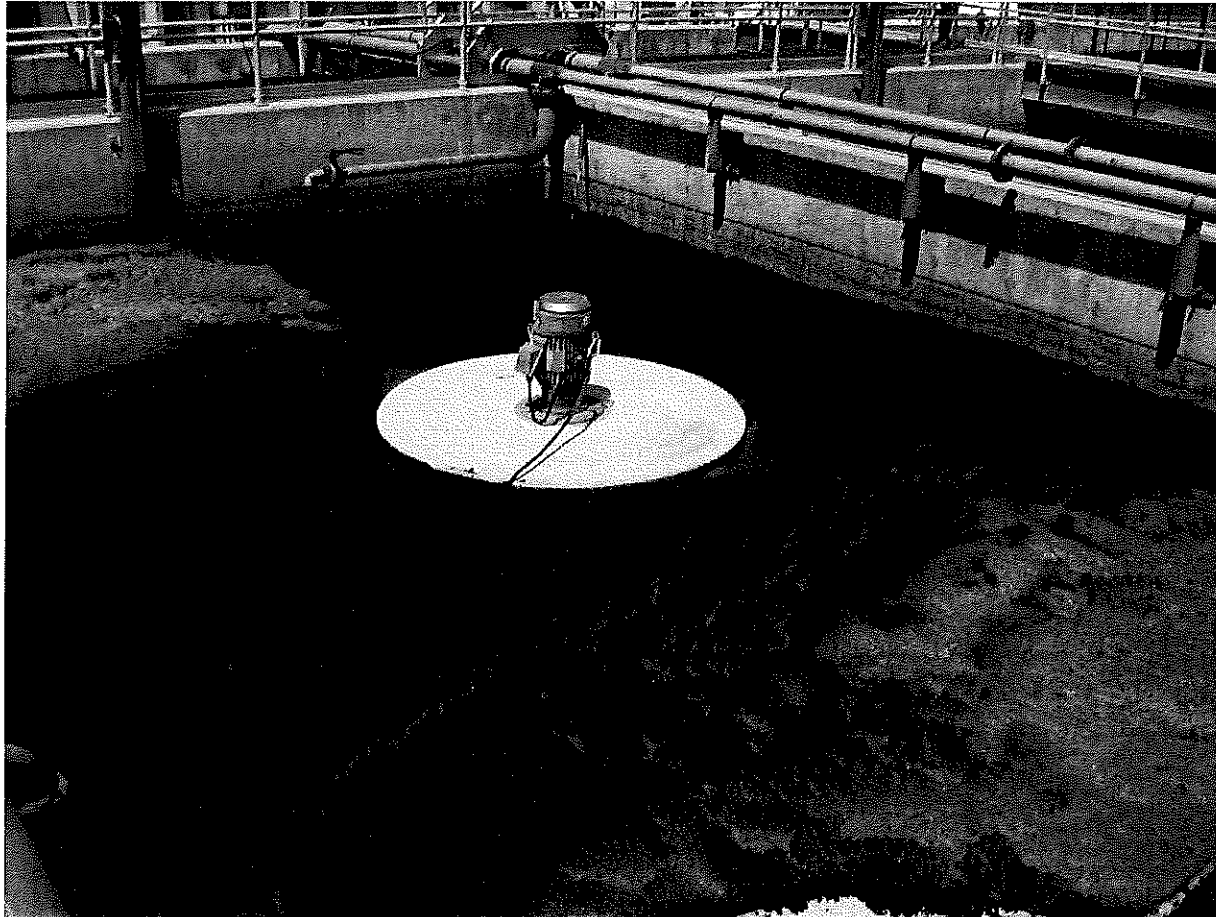
Photo File Name: P6070591

Description: SBR #1 – Note heavy sludge buildup

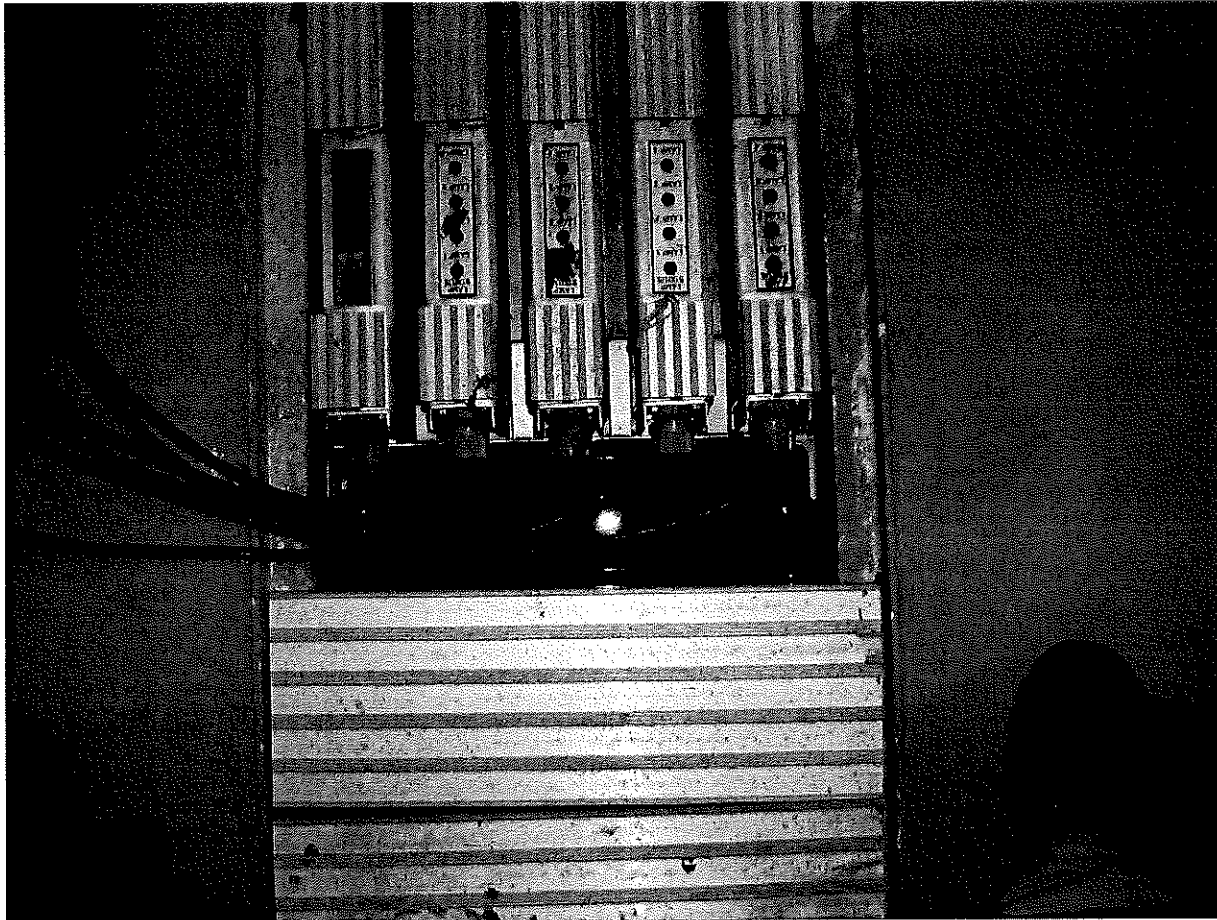
Photo File Name: P6070595

Description: UV disinfection system not online at time of inspection

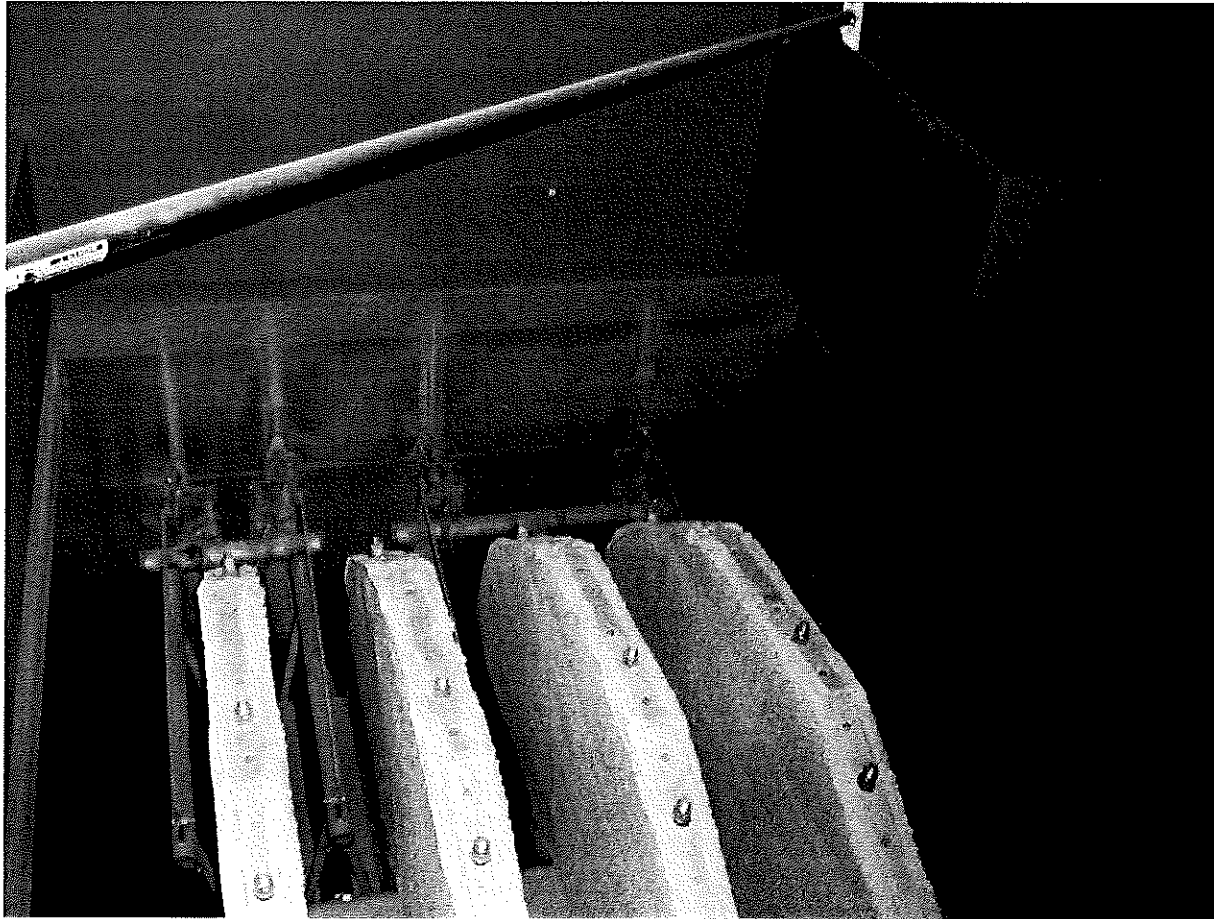
Photo File Name: P6070597

Description: Solids filtration system prior to UV disinfection has been offline for over six months

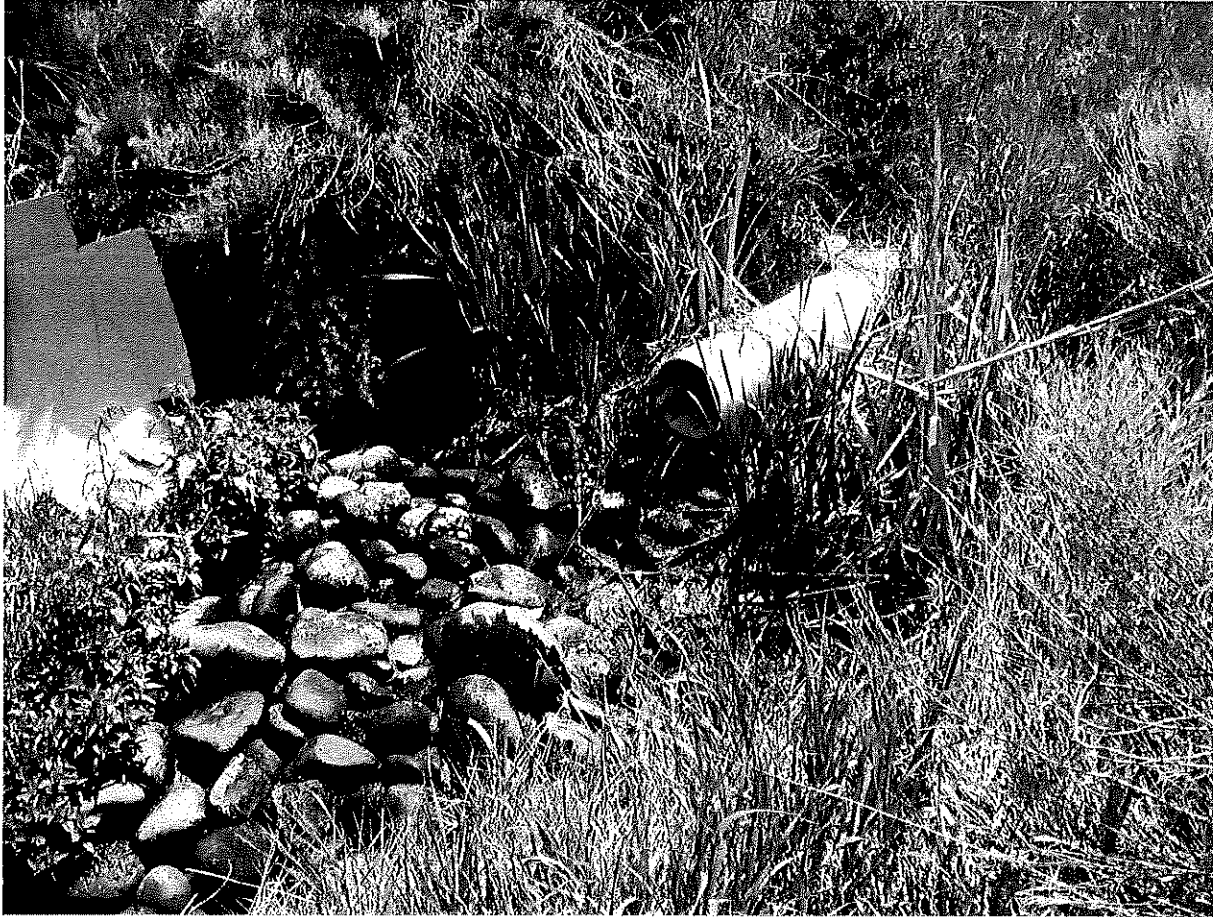
Photo File Name: P6070605

Description: Low rate of discharge to Outfall 001 due to maintenance in the SBR system at the time of inspection

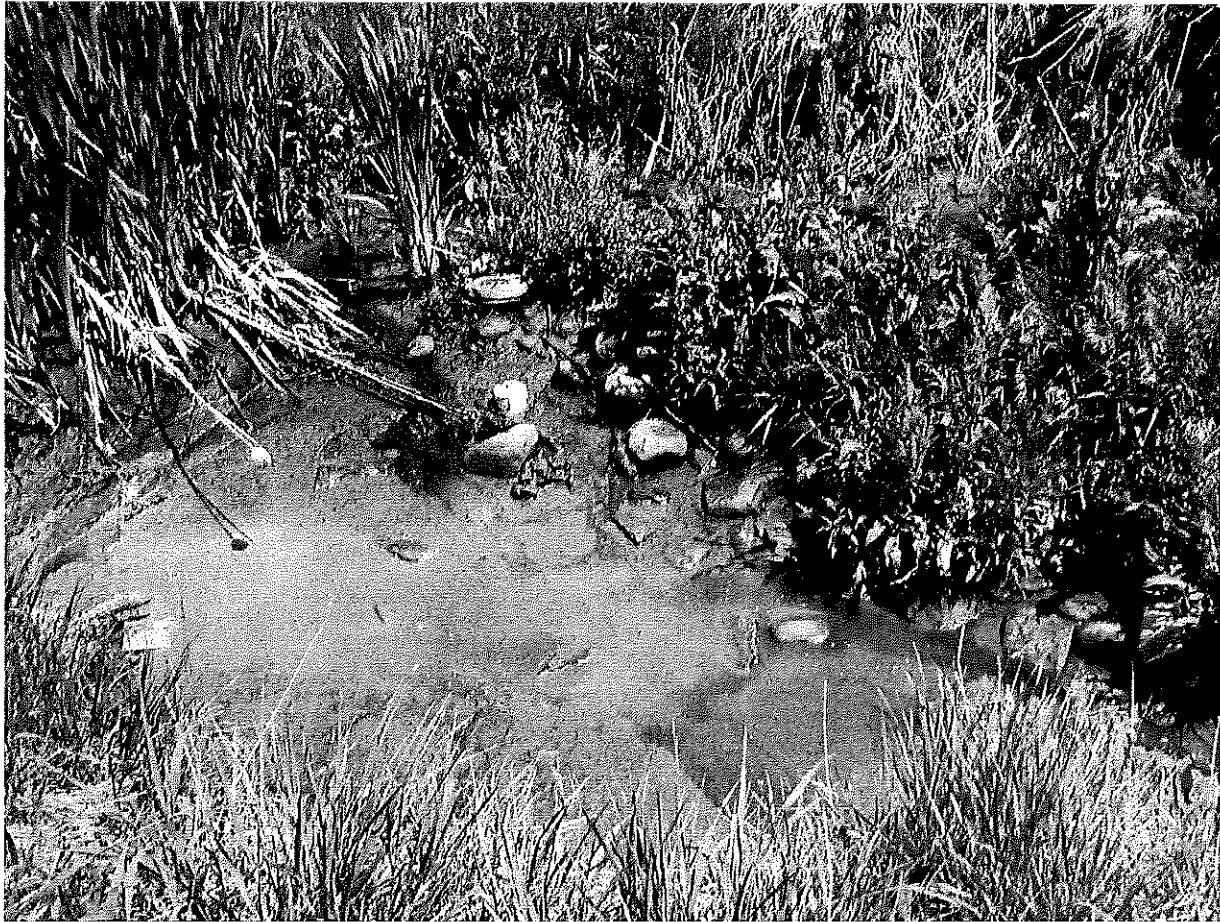
Photo File Name: P6070606

2. An unacceptable number of treatment units were not in operating condition at the time of inspection (some have been out of service since their last EPA inspection in July 2015) including their influent grit pump, sludge belt press, and solids filtration/removal system. Due to the lack of proper solids removal and wasting, a layer of sludge was noted at the facility's outfall

Description: Heavy sludge deposition at Outfall 001 due to lack of sludge wasting within the treatment system
