Re: U.S. EPA-Region 1 Inspection Report of Solvay, September 7, 2022

RCRA Compliance Inspection of:

Solvay
1937 West Main Street
Stamford, CT 06902

RCRA HAZARDOUS WASTE INSPECTION REPORT

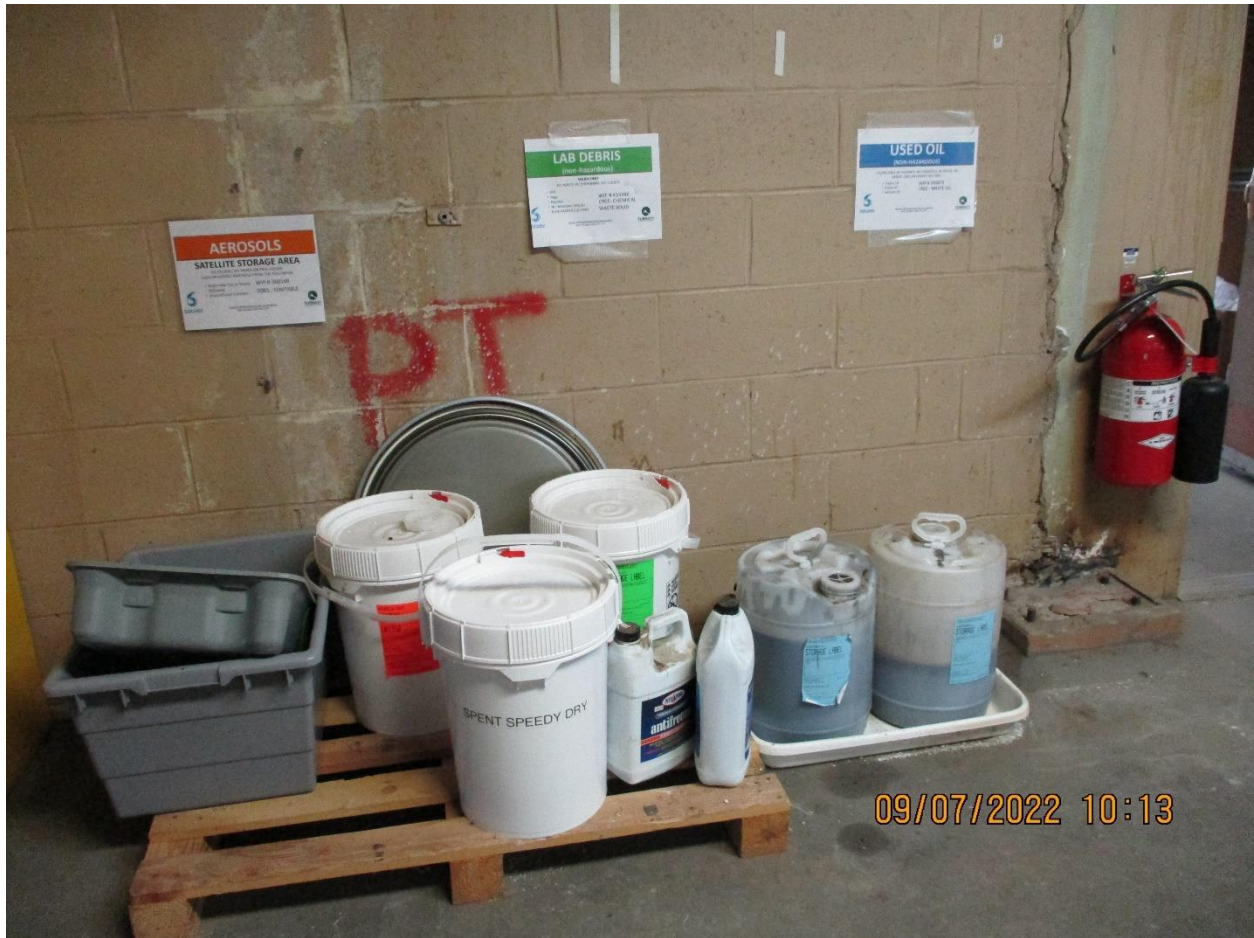
Photo 3

The inspection team observed a Satellite Accumulation Area (SAA) for hazardous waste, non-hazardous lab debris and used oil at the back of the Maintenance Shop (*See Attachment 1, Photo #3*). There were signs attached to the wall at the area for each type of waste stored here. The hazardous waste SAA sign was for hazardous waste aerosols. The sign included the waste code D001: Ignitable (*See Attachment 1, Photo #4*). There was one 5-gallon bucket of hazardous waste stored at this area. The bucket had a hazardous waste label which stated the waste stream as waste aerosols, flammable (*See Attachment 1, Photo #7*). There were 4 containers of non-hazardous waste, and two containers of used oil. There was a fire extinguisher at the SAA.

HW Aerosols SAA, non-HW lab debris and Used Oil collection point located in the Maintenance Shop

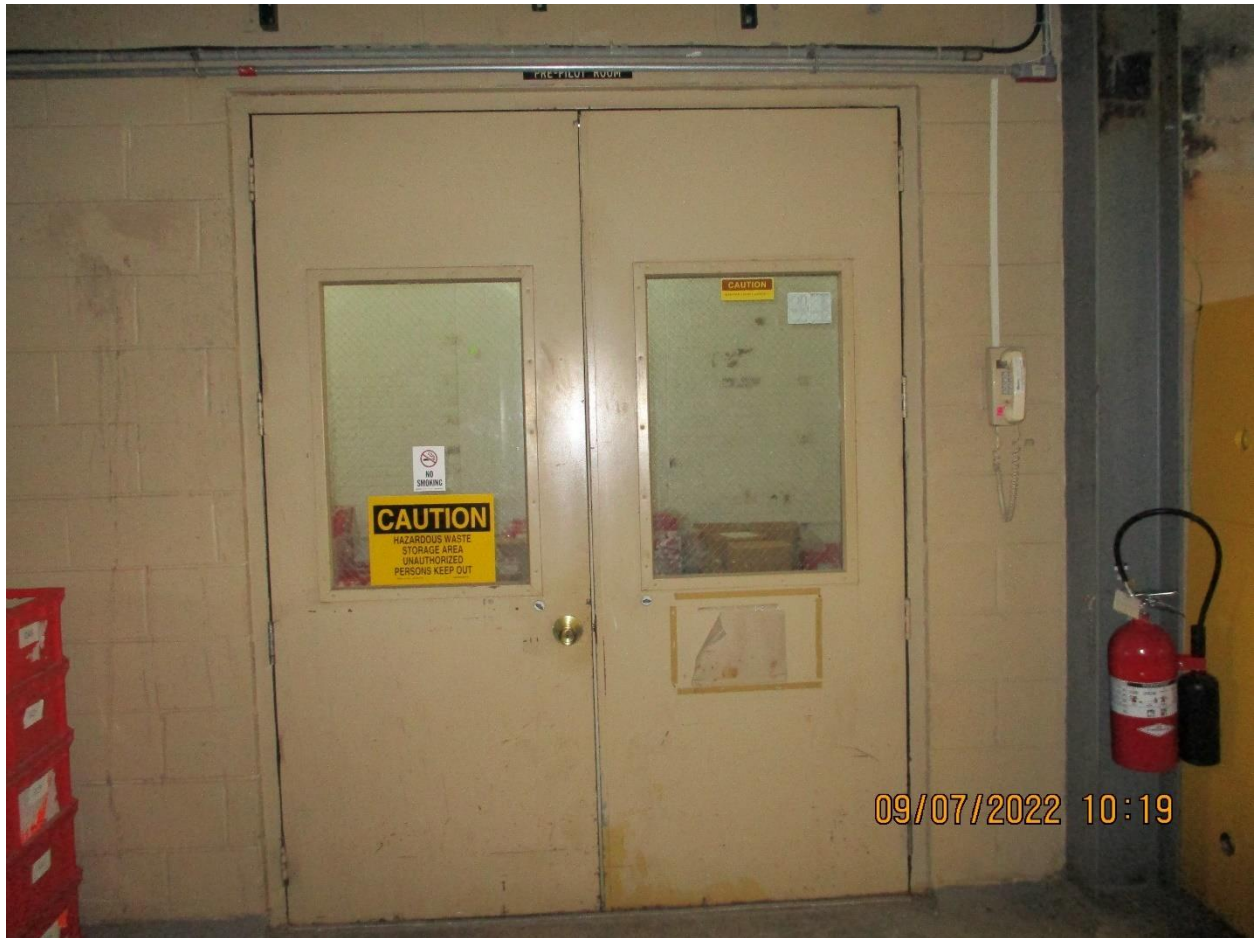
Photo 8

fire extinguisher, and a telephone located to the right of the entry doors. No emergency contact information, nor an evacuation route was present at or near the 90-day HWSA (*See Attachment 1, Photo #8 and #9*). Directly to the left when inside the HWSA there is a section of the room for corrosive waste. There were two secondary containment skids located in the area. One skid had 5 hazardous waste containers on it, and one had one 5-gallon bucket on it (*See Attachment 1, Photo #10*). The following is a description of the hazardous waste containers observed on these two skids:

Entry doors into 90-Day HWSA, located in the Maintenance Shop

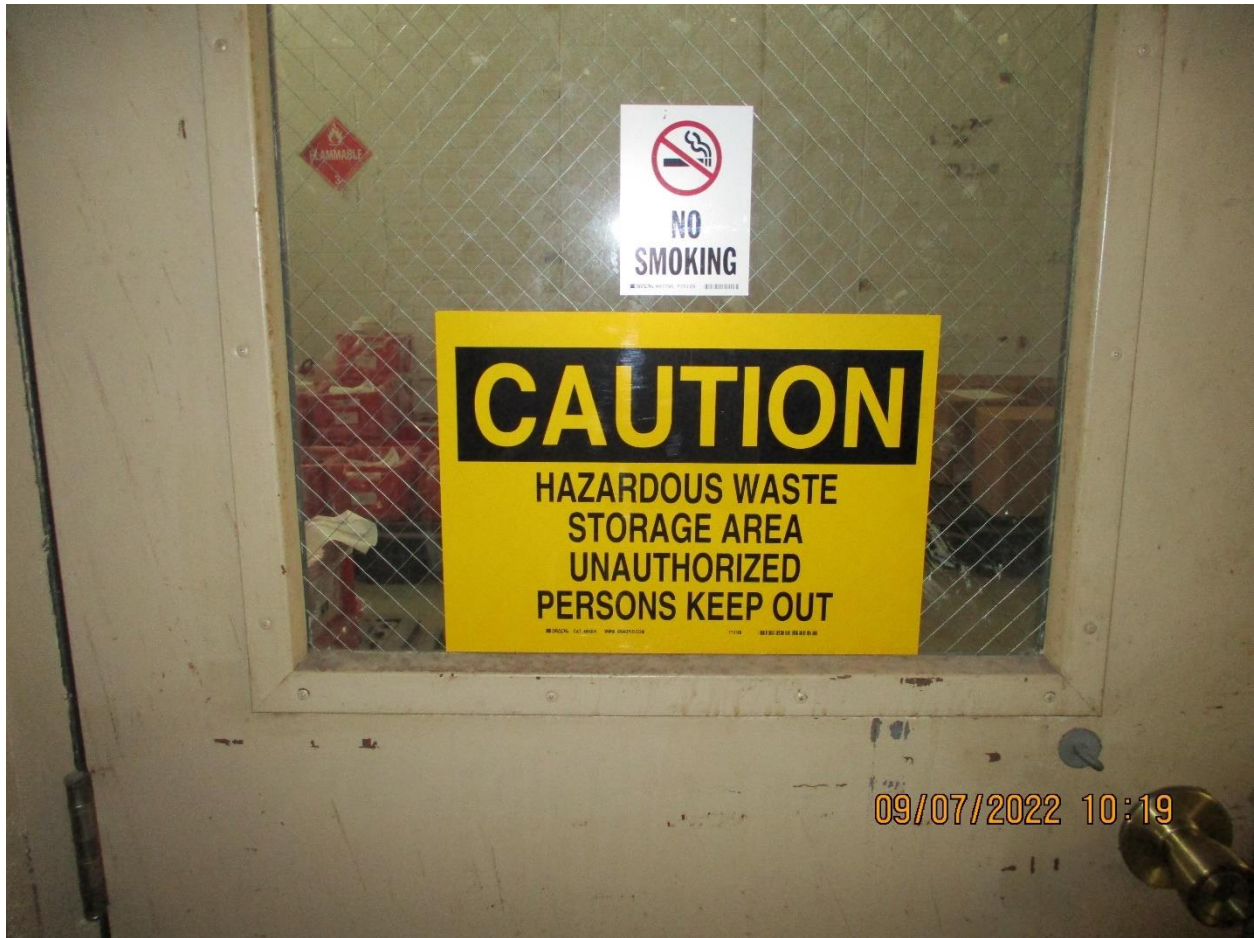
Photo 9

Signage on entry doors into 90-Day HWSA, located in the Maintenance Shop

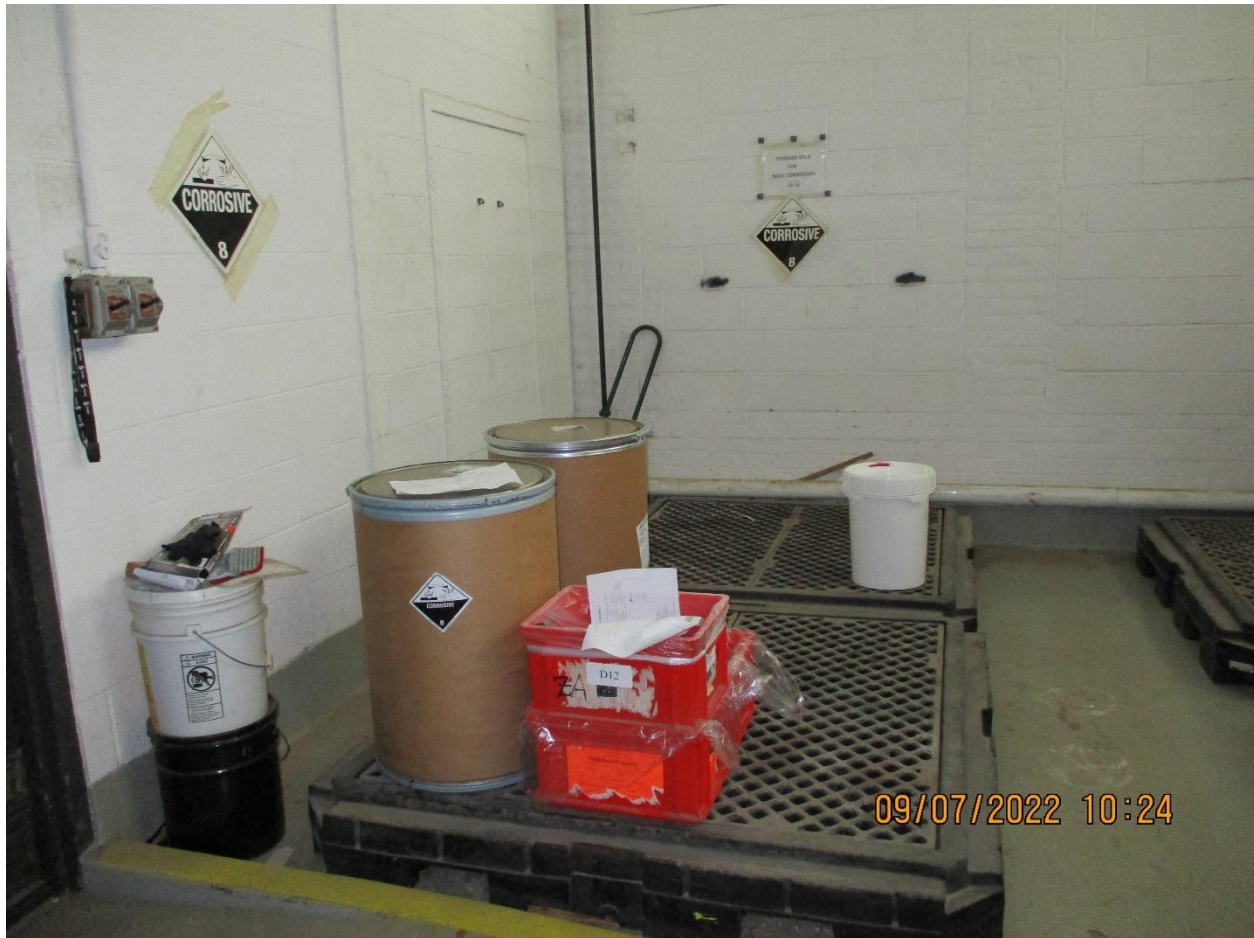
Photo 10

- One 55-gallon drum had a corrosive label and a hazardous waste label with the waste stream described as, waste corrosive liquid, basic, inorganic, n.o.s., (sodium hydroxide solution) 8, II. The label was marked with waste code D002 and was dated 07/12/2022. There was also a “Waste Material Inventory” sheet attached to the top cover of the drum, which listed HCl solution (*See attachment 1, Photos #11, #12 and #14*).
- One 55-gallon drum had a corrosive label, but no hazardous waste label and was not dated.
- Three red boxes containing lab pack hazardous waste, the boxes had “Waste Material Inventory” sheets in them, but no hazardous waste labels or dates on the boxes (*See attachment 1, Photos #10, #11 and #13*).

Left side corner of 90-Day HWSA, located in the Maintenance Shop

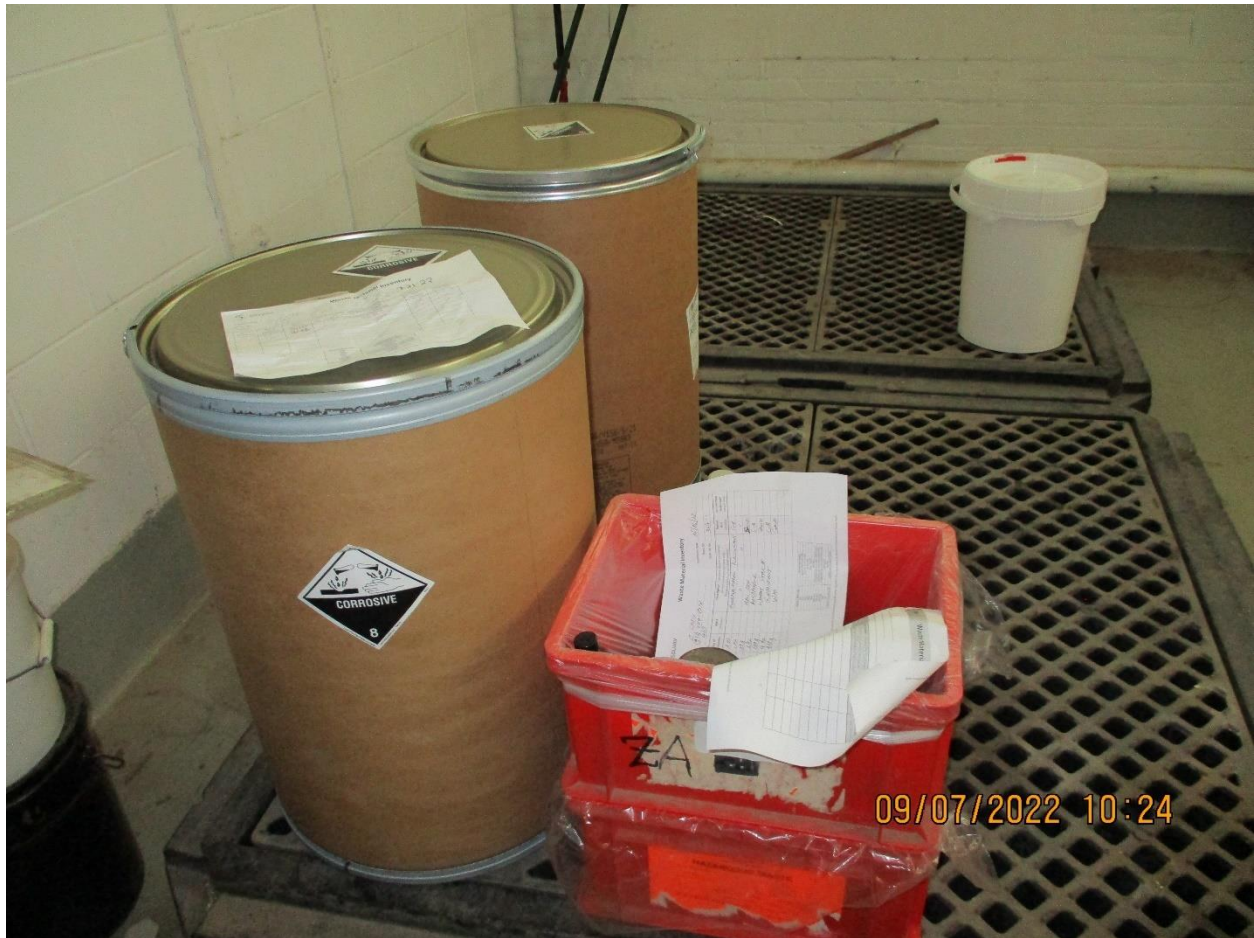
Photo 11

HW containers on left side corner of 90-Day HWSA, located in the Maintenance Shop

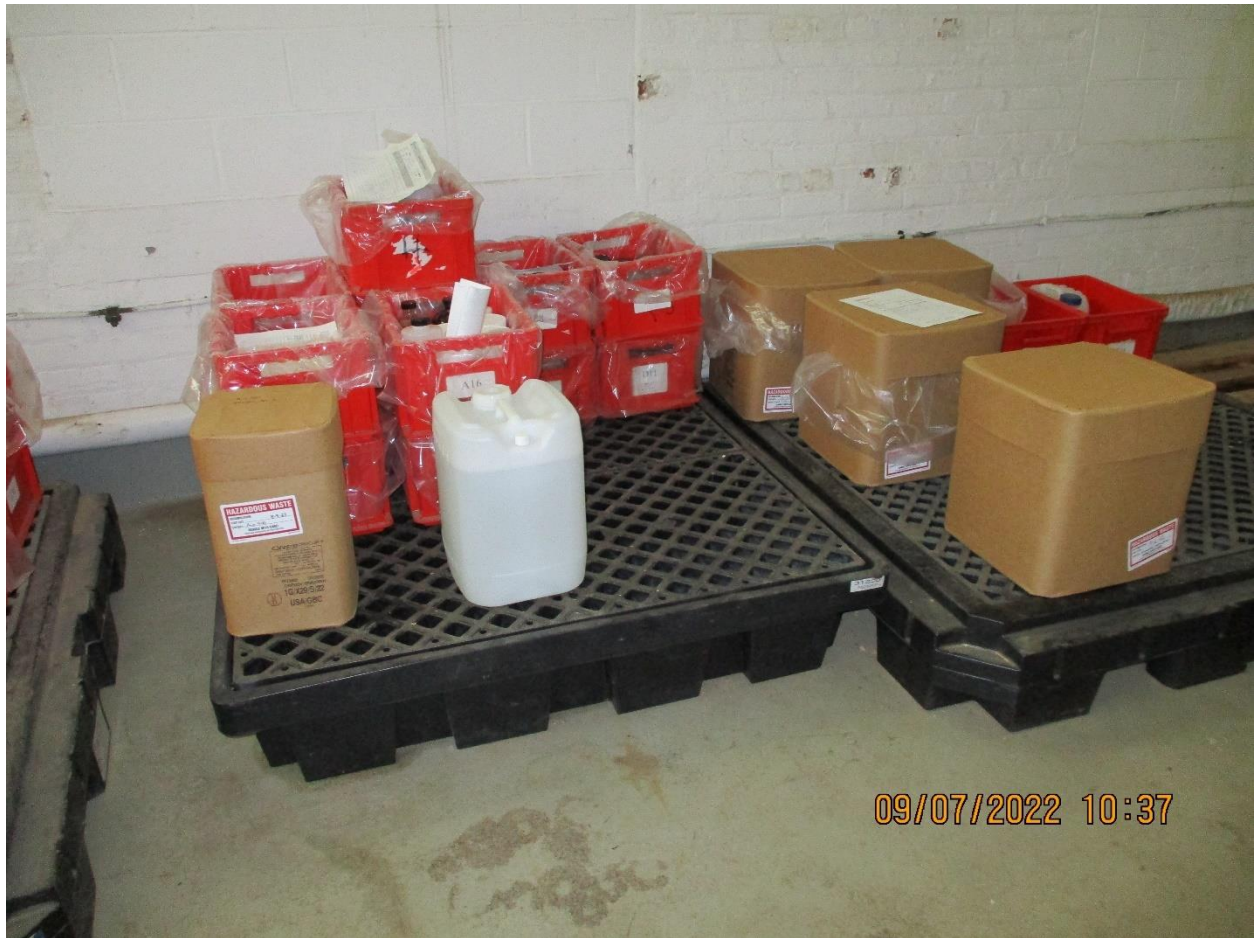
Photo 34

Skid 3. Thirteen red lab pack boxes, one square hazardous waste cardboard box and one white hazardous waste container (*See attachment 1, Photos #34-#42*).

Skid 4. Four hazardous waste cardboard boxes, and two red lab pack boxes (*See attachment 1, Photo #34 and #43-46*).

HW containers on skid 3 and skid 4, in center back of 90-Day HWSA, located in the Maintenance Shop

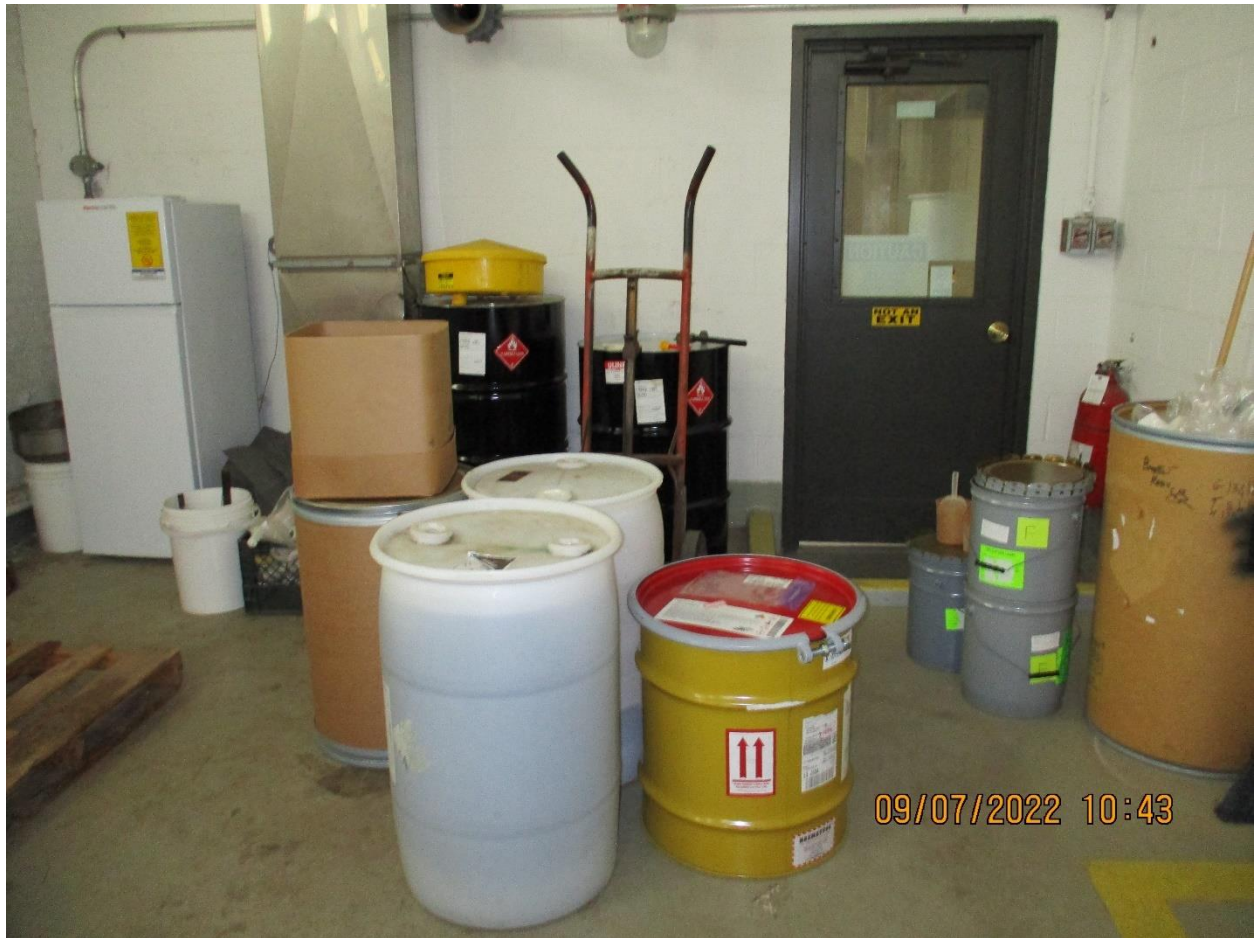
Photo 47

Also, in the 90-day HWSA, against the wall on the right side of the room were two black 55-gallon drums with hazardous waste labels which described the waste stream as, waste flammable liquids, n.o.s., (methanol, xylene), 3, II, RQ (D001). Both labels were dated with the date of 8-25-22. One drum was sitting on a secondary containment skid and was grounded. The other was on the floor and was not grounded, it was full. (*See attachment 1, Photo #47-#50*).

Right side of 90-Day HWSA, located in the Maintenance Shop

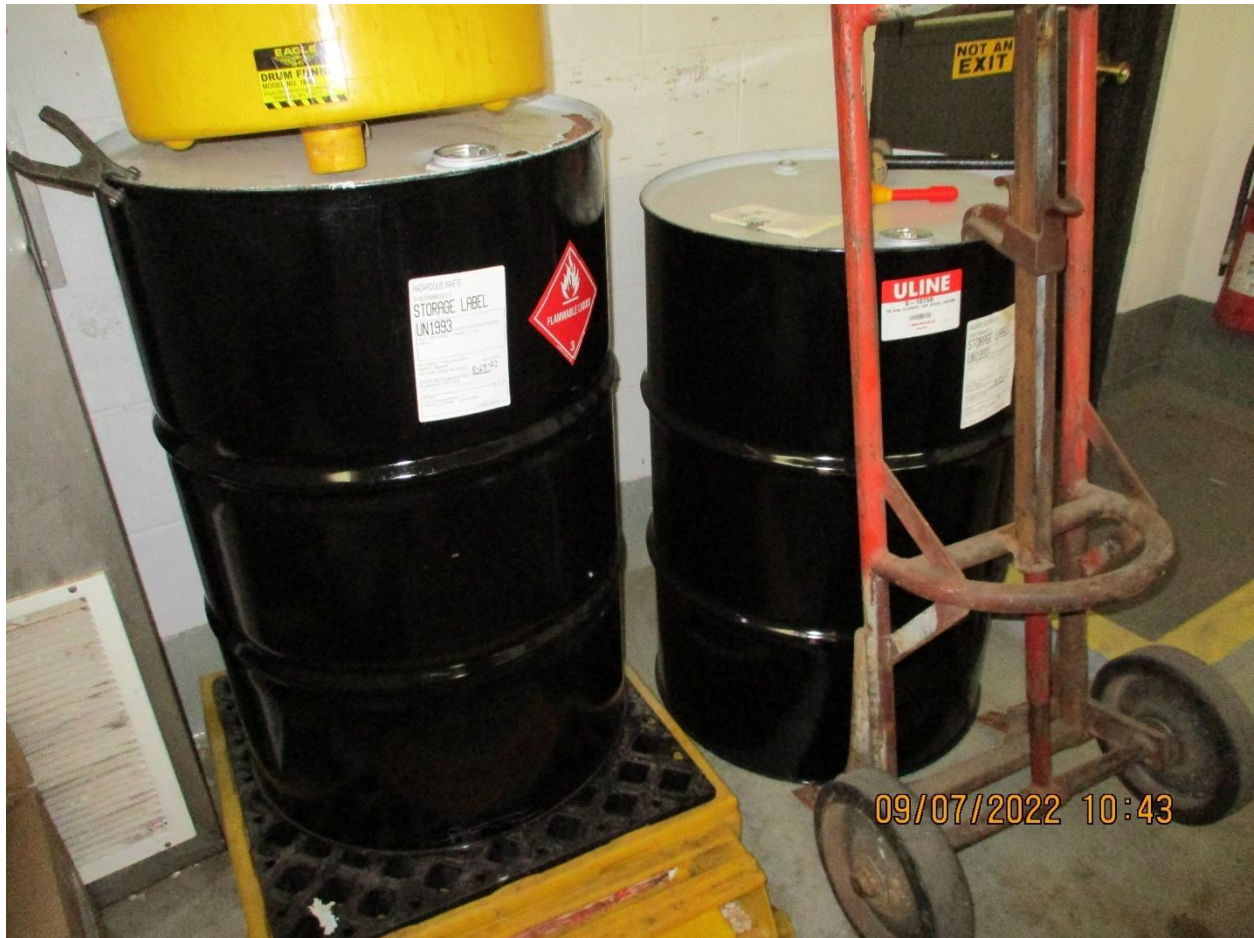
Photo 48

HW drums located on the right side back wall of 90-Day HWSA, located in the Maintenance Shop

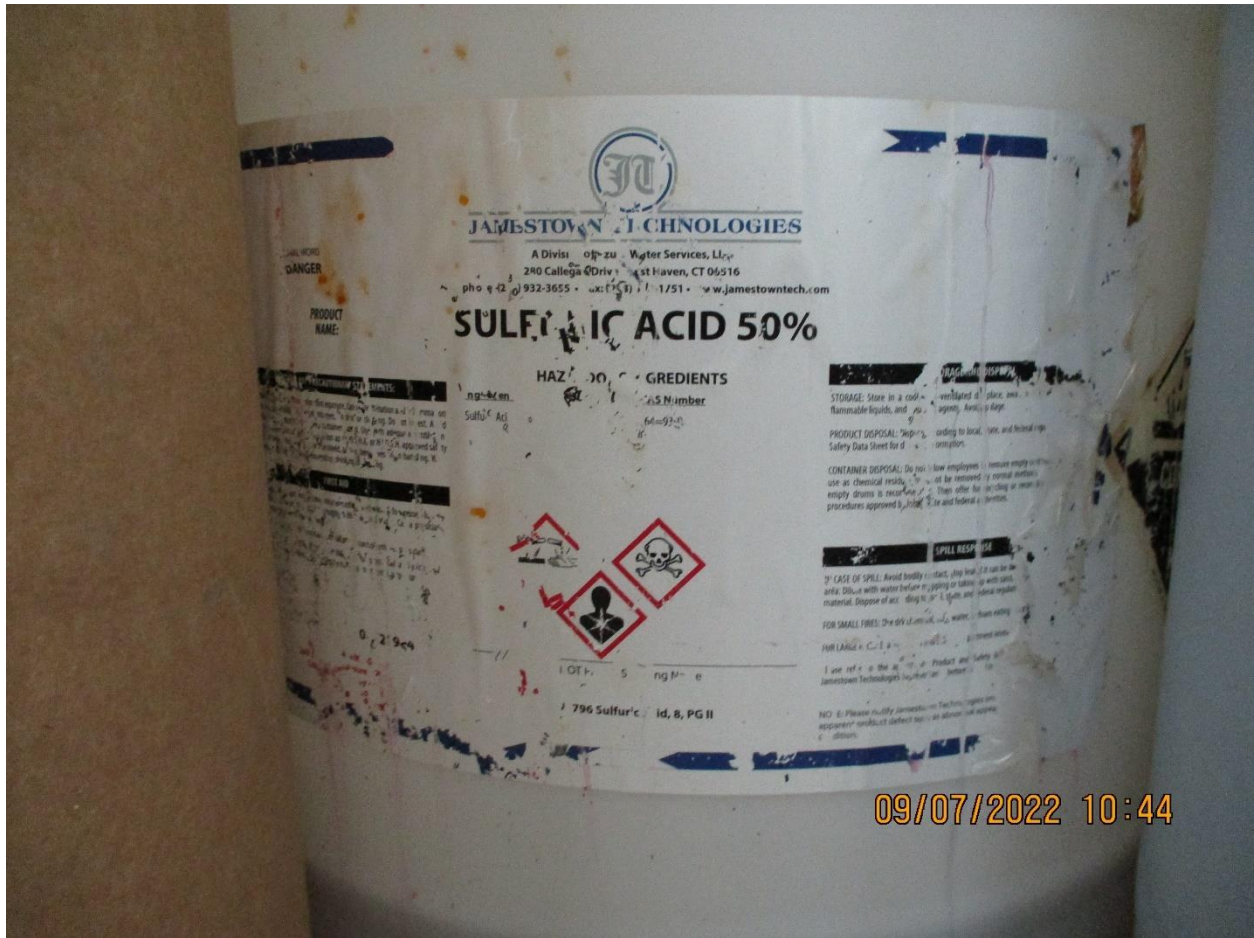
Photo 51

Staged in front of the two 55-gallon black drums were two white 55-gallon drums of hazardous waste. One had an old product label of sulfuric acid 50%, and the other had an old product label of Molygard-100. Neither drum had hazardous waste labels, they were not dated, and neither were on secondary containment pallets. Mr. Hannah explained that the Molygard-100 container was holding caustic, high pH chemical waste from the boiler at the wastewater treatment area (*See attachment 1, Photo #51-#52*).

Label on HW container located on the right side of 90-Day HWSA, located in the Maintenance Shop

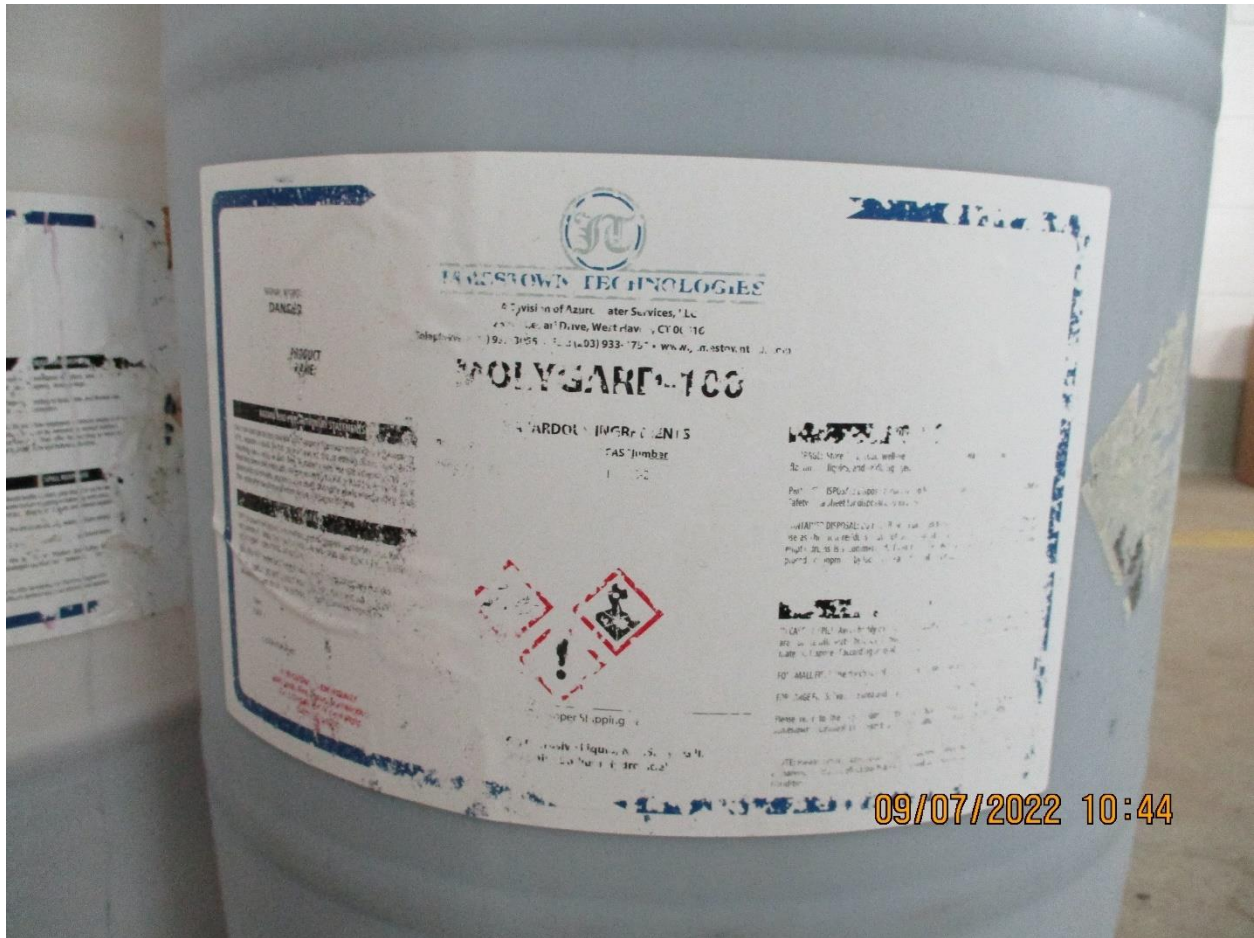
Photo 52

Label on HW container located on the right side of 90-Day HWSA, located in the Maintenance Shop

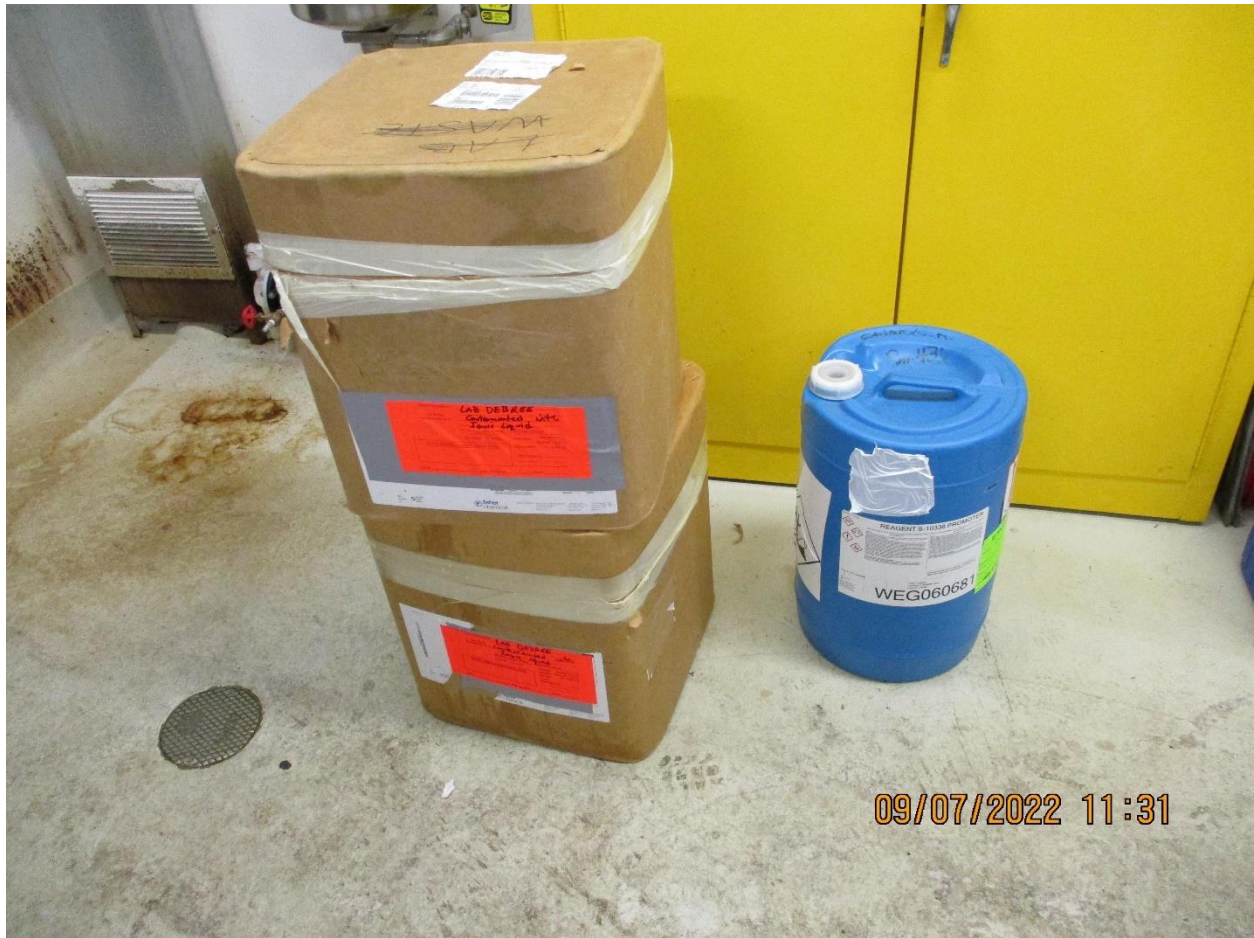
Photo 61

they have not run this process since the beginning of the year, or first part of the second quarter of the year. They stated that they are waiting for Veolia to create a Waste Identification Profile (WIP) for them before they add a hazardous waste label and move them to the 90-day area. They did state the blue container is unused material and is waste. The three containers had labels, but they were not hazardous waste labels. They did state the contents were contaminated "LAB DEBREE". The cardboard containers were not dated. The blue container had a retention label with a "DATE IN" of 11/27/17 and a "RETAIN UNTIL" date of 11/27/27" and it stated "Corrosive" (*See attachment 1, Photo #61-#64*).

3 containers of HW, located in Building 13, Prep Lab Room 4.4

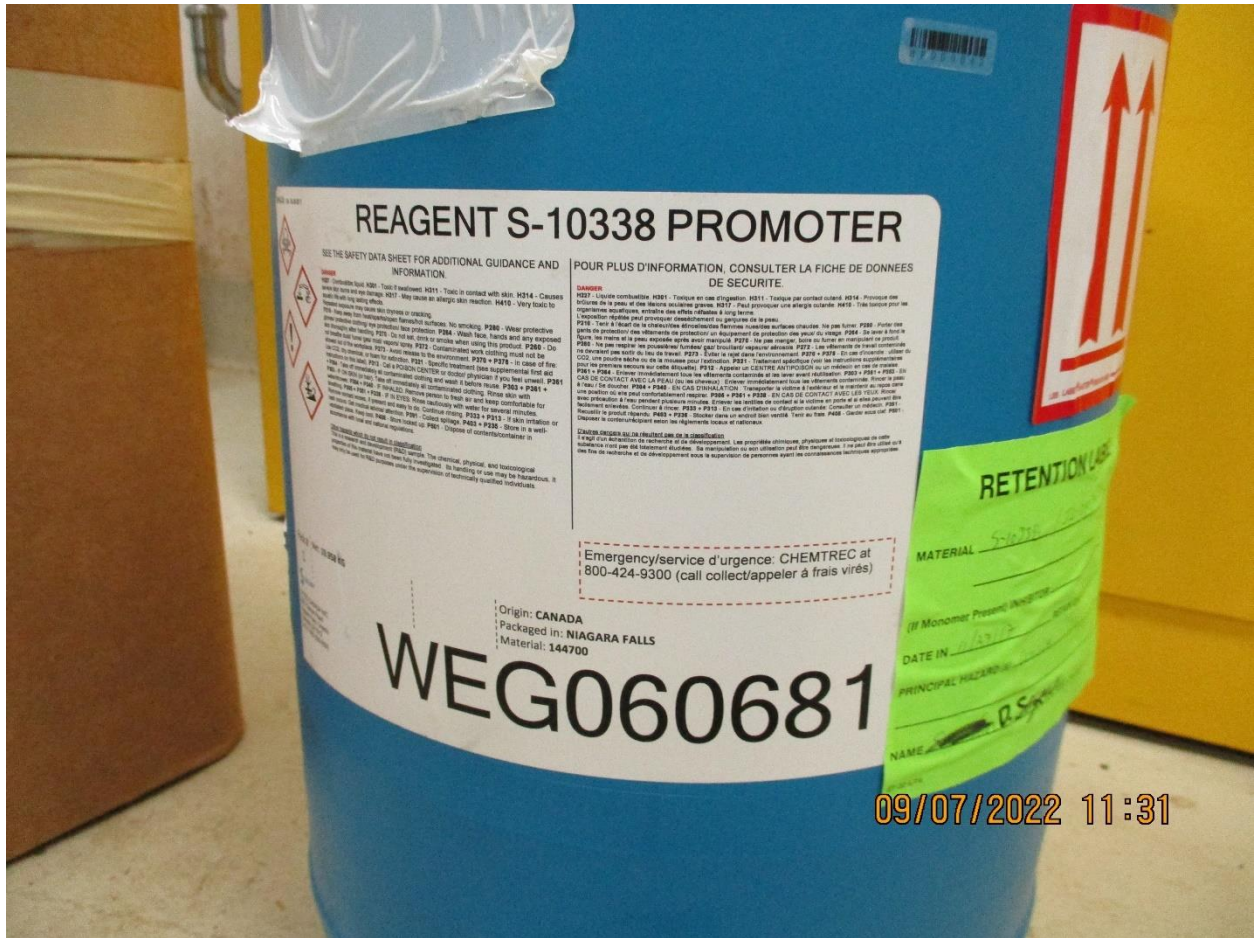
Photo 63

Label on blue container of 3 containers of HW, located in Building 13, Prep Lab Room 4.4

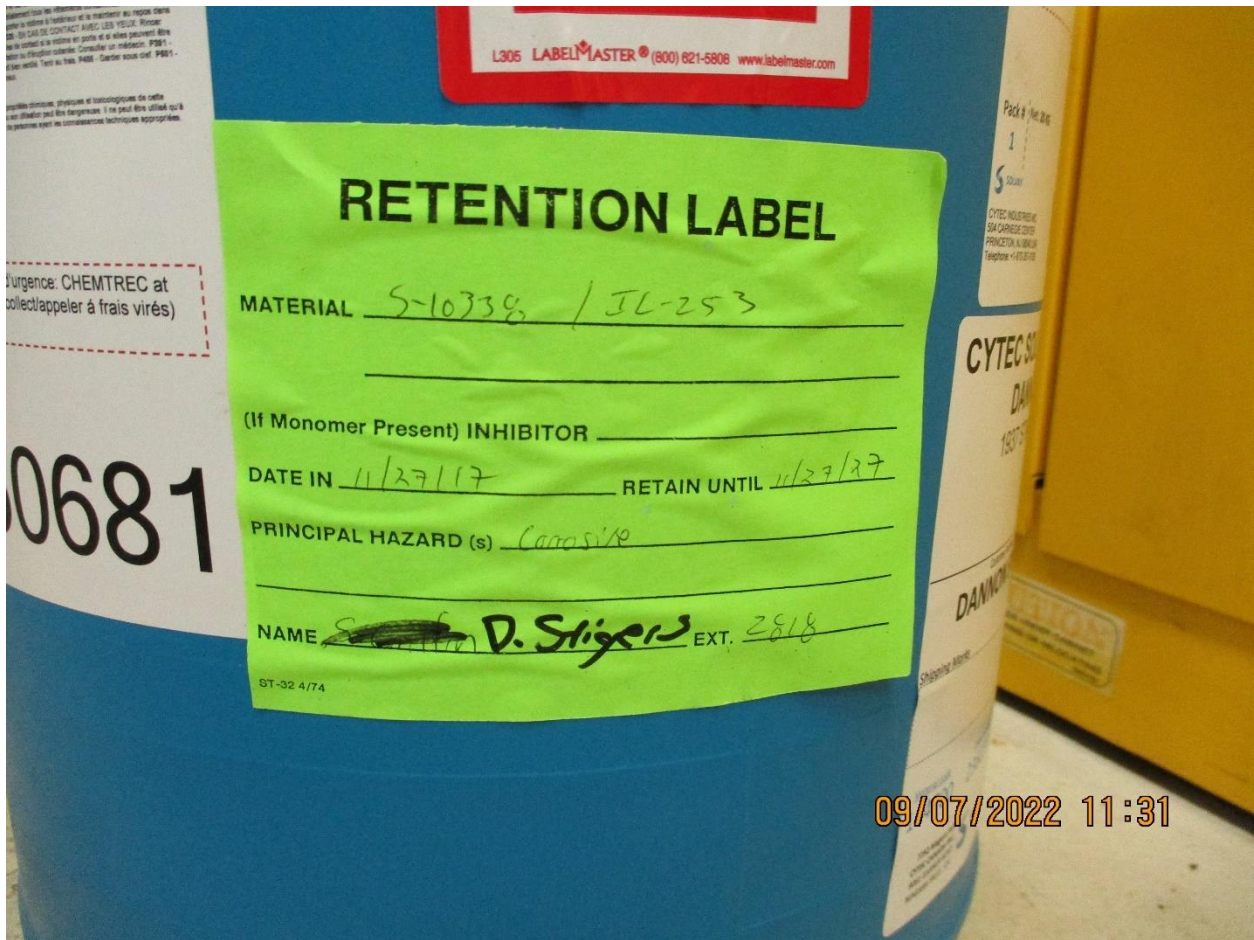
Photo 64

Label on blue container of 3 containers of HW, located in Building 13, Prep Lab Room 4.4

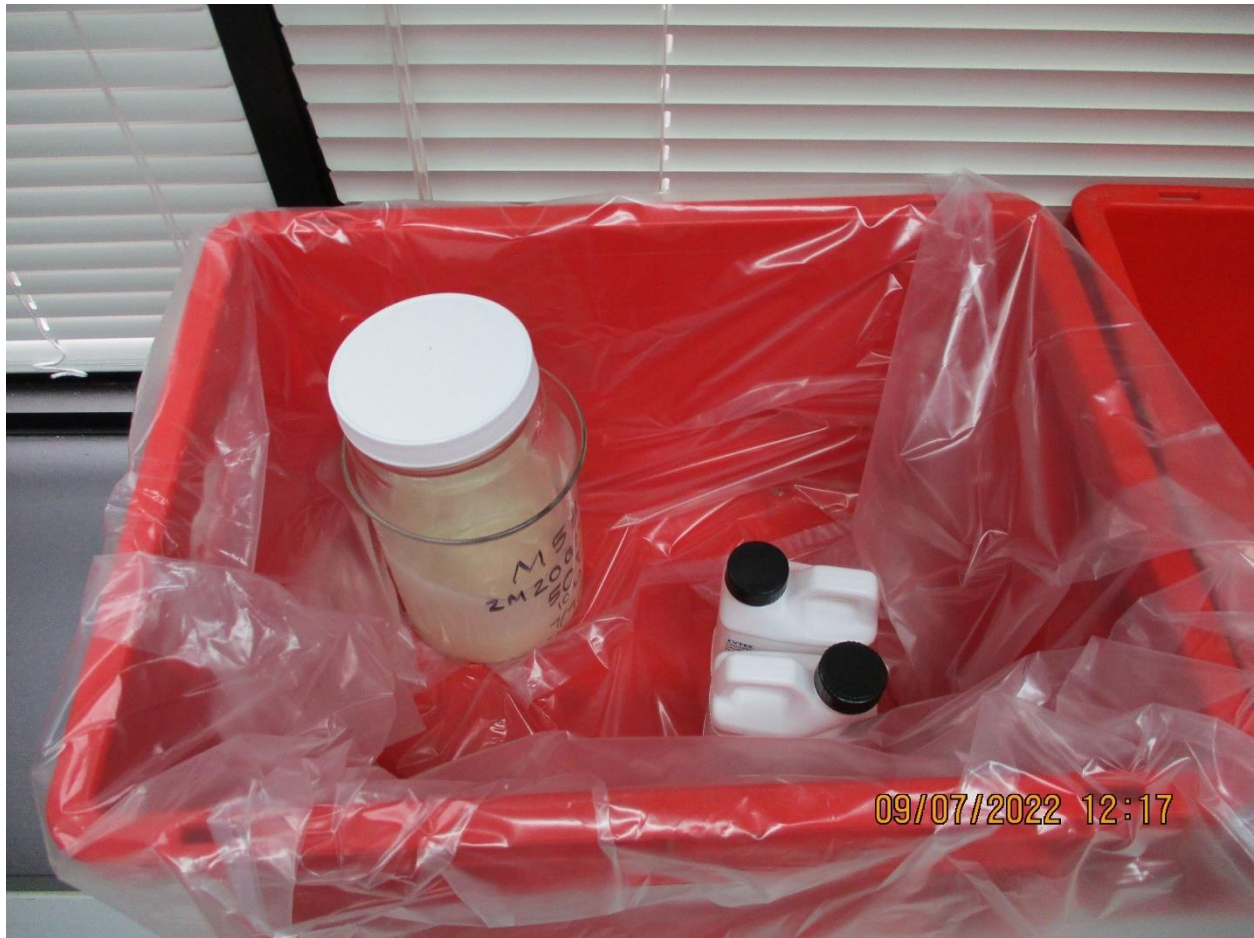
Photo 83

There were 5 red lab pack boxes, three located on the counter by the windows, and two on the floor. Two were empty, and three had hazardous waste lab pack containers in them. None of the boxes had a hazardous waste label, and none were dated. They were not in a designated SAA, or 90-day HWSA (*See attachment 1, Photo #82-#85*).

Contents inside one of five lab pack boxes, located in Building 13, Wet Lab 22

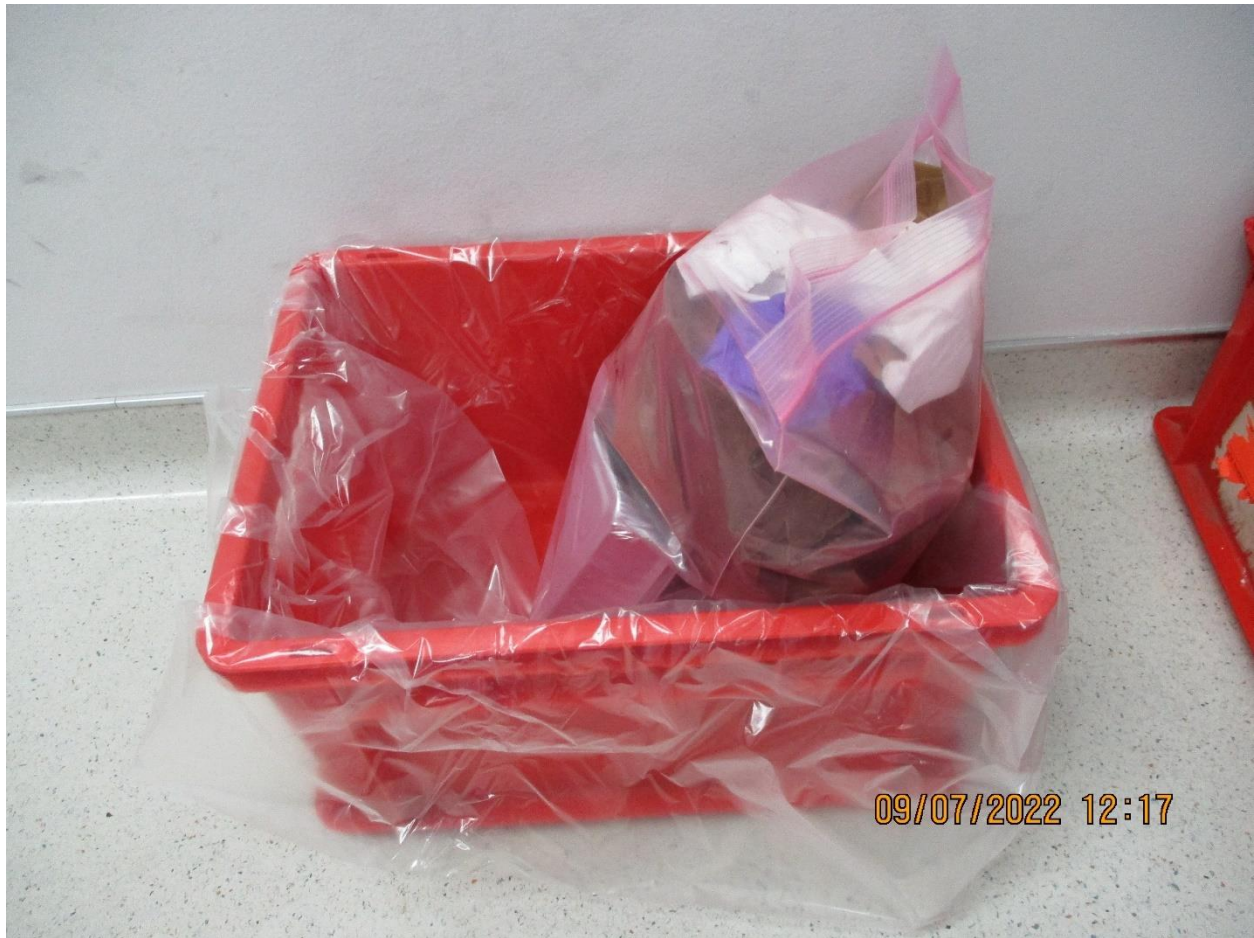
Photo 84

Contents inside one of five lab pack boxes, located in Building 13, Wet Lab 22

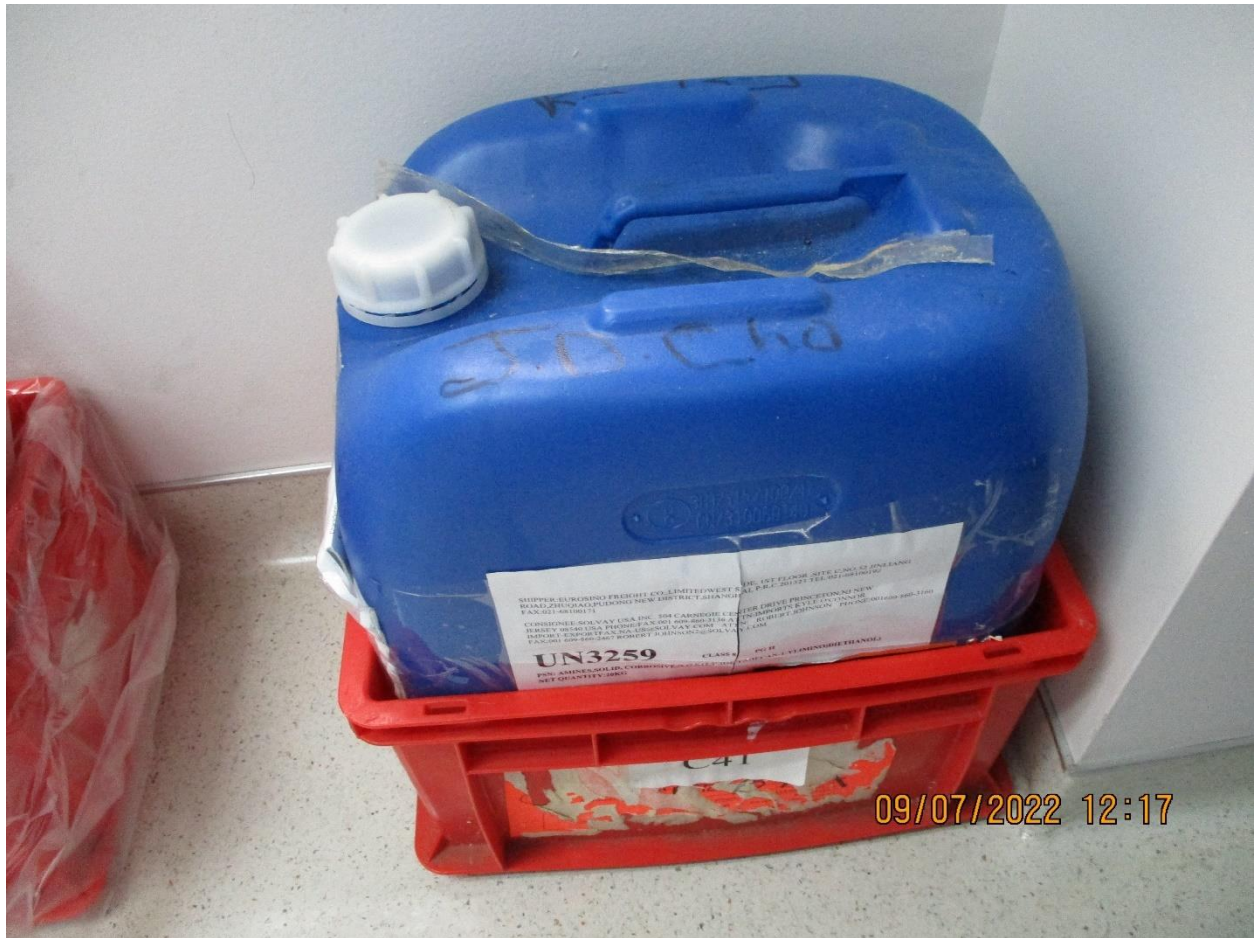
Photo 85

Contents inside one of five lab pack boxes, located in Building 13, Wet Lab 22
