CAA Inspection Report

Inspection Date: 5/9/2023
Facility Name: Atlantic County Utilities Authority Landfill
Facility Address: 6700 Delilah Road, Egg Harbor Township, NJ 08232
ICIS-Air ID #: NJ0000003400100209
Facility Contact: Greg Seher, Director, Solid Waste Operations, 609-272-6935, gseher@acua.com
EPA Lead Inspector: Joseph Cardile, Environmental Engineer, ECAD-ACB, 212-637-4054
EPA Asst. Inspector: Victor Tu, Environmental Scientist, ECAD-ACB, 212-637-3476
Other Inspector(s): Supriya Rao, EPA Environmental Engineer, LSASD-MAB, 732-321-3622
State Inspector(s): None

Leak Detection and Repair (LDAR) Inspection Report

Atlantic County Utilities Authority Landfill
6700 Delilah Road
Egg Harbor Township, NJ 08232

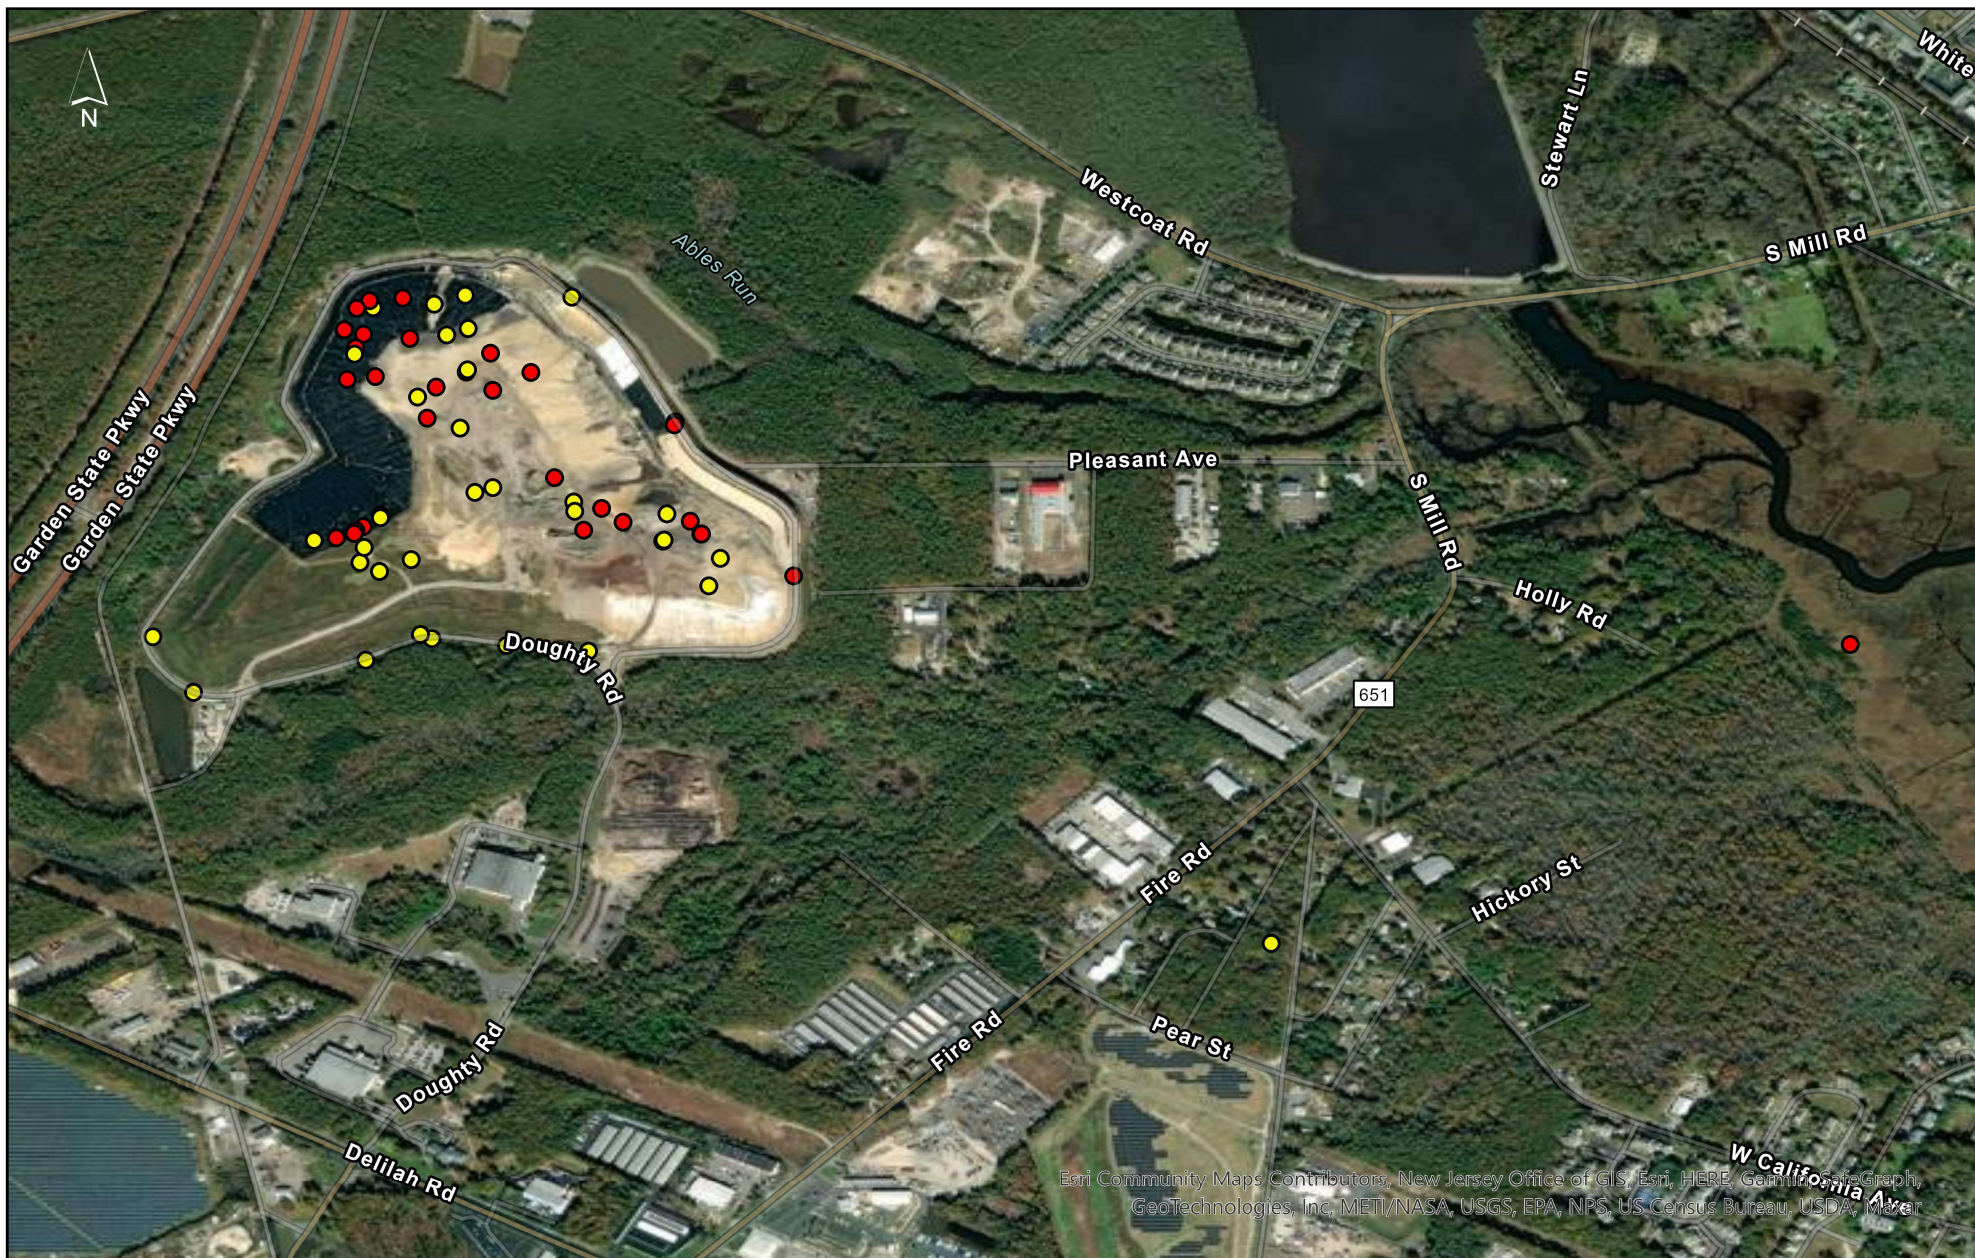
ACUA Landfill TVA Readings

Attachment 1, EPA detected 29 leaks, which equates to a leak rate of 42%. A majority of the leaks found were located at base of the wells, located in the landfill section covered with the black tarp.
