## PHOTO LOG

| Facility Name: | Amite BioEnergy (Drax) |
| EPA Media: | Stormwater - Industrial |

| Date Stamp: | 3/5/2024 |

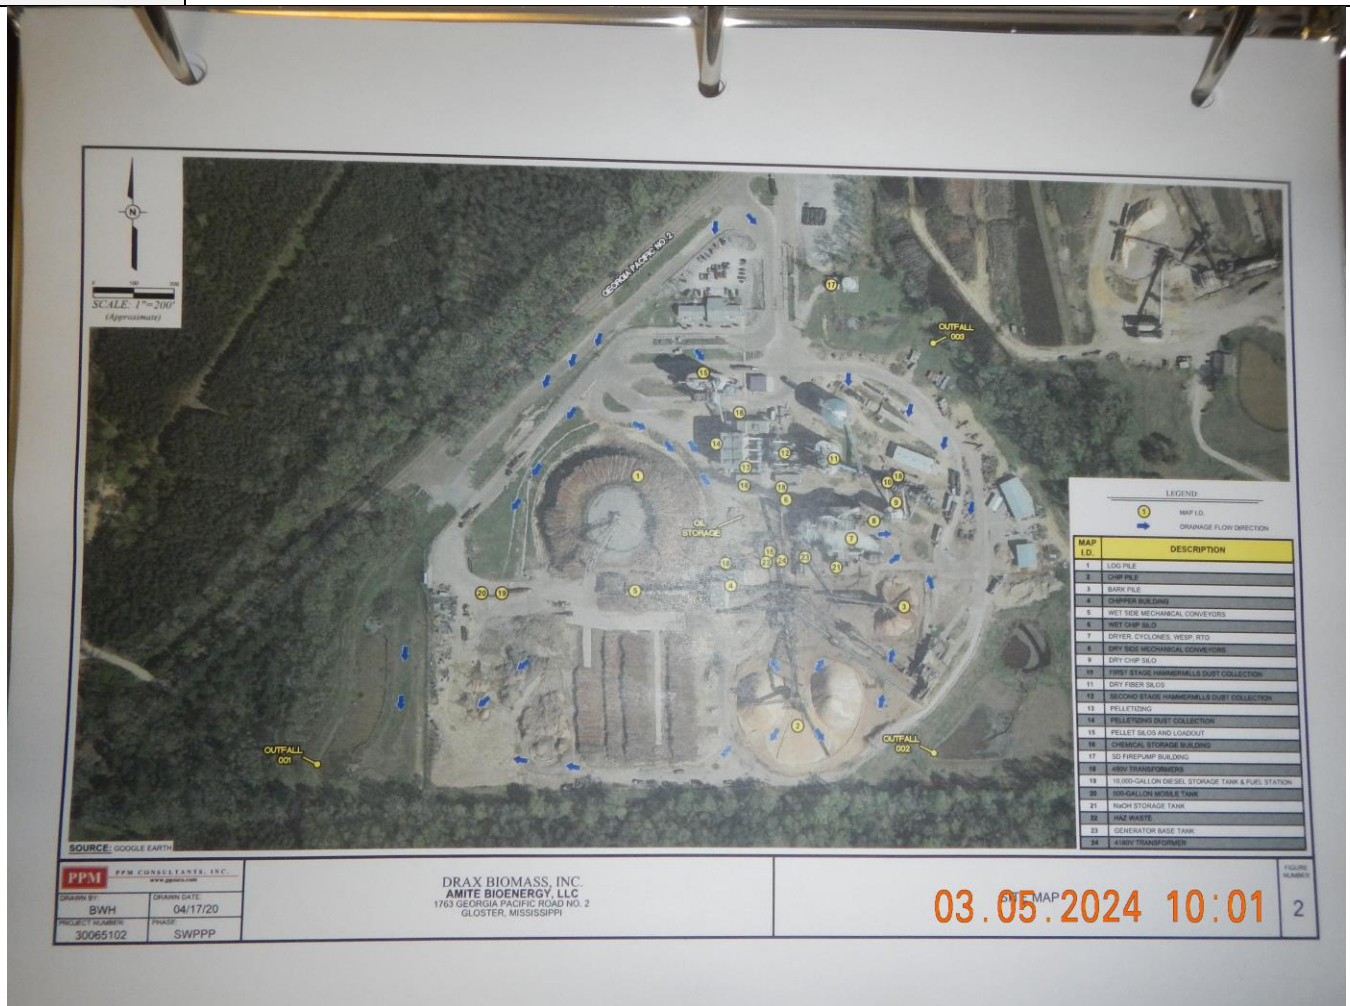
| Photo ID: | DSCN2892.JPG |

| Description: | Site map from the SWPPP, which shows three outfall locations. Outfall 004, which is no longer in use but is still covered under the 2021 permit, is not pictured. |

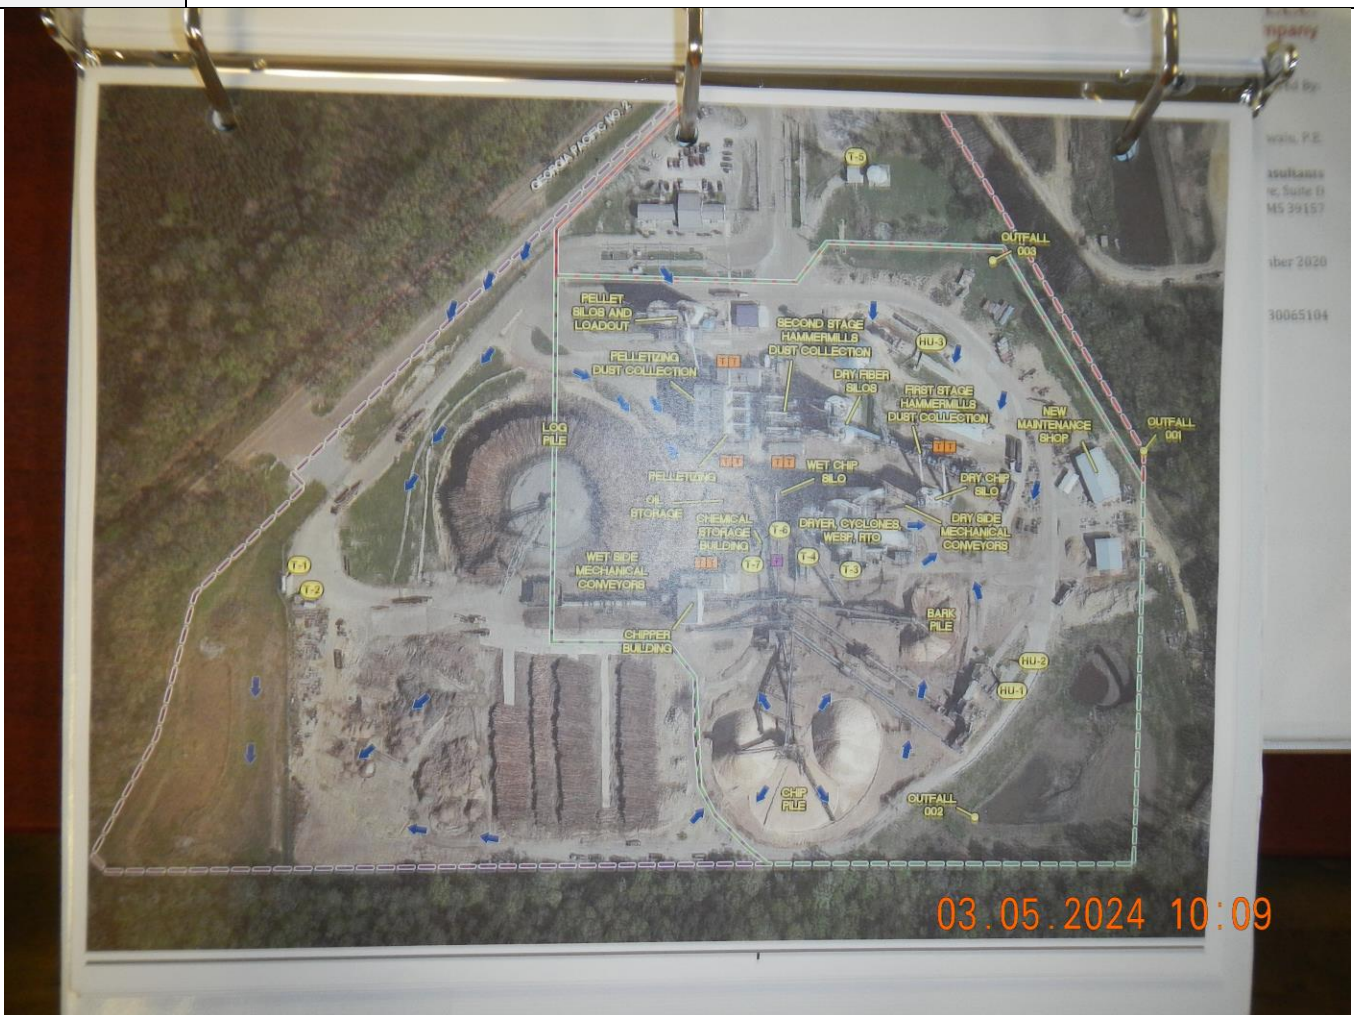
| <b>Photo ID:</b> | DSCN2893.JPG |

| <b>Description:</b> | Site map from the 2022 SPCC Plan. Outfall locations are mislabeled/inconsistent. Outfall locations in the site map shown in DSCN2892 are correct. |

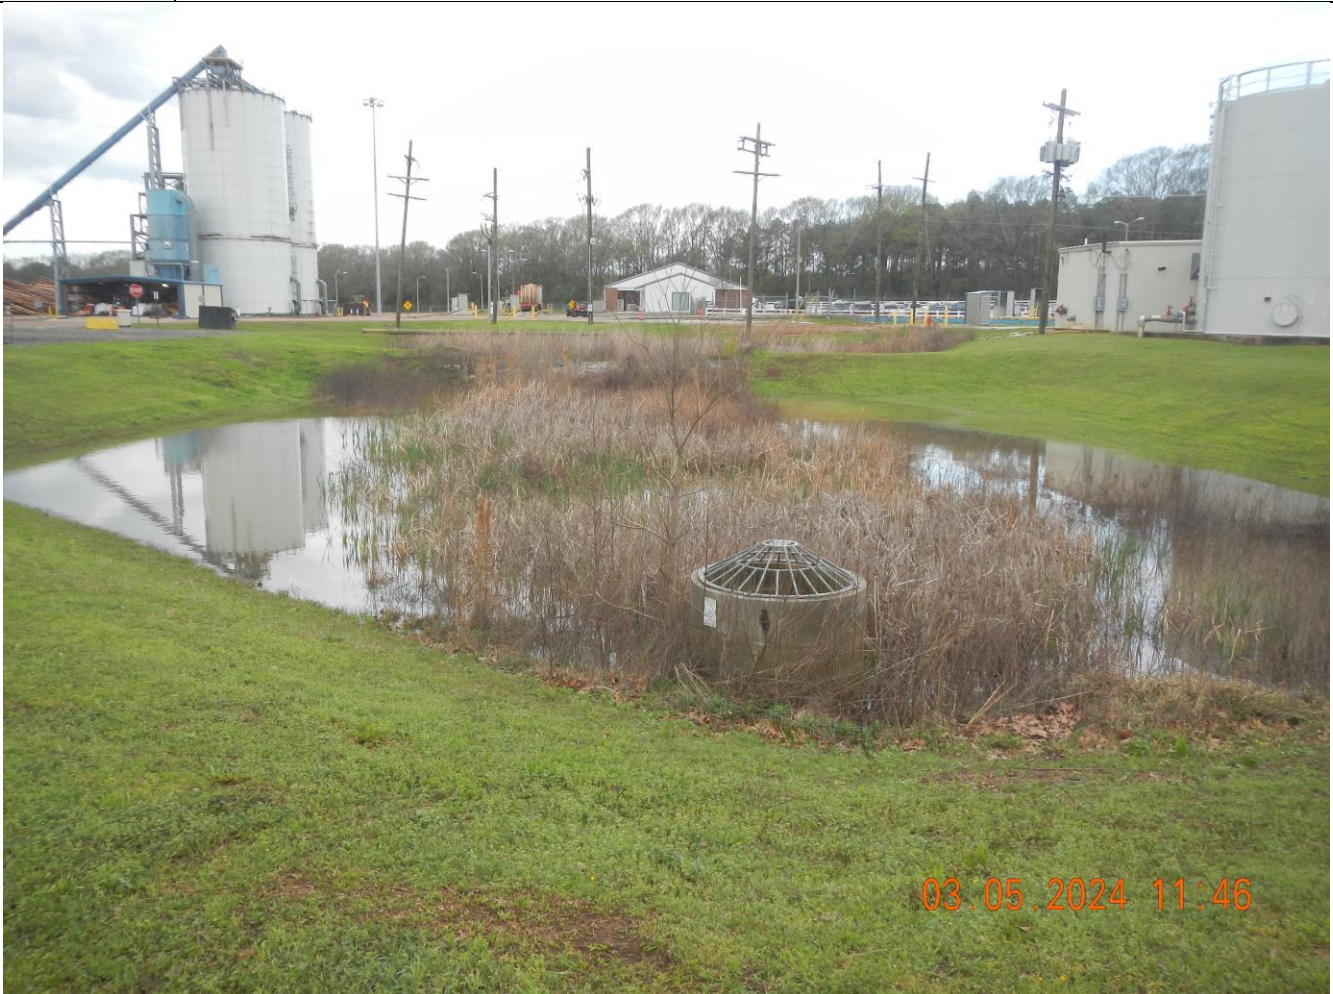
| <b>Photo ID:</b> | DSCN2894.JPG |

| <b>Description:</b> | Retention area upgradient of Outfall 003. Slopes appeared well-stabilized with vegetative cover. The outlet of this riser structure is shown in photo DSCN2895. |

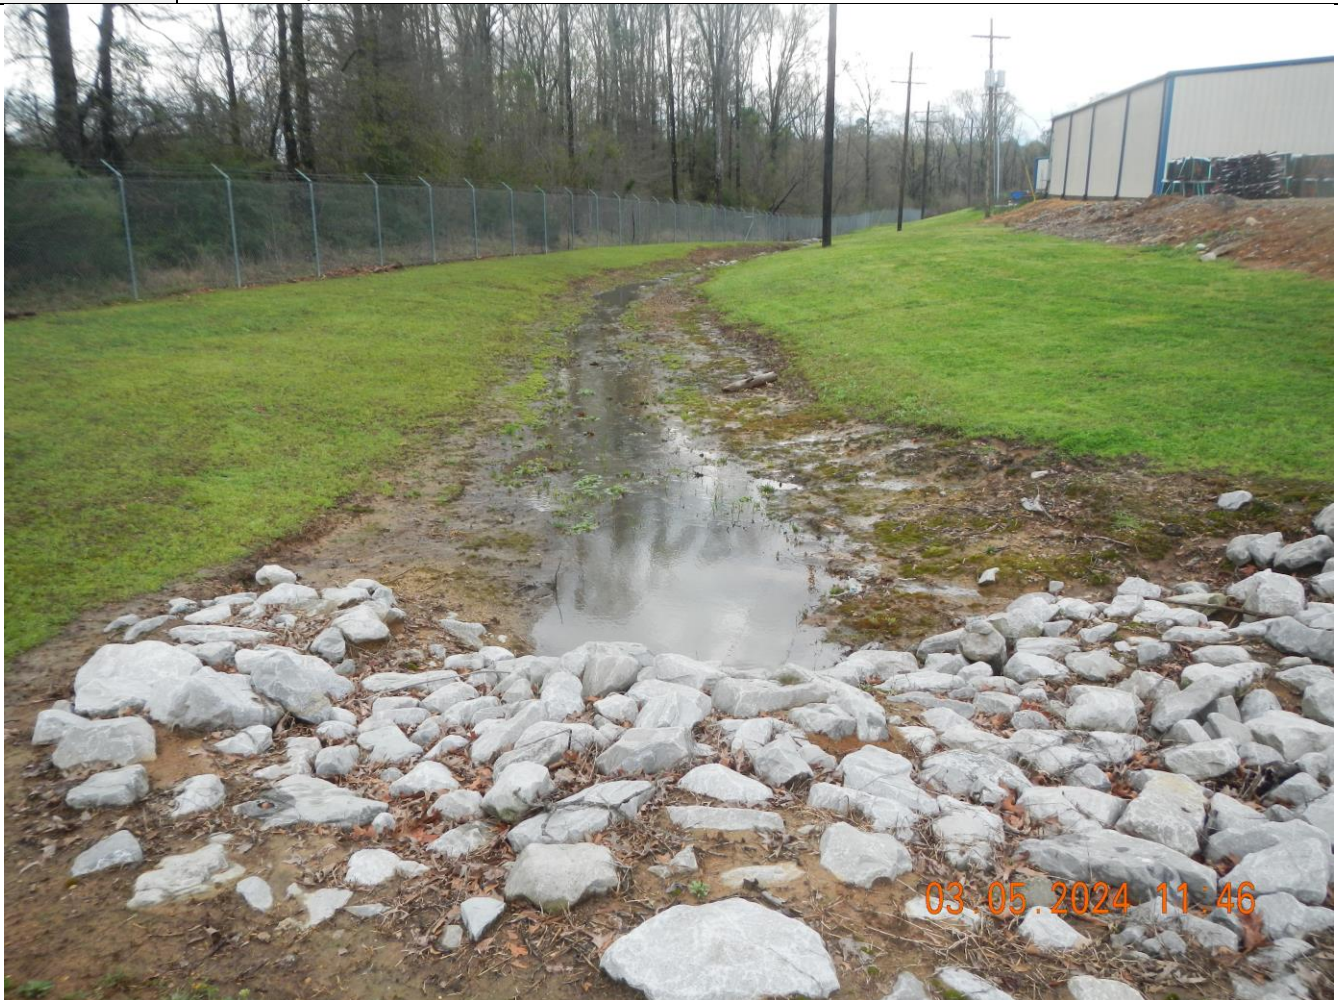
| <b>Photo ID:</b> | DSCN2895.JPG |

| <b>Description:</b> | The retention basin above Outfall 003 (see previous photo) discharges into a vegetated swale and continues in the direction shown here. Additional downgradient views of this conveyance are shown in photos DSCN2912. |

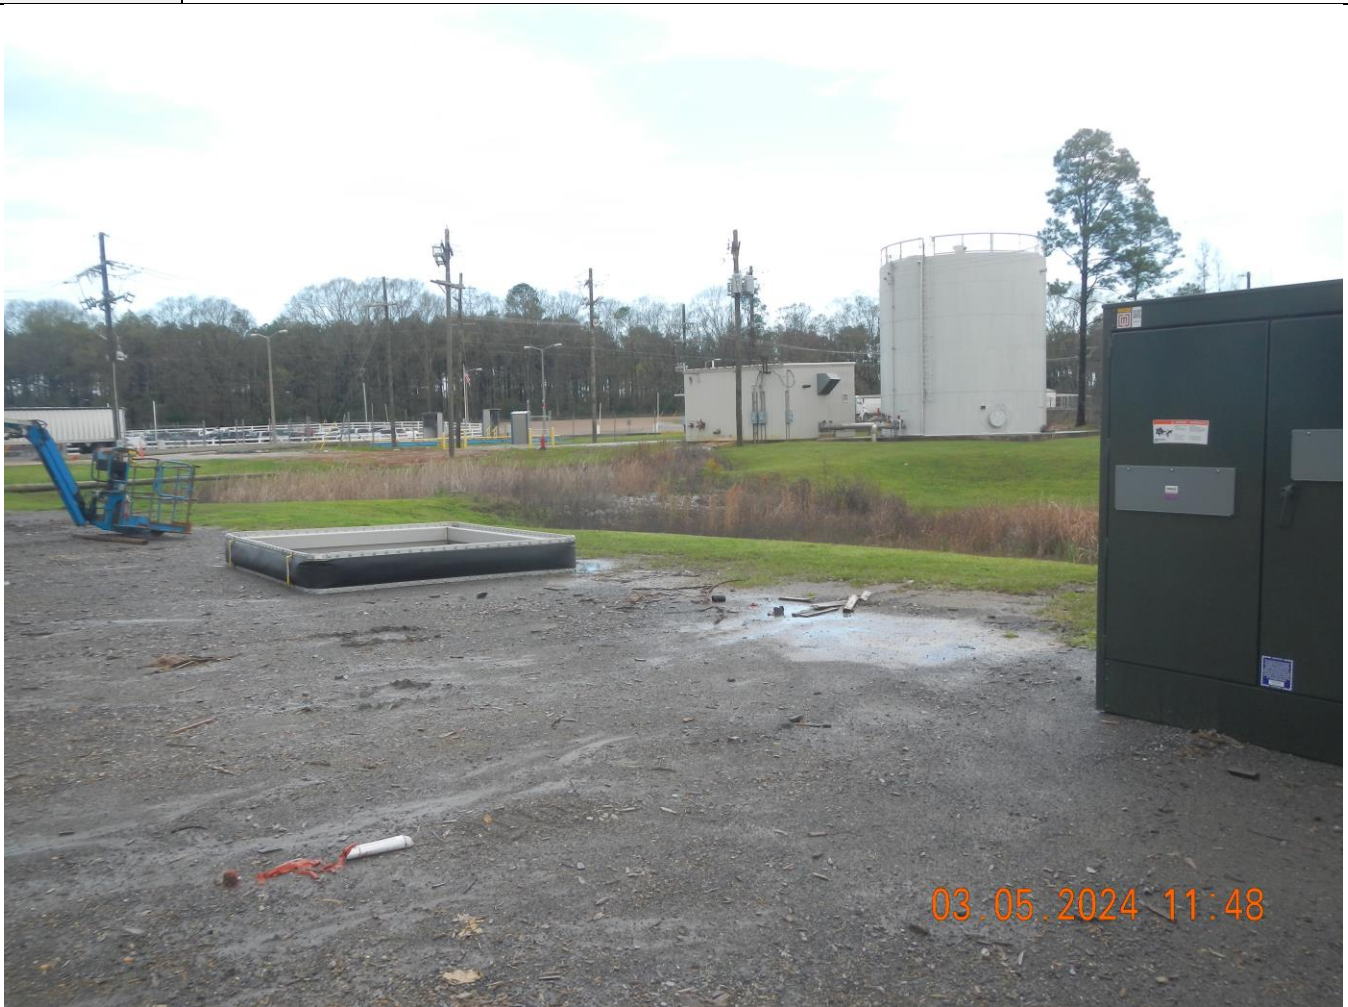
| <b>Photo ID:</b> | DSCN2896.JPG |

| <b>Description:</b> | Additional view of the retention basin of Outfall 003 with well vegetated slopes. Evidence of a minor oil sheen near center right of photo. |

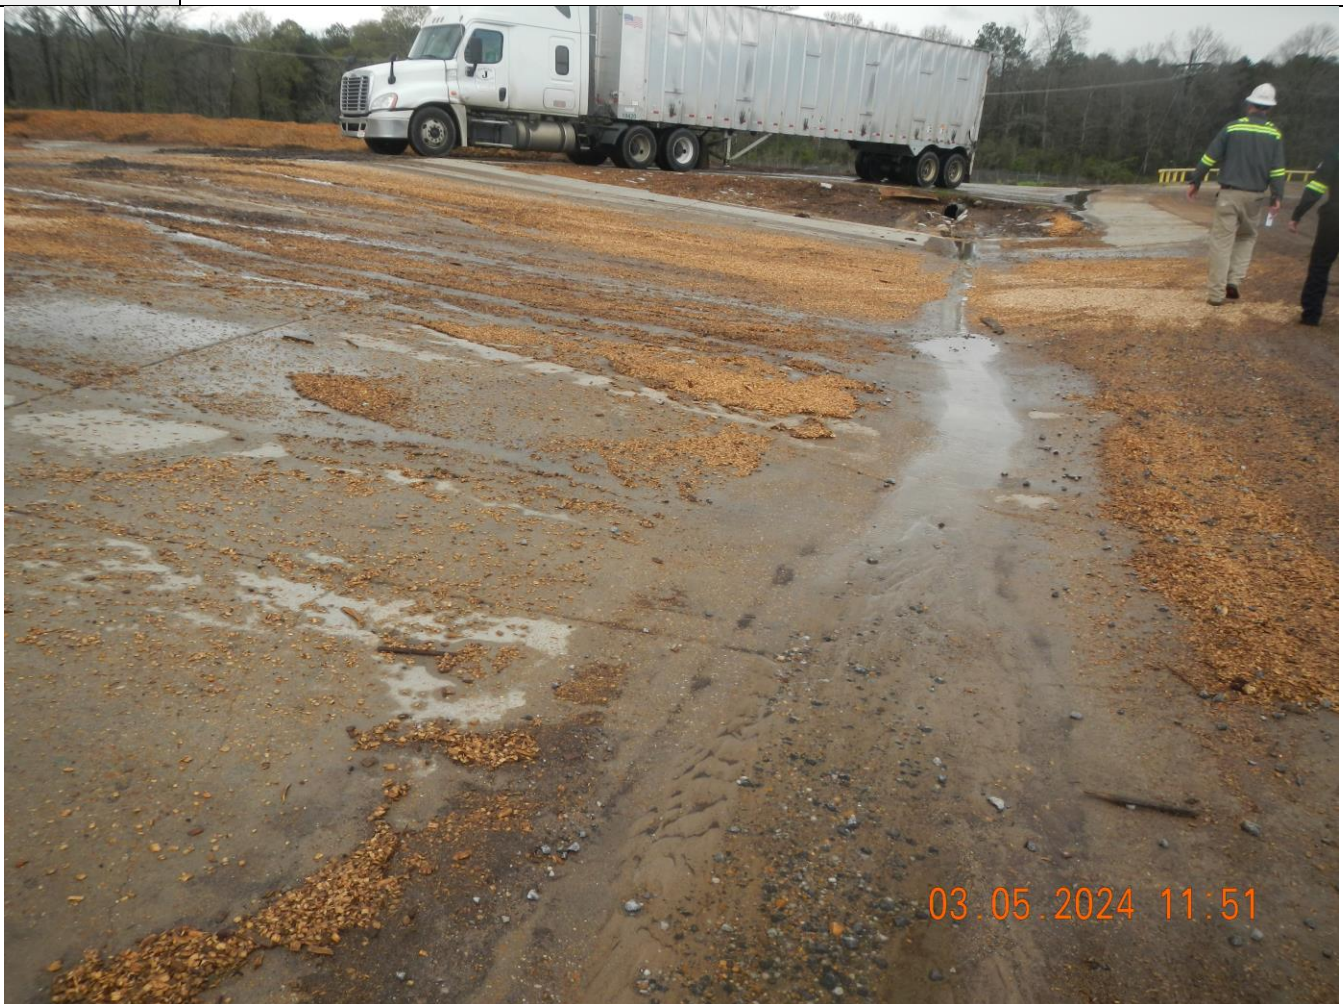
| <b>Photo ID:</b> | DSCN2897.JPG |

| <b>Description:</b> | Looking downgradient at a conveyance near the bark/chip storage and unloading areas. Conveyance discharges into the pond system at Outfall 002 as shown in photo DSCN2898. |

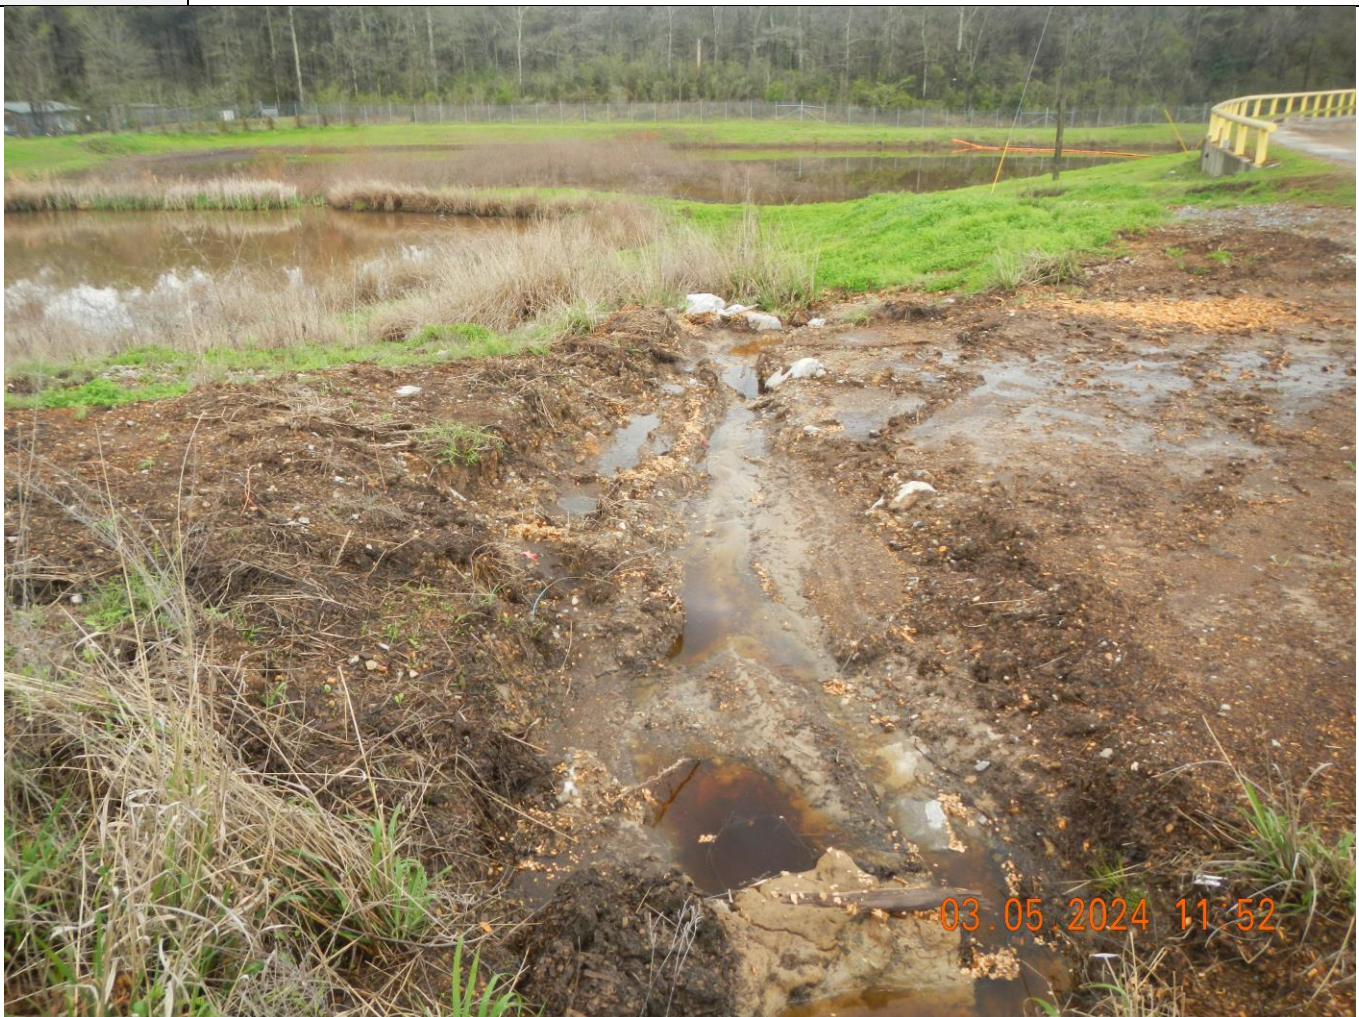
| <b>Photo ID:</b> | DSCN2898.JPG |

| <b>Description:</b> | See photo DSCN2987. View of drainage channel leading to the pond system of Outfall 002. |

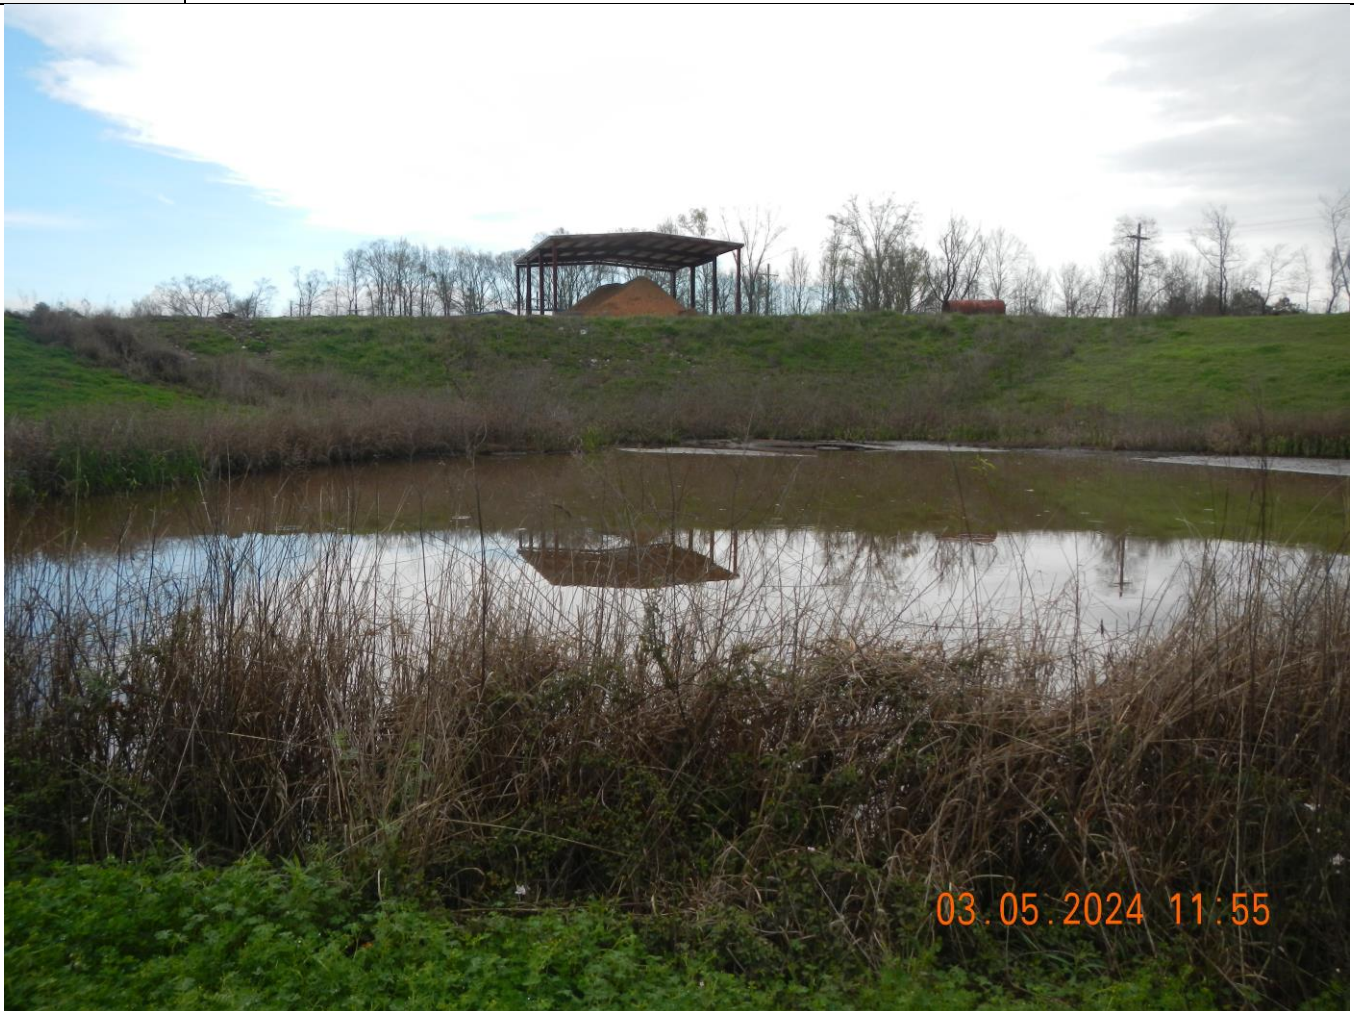
| <b>Photo ID:</b> | DSCN2899.JPG |

| <b>Description:</b> | Looking upgradient at the upper pond at Outfall 002. Stockpiles are visible in the background. |

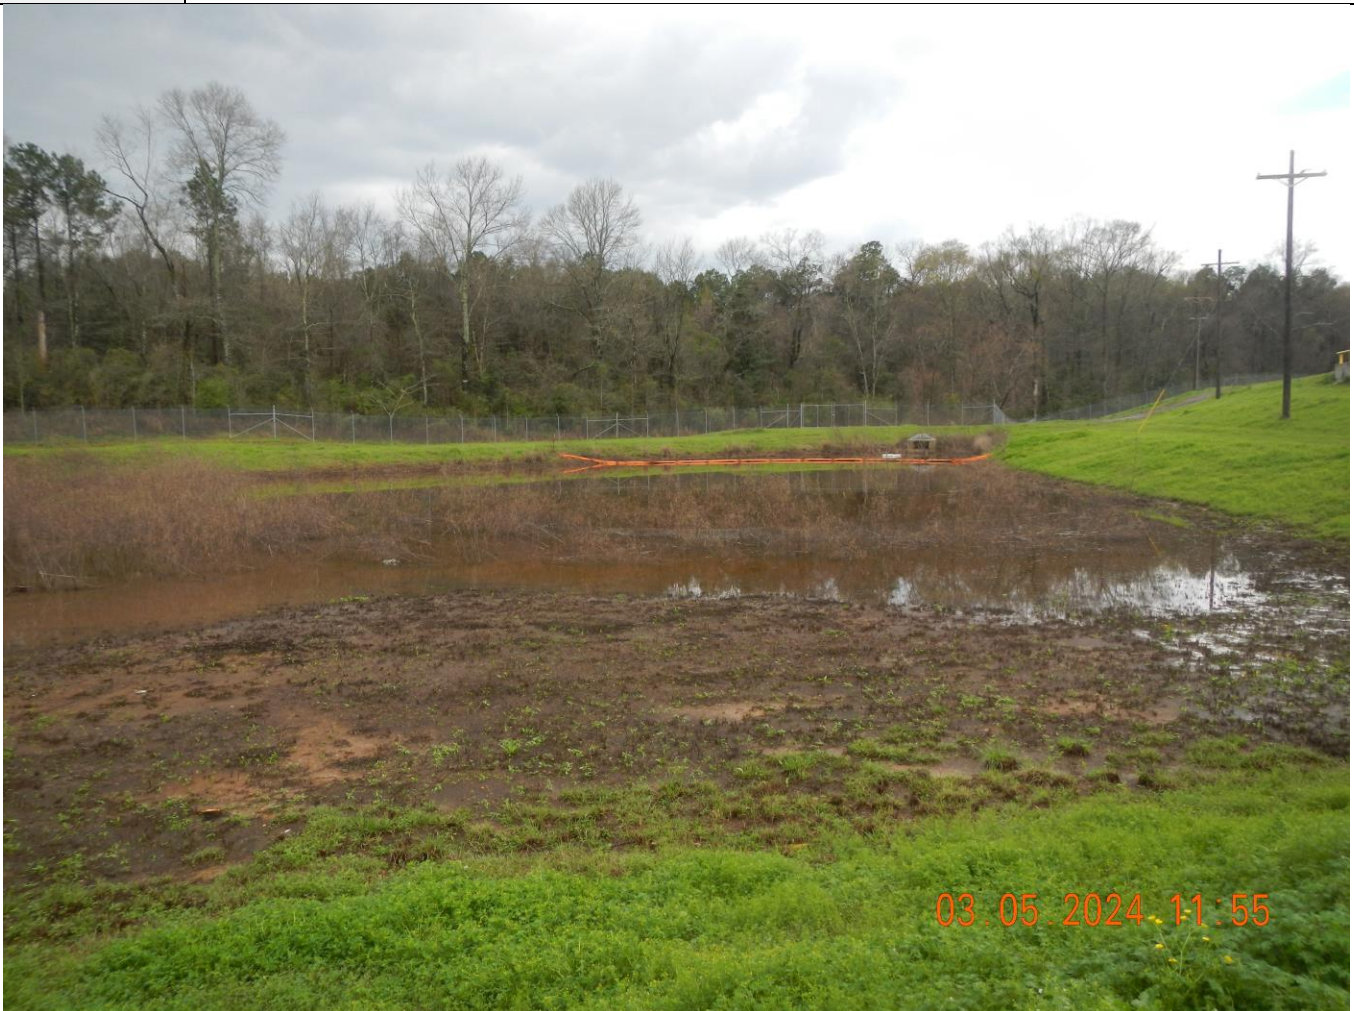
| <b>Photo ID:</b> | DSCN2900.JPG |

| <b>Description:</b> | Looking downgradient at the lower pond at Outfall 002. Baffle was installed near the outlet. A closer view of the pond's riser structure is shown in photo DSCN2901. |

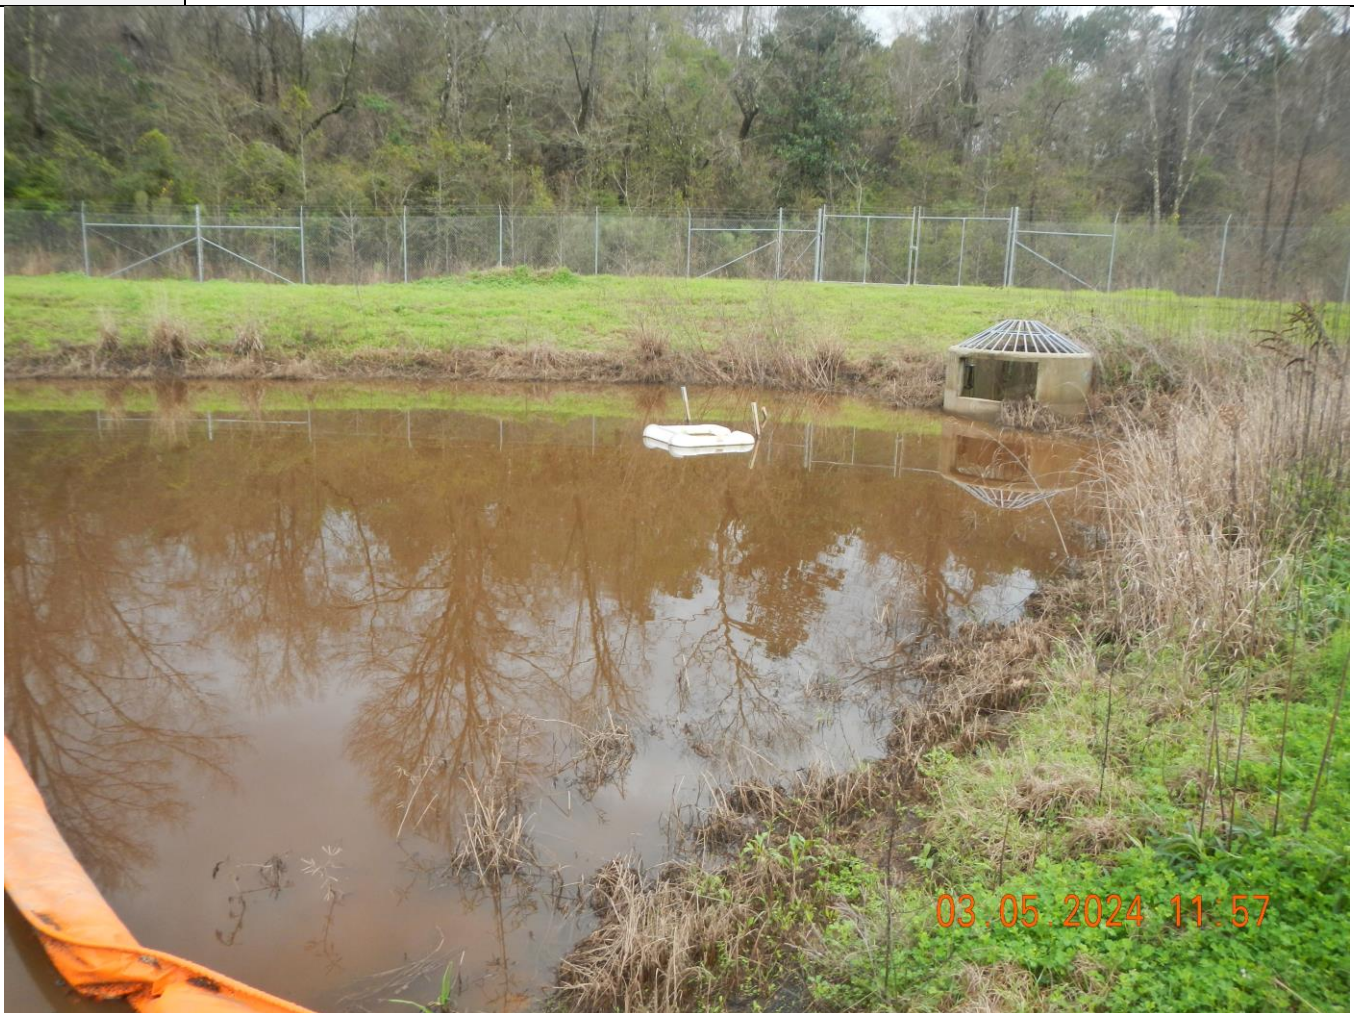
| <b>Photo ID:</b> | DSCN2901.JPG |

| <b>Description:</b> | Outlet structure of Pond #2 was equipped with a floating surface skimmer and an upstream baffle. Outfall 002 is shown in photos DSCN2902-2903. |

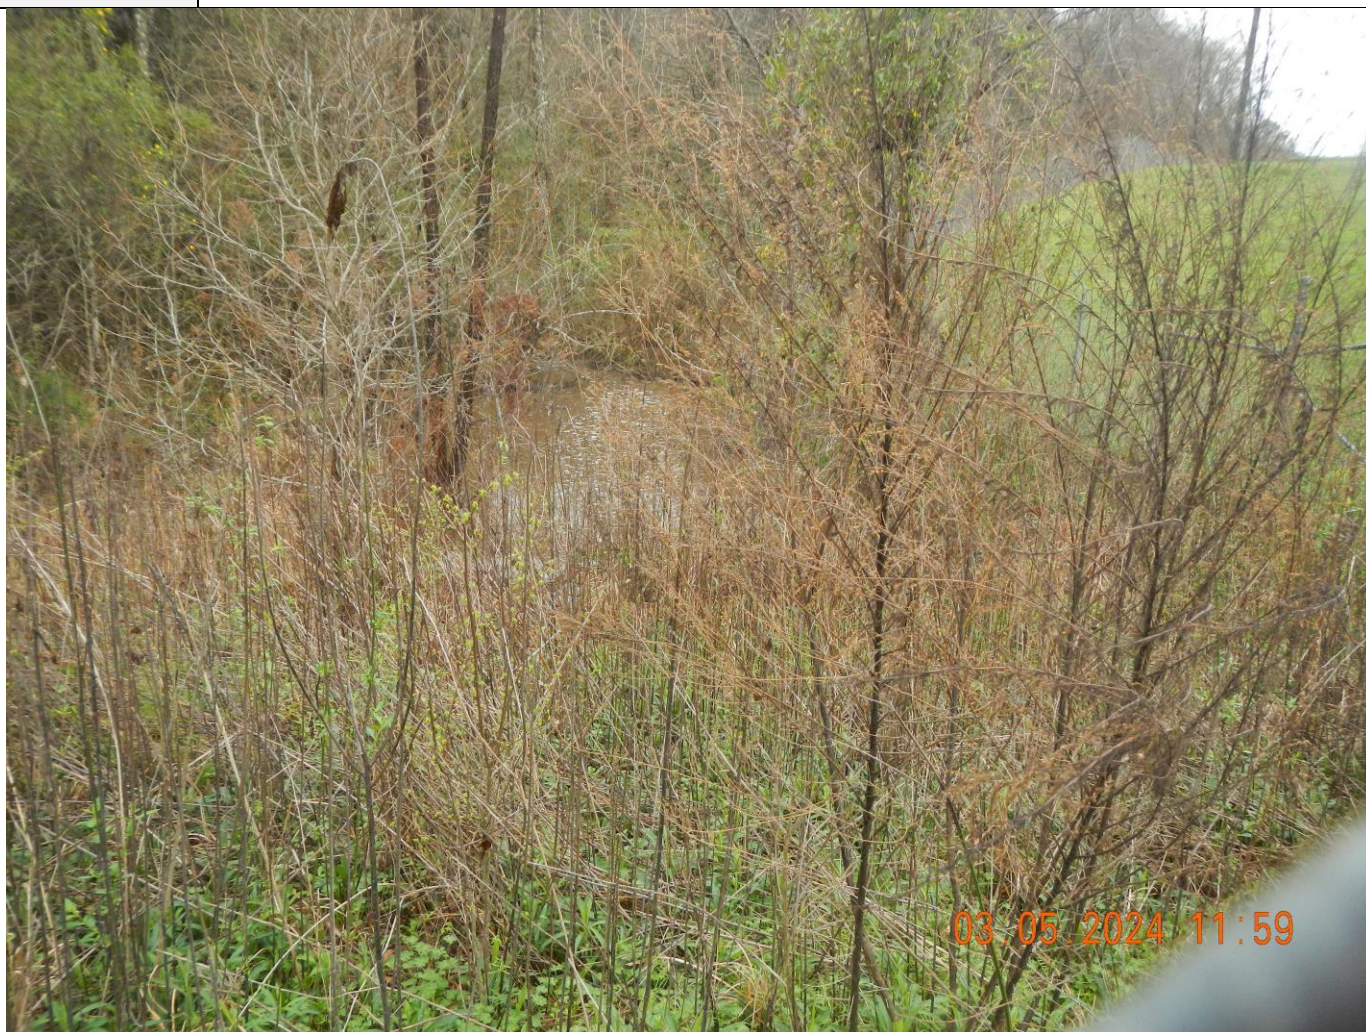
| <b>Photo ID:</b> | DSCN2902.JPG |

| <b>Description:</b> | Looking downgradient at Outfall 002. See also photo DSCN2903. |

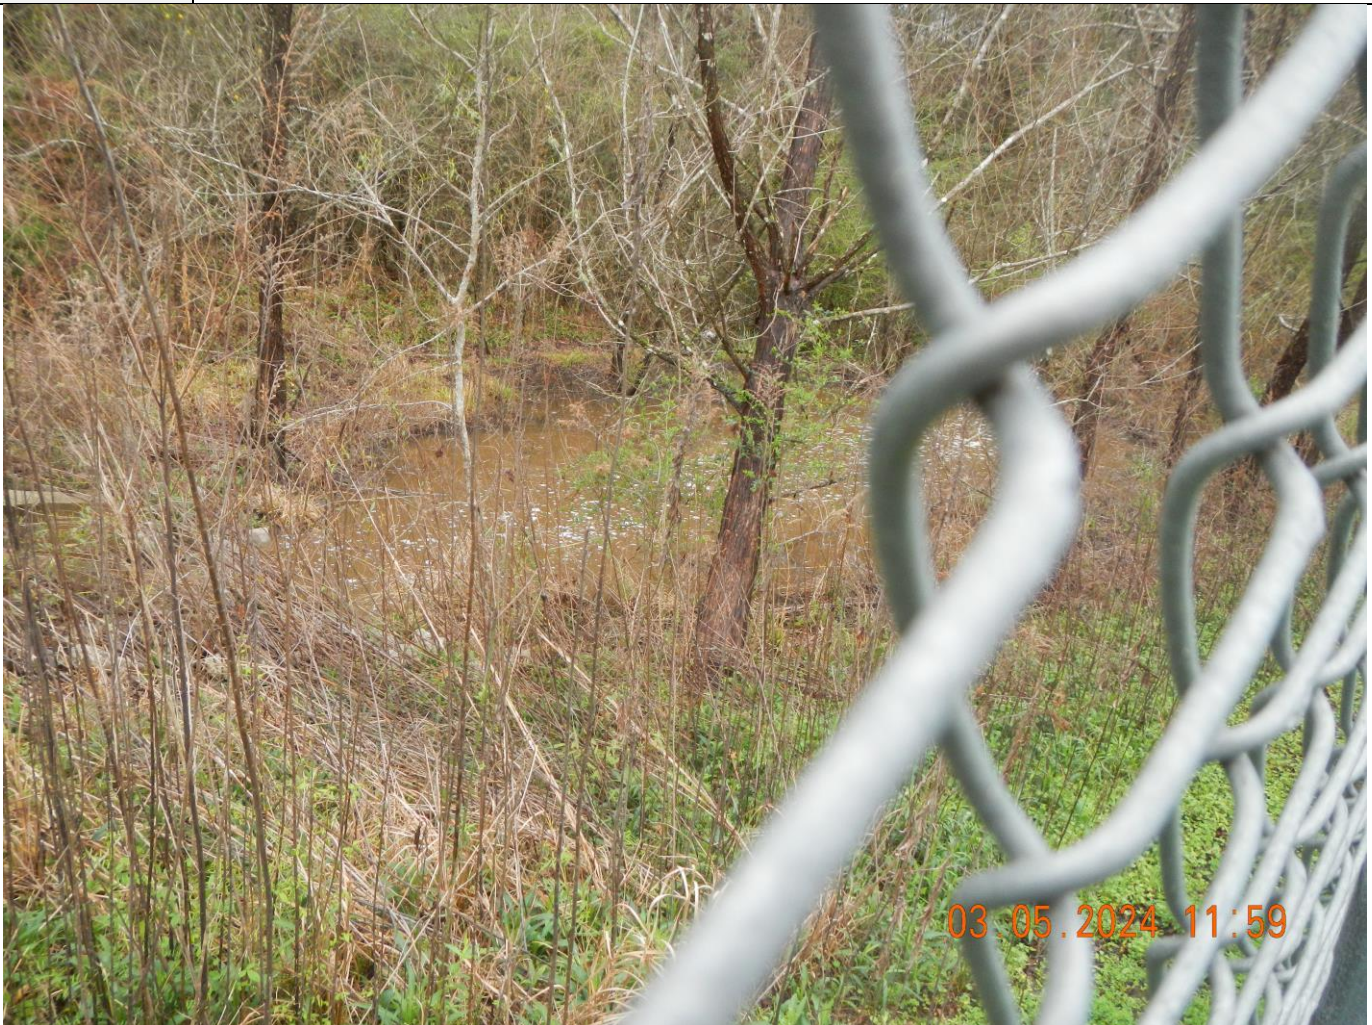
| <b>Photo ID:</b> | DSCN2903.JPG |

| <b>Description:</b> | Additional view of Outfall 002. Outlet pipe is visible in the leftmost side of the photo. Water travels from photographer's left to right. |

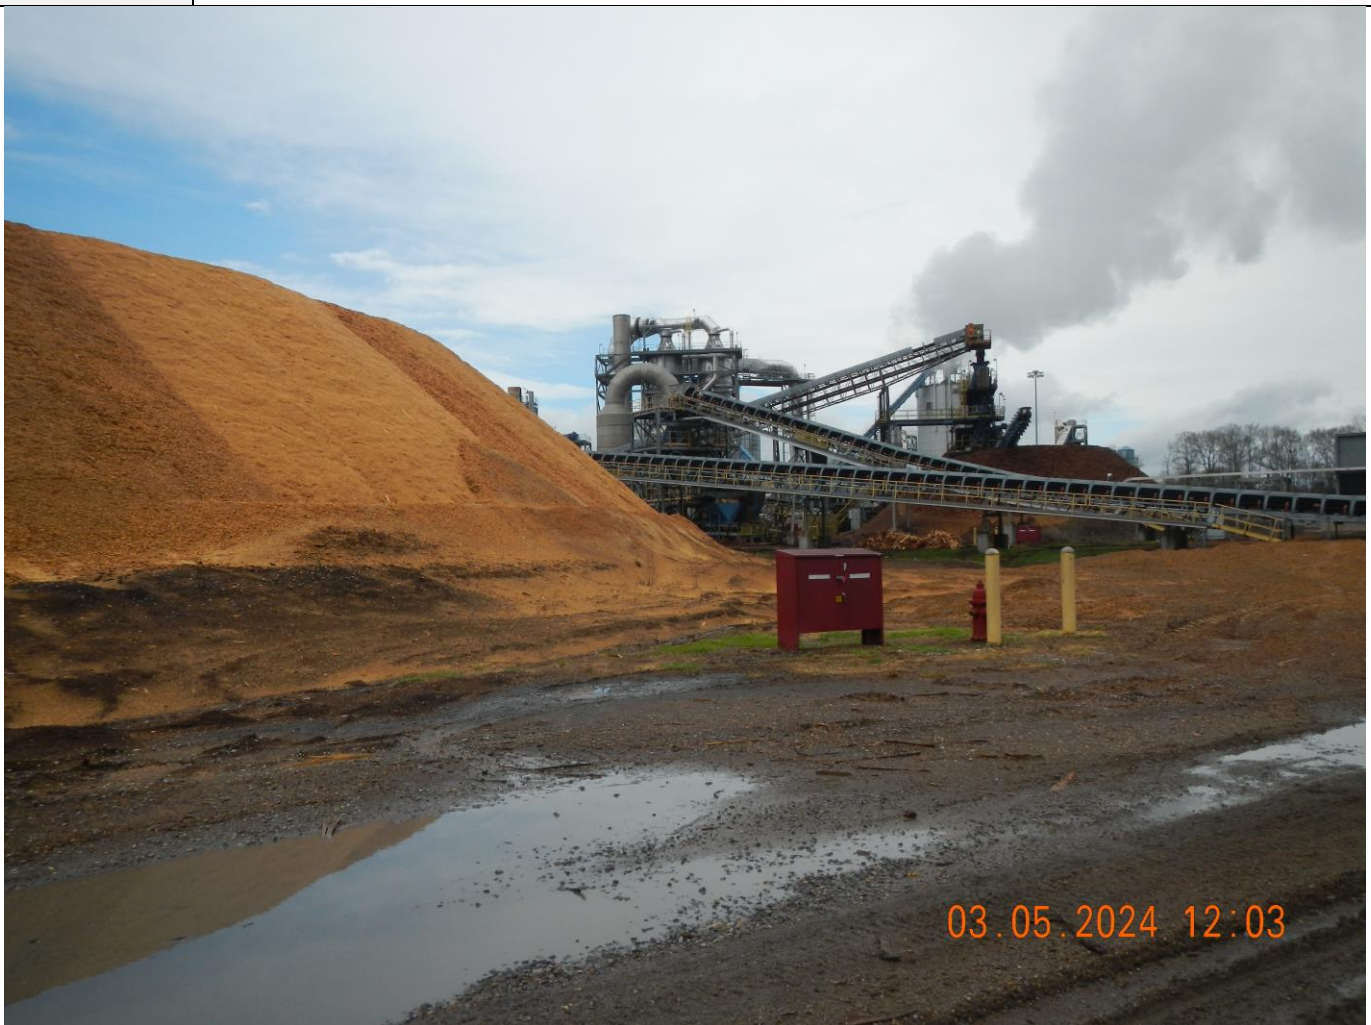
| <b>Photo ID:</b> | DSCN2904.JPG |

| <b>Description:</b> | View of chip storage pile |

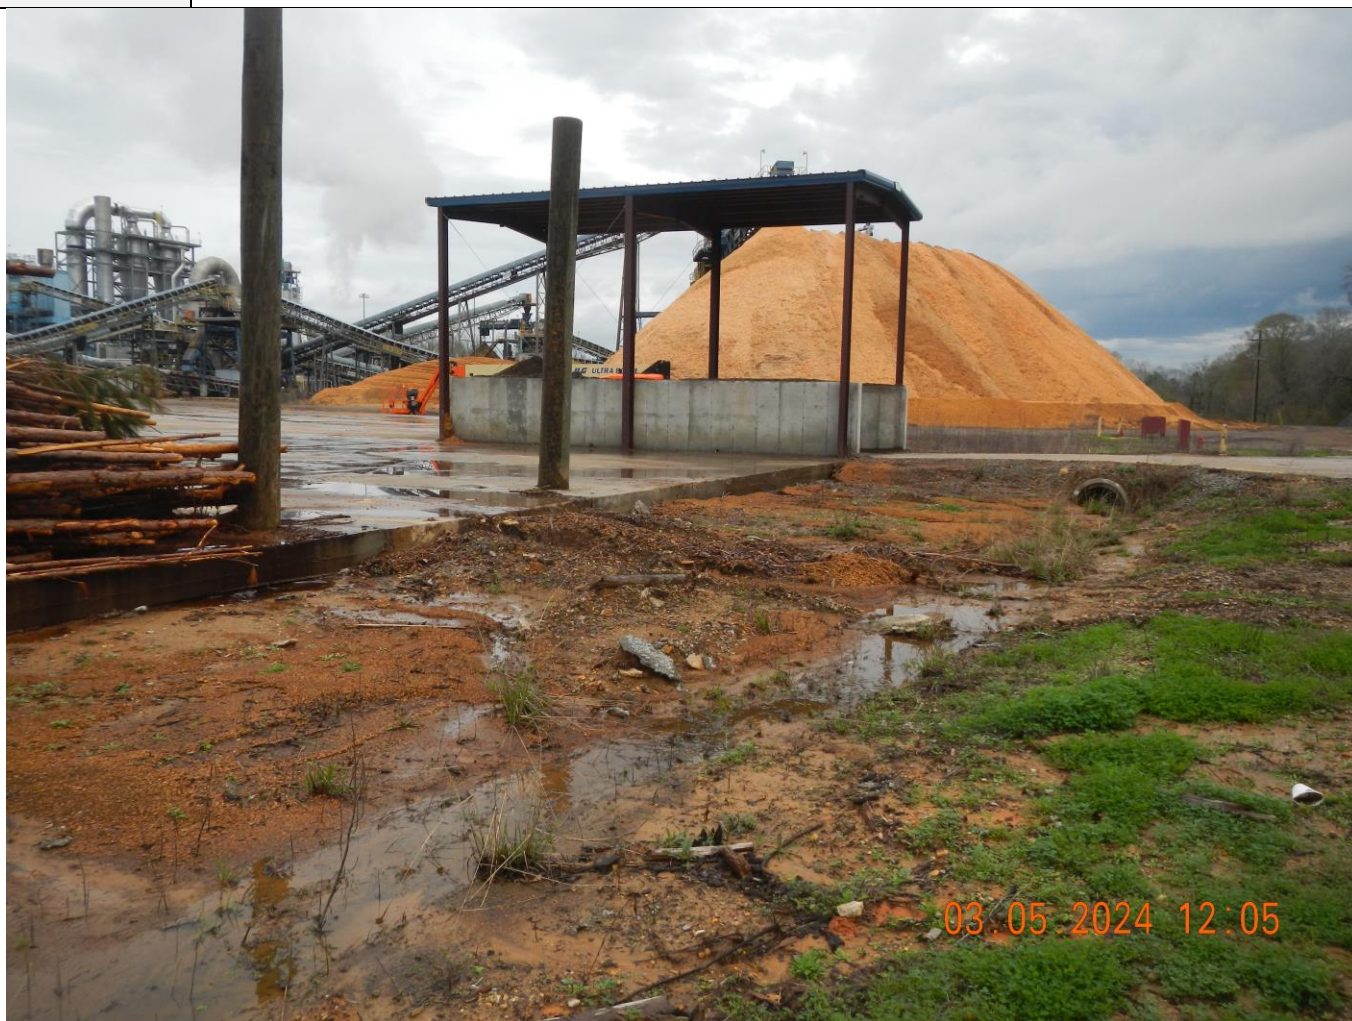
| <b>Photo ID:</b> | DSCN2905.JPG |

| <b>Description:</b> | Conveyance at the downgradient end of the log storage area. Collected water is conveyed in the direction shown into the retention pond system. |

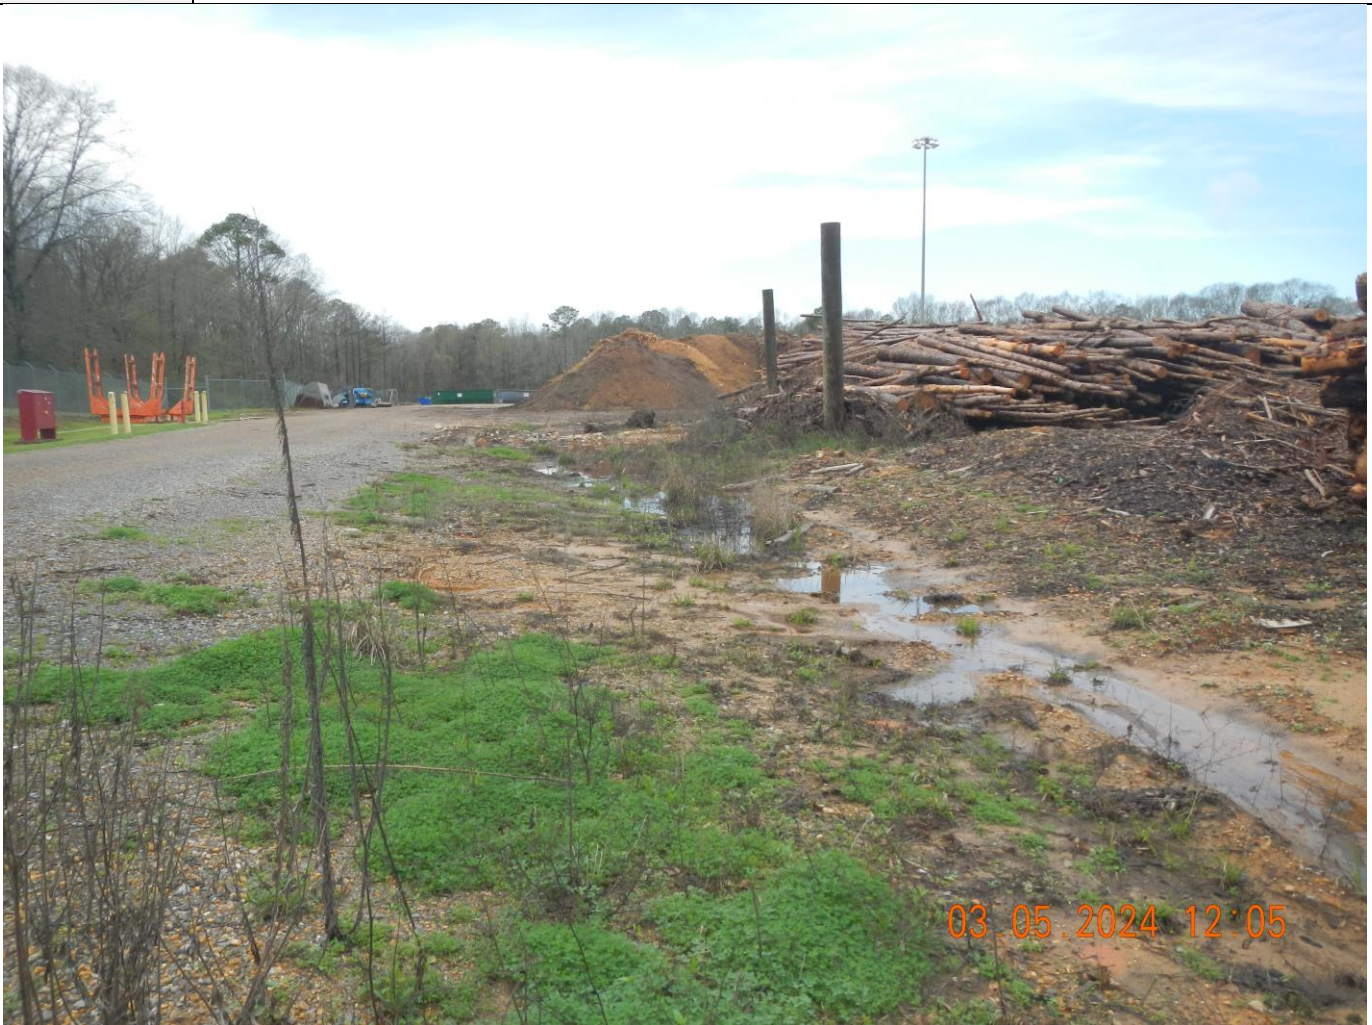
| <b>Photo ID:</b> | DSCN2906.JPG |

| <b>Description:</b> | Additional view of the drainage channel shown in photo DSCN2905 by the log storage area. The site is graded such that runoff does not discharge offsite at the back of the property. |

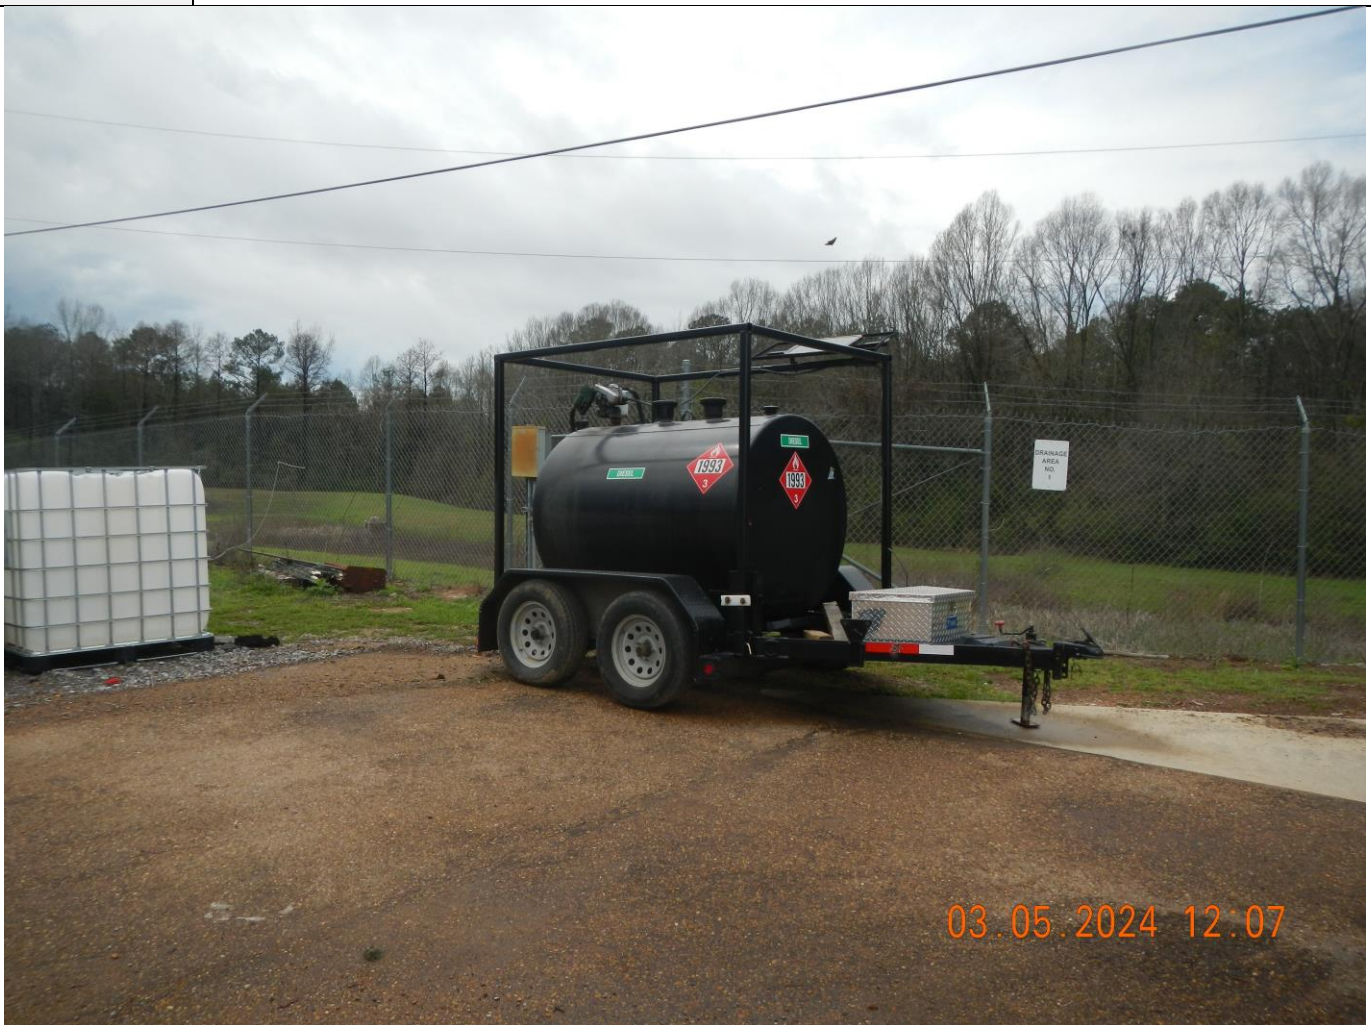
| <b>Photo ID:</b> | DSCN2907.JPG |

| <b>Description:</b> | 500 gallon mobile diesel fuel tank, consistent with SPCC |
